HARBOUR TOWN GOLF LINKS 18TH GREEN SHORELINE RESTORATION AND MARSH RESTORATION PROJECT

Chris Creed, P.E.
olsen associates, inc.
Jacksonville, Florida
c Creed@olsen-associates.com

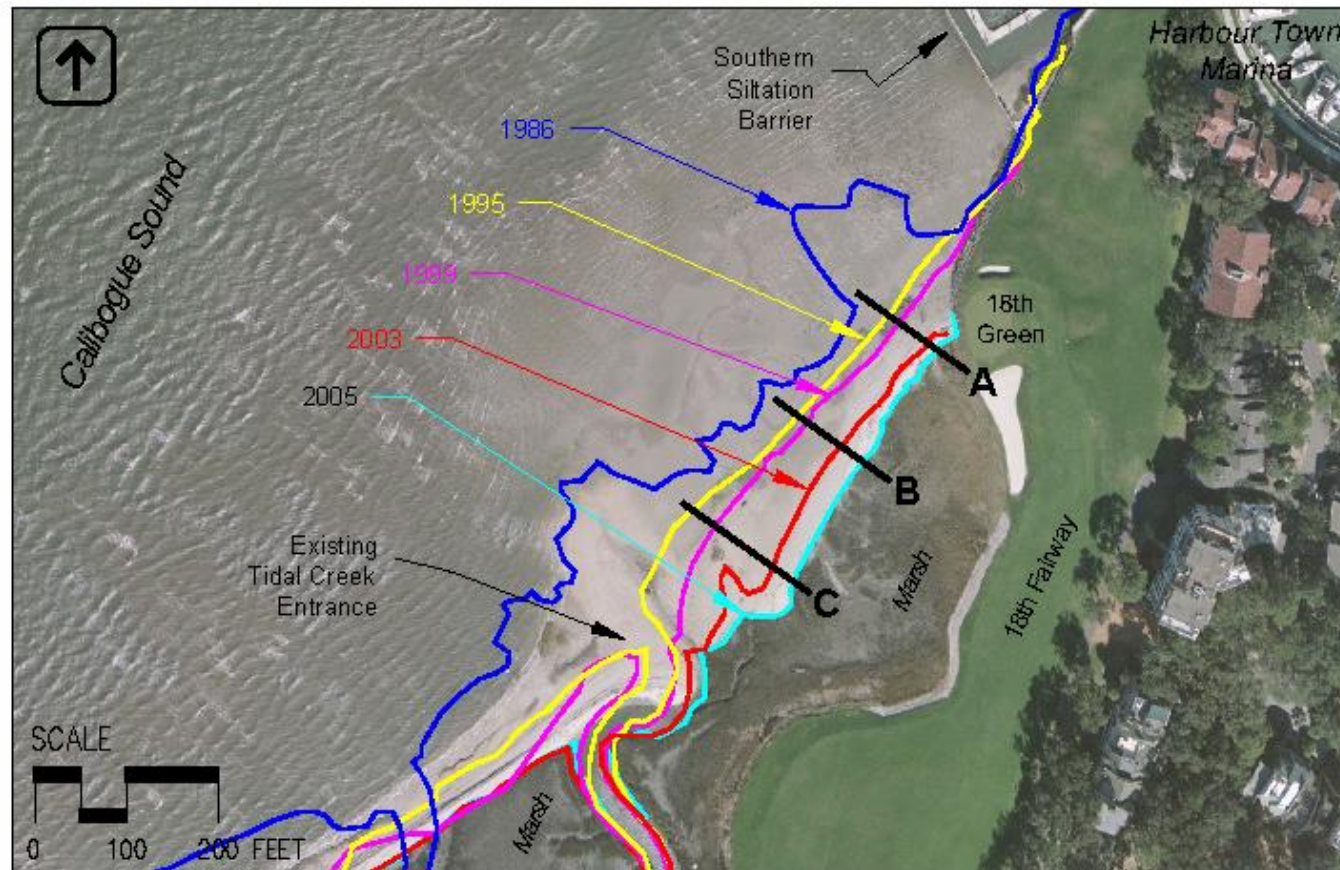
Date of Photography: January 2005

Representative Dates for Shoreline Locations		Time (yrs)	Recession Rate (ft/yr)			
			Transect A	Transect B	Transect C	Average
Jan-95	Jan-99	4.0	-3.6	-3.1	-7.5	-4.7
Jan-99	Dec-03	4.9	-7.5	-9.2	-13.8	-10.2
Dec-03	Jan-05	1.1	-13.7	-27.0	-34.0	-24.9
Average			-8.2	-13.1	-18.5	-13.3

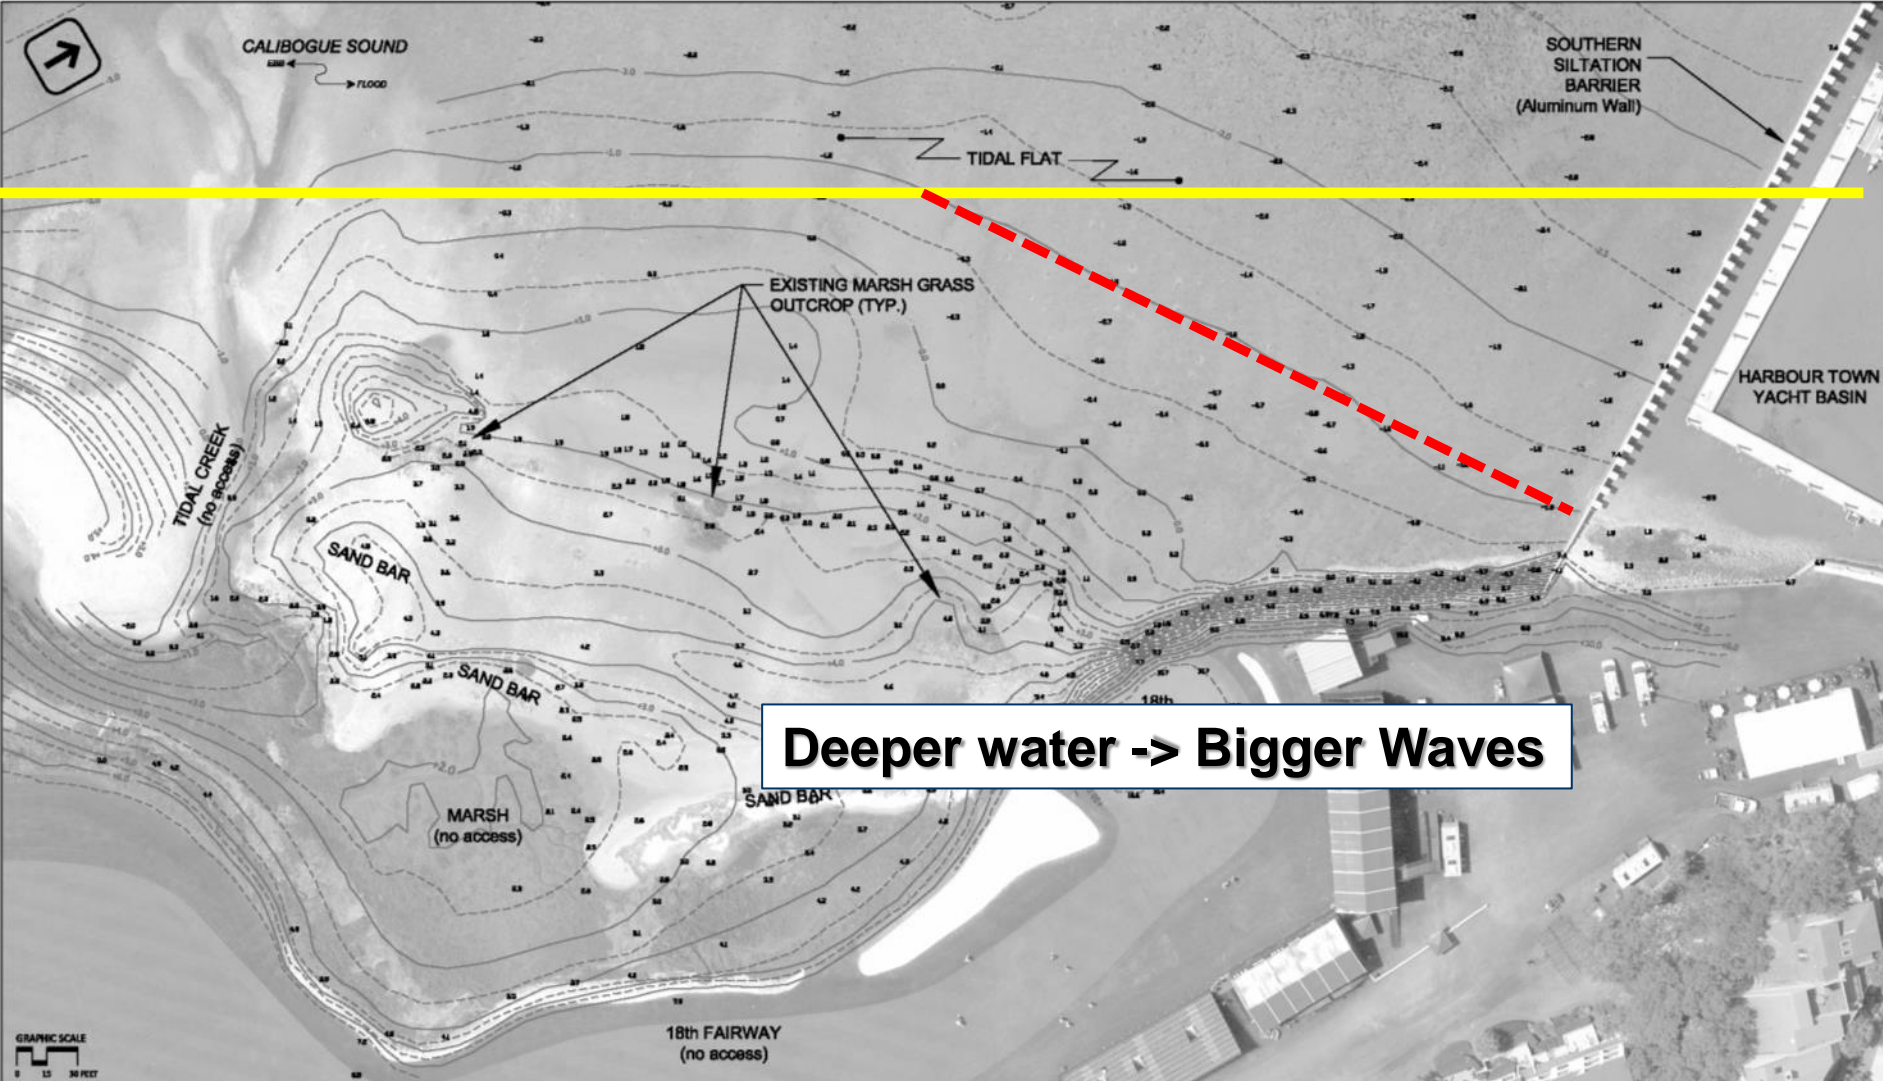
Deeper water -> Bigger Waves

Sea Floor Deepening Seaward of Marsh

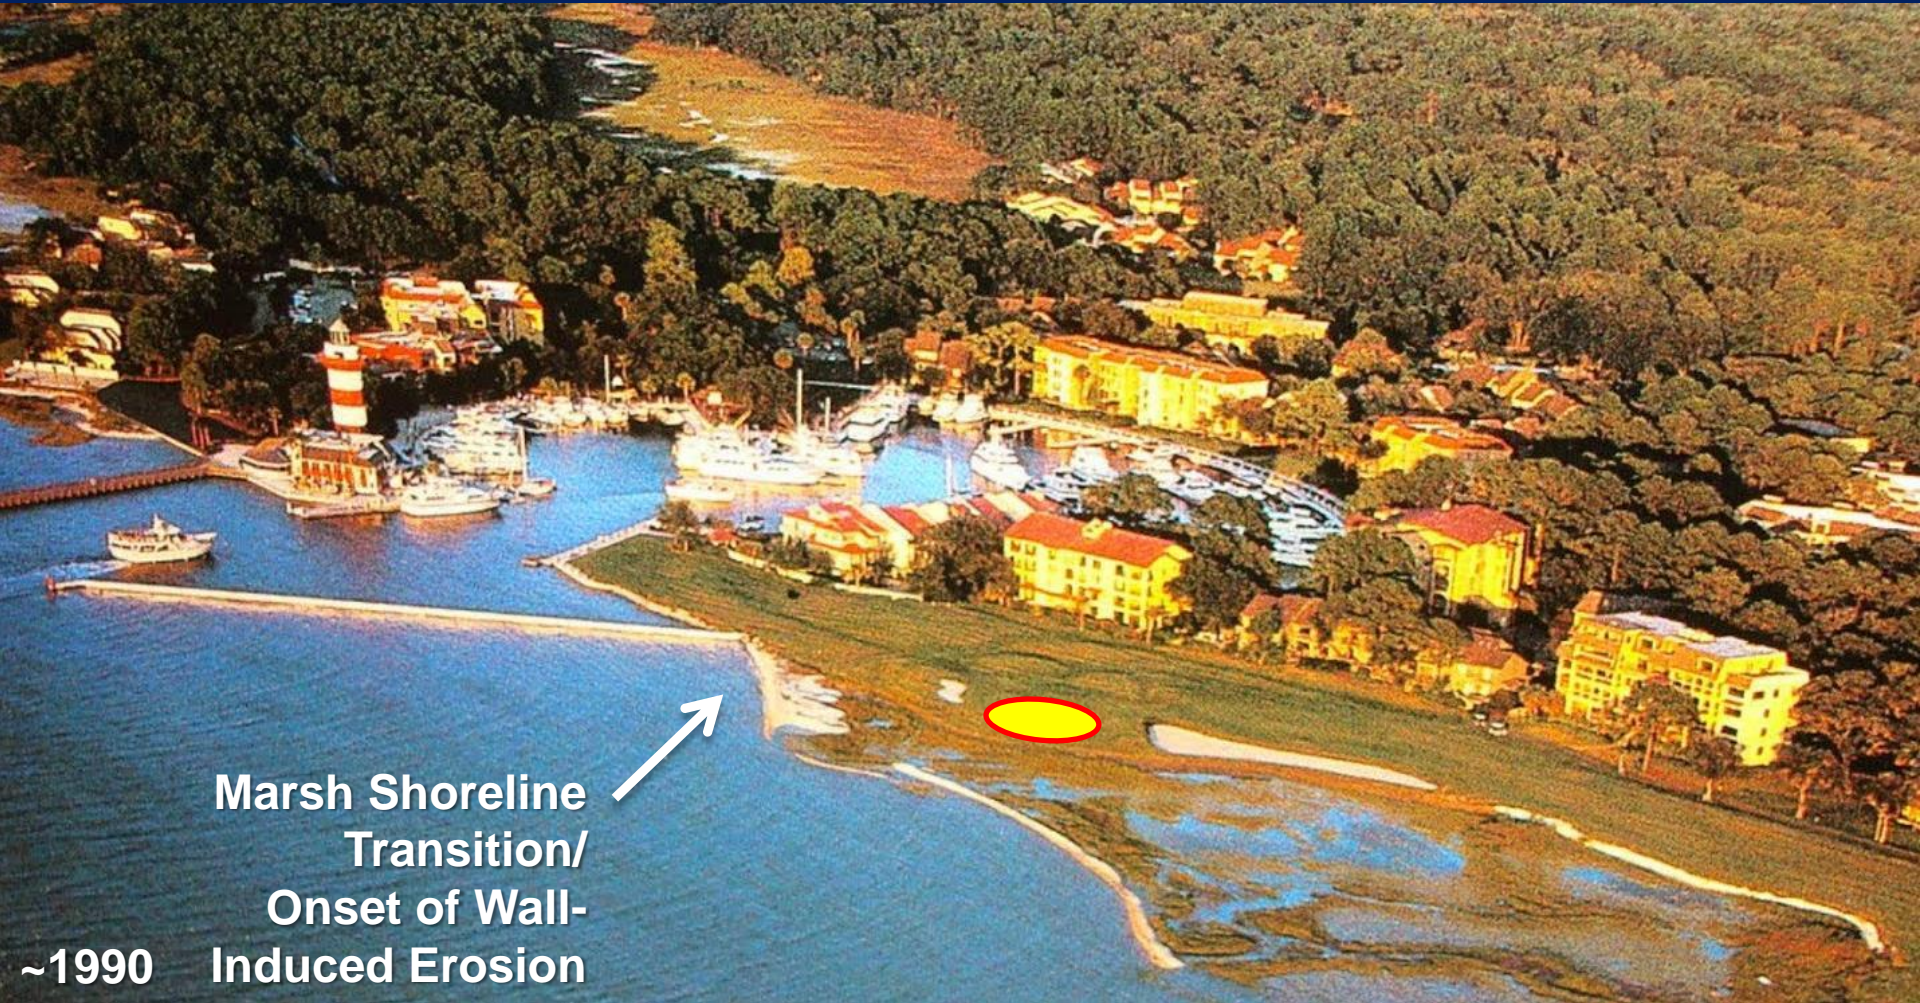
~1990

Marsh Shoreline
Transition/
Onset of Wall-
Induced Erosion

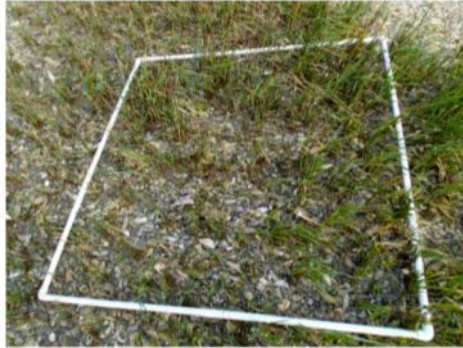
Quadrant # 7
contained accreted oyster shells
within existing Spartina density of 50%

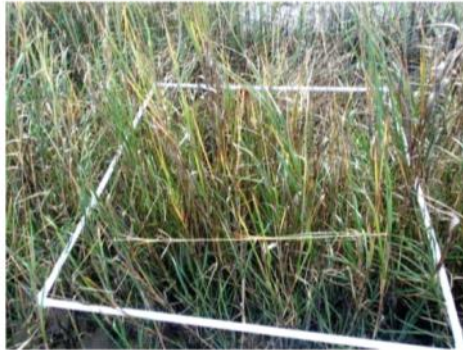
Quadrant # 8
contained marsh periwinkles
within planted Spartina density of 100%

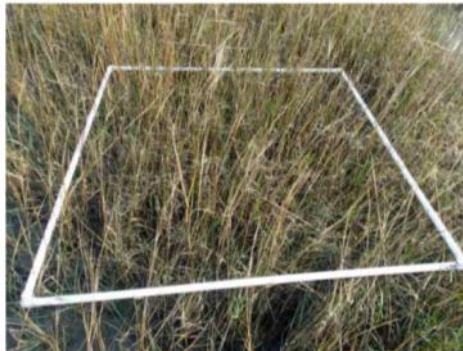
Quadrant # 9
contained marsh periwinkles within
existing Spartina density of 100%
