HURRICANE IRMA IMPACTS TO SOUTHWEST FLORIDA LEE – CHARLOTTE BARRIERS NOVEMBER 6, 2017

CHARLOTTE BARRIERS

MANASOTA KEY POST-IRMA CONDITIONS

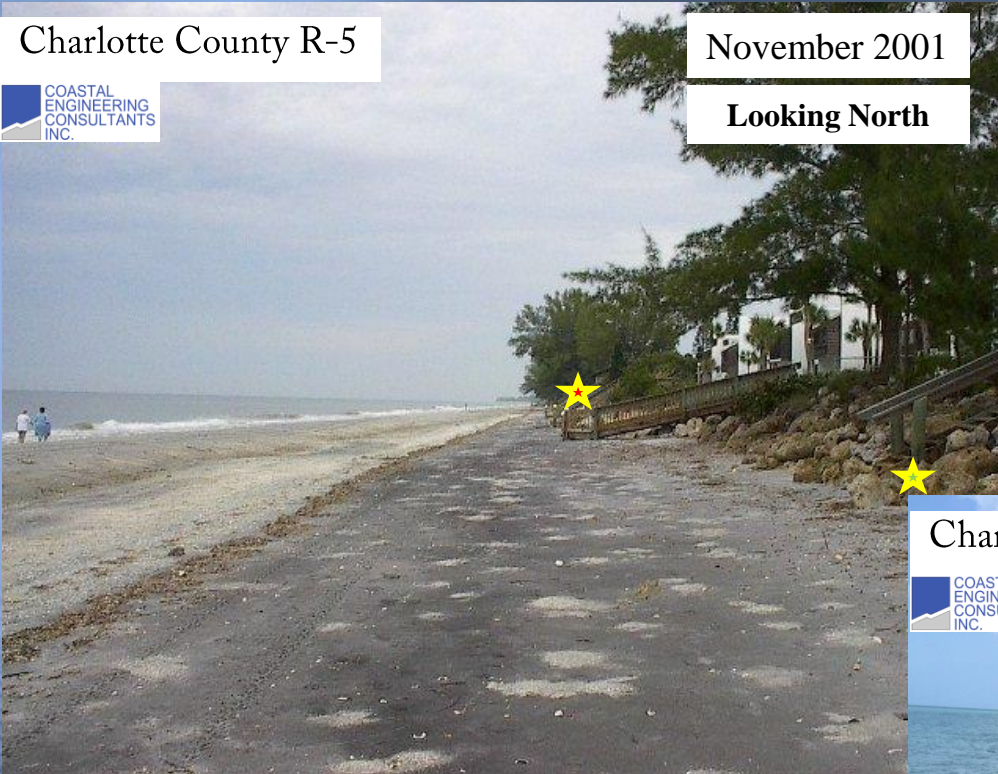
Charlotte County R-5

2001 Beach
Erosion Study
Conditions

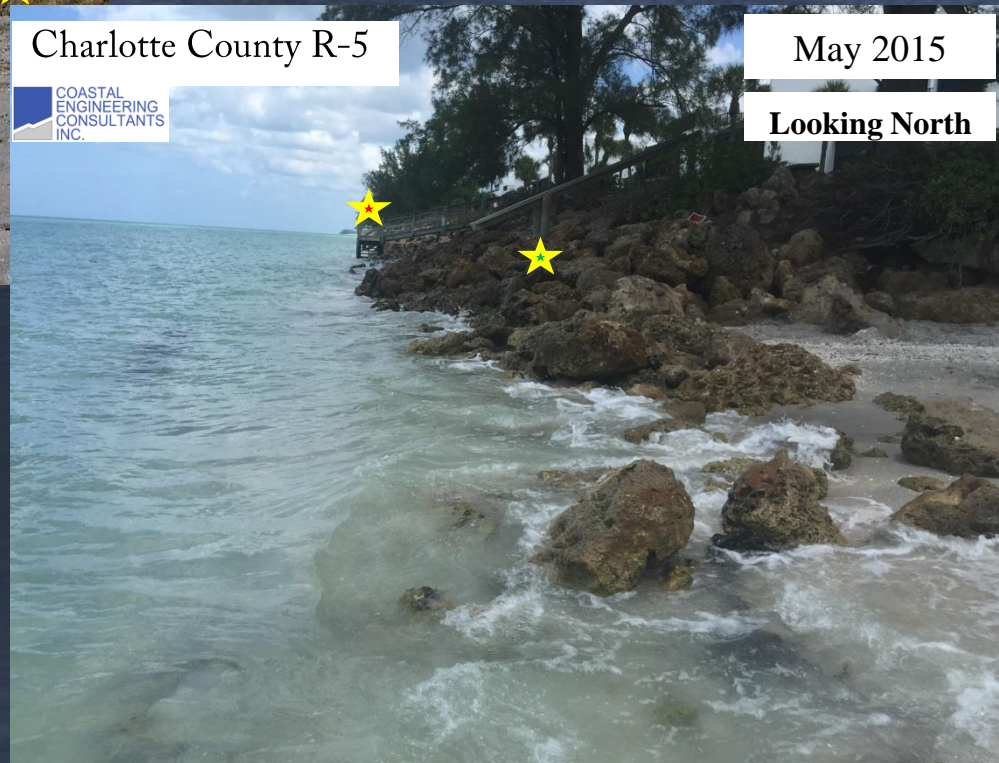
Charlotte County R-5

2015 Beach
Erosion Update
Conditions

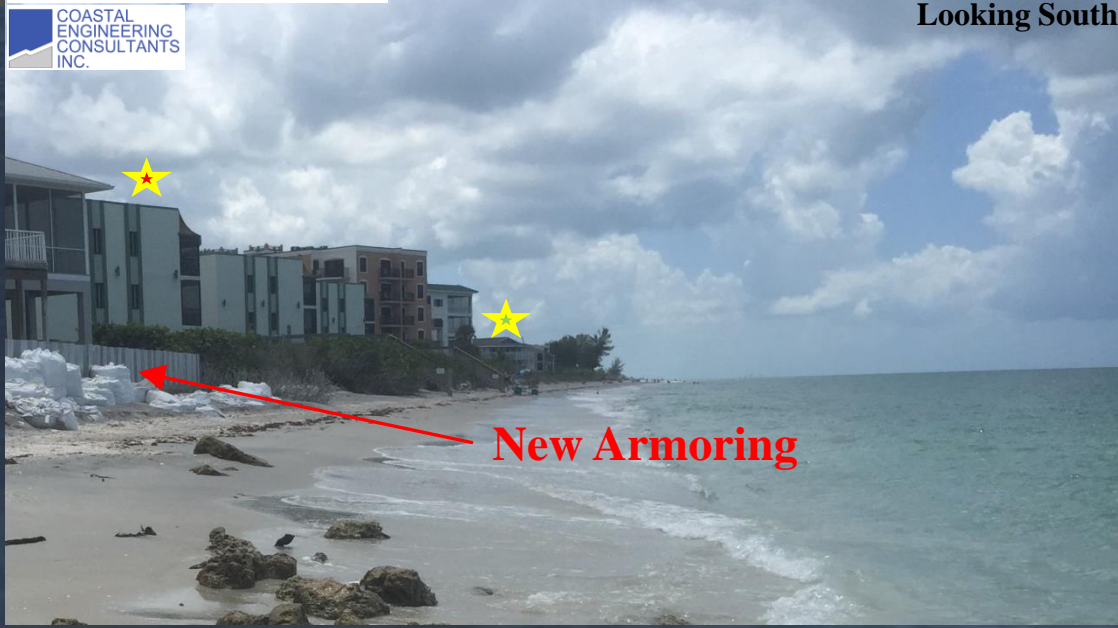
New Armoring

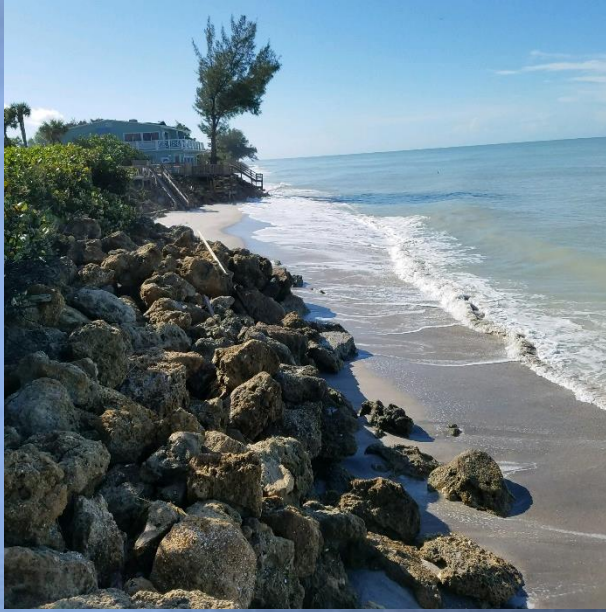
- Some Segments Experienced Erosion While Other Segments Experienced Accretion
- Minor Flanking of Armoring Structures
- No Net Increase in Design Quantities for Restoration Plan

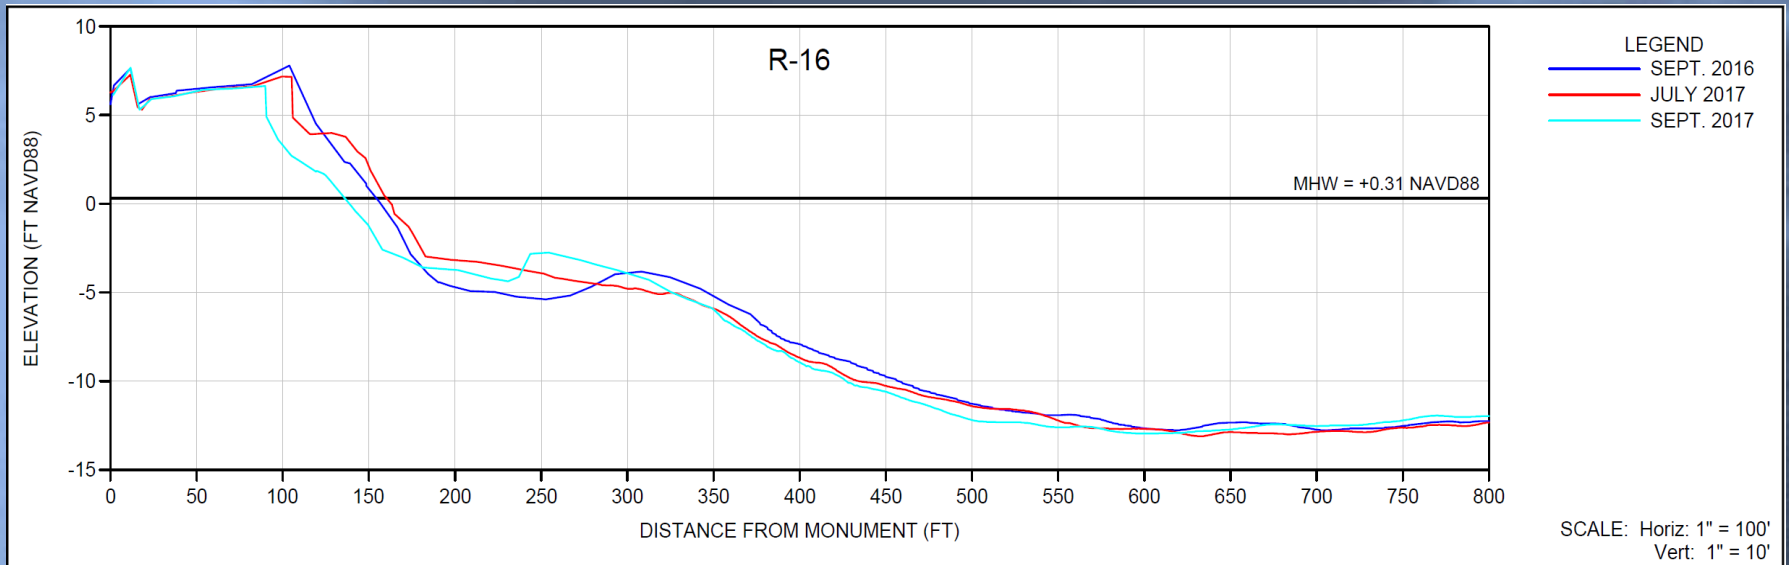
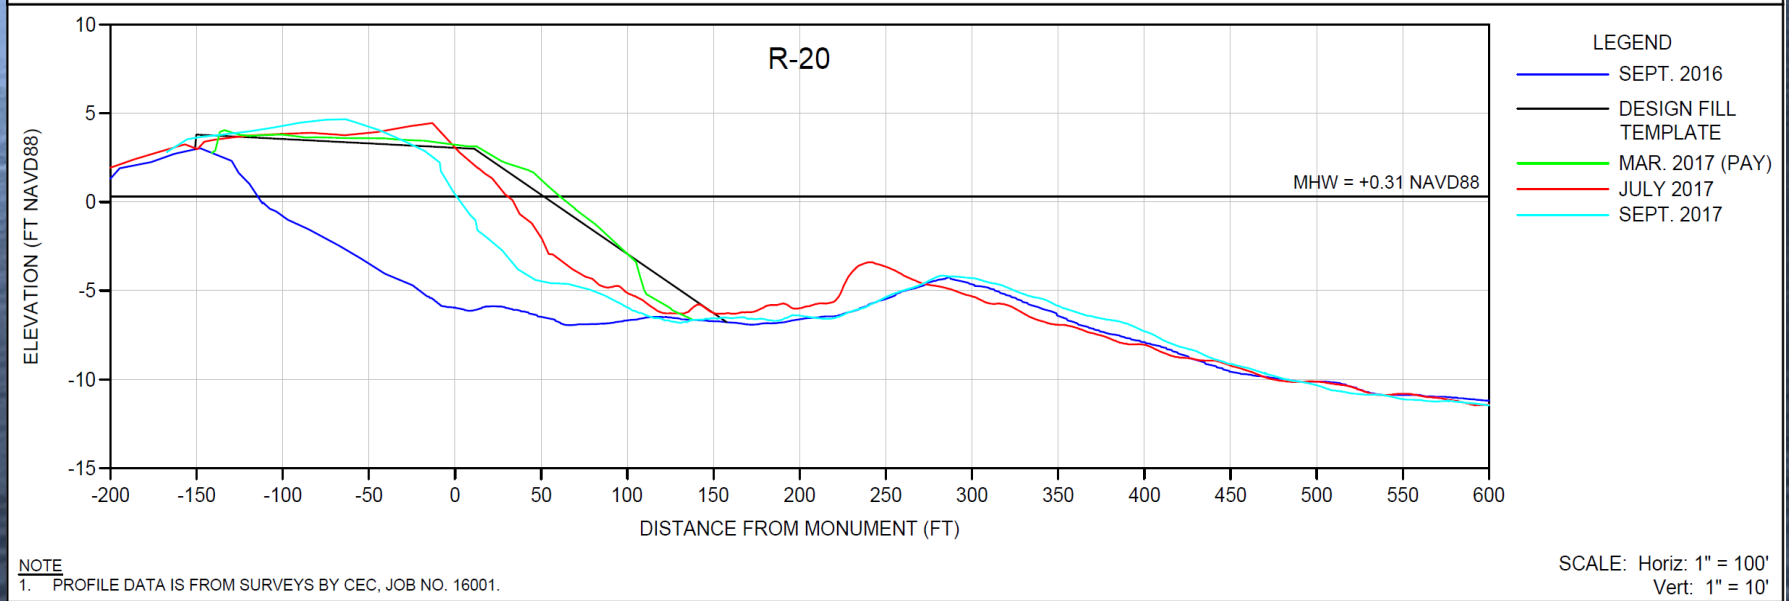
UPDRIFT BEACH PROFILE COMPARISONS

EROSION VOLUME = 29,670 CY

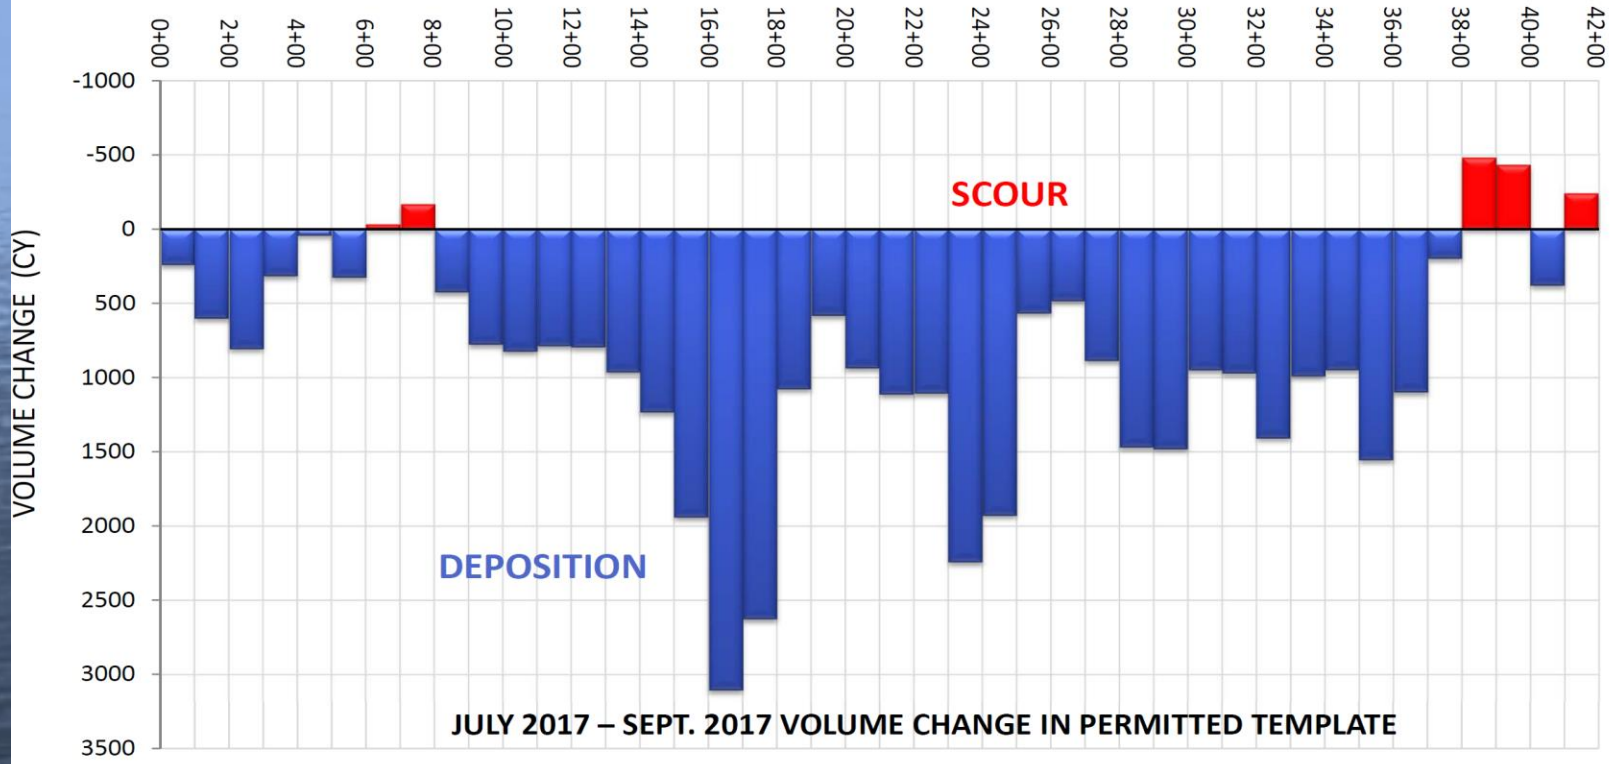
STUMP PASS NAVIGATION CHANNEL

INFILL VOLUME = 36,820 CY

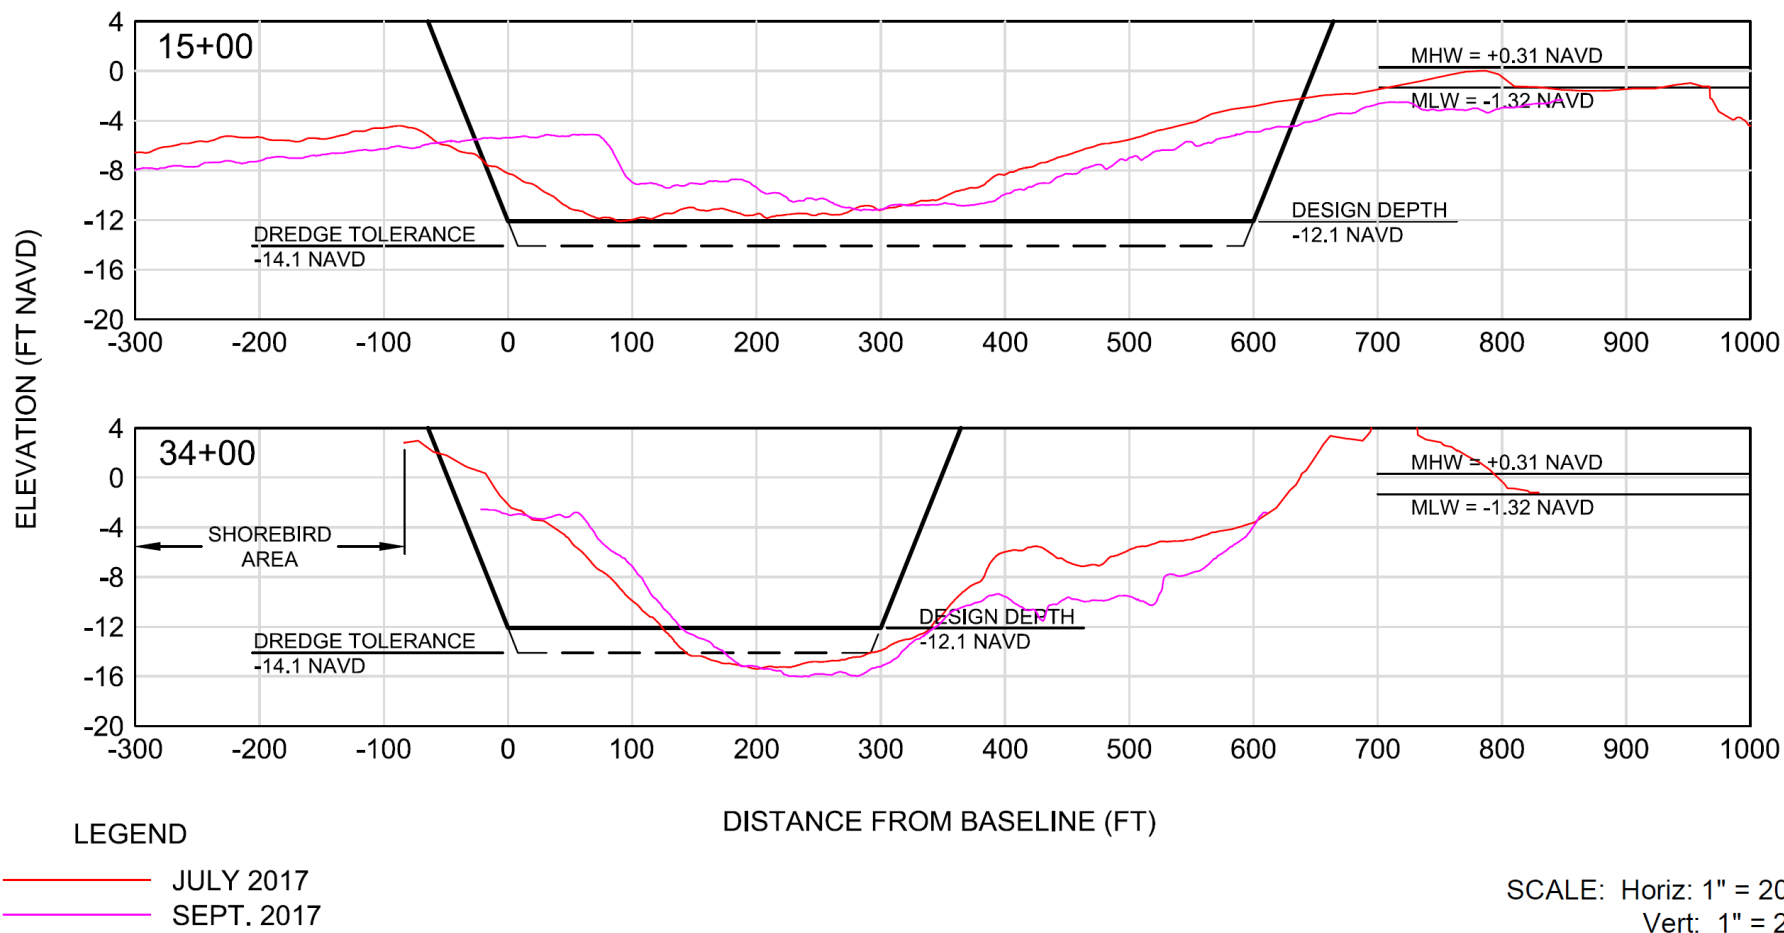
NAVIGATION CHANNEL TYPICAL SECTIONS

CONTROL DEPTH REDUCED TO 5.4 FT. MLW

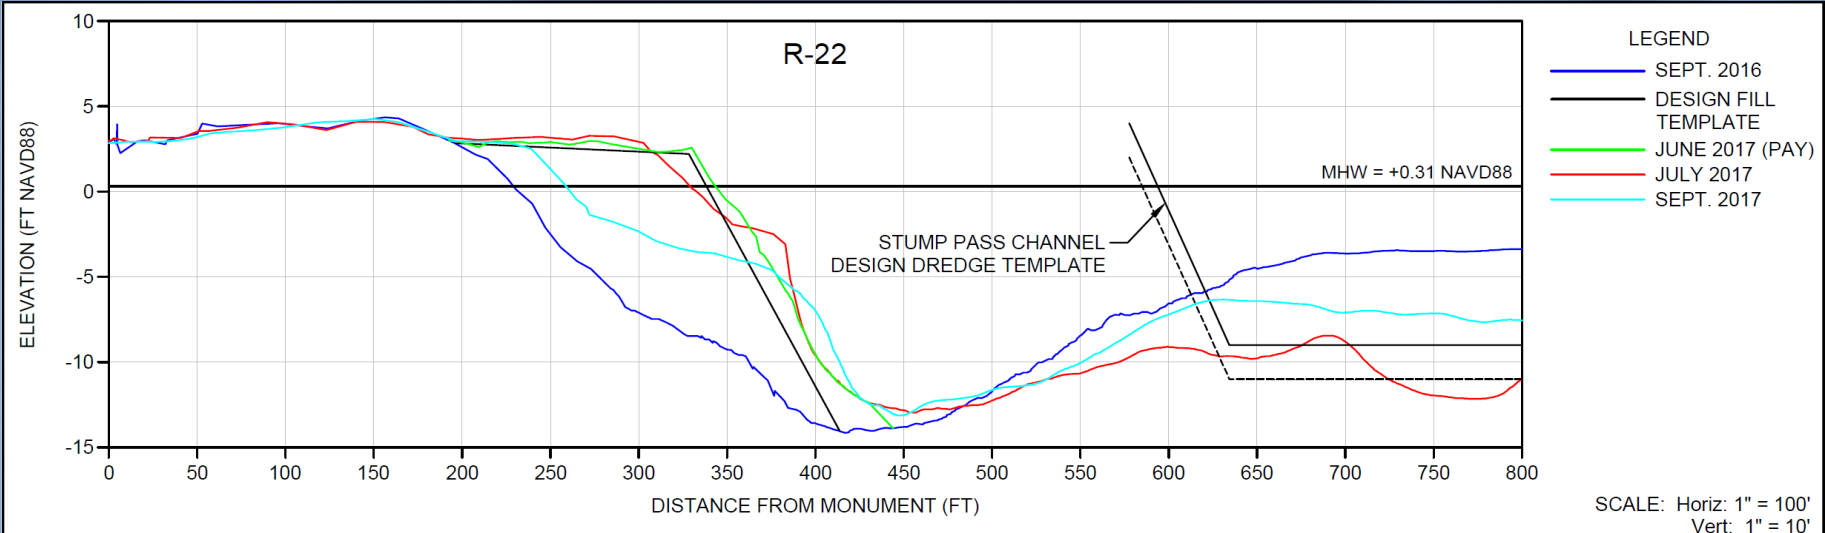
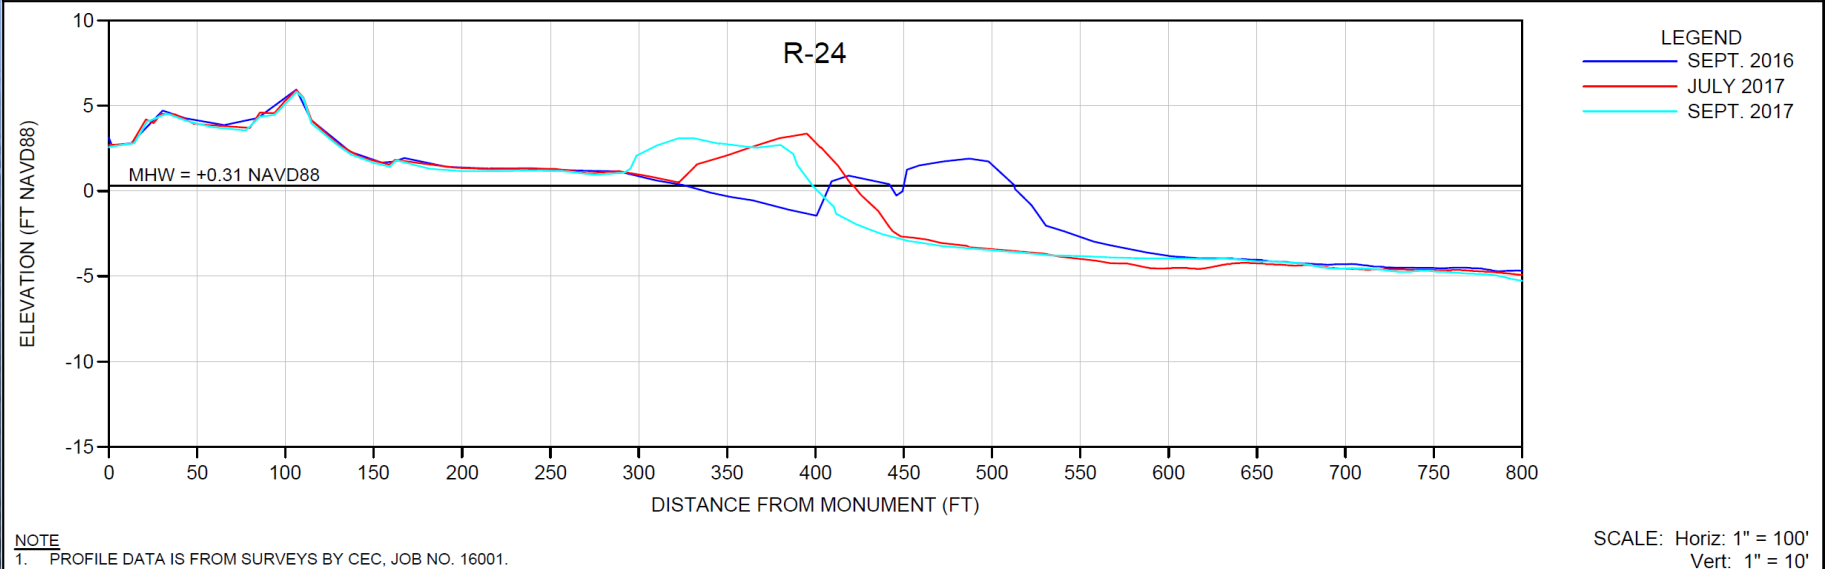
DOWNDRIFT BEACH PROFILE COMPARISONS

EROSION VOLUME = 16,840 CY

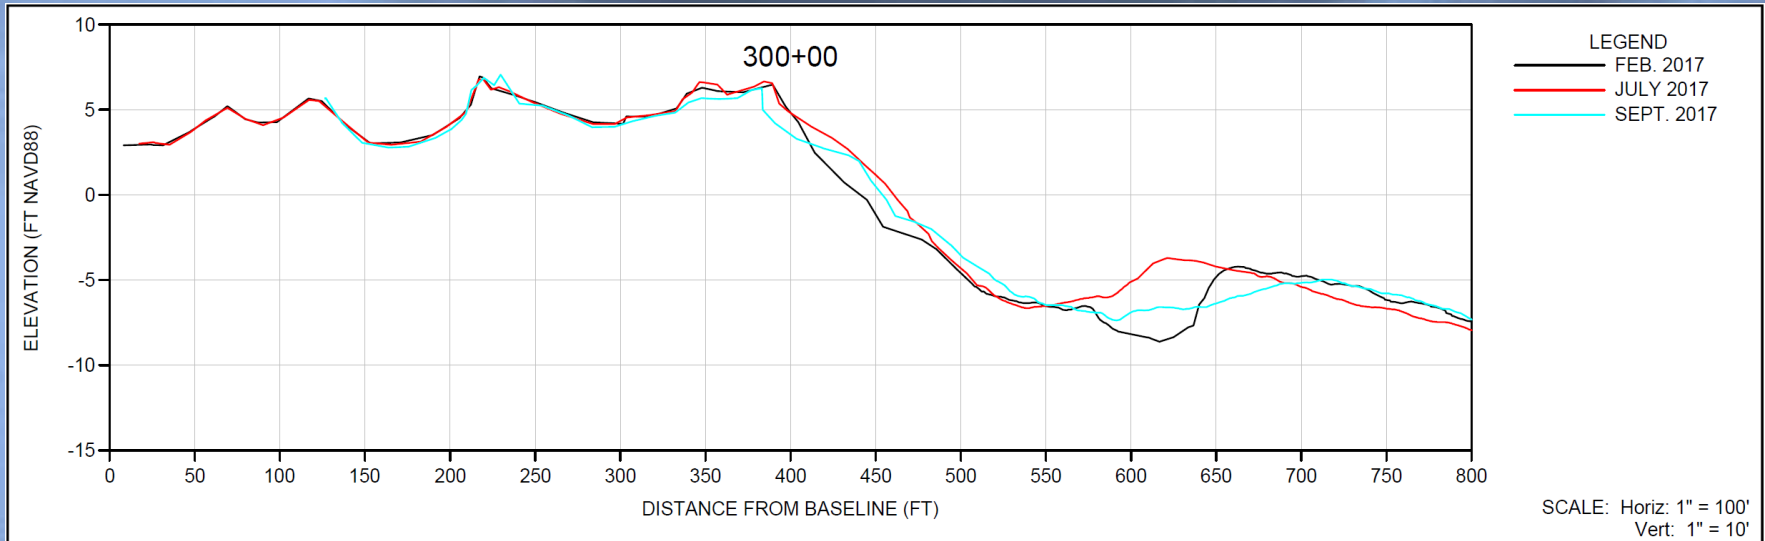
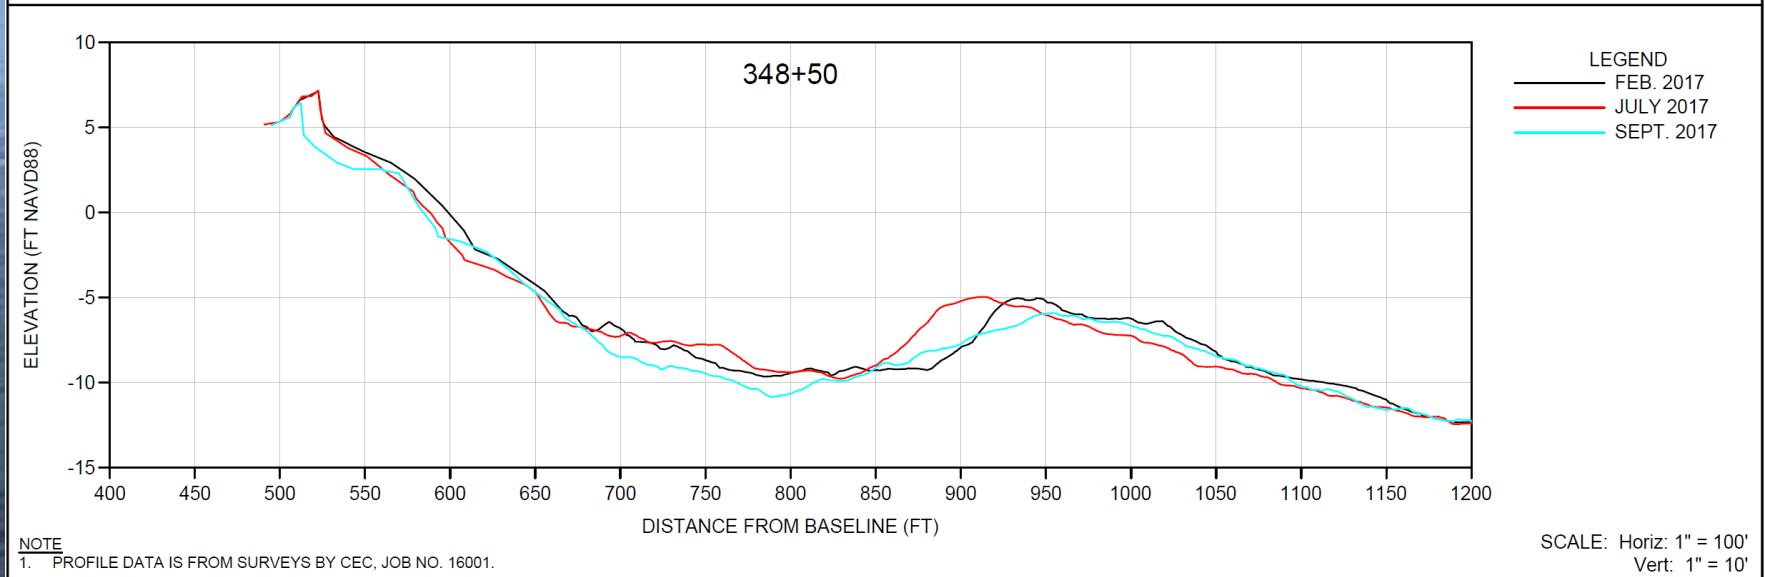
KI-DPI PROFILE COMPARISONS

EROSION VOLUME = 65,200 CY

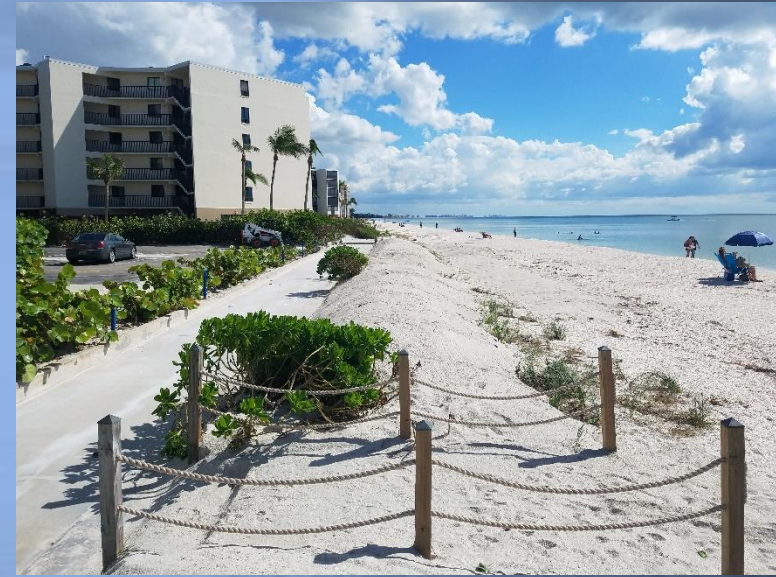
ESTERO ISLAND POST-IRMA CONDITIONS

- Dune Overwash
- Significant Erosion of Dry Beach (Above MHW)
- Minimal "Net" Volume Gains when computed to Depth of Closure

BEACH PROJECT NET VOLUME CHANGE (DoC) = +3,100 CY

BEACH PROJECT EROSION VOLUME (>MHW) = -12,700 CY

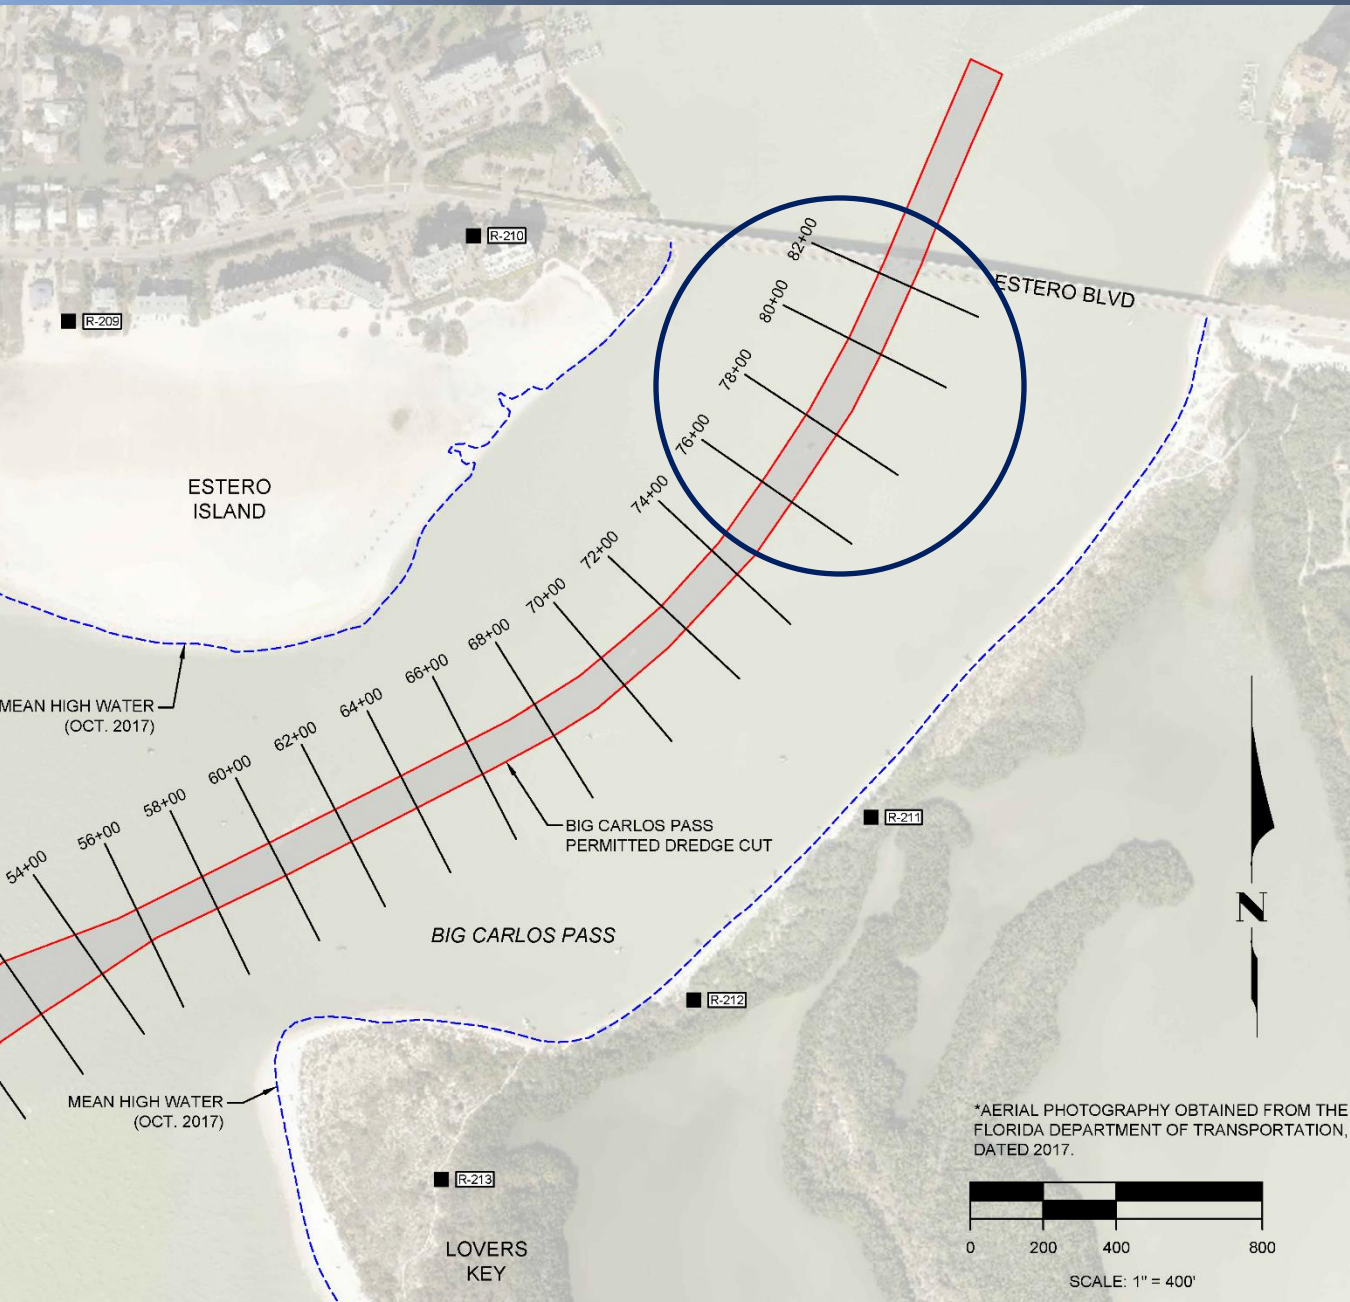
BIG CARLOS PASS POST-IRMA CONDITIONS

- Inlet Shoreline Erosion
- Channel Deposition
- Scour at Bridge Piles

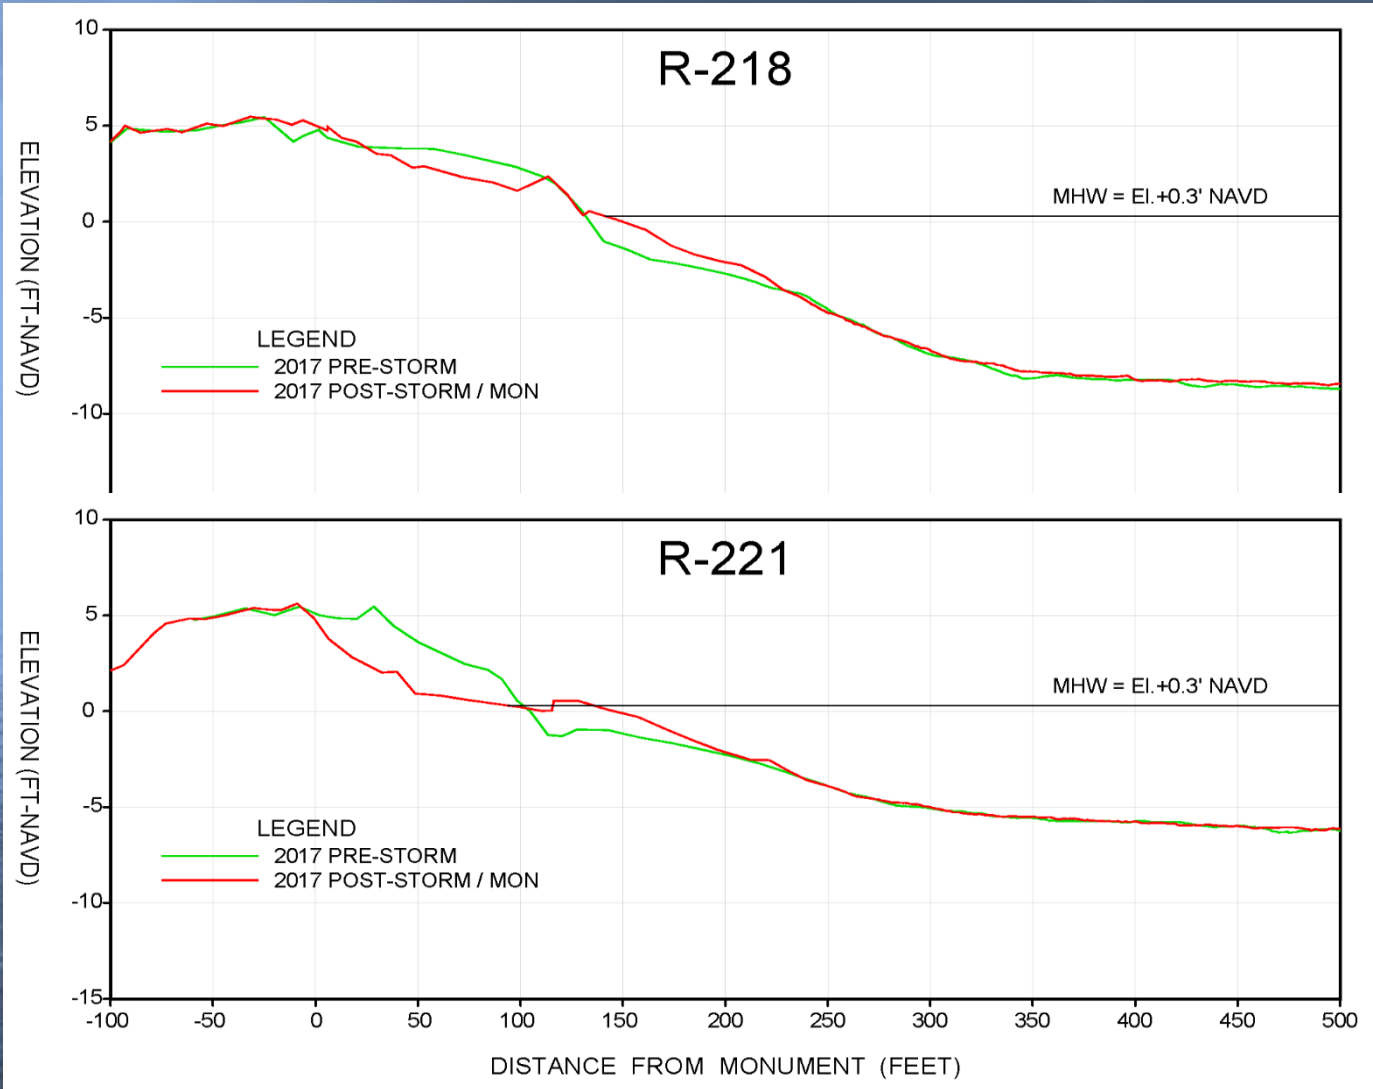
LOVERS KEY POST-IRMA CONDITIONS

- Dune Overwash
- Significant Erosion of Dry Beach (Above MHW)
- Minimal "Net" Volume Gains (Depth of Closure)

BEACH PROJECT NET VOLUME CHANGE (DoC) = +8,600 CY
BEACH PROJECT EROSION VOLUME (>MHW) = -14,500 CY

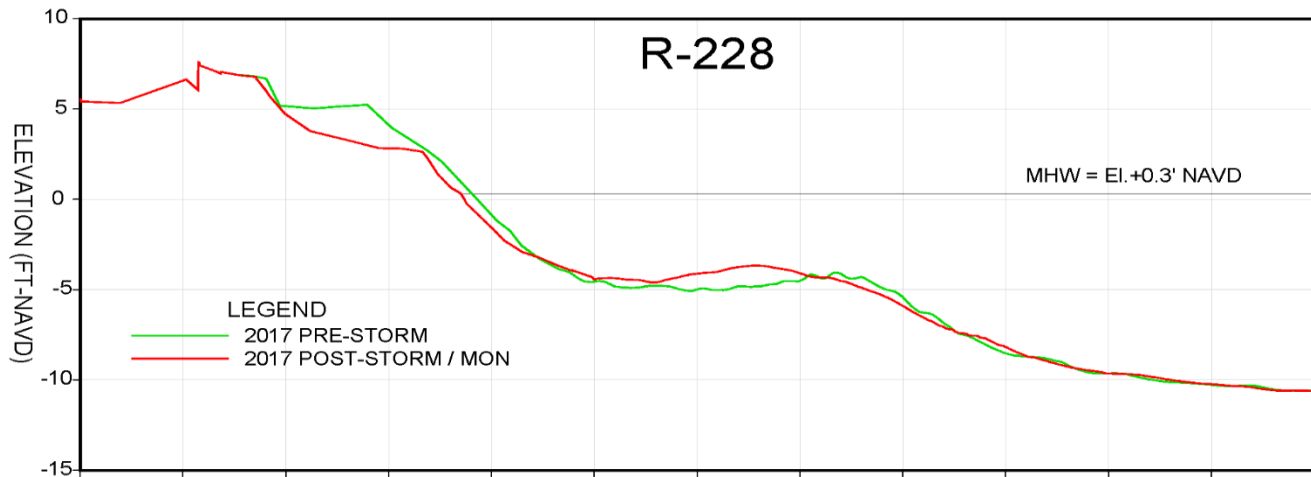
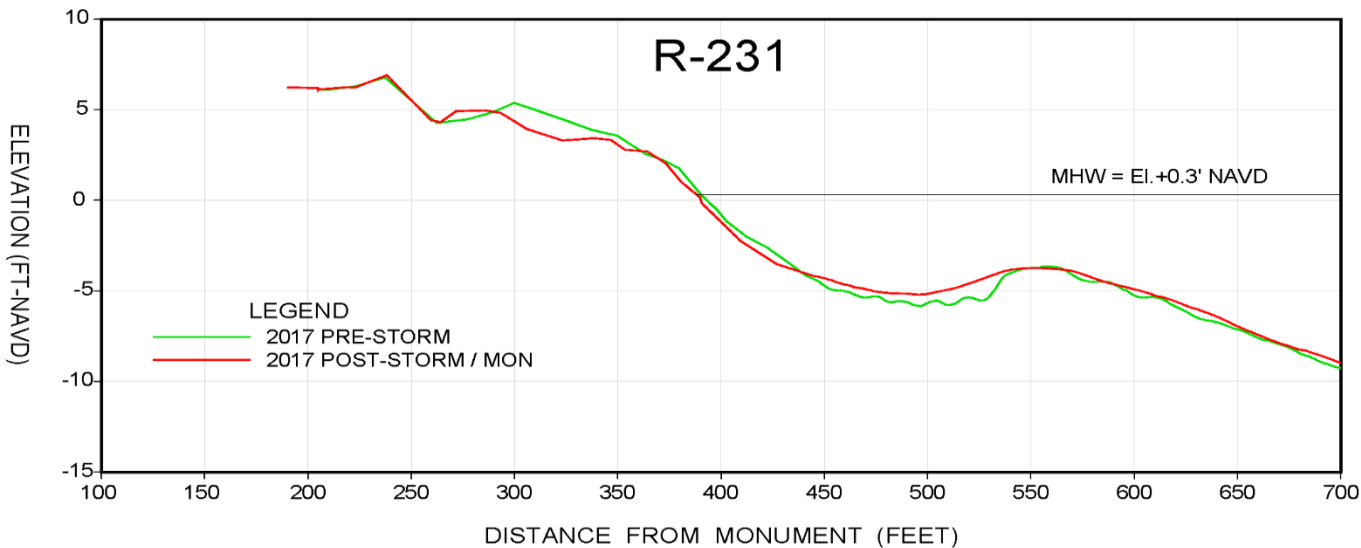
BONITA BEACH POST-IRMA CONDITIONS

- Significant Erosion of Dry Beach (Above MHW)
- Net Erosion (Depth of Closure)

BEACH PROJECT EROSION LOSSES (DoC) = -6,400 CY
BEACH PROJECT EROSION VOLUME (>MHW) = -15,200 CY
