# DRONE TECHNOLOGY AND RUBBLE MOUND STRUCTURES

## ST. LUCIE INLET SOUTH JETTY CASE STUDY

Presented By: Andrew Wycklendt, P.E.

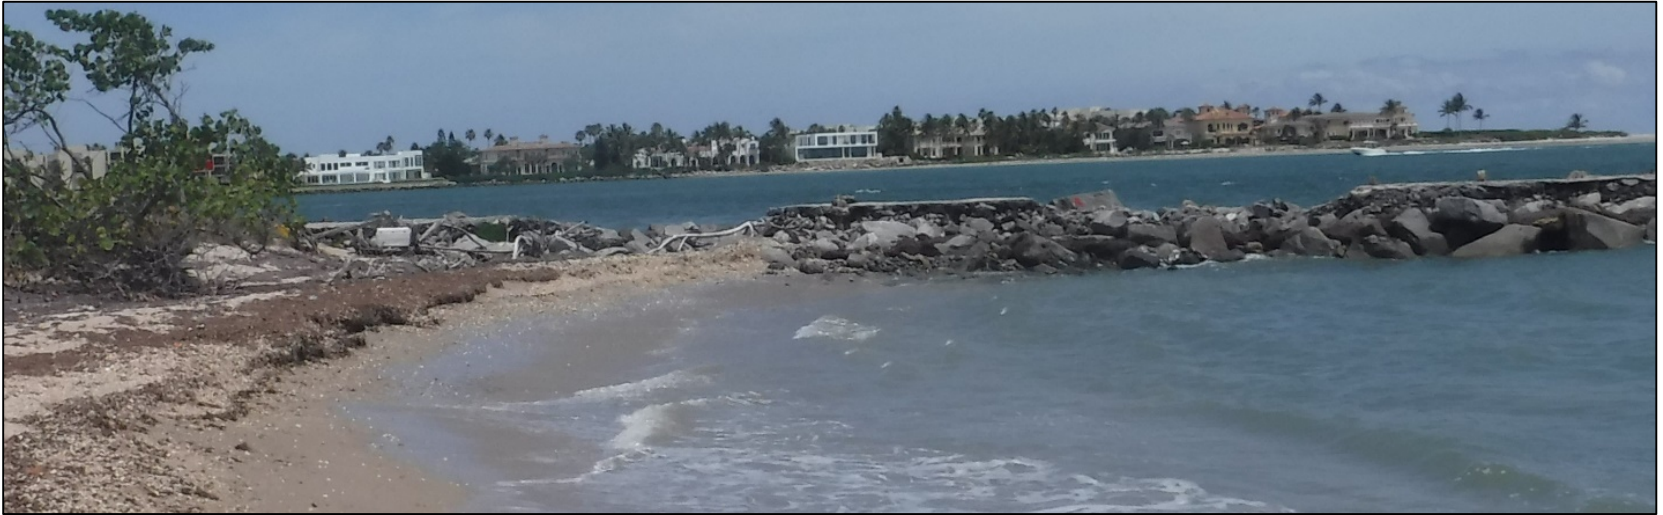
# PROBLEM IDENTIFICATION

## › June 2019 Engineering Investigation

- Level 1 Evaluation – 100% Structure
- Level 2 Evaluation – 10% Structure (i.e. profiles every 100 feet)
- Condition Rating = Fair; primary structure elements are sound, but minor to moderate defects or deterioration was observed

## › March 2020 Post-Dorian Drone Assessment

- Negligible change to breach, crest elevation, and side slopes

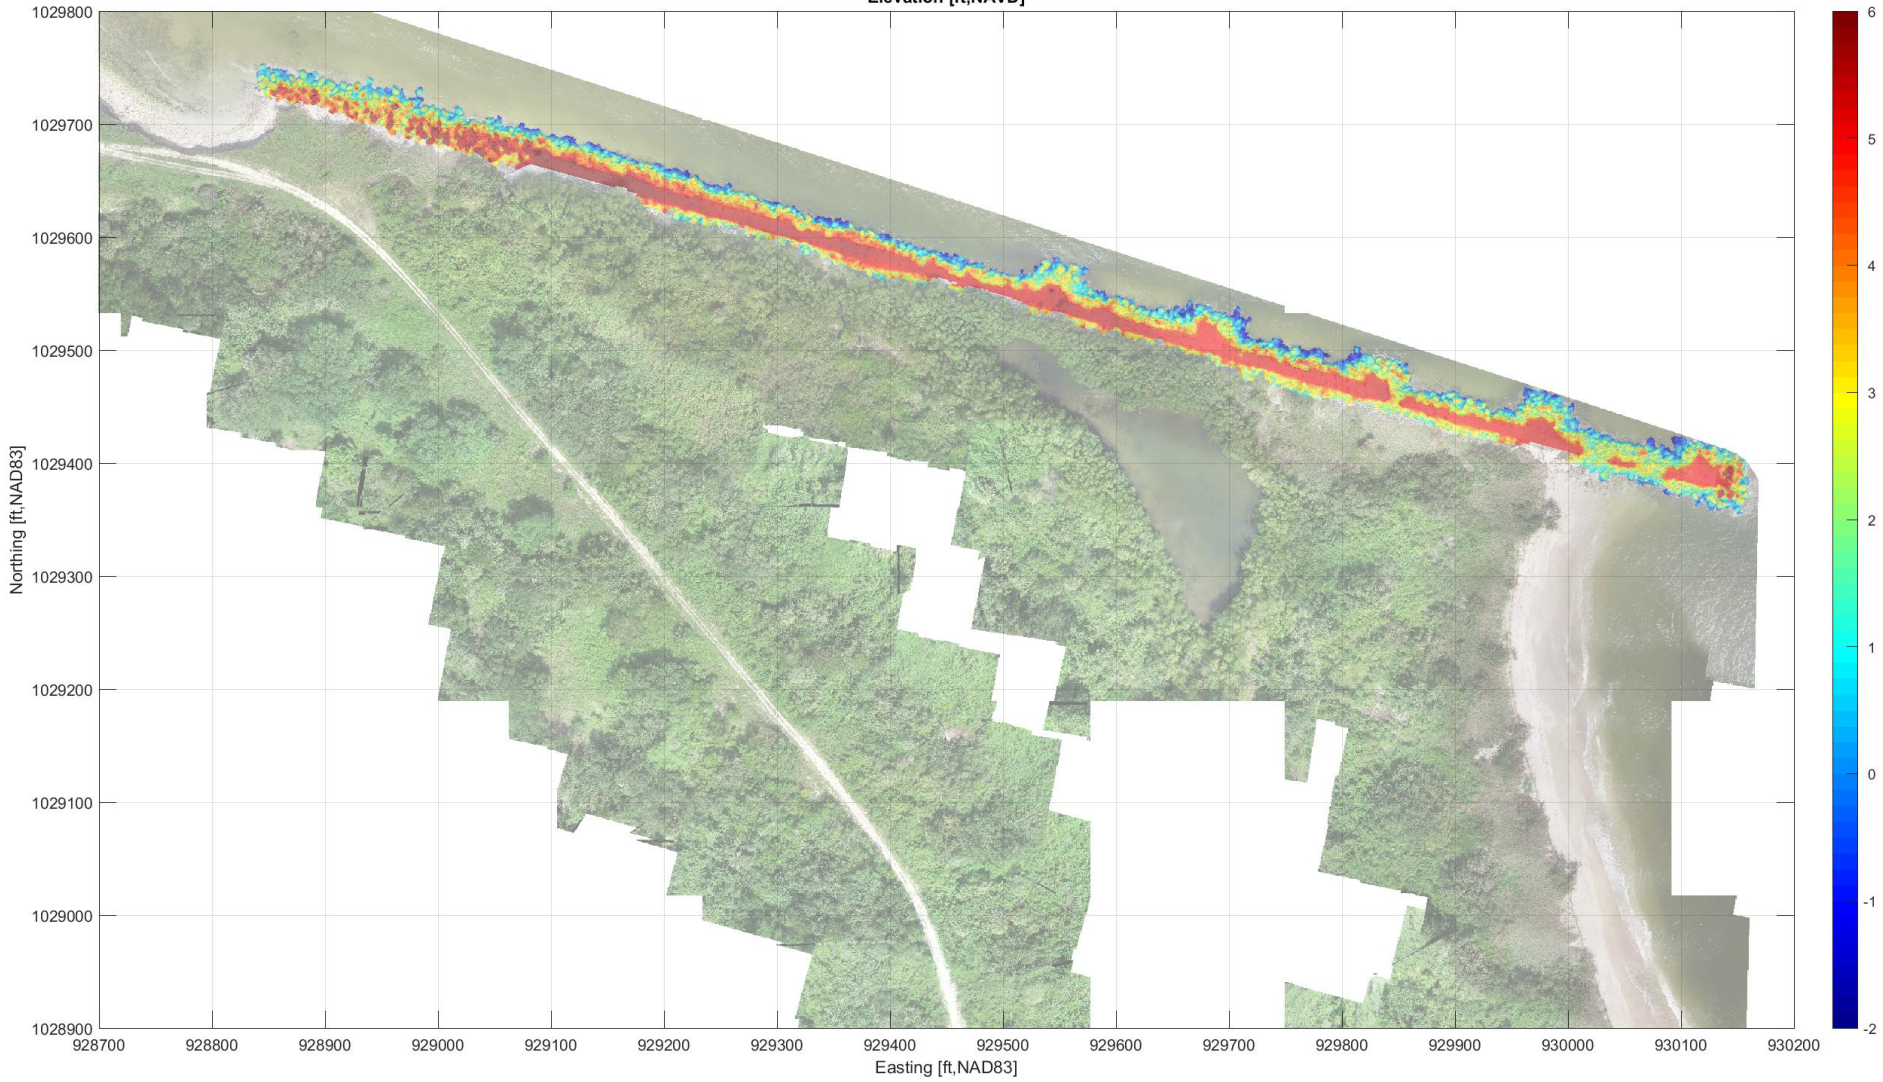
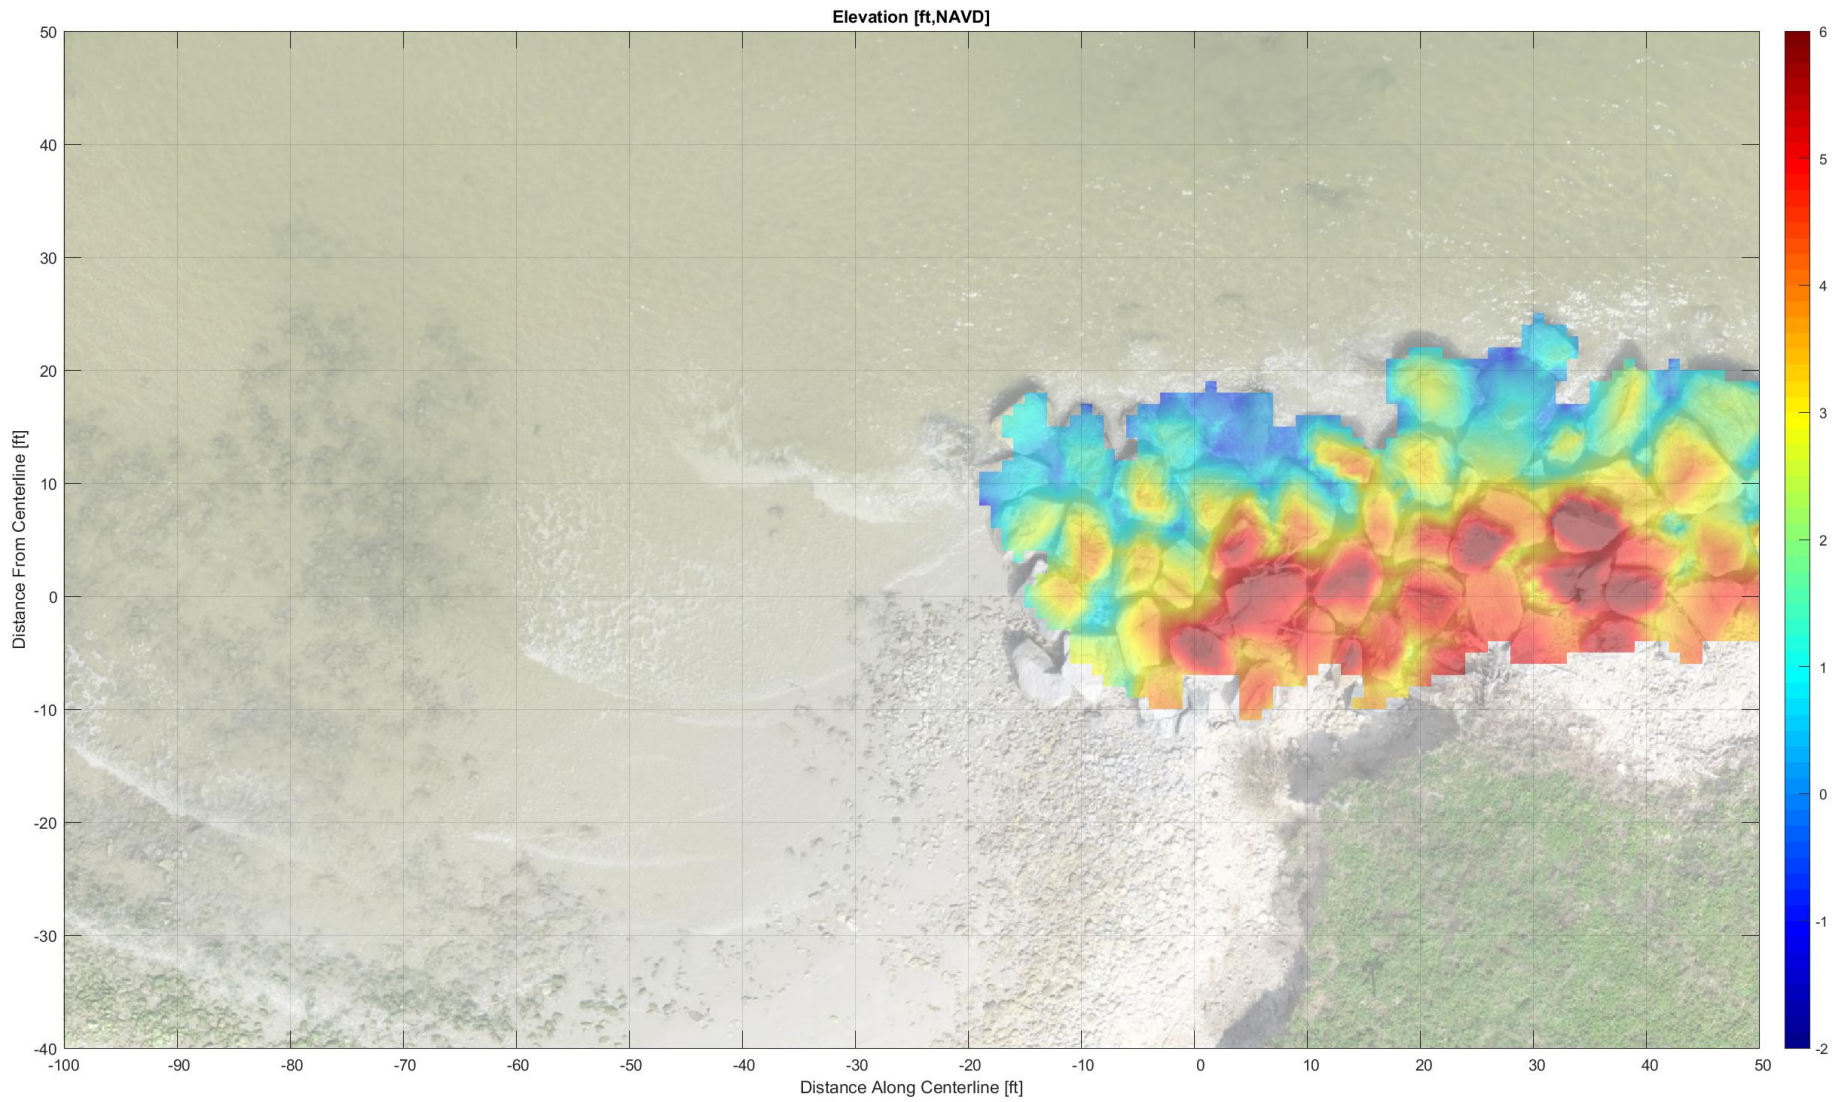
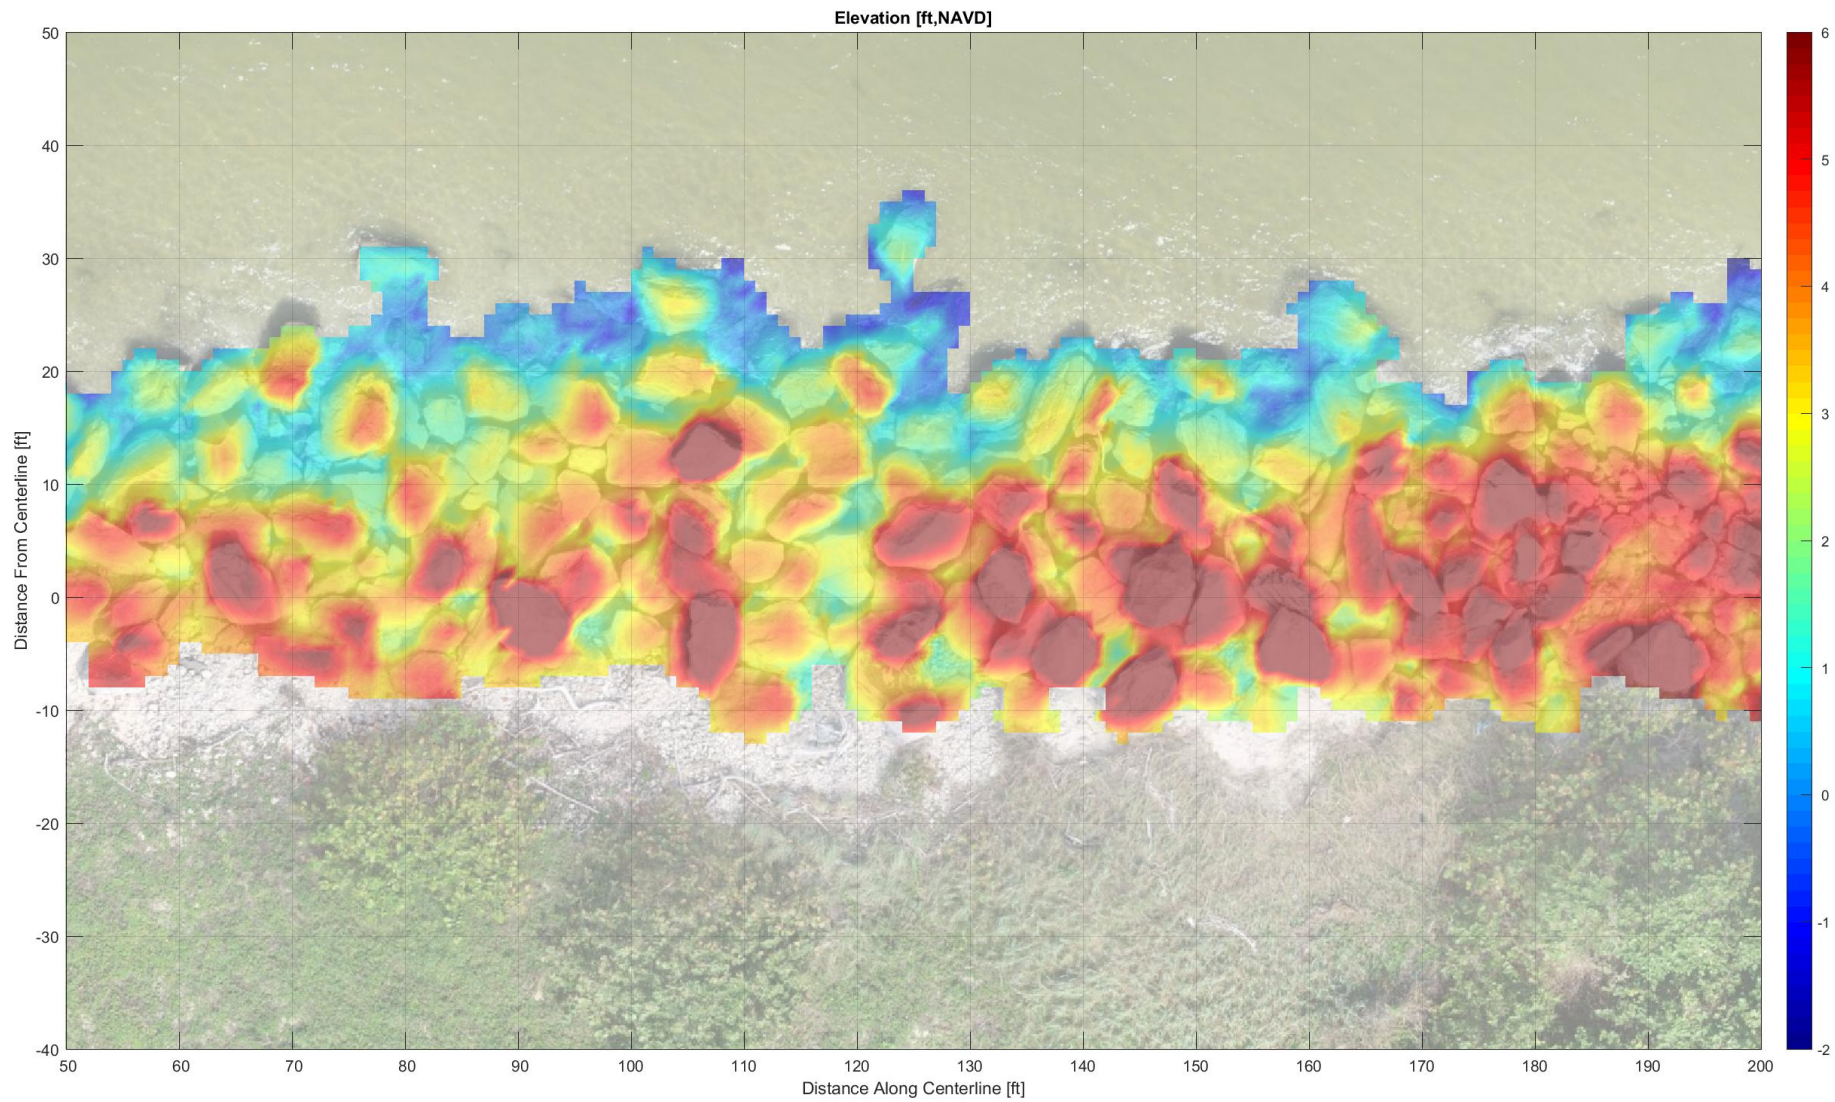
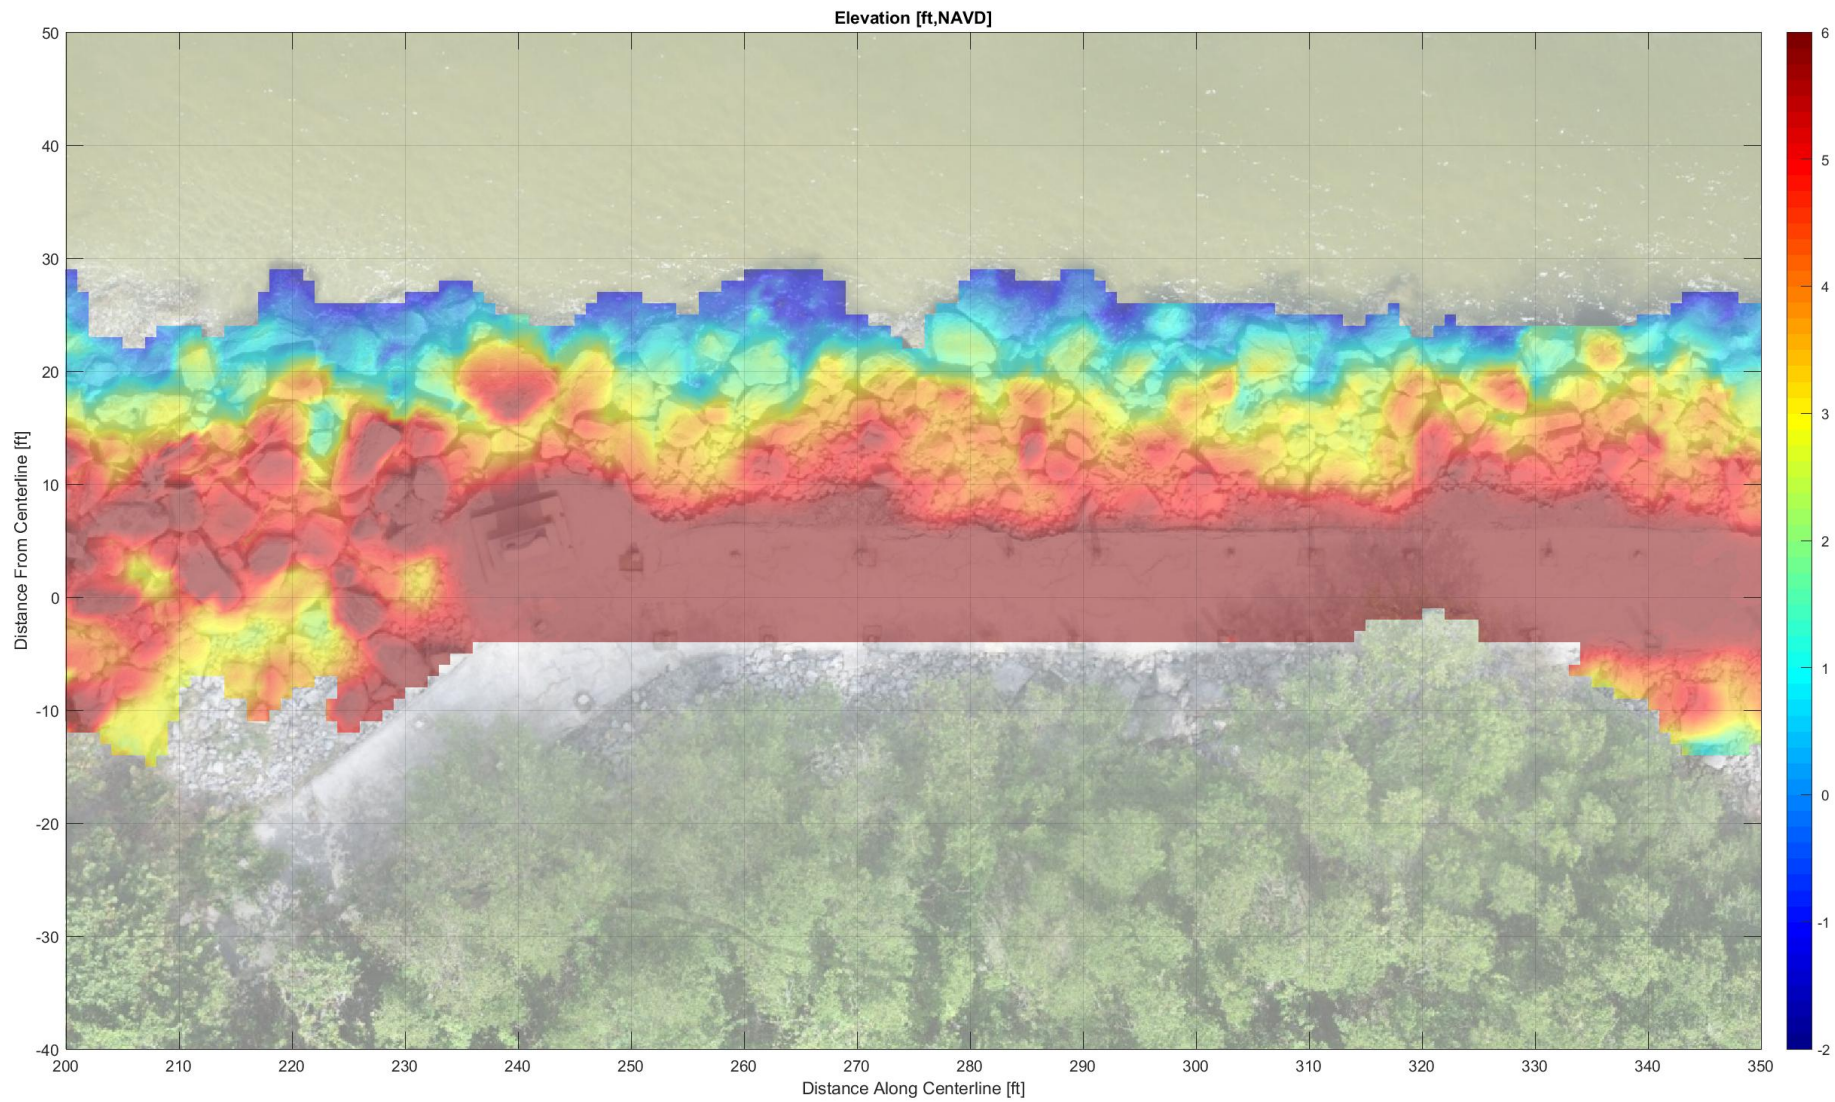
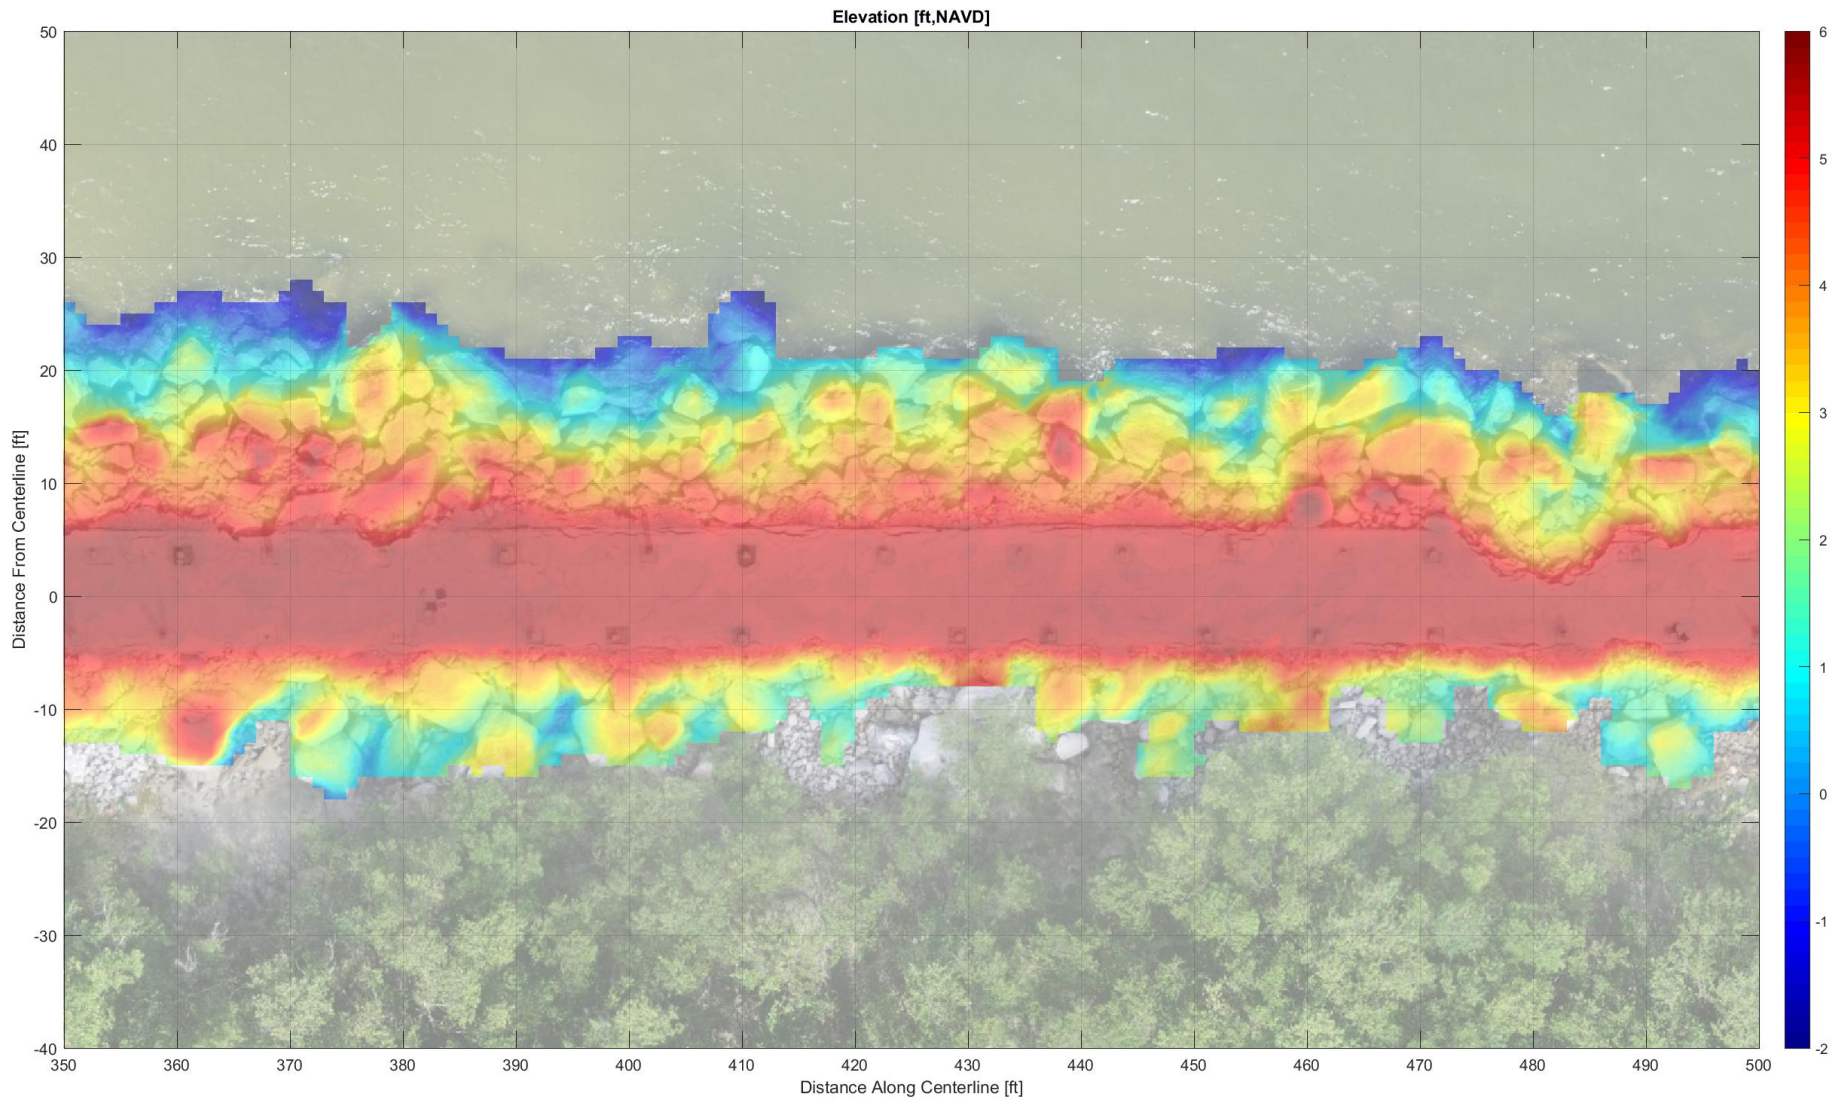
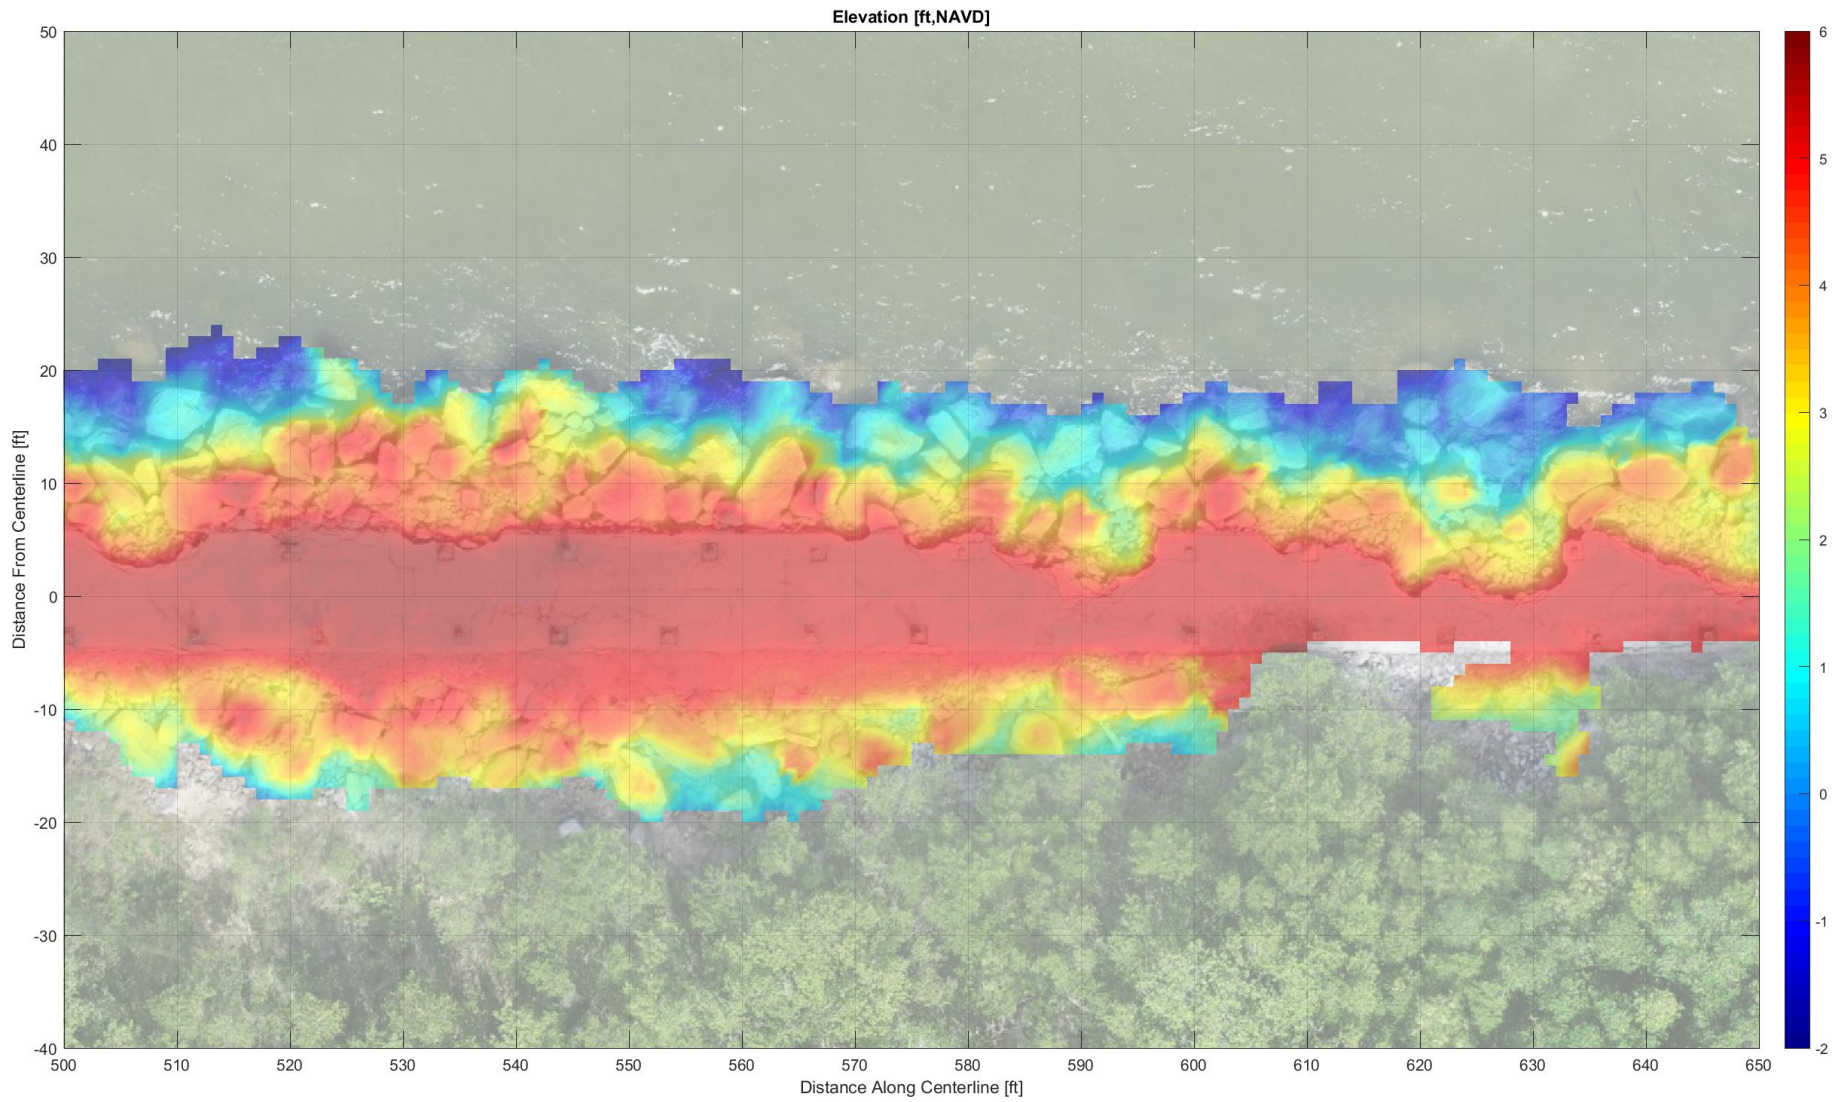
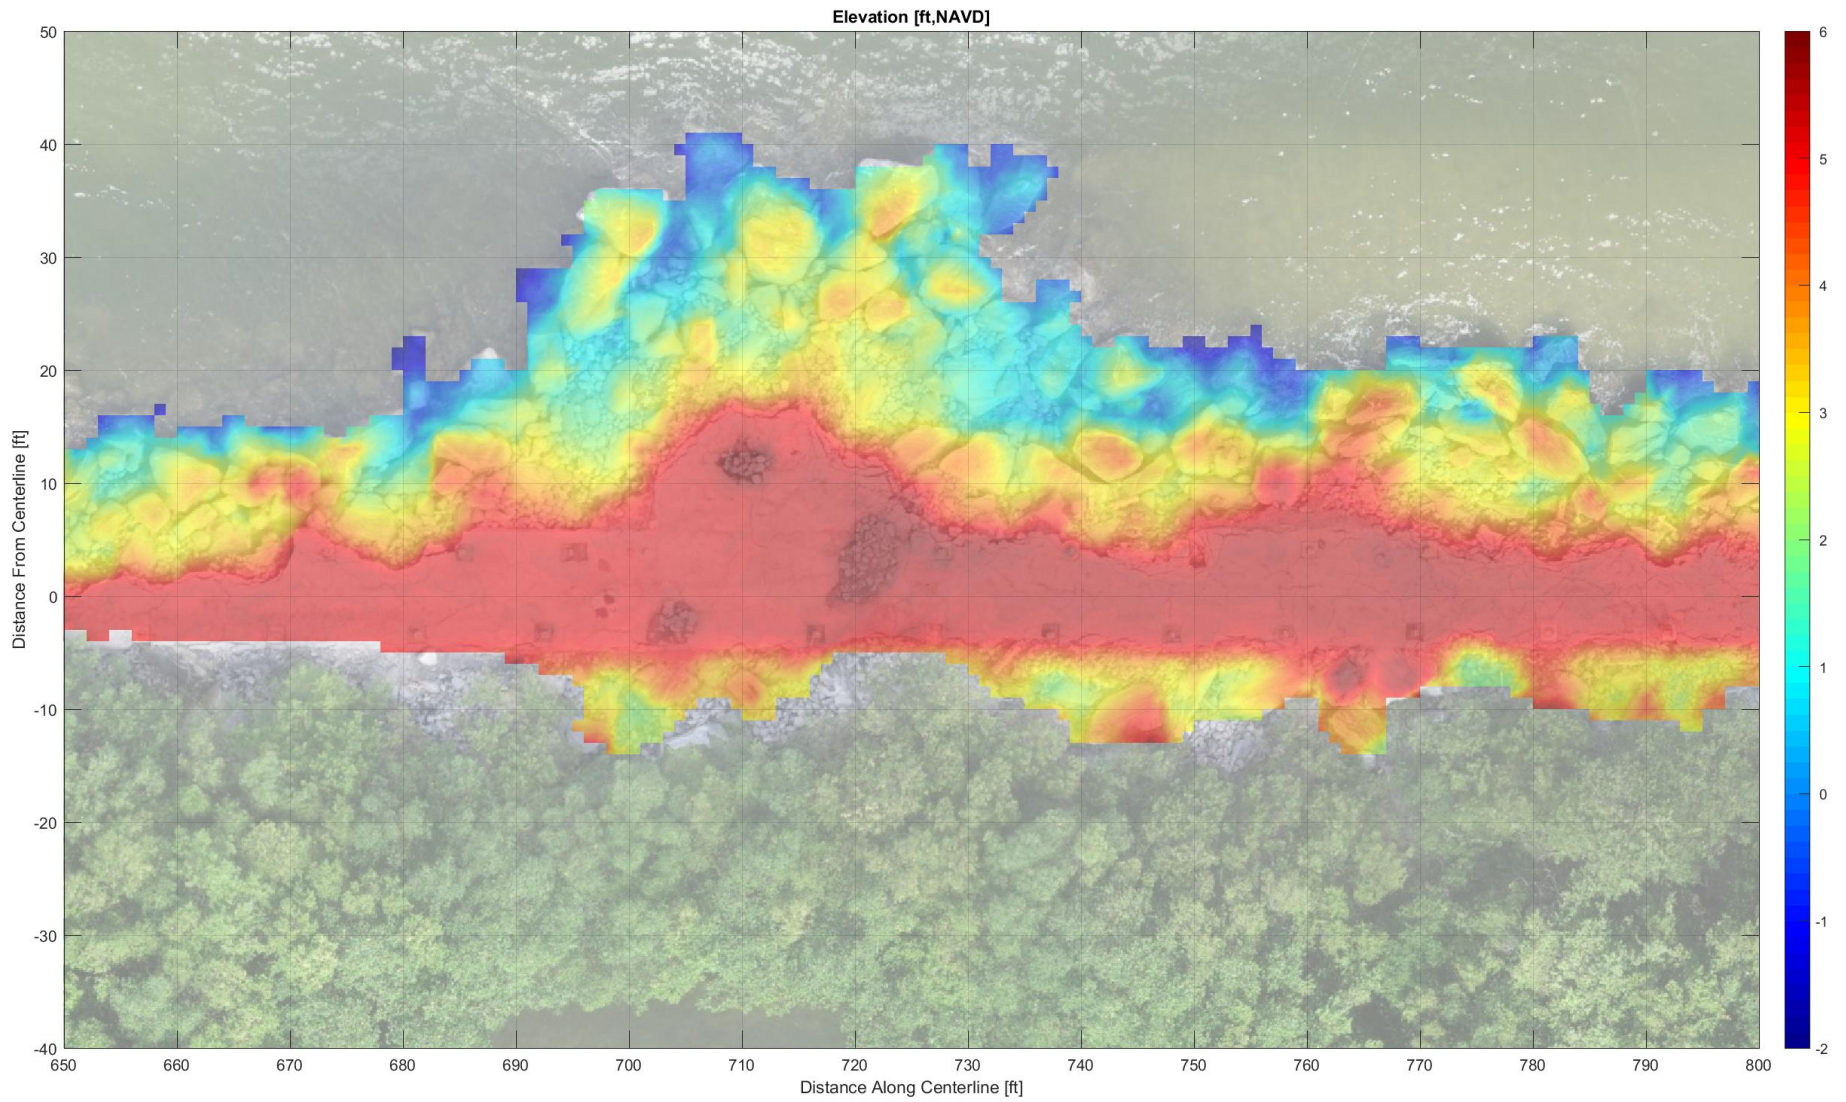
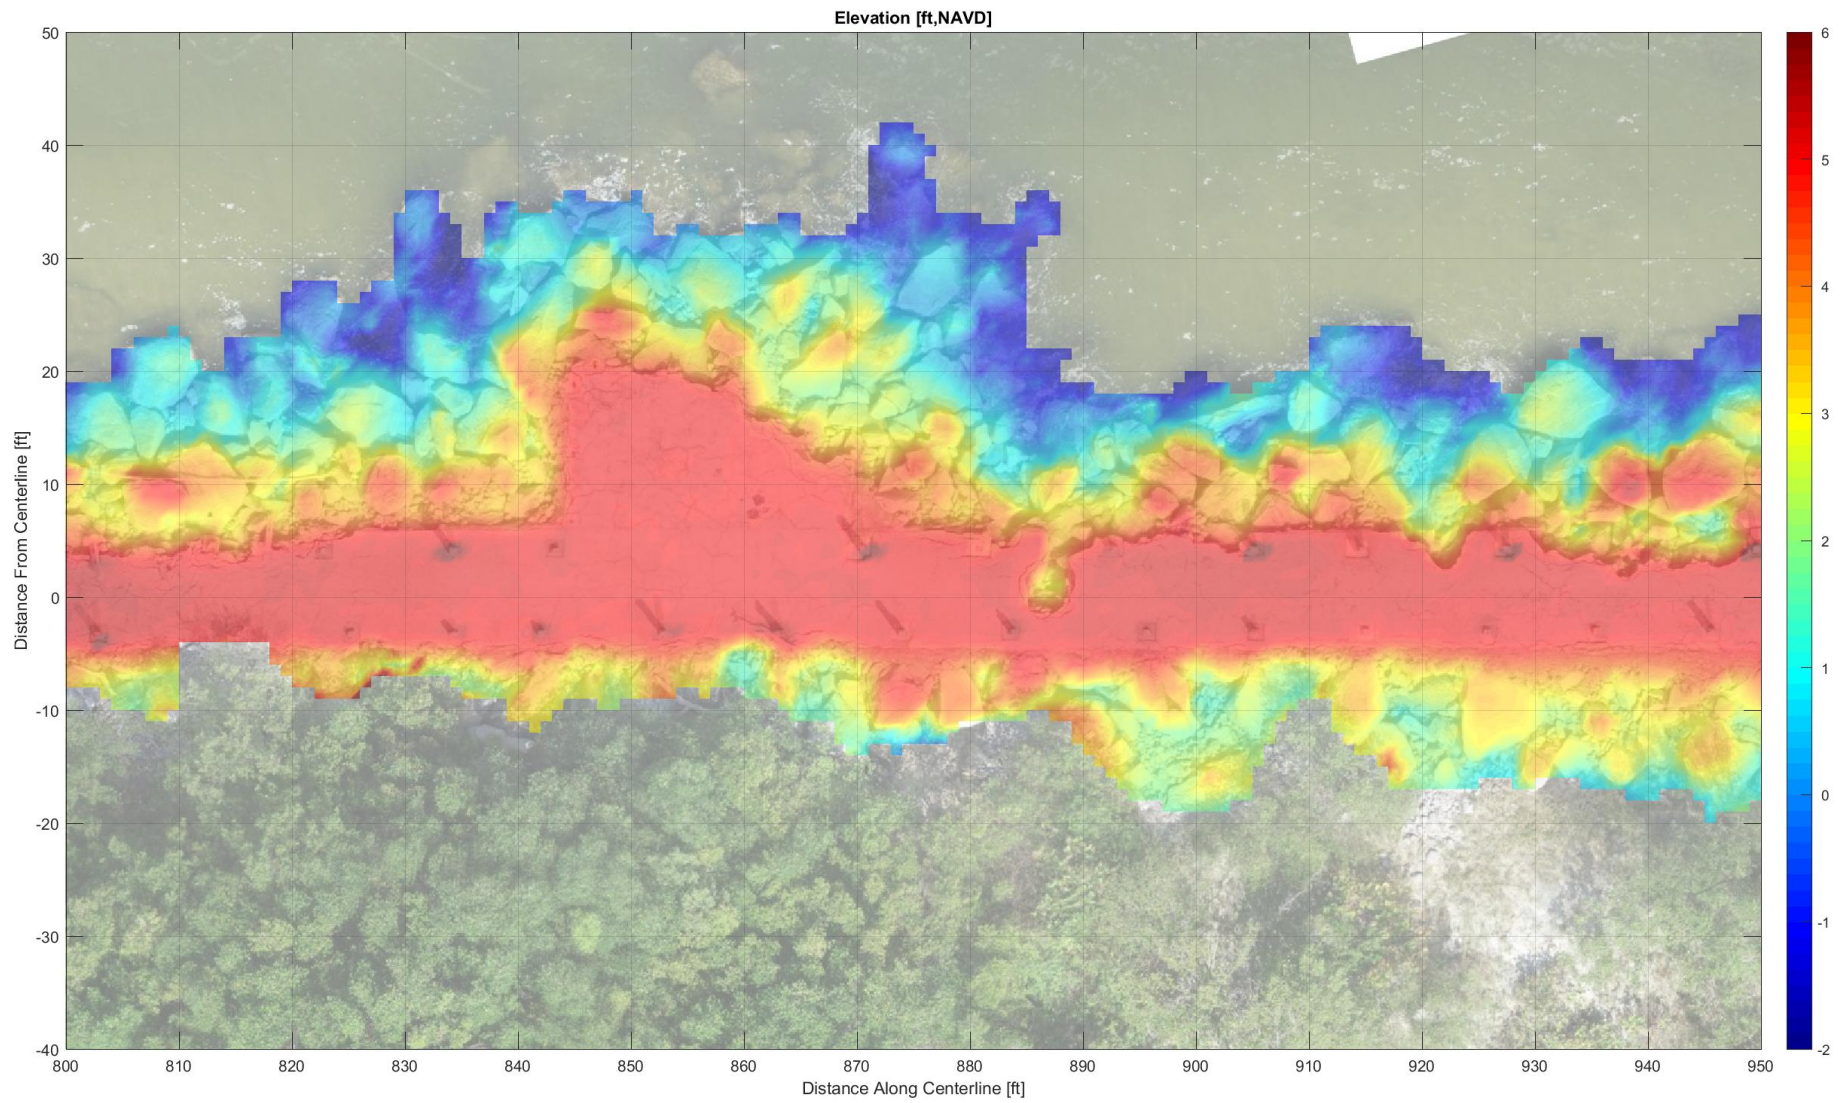
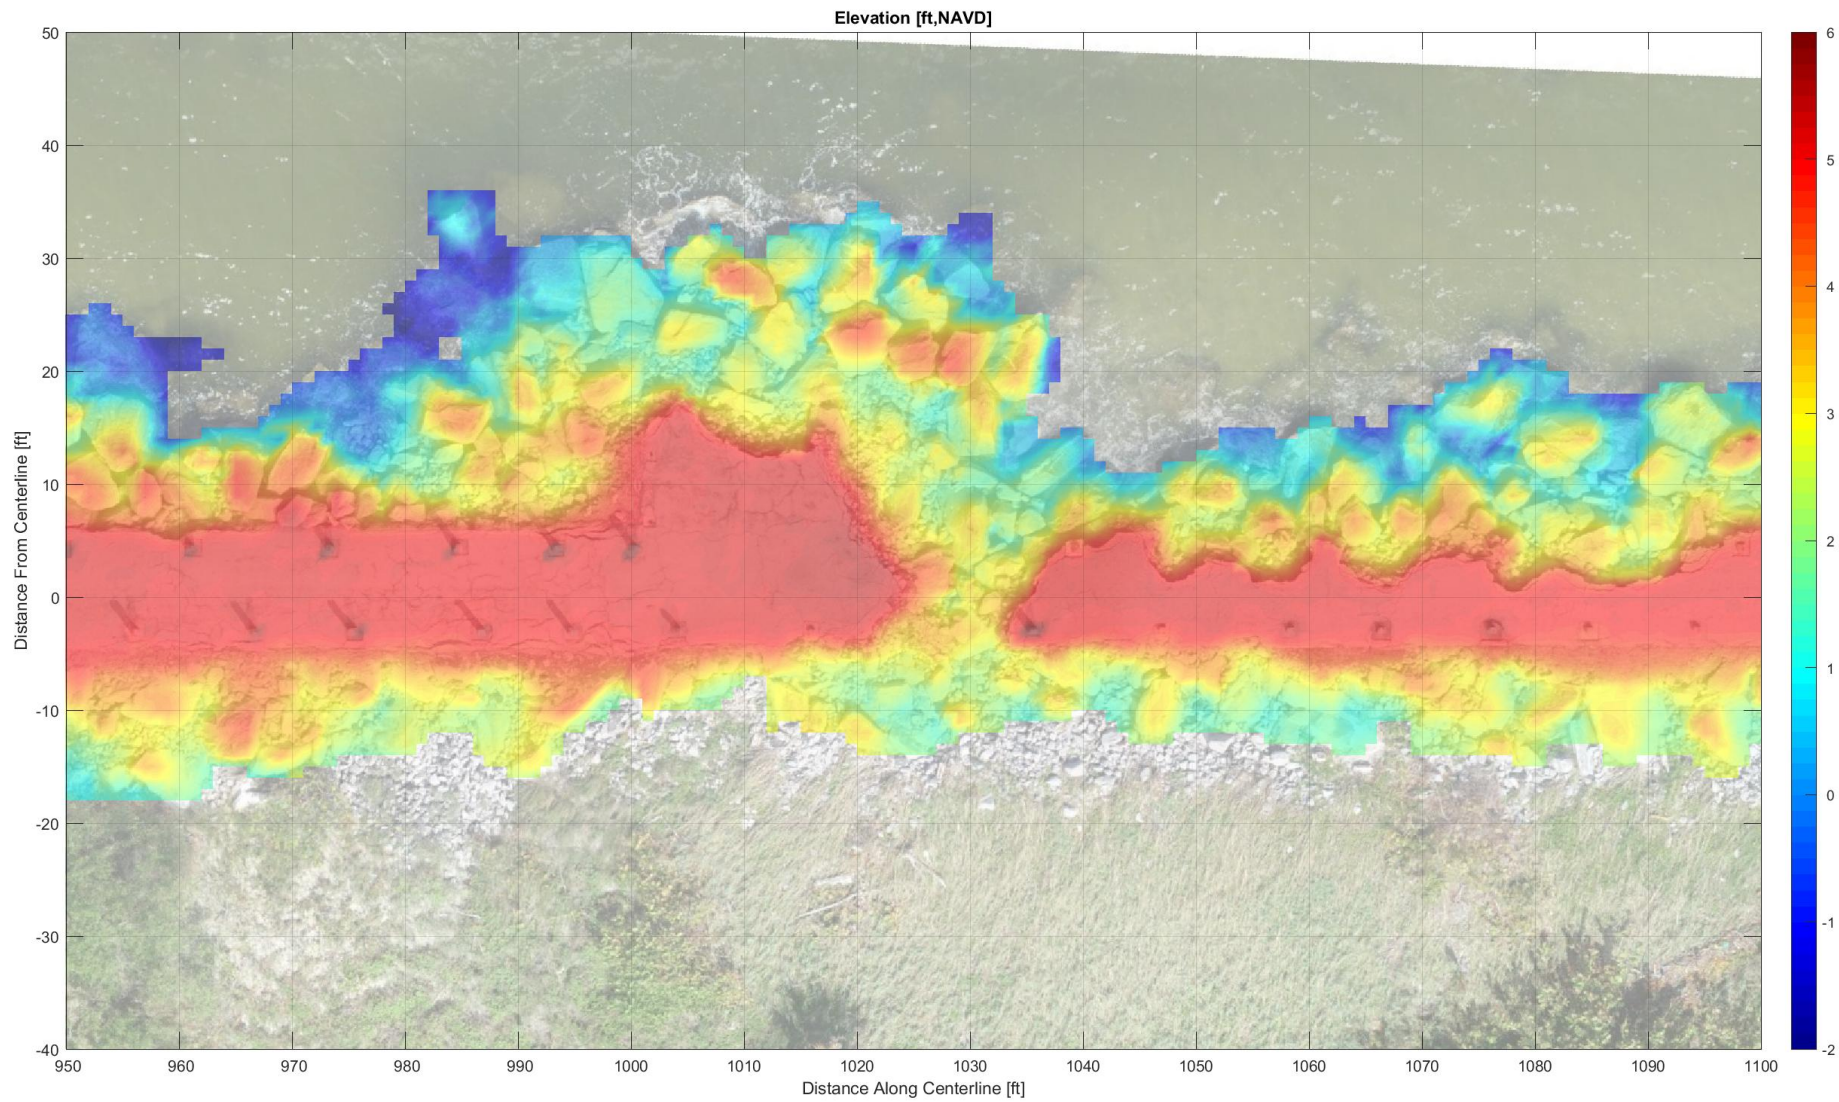
# JETTY CREST ELEVATION

› Minimum, maximum, and average crest elevations were calculated for each 20-foot segment along the jetty.

Face	Min	Max	Avg
Crest	1.5	8.1	4.9
