# DRONE TECHNOLOGY AND RUBBLE MOUND STRUCTURES

## ST. LUCIE INLET SOUTH JETTY CASE STUDY

Presented By: Andrew Wycklendt, P.E.

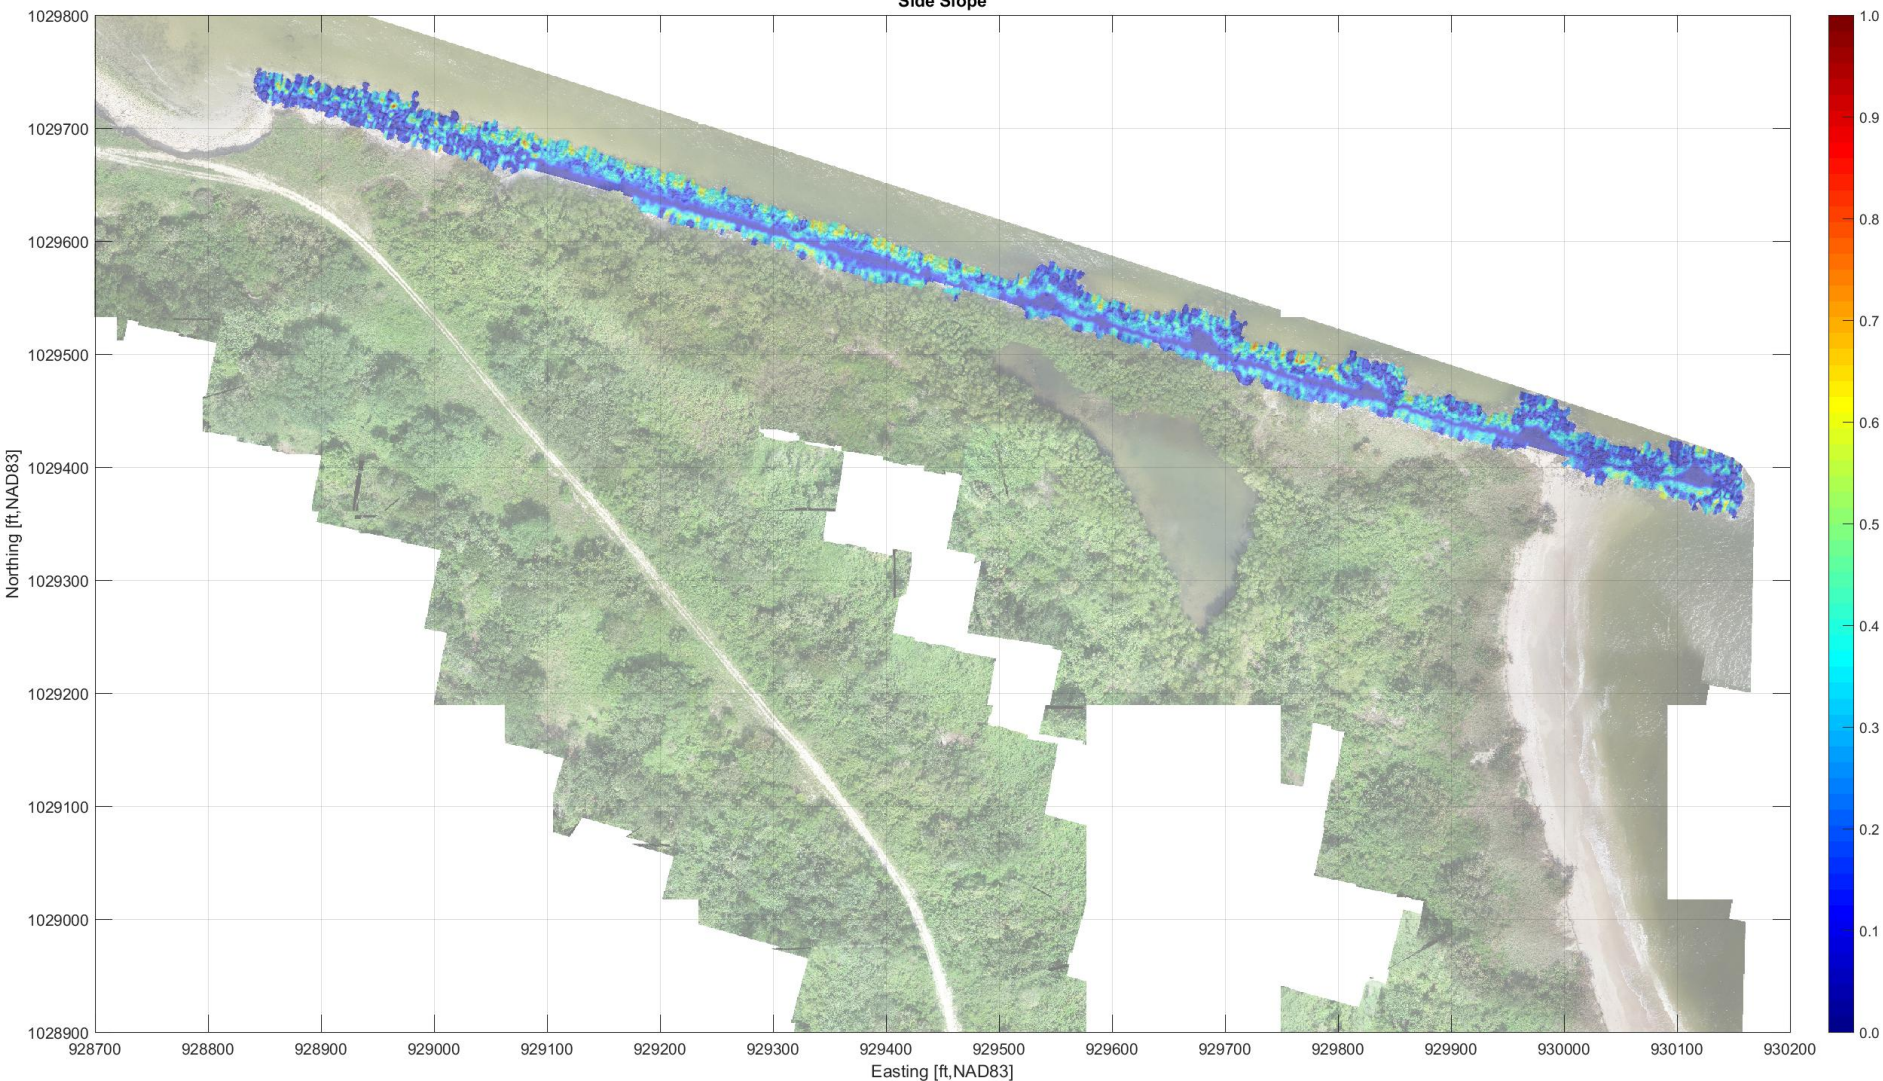
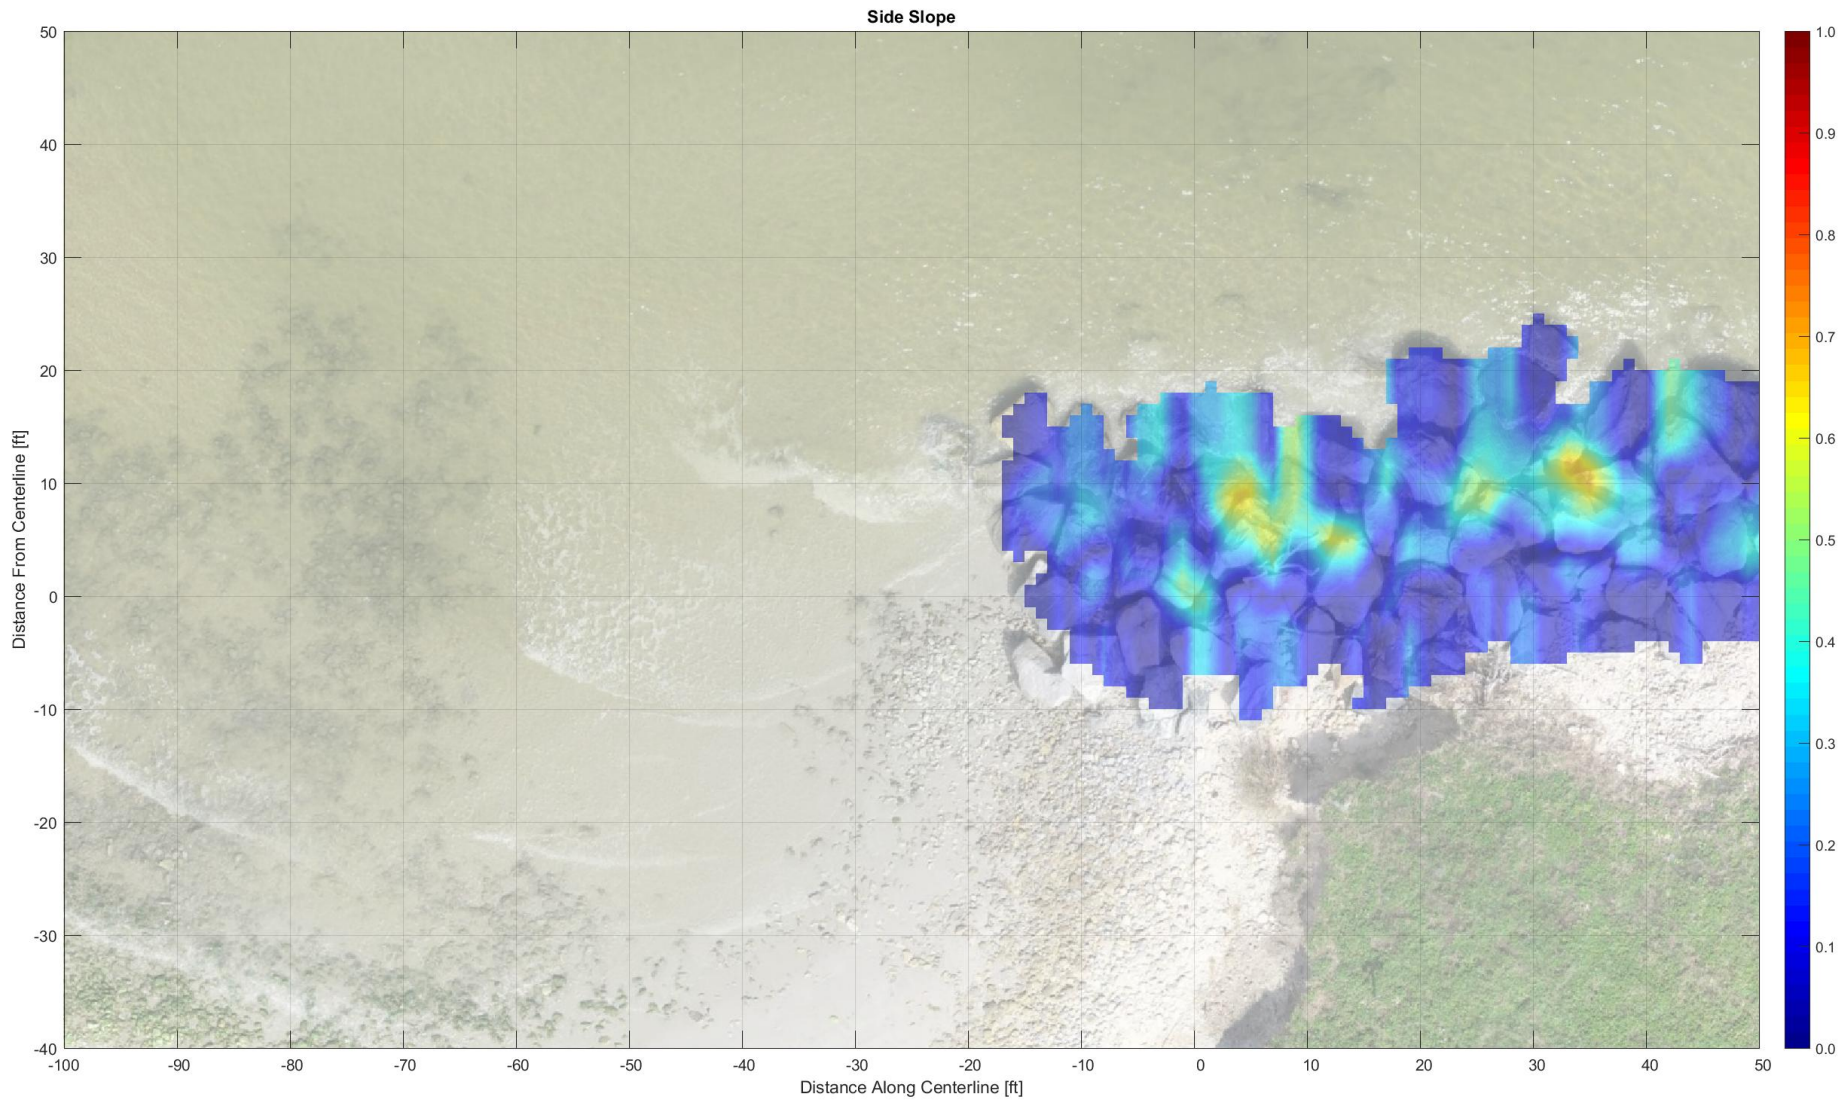
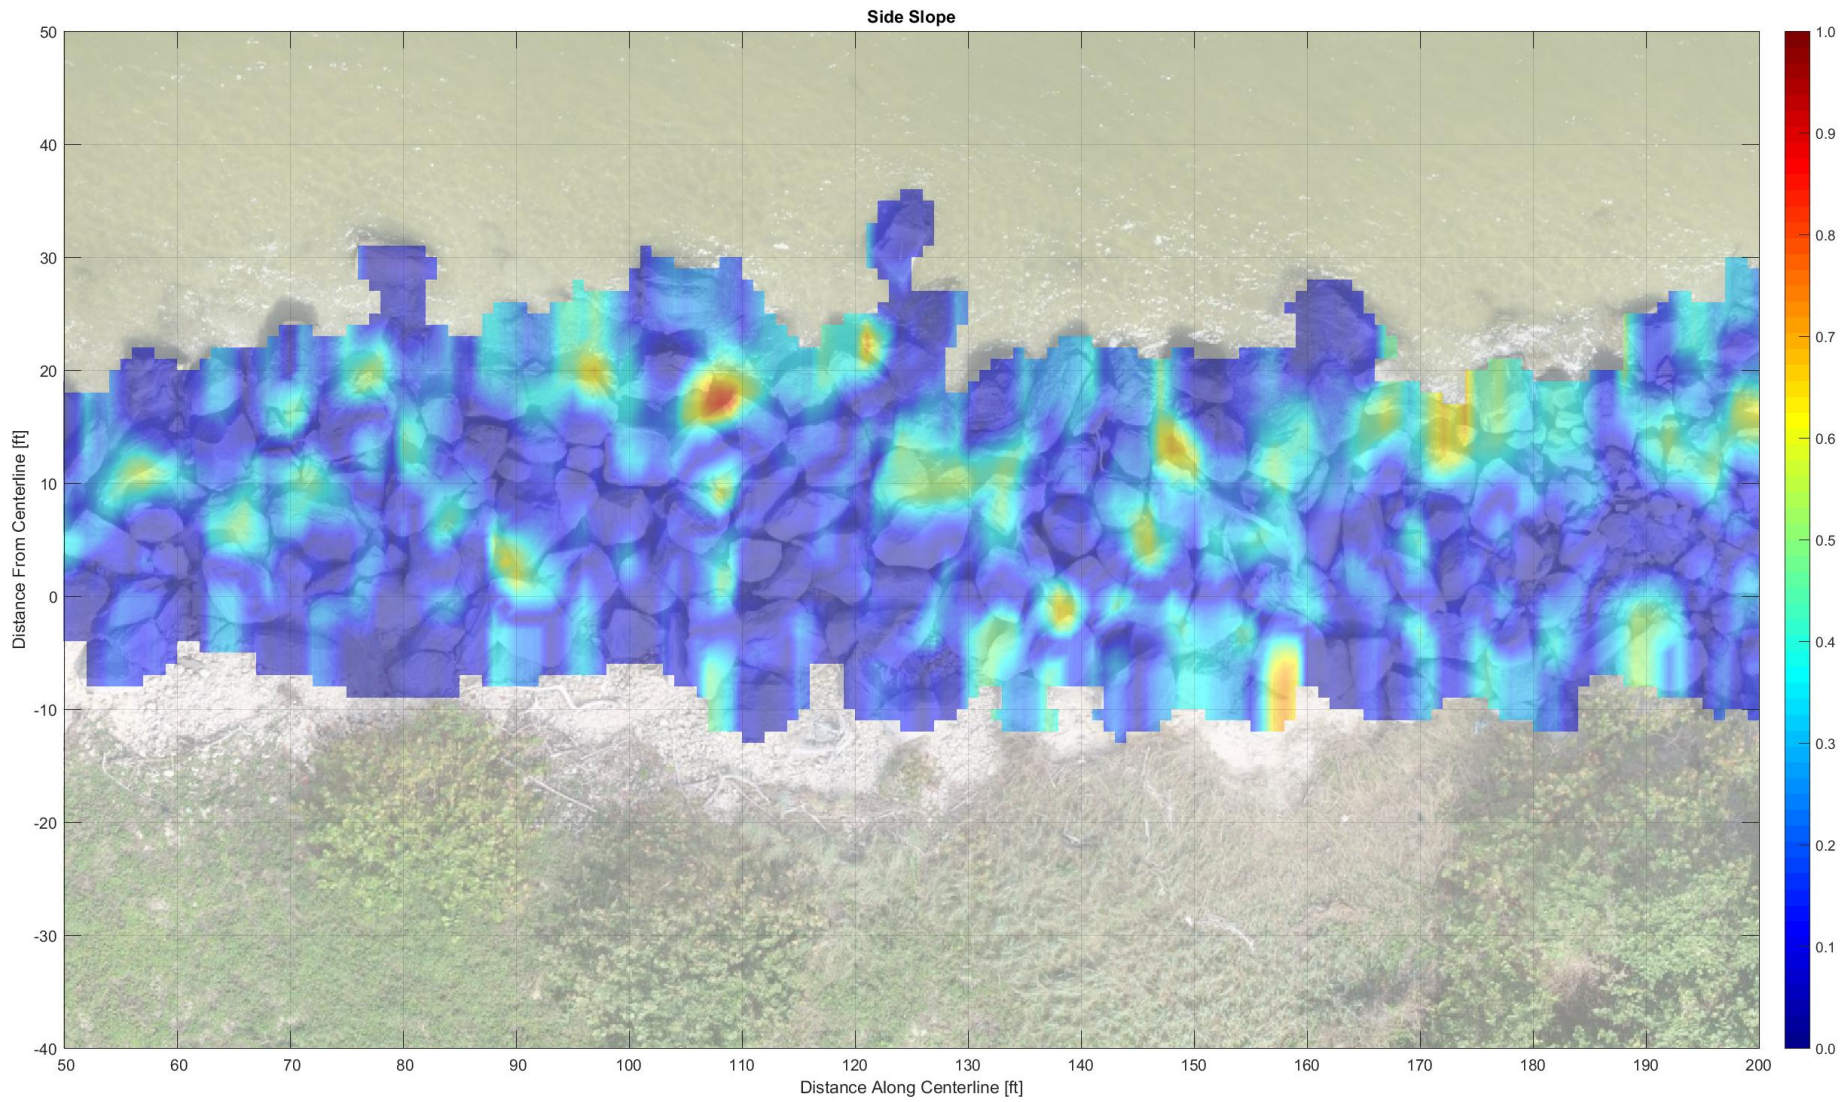
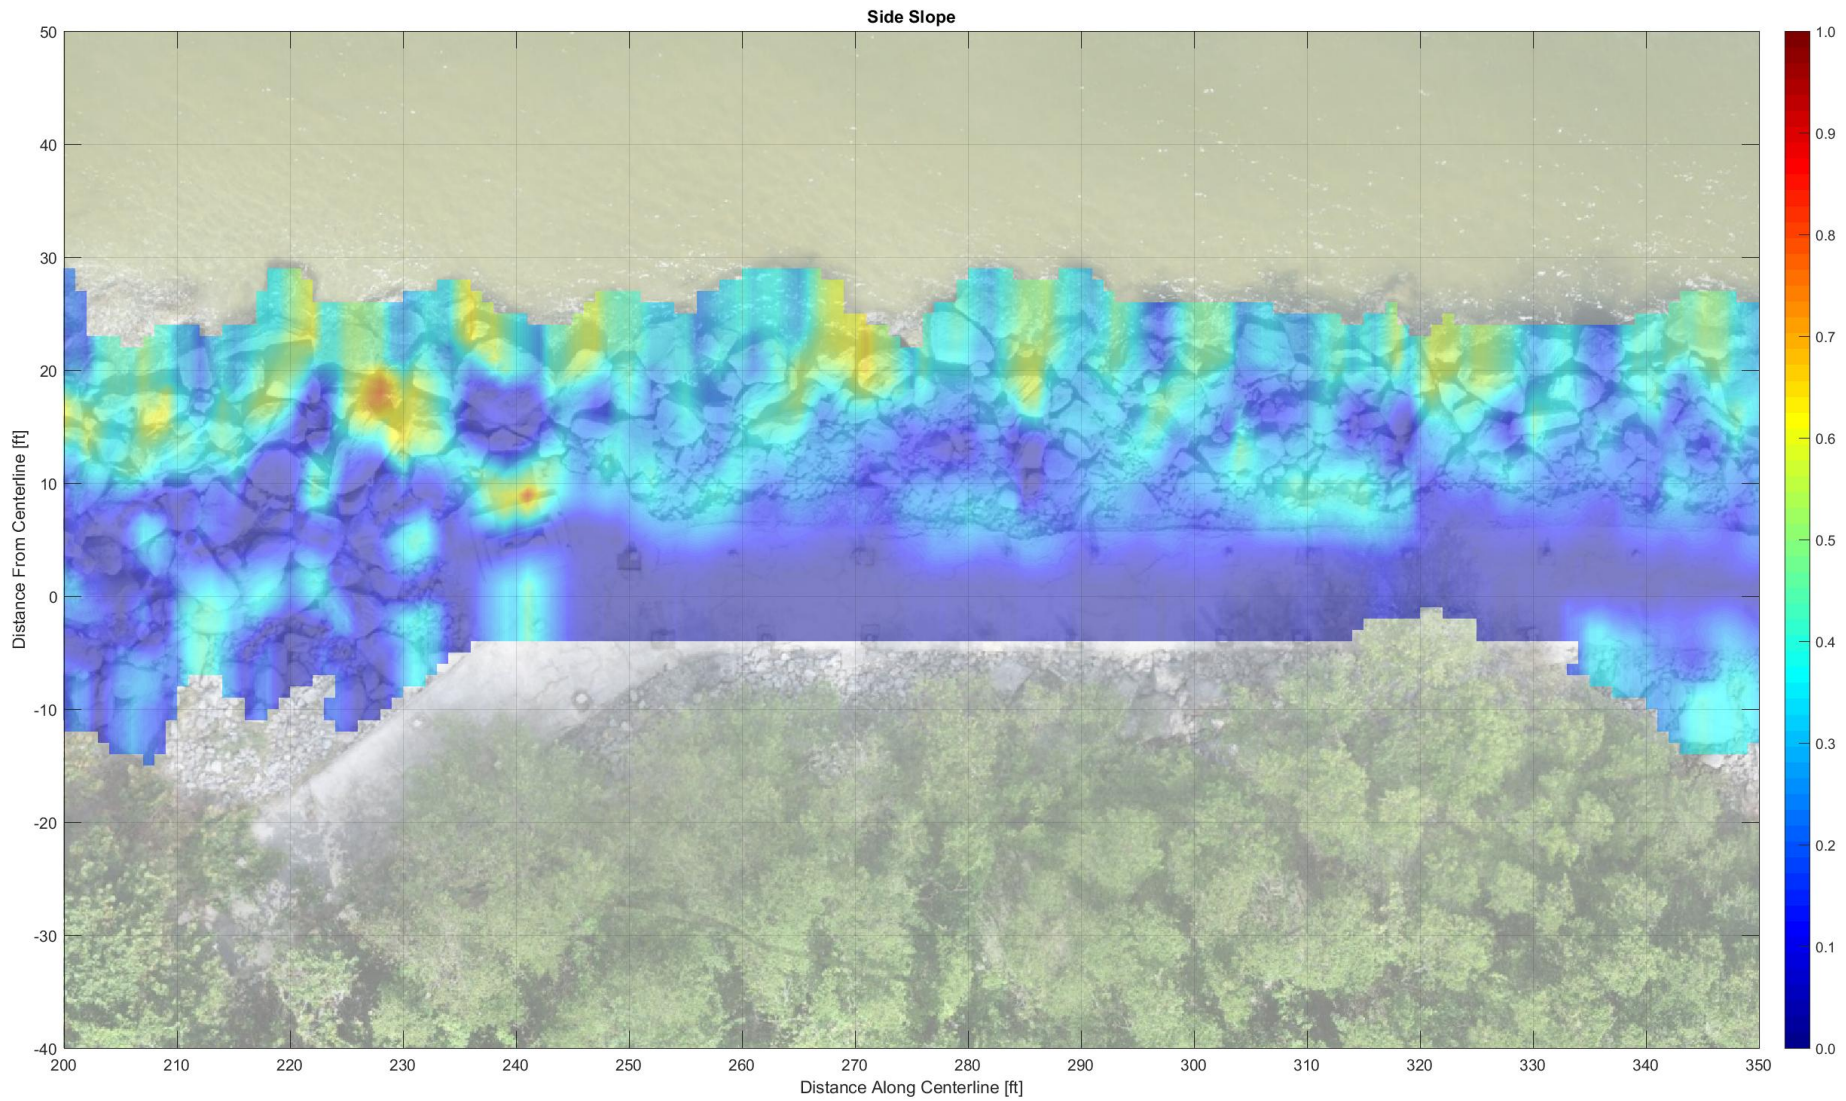
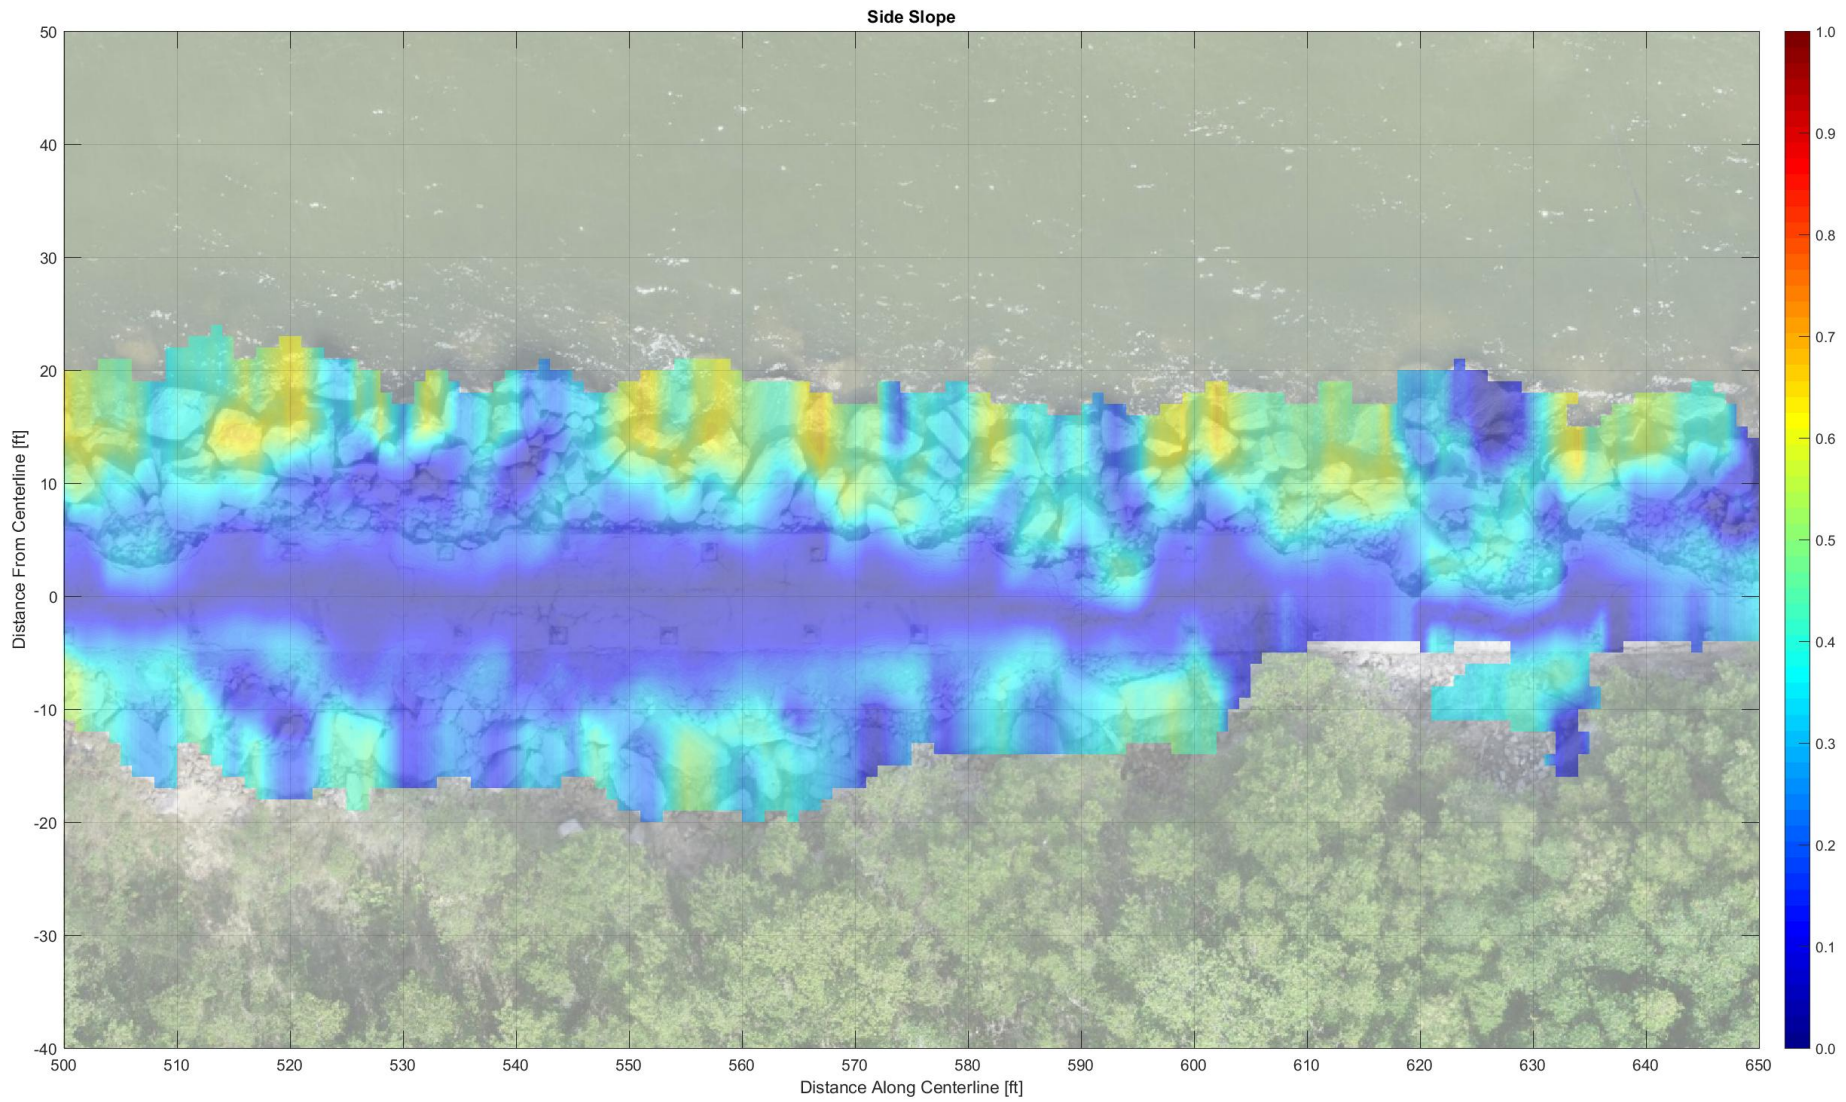
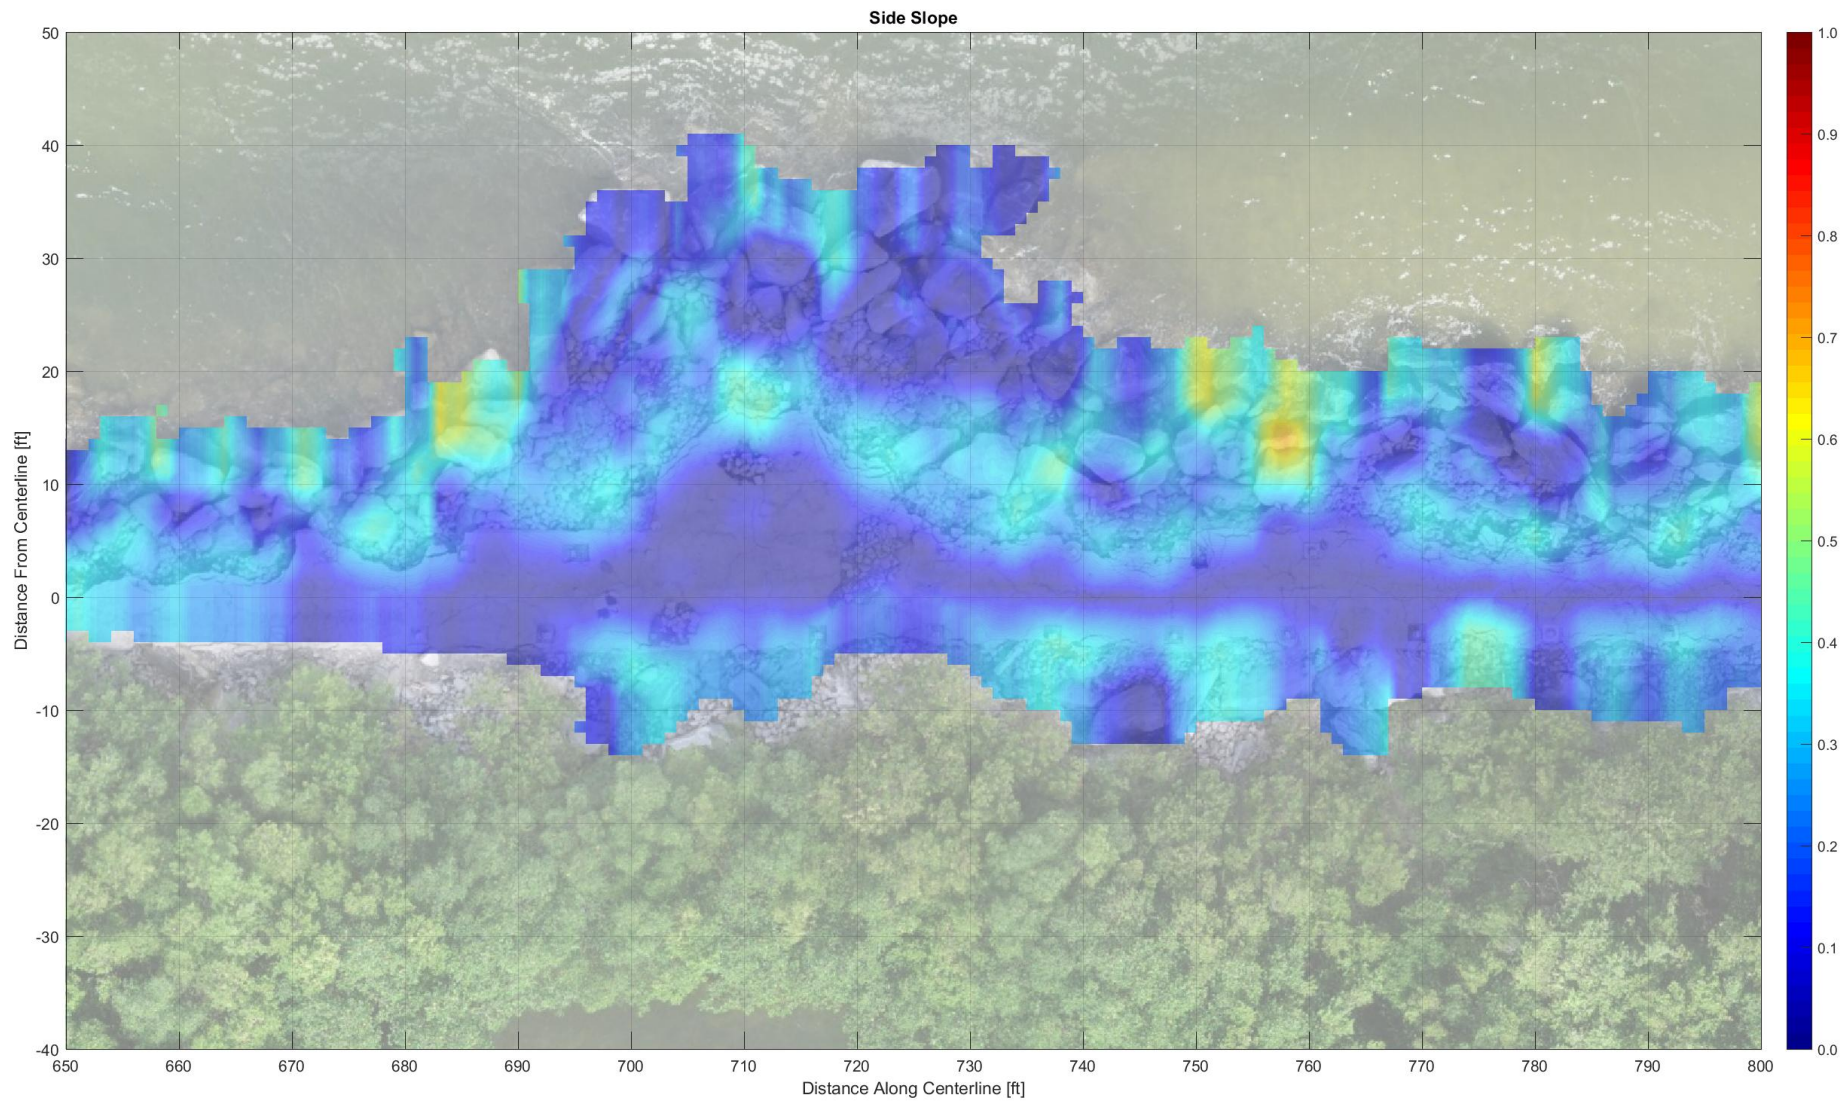
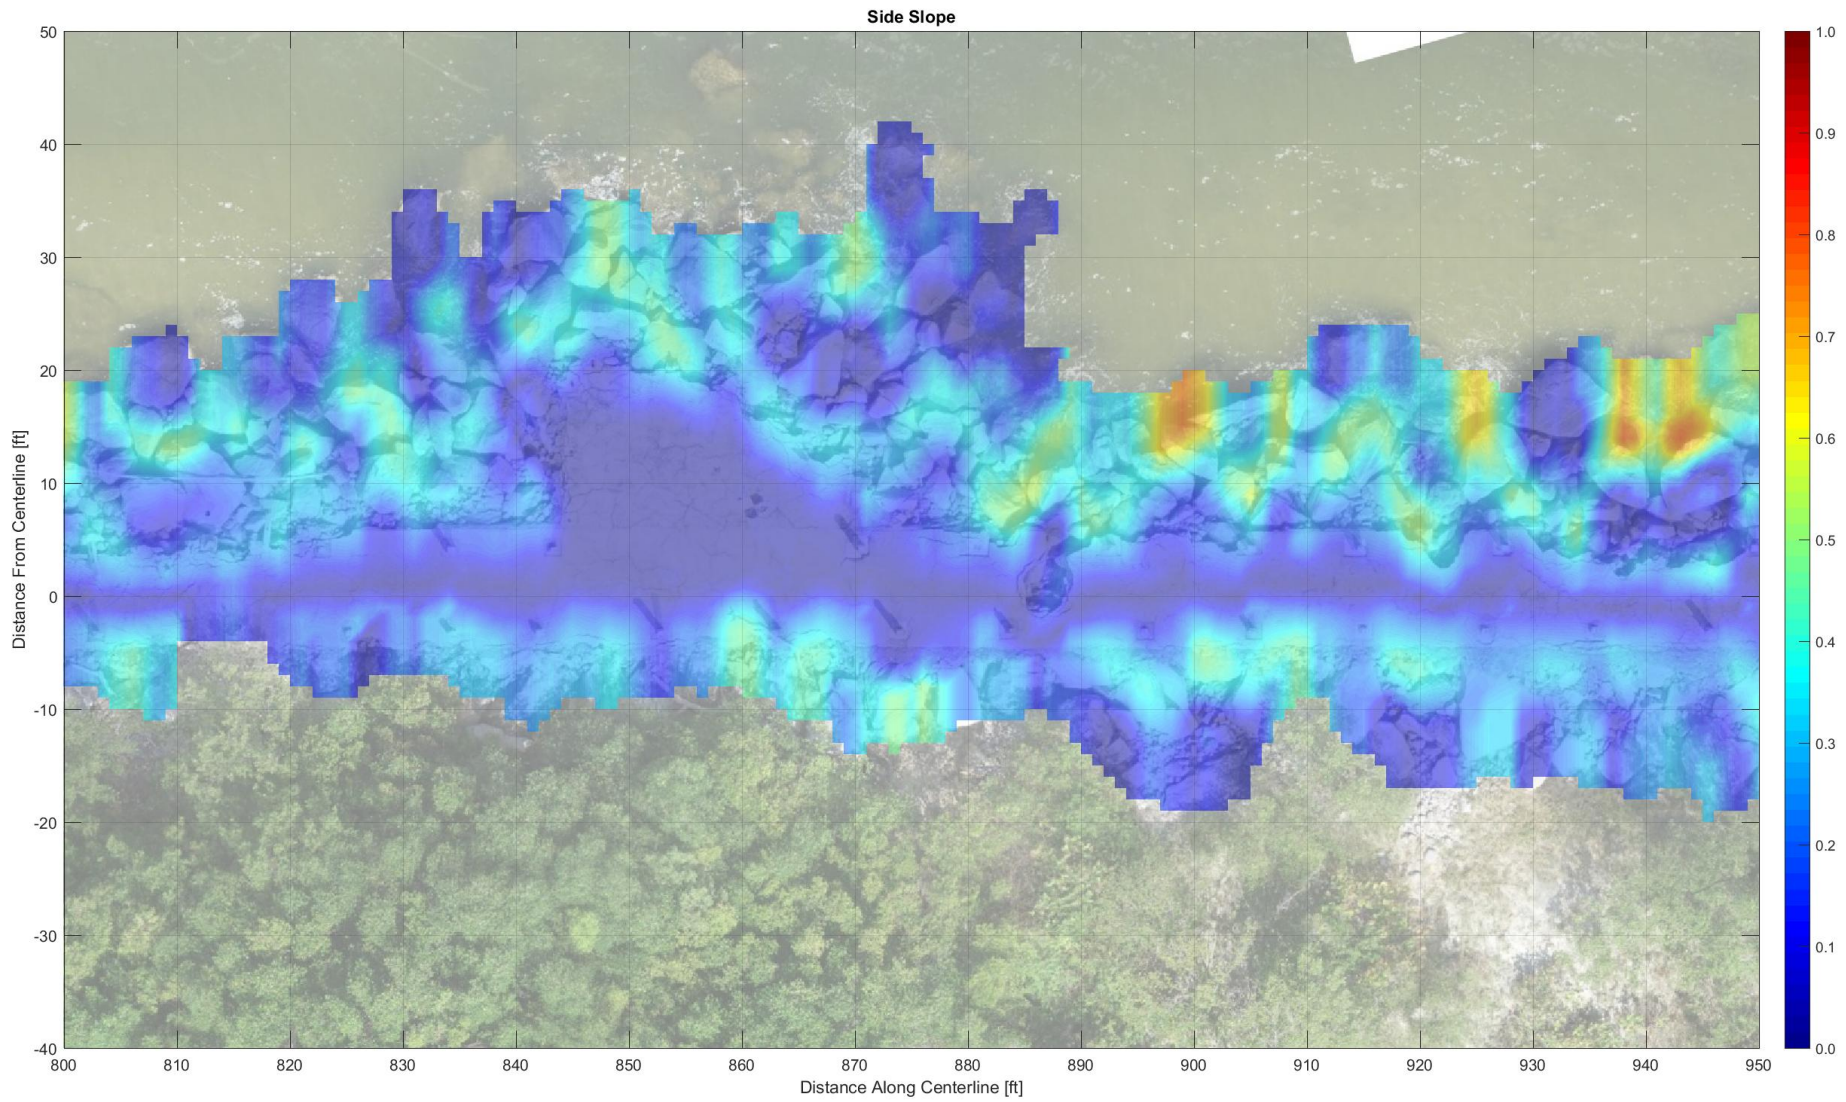
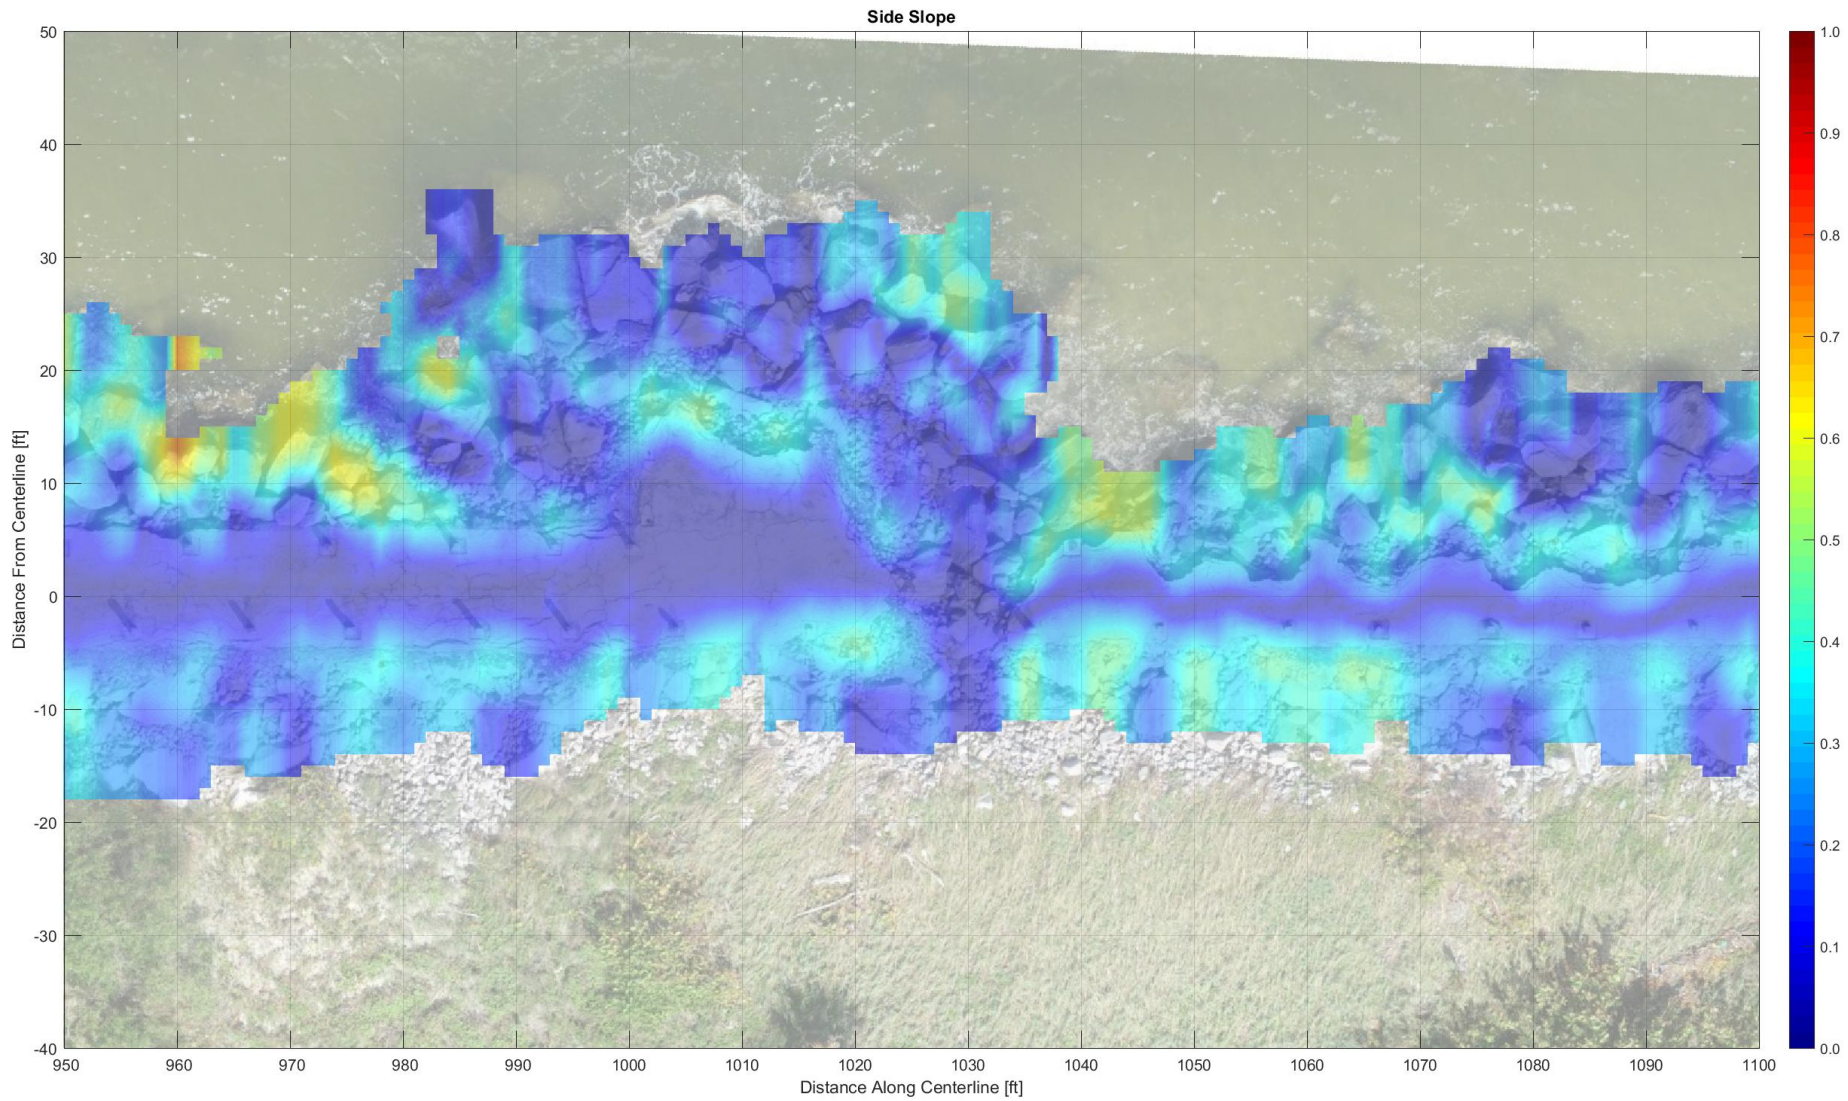
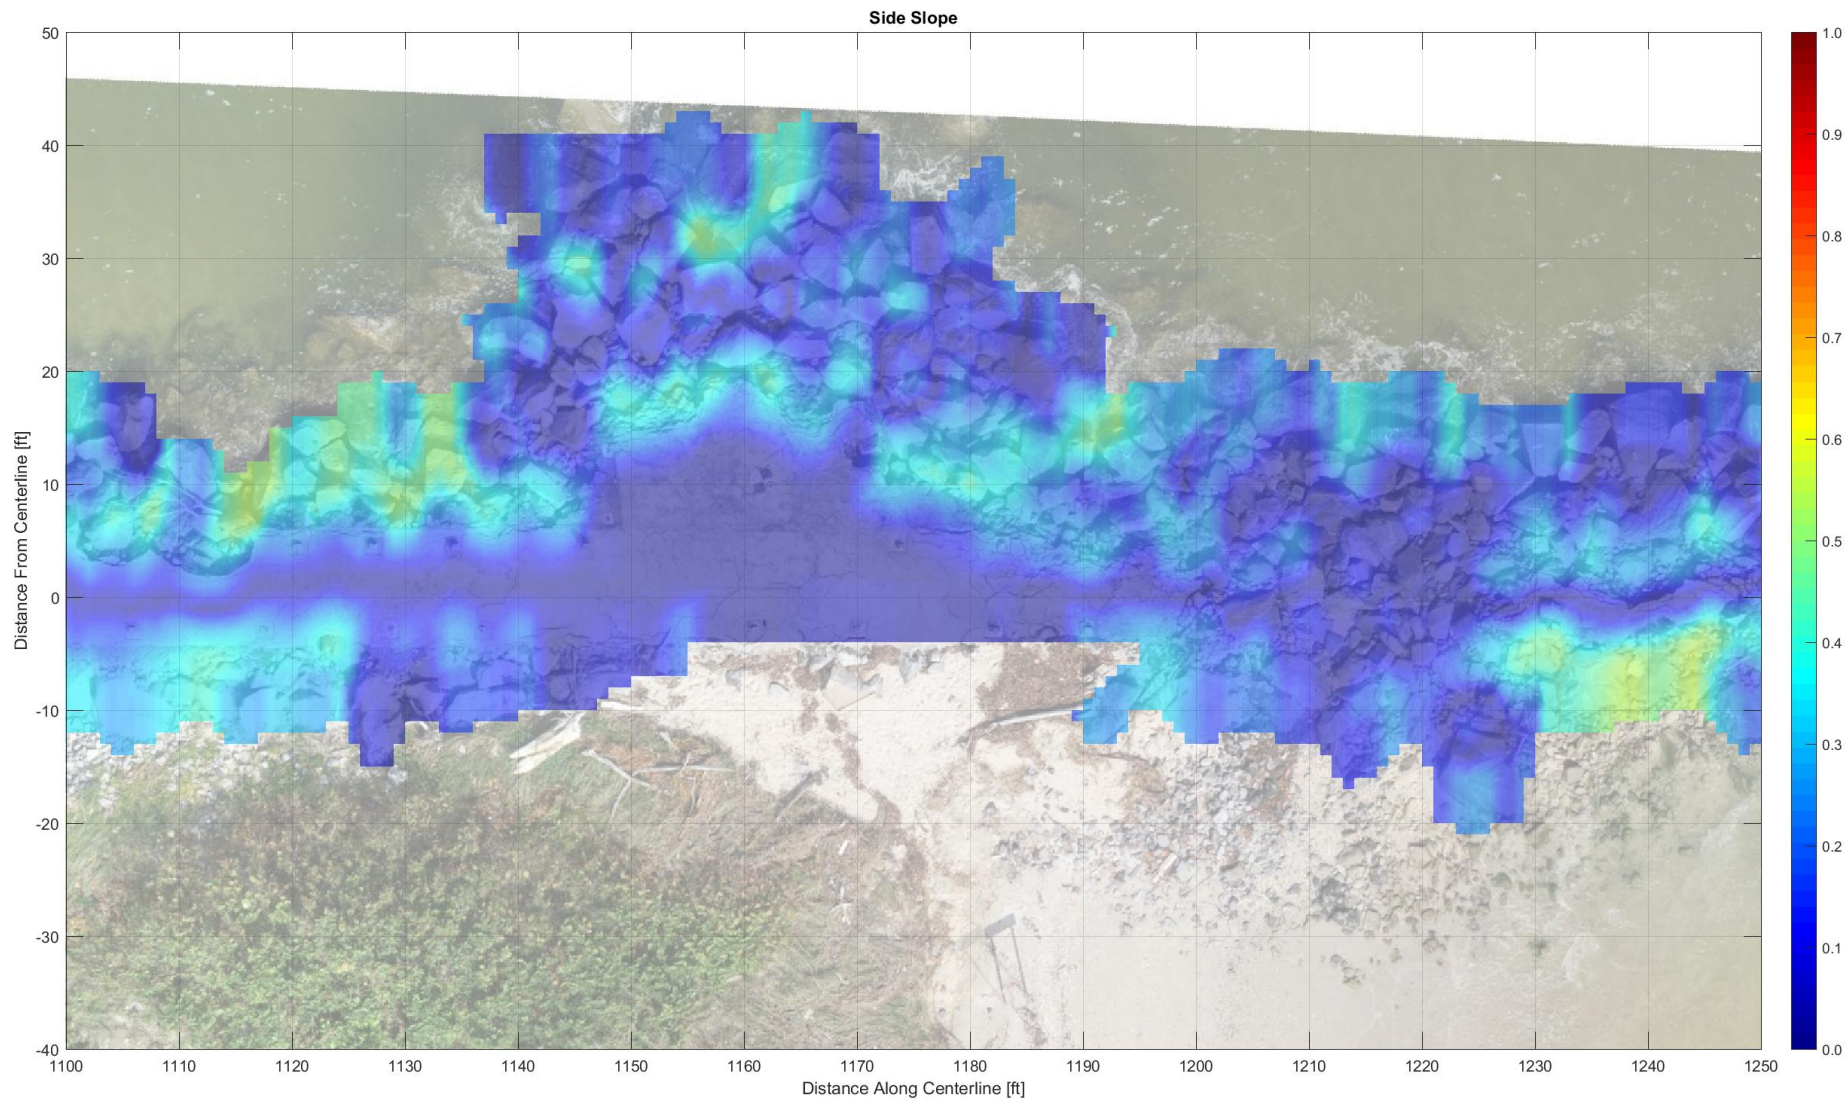
# JETTY SIDE SLOPES

Face	Min	Max	Avg
North	1V:3.0H	1V:1.2H	1V:3.7H
South	1V:7.7H	1V:1.4H	1V:4.1H

› Average and maximum side slopes were calculated for each 20-foot segment along the north and south jetty faces.
