# DRONE TECHNOLOGY AND RUBBLE MOUND STRUCTURES

## ST. LUCIE INLET SOUTH JETTY CASE STUDY

Presented By: Andrew Wycklendt, P.E.

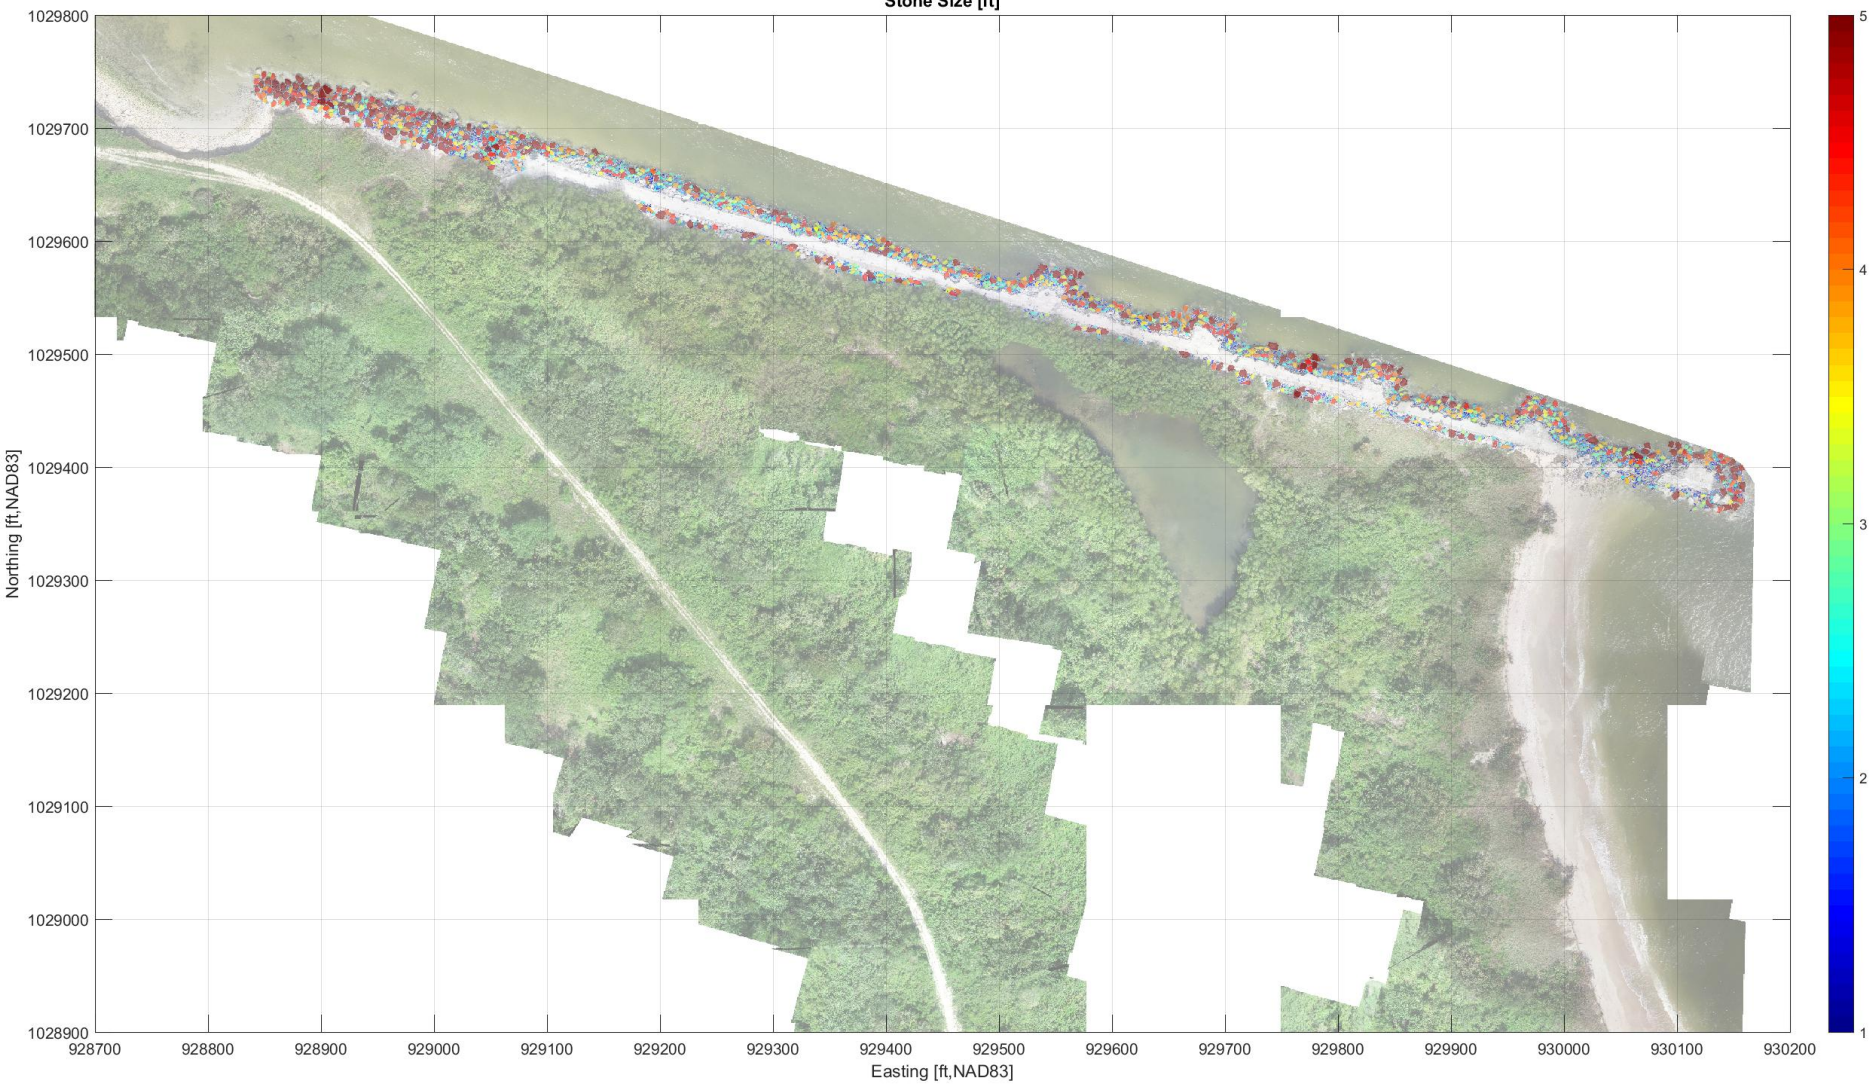
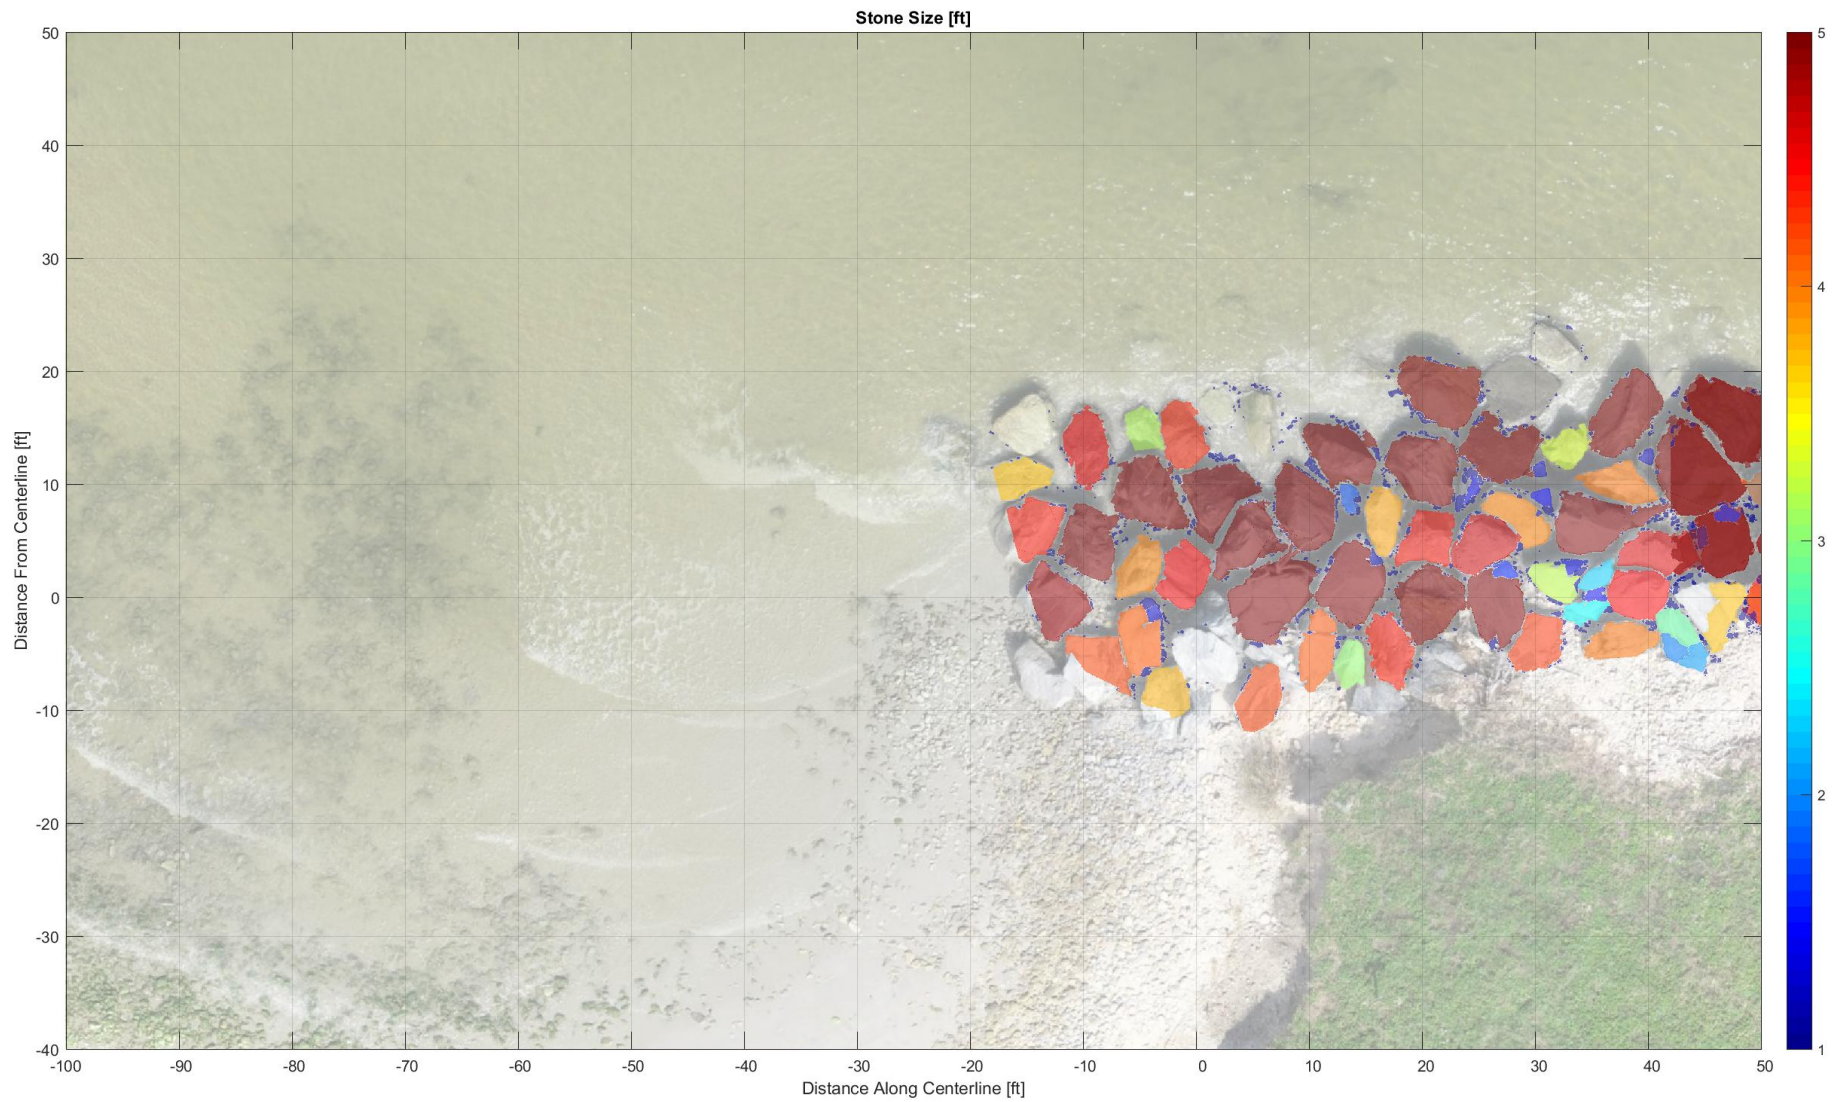
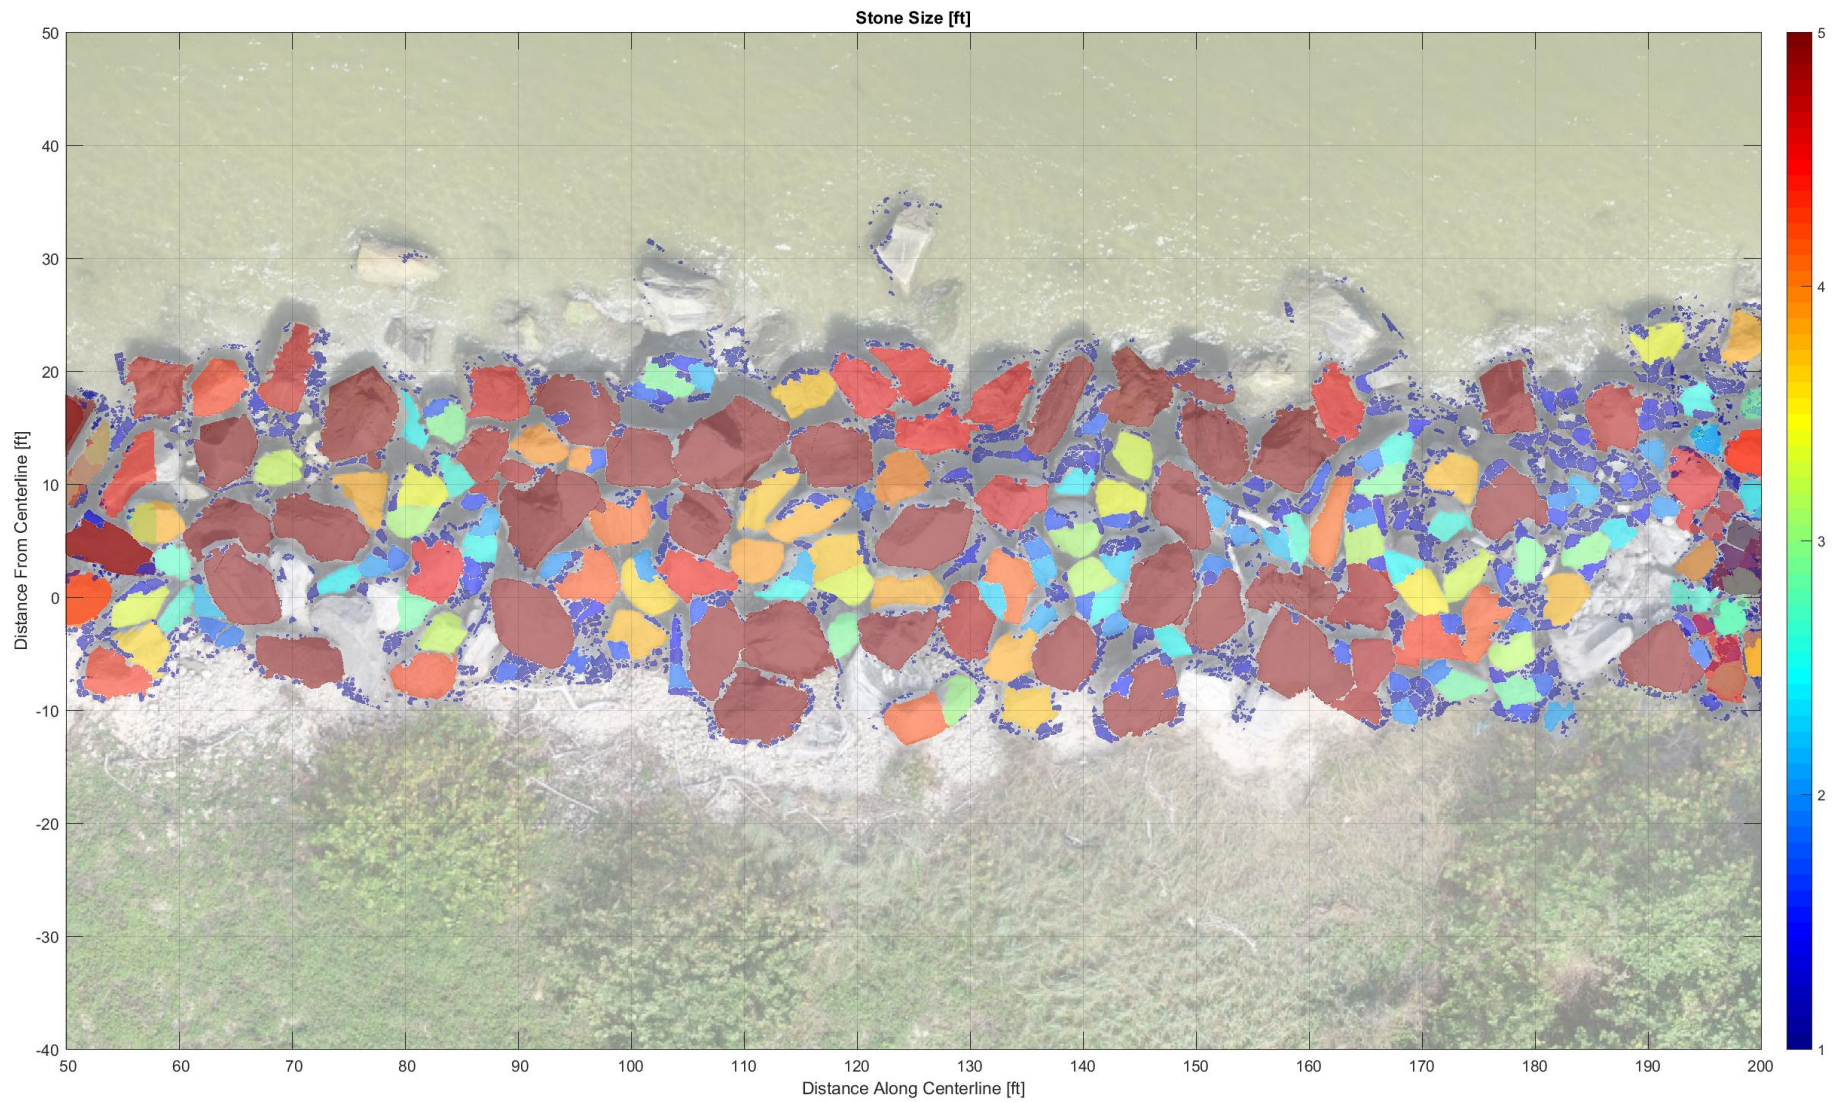
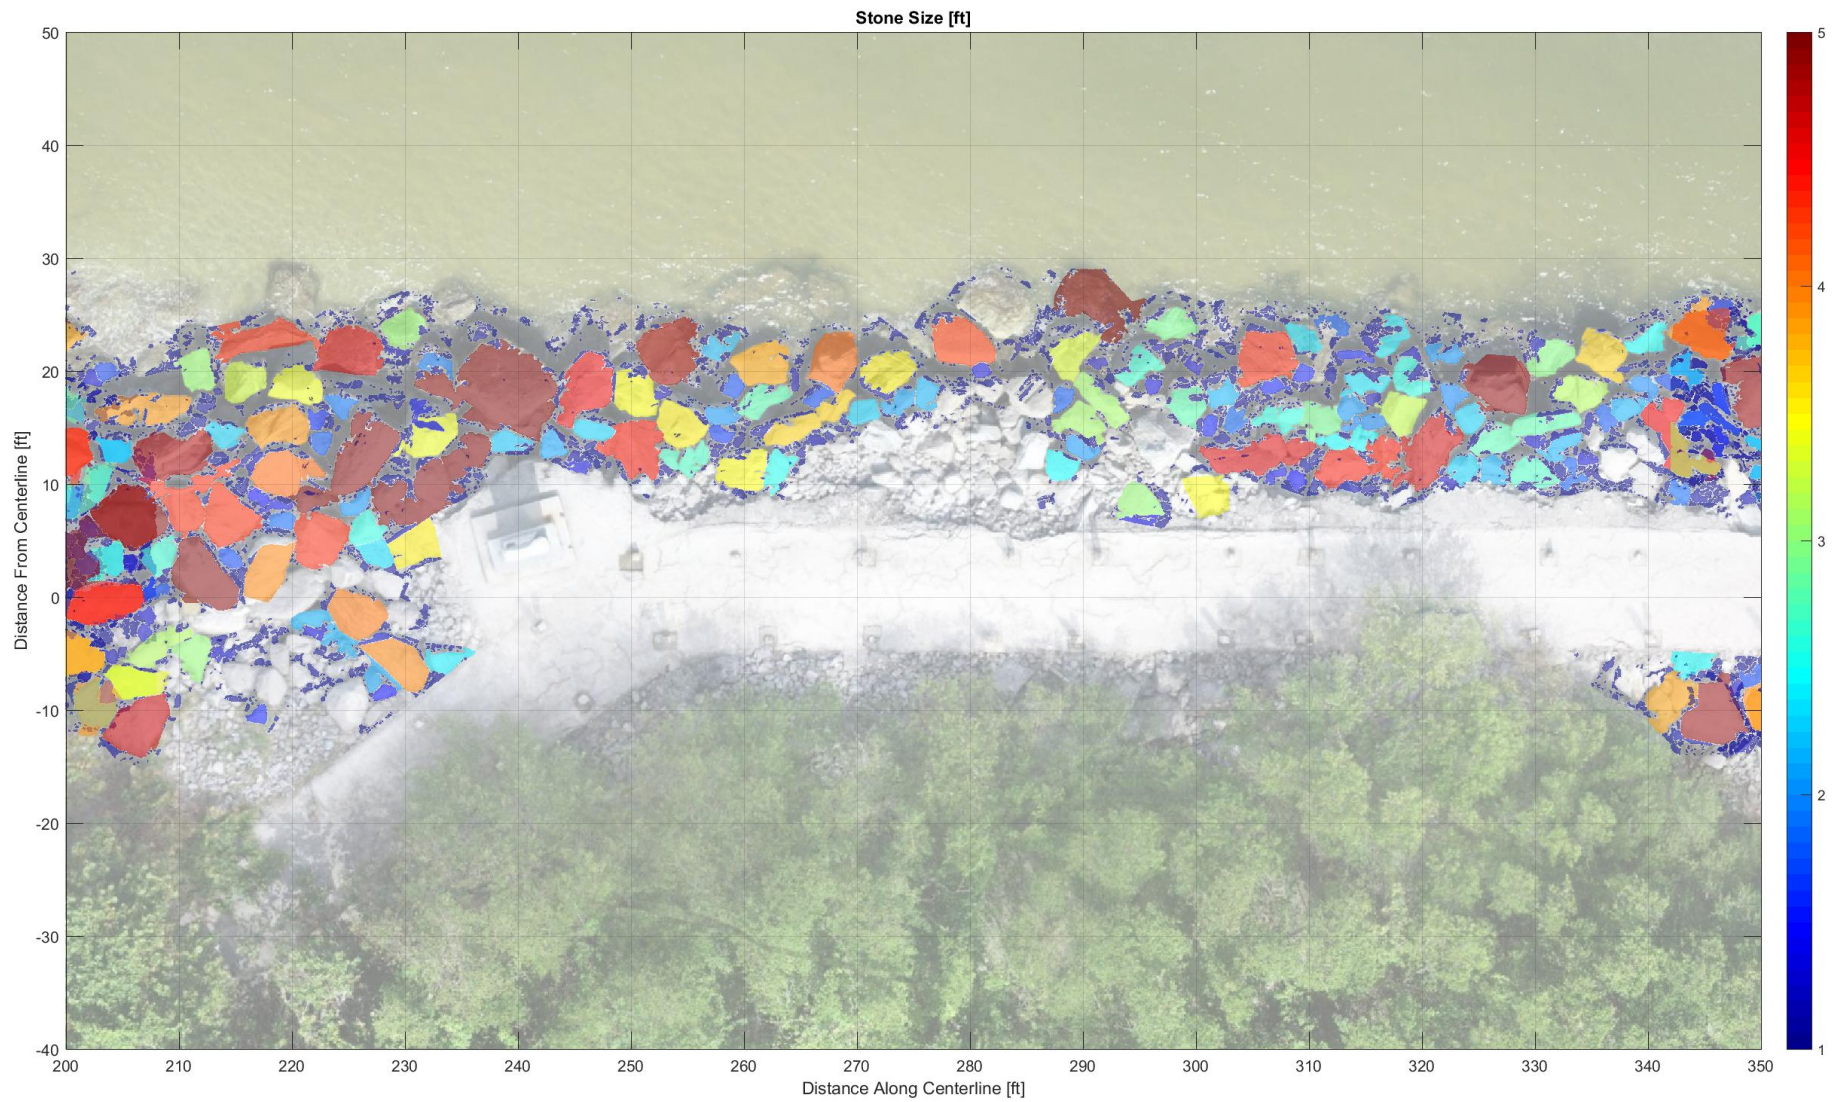
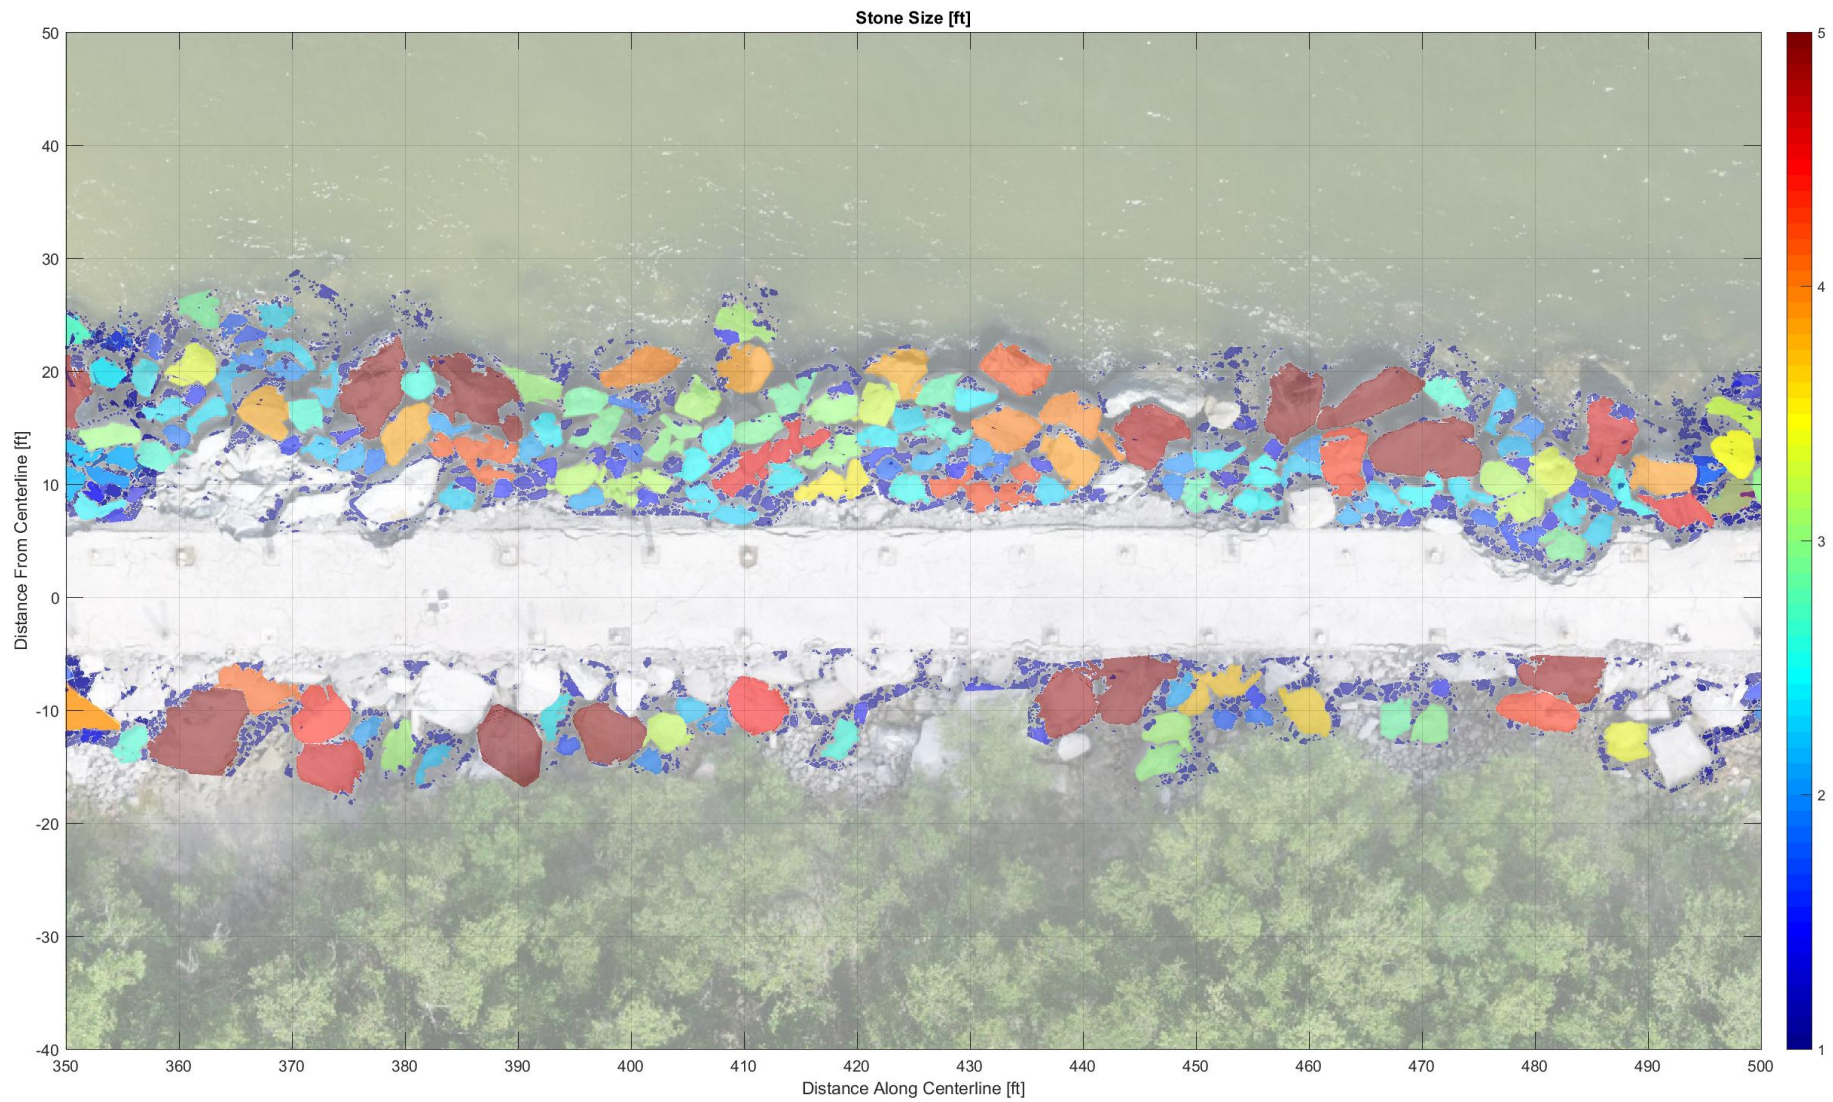
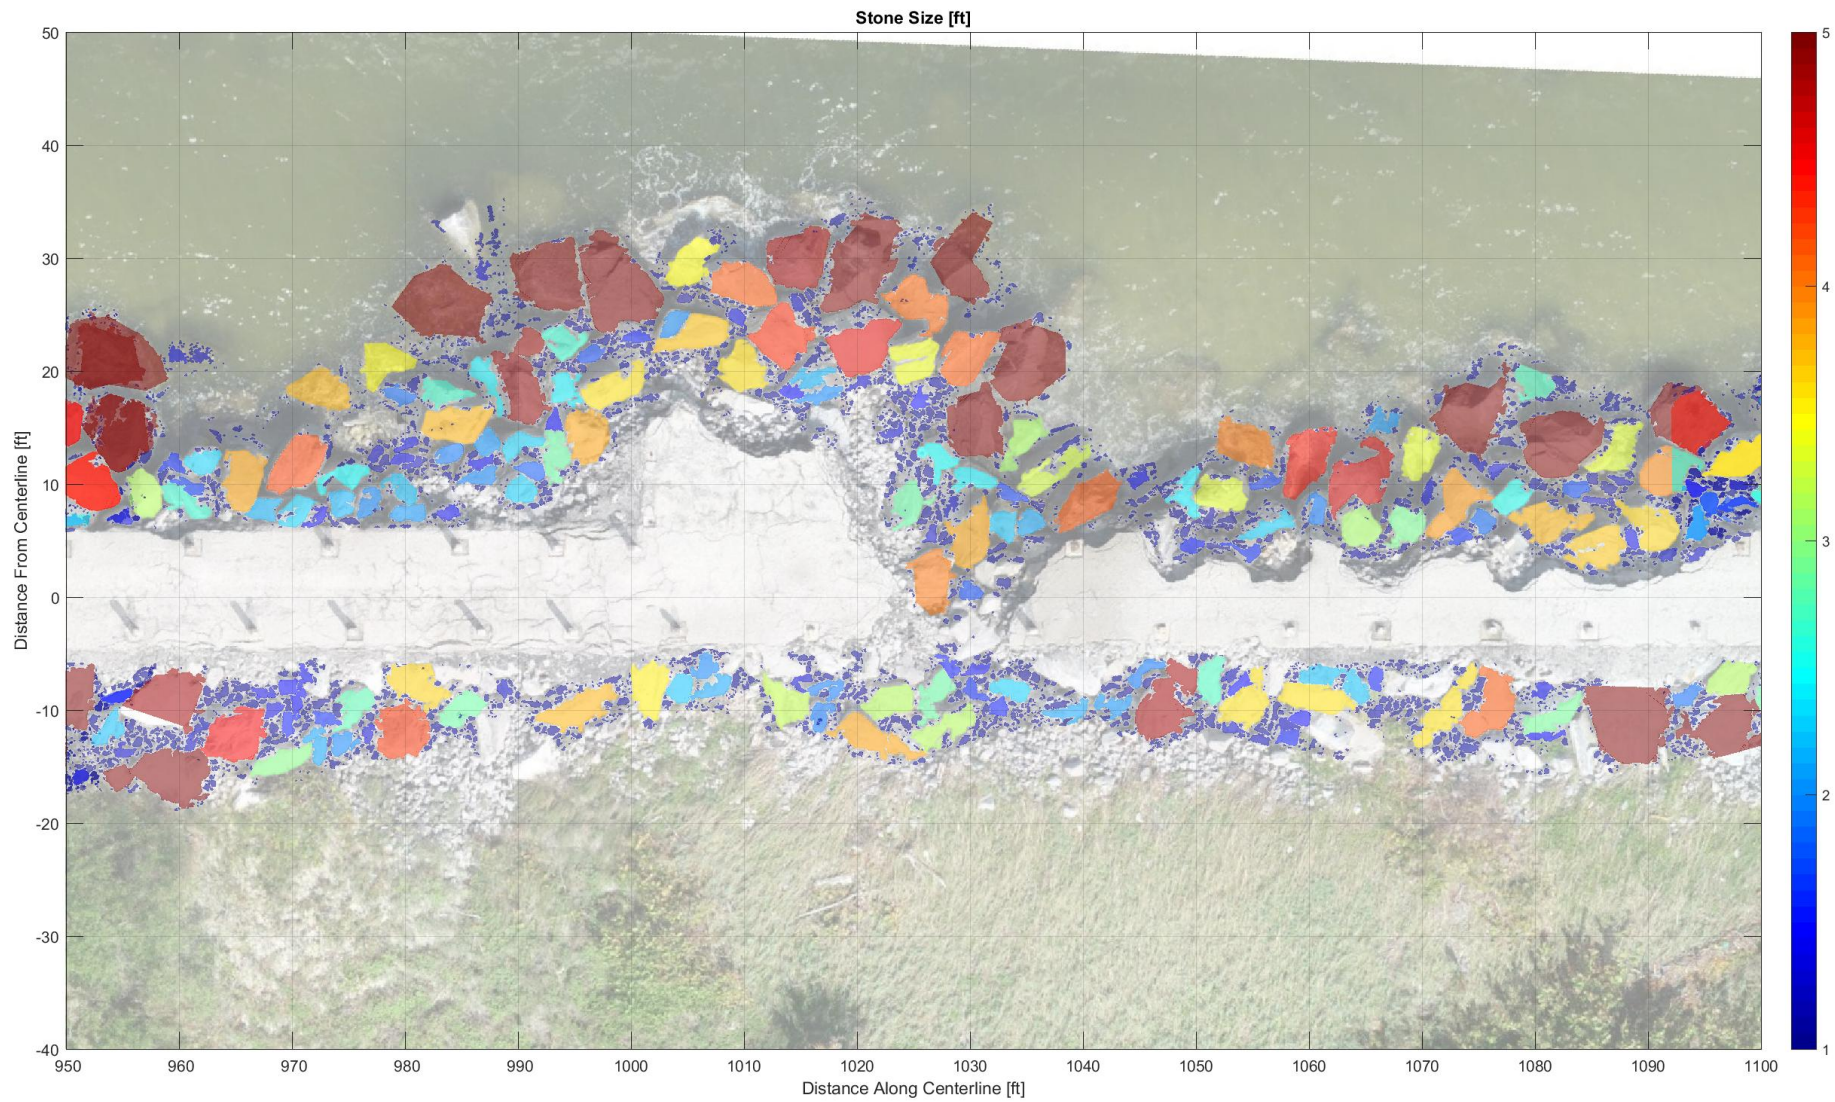
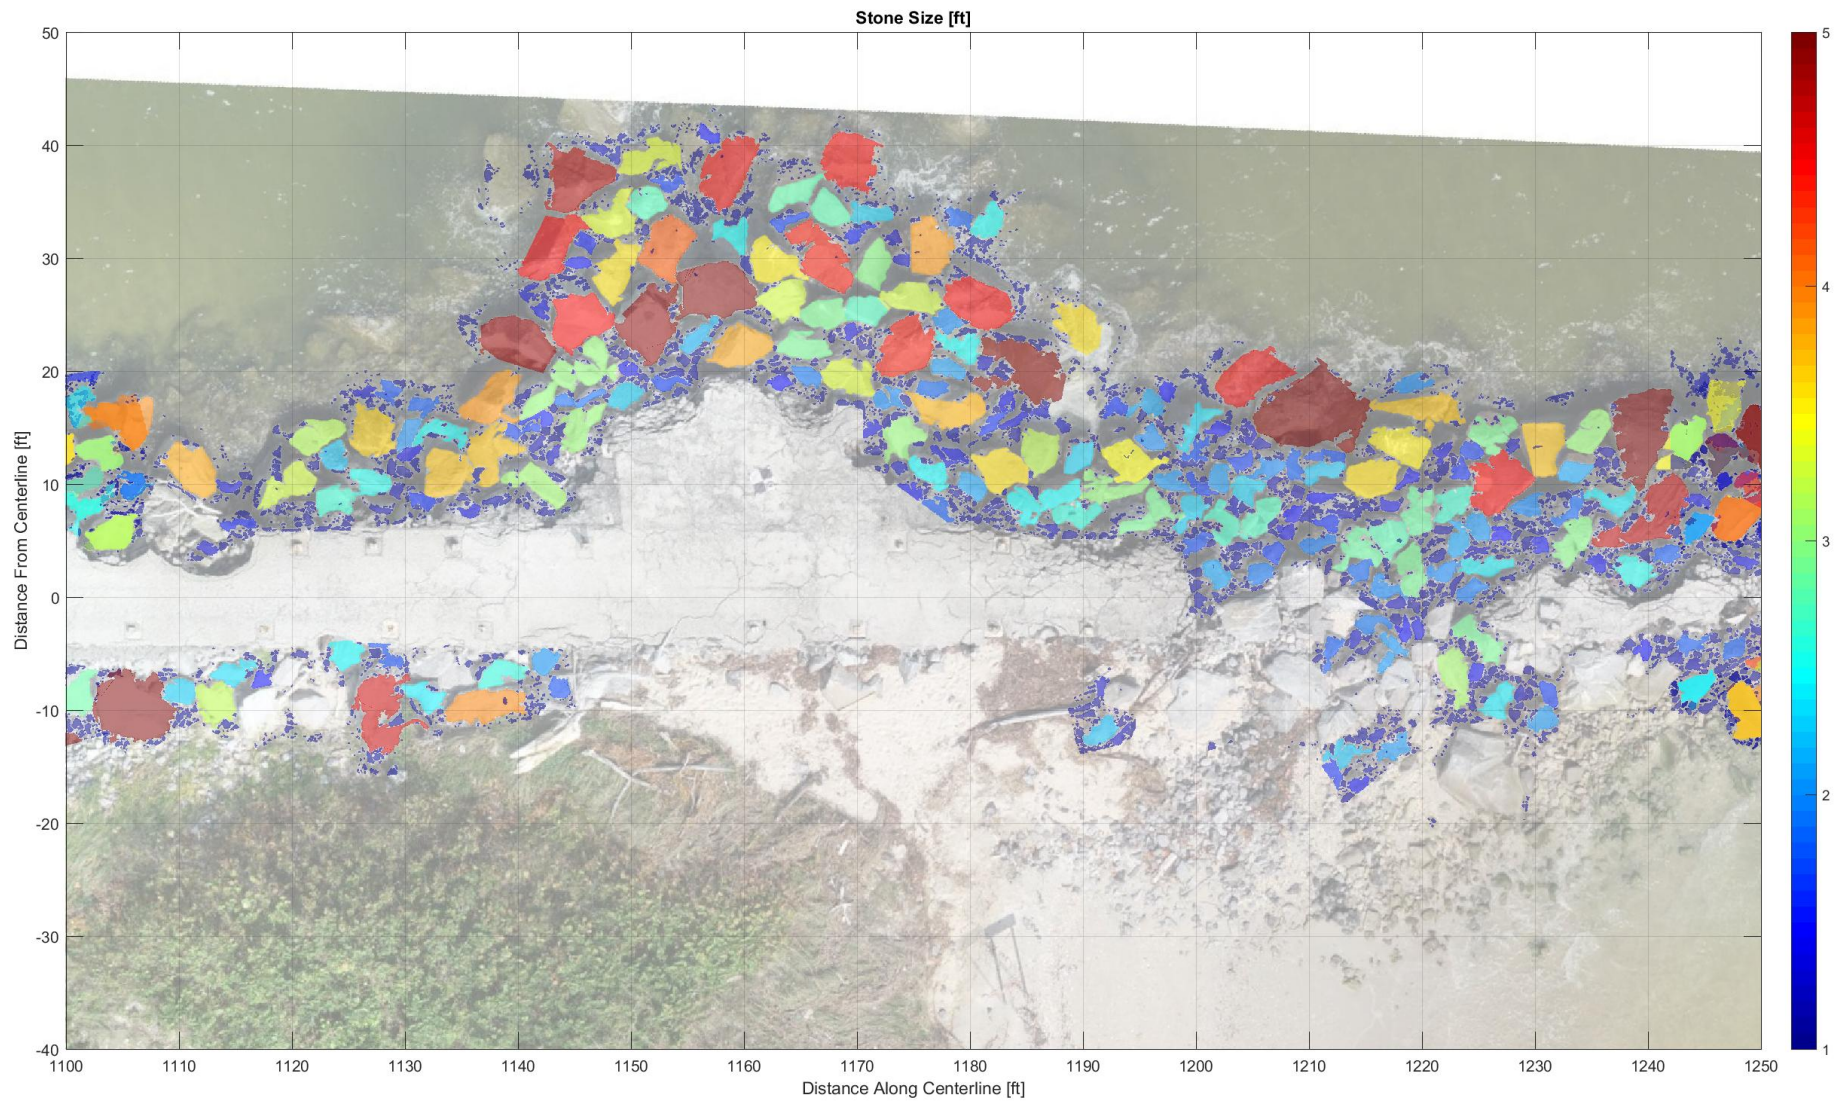
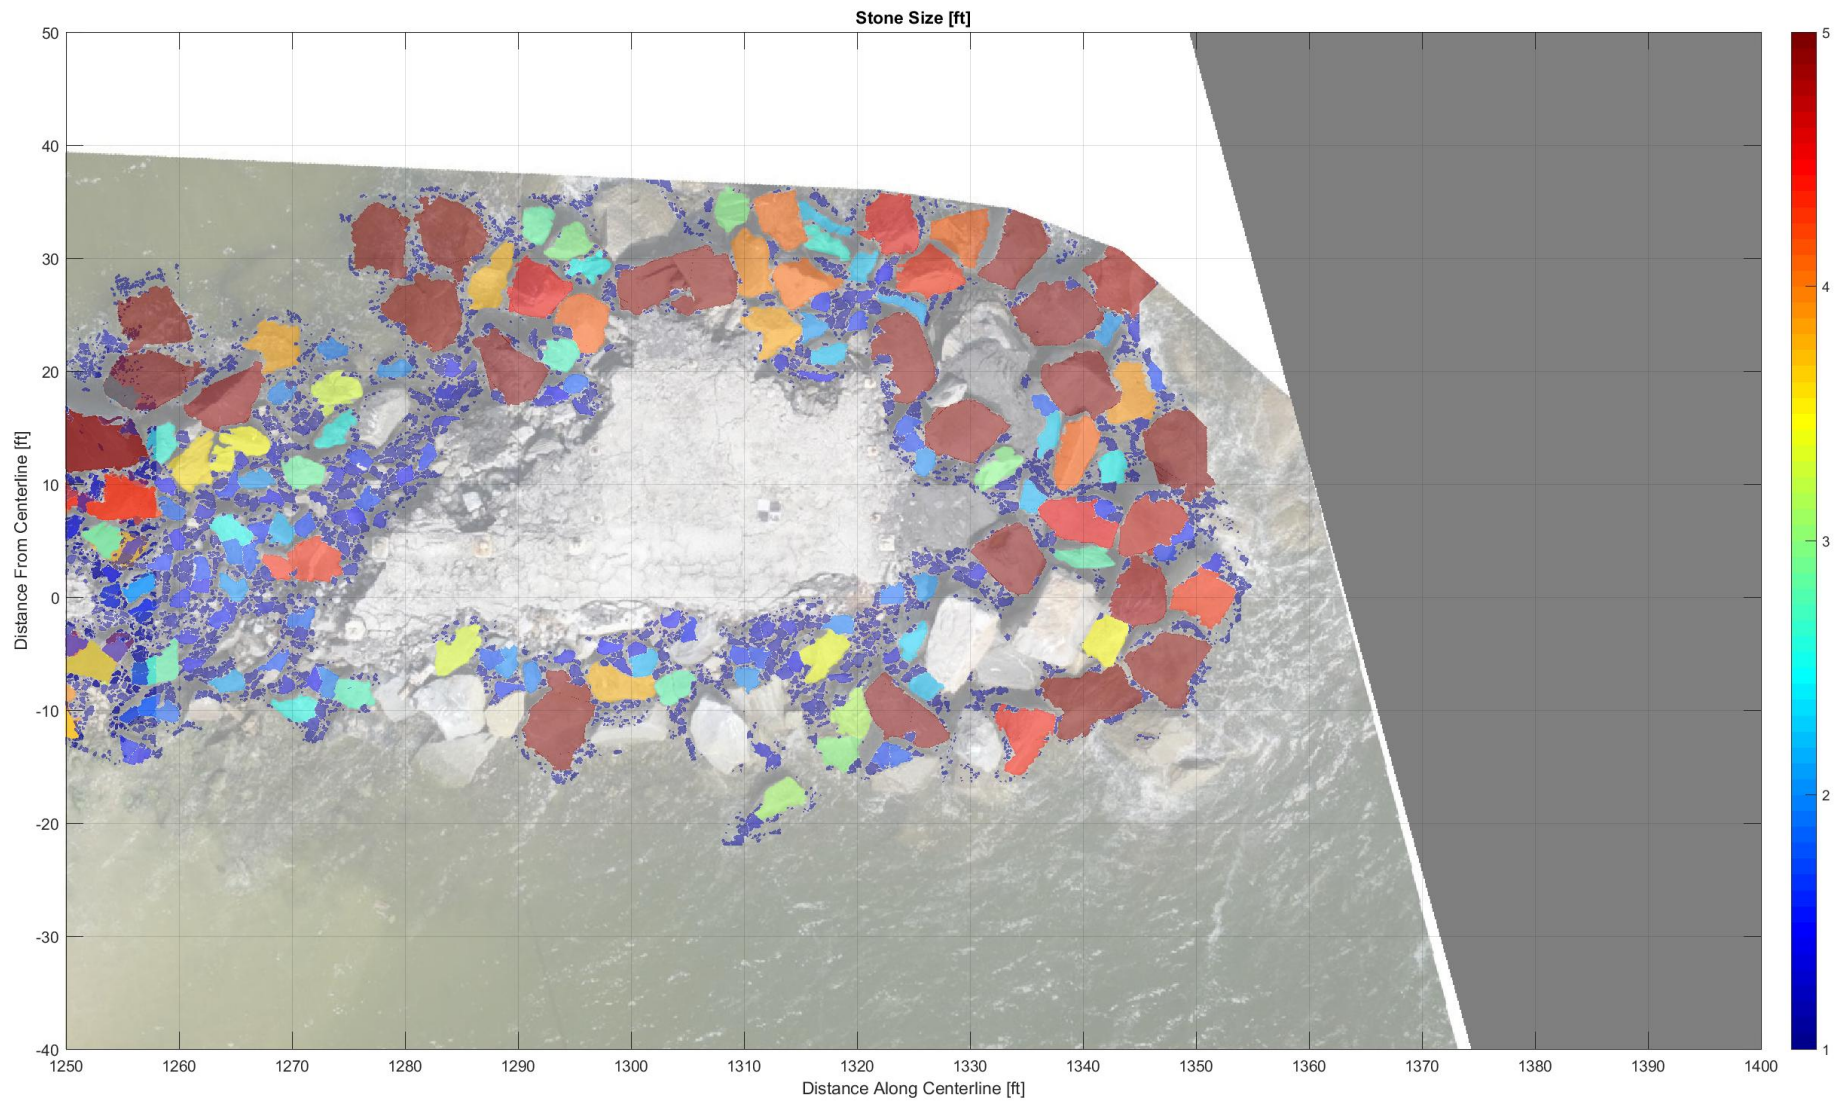
# JETTY STONE SIZES

Face	Min	Max	Avg
North	1.8	4.8	3.1
South	0.5	6.1	2.9

- Minimum, maximum, and average stone sizes were calculated for each 20-foot segment along the north and south jetty faces.
