# DRONE TECHNOLOGY AND RUBBLE MOUND STRUCTURES

## ST. LUCIE INLET SOUTH JETTY CASE STUDY

Presented By: Andrew Wycklendt, P.E.

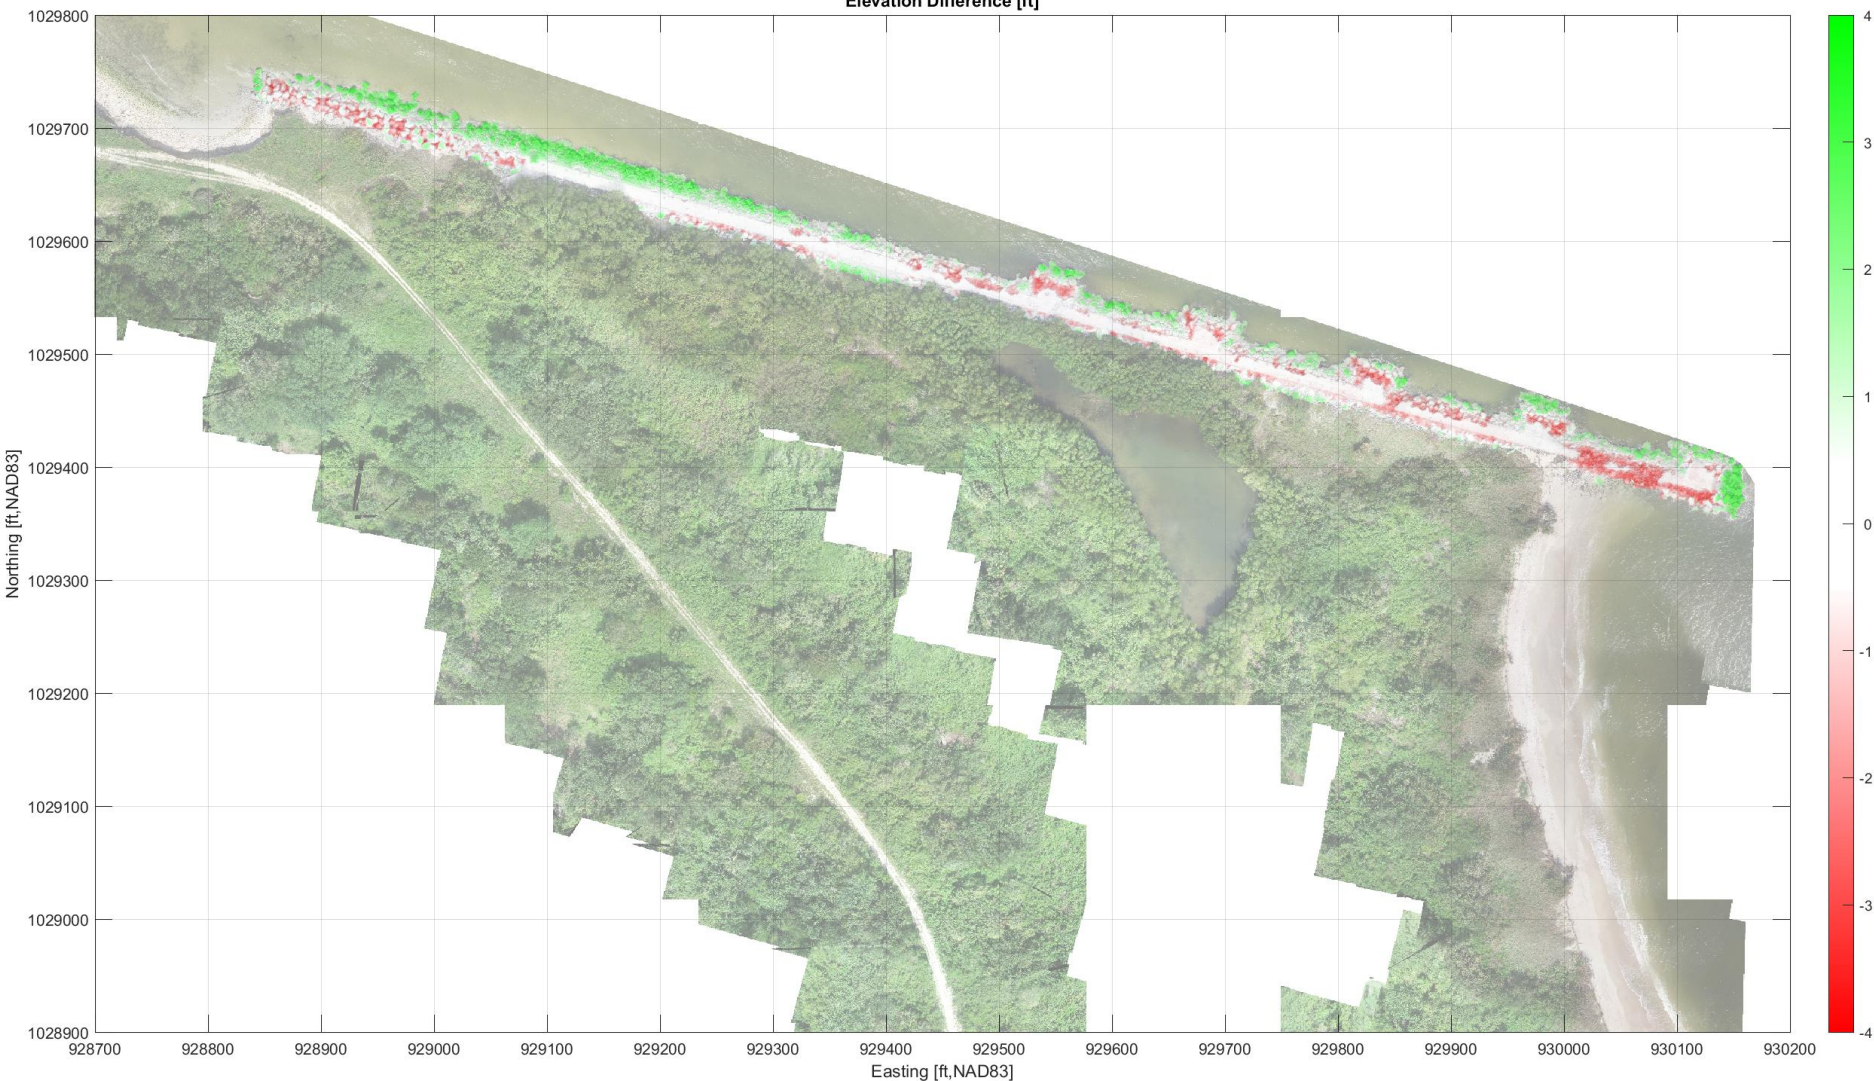
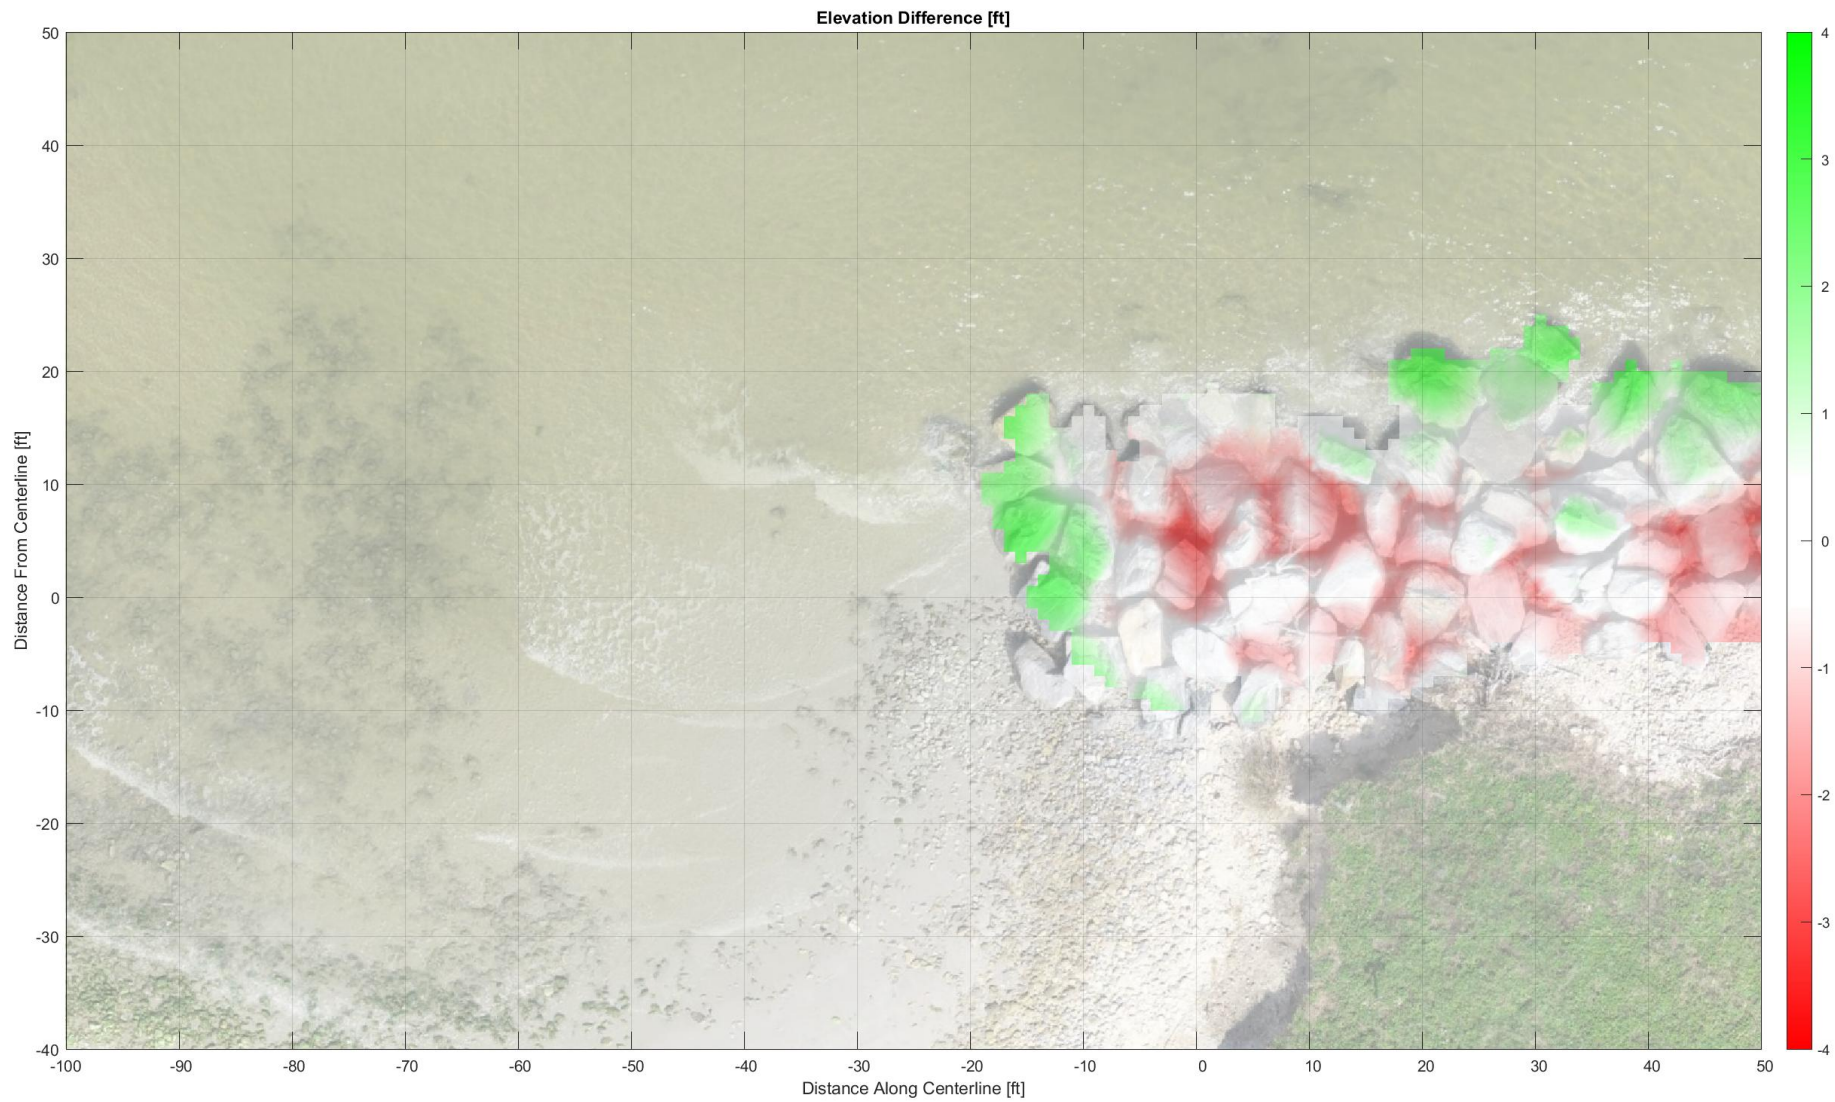
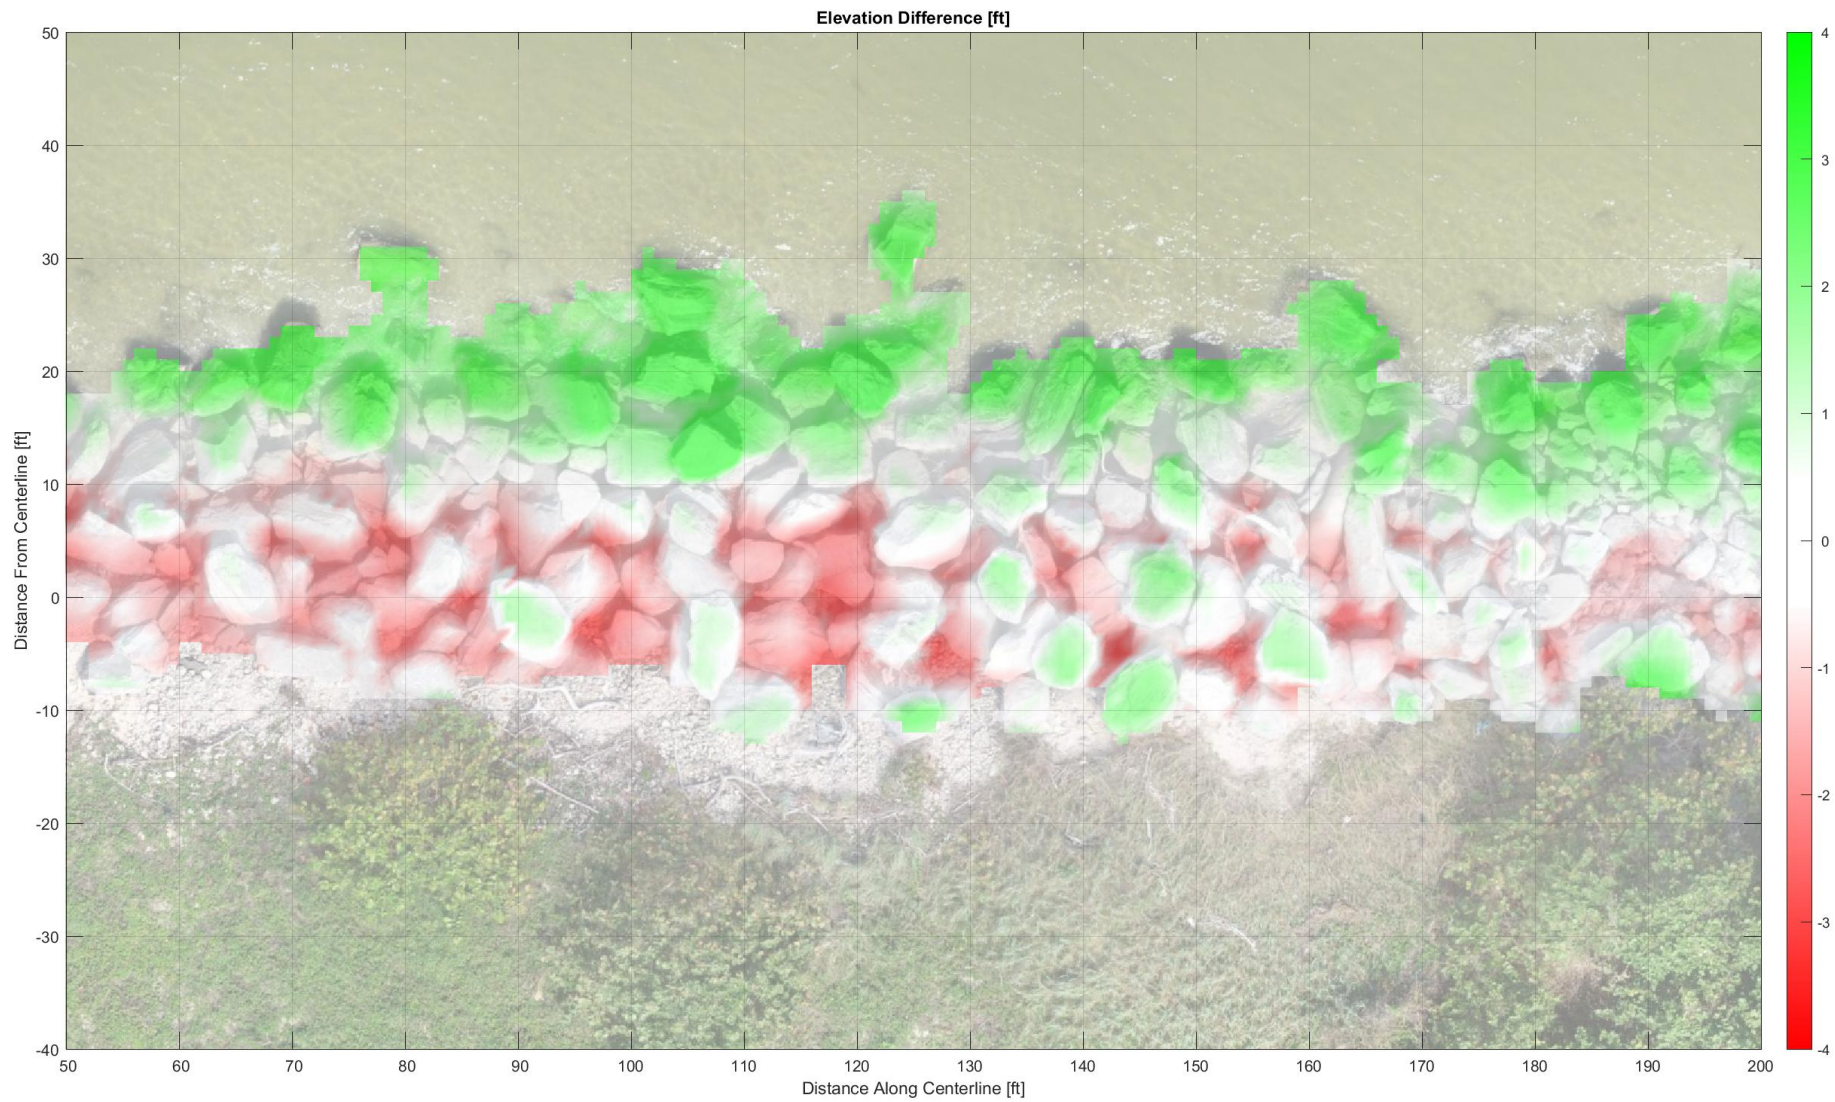
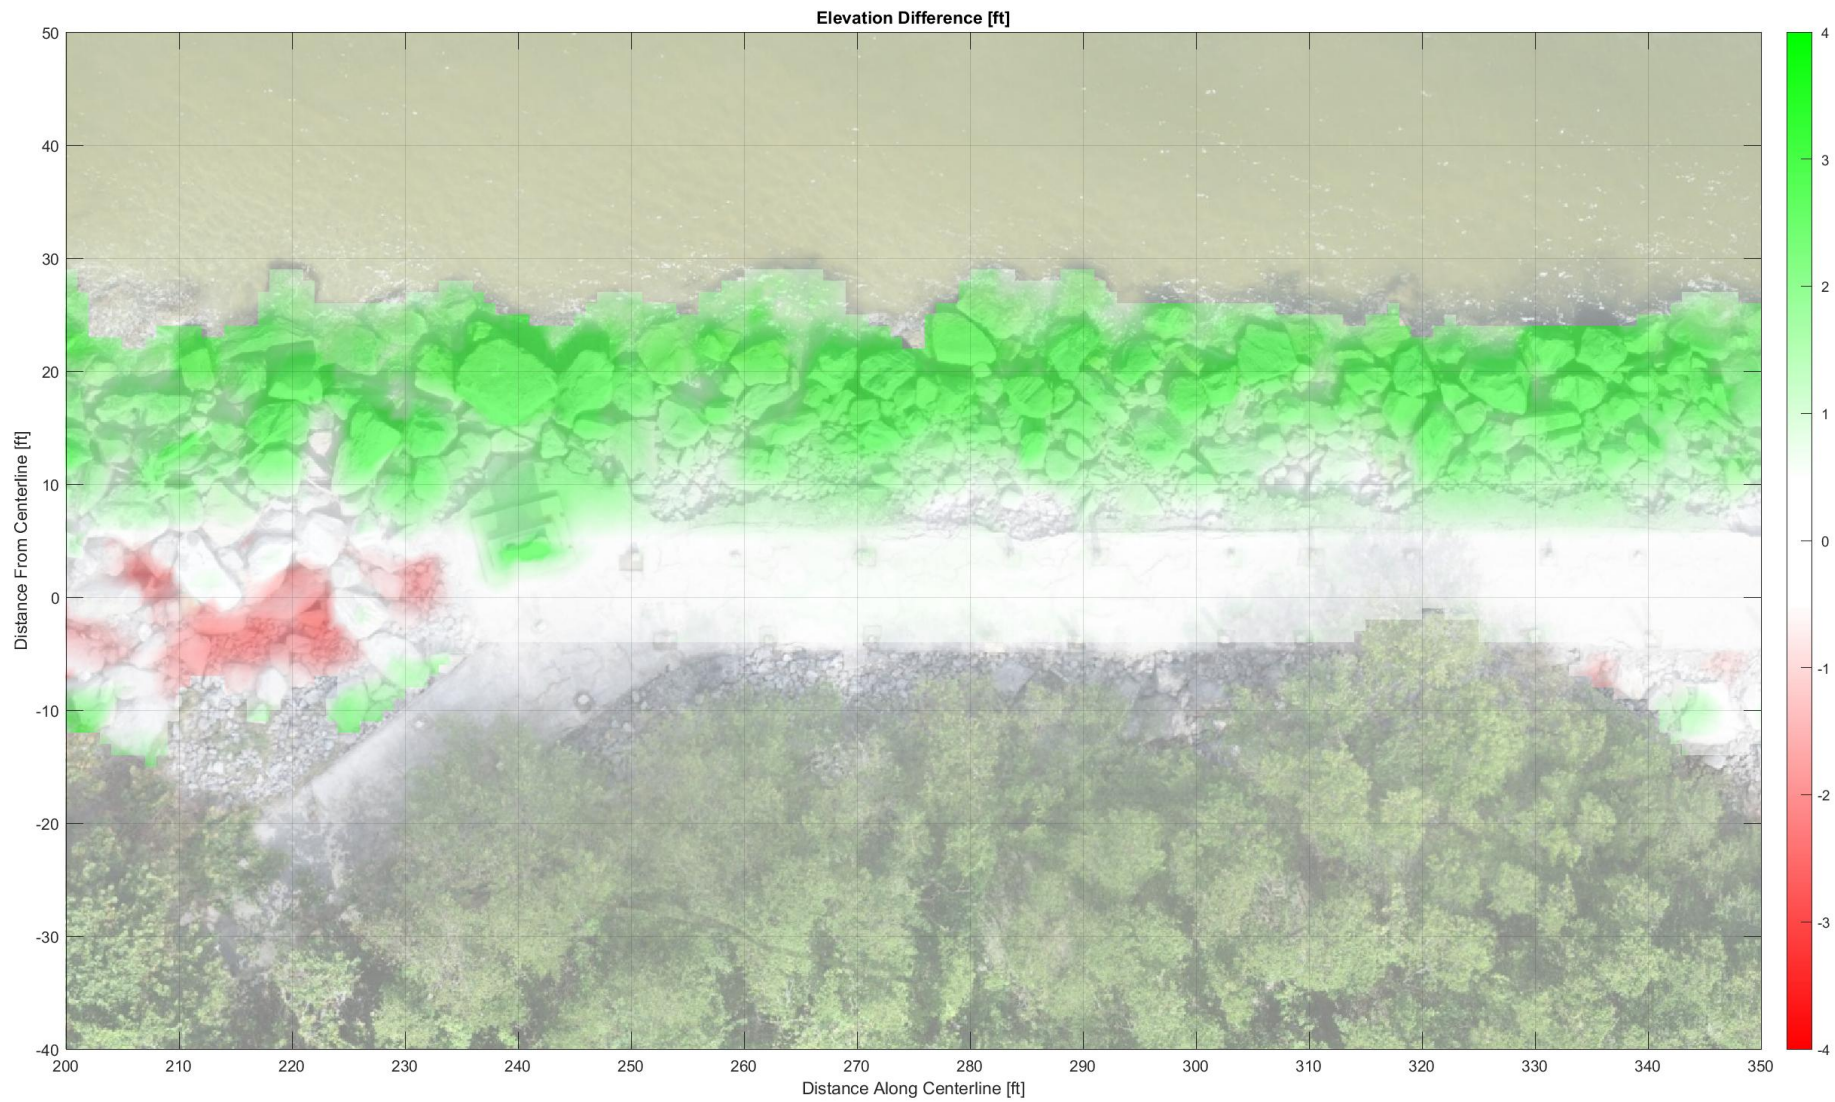
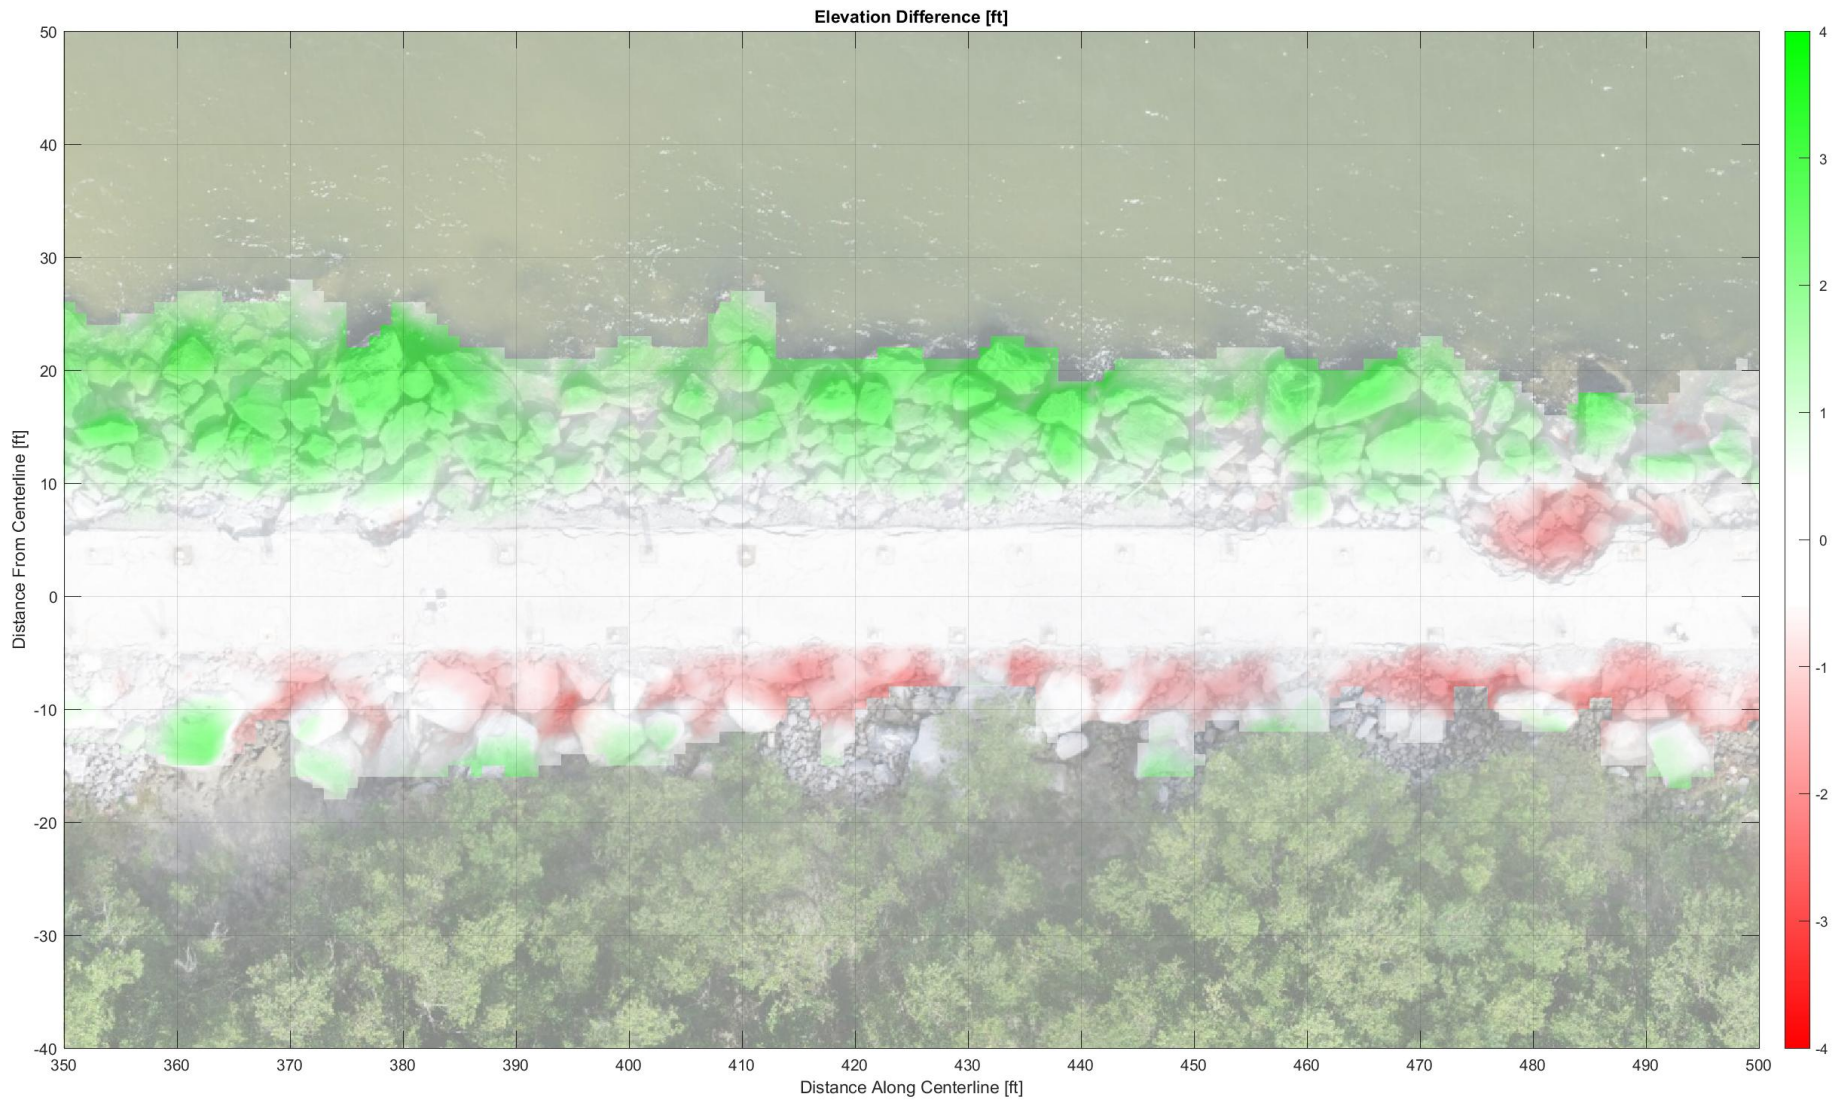
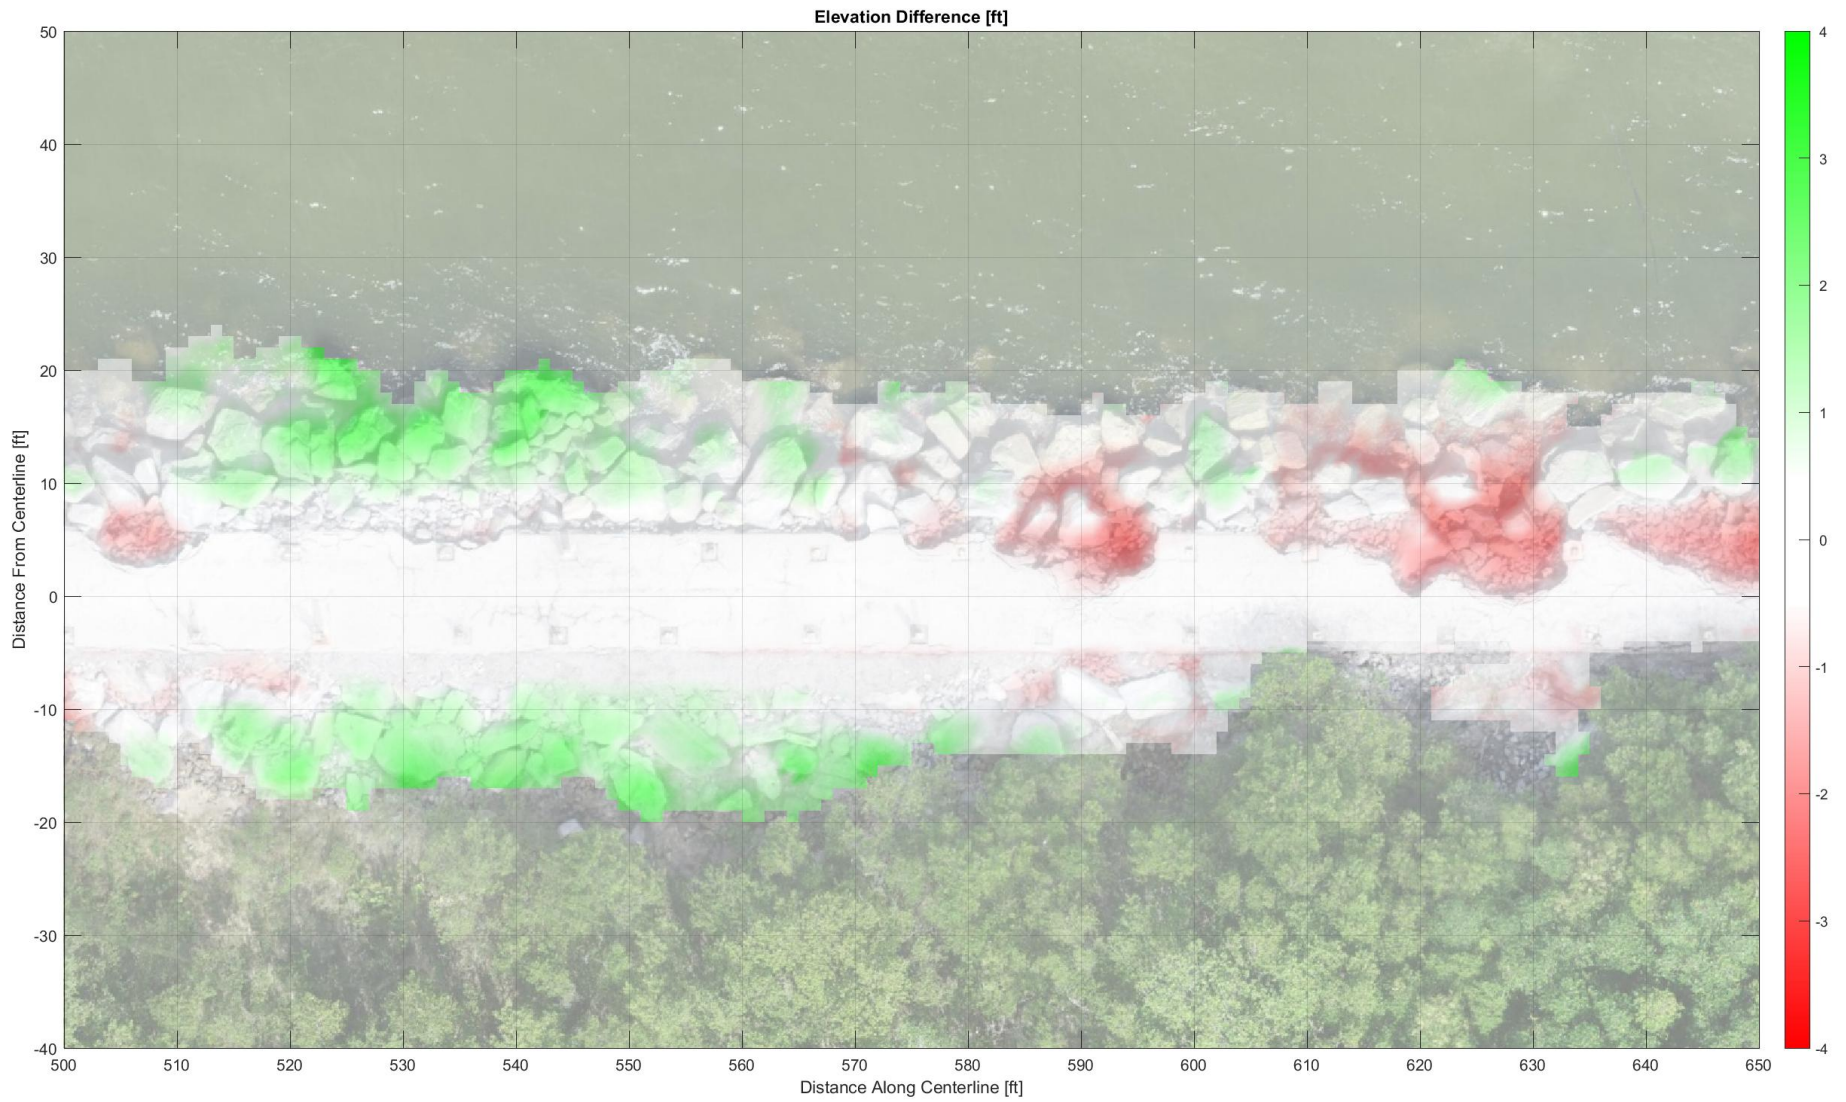
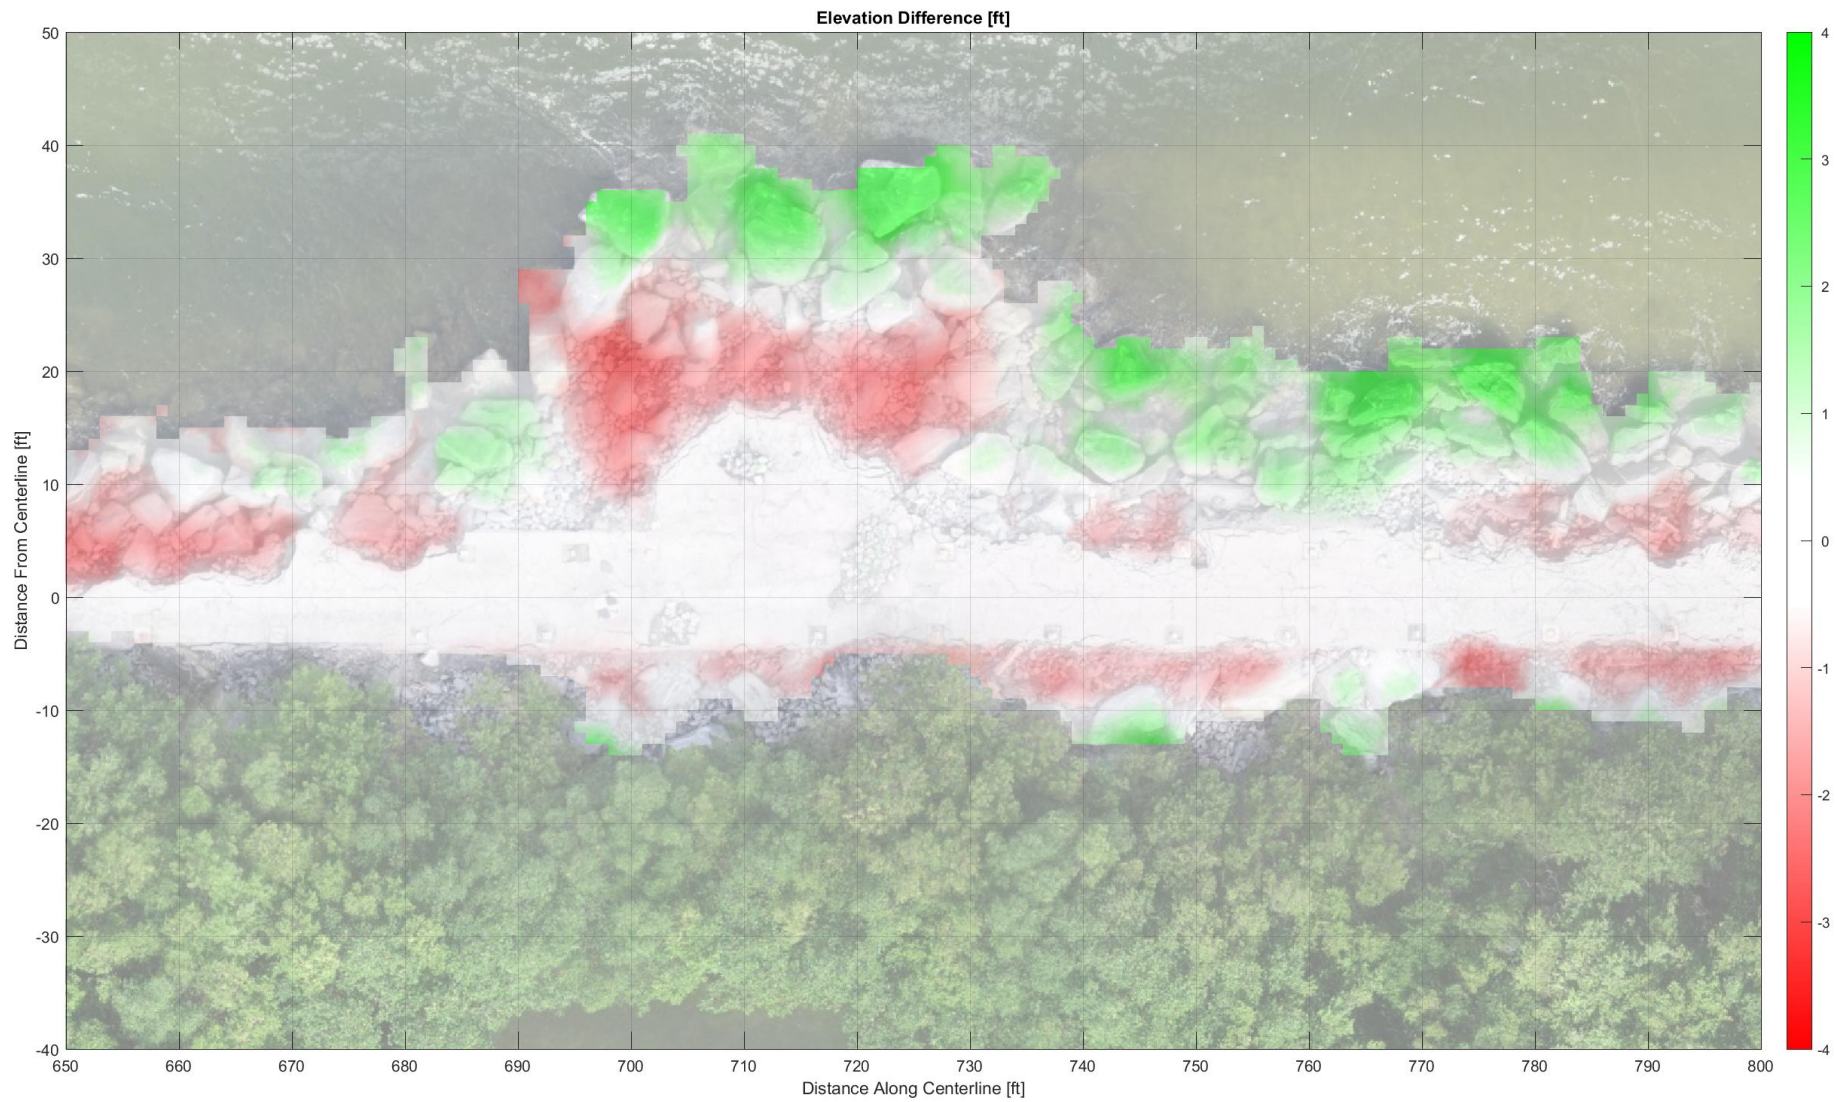
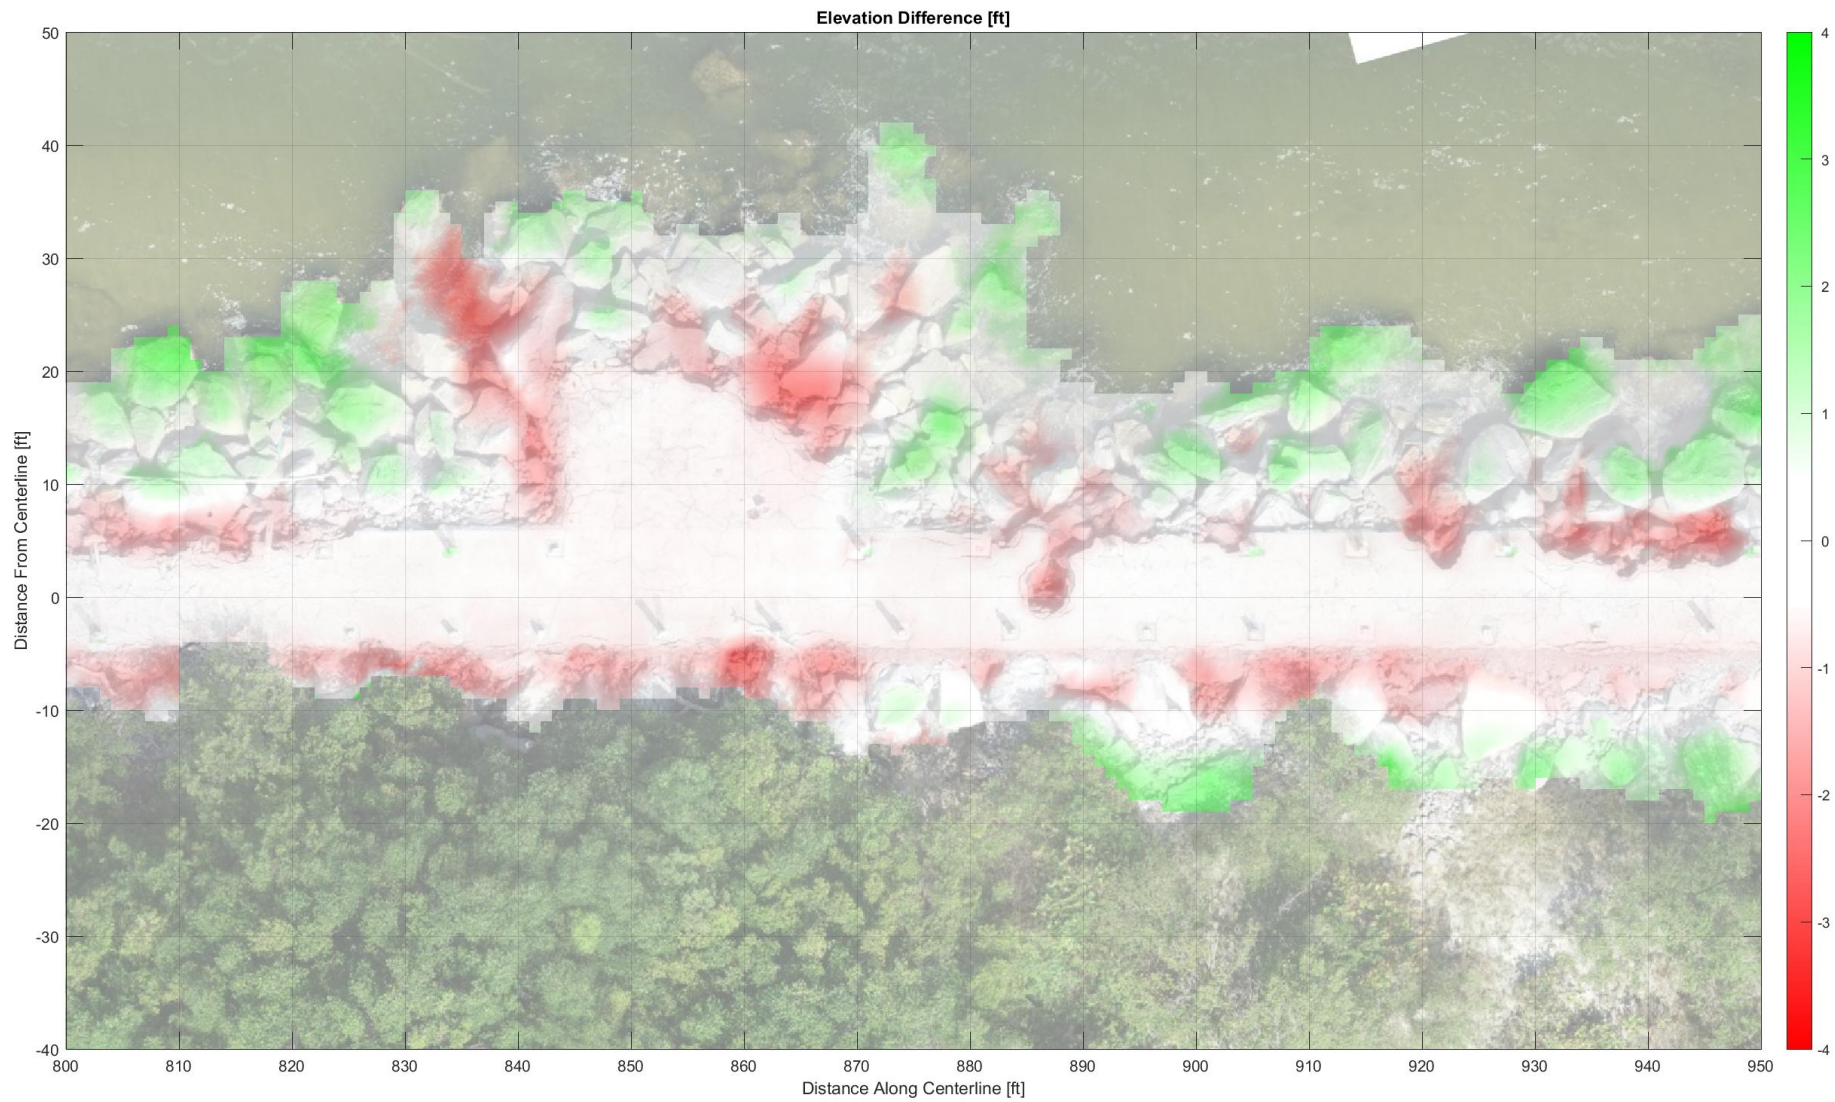
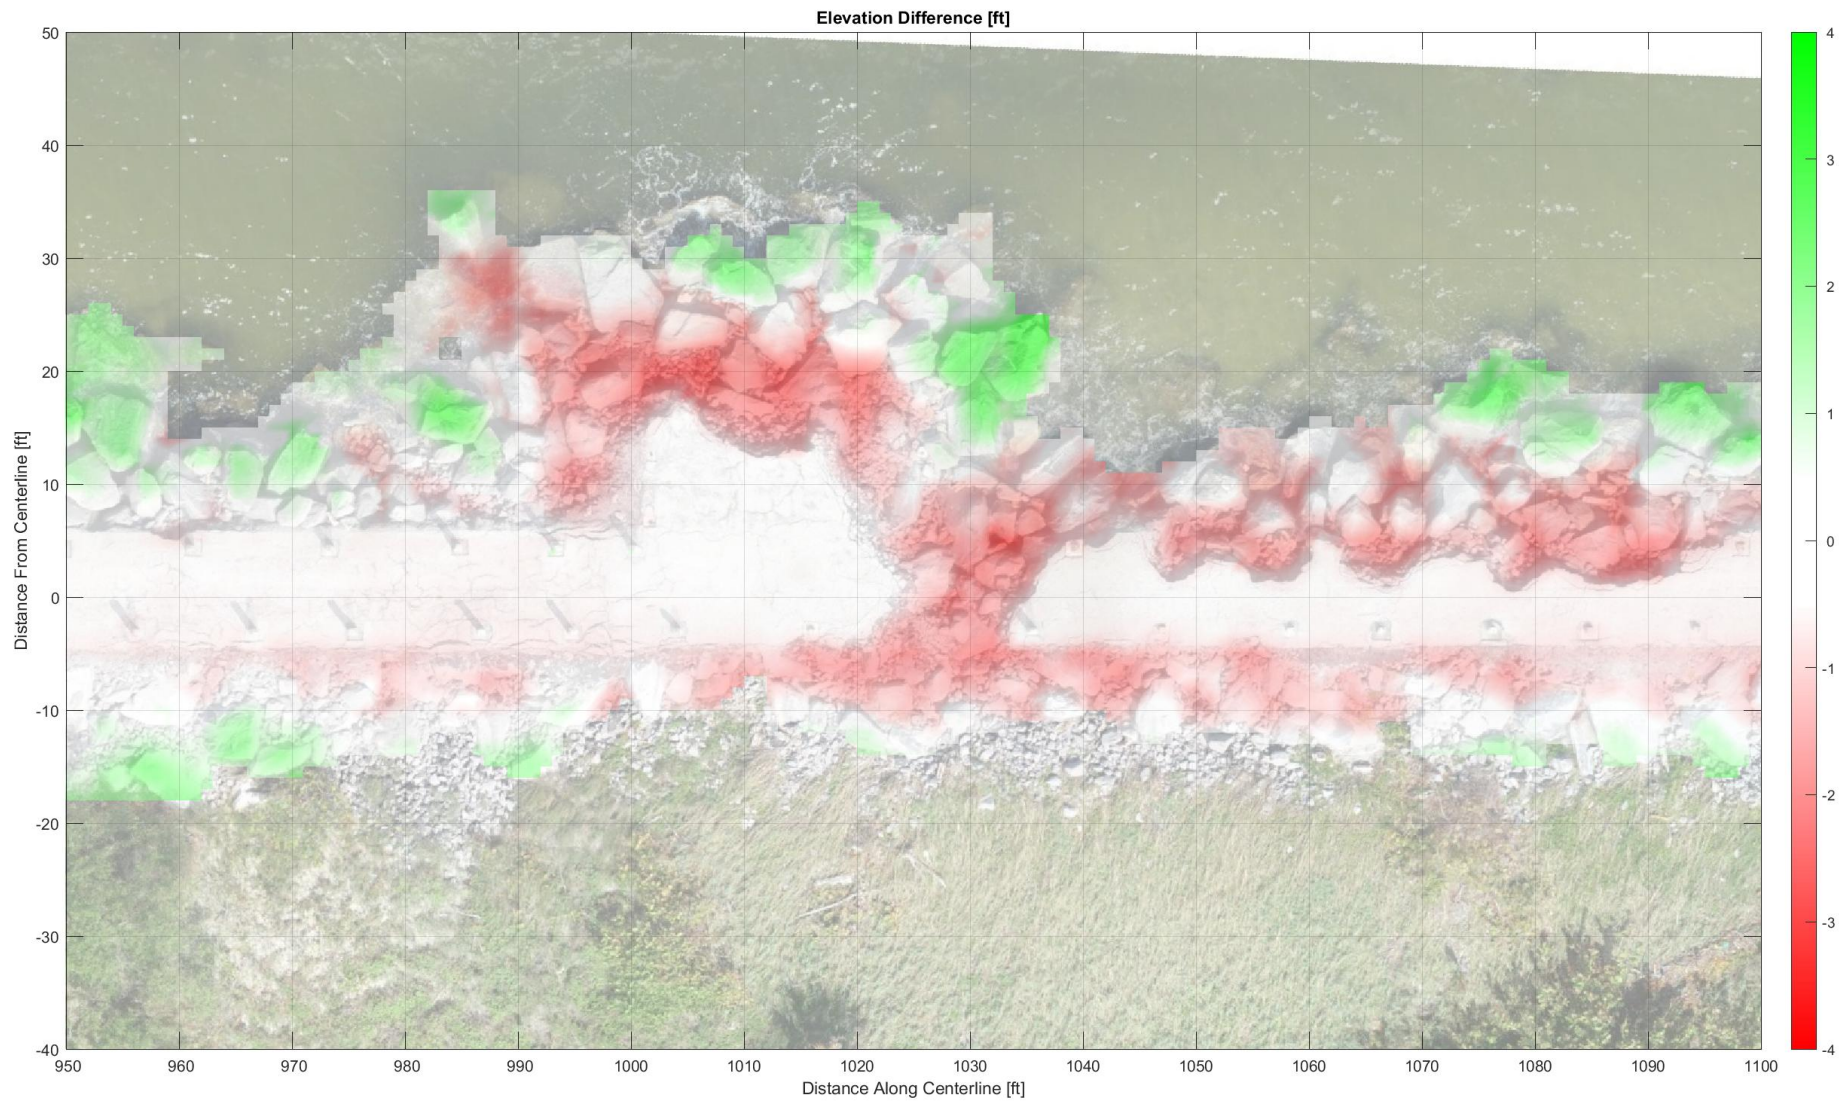
# JETTY ELEVATION COMPARISONS

- › Elevation deficiencies were calculated for each 20-foot segment along the jetty crest.

Quantity	< 5.65	< 5.00	< 4.00
Area	12,890	5,420	2,530
Percent	85%	6.1%	2.9%

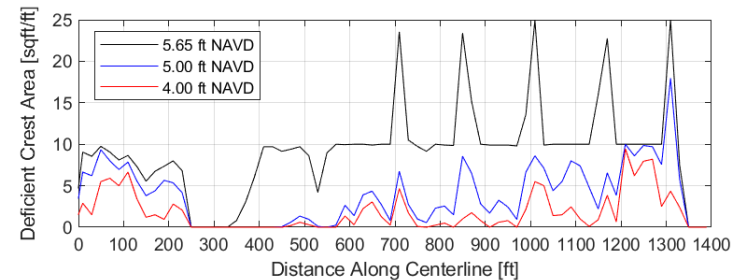
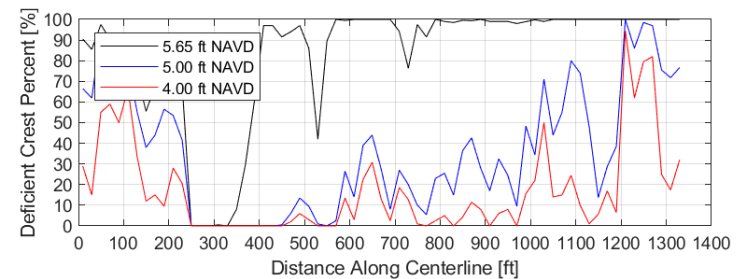
# JETTY VOLUME COMPARISONS

› Volumetric requirements were calculated for each 20-foot segment along the jetty.

Face	Volume (cft)	Weight (tons)
Crest	12,450	1,030
North	7,940	650
South	8,480	700
<b>Total</b>	<b>28,870</b>	<b>2,380</b>
