# DRONE TECHNOLOGY AND RUBBLE MOUND STRUCTURES

## ST. LUCIE INLET SOUTH JETTY CASE STUDY

Presented By: Andrew Wycklendt, P.E.

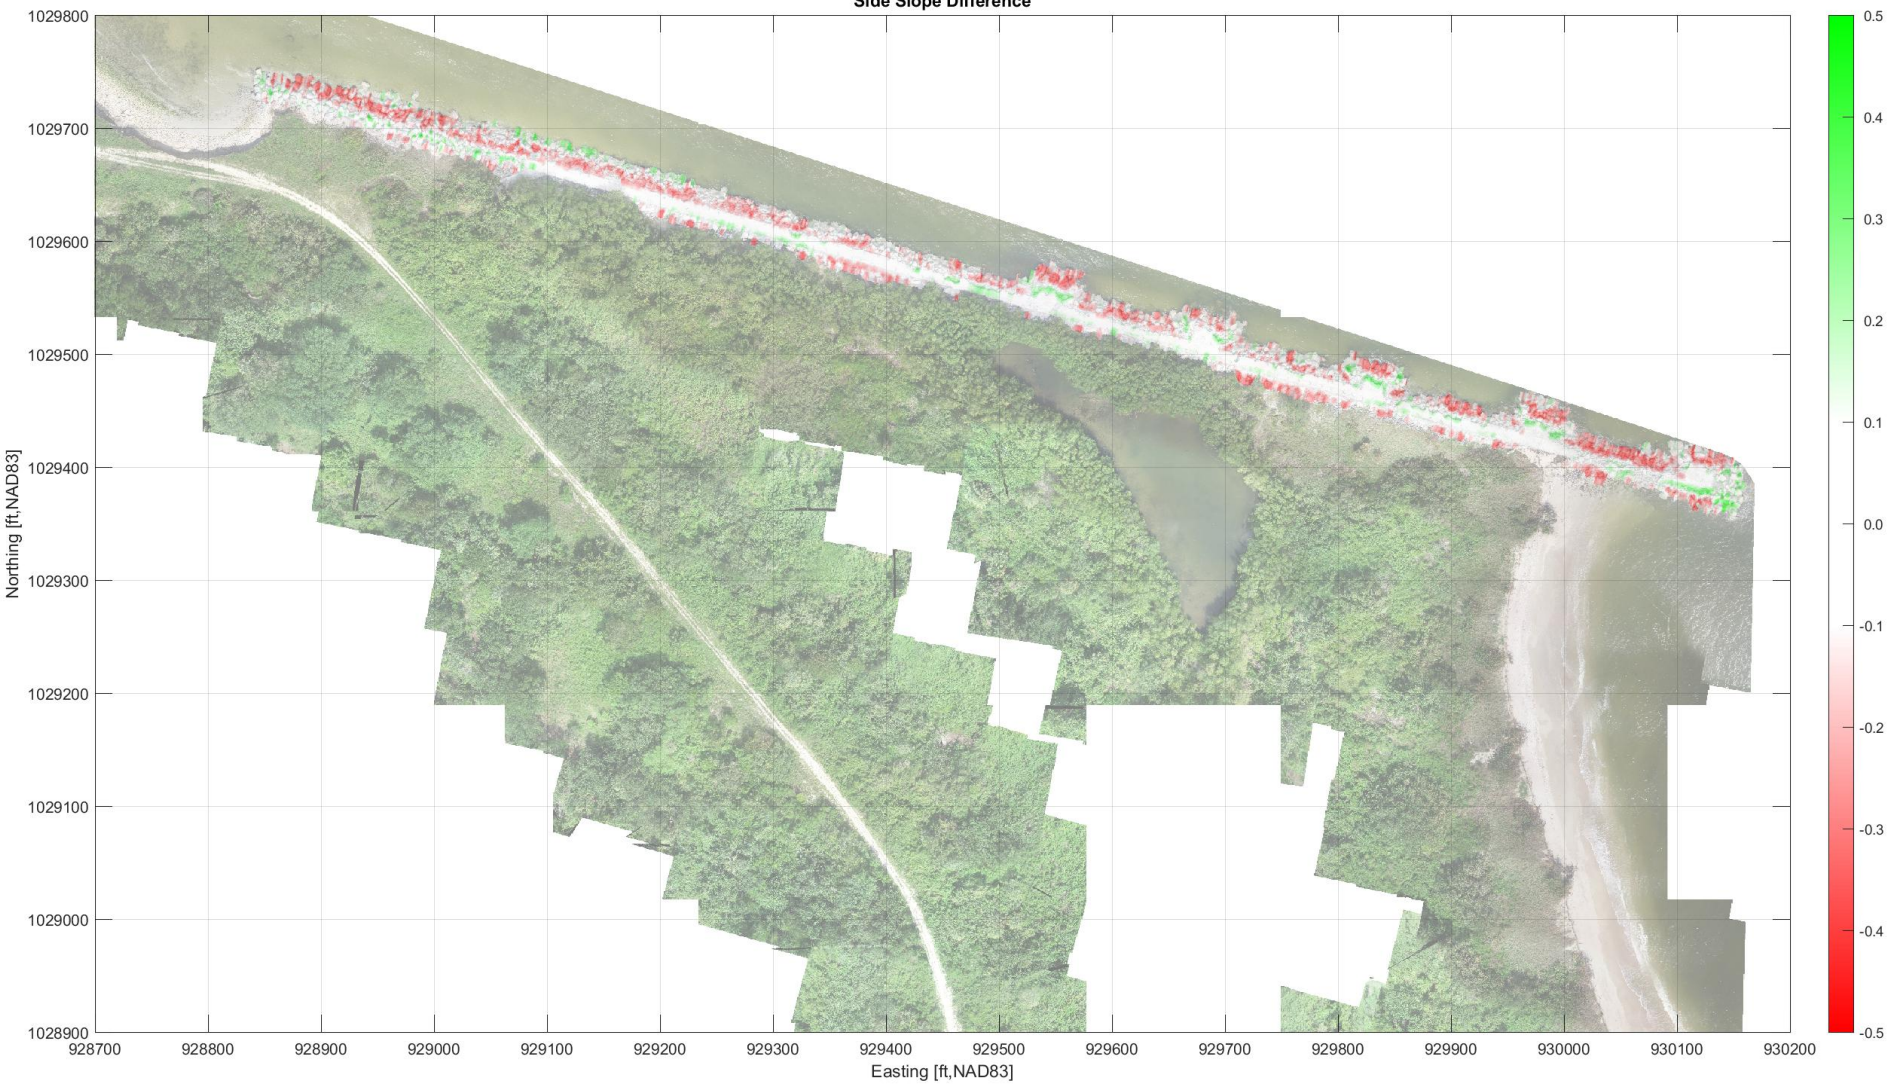
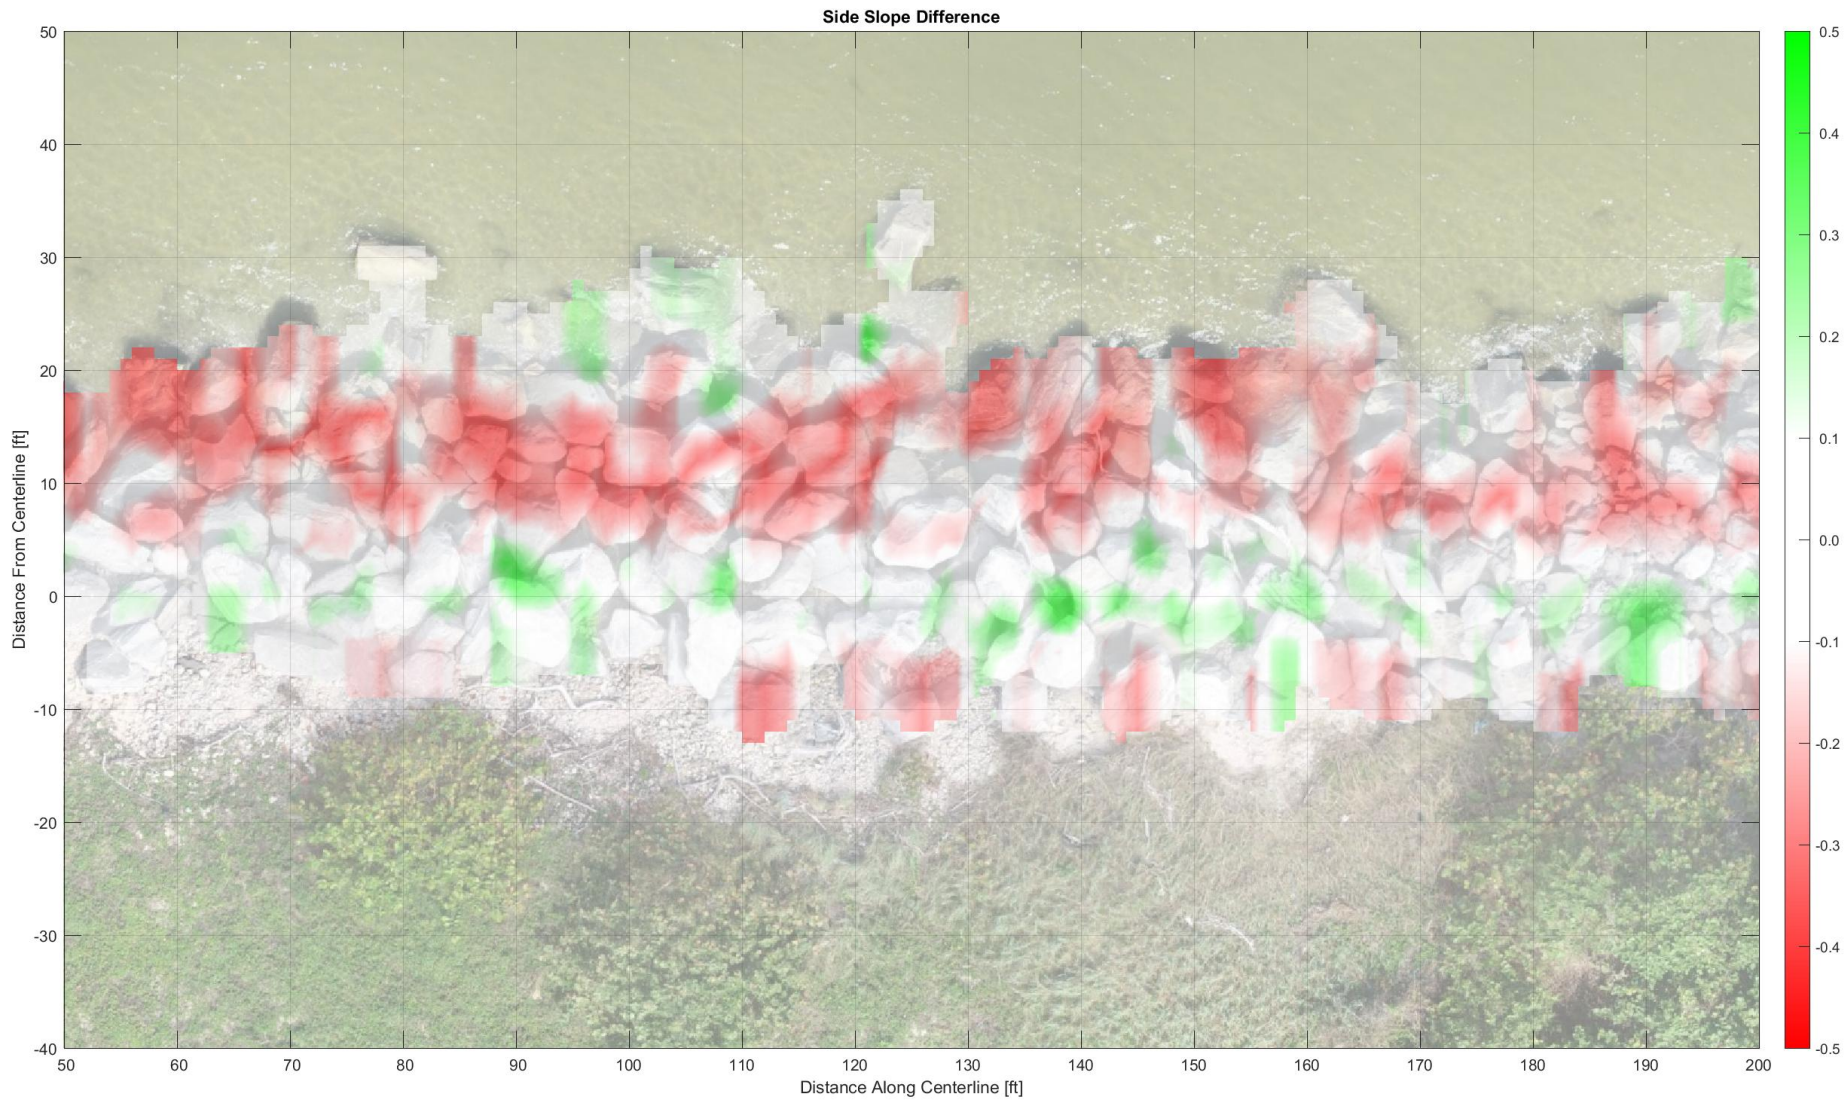
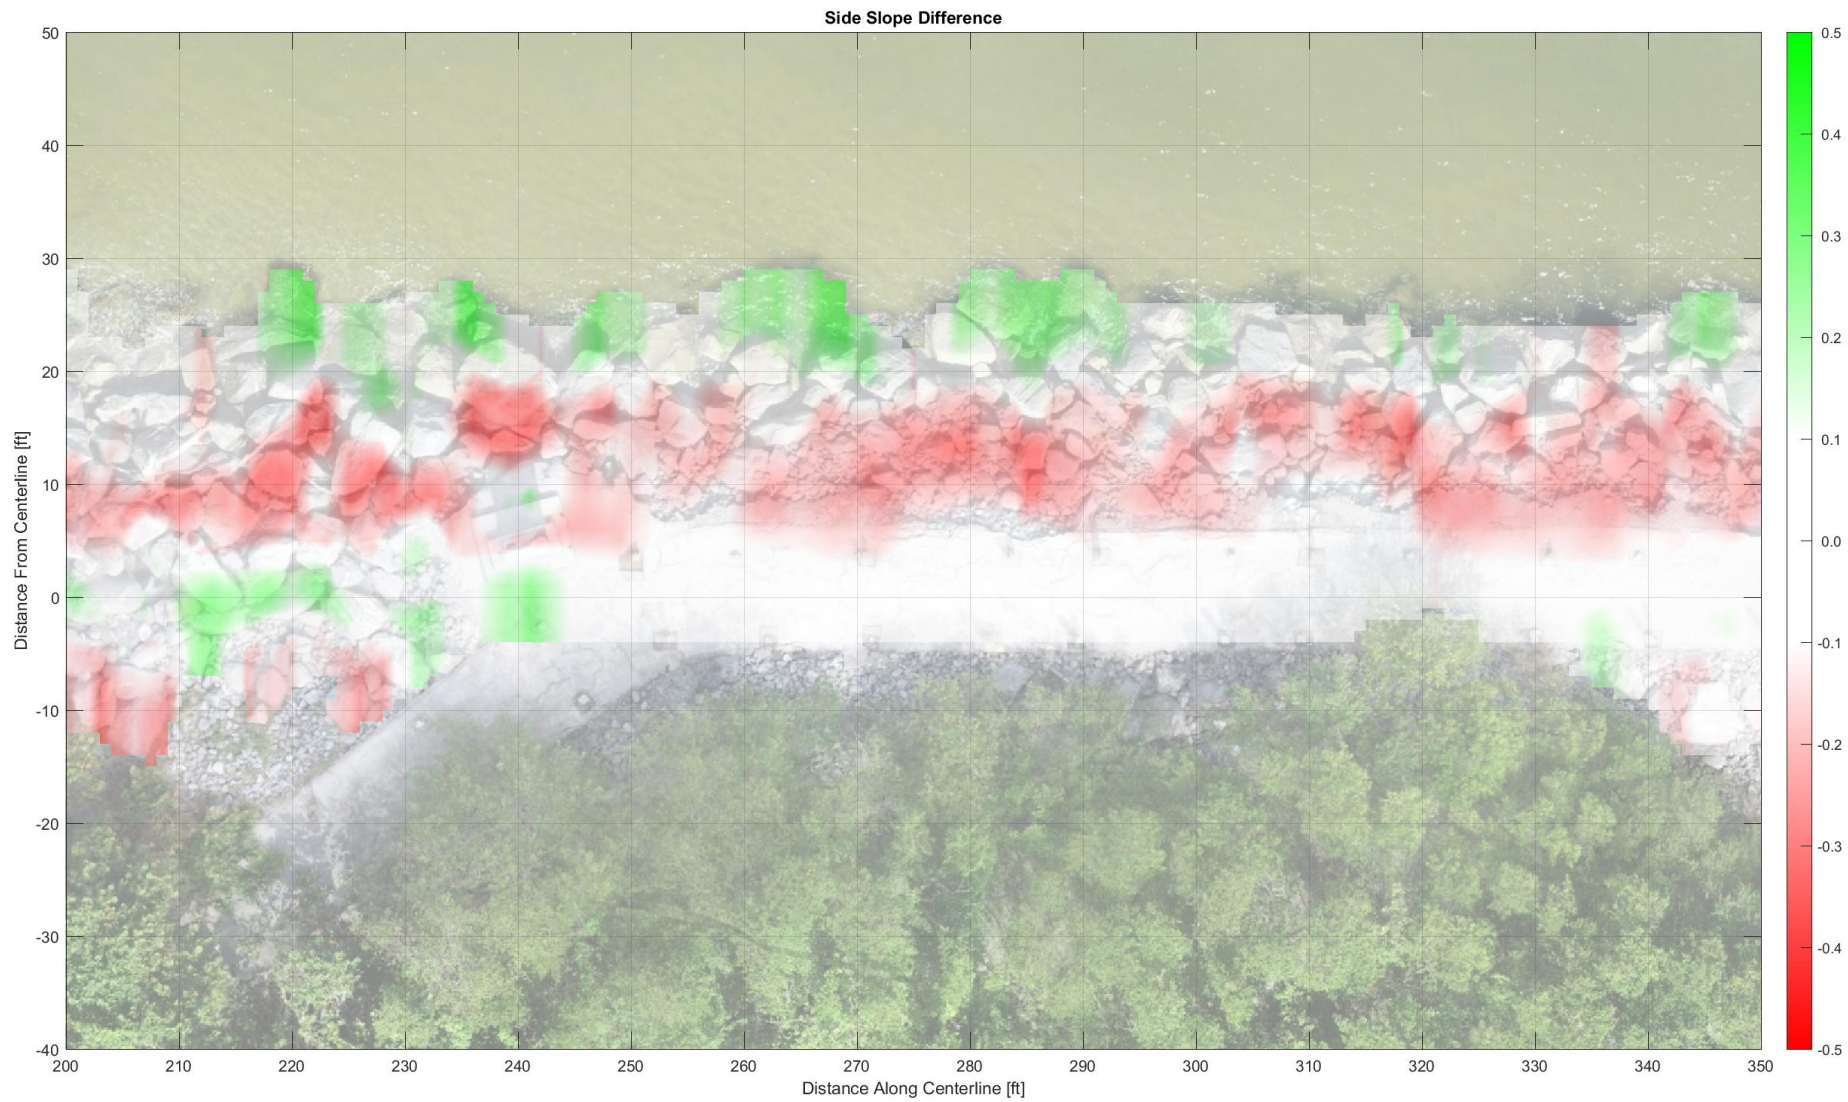
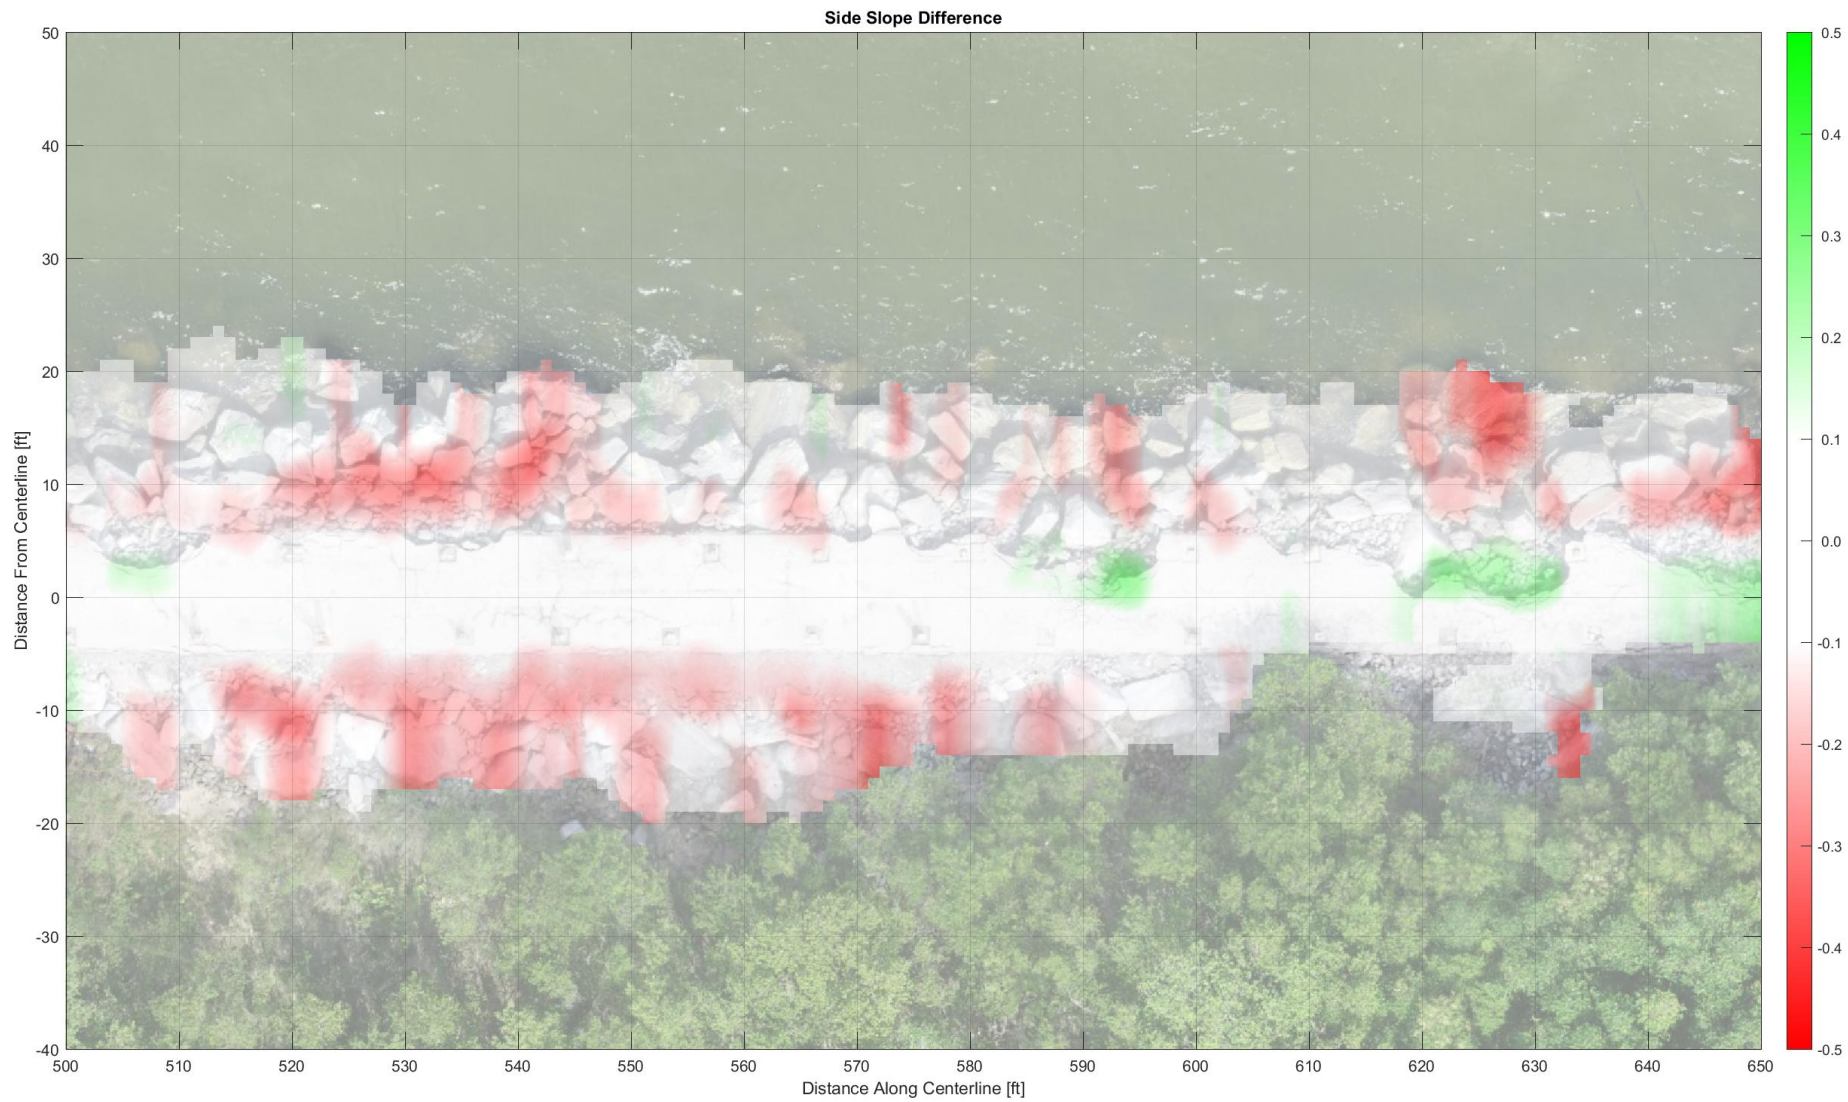
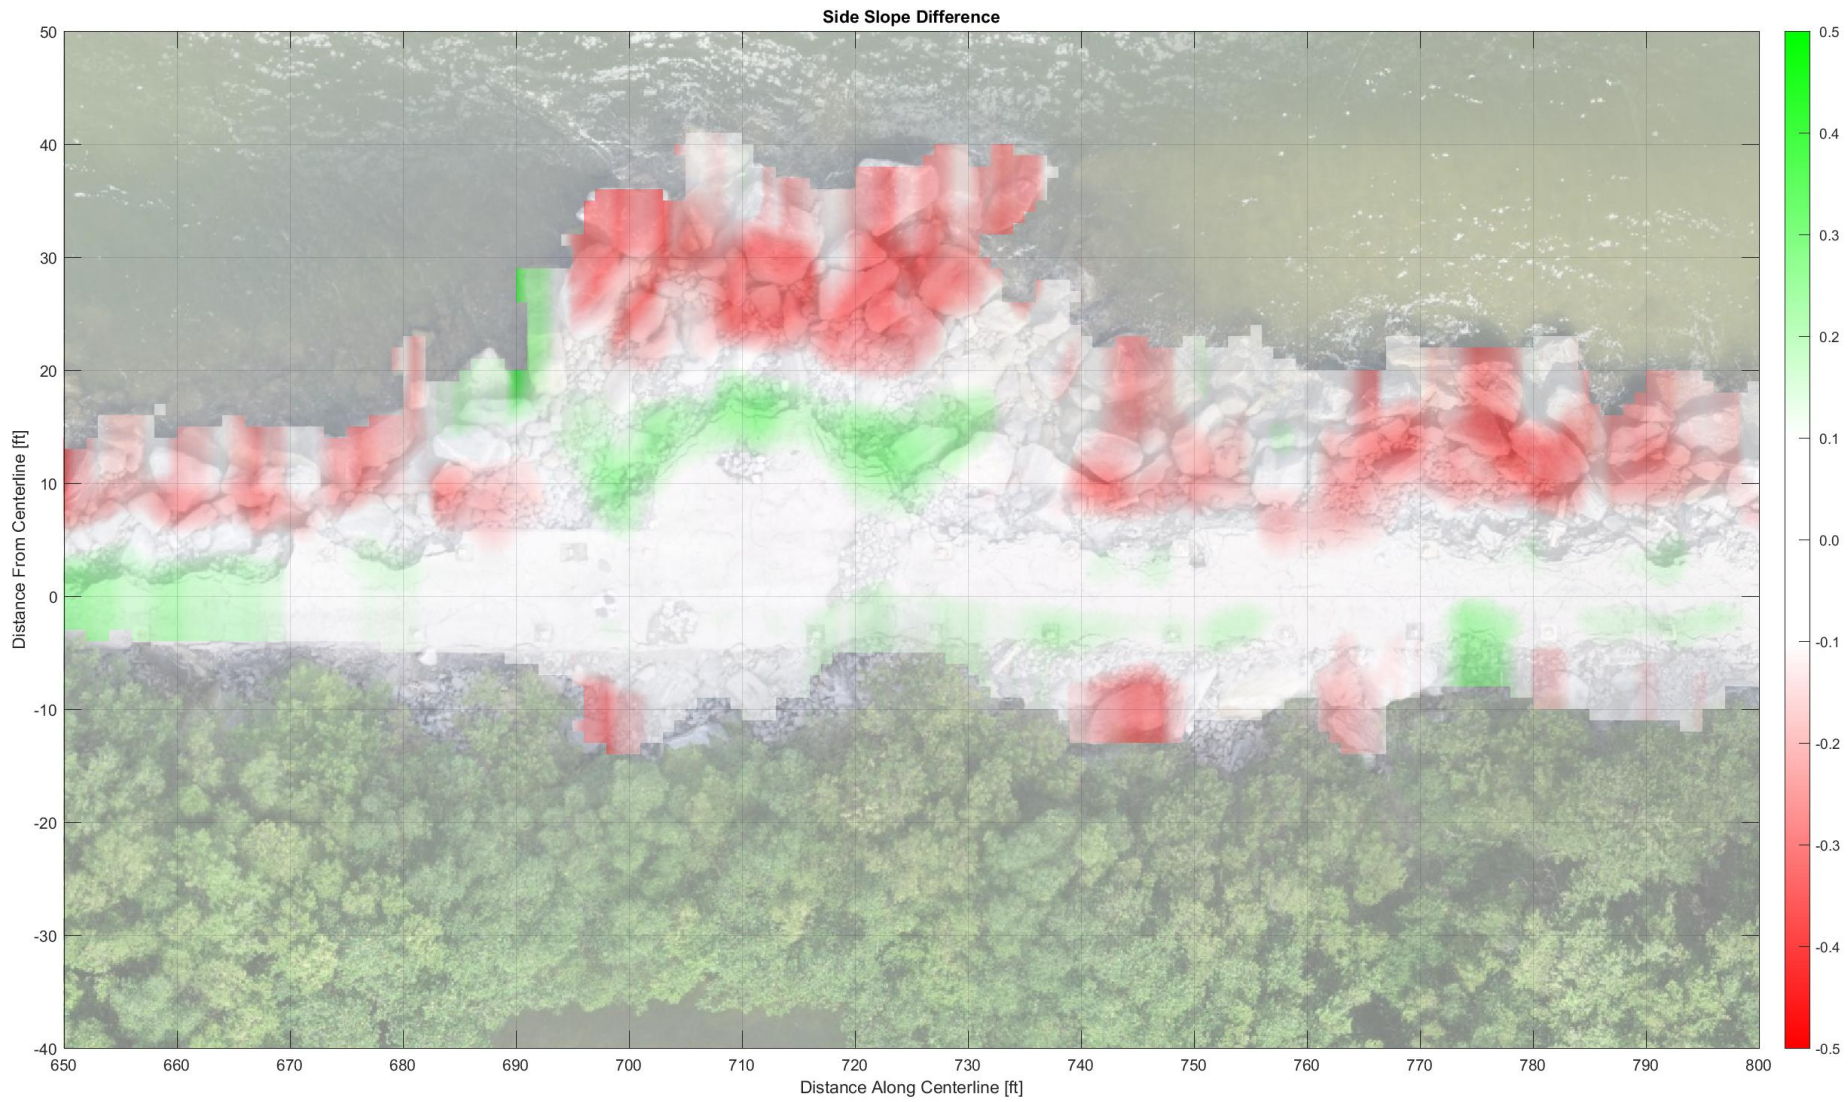
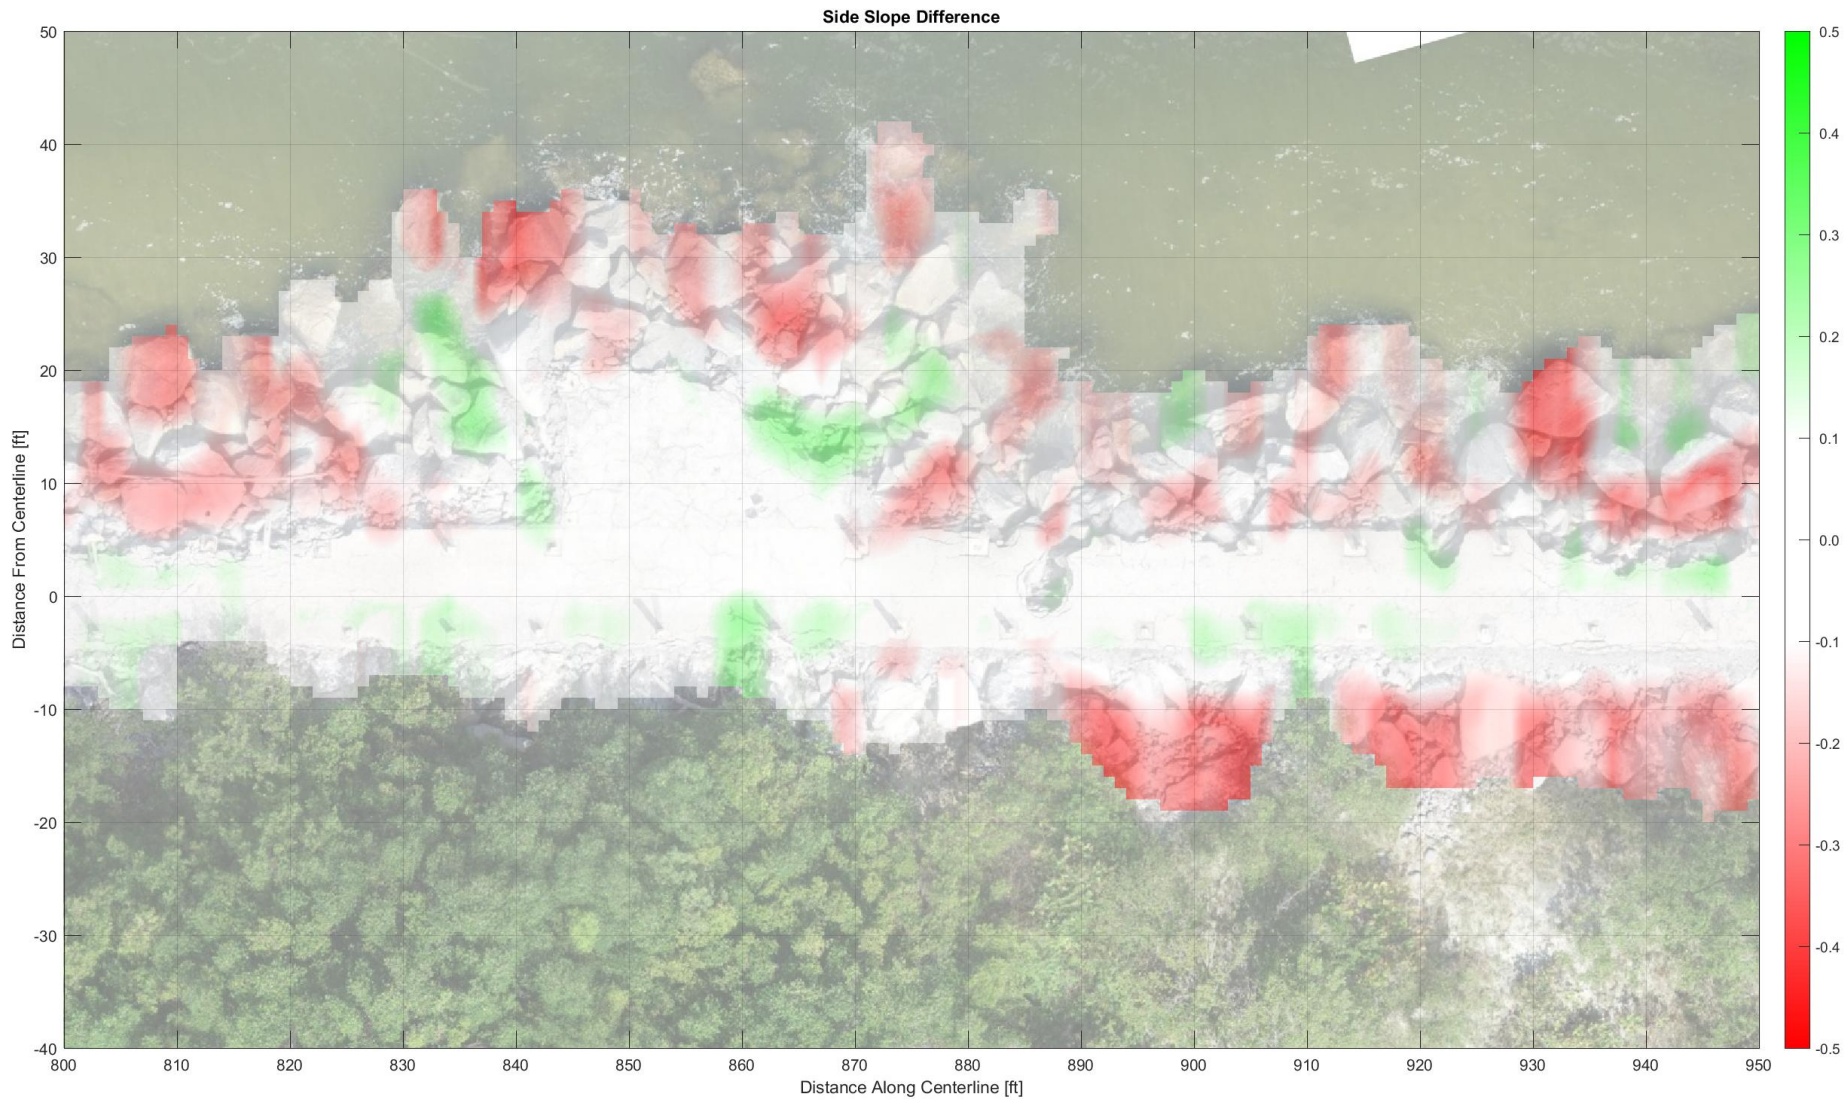
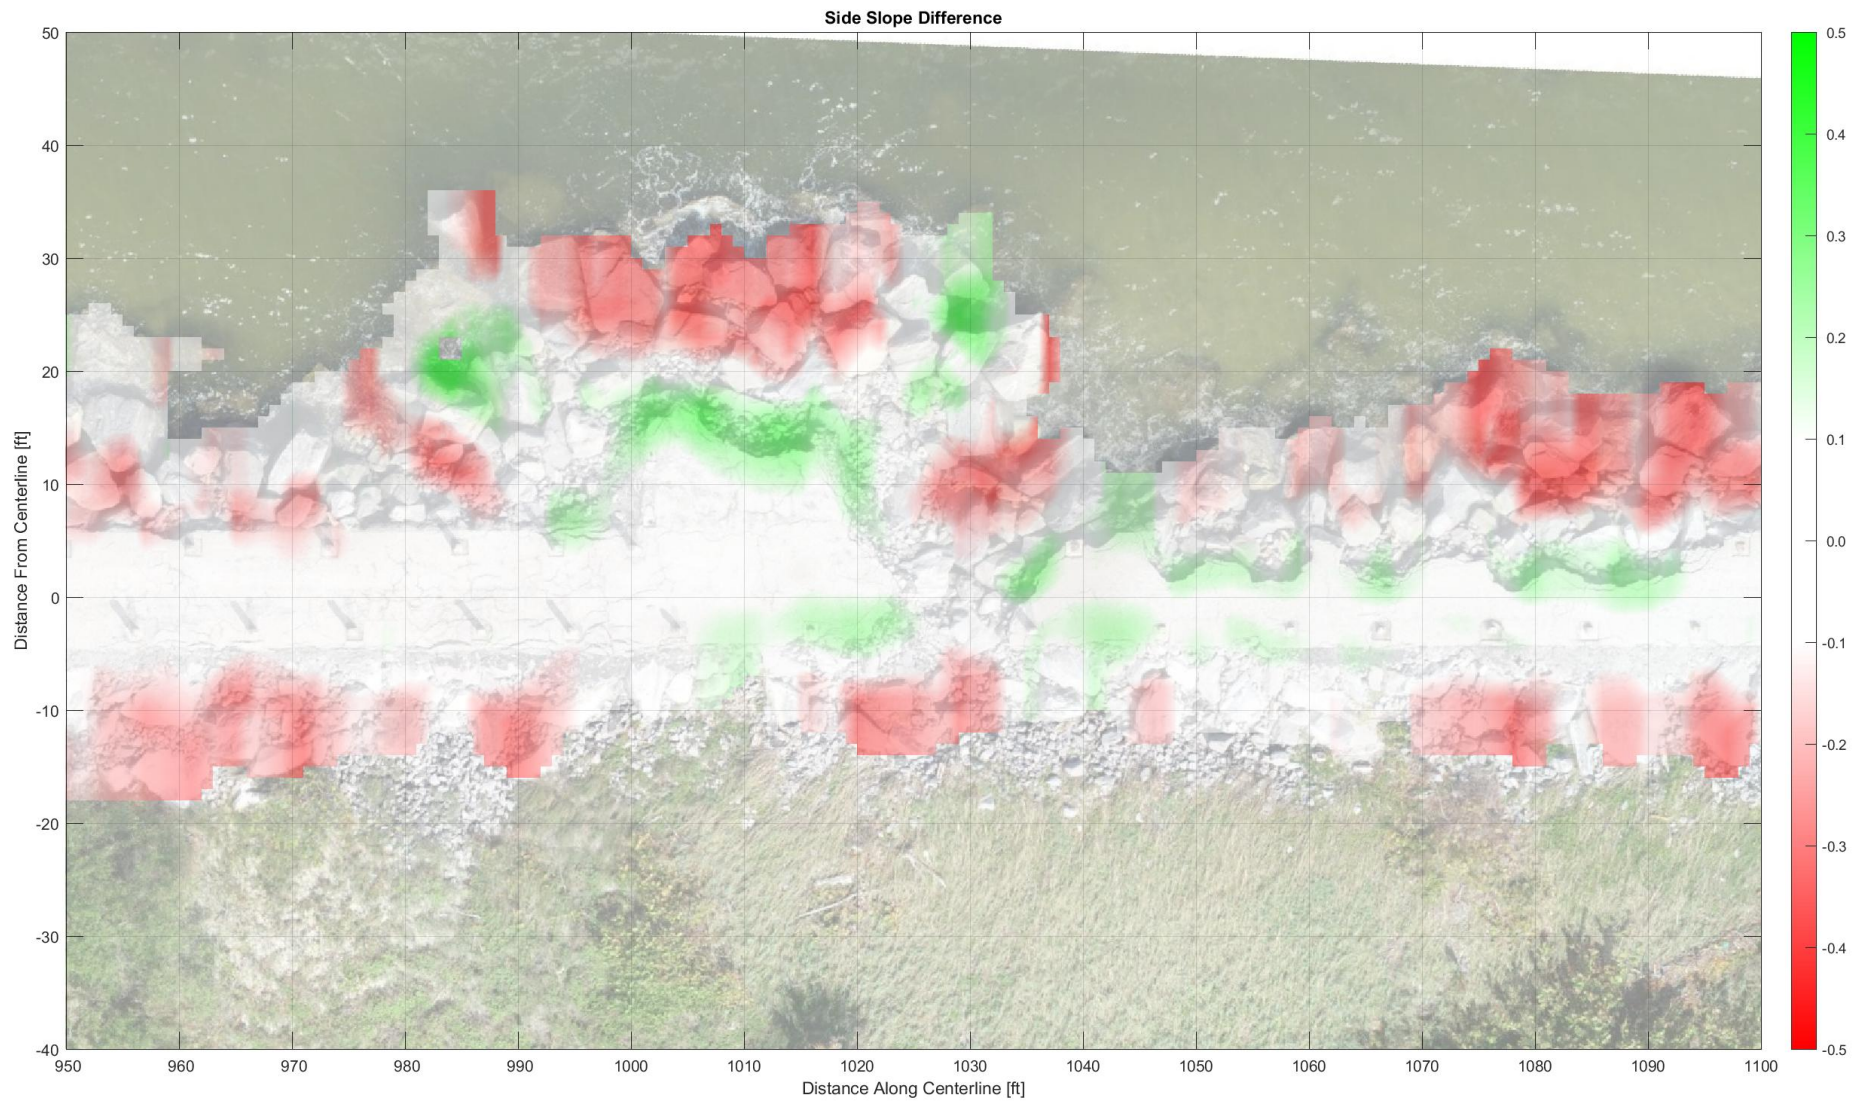
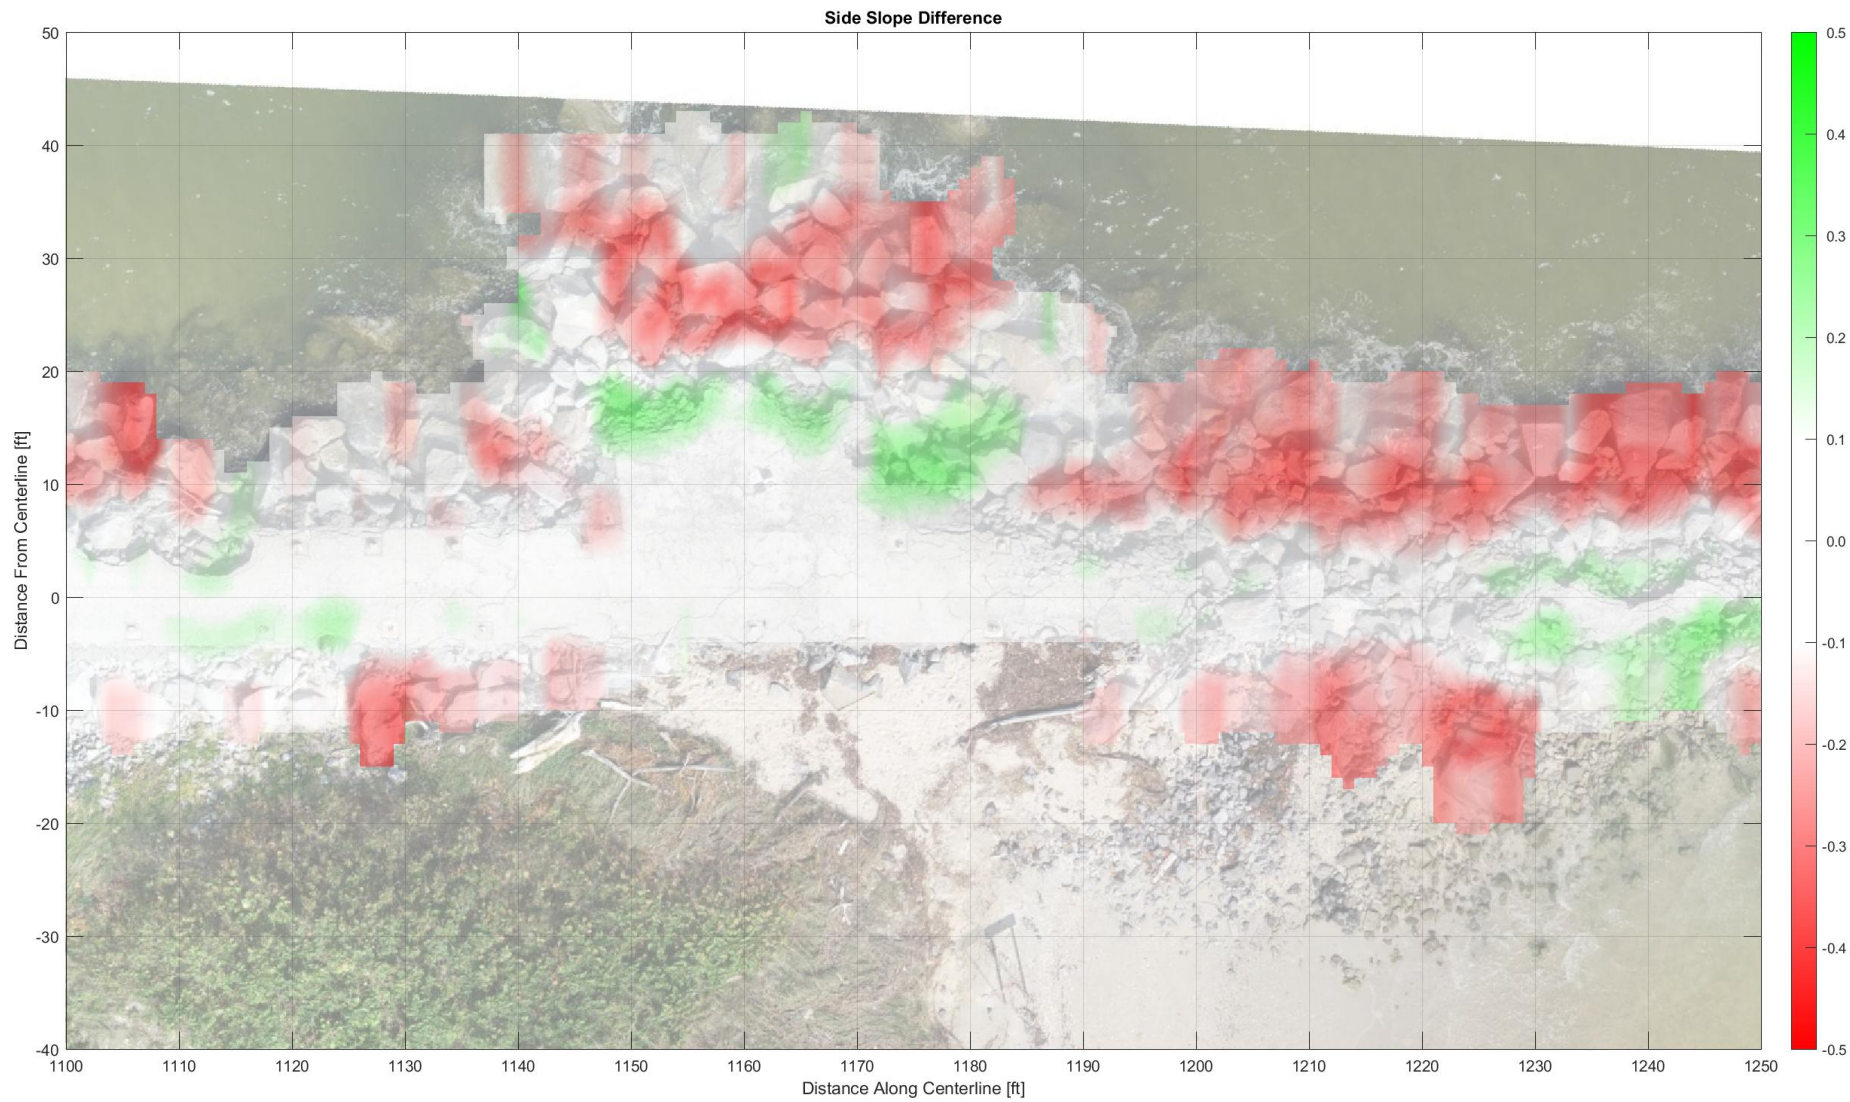
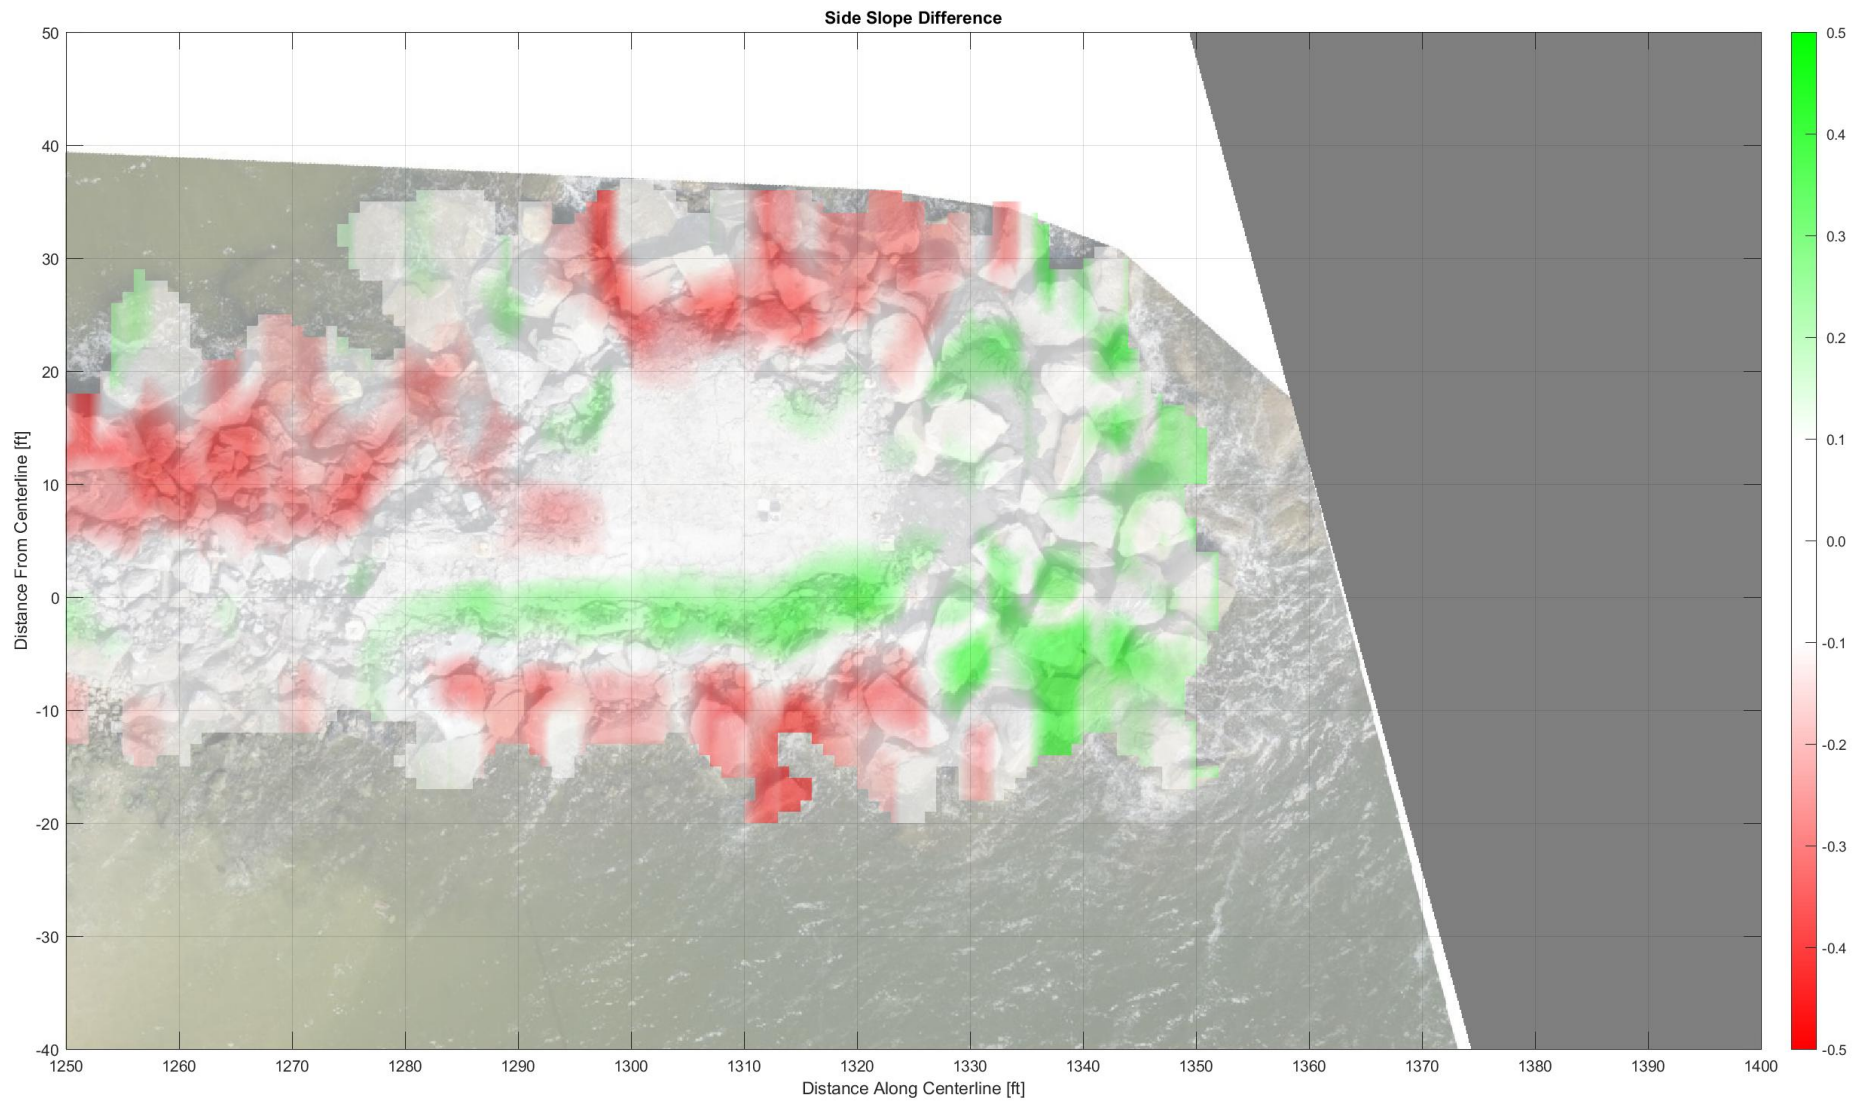
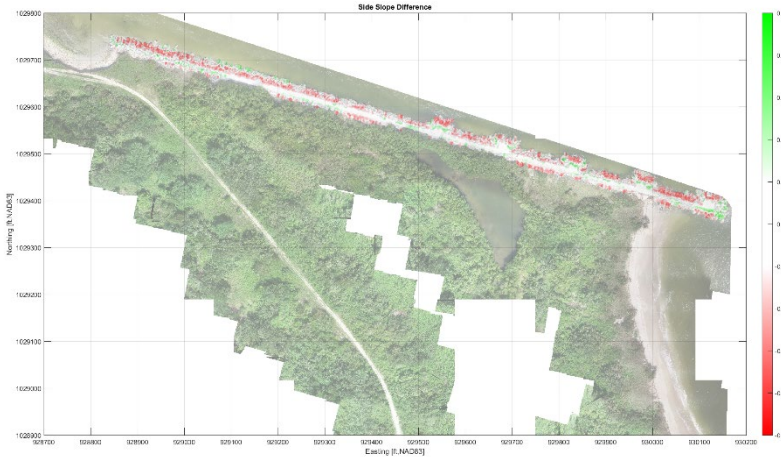
# JETTY SLOPE COMPARISONS

› Side slope deficiencies were calculated for each 20-foot segment along the north and south jetty faces.

Face	Analyzed	Deficient	Percent
North	24,970	1,750	7%
South	9,780	384	4%
<b>Total</b>	<b>34,750</b>	<b>2,134</b>	<b>6%</b>
