# DRONE TECHNOLOGY AND RUBBLE MOUND STRUCTURES

## ST. LUCIE INLET SOUTH JETTY CASE STUDY

Presented By: Andrew Wycklendt, P.E.

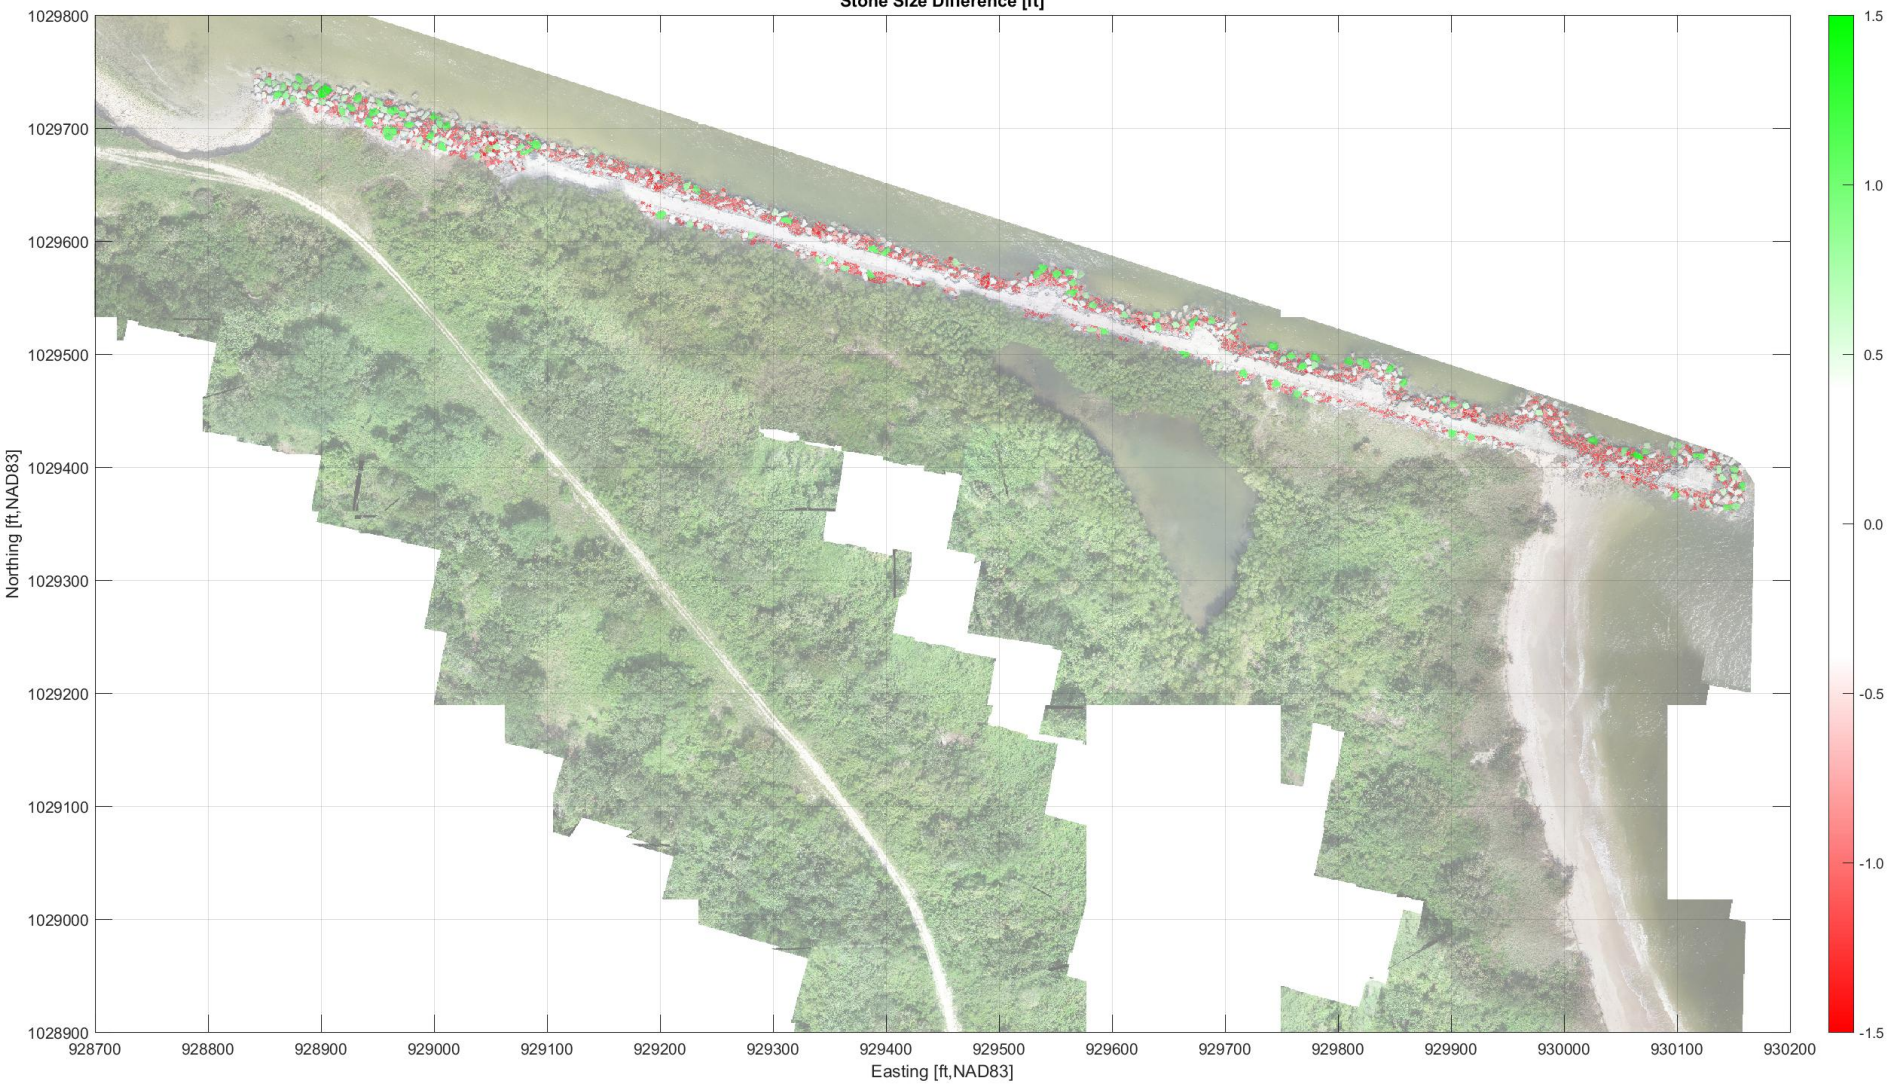
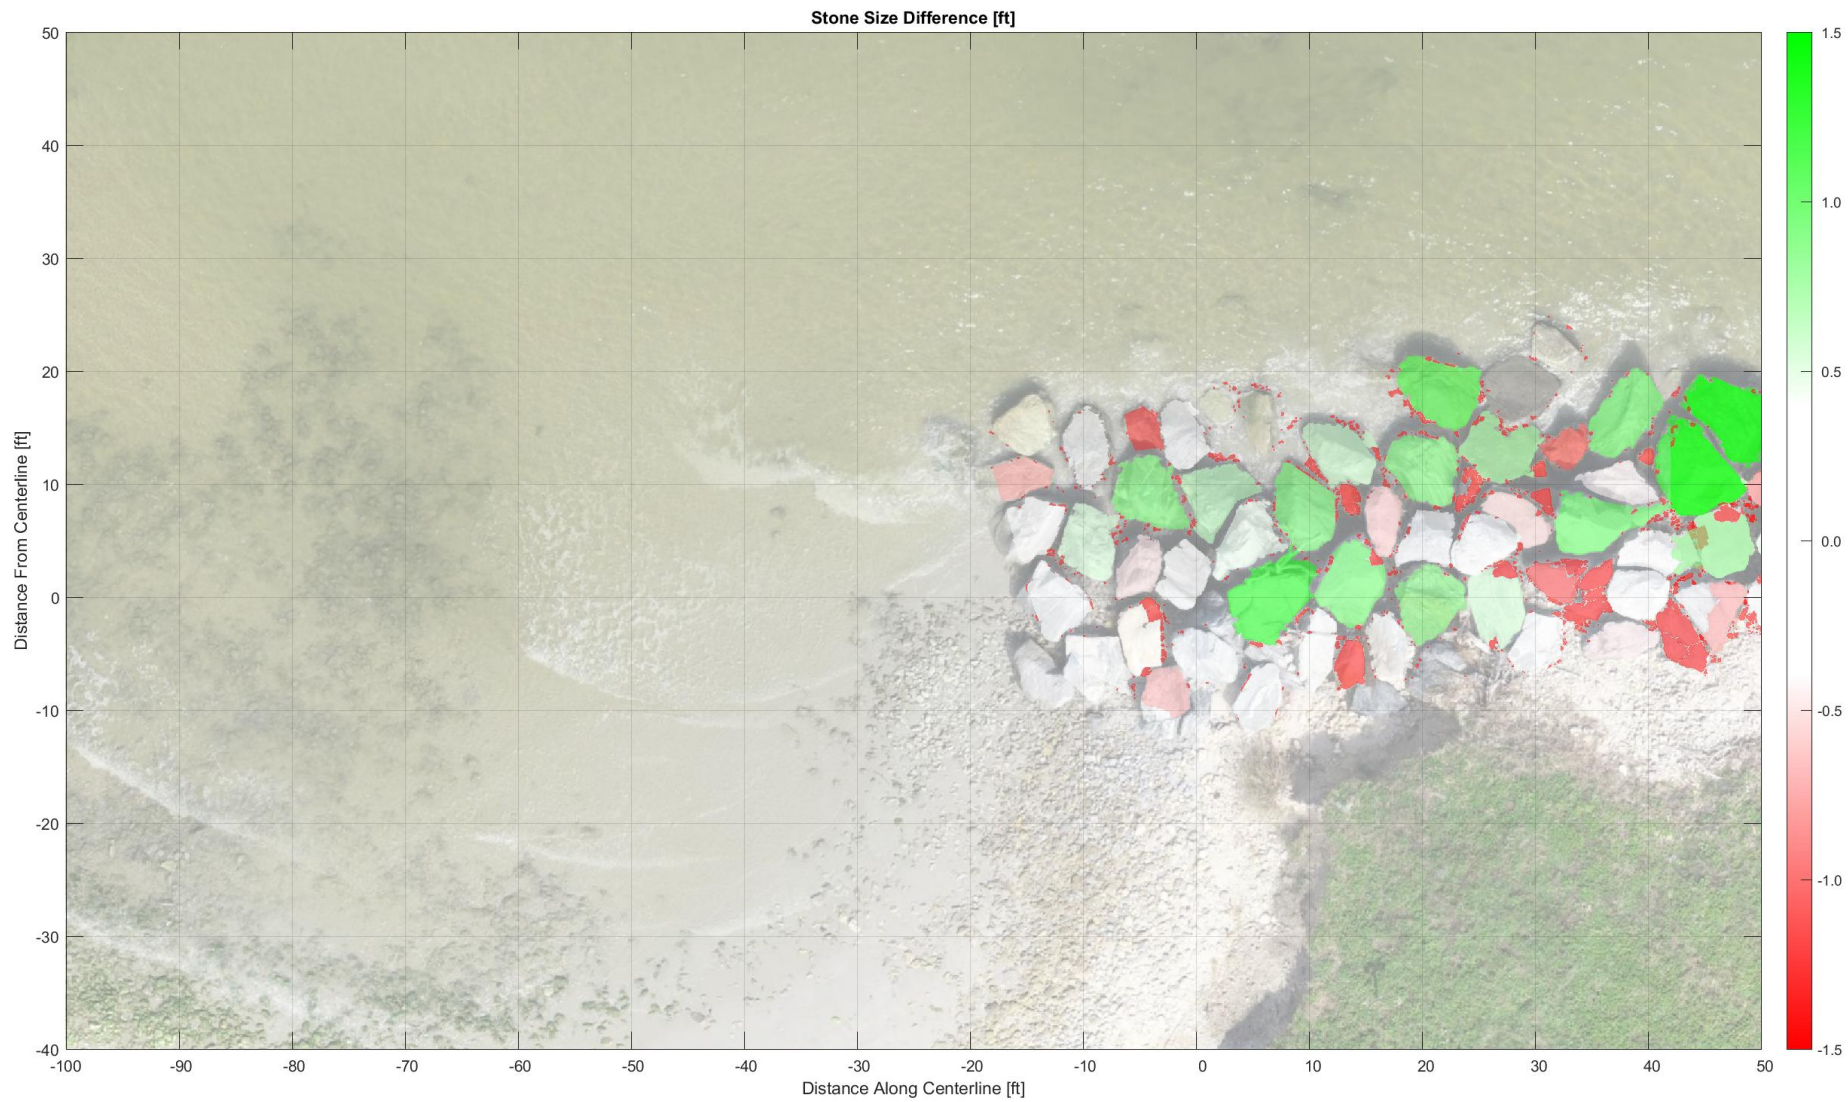
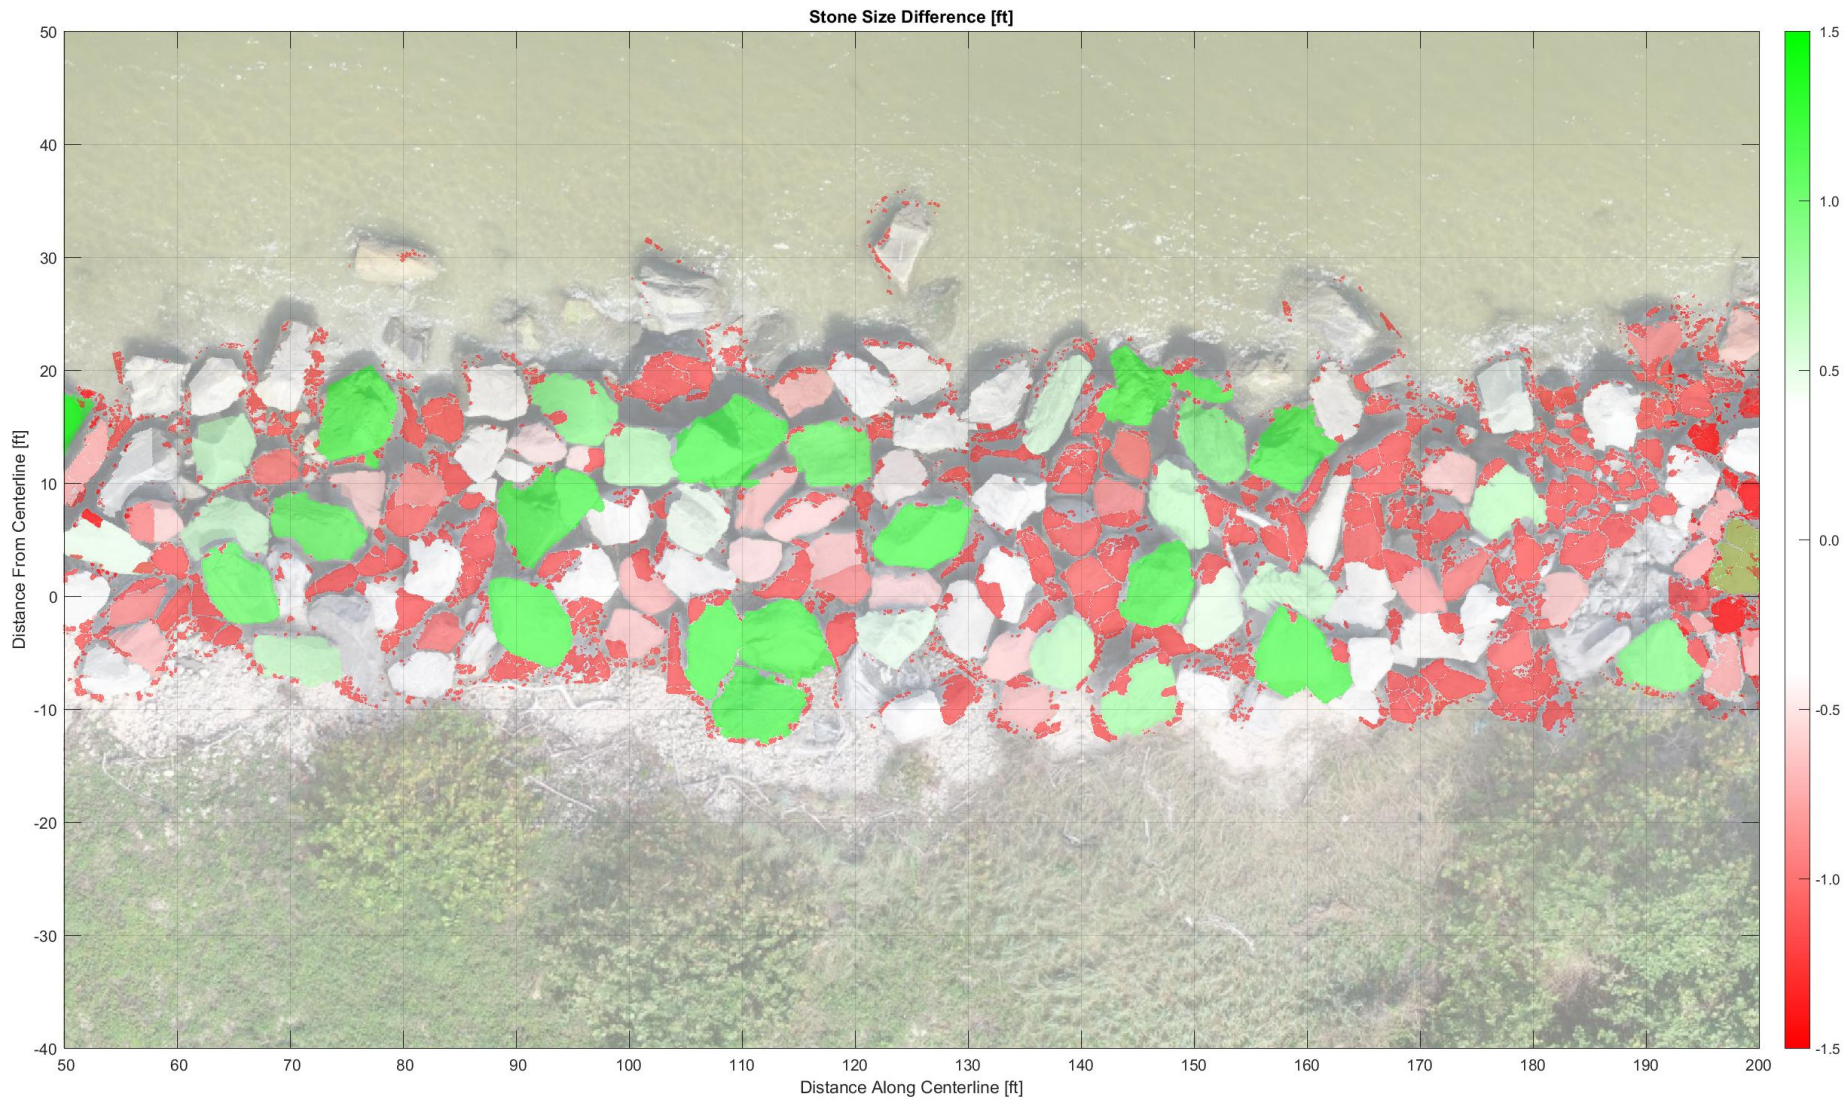
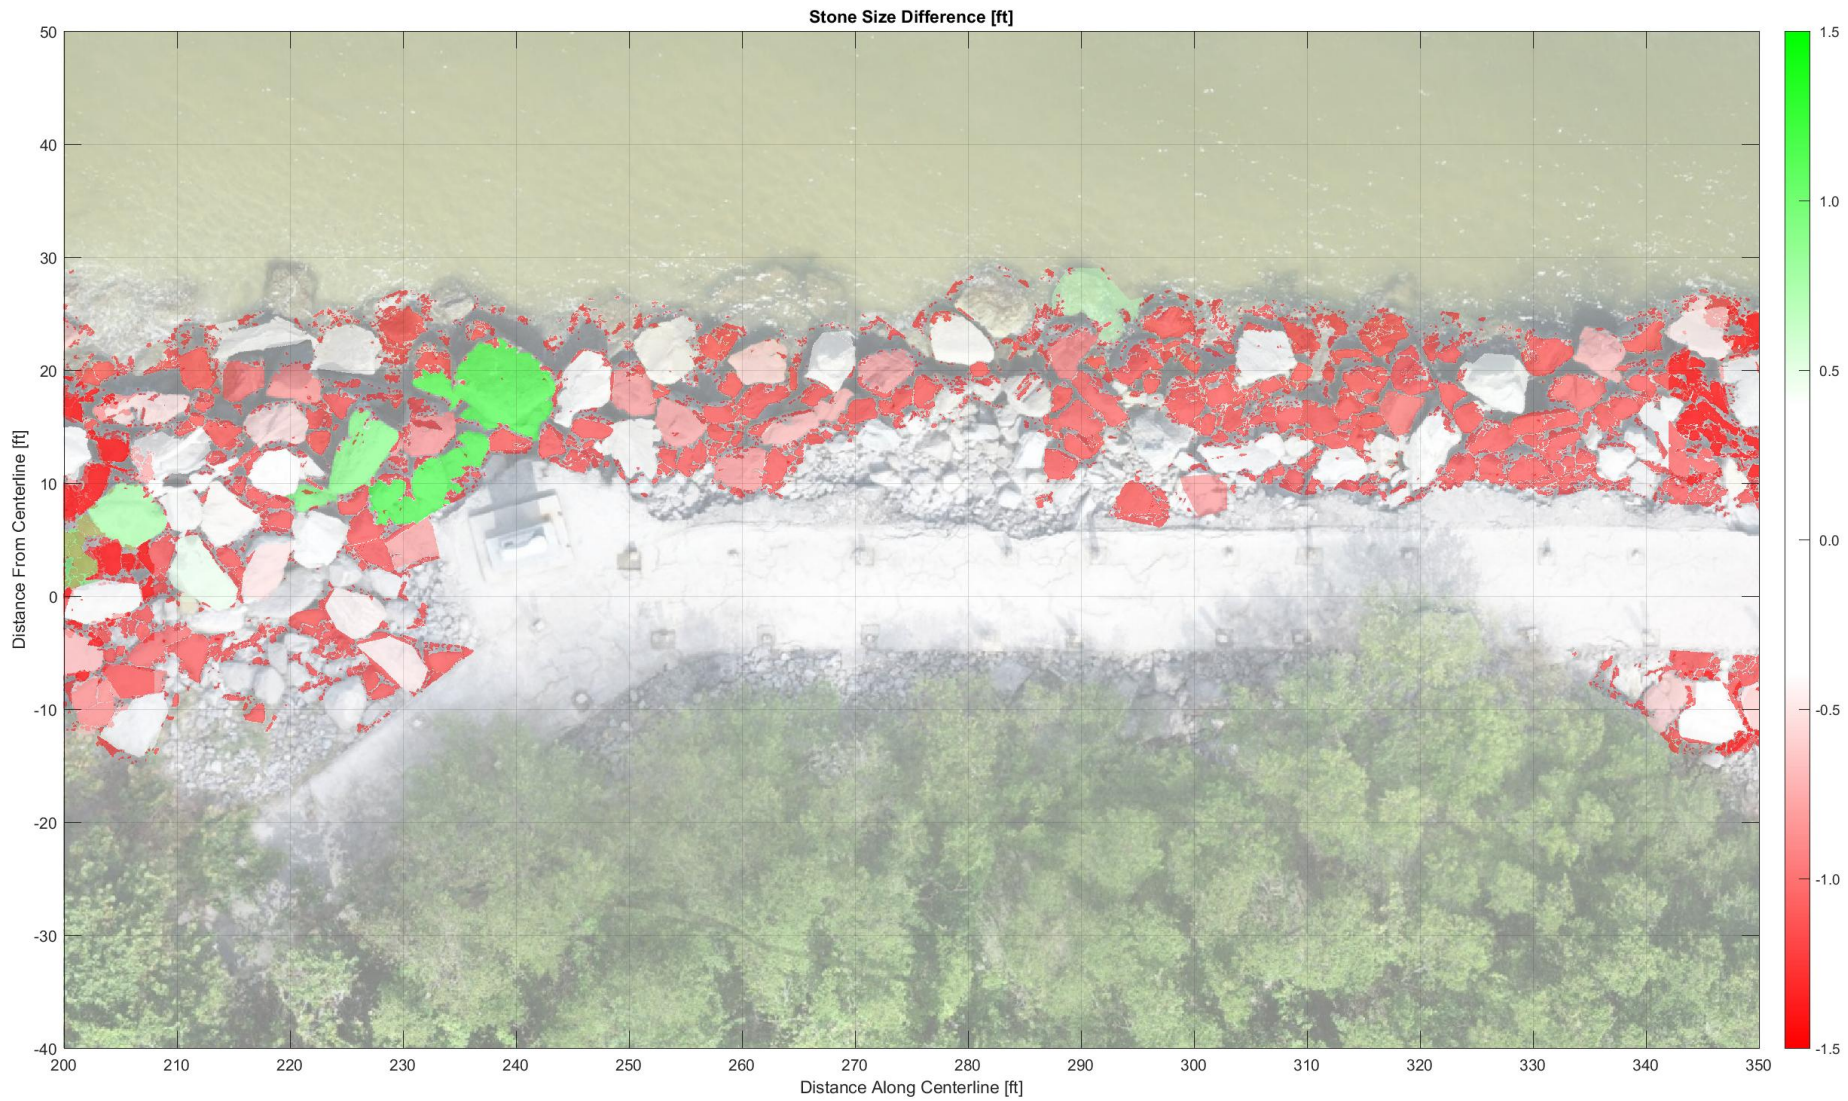
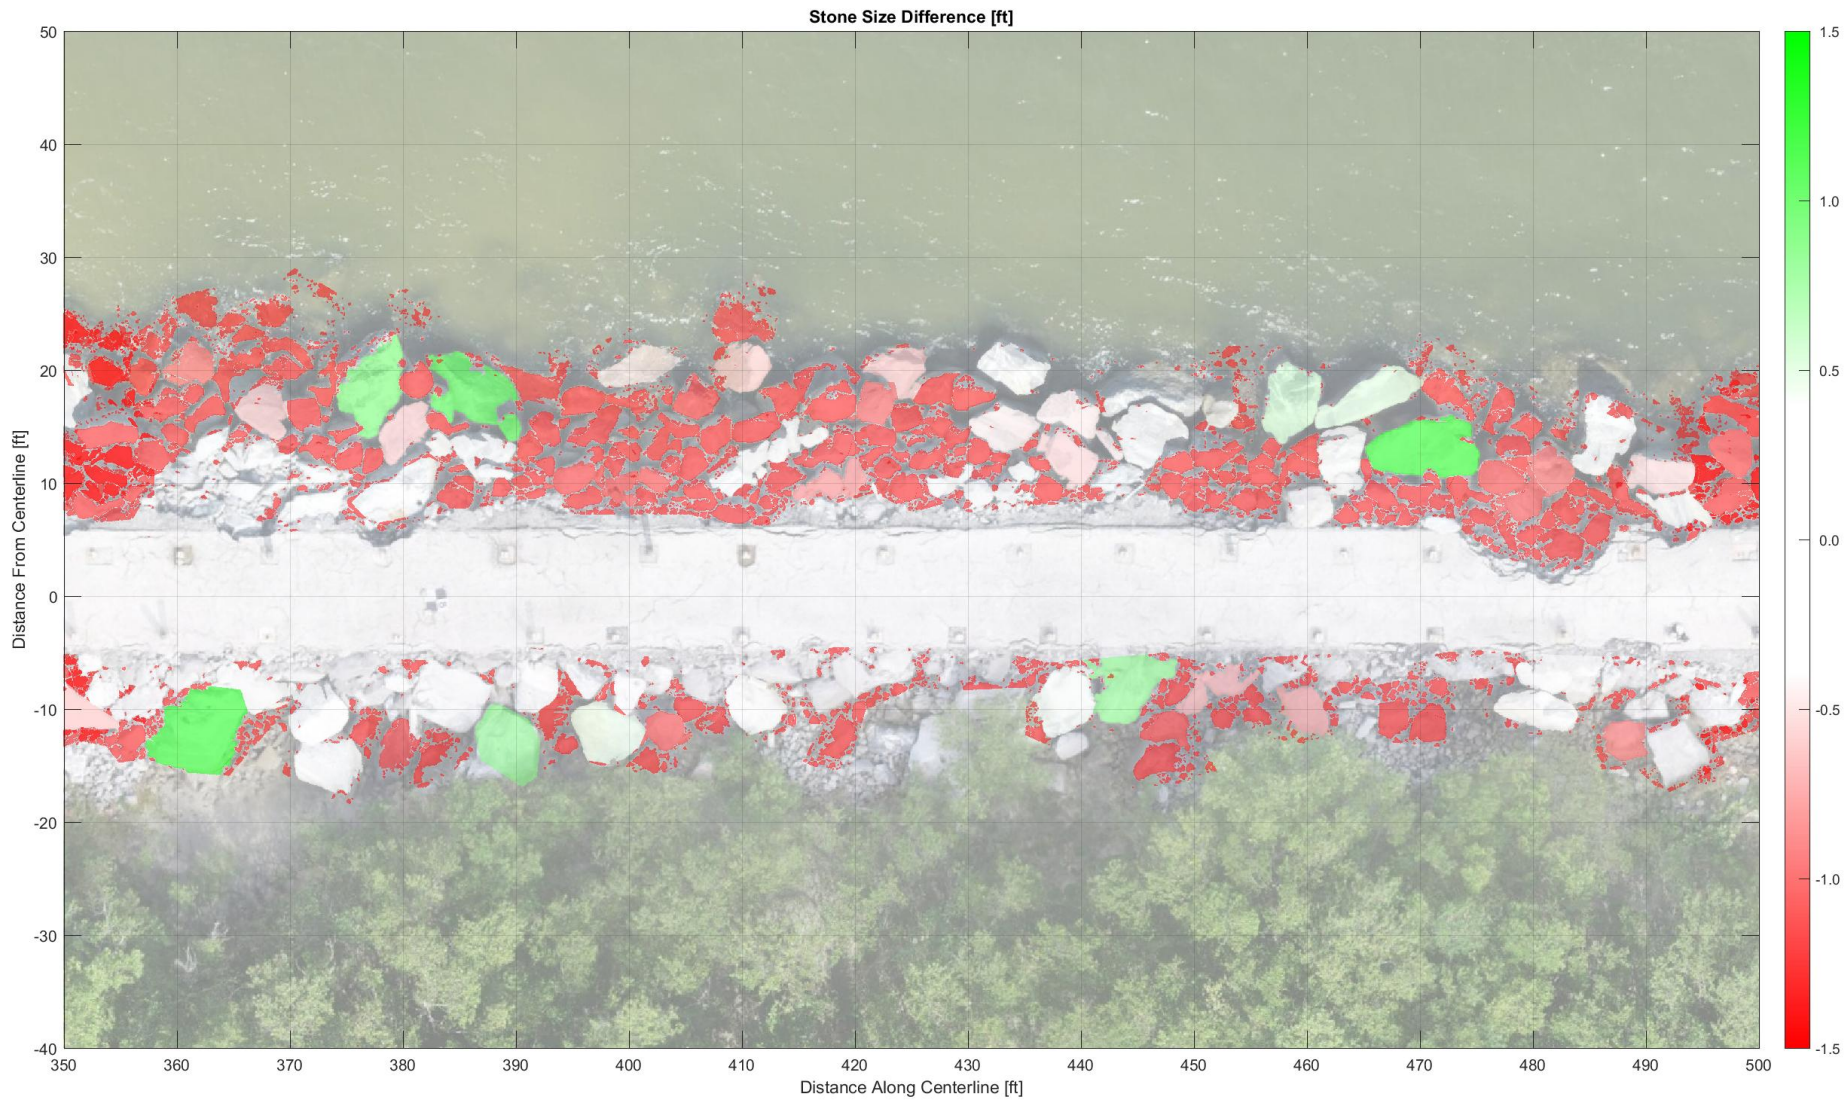
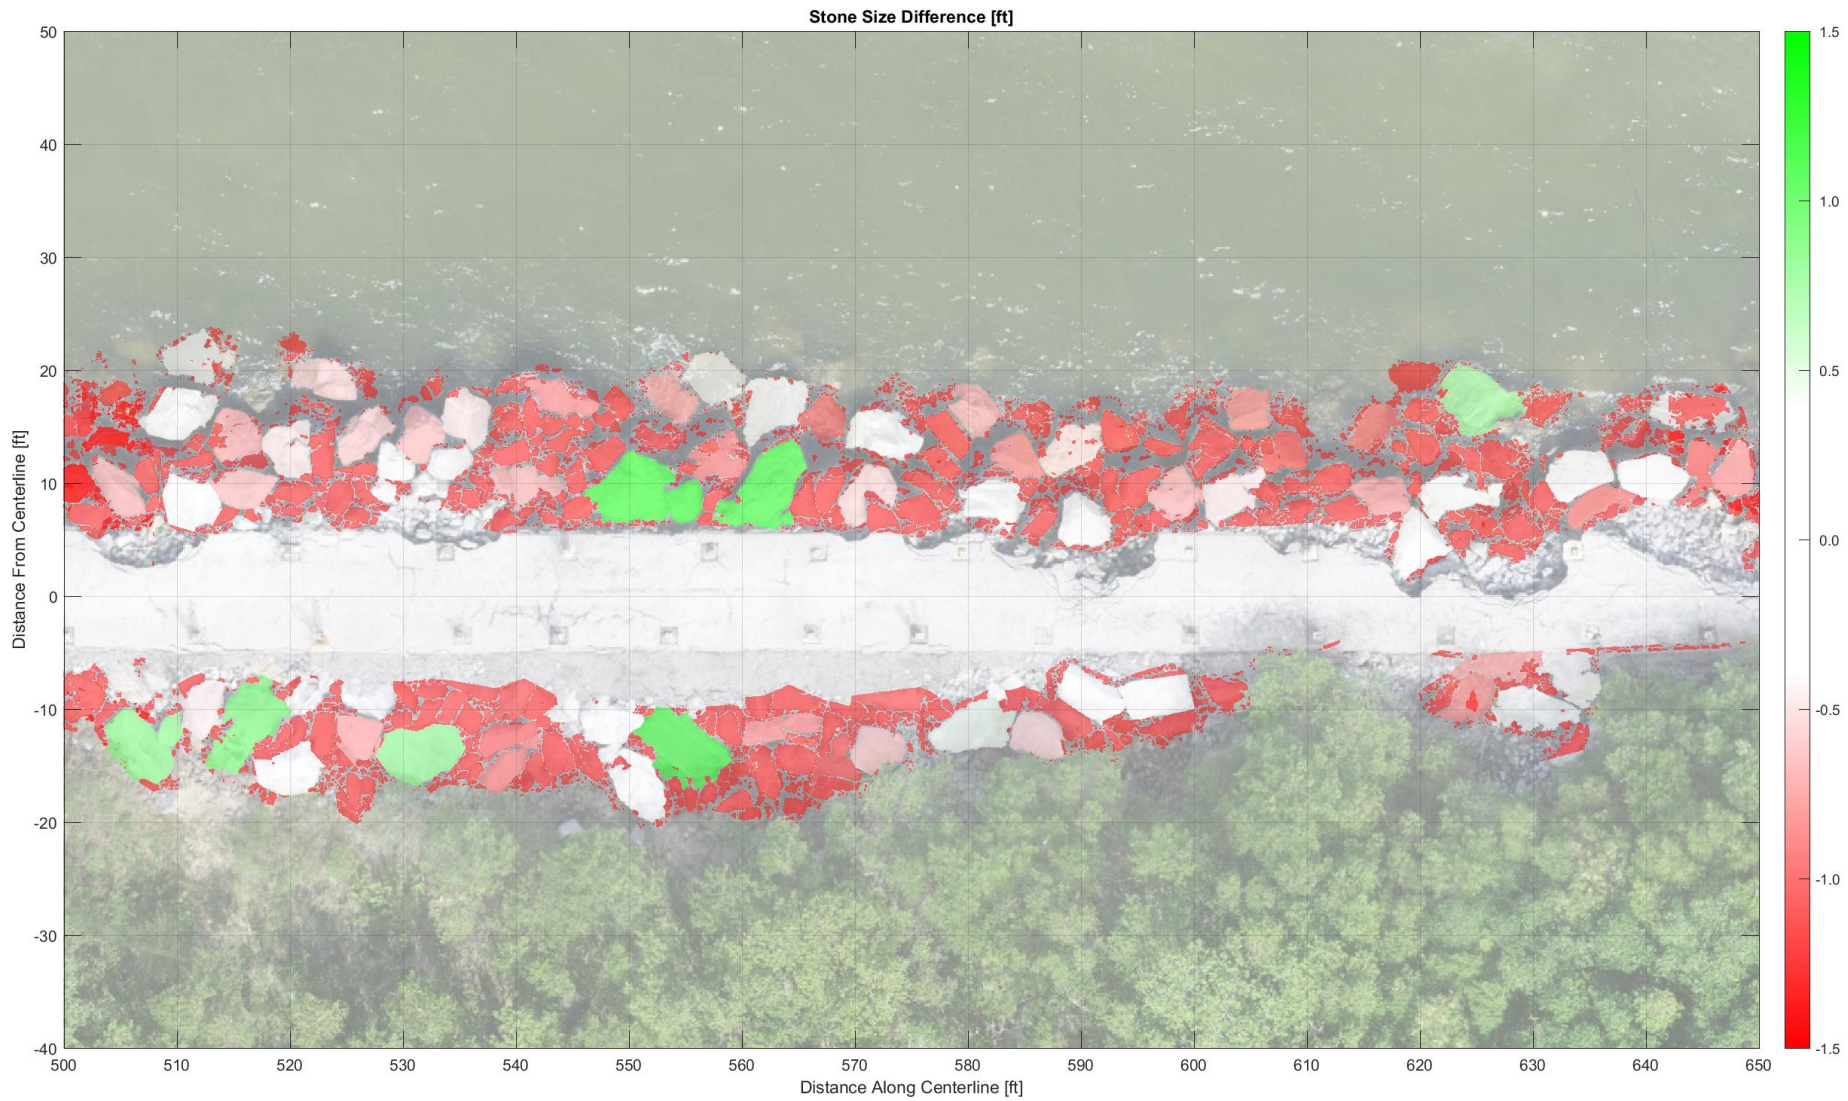
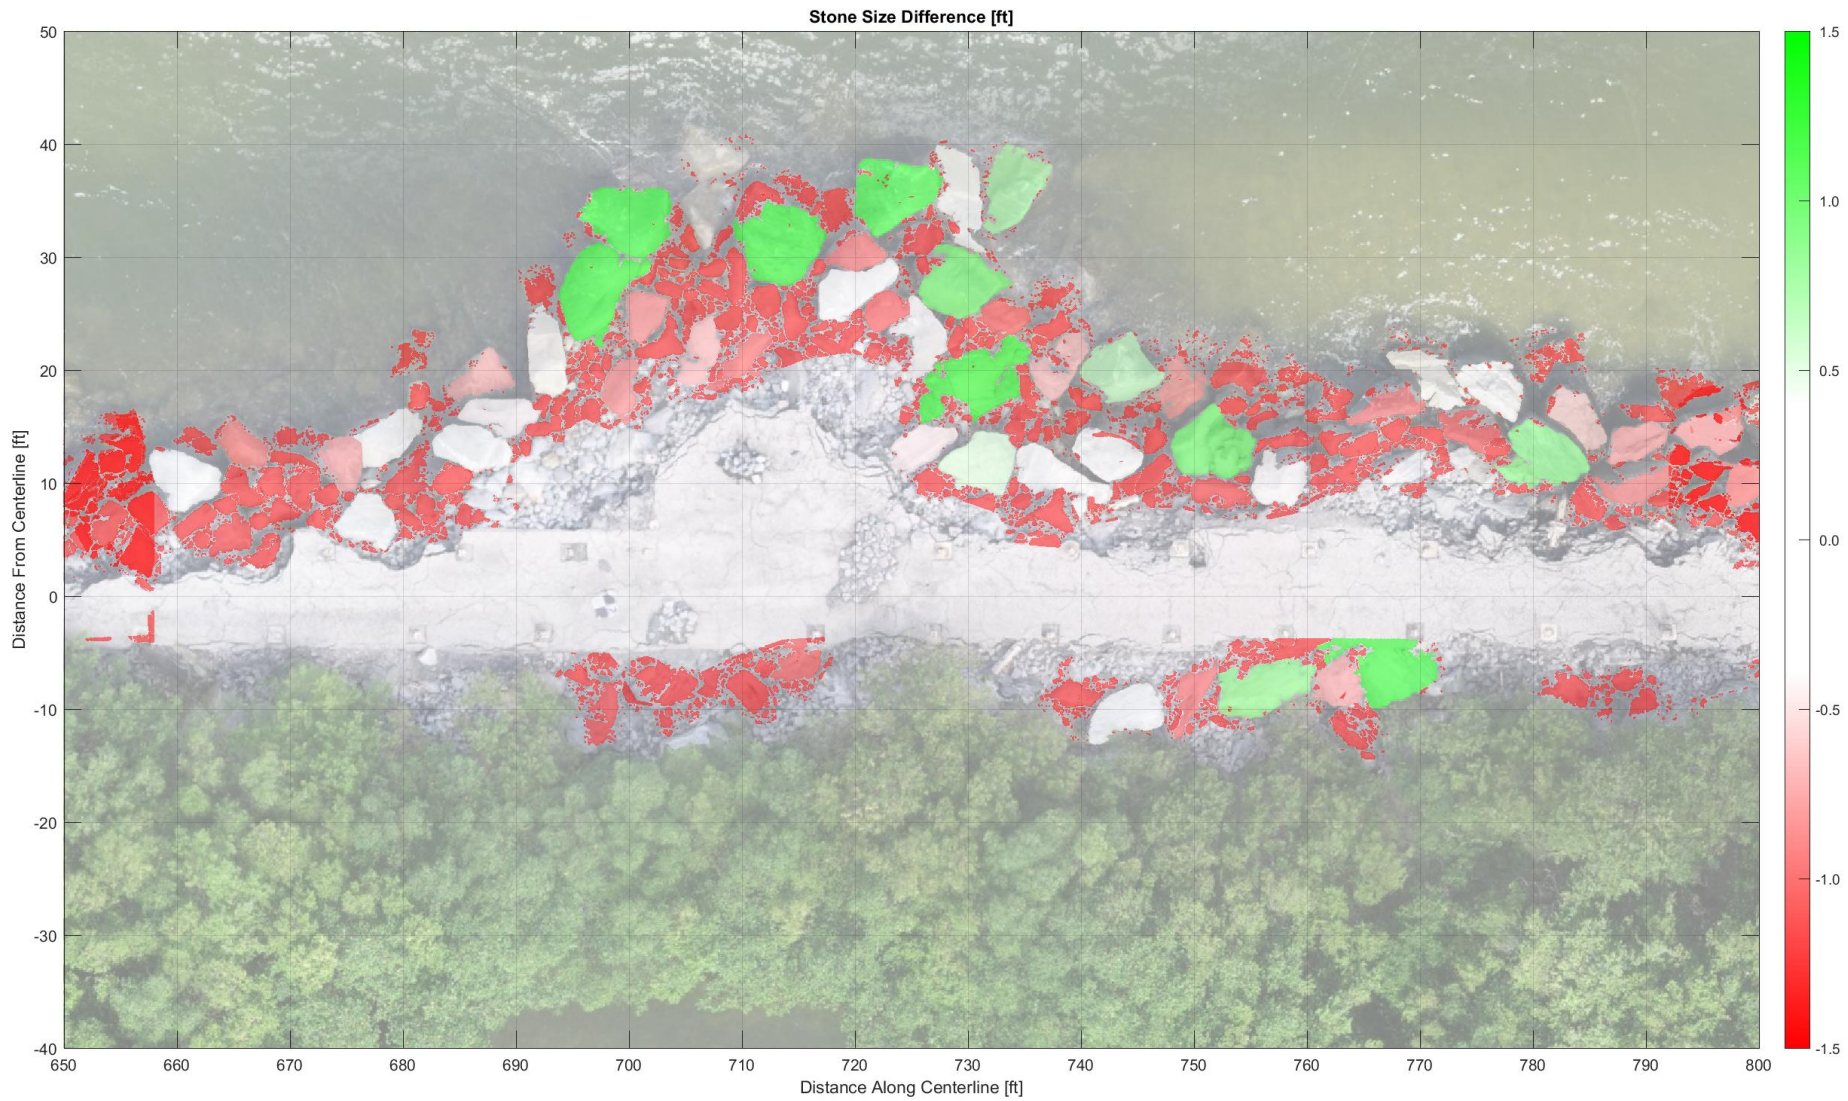
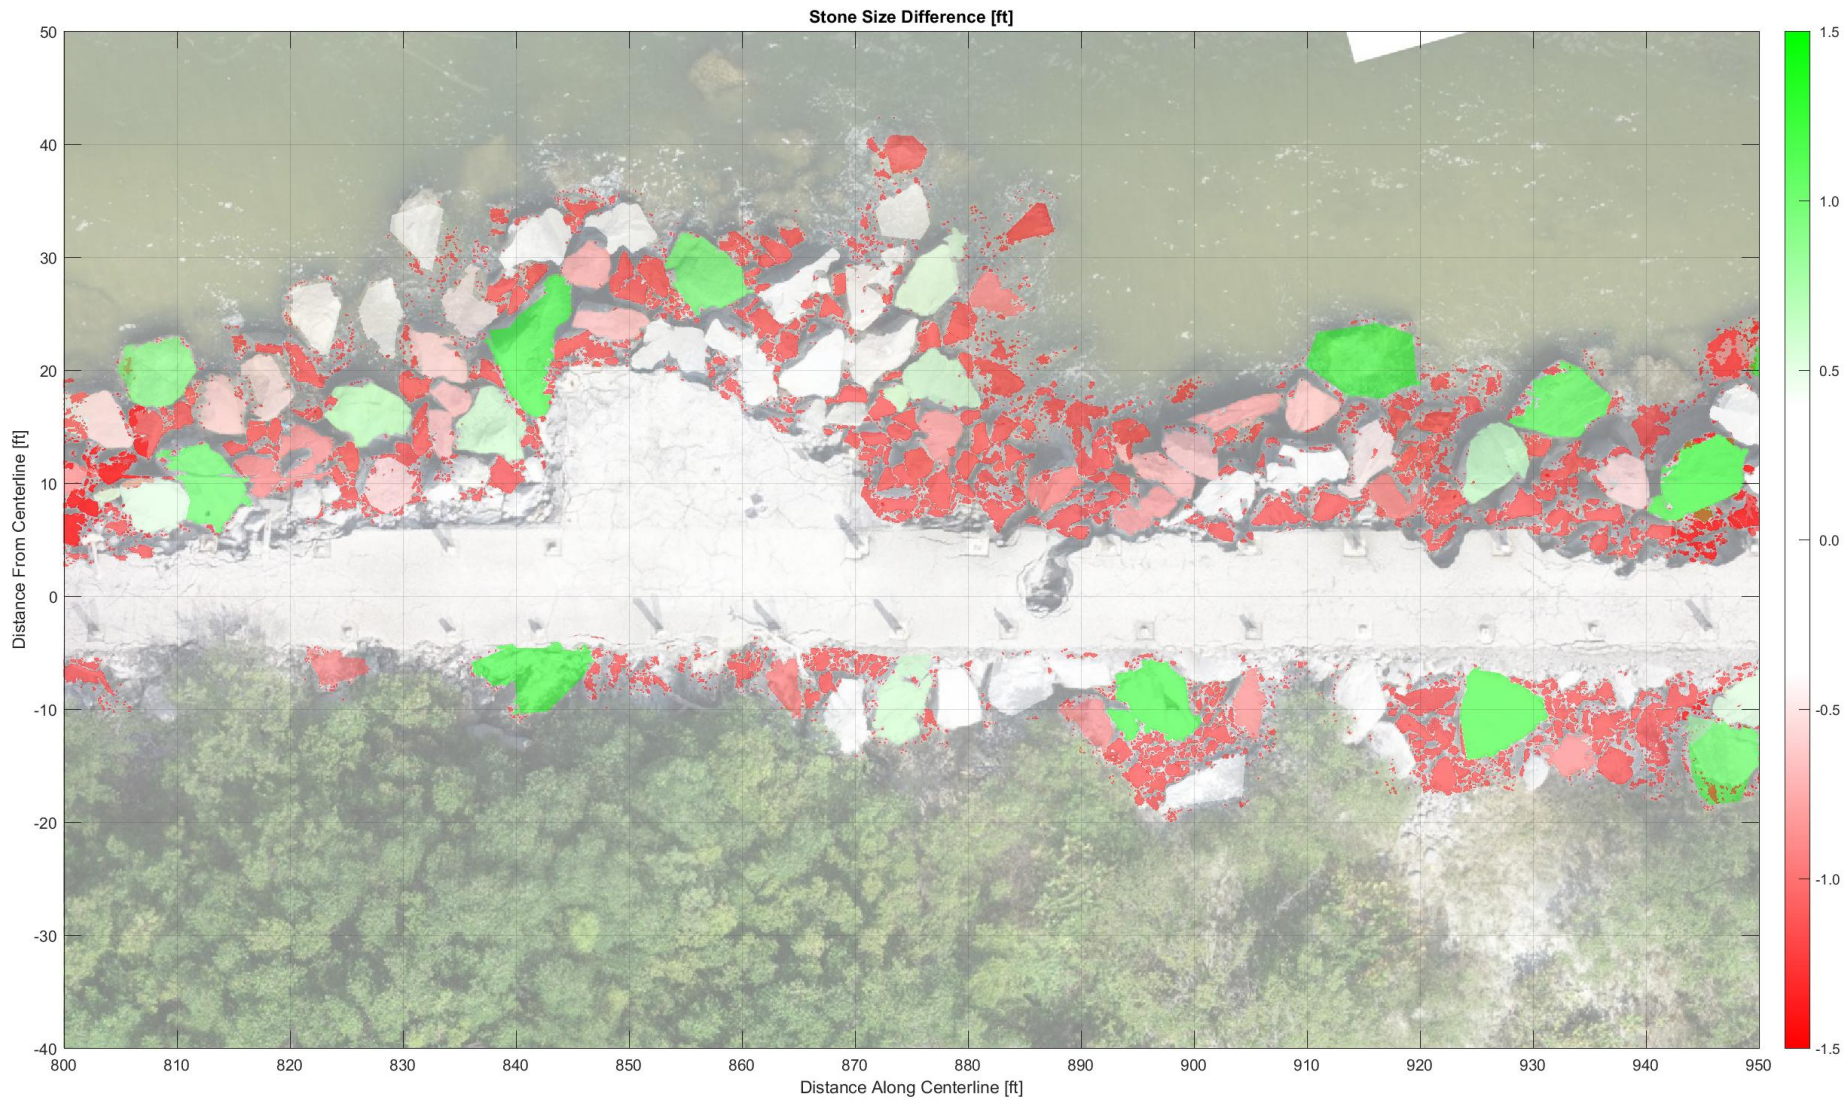
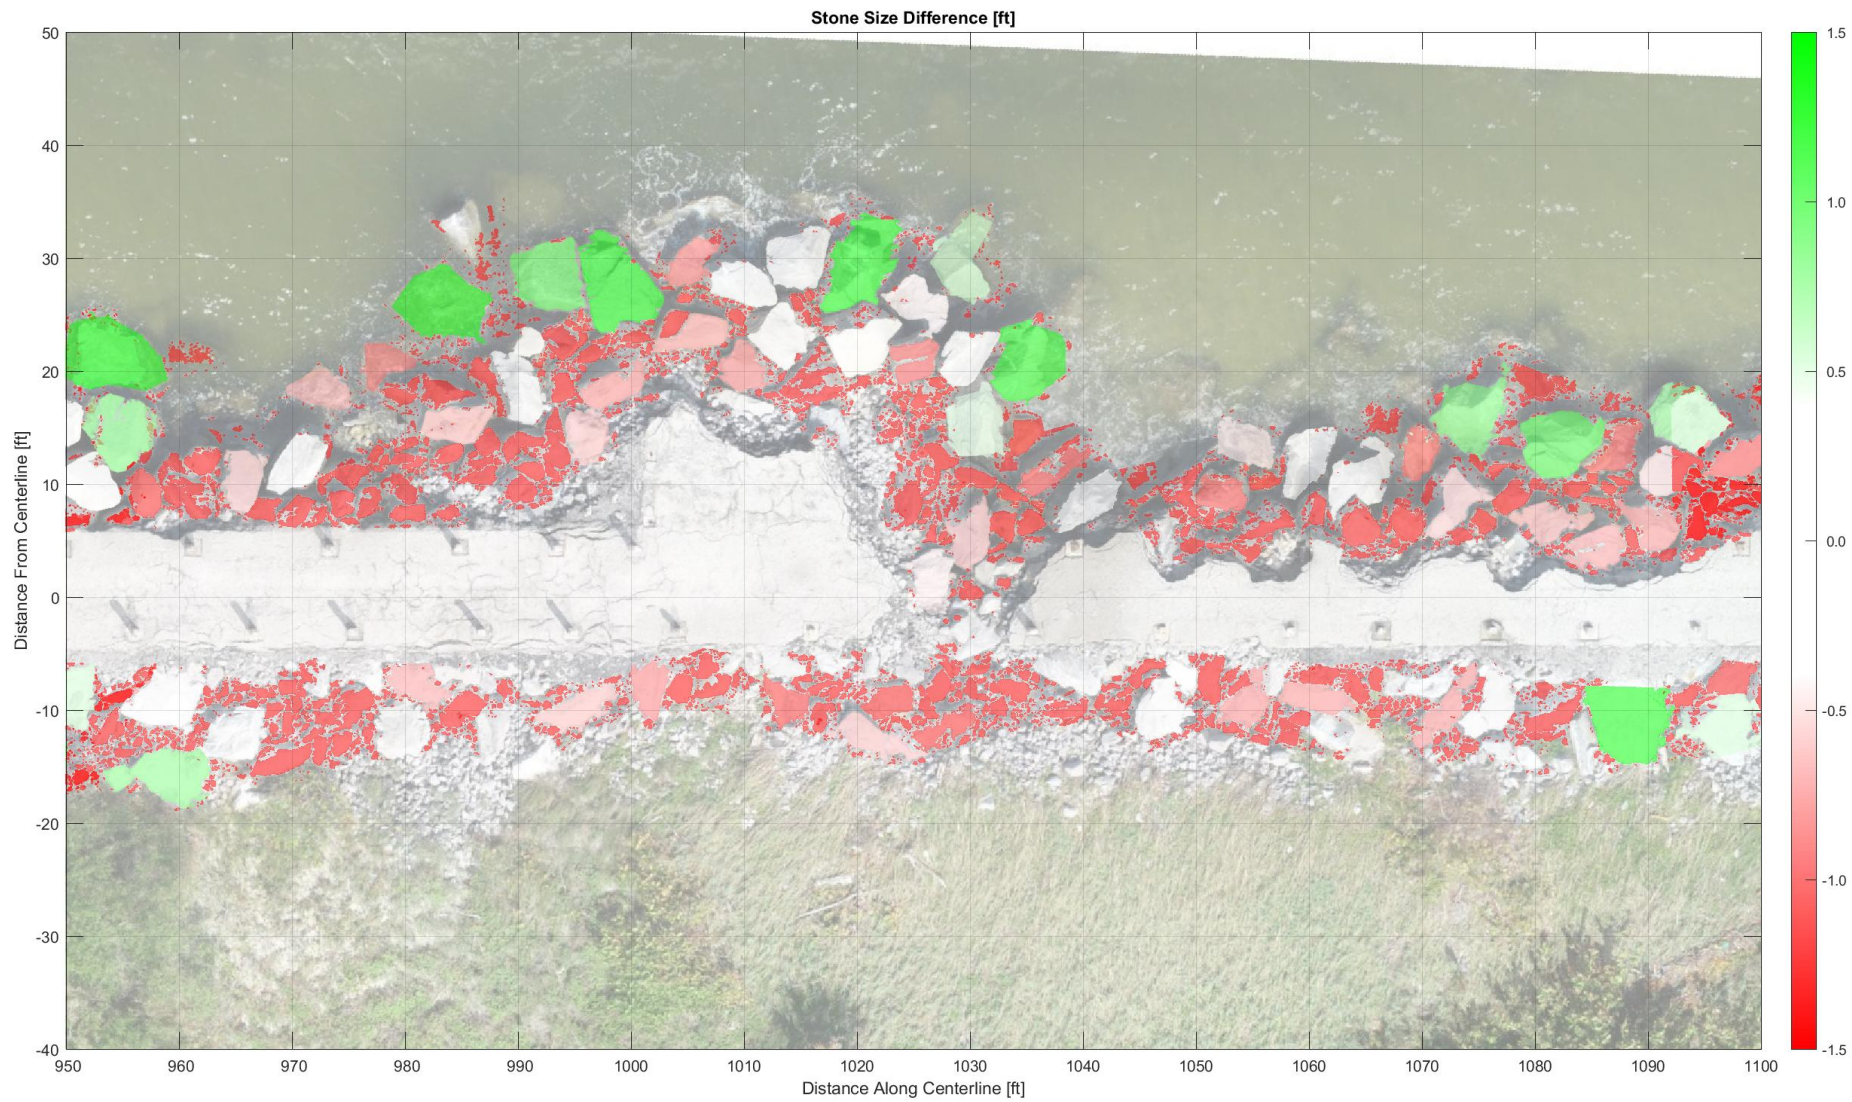
# JETTY STONE COMPARISONS

- › Armor stone size deficiencies were calculated for each 20-foot segment along the jetty crest and north and south jetty faces.

Face	Analyzed	Deficient	Percent
Crest	2,350	1,750	50%
North	14,350	8,850	62%
South	5,740	3,470	60%
<b>Total</b>	<b>22,440</b>	<b>8,950</b>	<b>60%</b>
