# Assessment of Pinellas County Coastal Erosion Control Structures

**APTIM:** James Austin, P.E.,  
Douglas Mann, P.E., BC.CE.,  
**Pinellas County:** John Bishop, Ph.D.,  
Zachary Westfall

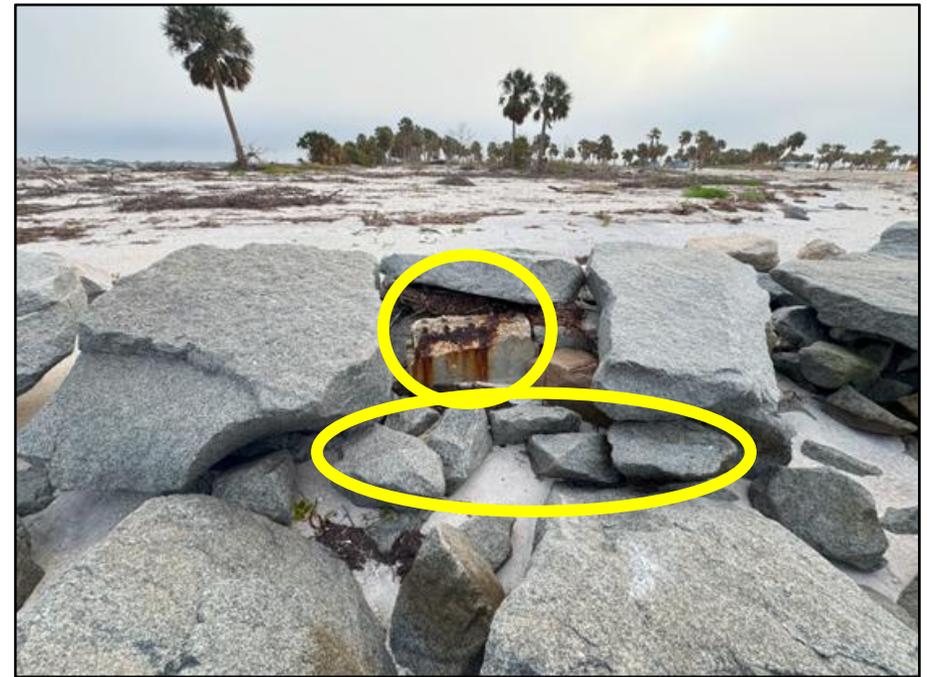
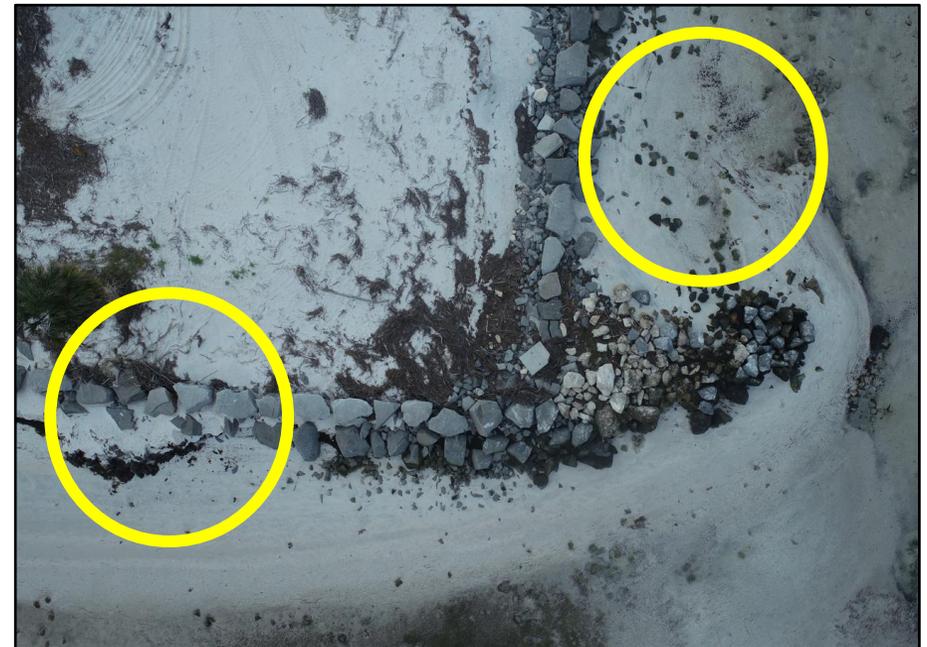
- Observed defects:
  - Displaced stone
  - Minimal cross section
  - Exposed bedding stone
  - Exposed tie backs
  - Rusting and spalling of concrete sheet pile

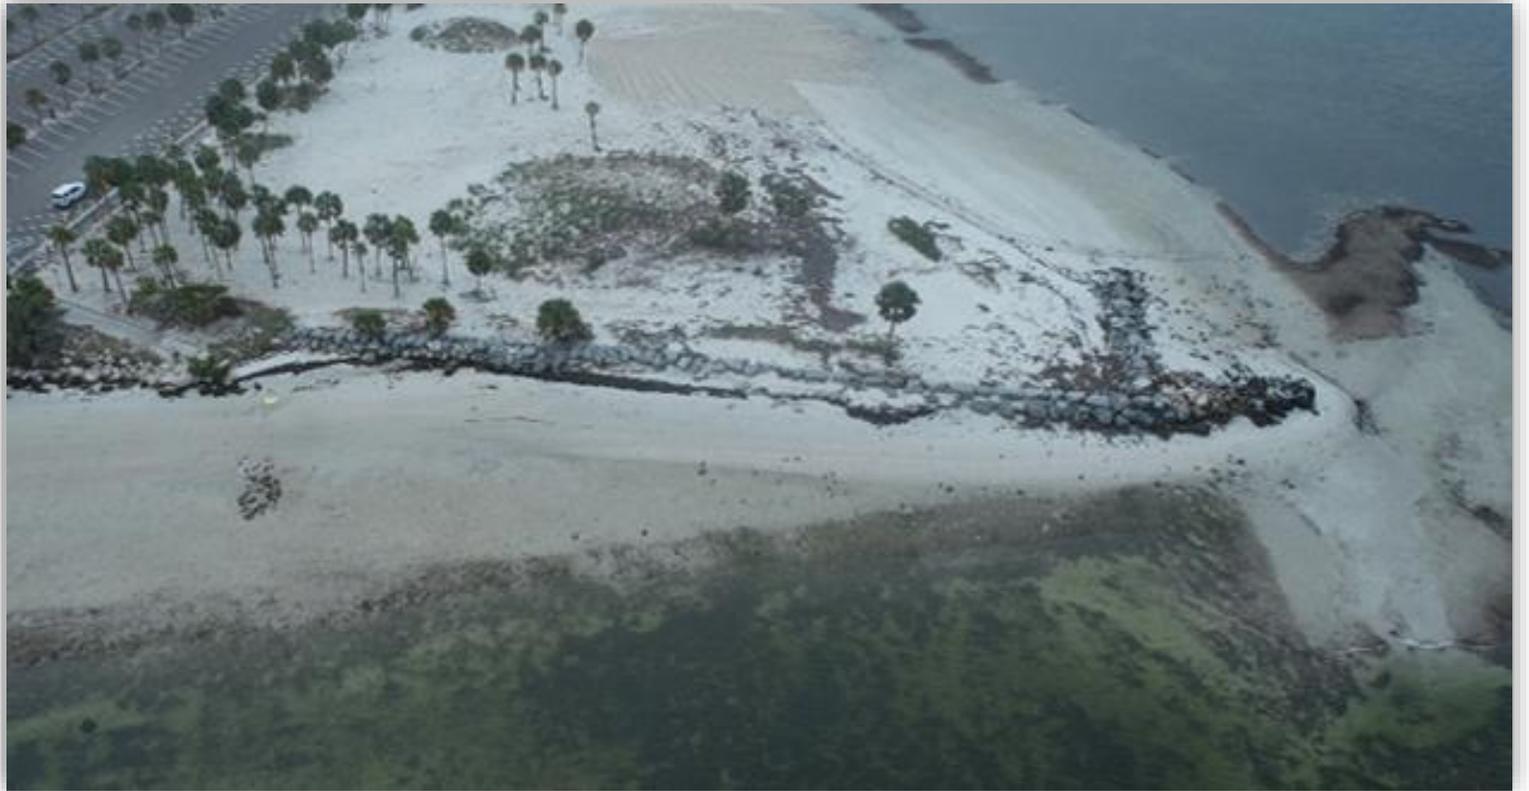
- Functionality:
  - Leaking some sand
- Rating:
  - Poor (3)
- Recommendation:
  - Add supplemental stones

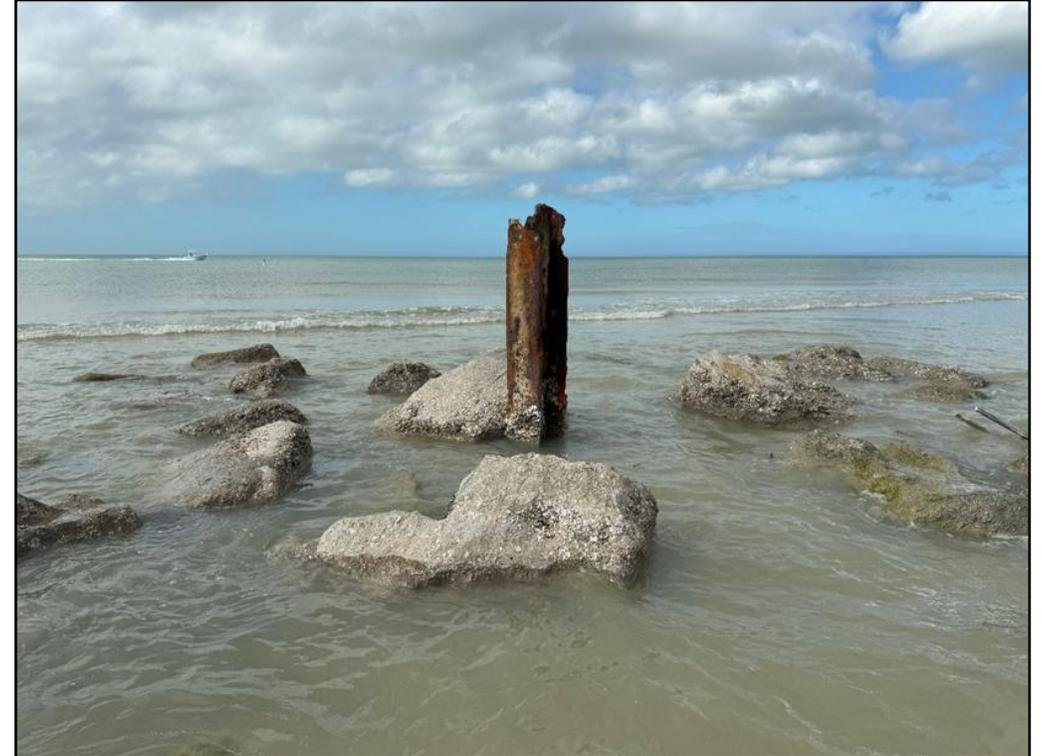
- Observed defects:
  - Large gaps between stones and proximity to shoreline creates safety hazard

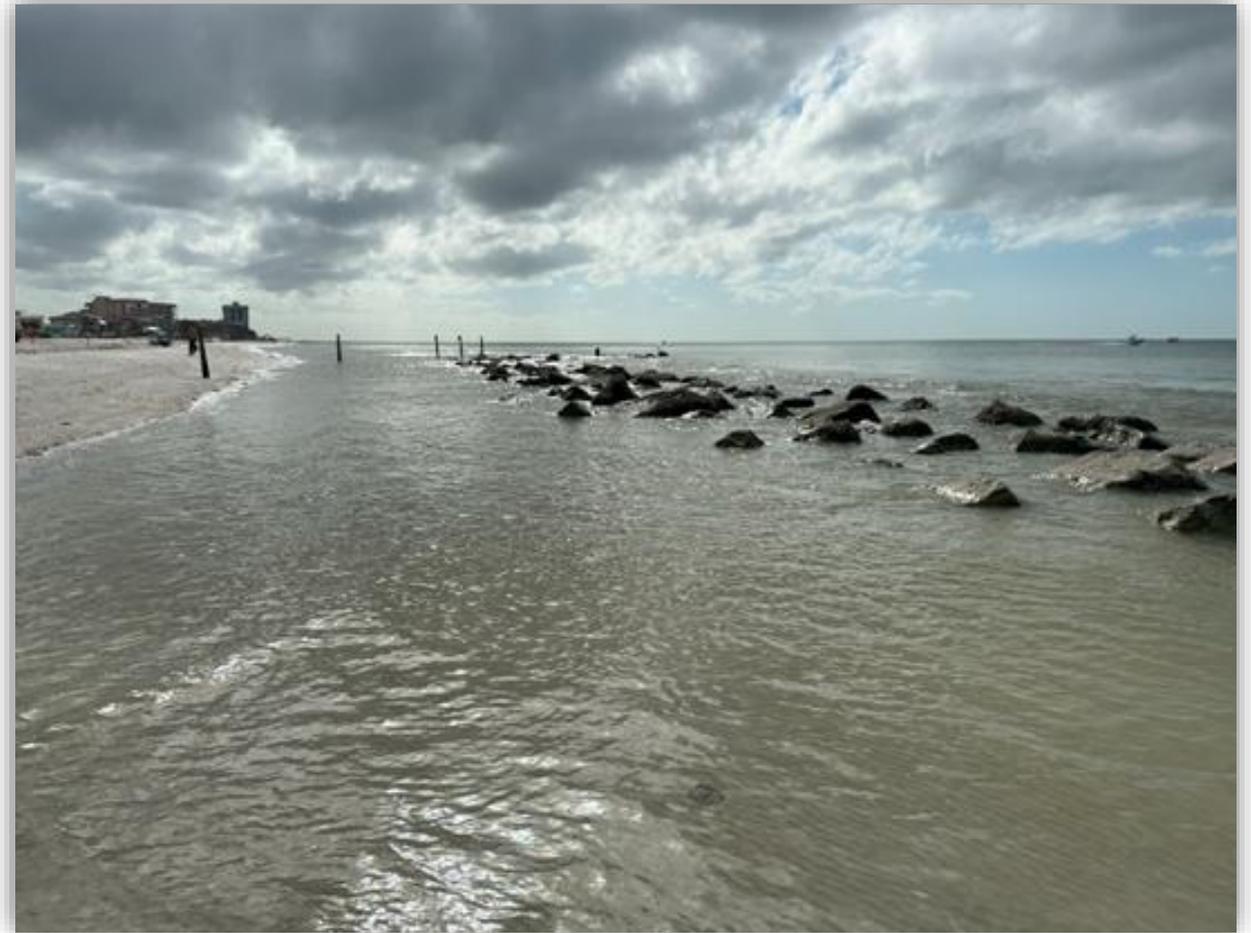
- Functionality
  - Dissipation of wave energy
  - Formation of slight salient
- Rating:
  - Serious (2)
- Recommendation:
  - Modeling of alternatives

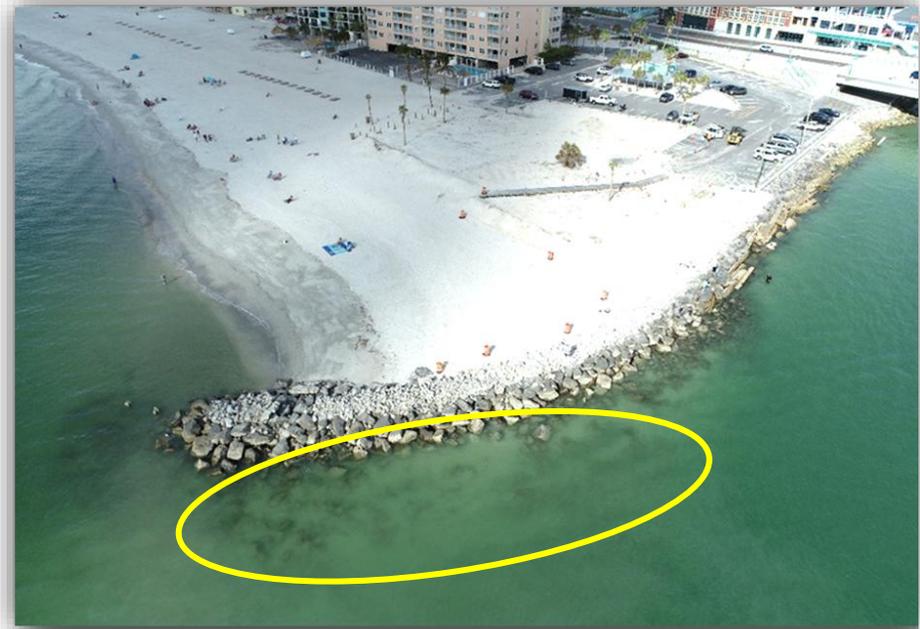
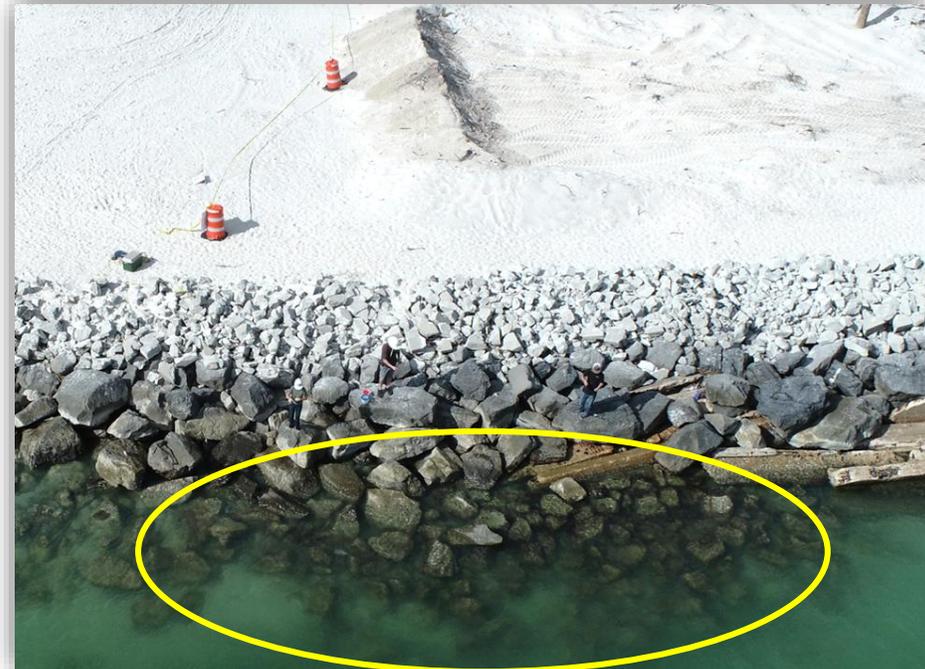
- Observed defects:
  - Displacement of armor stone
  - Sloughing of side slopes

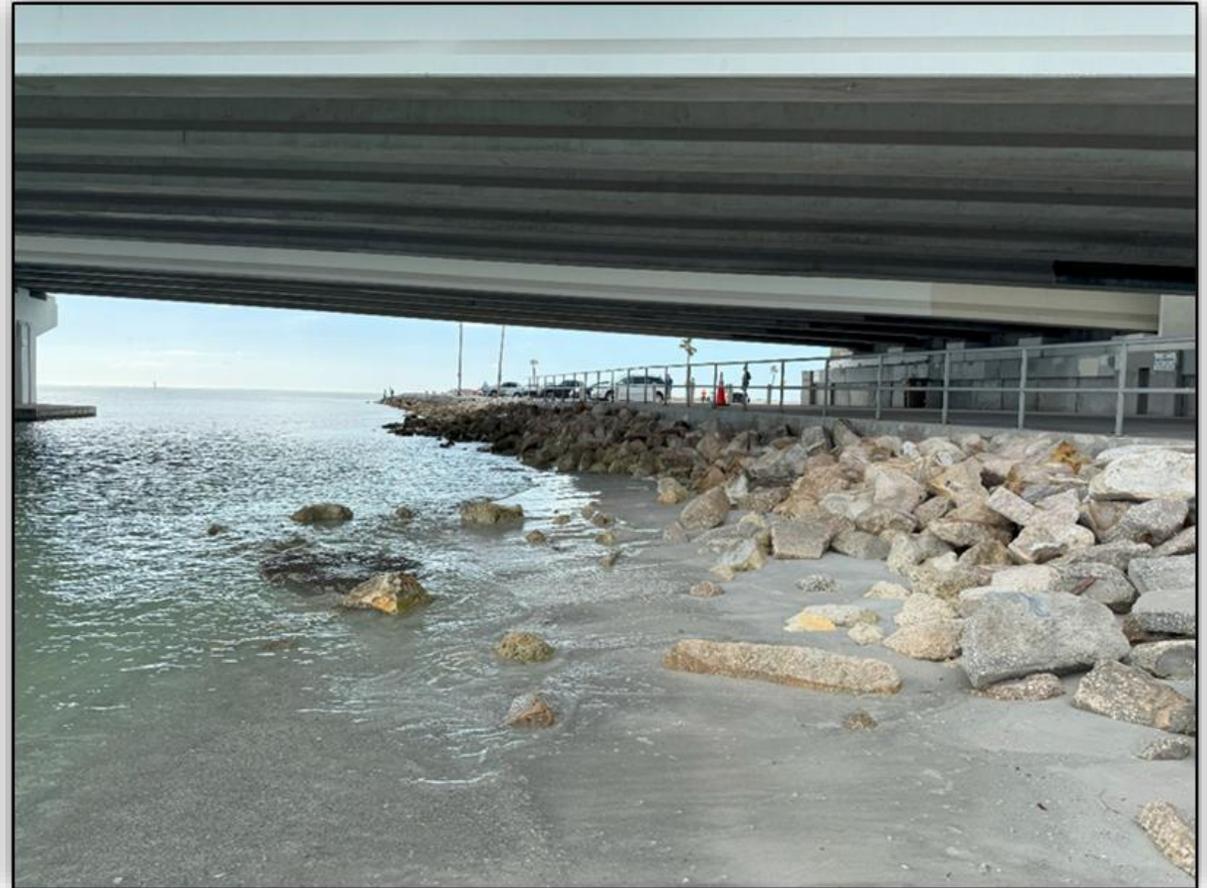
- Functionality:
  - Sand bypasses around jetty
- Rating:
  - Fair (4)
- Recommendation:
  - Continued monitoring

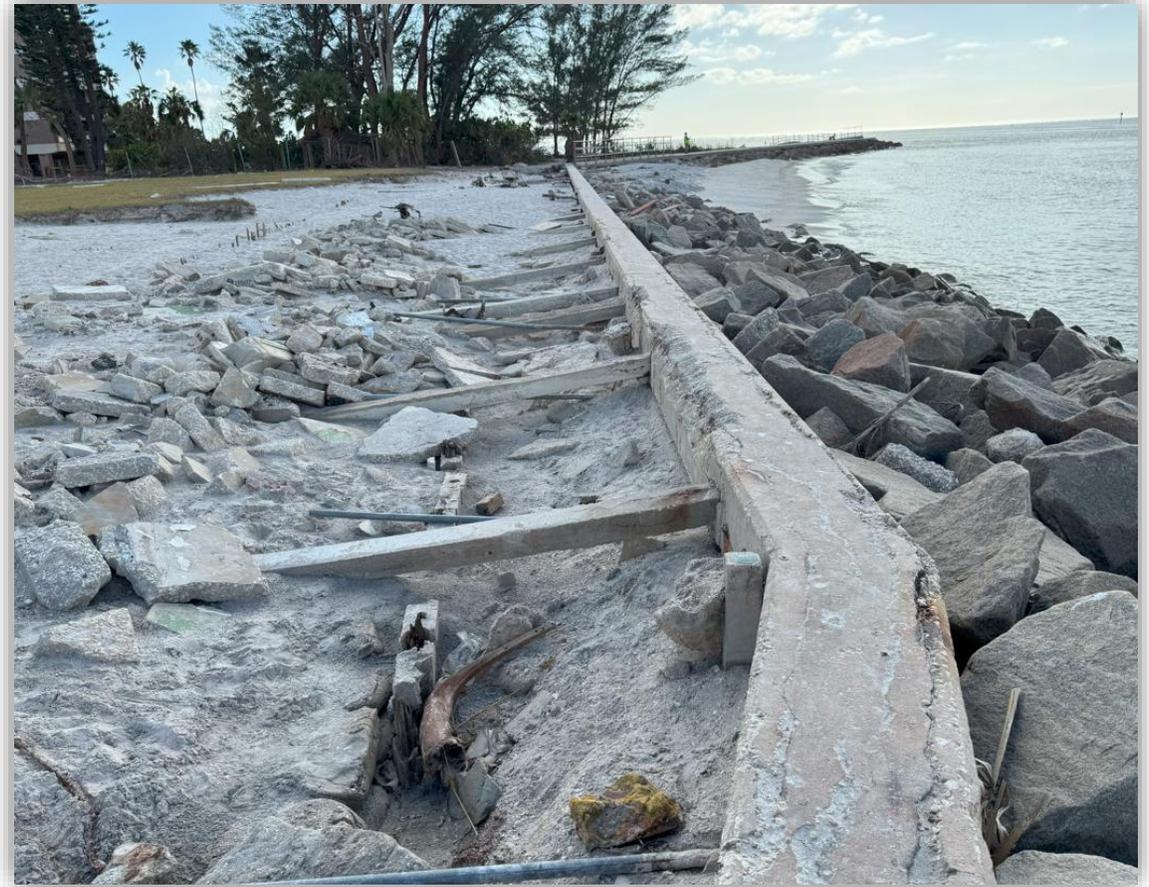
- Observed defects:
  - Exposed tie backs
  - Concrete spalling and rust stains on seawall cap and tie rods

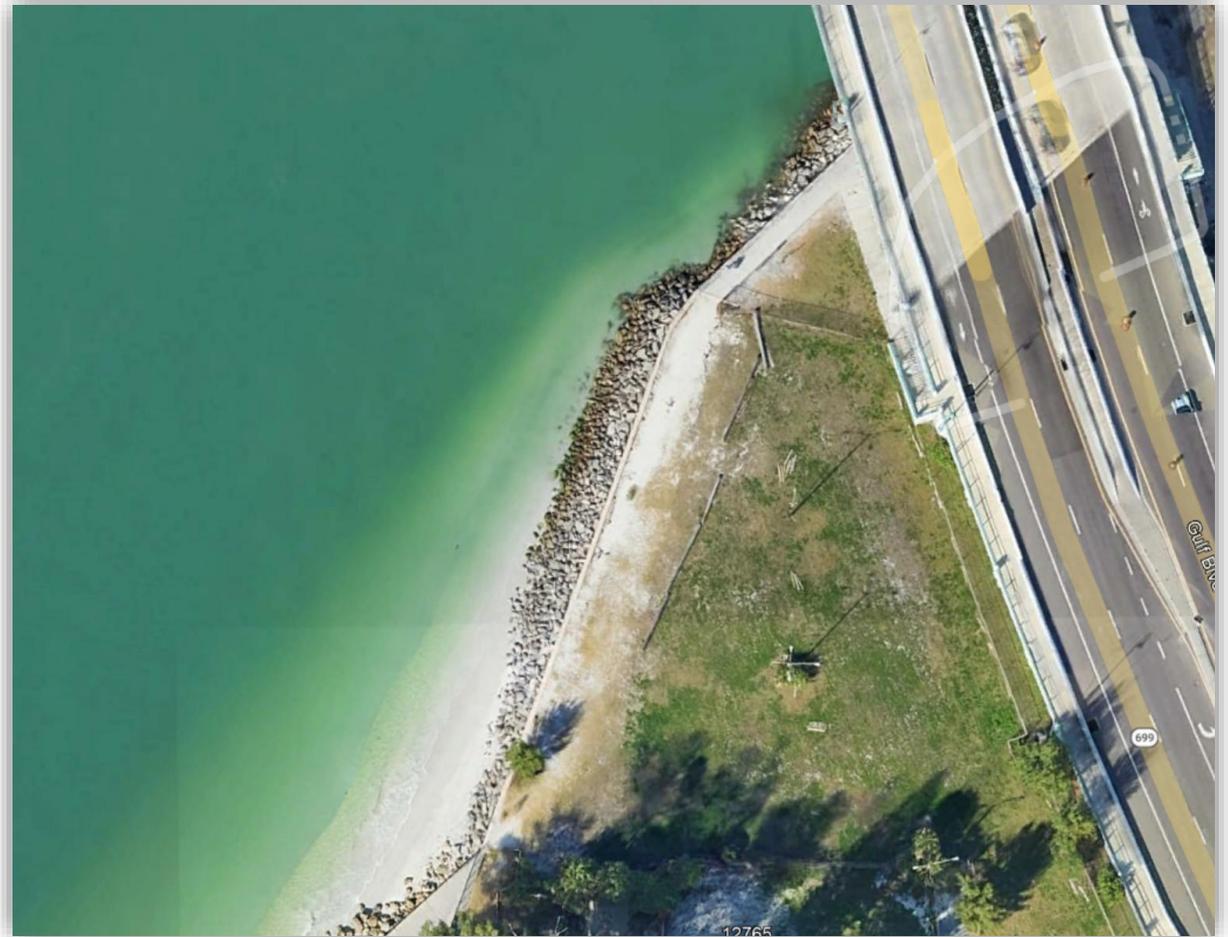
- Functionality:
  - Retaining sand
- Rating:
  - Poor (3)
- Recommendation:
  - Backfill seawall
  - Continued monitoring

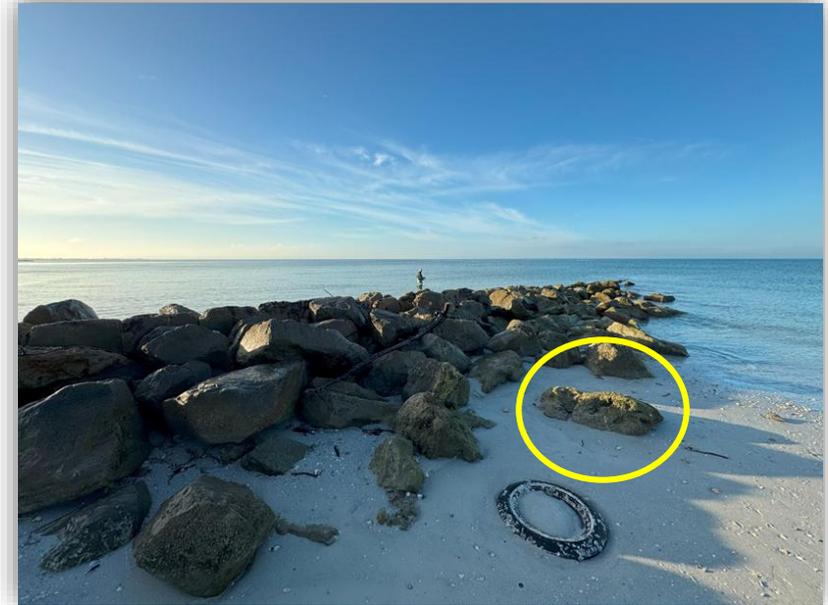
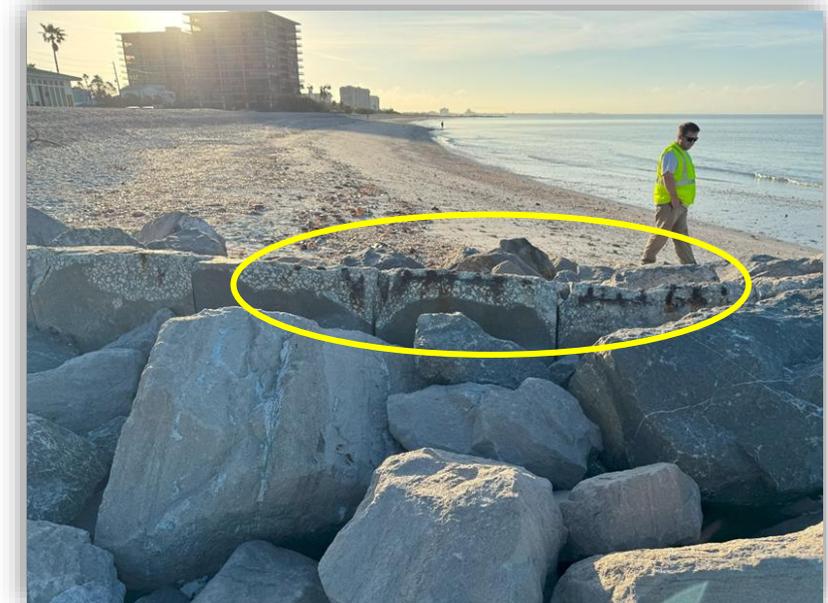
- Observed defects:
  - Displaced armor stones
  - Concrete spalling and rust stains on sheet piles

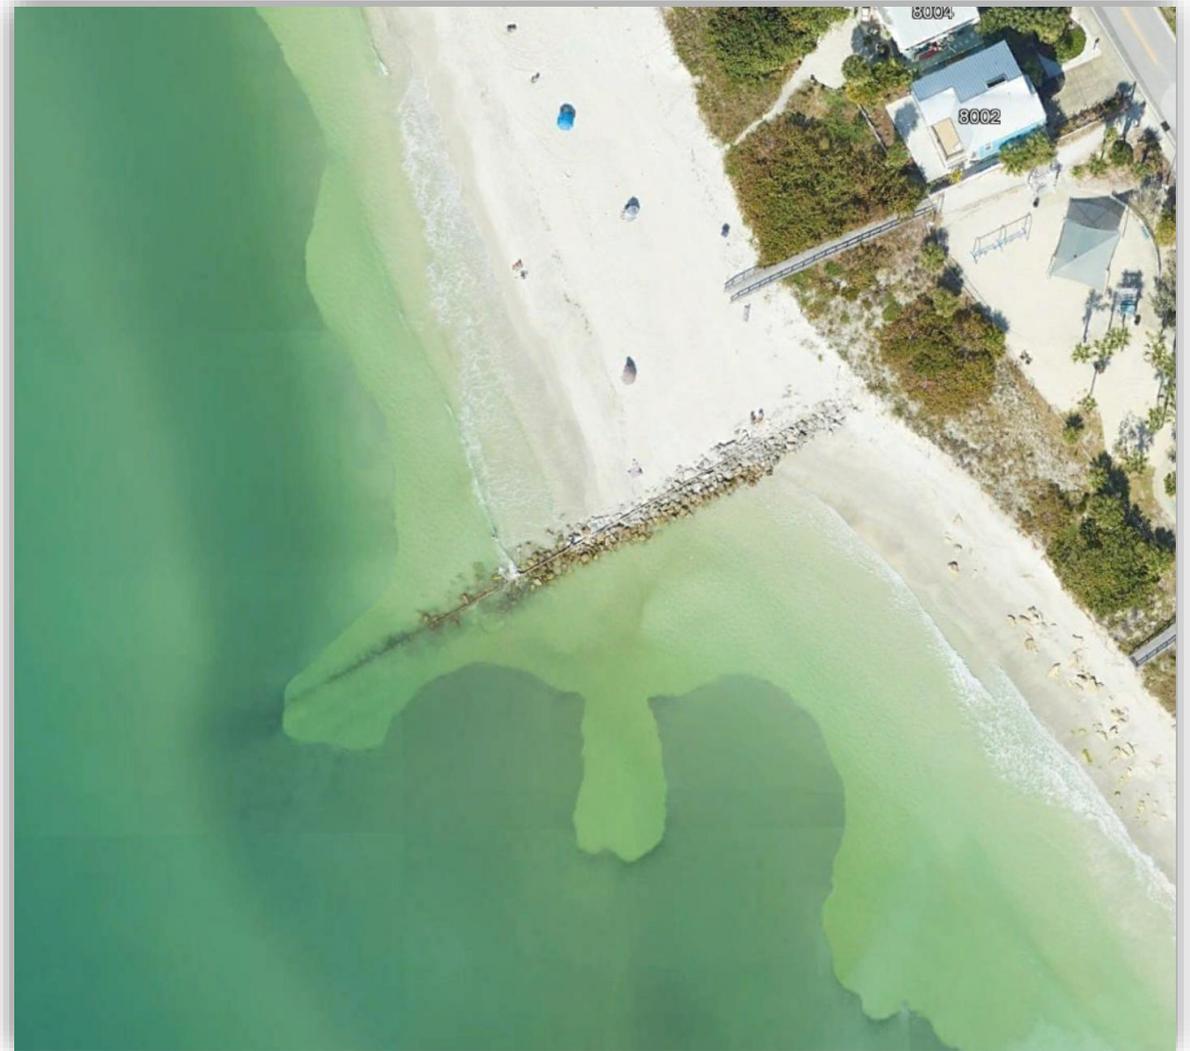
- Functionality:
  - Retaining sand
- Rating:
  - Fair (4)
- Recommendation:
  - Continued monitoring
  - Modeling study performed in 2024

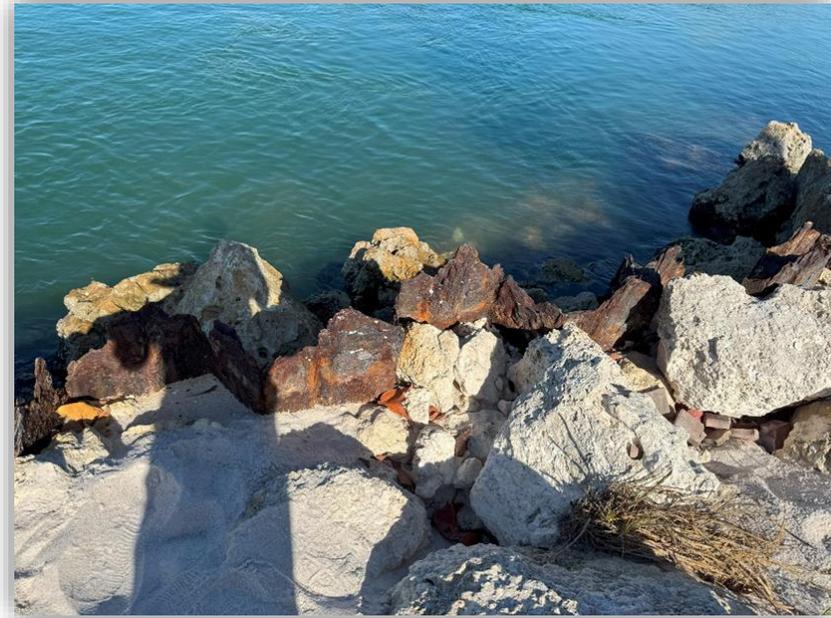
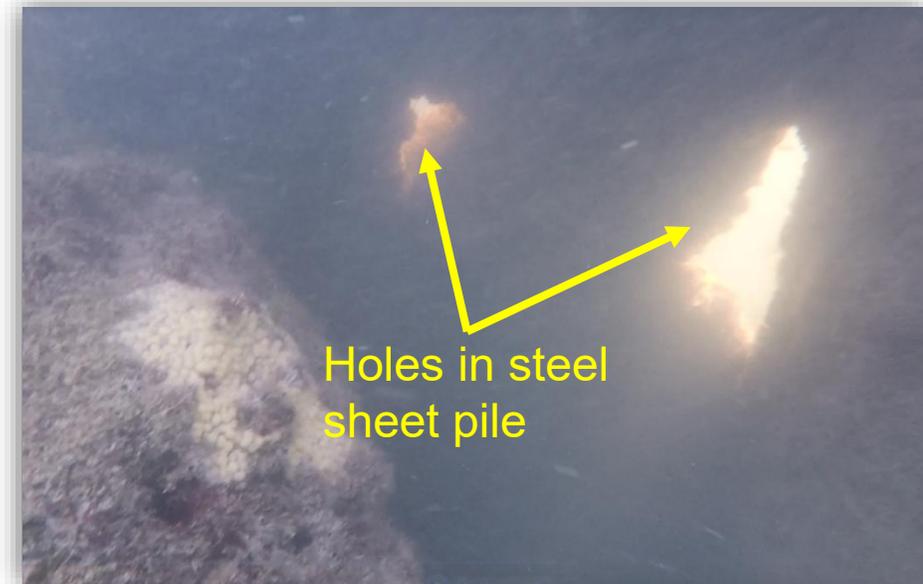
- Observed defects:
  - Sheet pile severely rusted and deteriorated
  - Inconsistent cross section of revetment fronting seawall

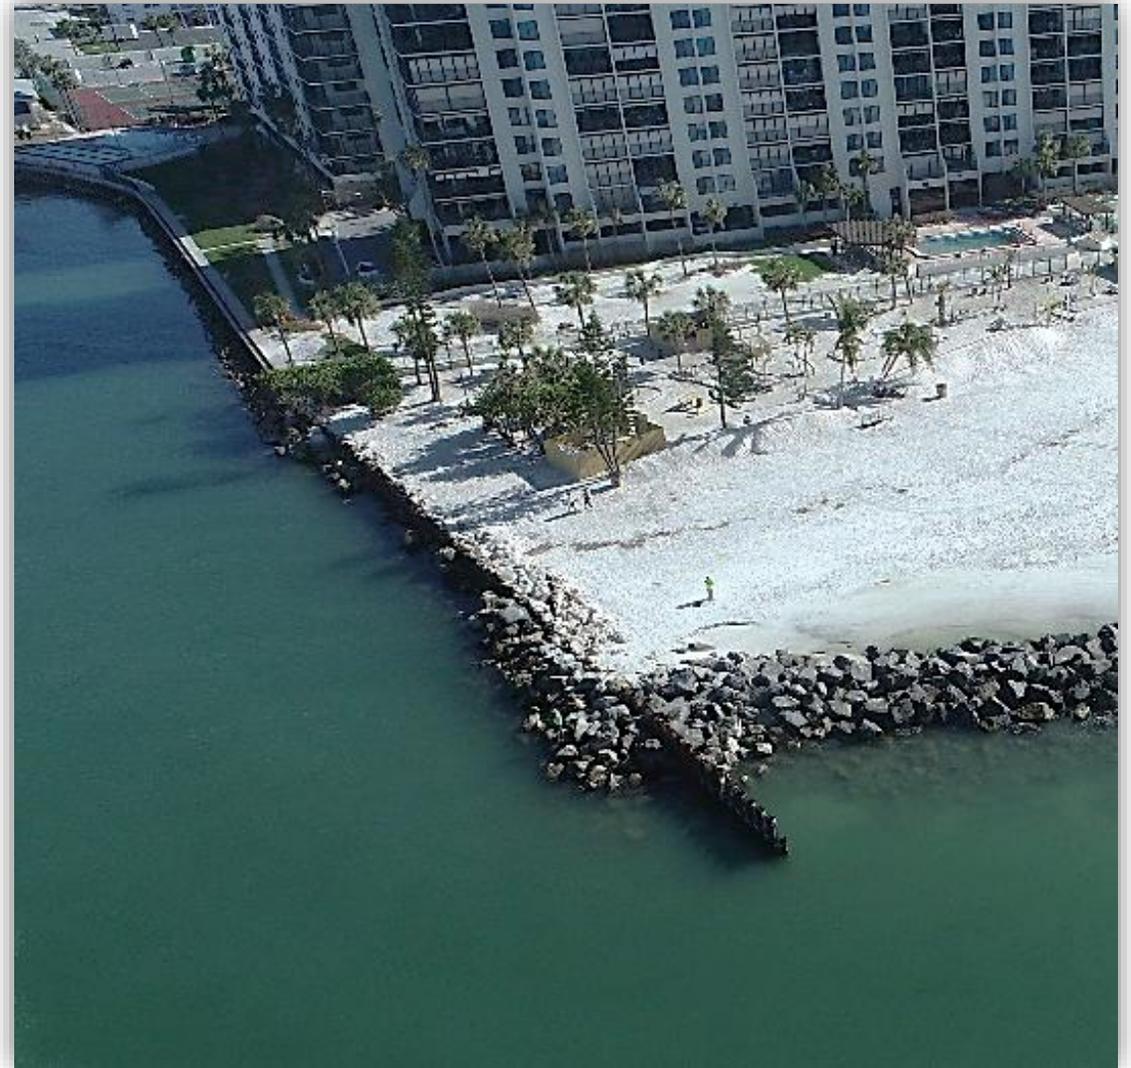
- Functionality:
  - Retaining sand
- Rating:
  - Critical (1)
  - Failure of seawall may occur suddenly
- Recommendation:
  - Replace seawall
