**Florida Department of Environmental Protection**

# **The Impact of Hurricane Irma on the Coast of Florida**

**February 8, 2018**

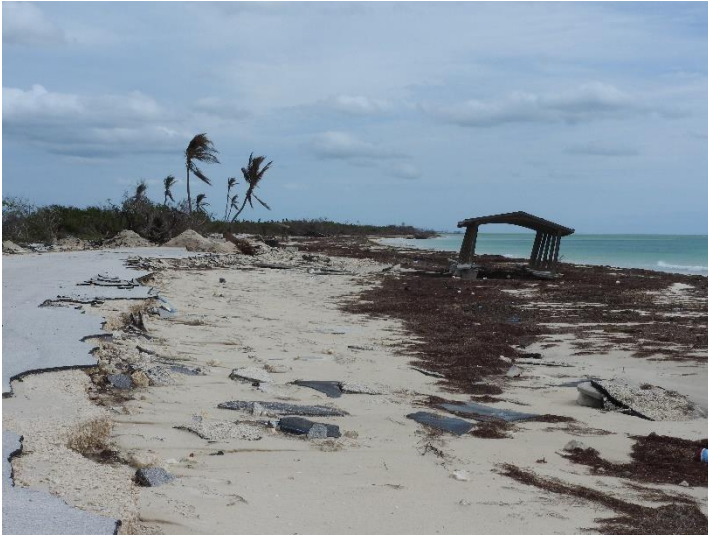
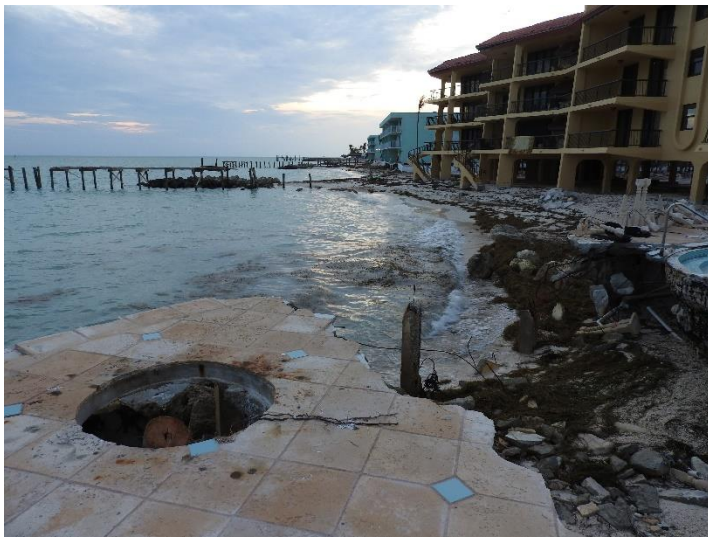
# Beach Erosion in the Florida Keys

- The eye of Hurricane Irma made landfall at Cudjoe Key on Sept. 10, 2017
- Major beach erosion along the Florida Keys from Sea Oats Beach to Cudjoe Key (Condition IV)
- Minor beach erosion between Cudjoe Key and Key West (Conditions I-II)

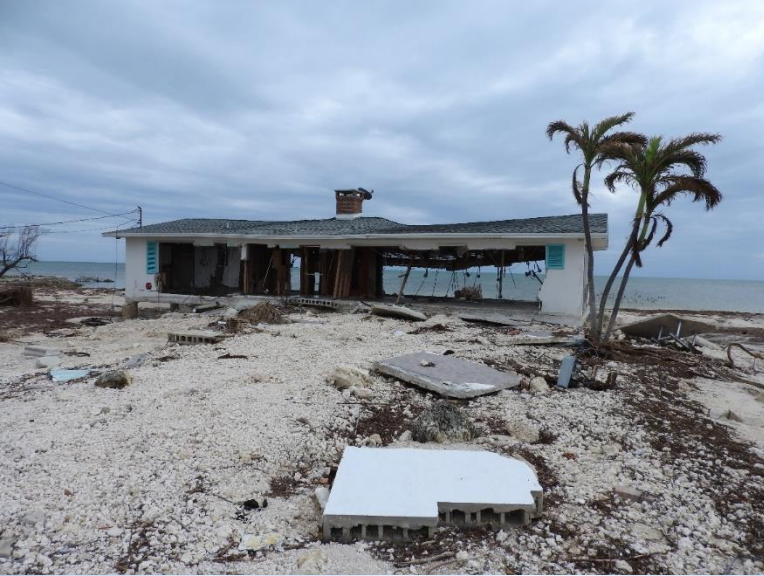
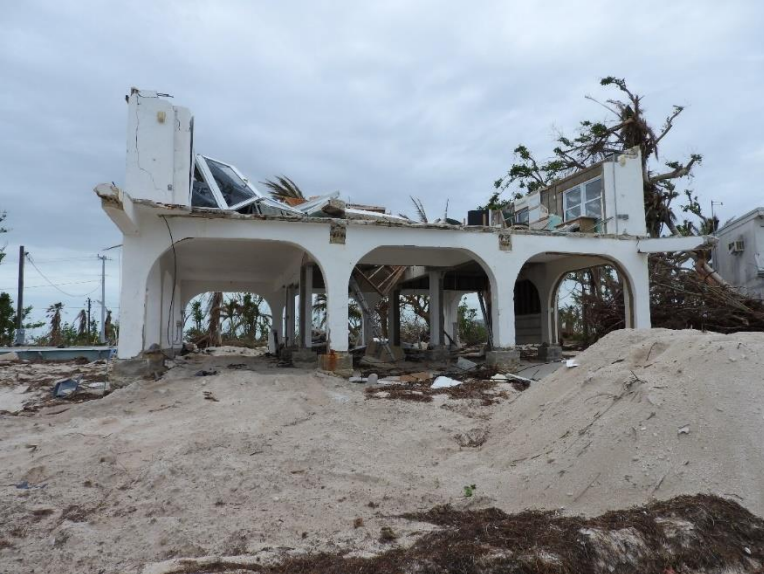
# Structural Damages in the Keys

- Max. Wind – 133 mph
- Peak Tide - +8.0 ft NAVD (measured by USGS)
- 1,179 Buildings Destroyed
- 8,725 ft Seawalls & Revetments Damaged

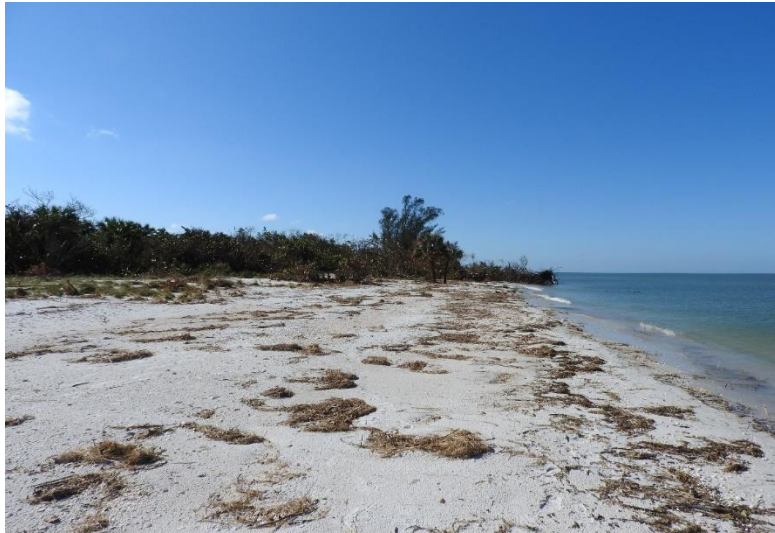
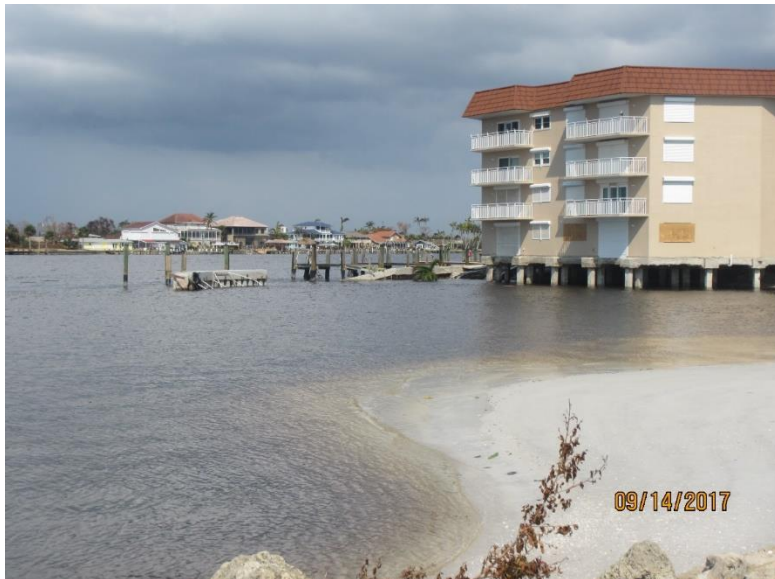
# Collier County

- Major beach and dune erosion at Wiggins Pass (Now critical in state park)
- Significant erosion at the north end of Marco Island
- Major damage to 231 major structures  
Barrier islands – 15 major structures  
5 communities adjacent the 10,000 Islands – 216 major structures damaged
- 3,575 feet of armoring damaged or destroyed, including 3,000 feet of revetment at south end of Marco Island
- Lee thru Pinellas Counties –  
9 major structures damaged  
Generally minor erosion with hotspots

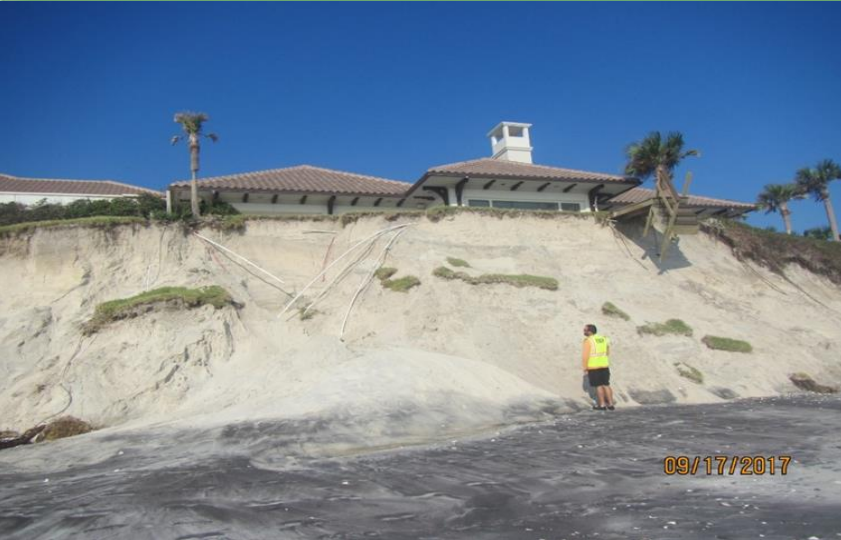
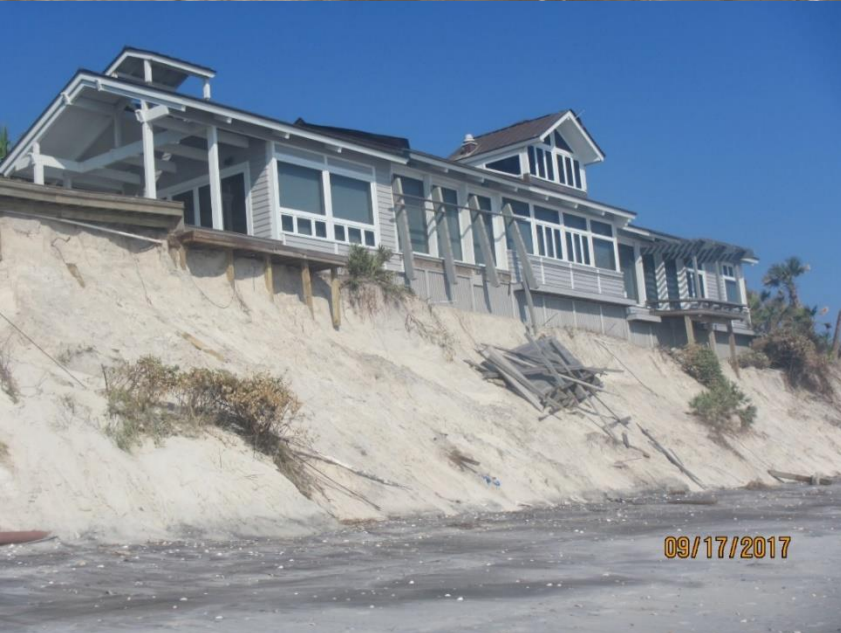
# Northern St. Johns County – Ponte Vedra

- Severe impacts north of St. Augustine Inlet
- Ponte Vedra R26-R31 now critical

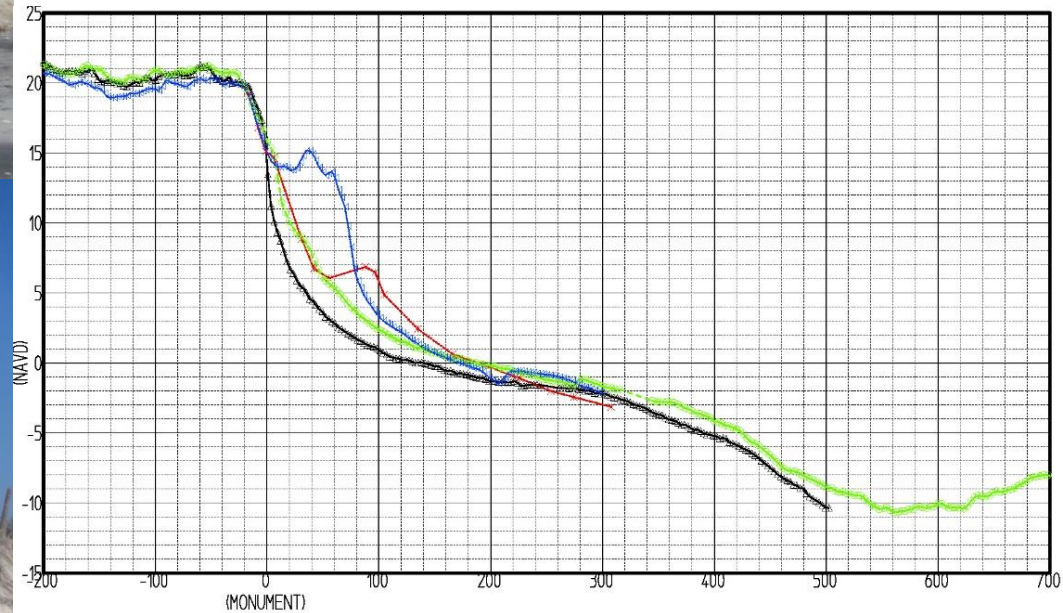
Range: R-028  
 Mon. Est.: JUN1972  
 DOT DATE:  
 BEACH DATE: 00SEP17  
 OFFSHORE DATE:

BEACH PROFILE  
 2017-SEP POST-IRMA LIDAR  
 2017-JUN/JUL FDEP SURVEY  
 2016 POST-MATTHEW LIDAR  
 2016 PRE-MATTHEW LIDAR

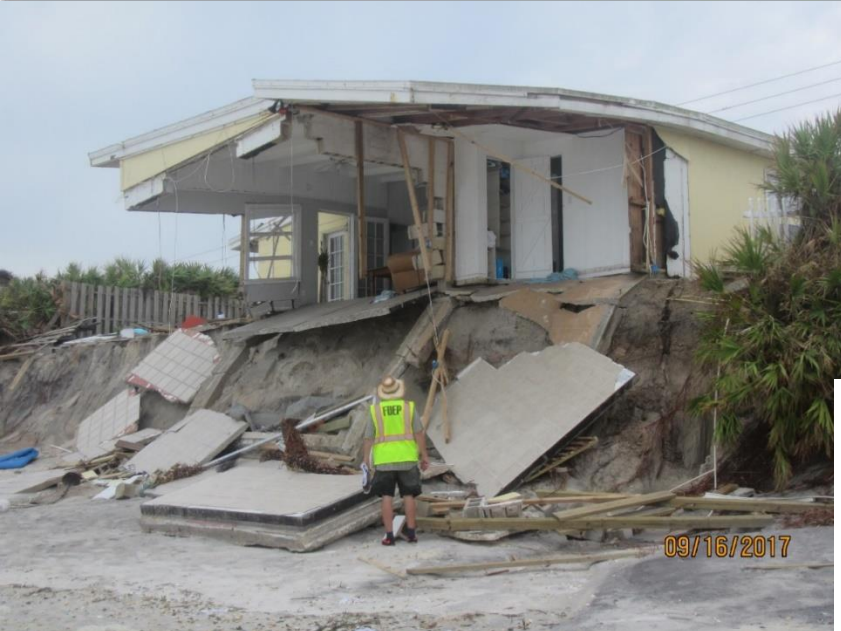
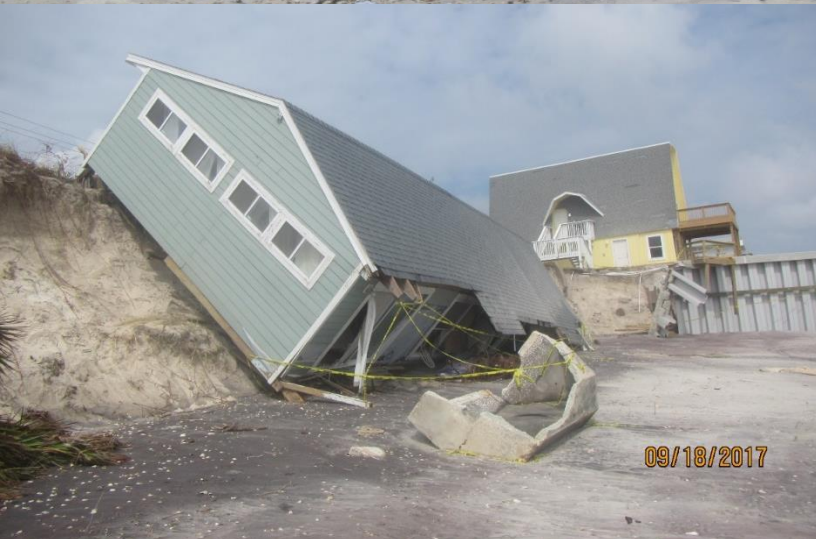
# Northern St. Johns Co. – South Ponte Vedra & Vilano Beach

- Critical erosion area extended northward – R76-R84
- Total area critical now R76-R117 8.1 miles

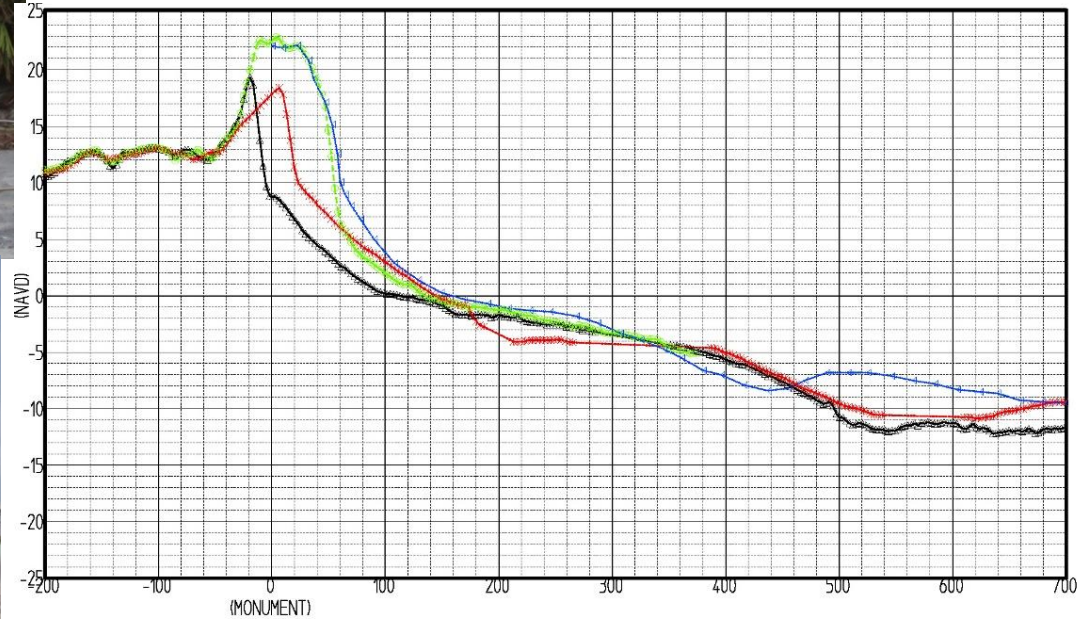
Range: R-094  
 Mon. Est: JUN1972  
 DOT DATE:  
 BEACH DATE: 00SEP17  
 OFFSHORE DATE:

BEACH PROFILE	
—●—	2017-SEP POST-IRMA LIDAR
—●—	2016 POST-MATTHEW LIDAR
—●—	2016 PRE-MATTHEW LIDAR
—●—	2015-JUN/JUL M&E SURVEY

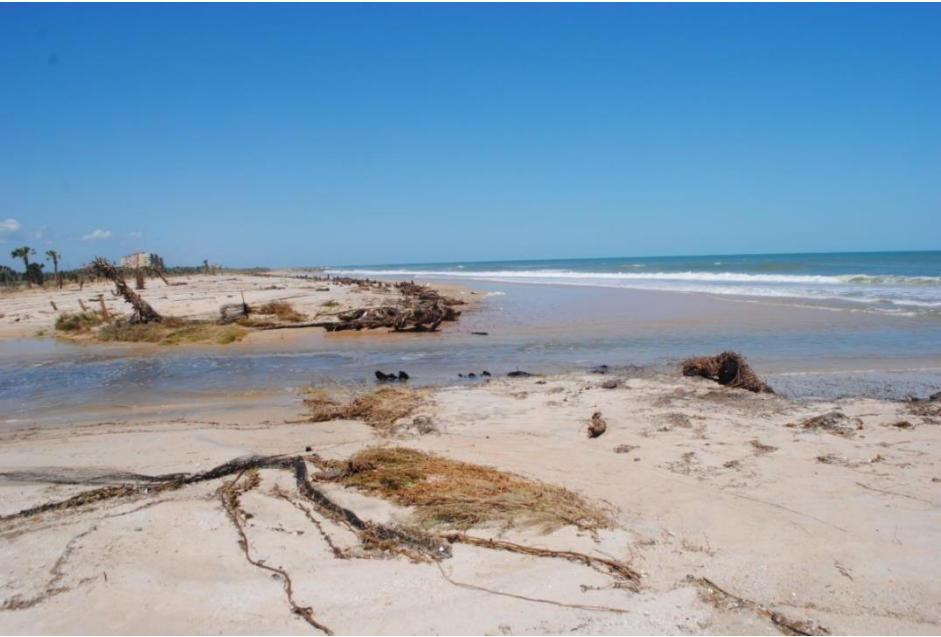
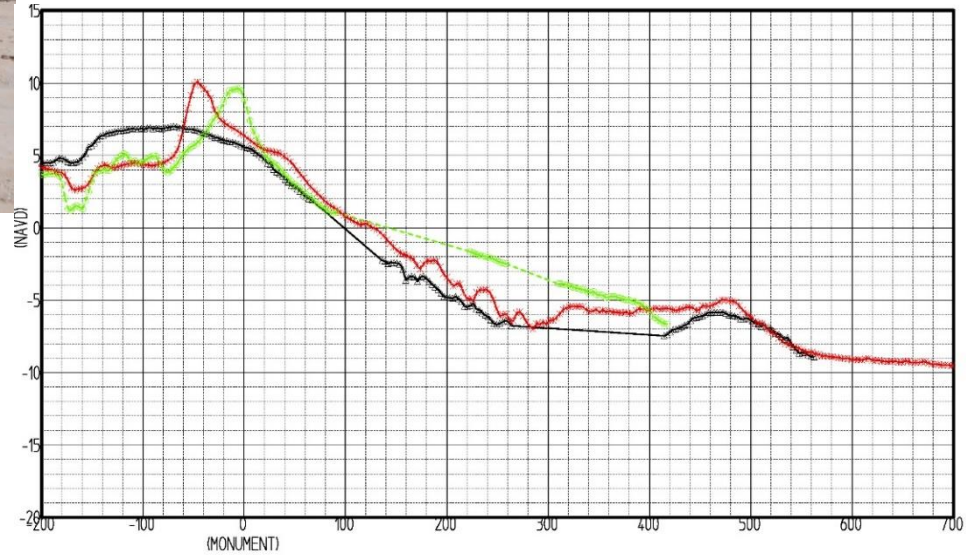
# Dune breach at Washington Oaks State Park

BEACH PROFILE  
— 2017-SEP-POST-IRMA LIDAR  
— 2016-POST-MATTHEW LIDAR  
— 2016-PRE-MATTHEW LIDAR

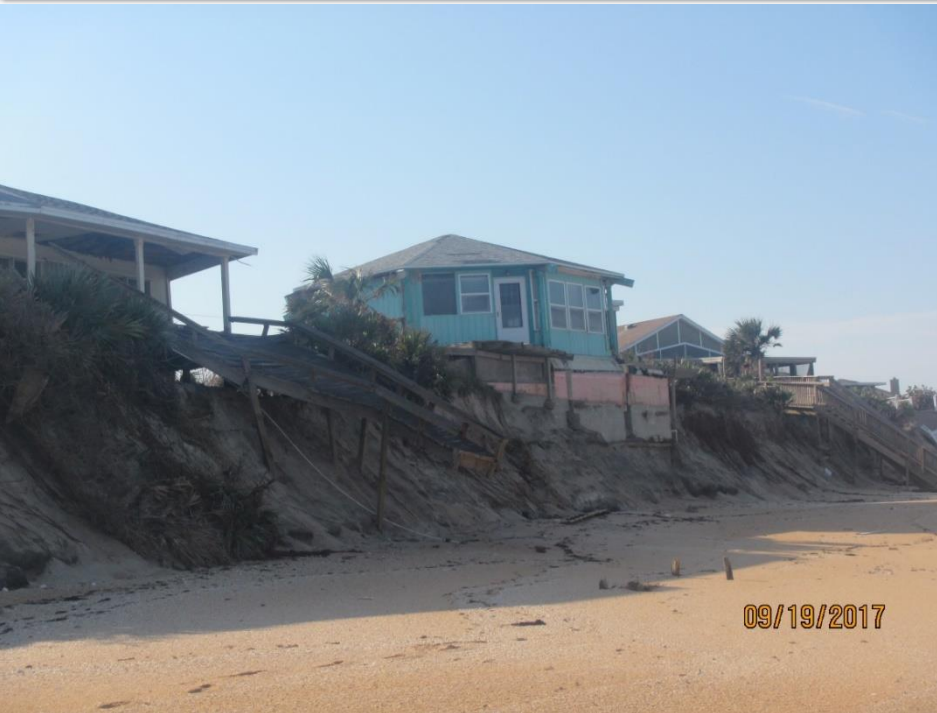
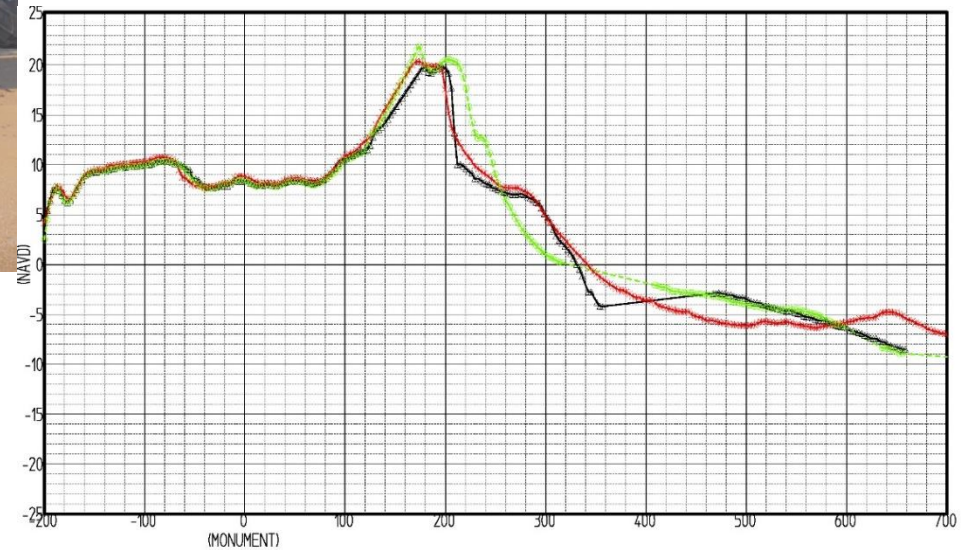
# Painter's Hill, R50-R57, Flagler County

BEACH PROFILE  
2017-SEP POST-IRMA LIDAR  
2016 POST-MATTHEW LIDAR  
2016 PRE-MATTHEW LIDAR

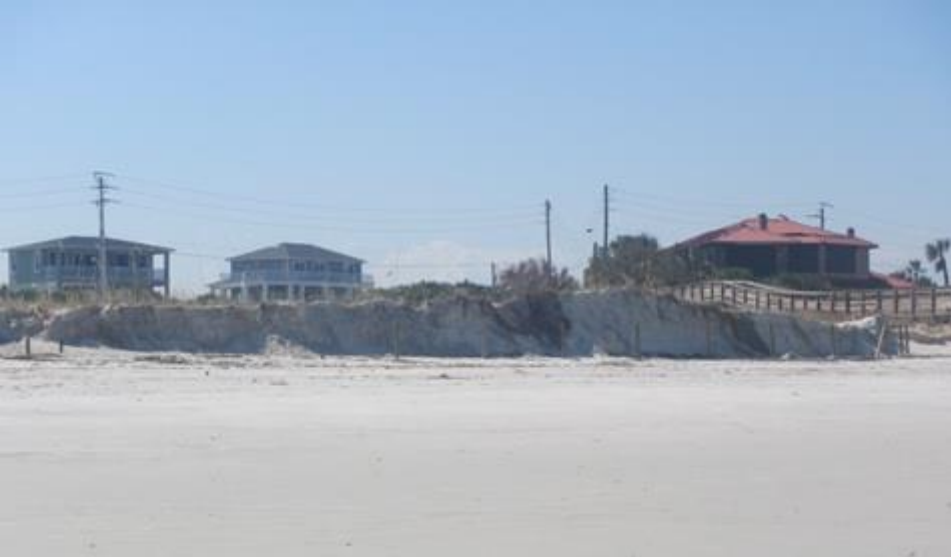
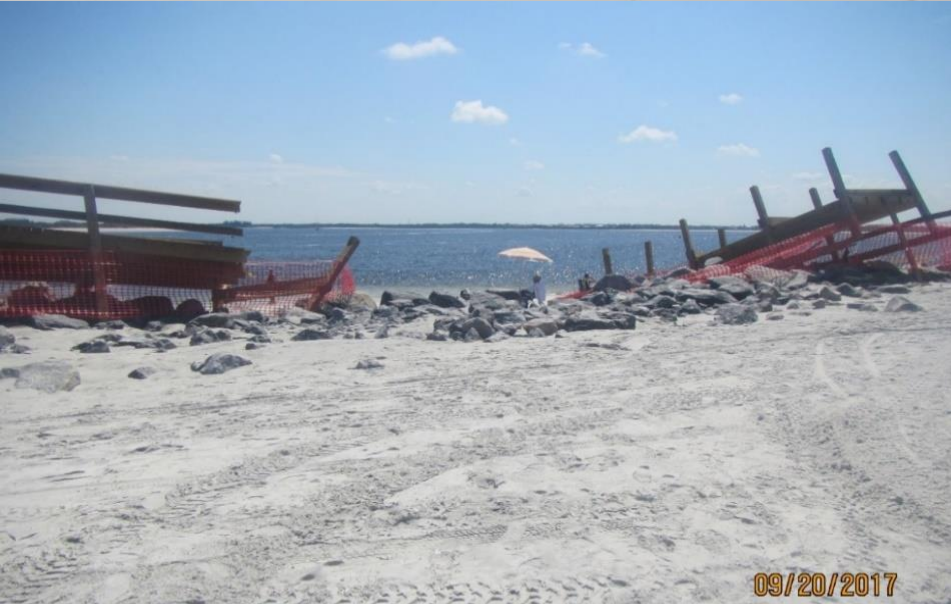
# Volusia County

- Major damage to 106 major structures
- County sustained mostly wind damage from Irma
- 225 feet of major damage to boulder mound north jetty at Ponce de Leon Inlet

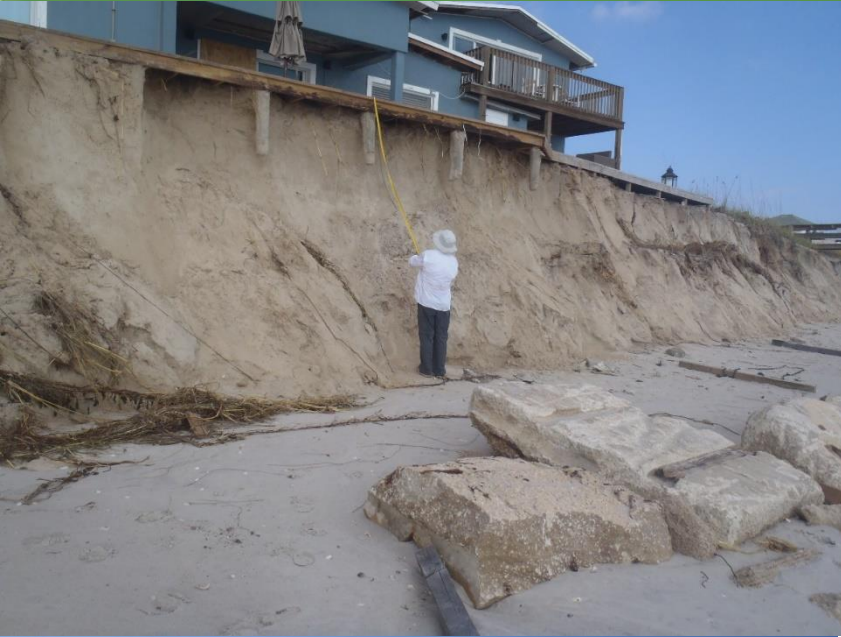
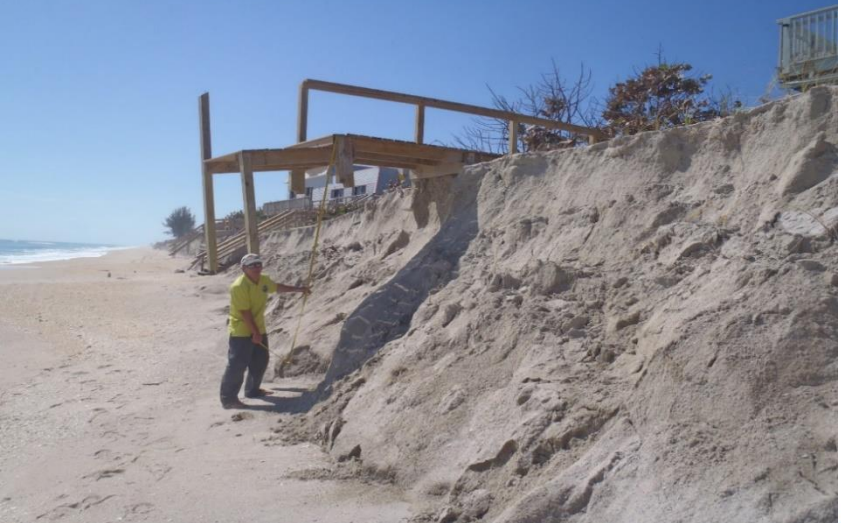
# Brevard County

- Beach project areas appeared to fare best. Dune erosion added to Matthew's impact.
- Major beach/dune erosion observed near Canaveral Inlet, along Indian Harbor Beach, and in the south county area

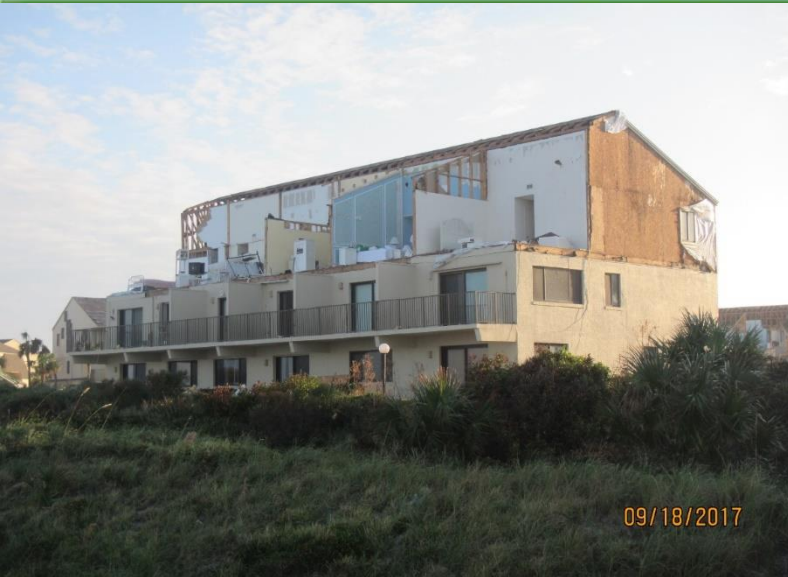
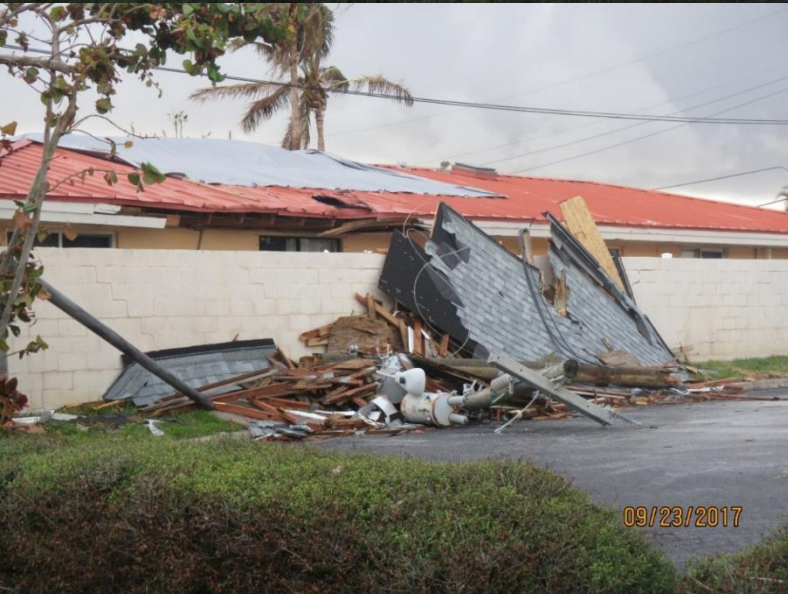
# Coastal Tornadoes

- Irma's rain bands brought cross-shore tornadoes
- Matanzas Shores tornado(es)
  - 4 condominium bldgs destroyed
  - 5 condominium bldgs damaged
  - 8 SFD's damaged
- Indialantic tornado(es)
  - 1 condominium bldg destroyed
  - 1 condominium bldg damaged
  - 6 SFD's damaged
  - 2 commercial bldgs damaged
  - 1 motel damaged
