25 YEARS FROM RECOMMENDATION TO CONSTRUCTION OF THE UPHAM BEACH STABILIZATION PROJECT

Thomas Pierro, P.E., D.CE

Director of Operations, APTIM, Boca Raton, Florida

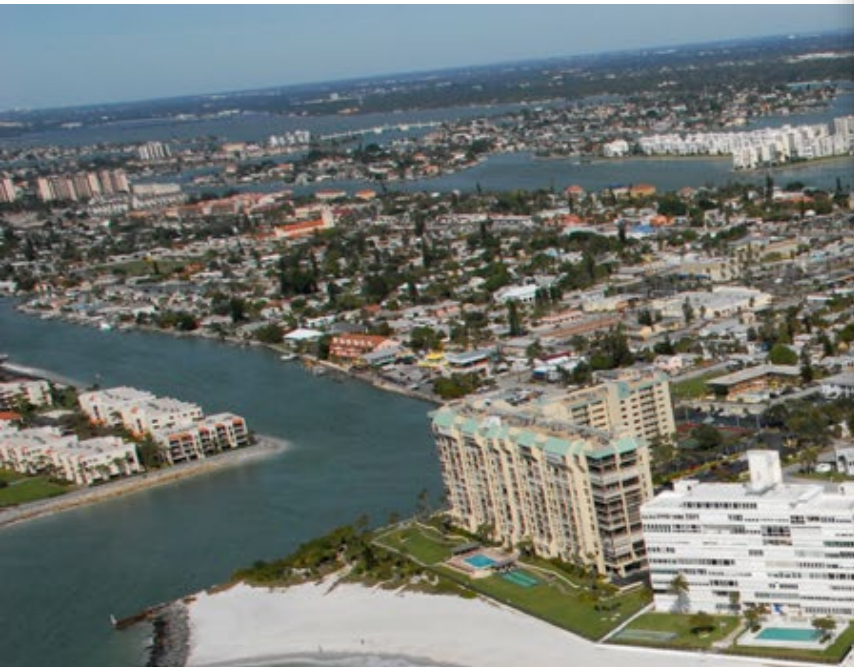
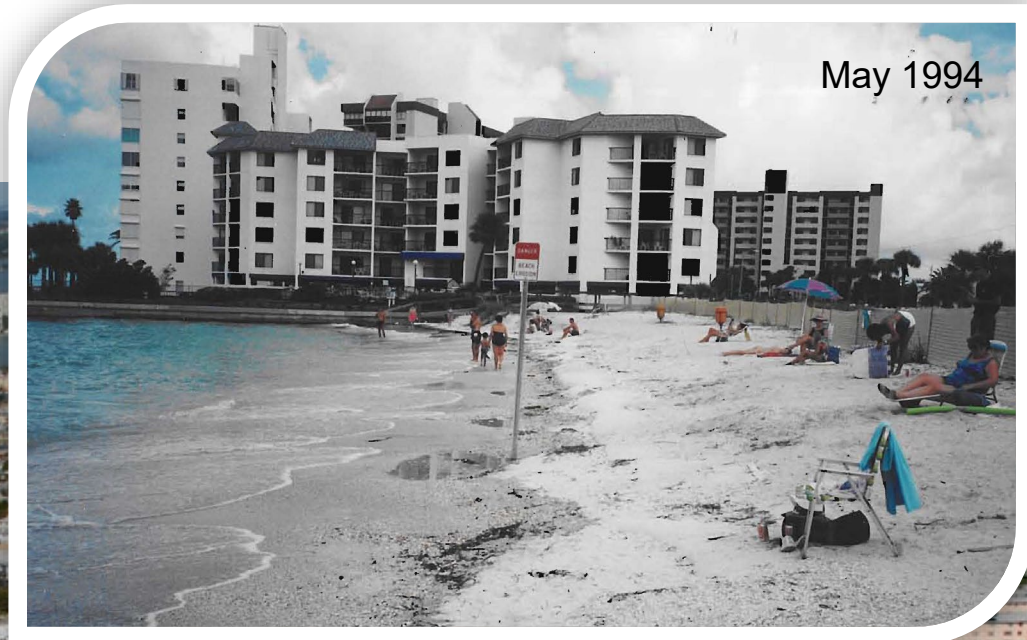
UPHAM BEACH

May 1994

- ▶ Persistent erosion hotspot
- ▶ Periodic nourishment from multiple sources; acts as feeder beach
- ▶ Structural stabilization & geotextile tube experiment

January 2012

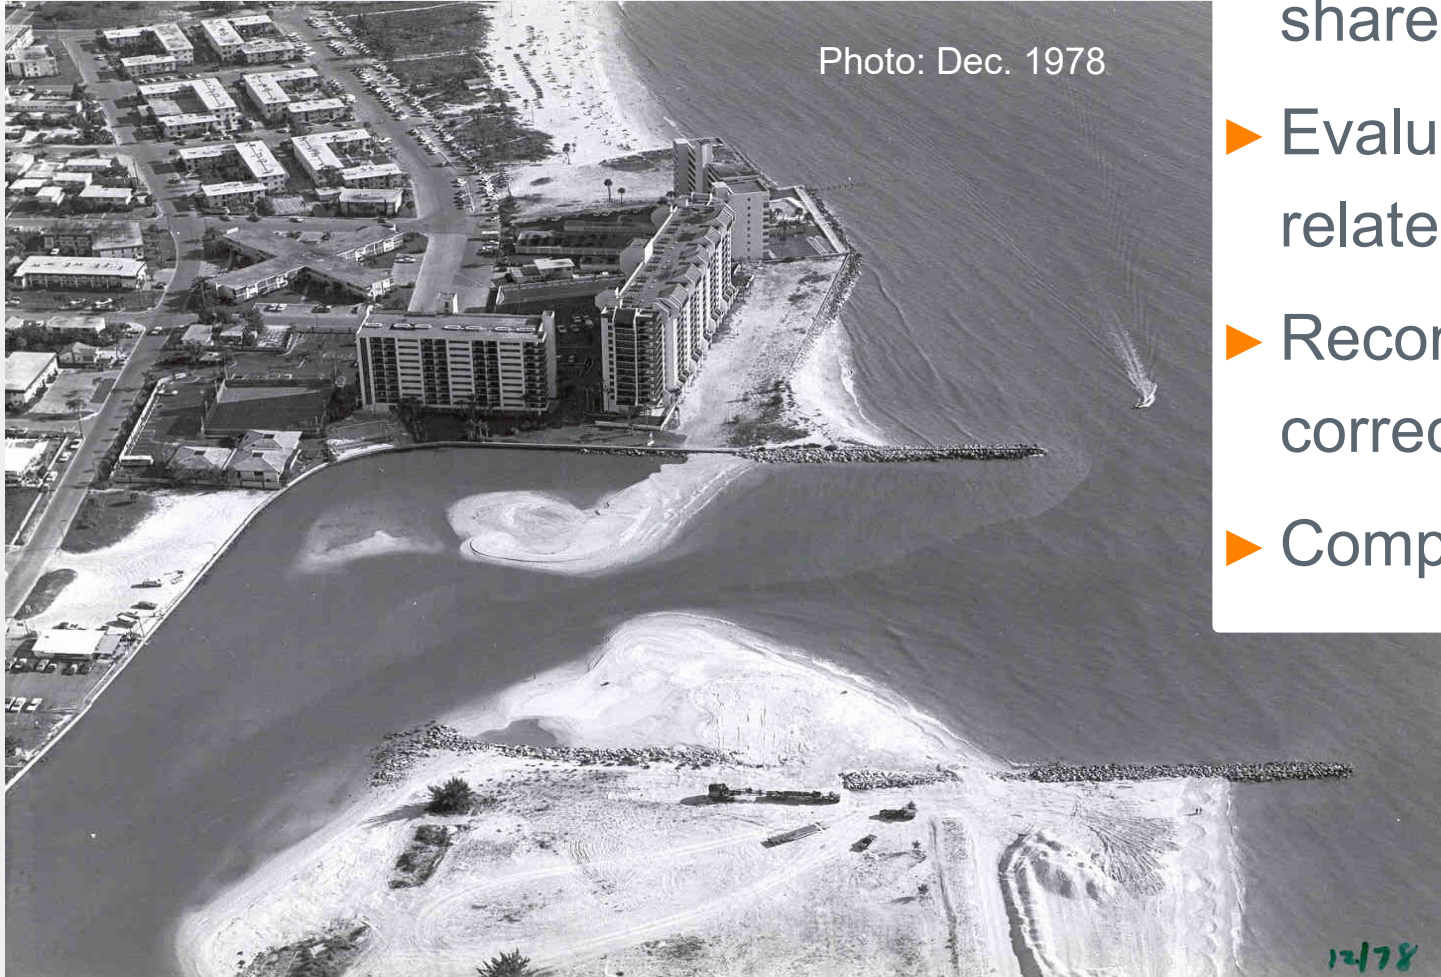
BLIND PASS INLET MANAGEMENT PLAN

- ▶ Required and cost-shared by FDEP
- ▶ Evaluated erosion related to inlet
- ▶ Recommended corrective actions
- ▶ Completed 1992

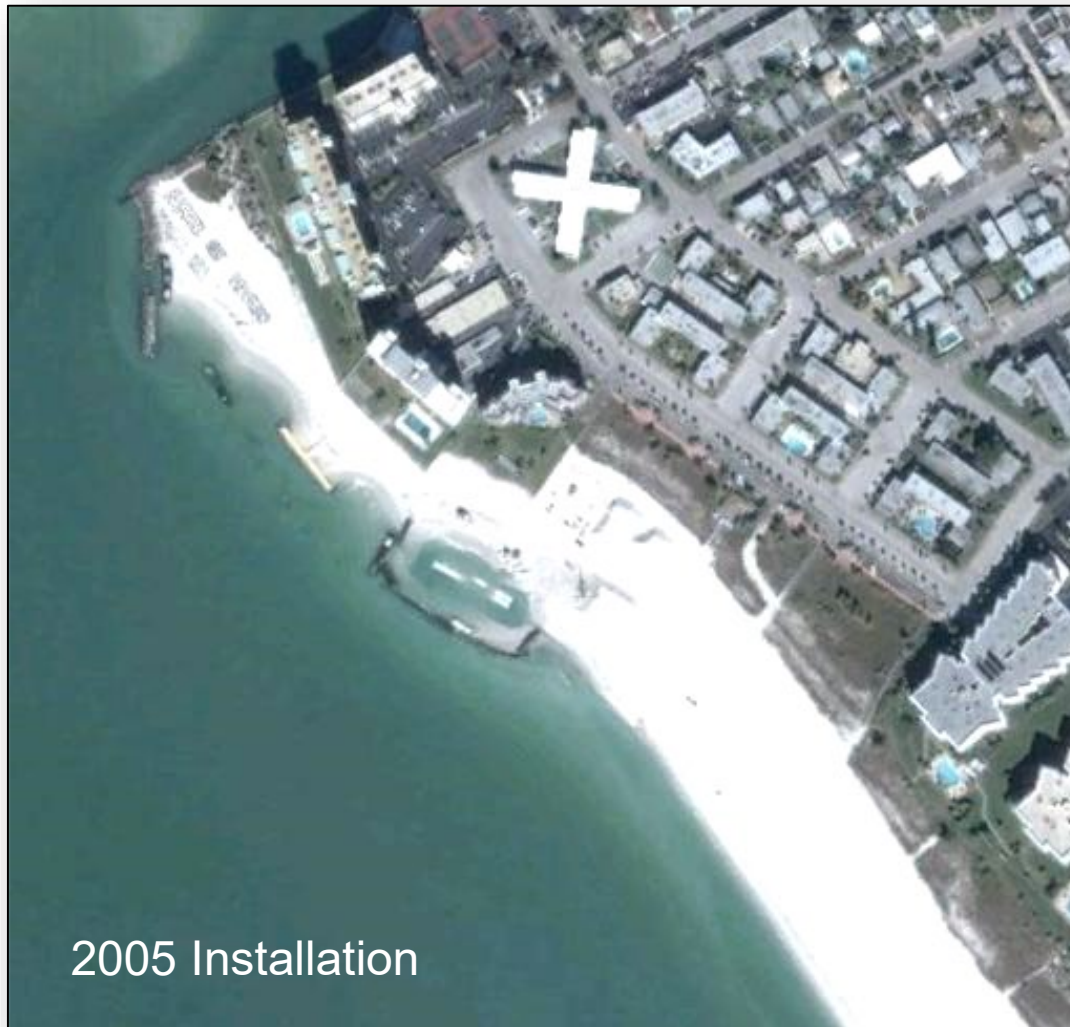
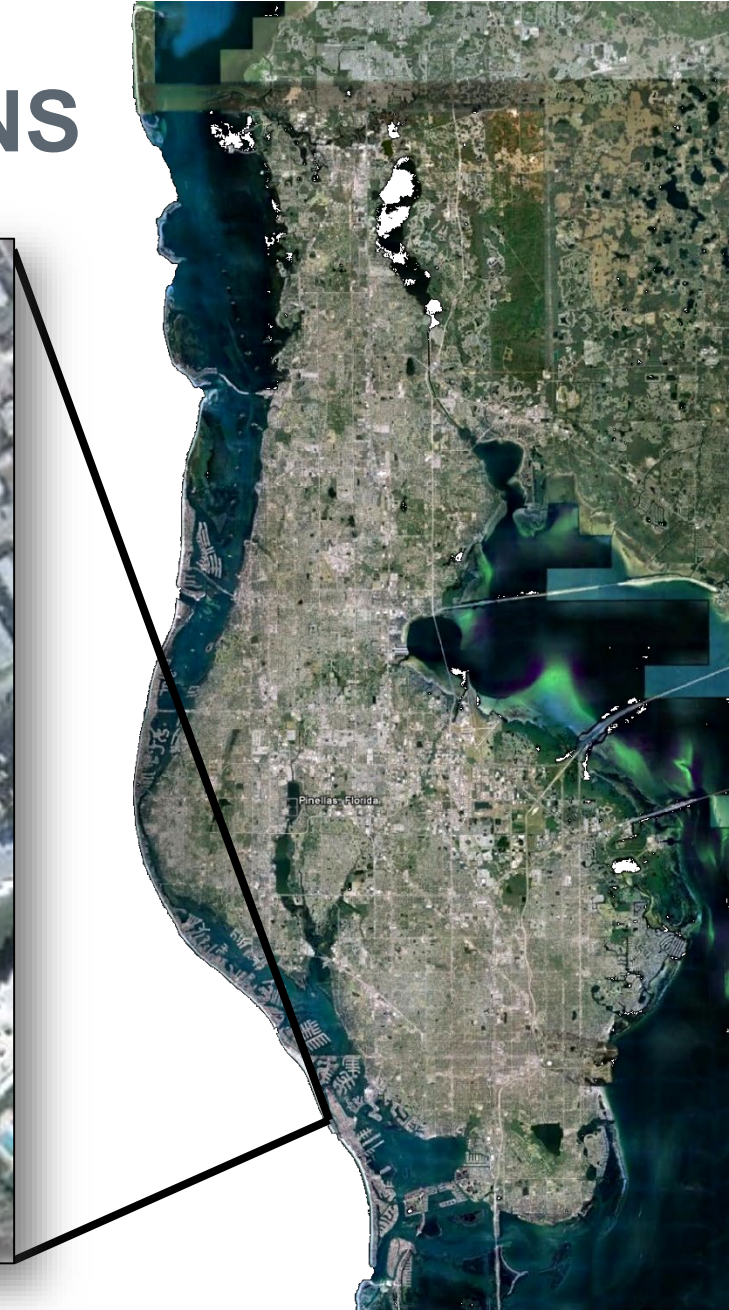
GEOTEXTILE TUBE GROINS

Geotextile groins installed in 2005 to test stabilization of Upham Beach and evaluate reduction of nourishment needs

1995-2008 Time Series

2008 Condition

- ▶ Geotextile tubes installed in 2005 effectively reduced erosion without creating downdrift impacts.
- ▶ Performance monitoring:
 - > Geotextile tubes worked well, but sustained repeated damage
 - > Seawall only exposed after damage to geotextile tubes
 - > Some improvements can be made to design layout
- ▶ County desired to install permanent structures and received support from the City of St. Pete Beach (July 2008)
- ▶ County moved to development of a modeling study to evaluate structural alternatives to maintain storm protection and minimize impacts to beach users

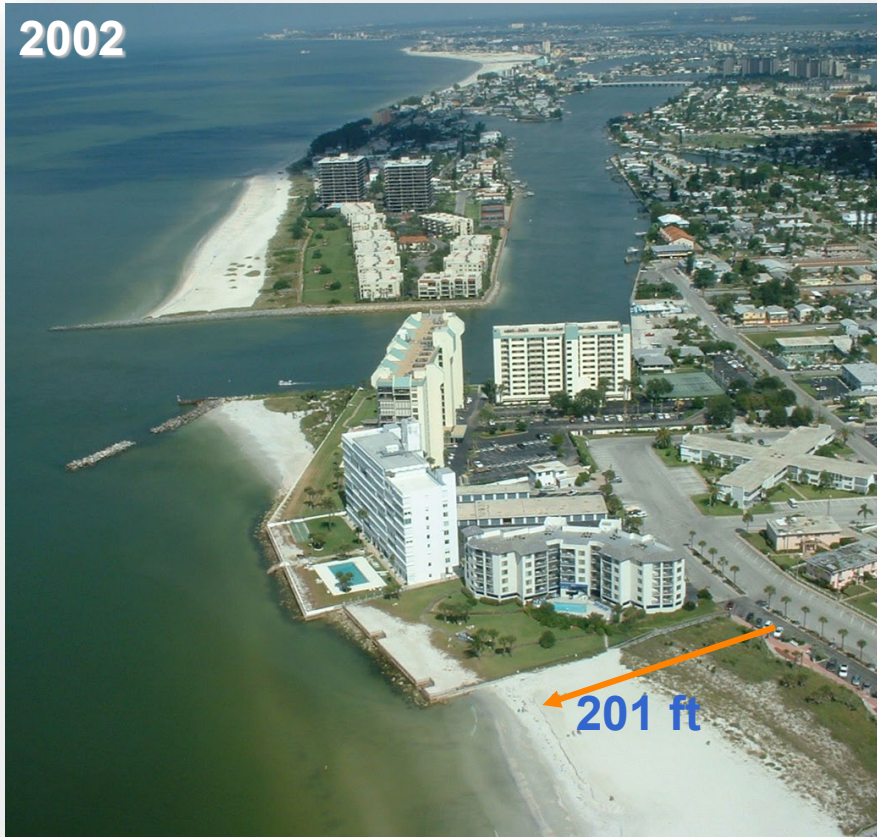
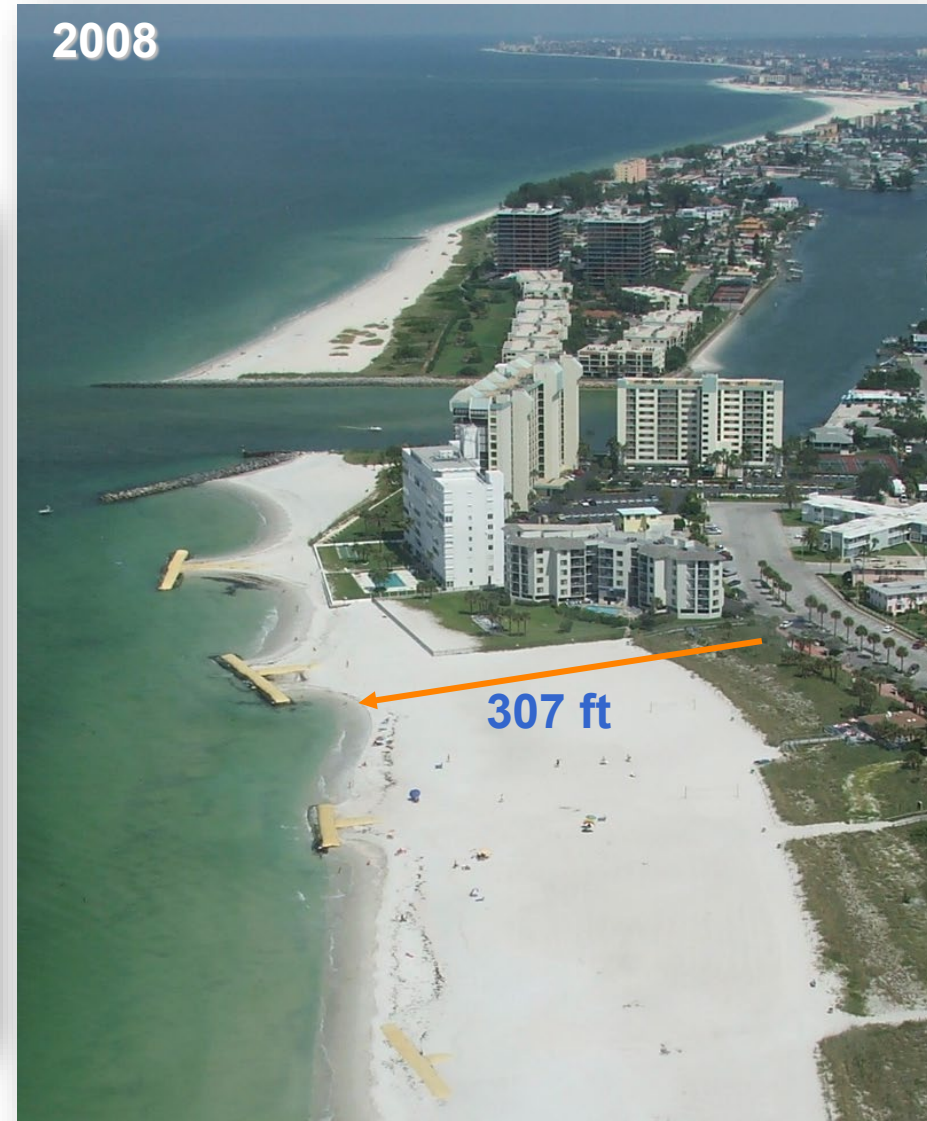
HOW DID WE DO??

- ▶ Two years after nourishment:

>100 ft wider beach!

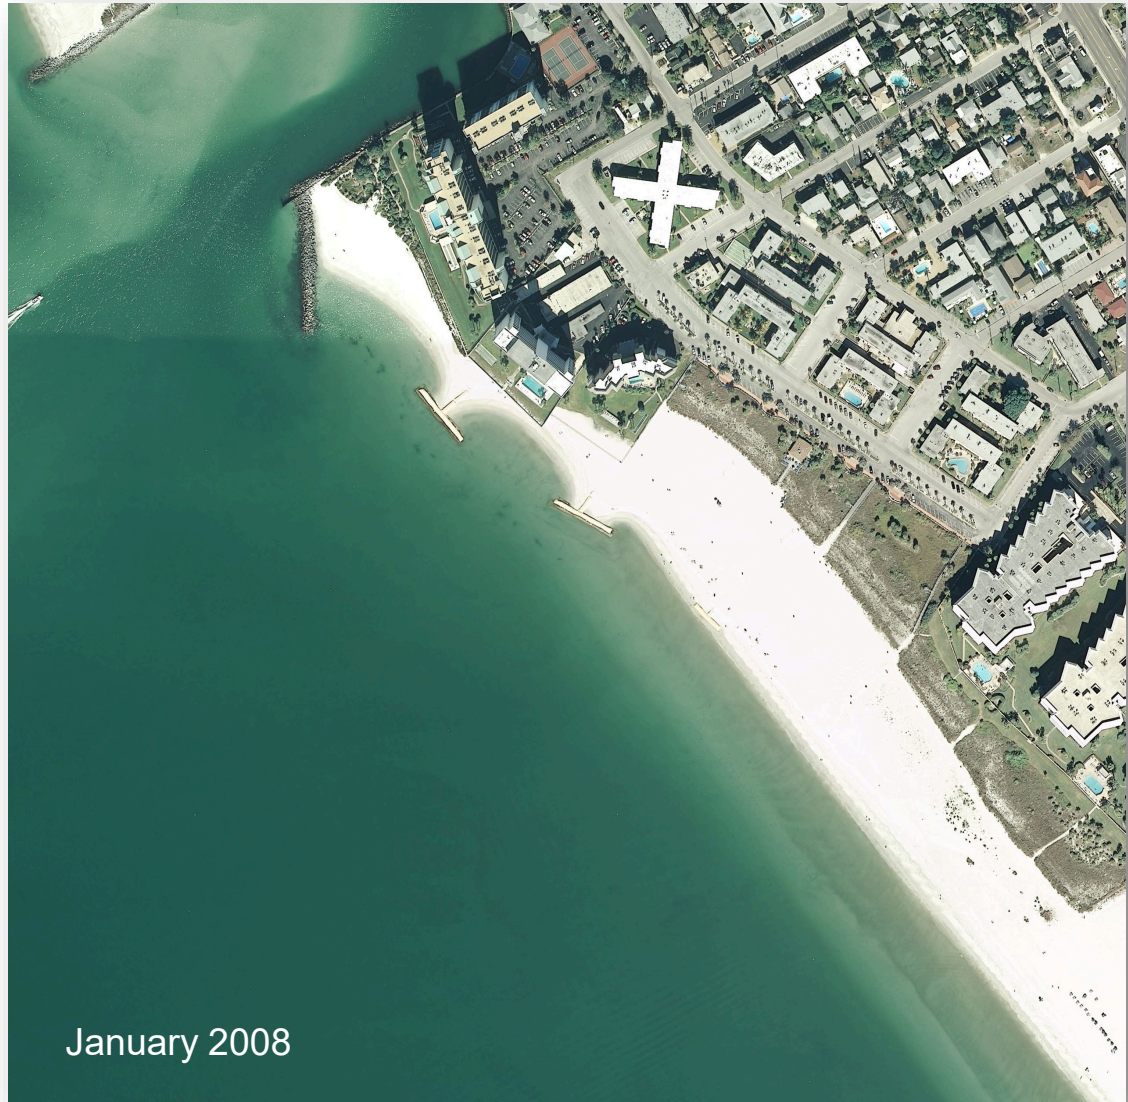
PROJECT AREA MONITORING DATA

▶ 2 Years Post-
Construction Report:

“Overall, during the 2006-2008 nourishment monitoring period, the beach retained more sand [38%] with the structures as compared to the 2000-2002 nourishment monitoring period without structures.”

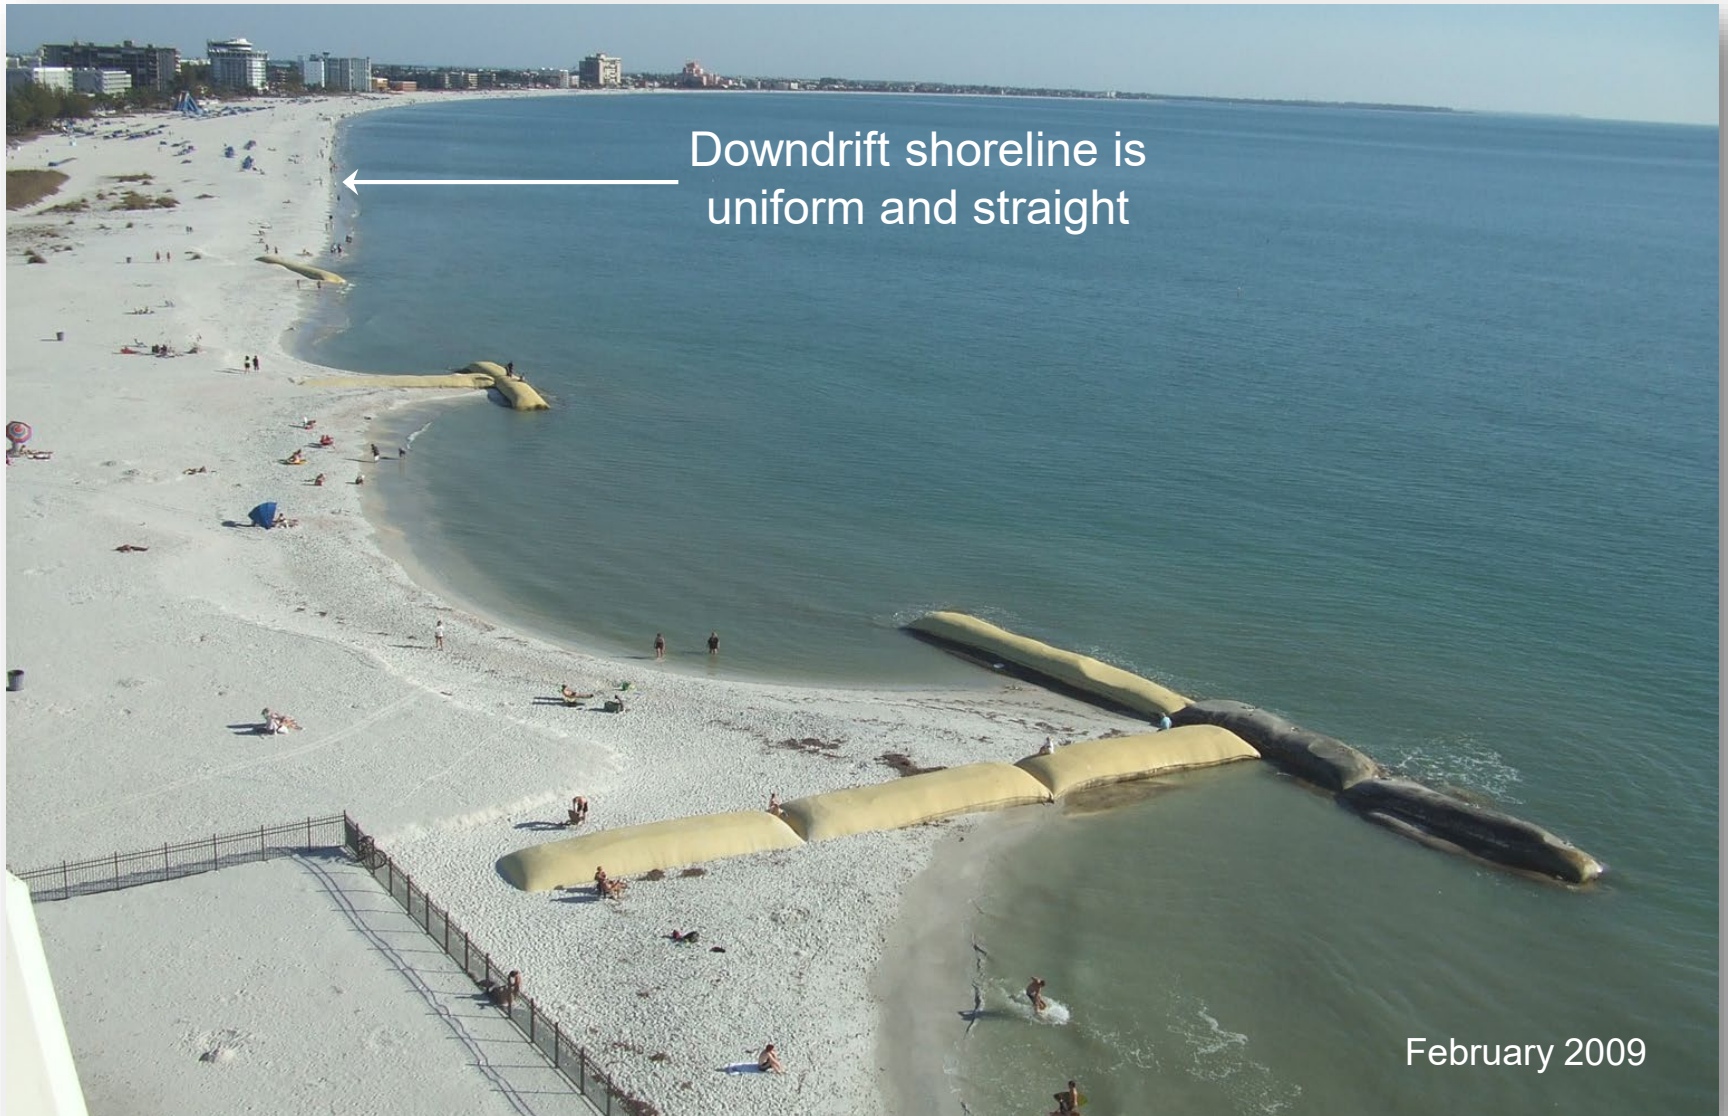
FEEDER BEACH PROCESS

Downdrift shoreline is uniform and straight

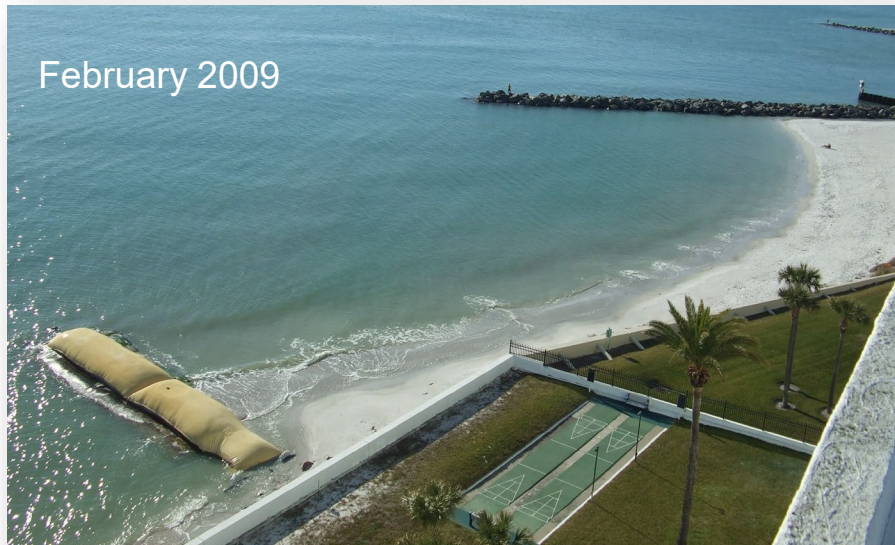
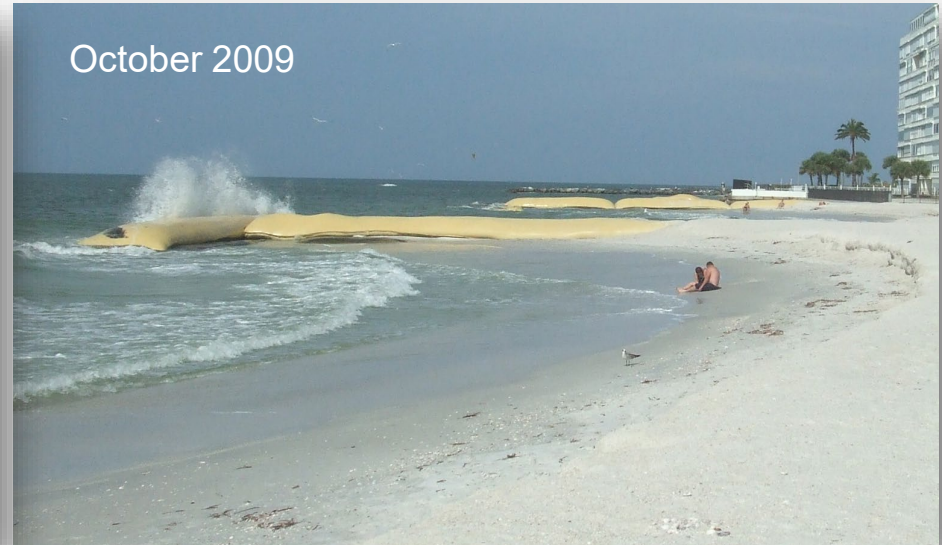
ALTERNATIVES ANALYSIS

- ▶ Existing geotextile tube configuration and four alternatives:
 1. Straight Groins with Extended Jetty
 2. Modified T-Head Design (4 structures)
 3. Curved T-Heads with and Artificial Reef
 4. Modified Existing Design (5 structures)

- ▶ BOUSS2D Wave Modeling:
 - > Simulates waves and surface currents
 - > Replicated existing conditions very well
 - > Verified through comparison with observed conditions
 - > Model simulations included cold fronts and hurricane conditions

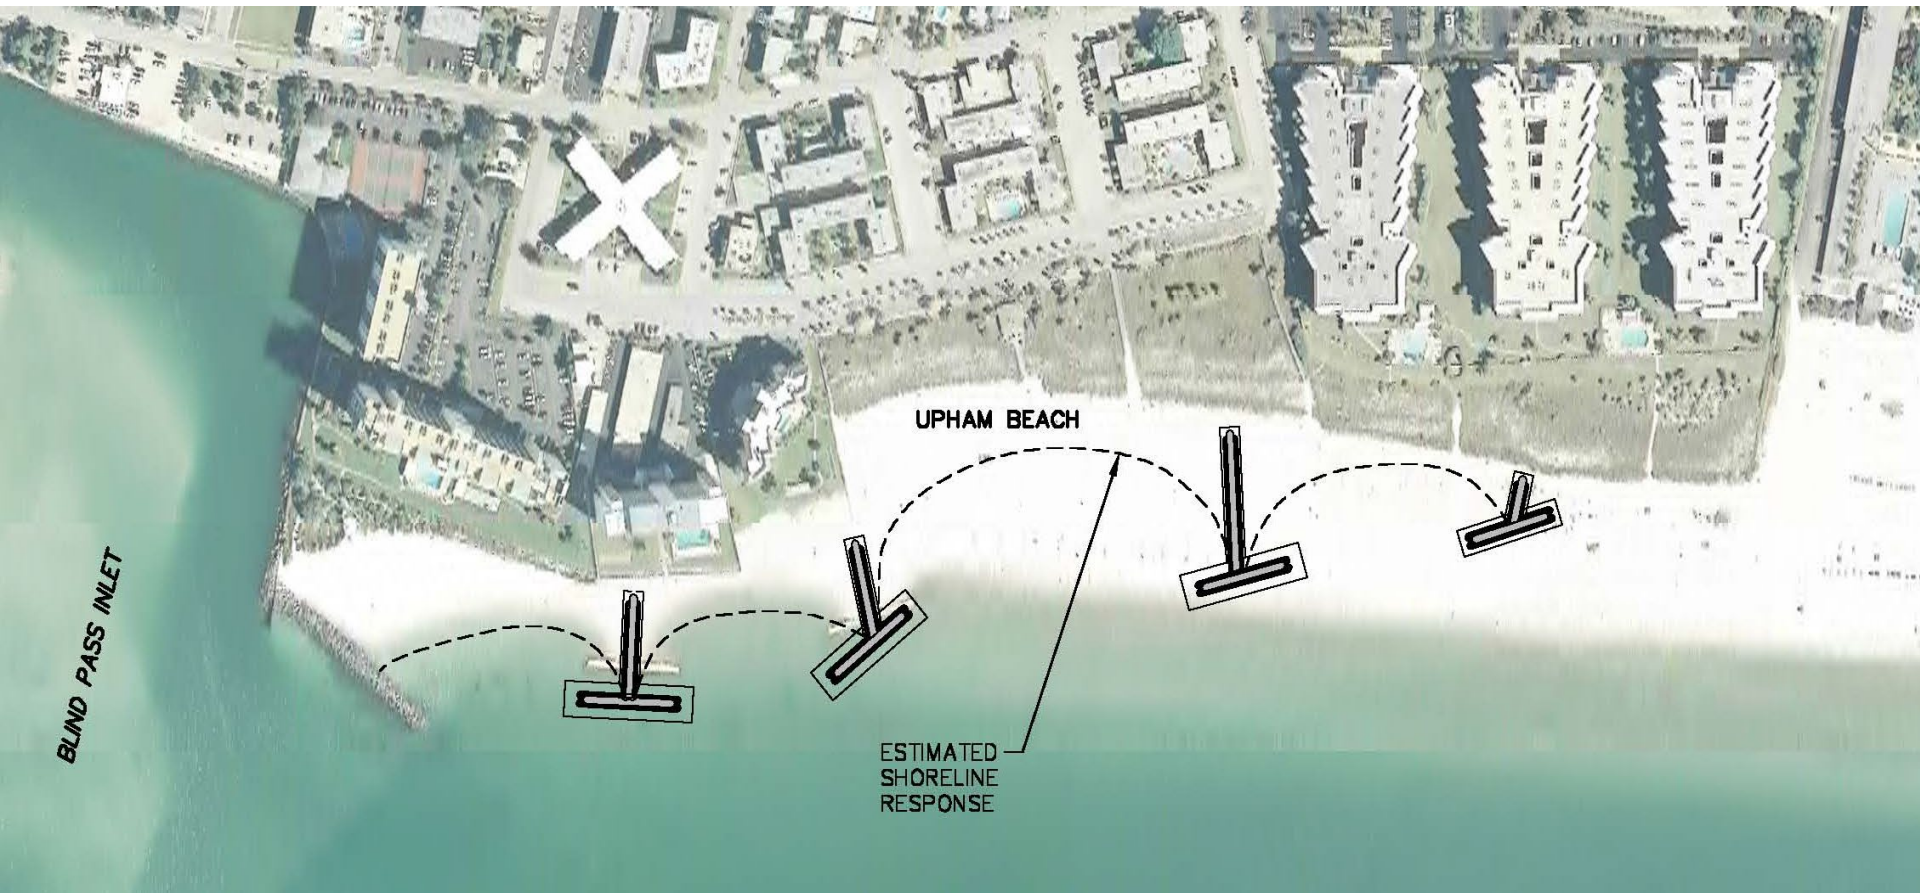
SELECTED ALTERNATIVE (#2)

- ▶ Modified design for improved protection with one less structure
- ▶ Less wave reflection and reduced obstruction along public beach

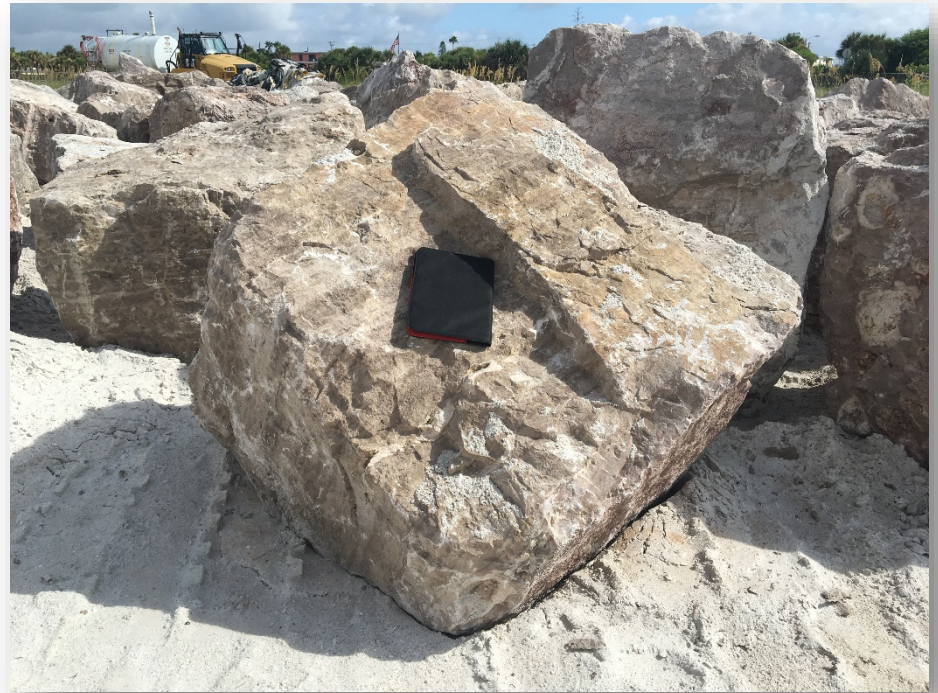
STRUCTURAL SPECIFICATIONS

- ▶ Two sizes of armor: 5.5 tons head stone; 2.1 tons stem stone
- ▶ Tolerances to accommodate limestone/granite (145 pcf minimum)
- ▶ Marine mattress foundation (72,000 SF)
- ▶ Multiple quarries needed
- ▶ Tonnage bid/placed (voids):
 - > Head: 30,700 / 18,195 (41%)
 - > Stem: 9,400 / 6,502 (31%)
- ▶ QC at quarry and QA at site
- ▶ Construction Cost:
 - > Estimate = \$8.2M
 - > Bid Price = \$8.7M
 - > Payment = \$7.1M

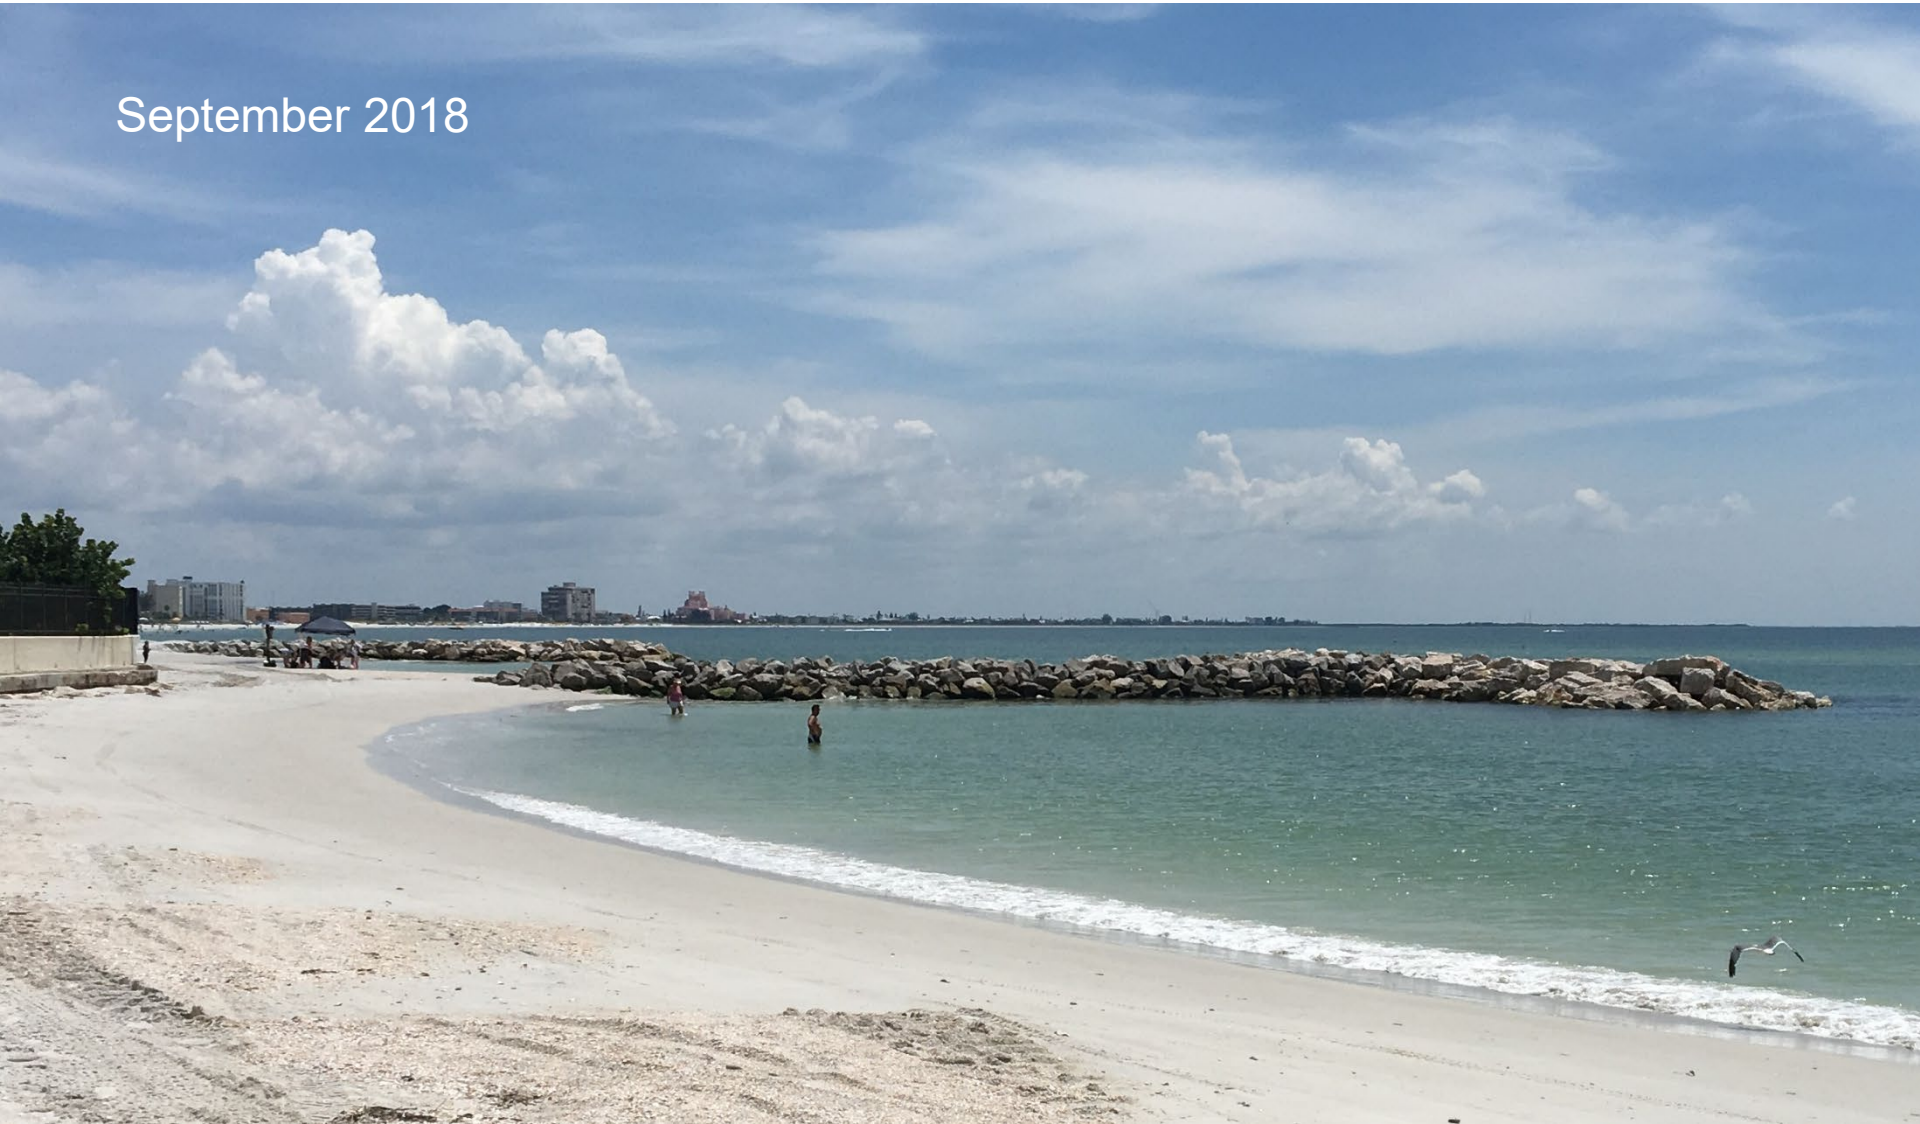
SUBSTANTIAL COMPLETION CONDITION

September 2018

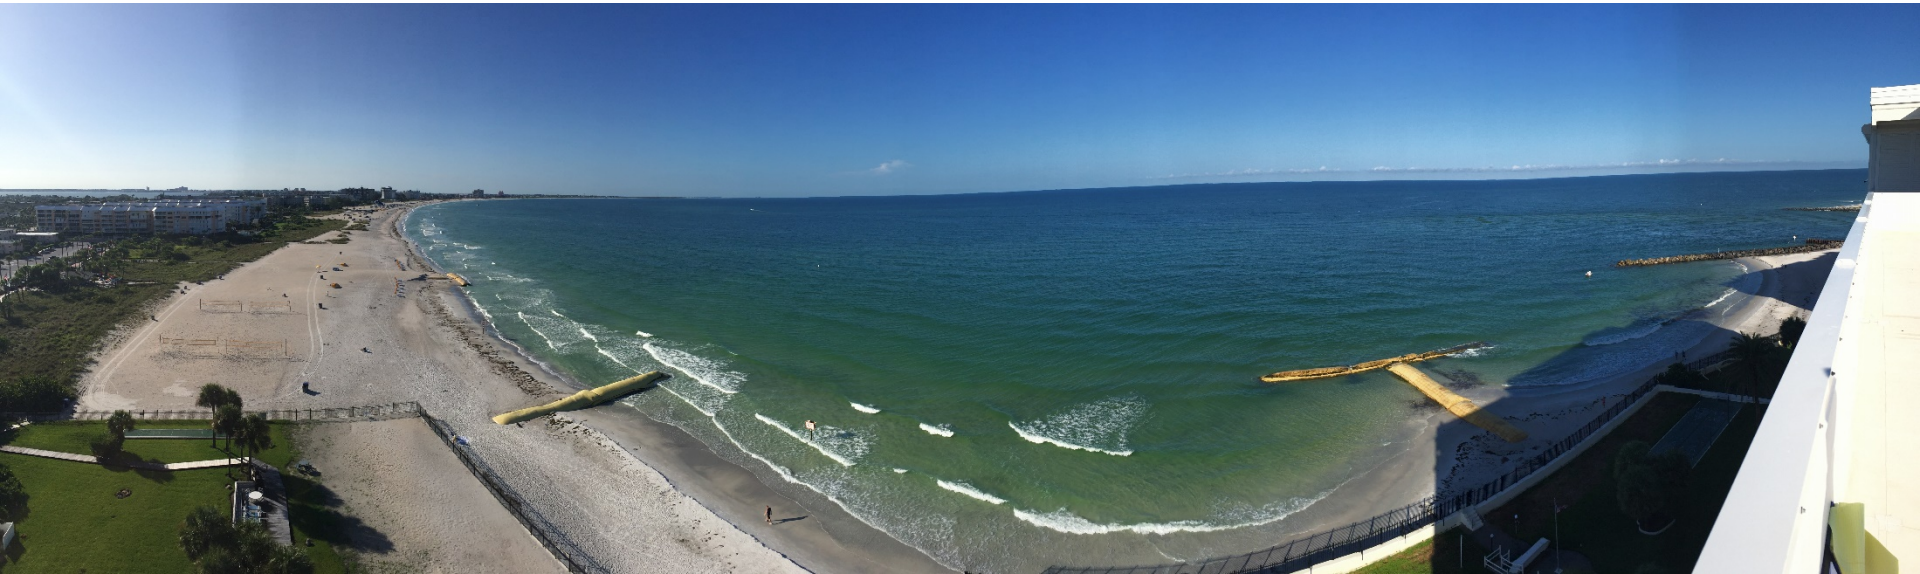
PRE-CONSTRUCTION CONDITION

- ▶ July 26, 2016 - Approximately 1 year prior to construction

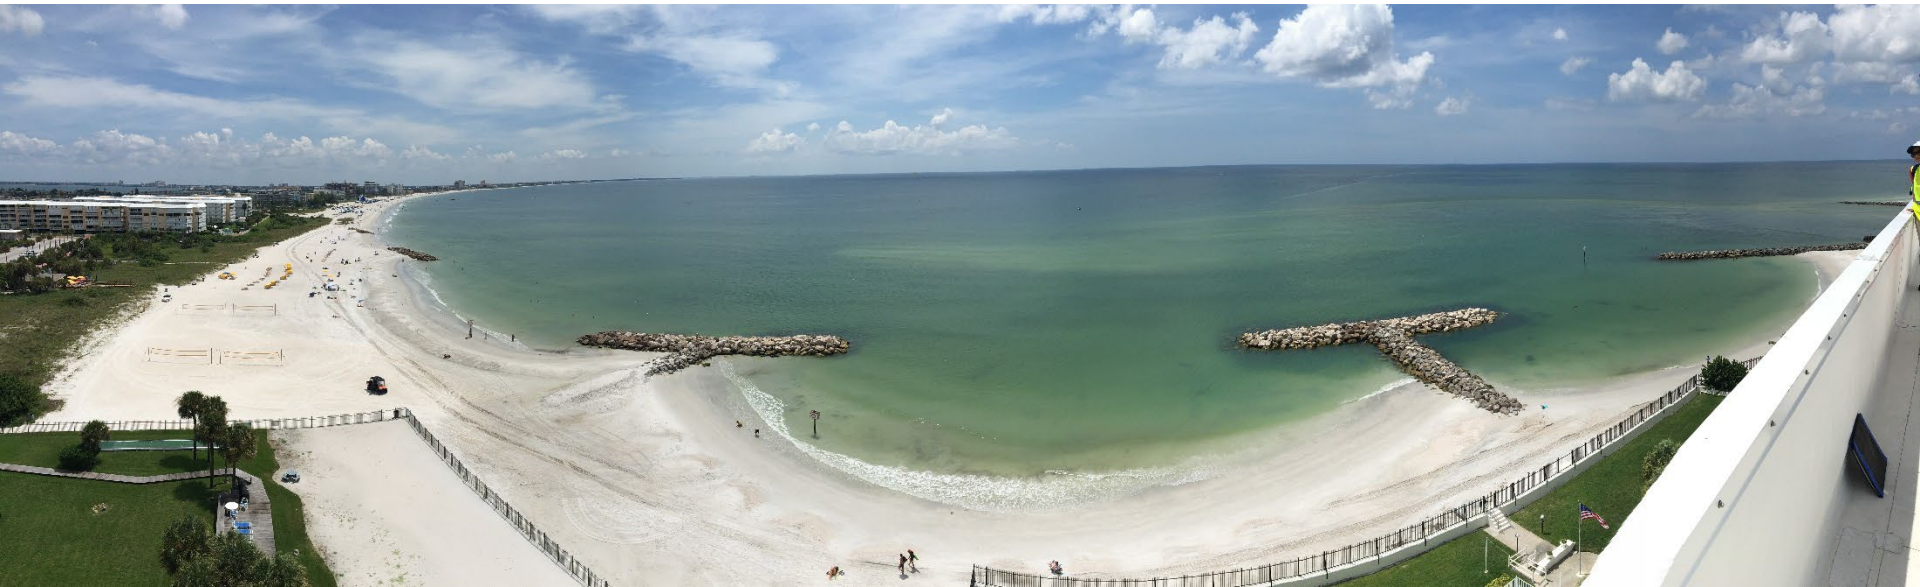
POST-CONSTRUCTION CONDITION

- ▶ September 5, 2018 - Substantial completion
