MANATEE COUNTY NEARSHORE HARDBOTTOM AND ARTIFICIAL REEF RED TIDE IMPACT AND RECOVERY

Katy Brown, MS, APTIM, Boca Raton, FL

MANATEE COUNTY BEACH PROGRAM OVERVIEW AND PROJECT HISTORY

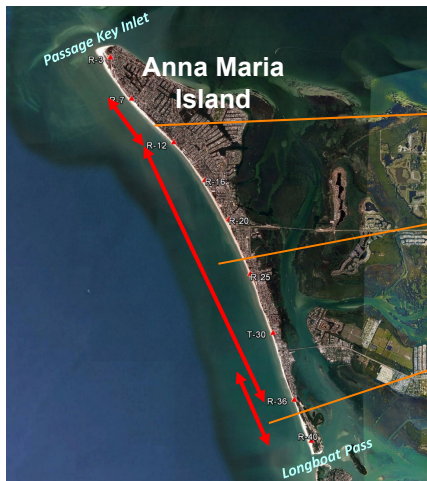
City of Anna Maria

Holmes Beach / Bradenton
Beach (Central Beach)

Bradenton Beach
(Coquina Beach)

Anna Maria Island experiences historic chronic beach erosion. Today I will reference two established beach nourishment projects that are maintained on the island: the federal Central Beach Nourishment Project, which includes Holmes Beach & Bradenton Beach and the locally sponsored Coquina Beach Nourishment Project, which includes Bradenton Beach south to Longboat Pass.

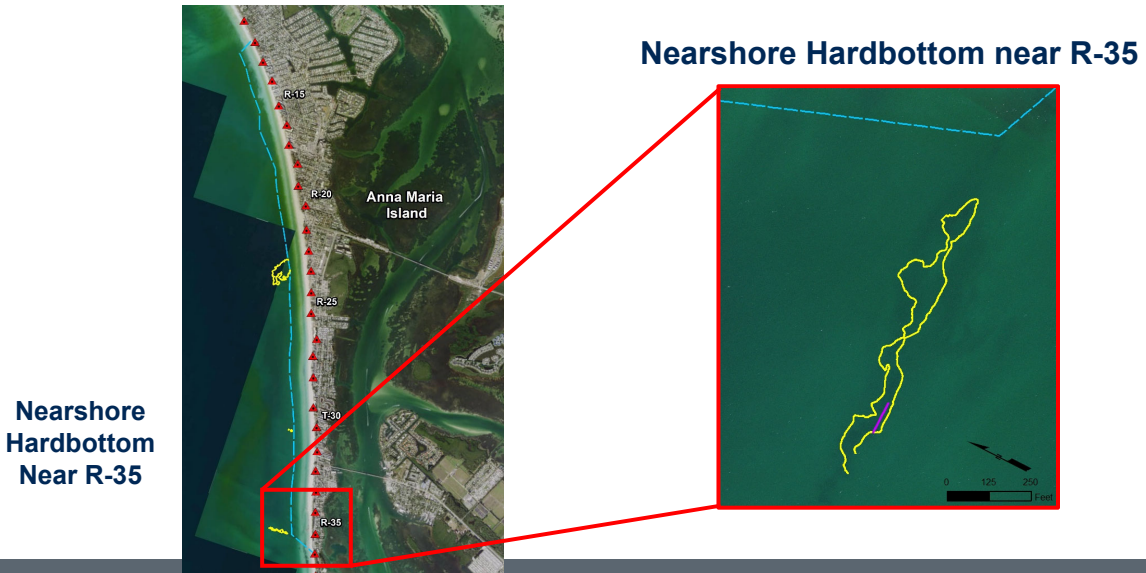
NEARSHORE HARDBOTTOM

The second area is near R monument 35 and consists of patchy, low relief hardbottom. Based on the County's decision to mitigate for this hardbottom a baseline survey using temporary transects was done to determine the mitigation required based on UMAM

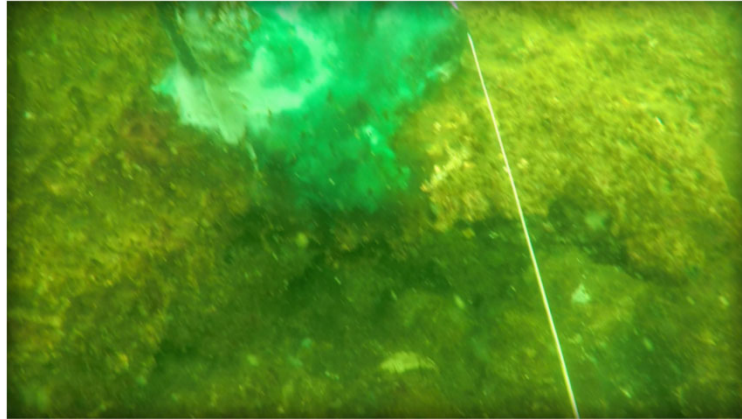
NEARSHORE HARDBOTTOM MID-RED TIDE (OCTOBER 2018)

Silence (no fish)

Soft bodies organisms (sponges, tunicates, octocorals) in severe stress or absent; sponge layers would slough off if you gently touched them

Cyanobacteria blanketing hardbottom

Unknown blue-green/white film on benthos (particular the clionaid sponge *Cliona celata*) - & substrate

Blackness underneath film would suspend in water column

Low visibility, lots of particulates in water column

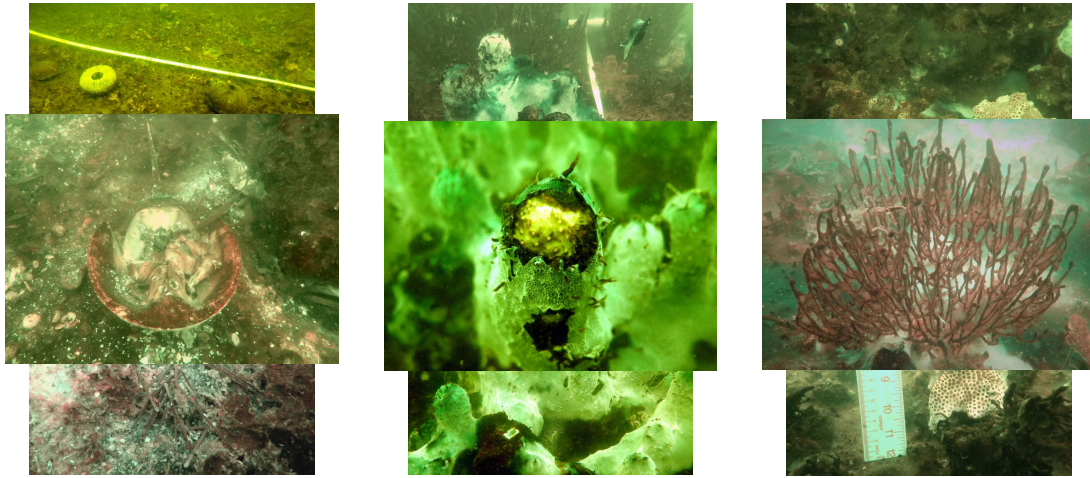
NEARSHORE HARDBOTTOM MID-RED TIDE (OCTOBER 2018)

Here are some more images from the mid red-tide event. Motile invertebrates were severely impacted, there were numerous empty urchin tests, piles of urchin spines, and dead crabs scattered along the nearshore hardbottom. Again here is the clionaid sponge *Cliona celata* we saw in the video completely covered in the unidentified blue-green/white film and in a state of decay. Stony corals showed signs of stress but did not seem as severely impacted as other functional groups. Octocorals, on the other hand were completely smothered in cyanobacteria.

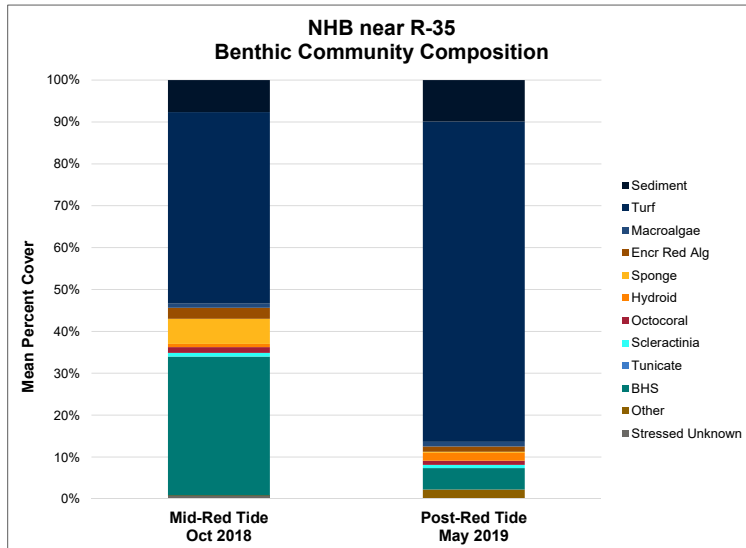
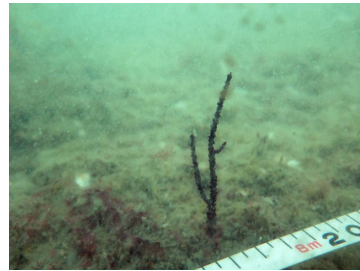
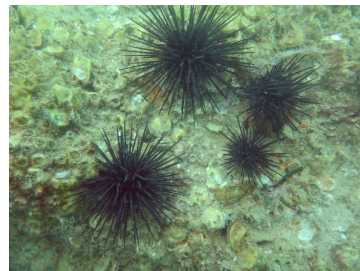
NEARSHORE HARDBOTTOM – R-35

Here we compare the mid-red tide data to the post-red tide data for the nearshore hardbottom near R-35. The chart shows the percent cover of functional groups surveyed using quadrats. During the red tide survey the dominant functional groups included turf algae and bare hard substrate, accounting for nearly 80% of the benthic composition. All of the sponges and octocorals observed during this event were severely stressed (*i.e.*, overgrown with cyanobacteria/dying) and no tunicates were observed. In general, the soft bodied organisms were in states of severe decay during the mid-red tide monitoring event. During the post-red tide survey conducted seven months later, the bare hard substrate cover decreased by approximately 30% as the turf algae cover increased by nearly the same amount.

Turf algae dominating during both surveys and the bare hard substrate (limestone, dead bivalves) decreased between surveys.

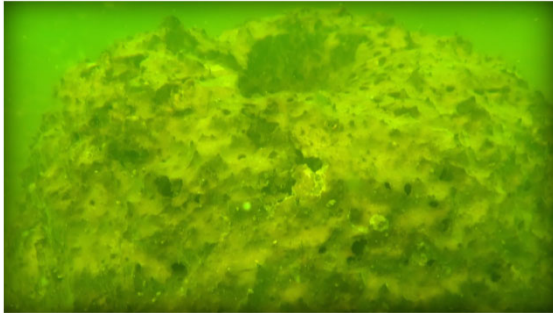
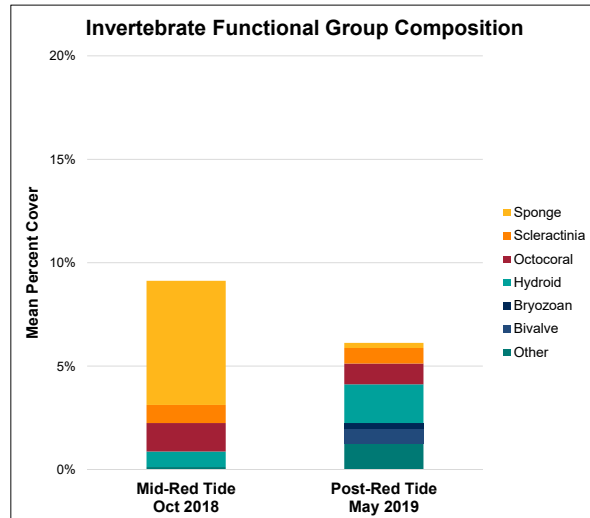
NEARSHORE HARDBOTTOM – R-35

The video here shows a black ball sponge (*Ircinia strobilina*) covered in cyano and in a state of decay. These observations translated to a decrease in sponge cover shown in the graph on the right. Increases in barnacle and bivalve cover were also recorded. The percent cover for stony coral and octocorals did not change to much but the level of stress decreased for both.

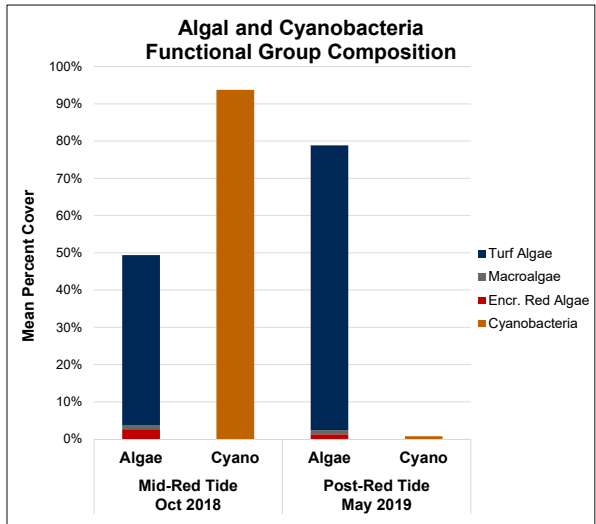
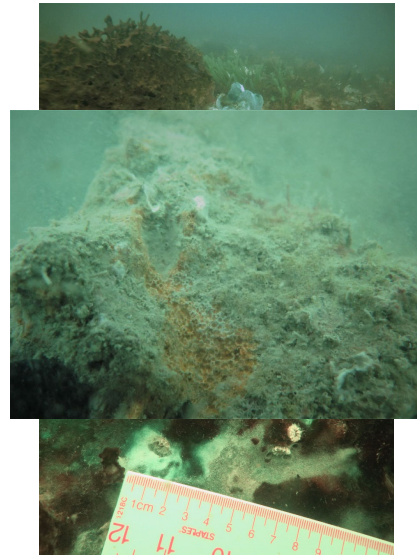
NEARSHORE HARDBOTTOM – R-35

This graph shows the huge decrease in cyano cover between monitoring events. It dropped from over 90%, as you can see in the photos, to less than 1%.

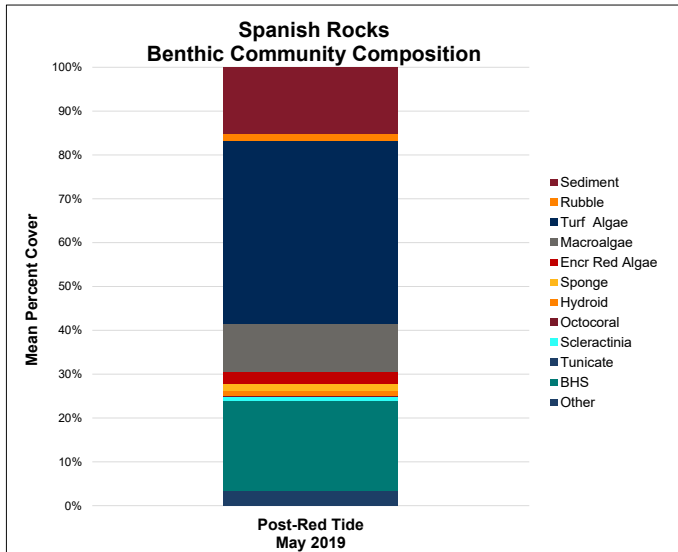
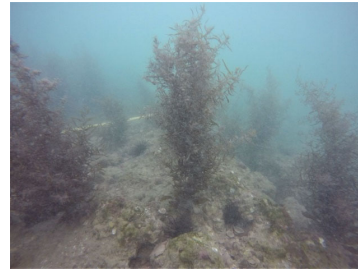
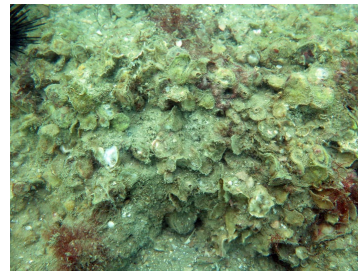
NEARSHORE HARDBOTTOM – SPANISH ROCKS

Moving to the Spanish Rocks area. We only collected quadrat data during the May 2019 pre-con monitoring event and have general observations, photos, and video for comparison to the mid-red tide. Turf algae and bare hard substrate, primarily dead bivalves shown on the right, were the dominant functional groups. We also observed fields of sargassum, shown in the photo, with some individuals reaching 60 cm in height. Cyano that blanketed the hardbottom in October 2018, decreased to less than 1% cover on the hardbottom.

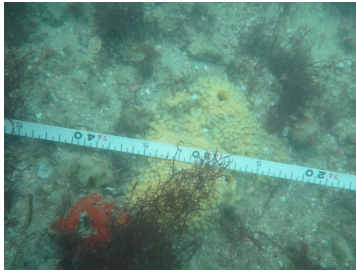
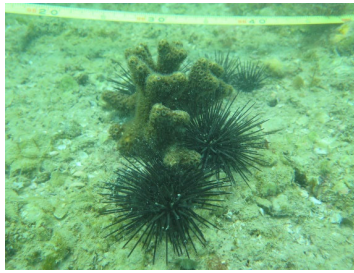
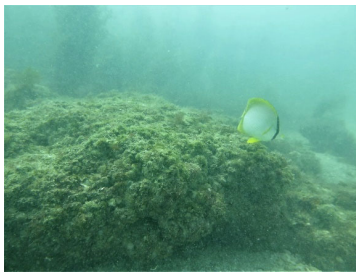
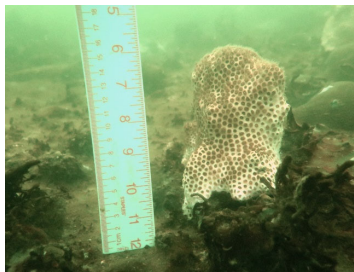
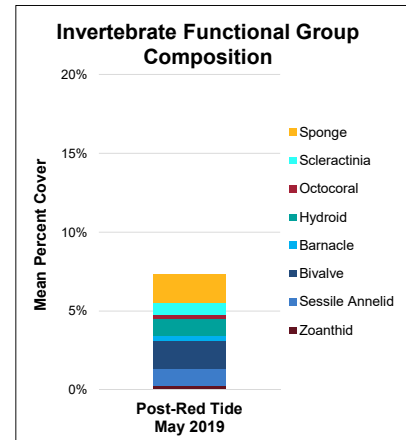
NEARSHORE HARDBOTTOM – SPANISH ROCKS

This chart shows the invertebrate functional groups. The sponge and octocoral cover were really low, at less than 2%. Stony corals did not show signs of stress. Bivalves, sessile annelids, and hydroids made up the benthic invertebrate composition. High numbers of rock boring urchins (*Echinometra lucunter*) were observed throughout the nearshore hardbottom.

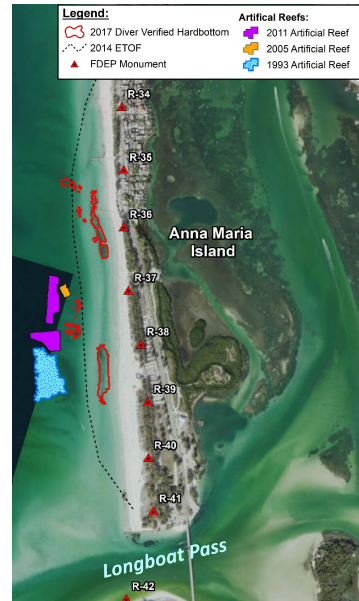
ARTIFICIAL REEFS

Artificial Reefs offshore of Coquina Beach shown on the map. Representative photos show the typical layout of each reef.

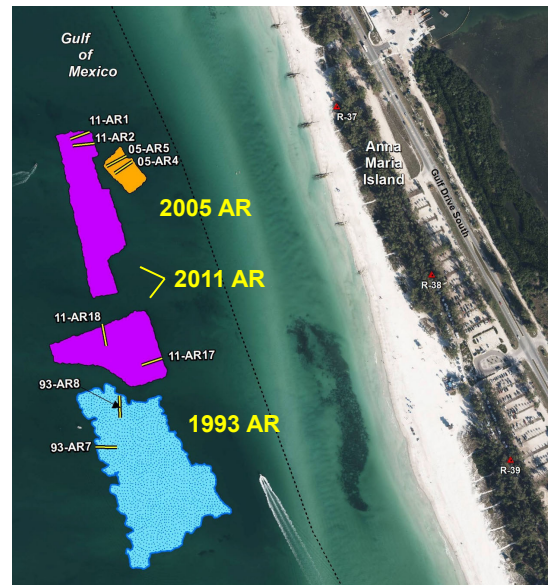
ARTIFICIAL REEFS

In May 2019, we visited a subset of these transects, shown on the map, to collect post-red tide data.

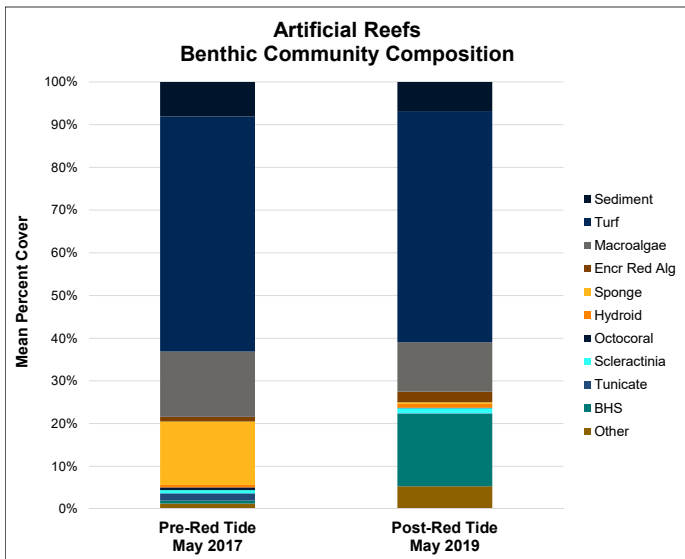
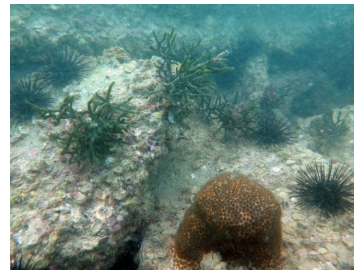
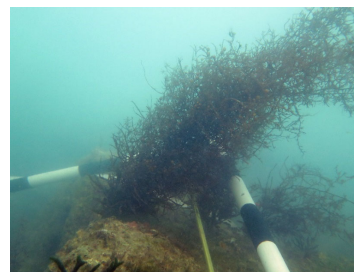
ARTIFICIAL REEFS

The artificial reef data shows similar increases in bare hard substrate, sessile invertebrates, and decreases in sponge and tunicate cover. Large numbers of rock boring urchins were also observed on all 3 artificial reefs.

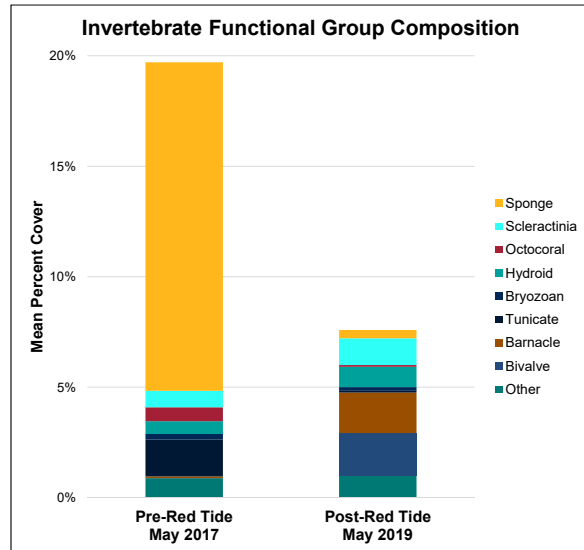
ARTIFICIAL REEFS

This chart details the 15% drop in sponge cover, of which 11% consisted of clionaid sponges (*Cliona celata* and *Pione lampa*). Tunicate cover decreased to nearly 0% while barnacle and bivalve cover increased.
