SUCCESSFUL INLET MANAGEMENT AT SOUTH LAKE WORTH INLET

Douglas W. Mann, P.E., D.CE.

Aptim Environmental & Infrastructure, LLC

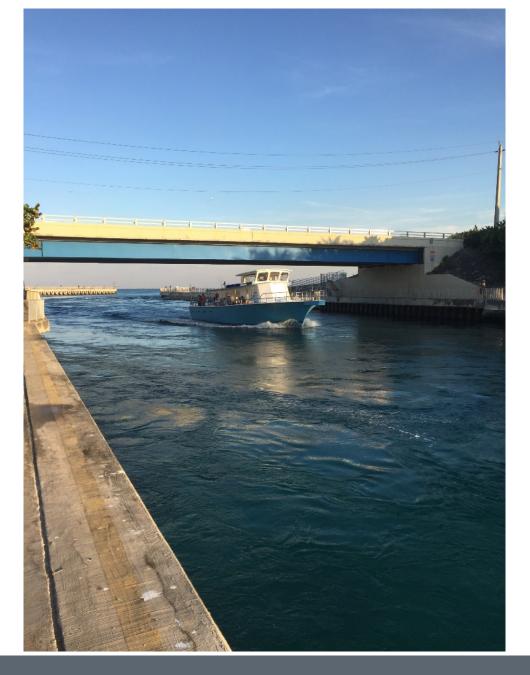
Photo by Mann (Nov 2019)

Mechanical bypassing began in 1937.

Inlet was modified with longer jetties in 1967.

Fixed bypassing plant last improved in 2011.

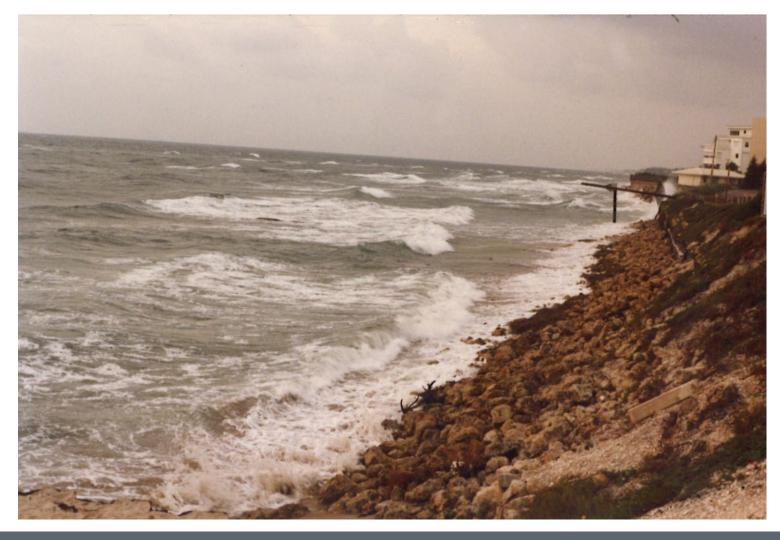
Photo by Mann (1987)

HISTORICAL DOWNDRIFT IMPACTS

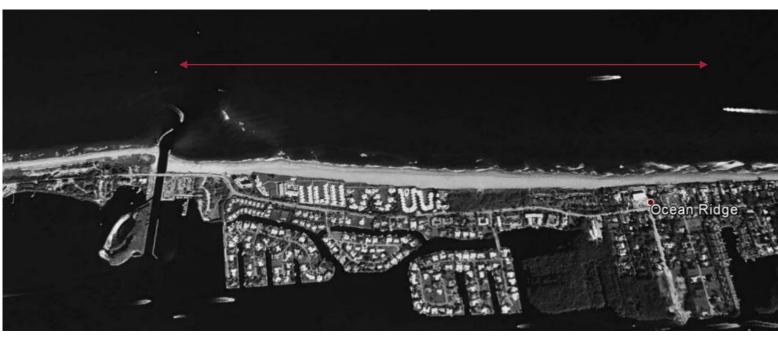
Photo by Google Earth 1999

OCEAN RIDGE SHORE PROTECTION PROJECT

Beach nourishment of 784,000cy along 1.4 miles of shoreline 8 T-head groins in the northern 1000 feet of beach.

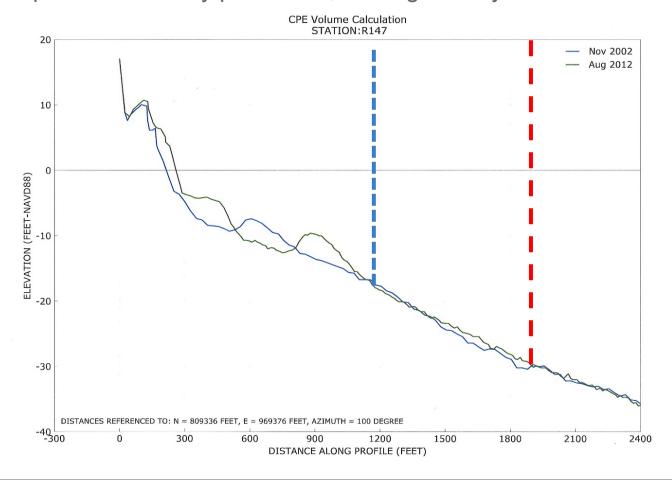
CROSS SHORE PROCESSES

- ▶ Depth of Closure = -30 feet NAVD. Deeper than previous studies.
- ► Noted general consistent trend of offshore accretion between 2002- 2018. This depth is variable by profile line, but is generally -16 to -20 feet.

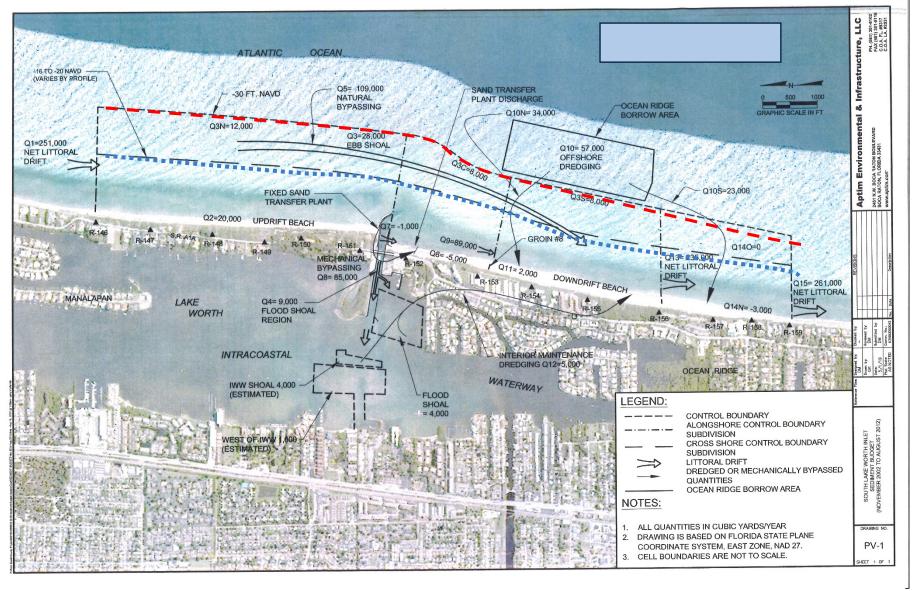
STUDY LIMITS

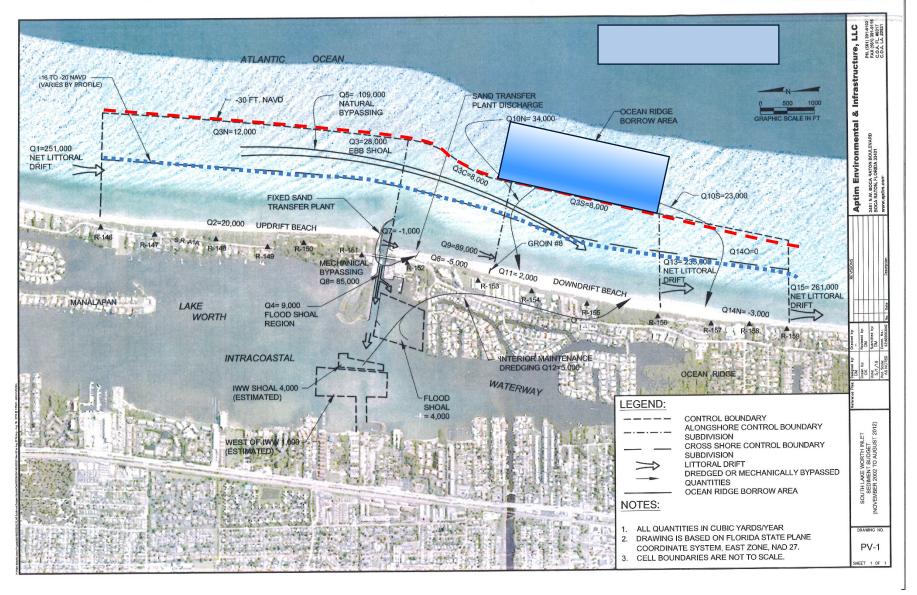
STUDY LIMITS-OFFSHORE BORROW AREA

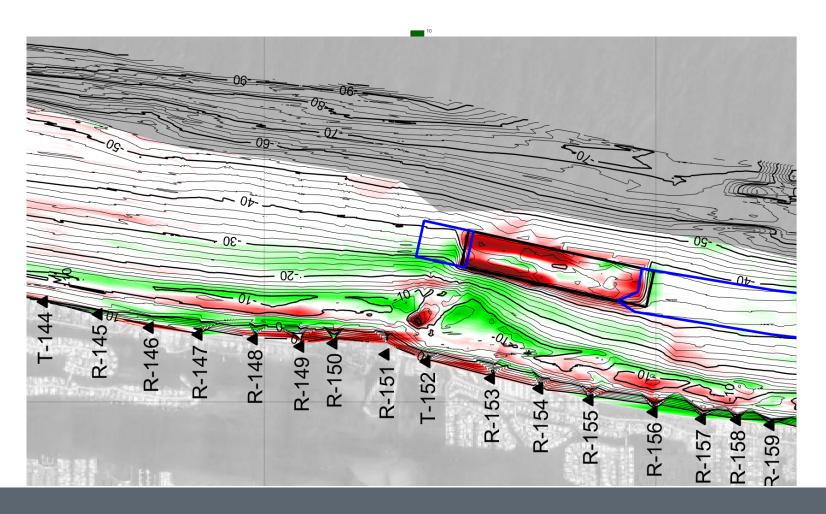
EBB SHOAL 2002-2012

- Mechanical bypassing was at or above the State's published goal for both time frames.
- Natural bypassing continues across the ebb shoal with attachment near Ocean Hammock Park.
- > Ebb shoal growth continues across a broad area.
- > Episodic storms have impacted the beach and ebb shoal morphologies.
- > Flood shoal regional dredging continues to maintain interior elevations and return beach sands to the beach.
- Offshore dredging continues to mitigate for any remainder of the inlet sedimentary impacts.

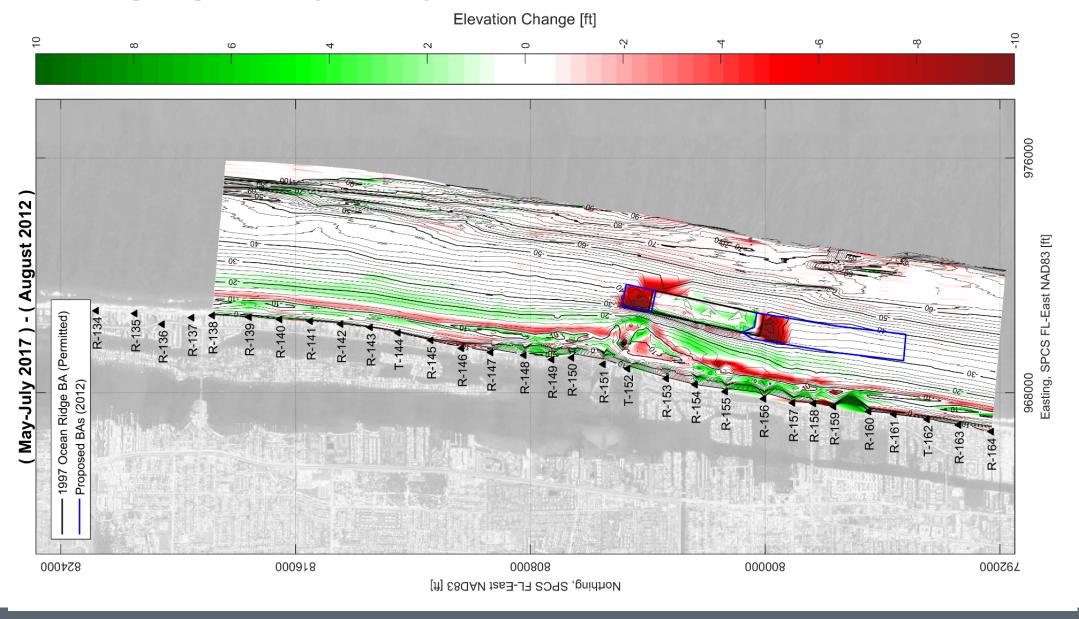
EBB SHOAL 2012-2017

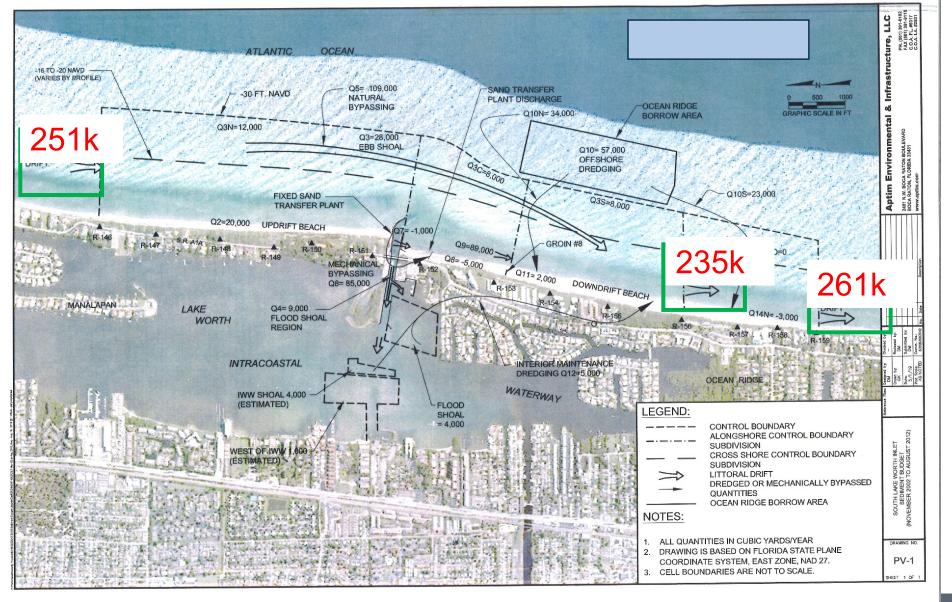
2002-2012 AVERAGE ANNUAL NET SEDIMENT BUDGET

- In Coastal Planning & Engineering, Inc. (1998, 2004) a net transport of 200,000 cy/yr was assumed.
- > This included an evaluation of hindcasted wave data and a calibrated sediment transport coefficient.
- APTIM re-calibrated the wave induced sediment transports for the previous time period (to 200,000 cy/yr) using sea and swell wave components separately, then computed the net transports for:
 - 2002-2012-----251,000 cy/yr
 - 2012-2018 -----242,000 cy/yr

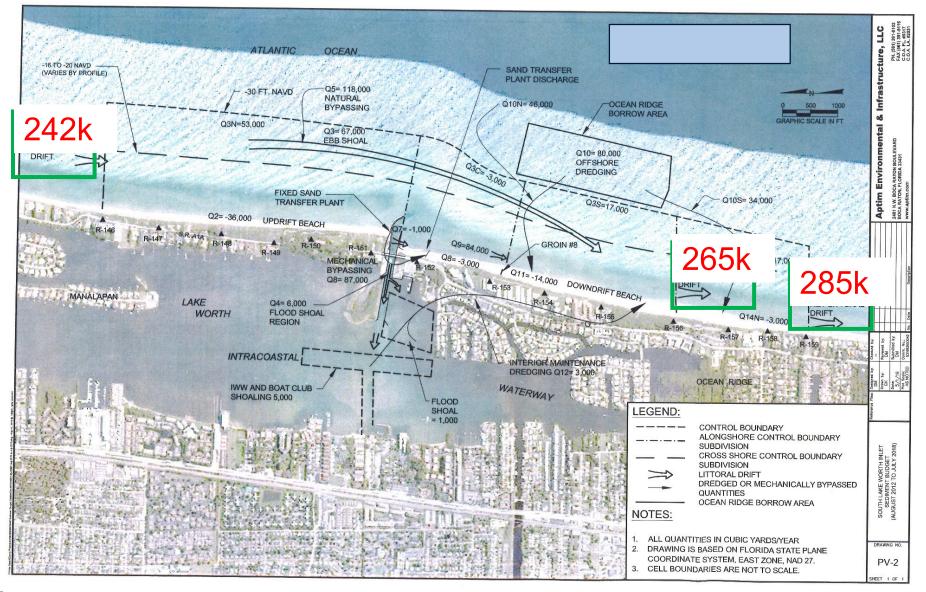
2012-2018 AVERAGE ANNUAL SEDIMENT BUDGET

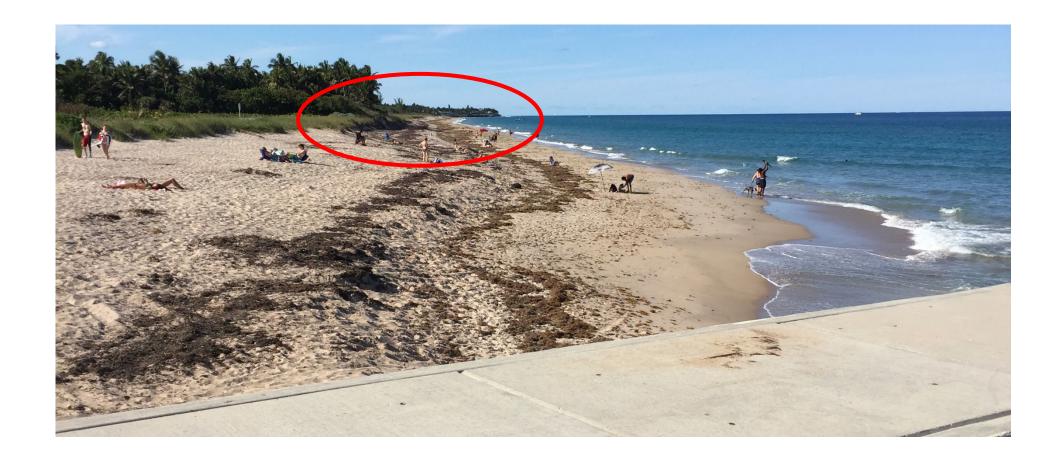
MANALAPAN APRIL 2019

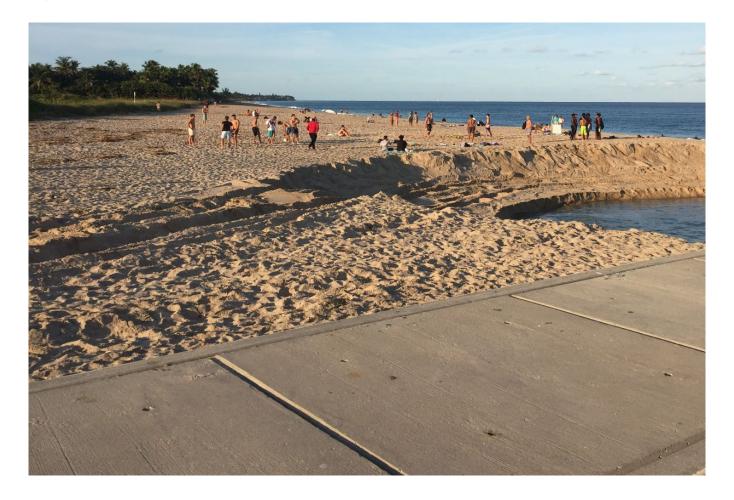
MANALAPAN NOV. 27 2019

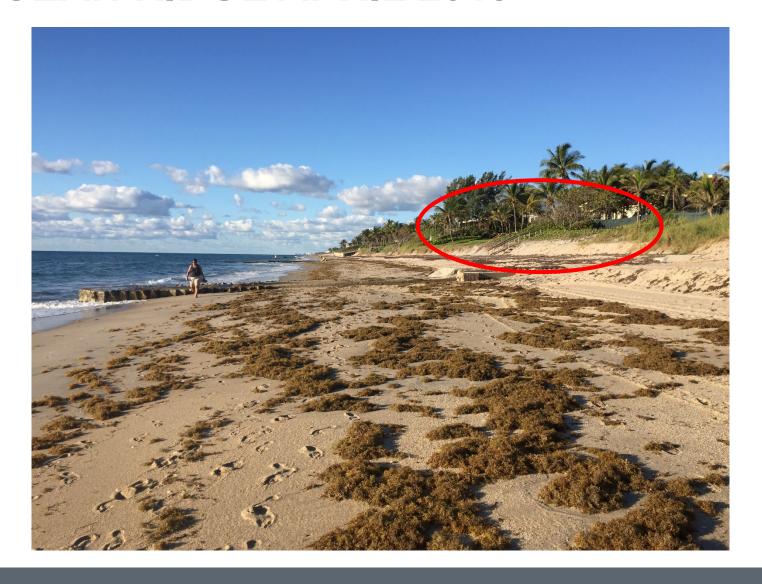
OCEAN RIDGE APRIL 2019
