Case Study: Navarre Beach – Performance during Hurricanes

2021 FSBPA Technical Conference February 3, 2021

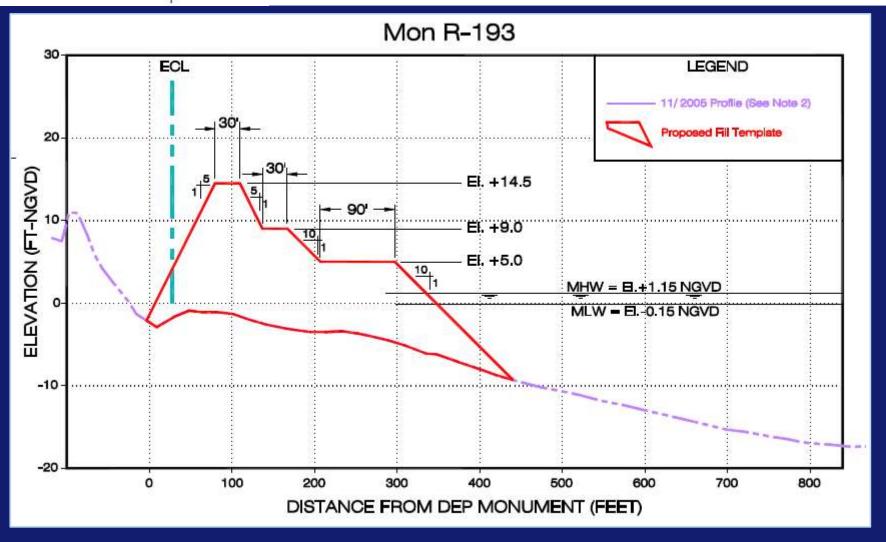
- 4.1 miles from R-192+460' to R-213.5+500'
- 2006 nourishment 3 million cubic yards of sand
- 2010 truck haul 11,500 cubic yards of sand
- 2016 renourishment 1.5 million cubic yards of sand

Project Limits R-192+460' Navarre Beach Fishing Pier

Project Limits R-213.5+500'

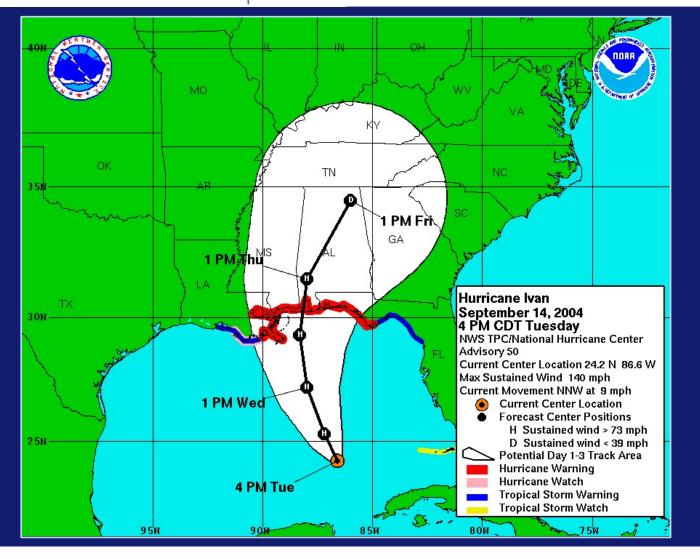
Beach/dune response – pre 2006

Hurricane Ivan

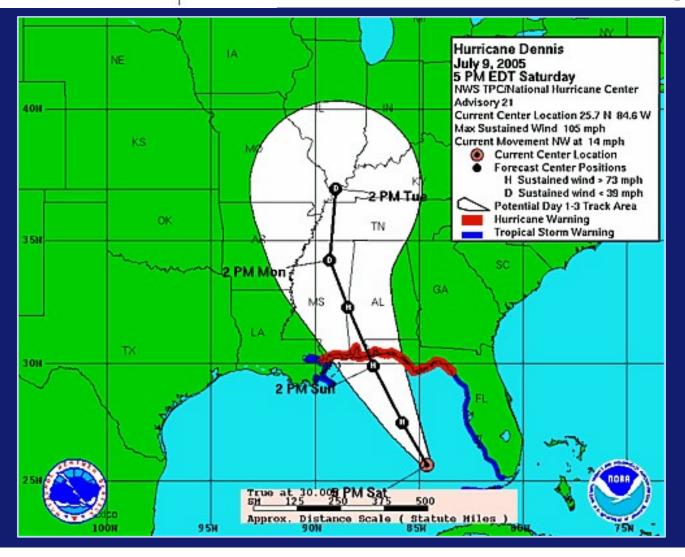
Beach/dune response – pre 2006

Hurricane Dennis

July 2005

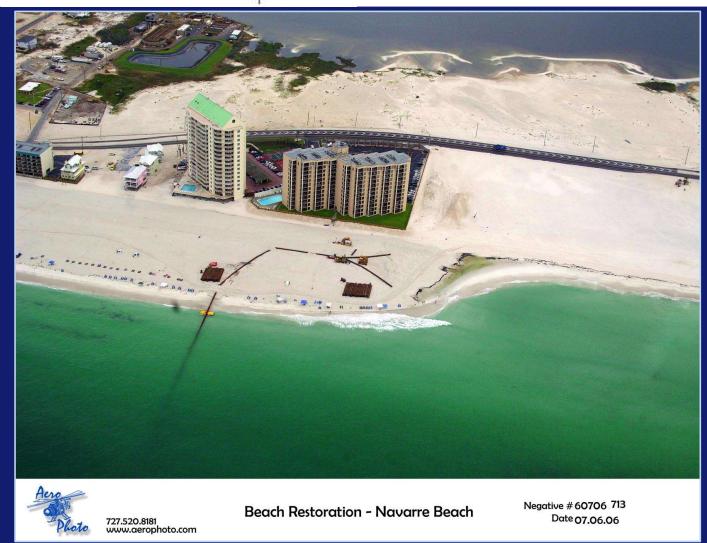
During Construction

July 2006

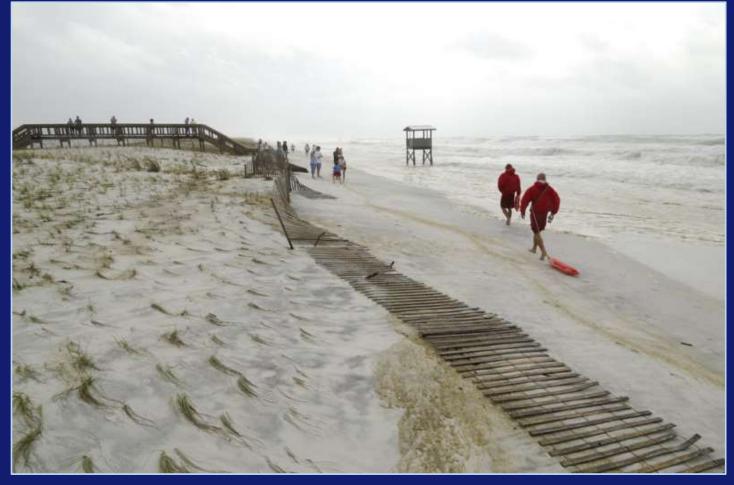
Hurricane Gustav

September 2008

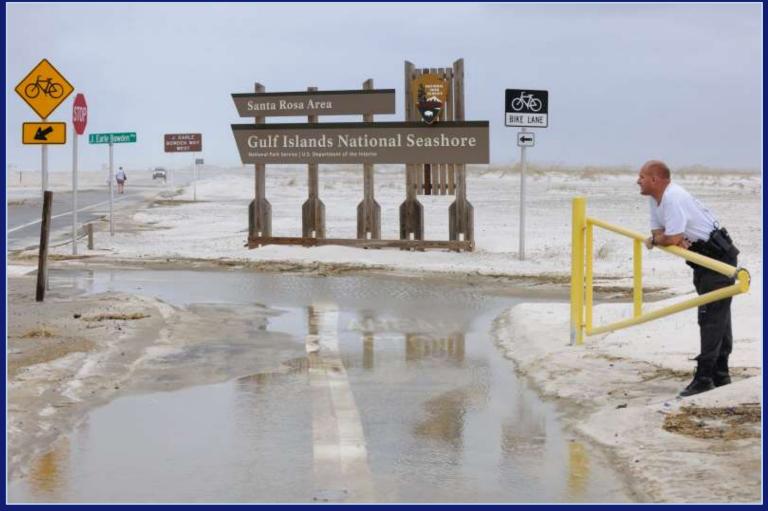
Hurricane Ida

November 2009

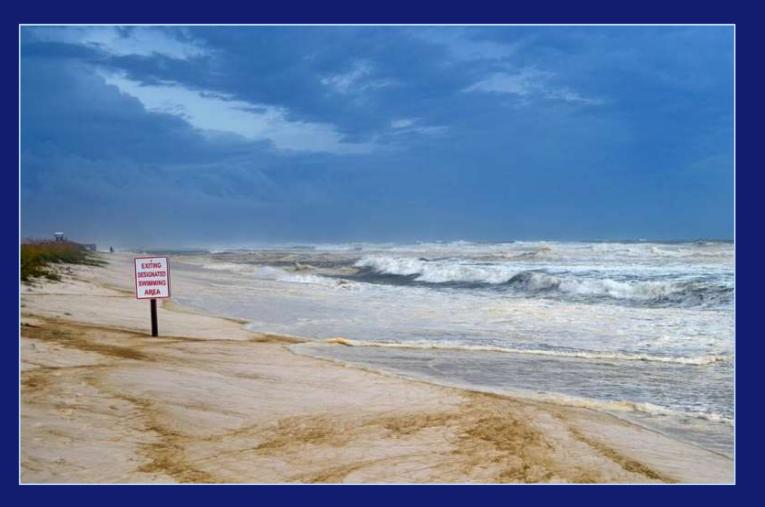
Hurricane Isaac

August 2012

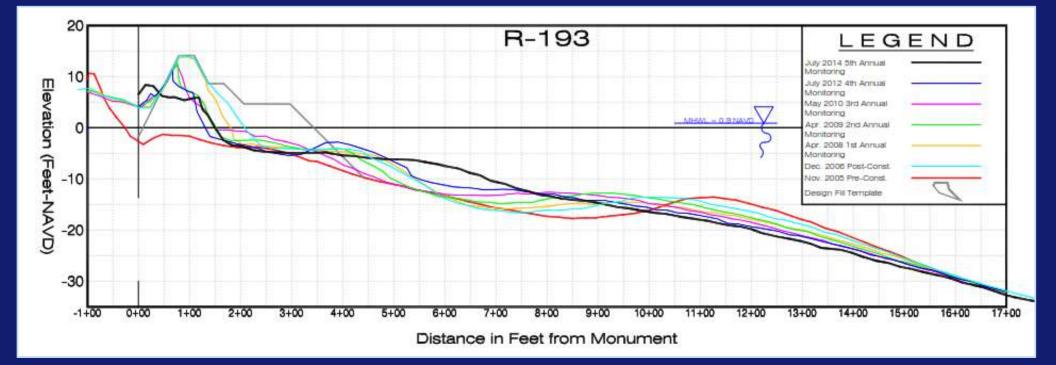
2016 Renourishment

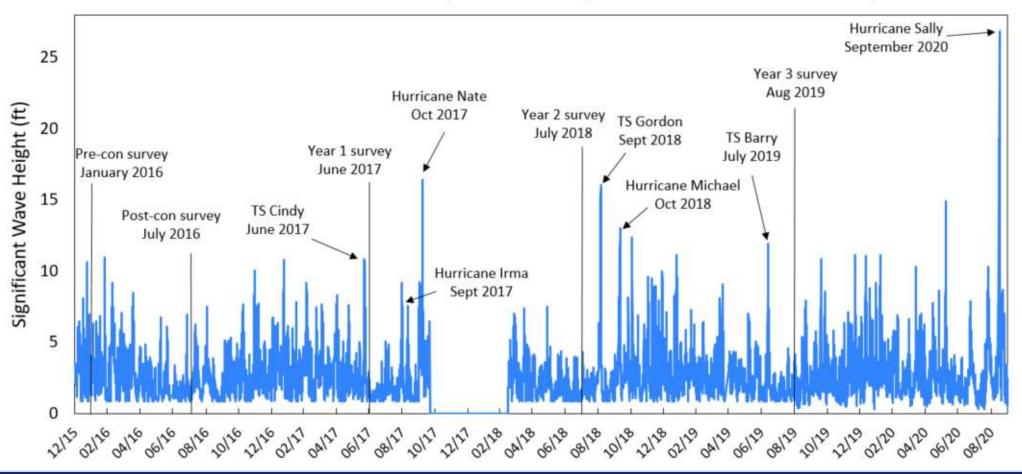
Wave Observations at Buoy 42012 - Orange Beach - 44 NM SE of Mobile, AL

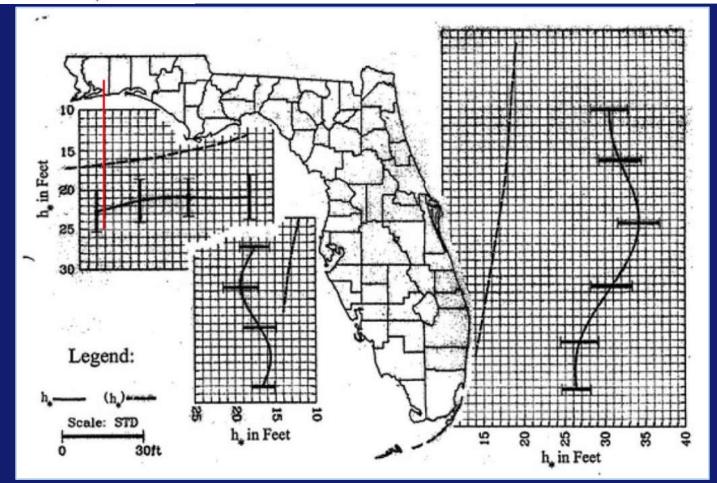
Depth of Closure

Source: "Closure Depth Considerations Along the Florida Shoreline" by Robert G. Dean and Subarna B. Malakar
