When a Project Performed Better than Expected

Beach Nourishment at Sagaponack and Bridgehampton, Town of Southampton, Long Island, New York

Haiqing Liu Kaczkowski, PhD PE

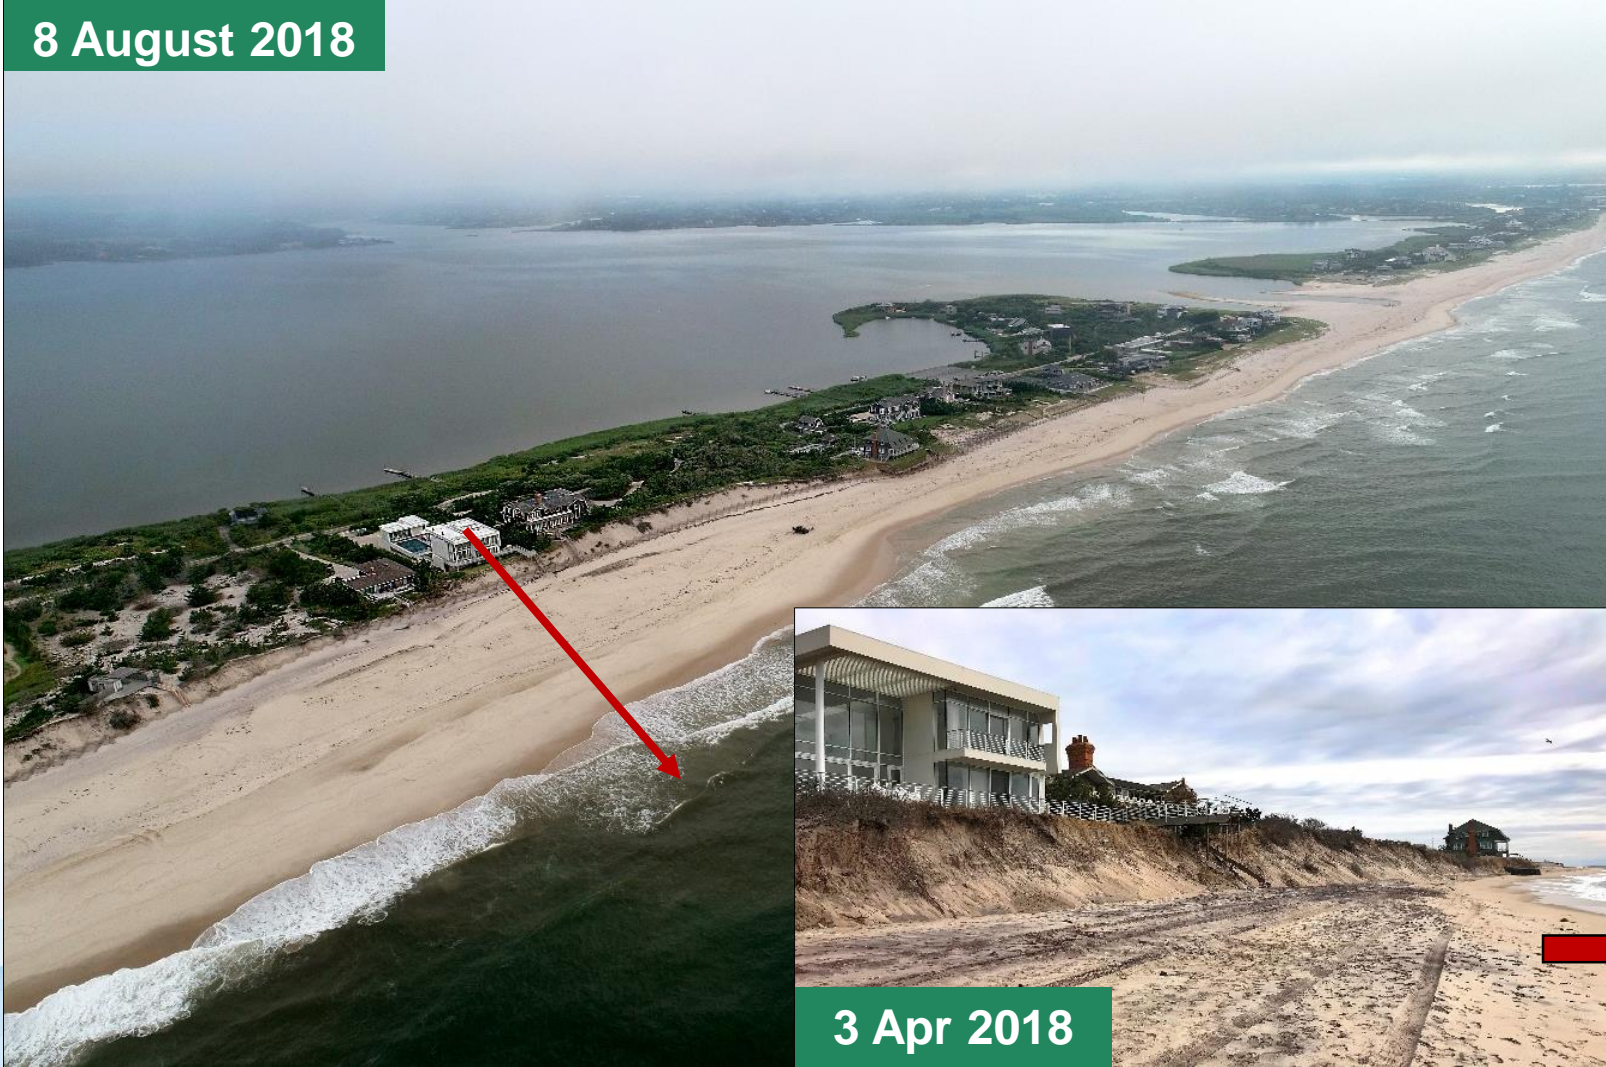
Bridgehampton Dune Recovery After 2018 Nor'easter

8 August 2018

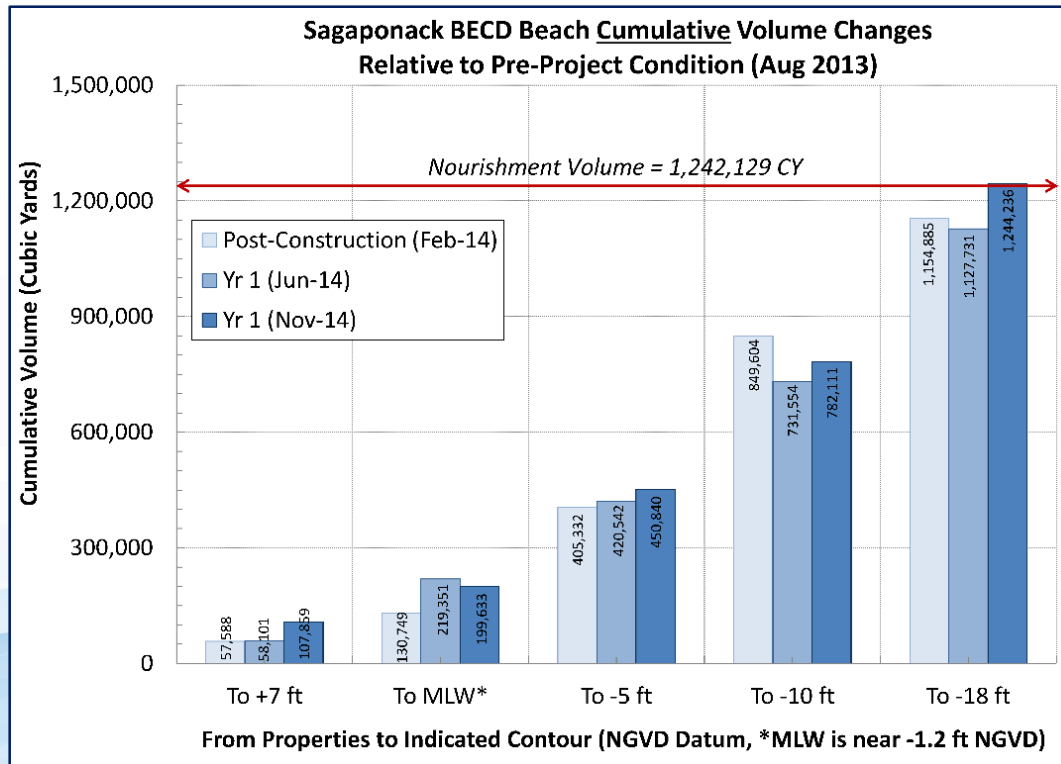
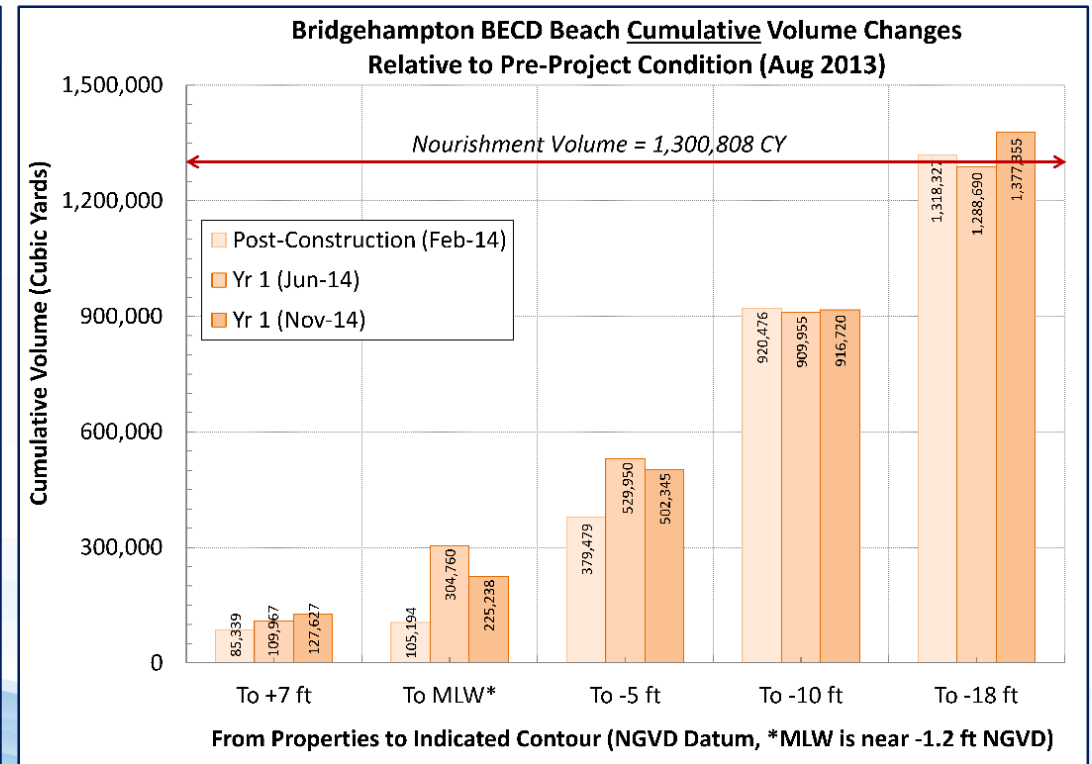
Post-Project Monitoring

– Year 1 (2014) Nourishment Sand Remaining

Year

1

Sagaponack

100%

Bridgehampton

106%

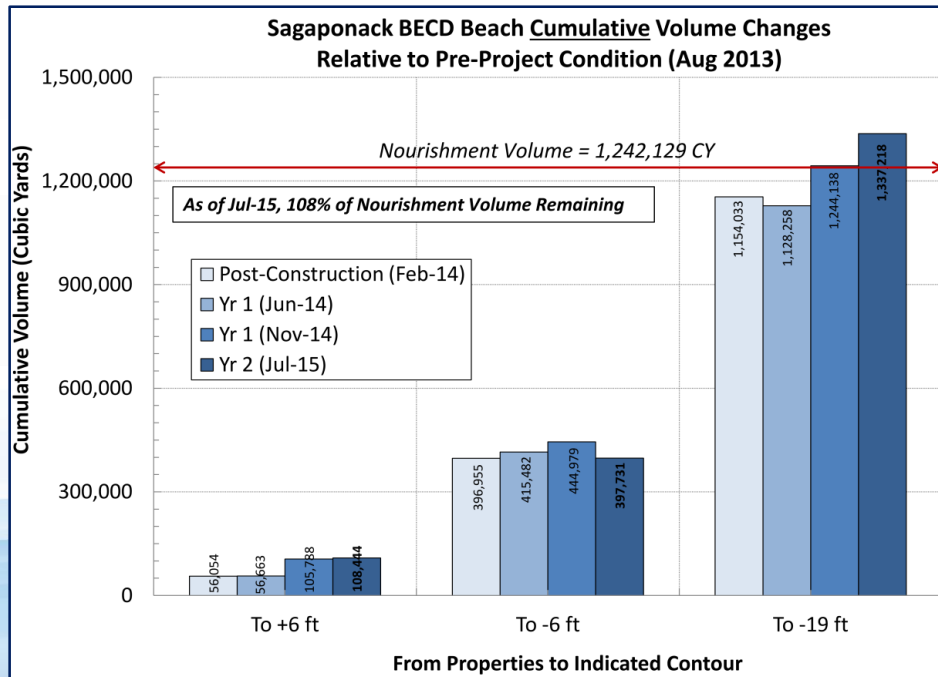
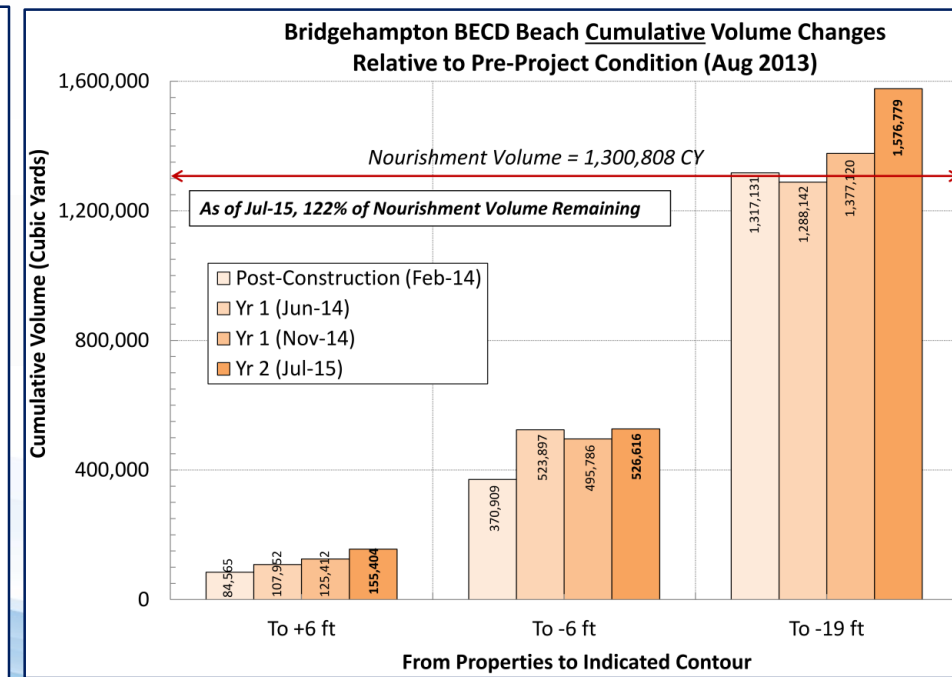
Post-Project Monitoring

– Year 2 (2015) Nourishment Sand Remaining

<u>Year</u>	<u>Sagaponack</u>	<u>Bridgehampton</u>
1	100%	106%
2	108%	122%

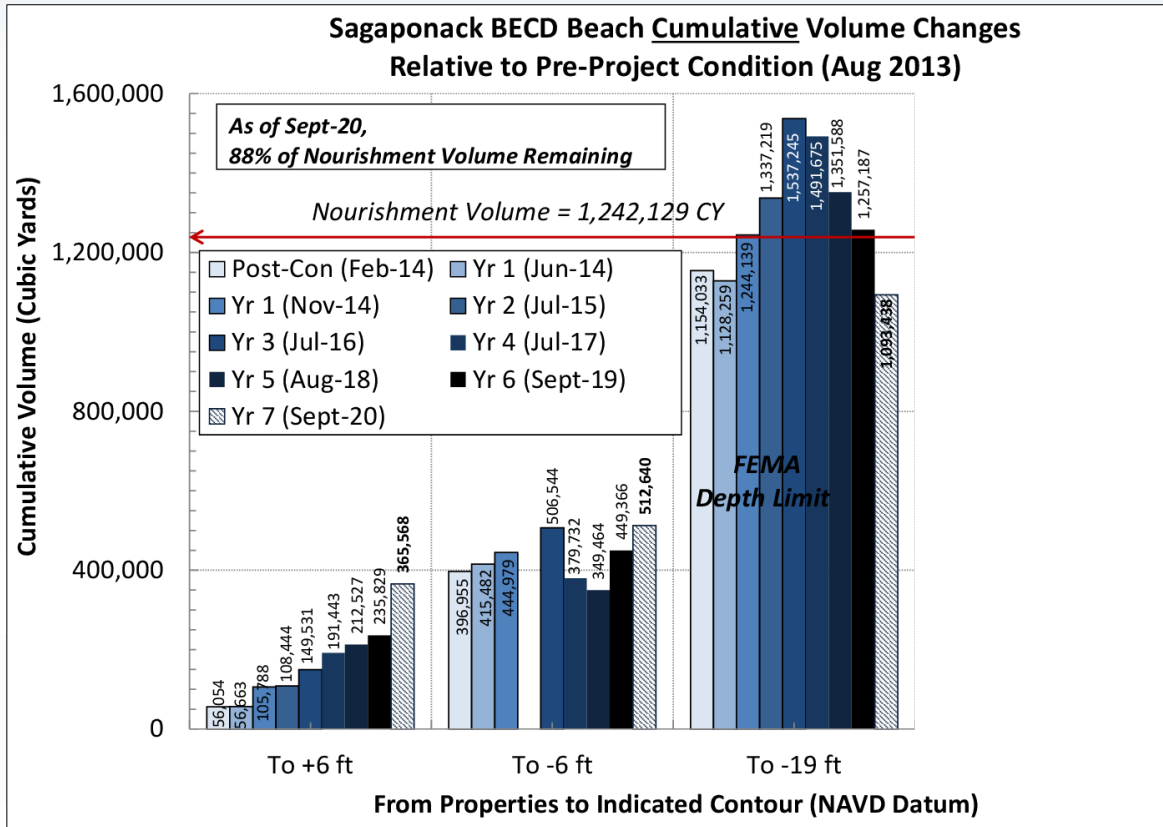
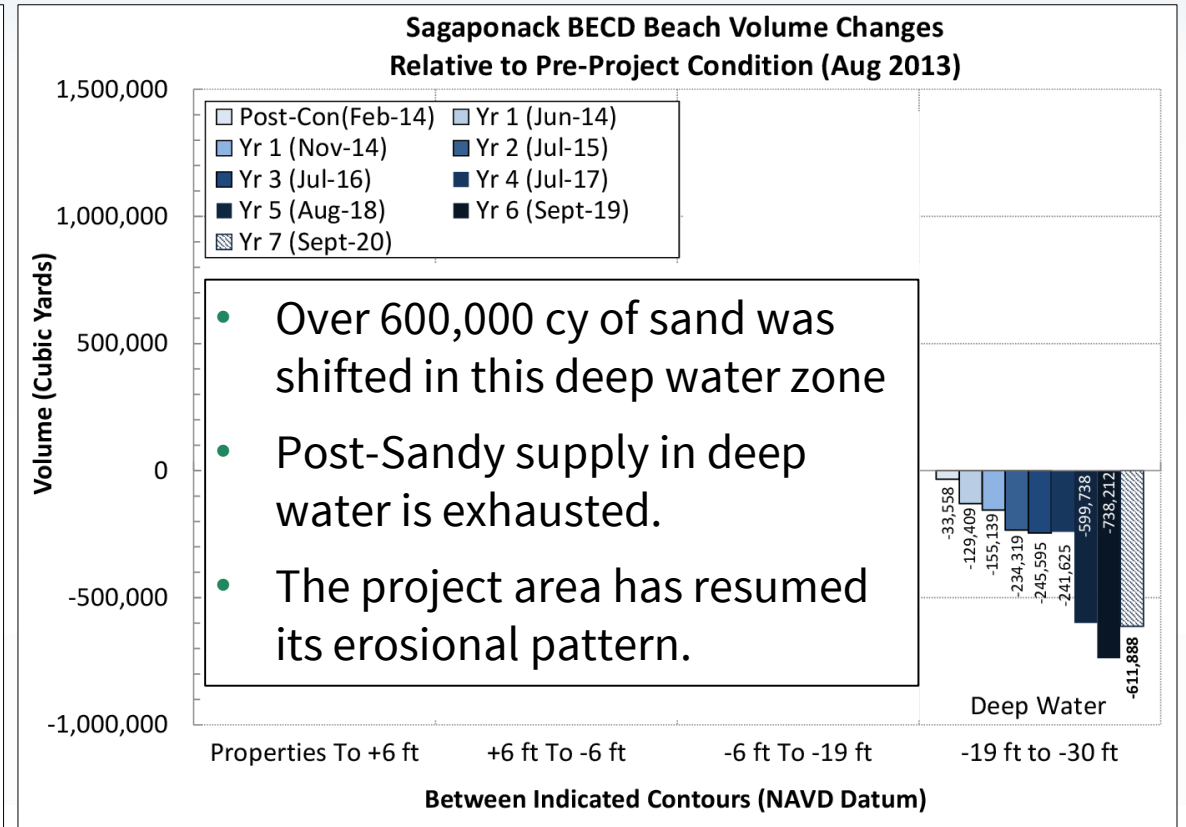
Yr 7 (2020) Sagaponack Project Performance

<u>Year</u>	<u>Sagaponack</u>	<u>Bridgehampton</u>
1 (2014)	100%	106%
2 (2015)	108%	122%
3 (2016)	124%	122%
4 (2017)	120%	118%
5 (2018)	109%	106%
6 (2019)	101%	113%
7 (2020)	88%	105%

- 2013-2014 nourishment project has performed better than expected with ~90% of the sand remaining as of Year 7 (2020).
- Sagaponack erosion rate was over 2.5 times higher than the historical average between 2019 and 2020, and 7 times higher between 2020 and 2021.
- Bridgehampton erosion rate was over 1.8 times higher than the historical average between 2019 and 2020, and 6 times higher between 2020 and 2021.
- Erosional hotspots were measured in both BECDs, and some of them have persisted over the past few years.
- Renourishment plan is critical to remain eligible for future FEMA restoration funds.
- It has been nine years since the last declared disaster (Superstorm *Sandy* in October 2012).
- Initiating planning and permitting for renourishment in fall 2023/2024.

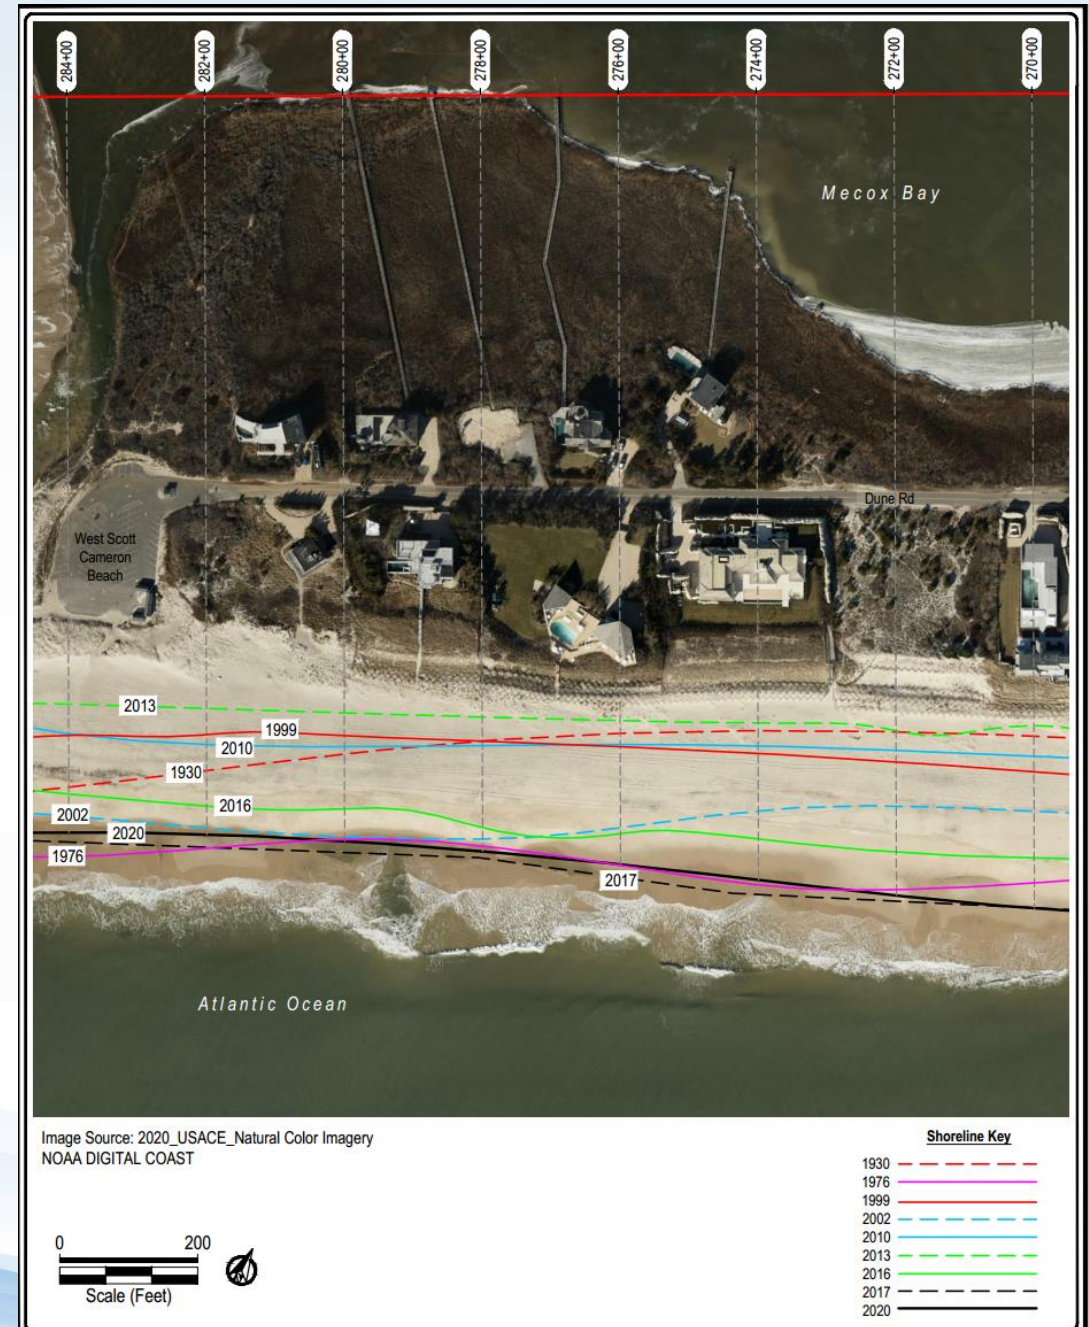
Historical Shorelines

- Aerial photos since 1930
- Position of mean high water as a measure of beach width
- Between June 2010 and Jan 2020: Sagaponack became 66 ft wider; Bridgehampton became 140 ft wider
- Between 1930 and 2020, Sagaponack MHW is about the same position as 1930 and 1976; Bridgehampton is over 100 ft wider
- Upcoast is 170 ft narrower; downcoast is 135 ft narrower
- **Nourishment has turned back the clock by 40-70 years**
