Impacts to SWFL Barrier
Islands and Inlets

HURRICANE IAN

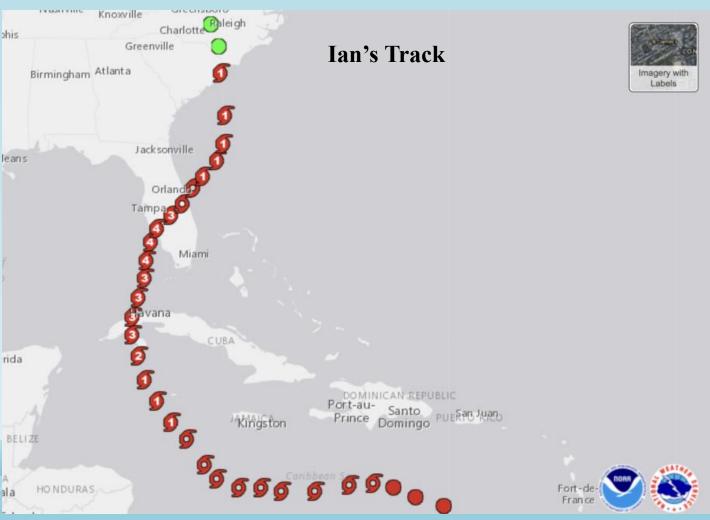
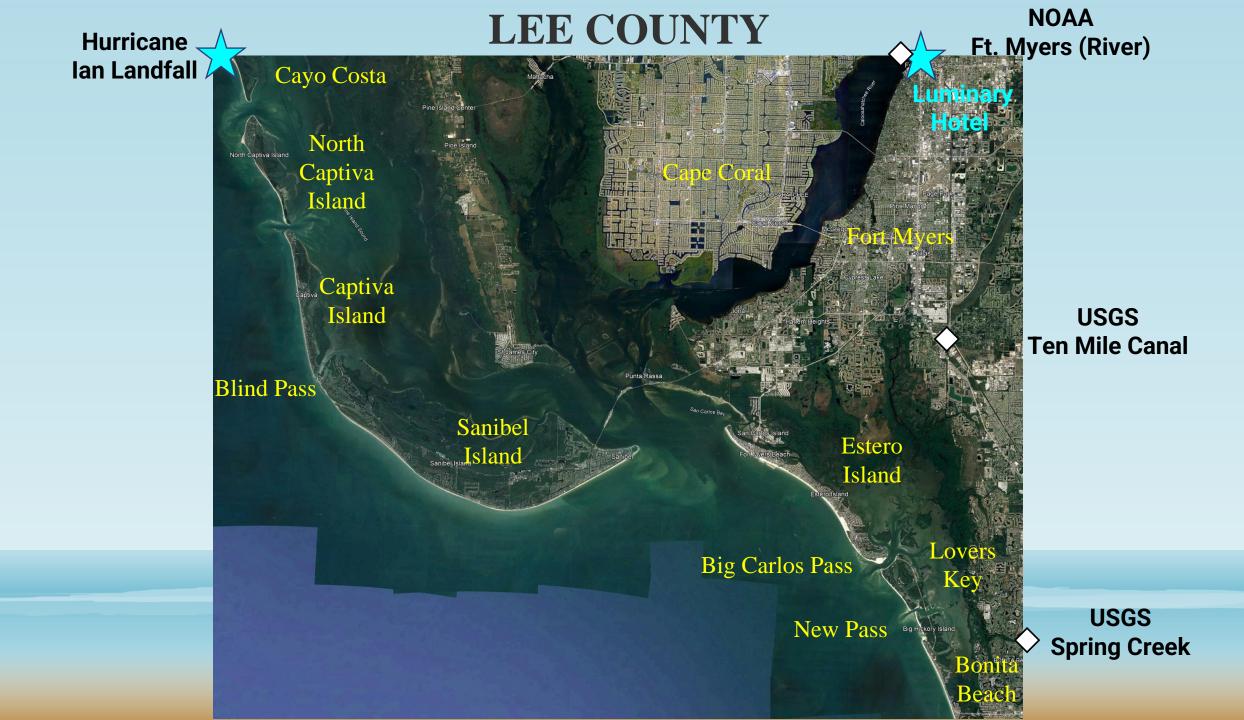
- ➢Fifth-strongest hurricane on record to strike the U.S.
- ≻Cat 4 with maximum sustained winds of 155 mph, just shy of a Cat 5
- Made landfall near Cayo
 Costa on Sep. 28, 2022 at
 3:05 PM EDT with maximum
 sustained winds of 150 mph

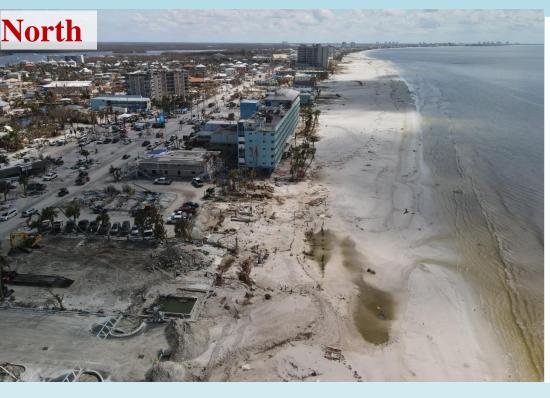
Estero Island

SEGMENT	DESCRIPTION *	EROSION (CY)	DENSITY (CY/LF)
North	Managed-Cat G	56,845	-7.8
Central-South	Natural	163,576	-5.5
Central-South	Cat B Emer Berm	89,406	-3.0

* Cat G calculation to depth of closure (with background erosion) Natural beach calculation to intersection of pre-/post-storm (no background erosion) Emergency Berm computed for erosion losses above 5-Yr SWL (up to 6.0 CY/LF) plus scour

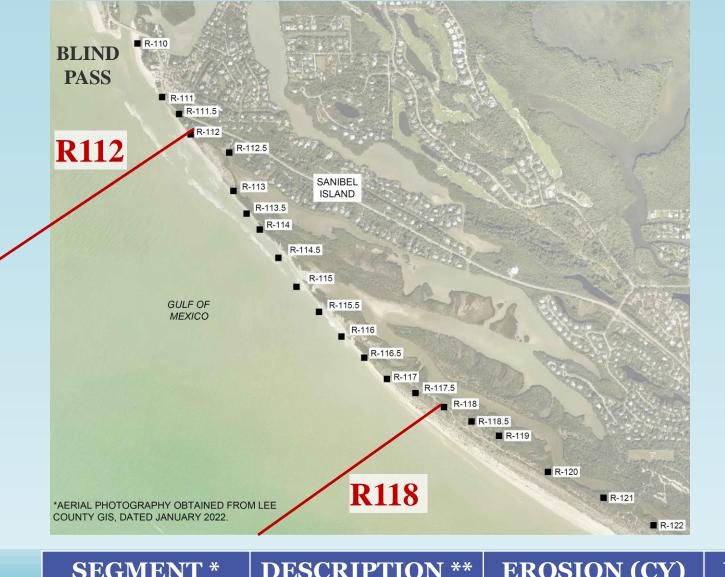
North Sanibel (R110-R122)

SEGMENT *	DESCRIPTION **	EROSION (CY)	DENSITY (CY/LF)
Beach Disposal	Natural	211,980	-16.9

- * Blind Pass Disposal Site
- ** Natural beach calculation to depth of closure (no background erosion [Aug-Oct])

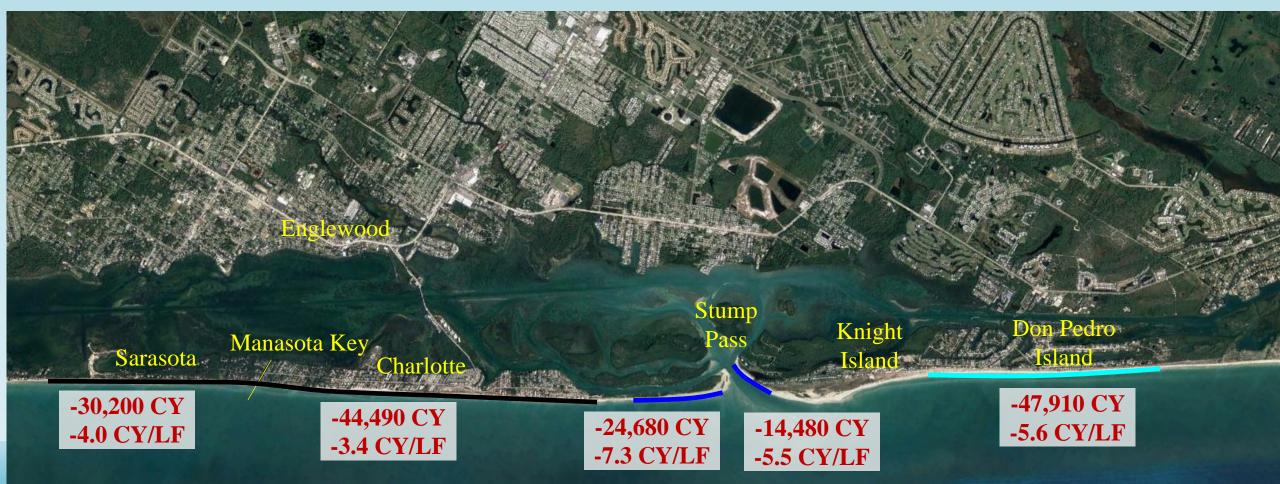
CHARLOTTE COUNTY EROSION CONTROL PROJECT AND MANASOTA KEY

*Erosion calculations to intersection of pre-/post-storm (with prorated background erosion)
