The Morphological Evolution of Little Estero Island

Ralph R. Clark, P.E.

Office of Resilience and Coastal Protection

Feb. 2, 2023

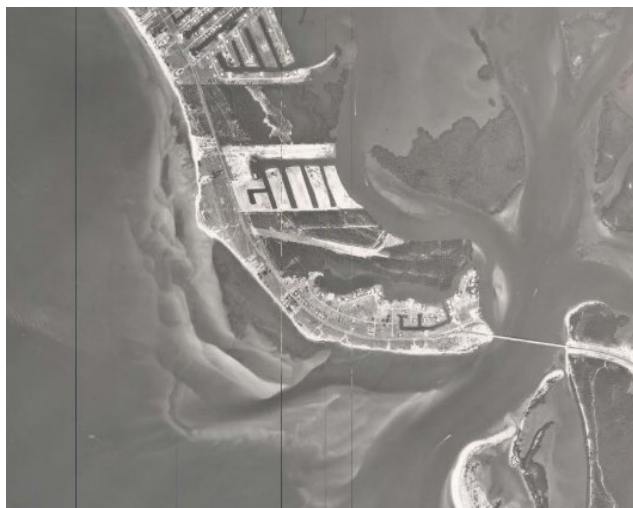
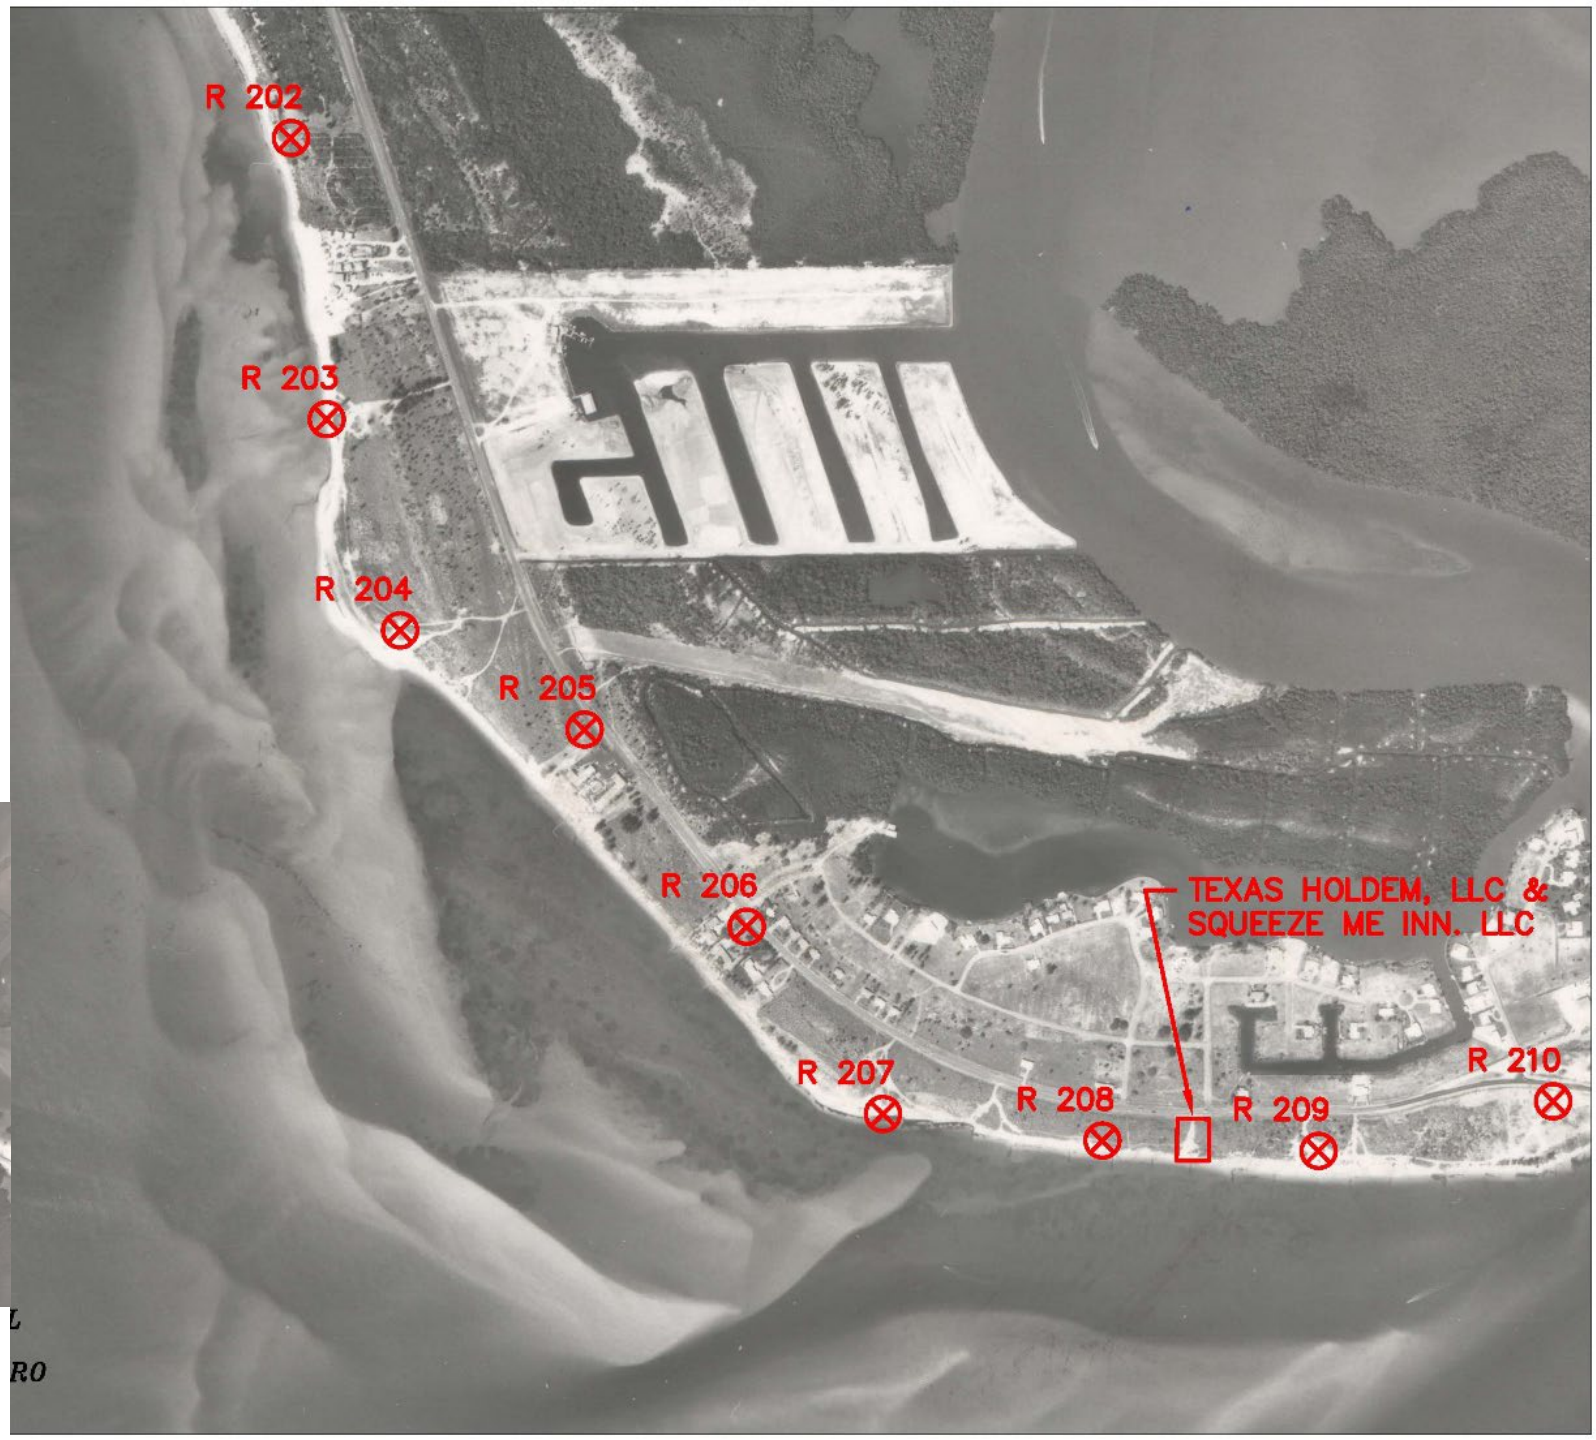
1968

Pre-emergence

Numerous submerged shoals exist as part of the Big Carlos Pass ebb tidal delta

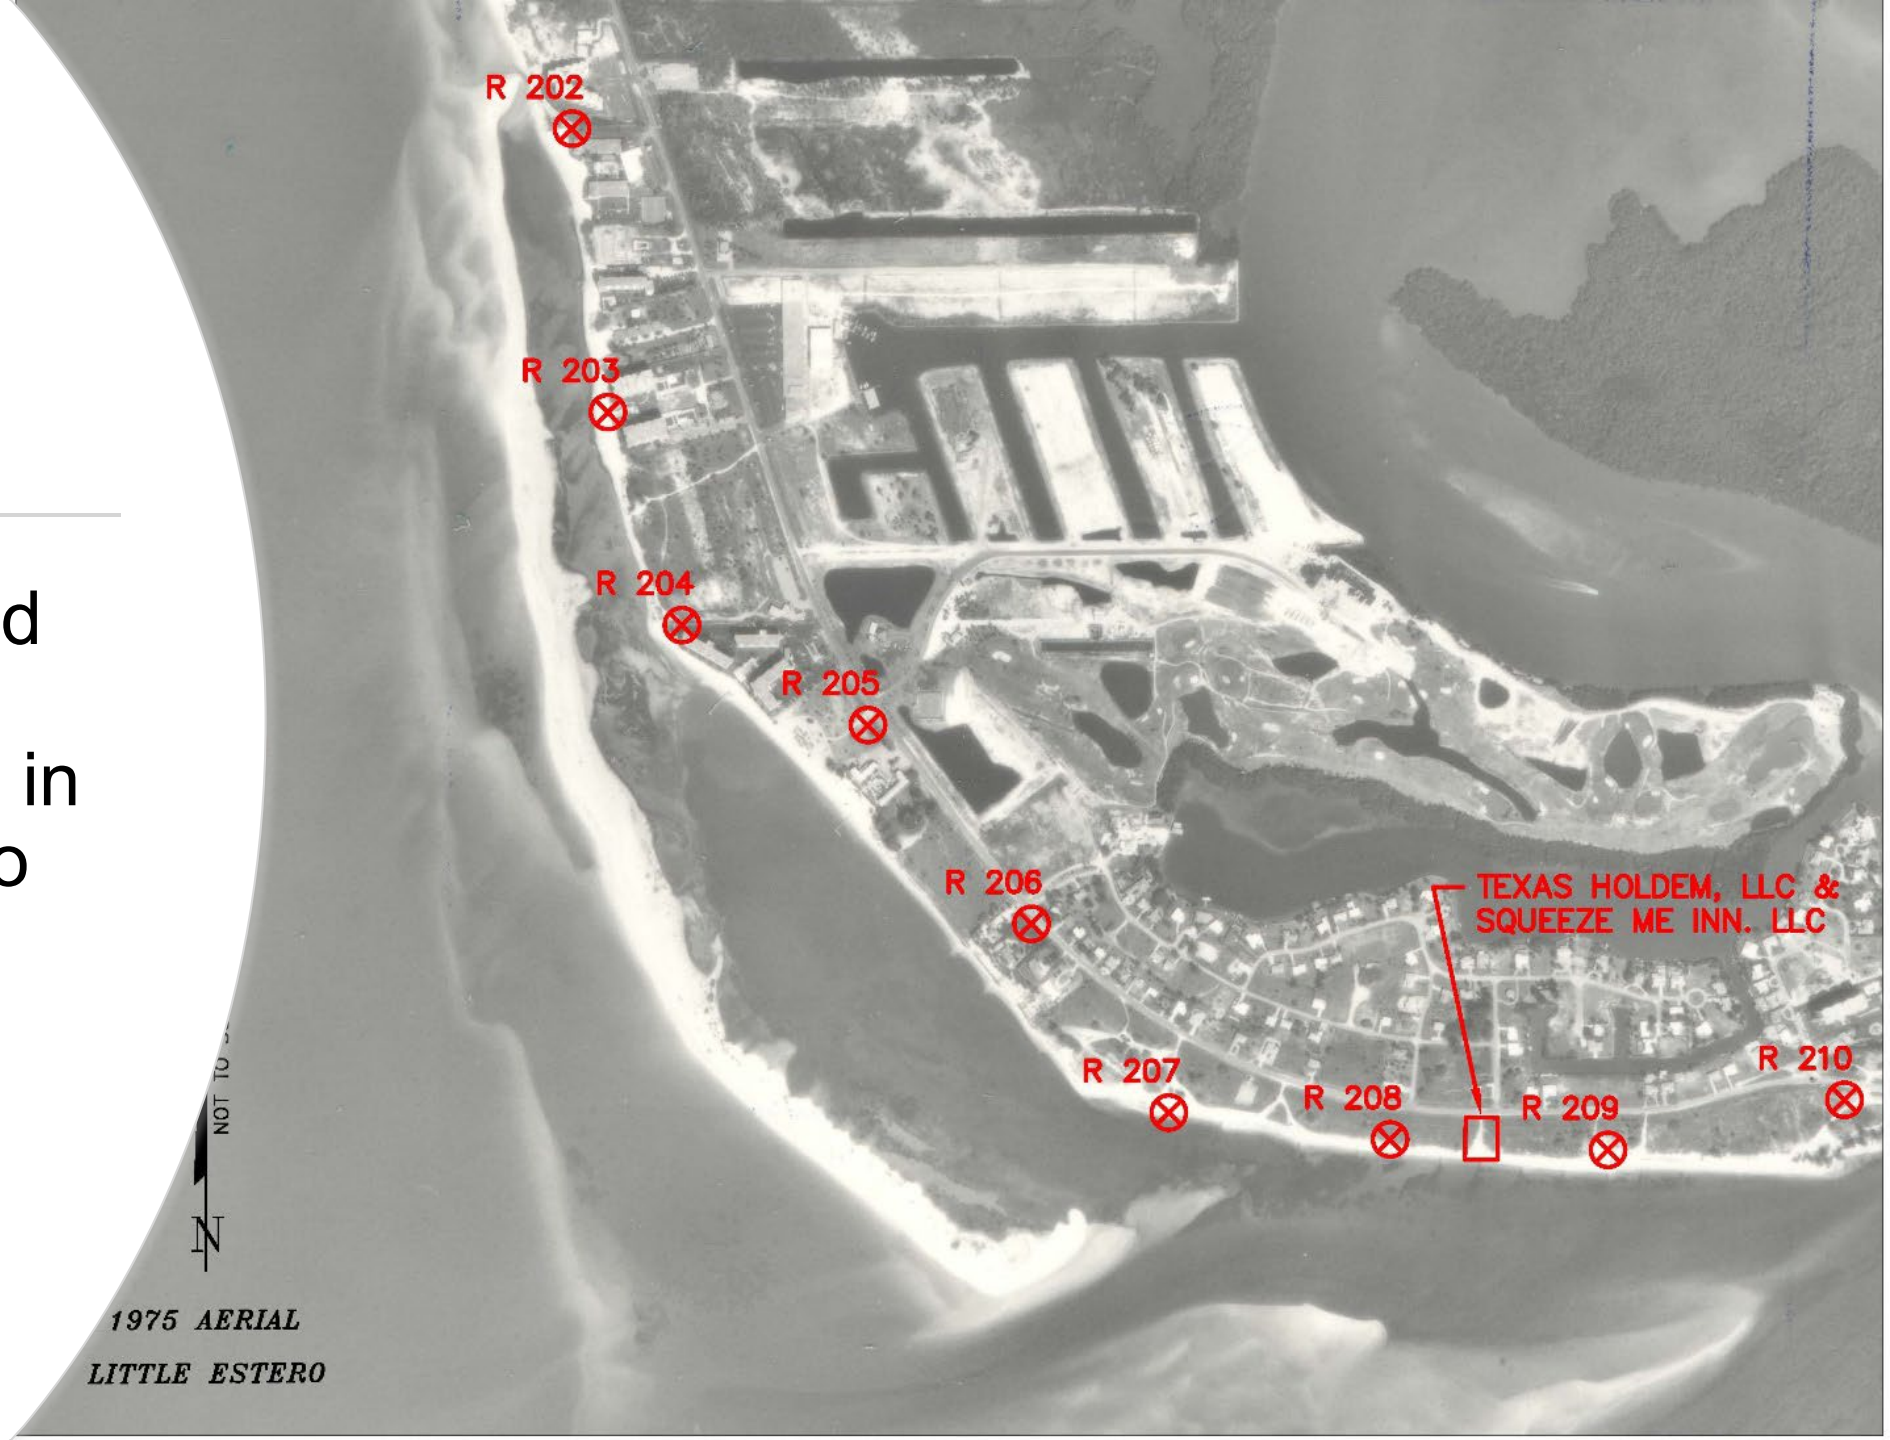
1975 AERIAL
LITTLE ESTERO

1975

Little Estero Island emerged from submerged lands in the Gulf of Mexico

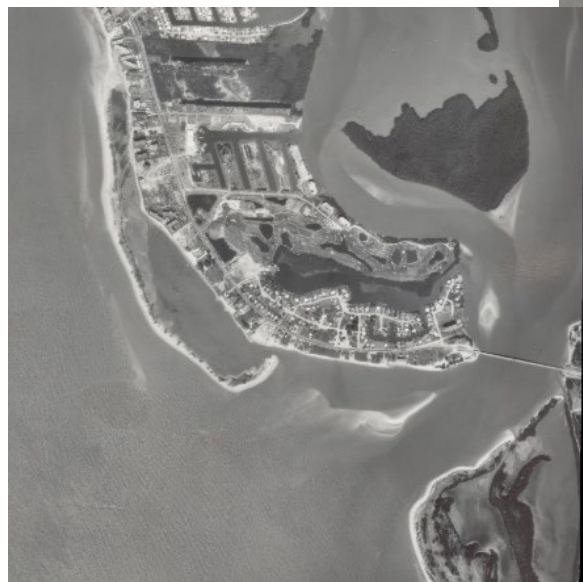
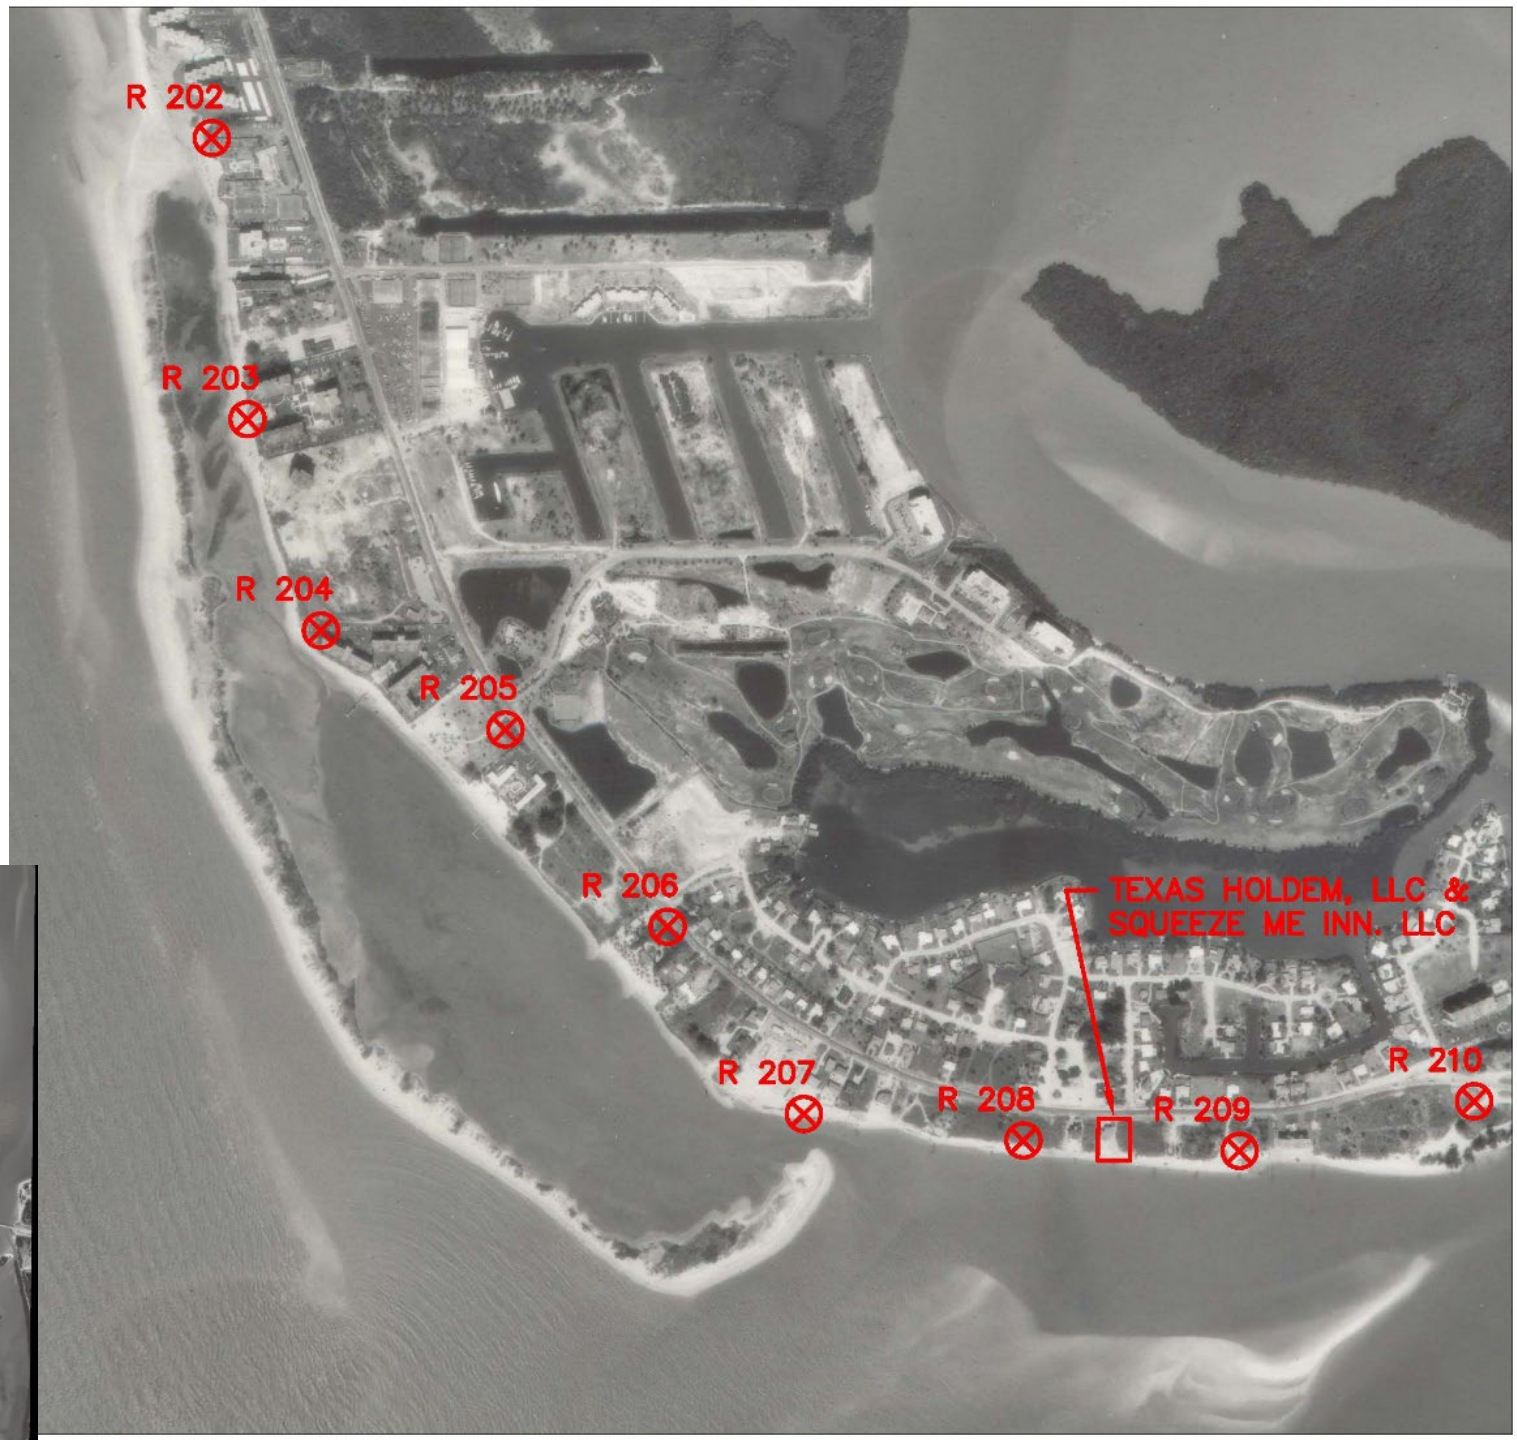
1979

North attachment

Attached near R202 at north end. Recurved growth at south end near R207 encloses lagoon. Submerged sand bar parallels Little Estero Island.

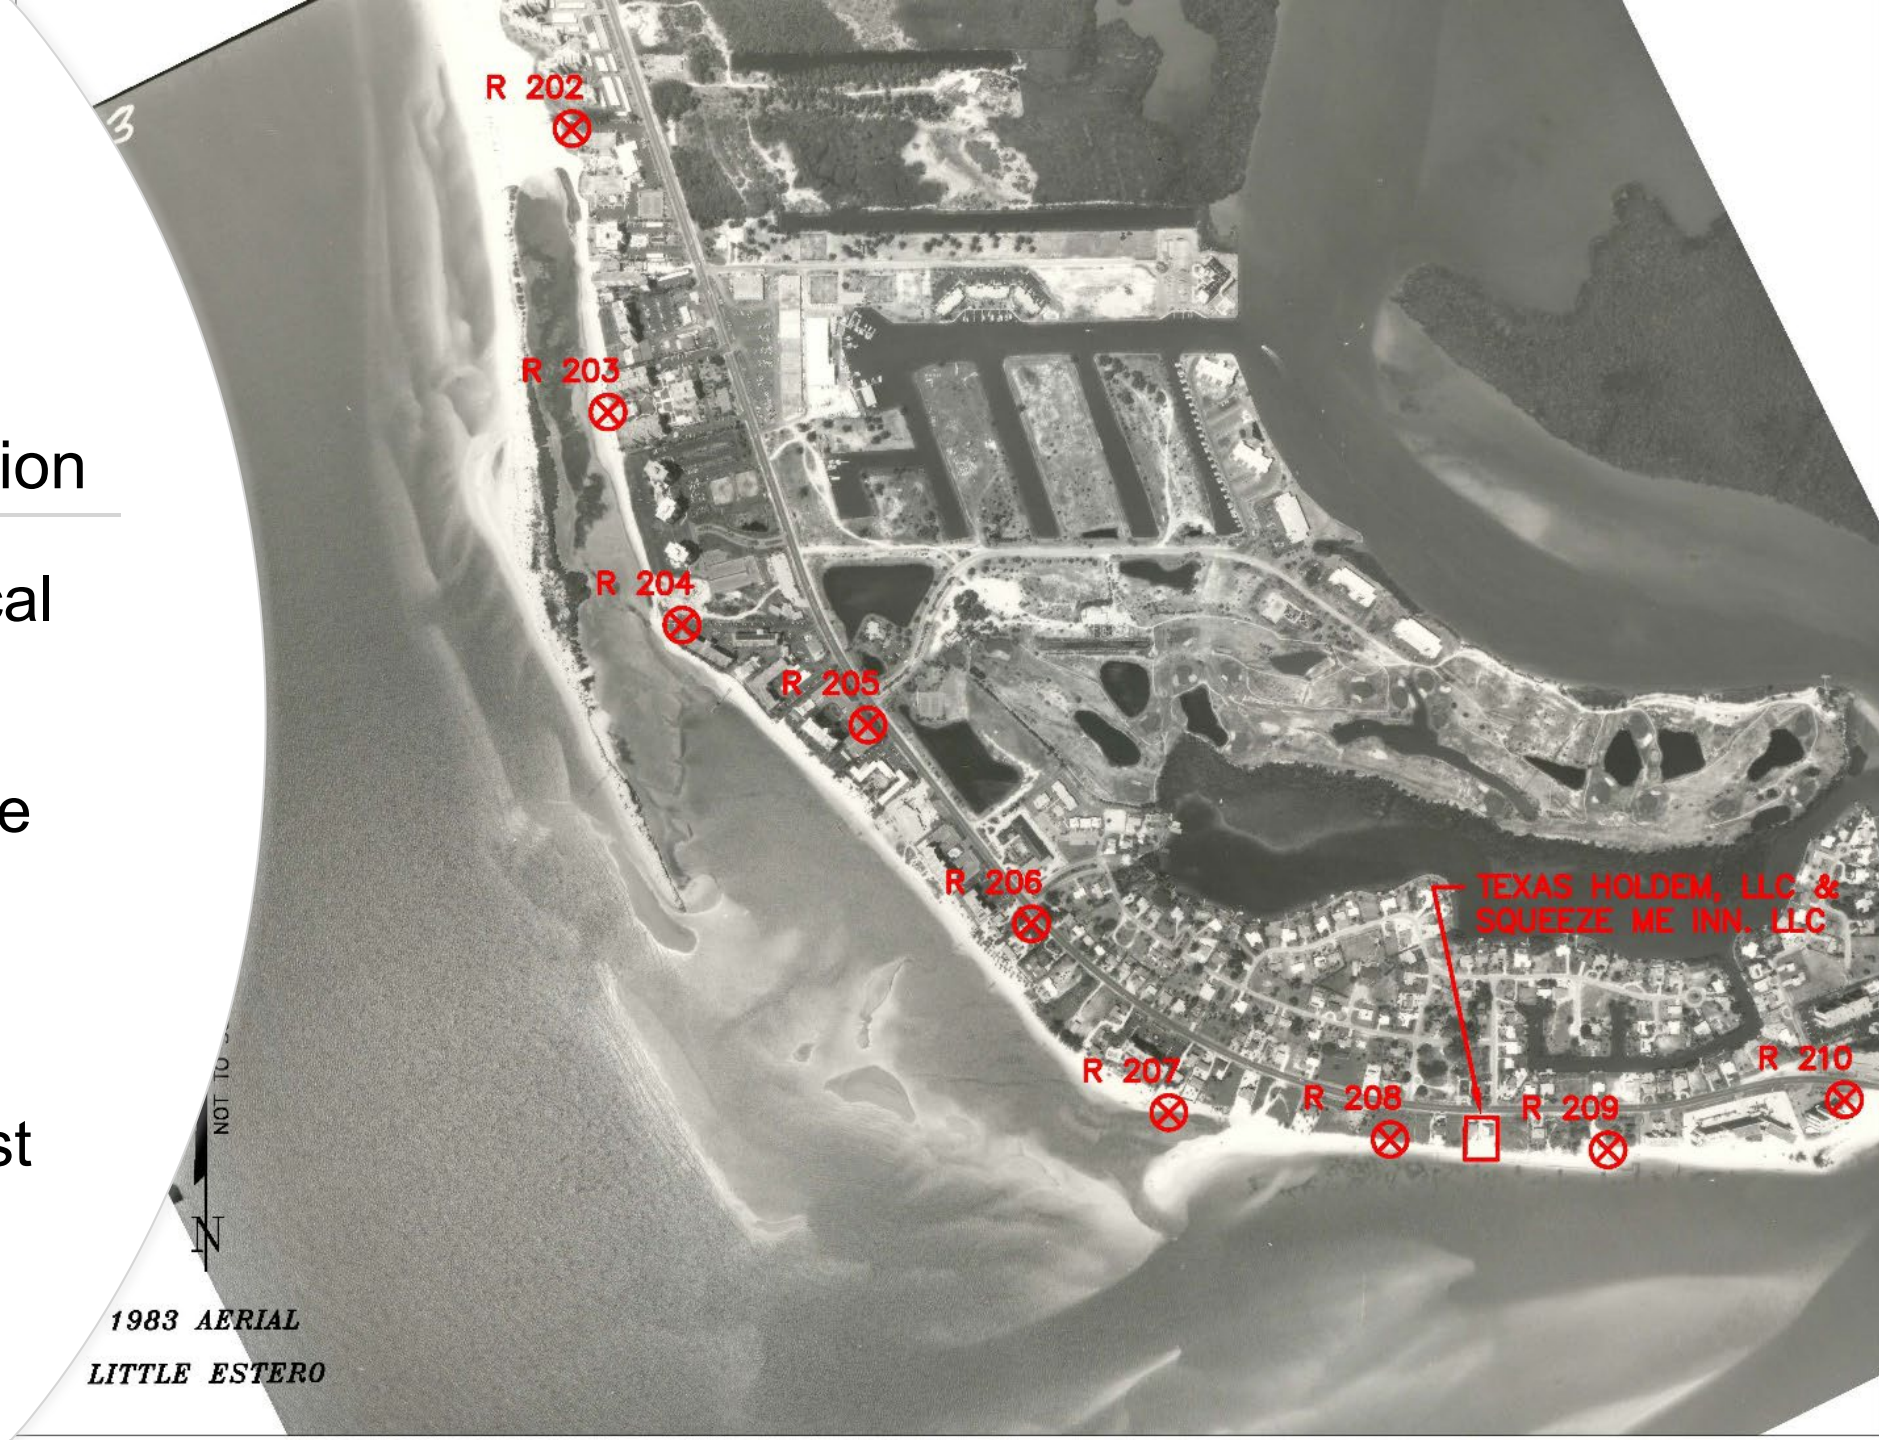
1983 AERIAL
LITTLE ESTERO

1983

Partial dissintegration

June 1982 subtropical storm caused major impacts.

Southern half of Little Estero Island now submerged with remnant swash bar.

Parallel barrier sand bar continues to exist

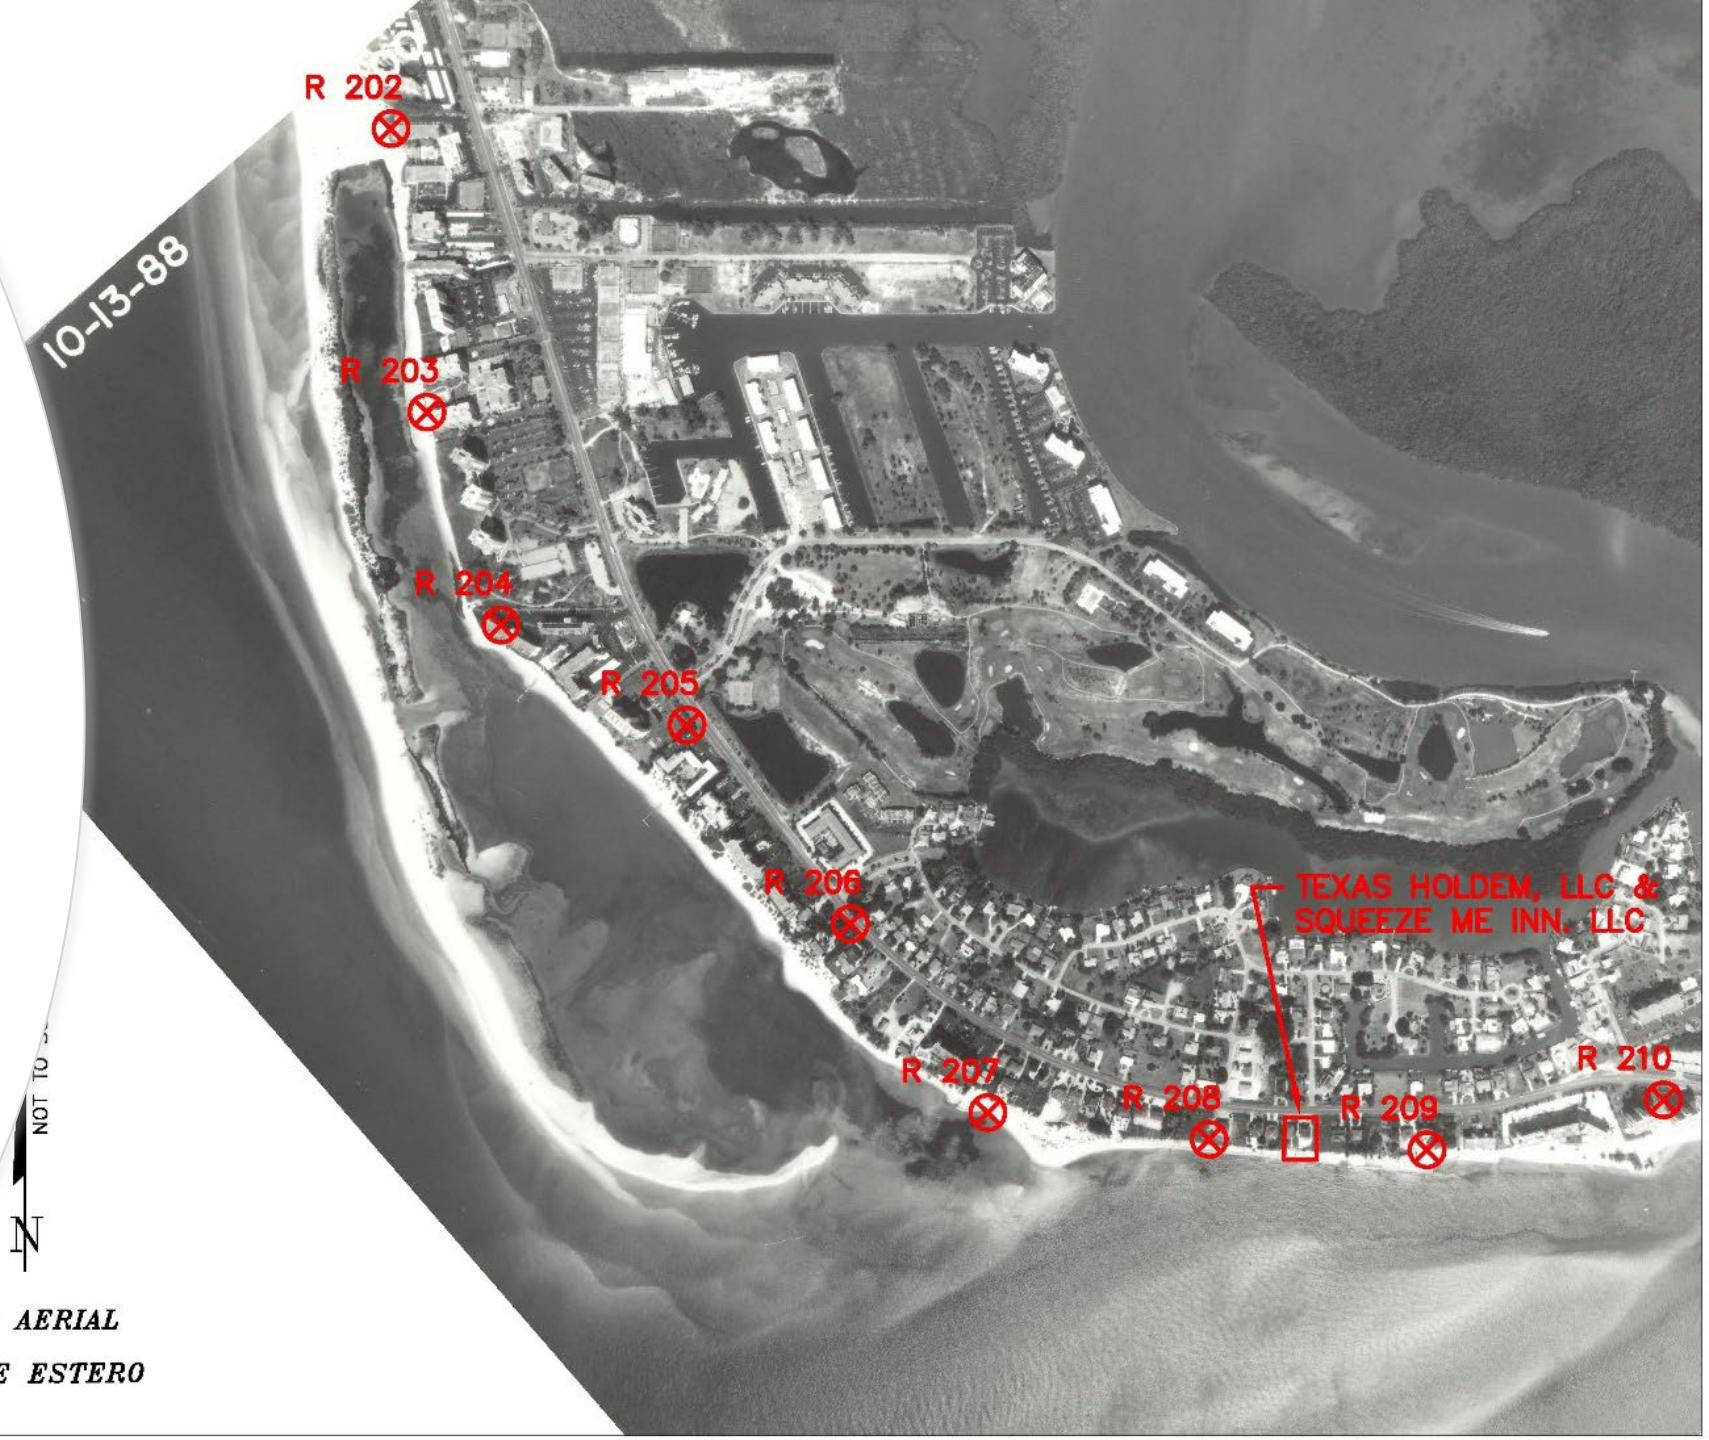
1988 AERIAL
LITTLE ESTERO

1988 Regrowth

Substantial regrowth
along southern half.
Caused by dominant
southward longshore
transport and the
emergence of sandbar.

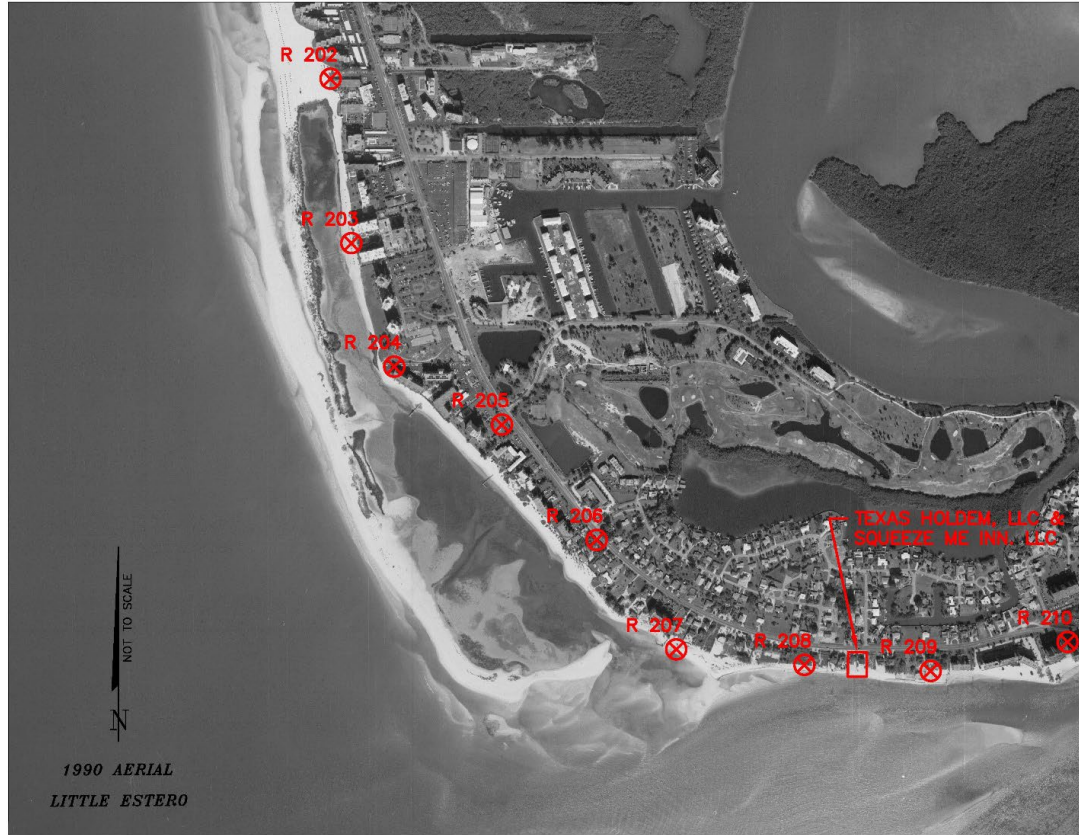
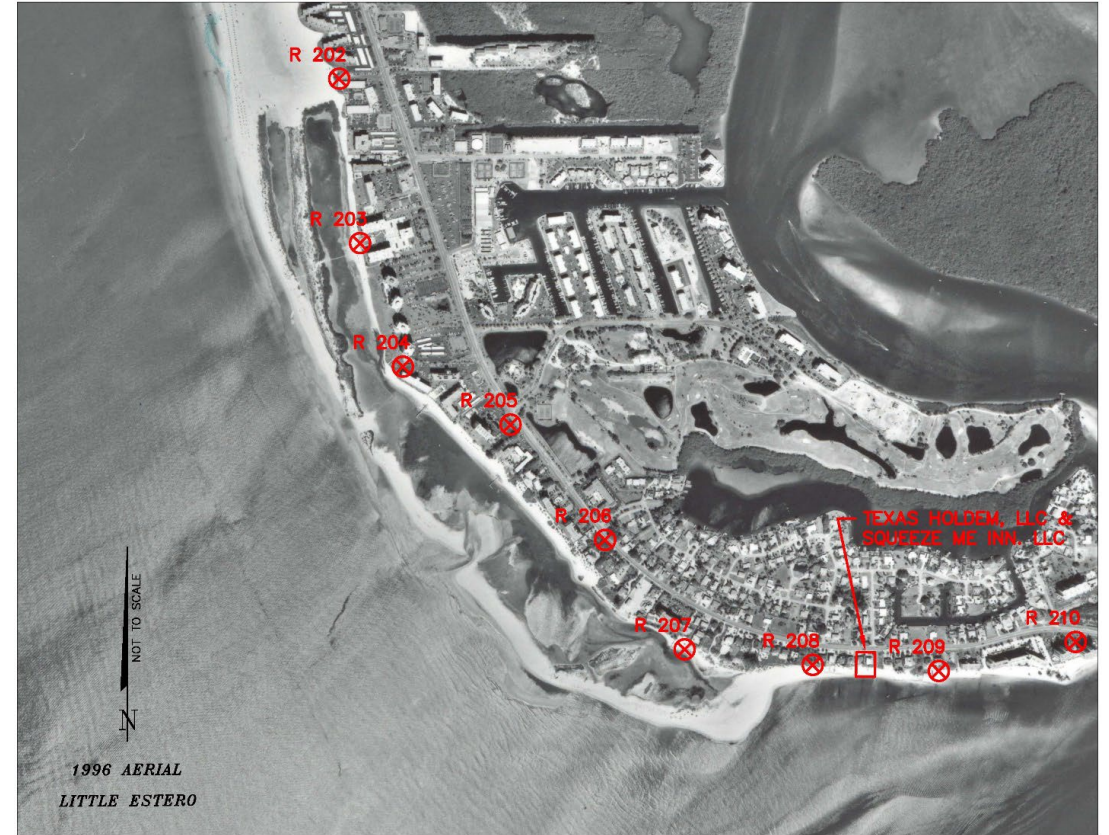
1990

Second prong of growth.

1996

Reattachment at south end.

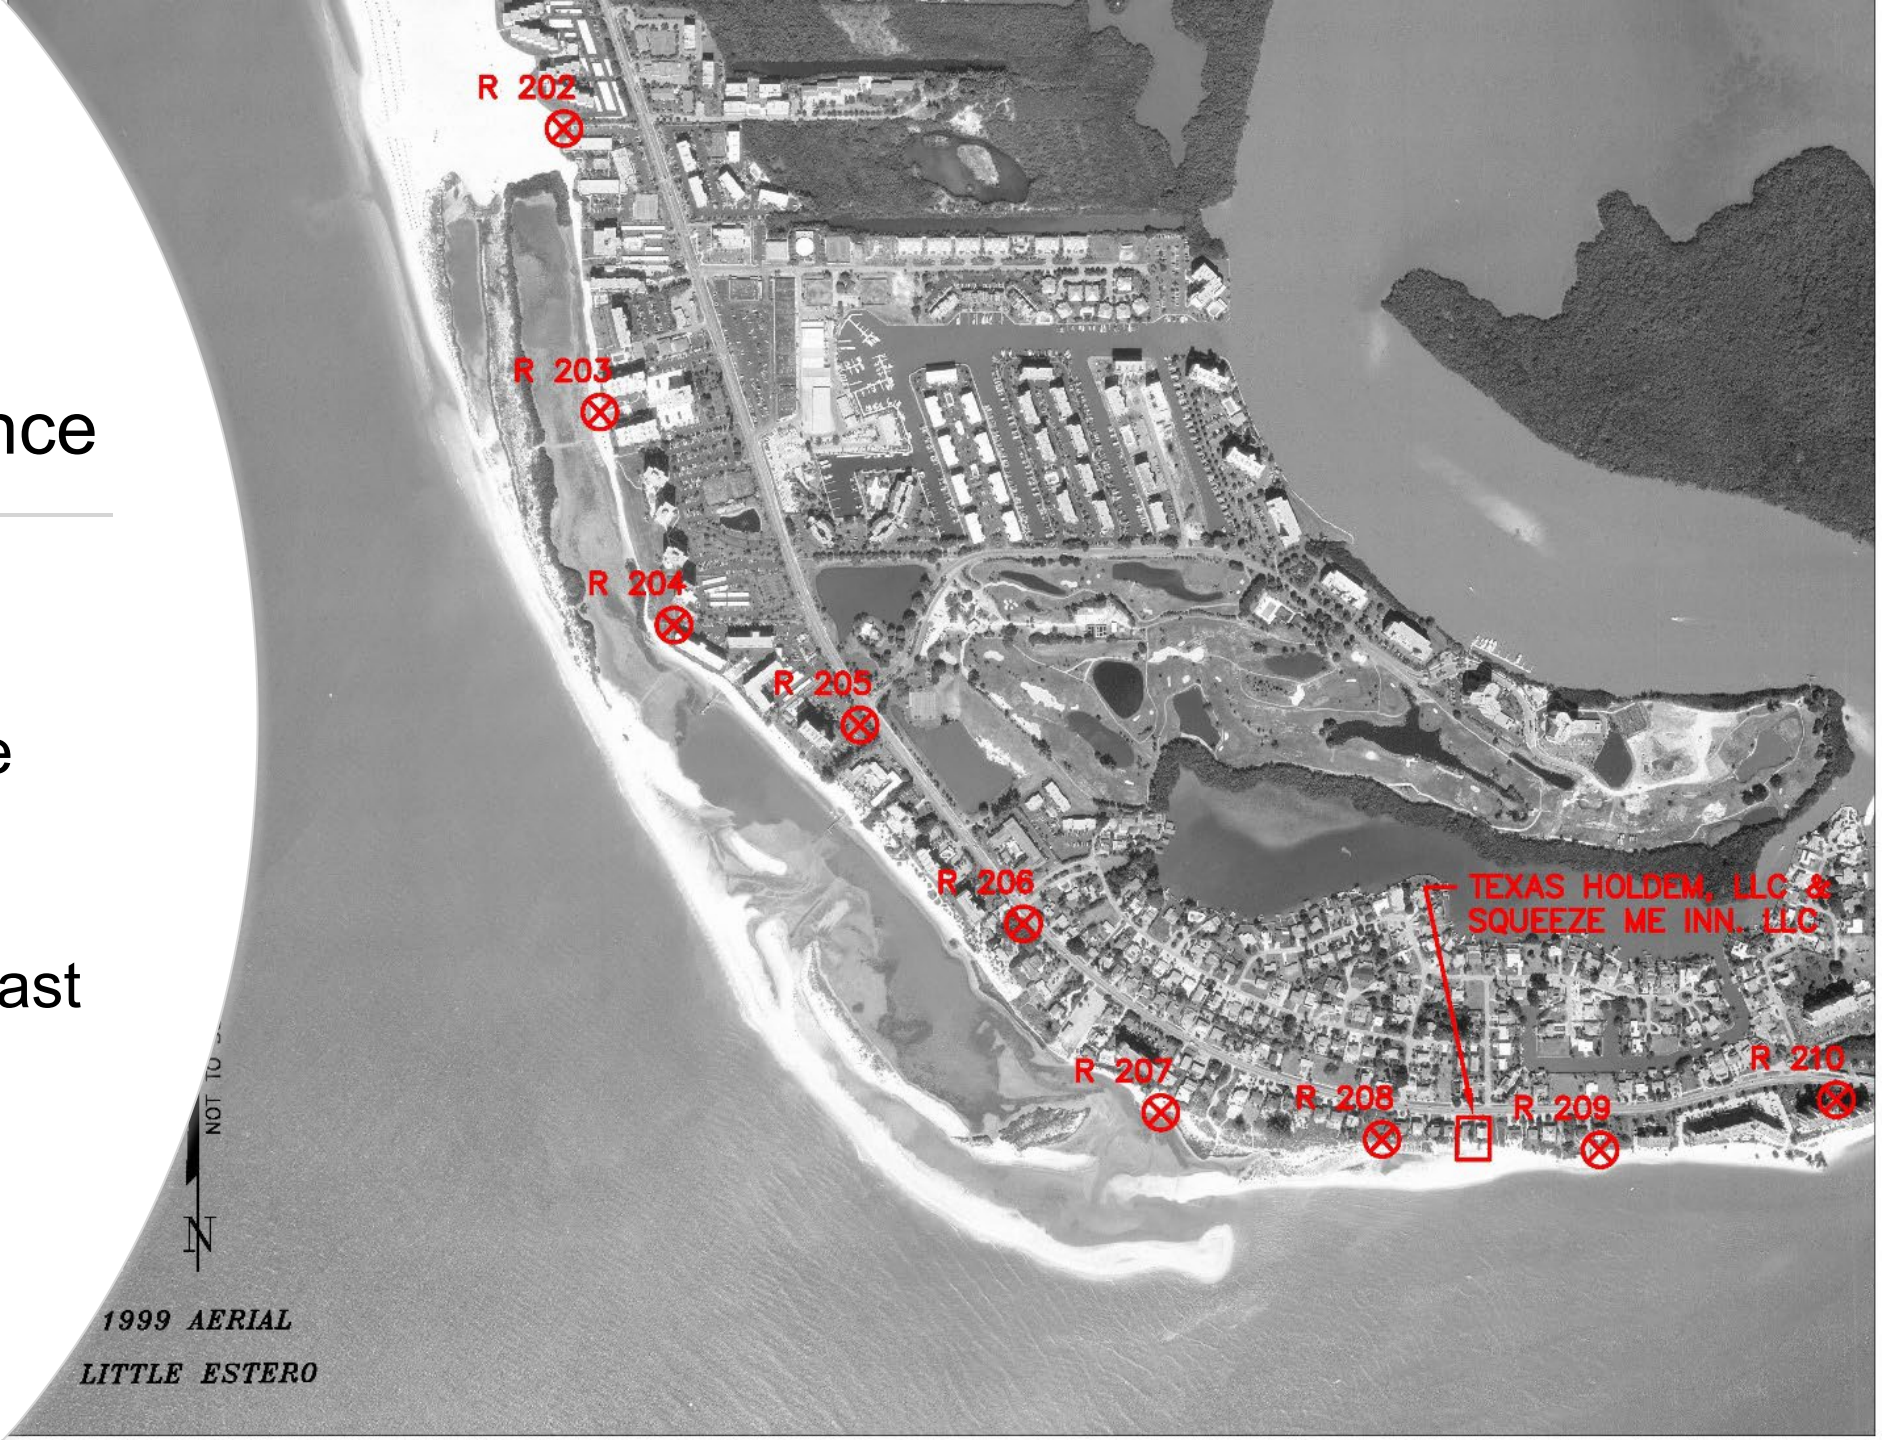
1999 AERIAL
LITTLE ESTERO

1999

New bar emergence

Submerged bar has emerged along southern half of Little Estero.

Attached at middle, growing south and east as barrier spit.

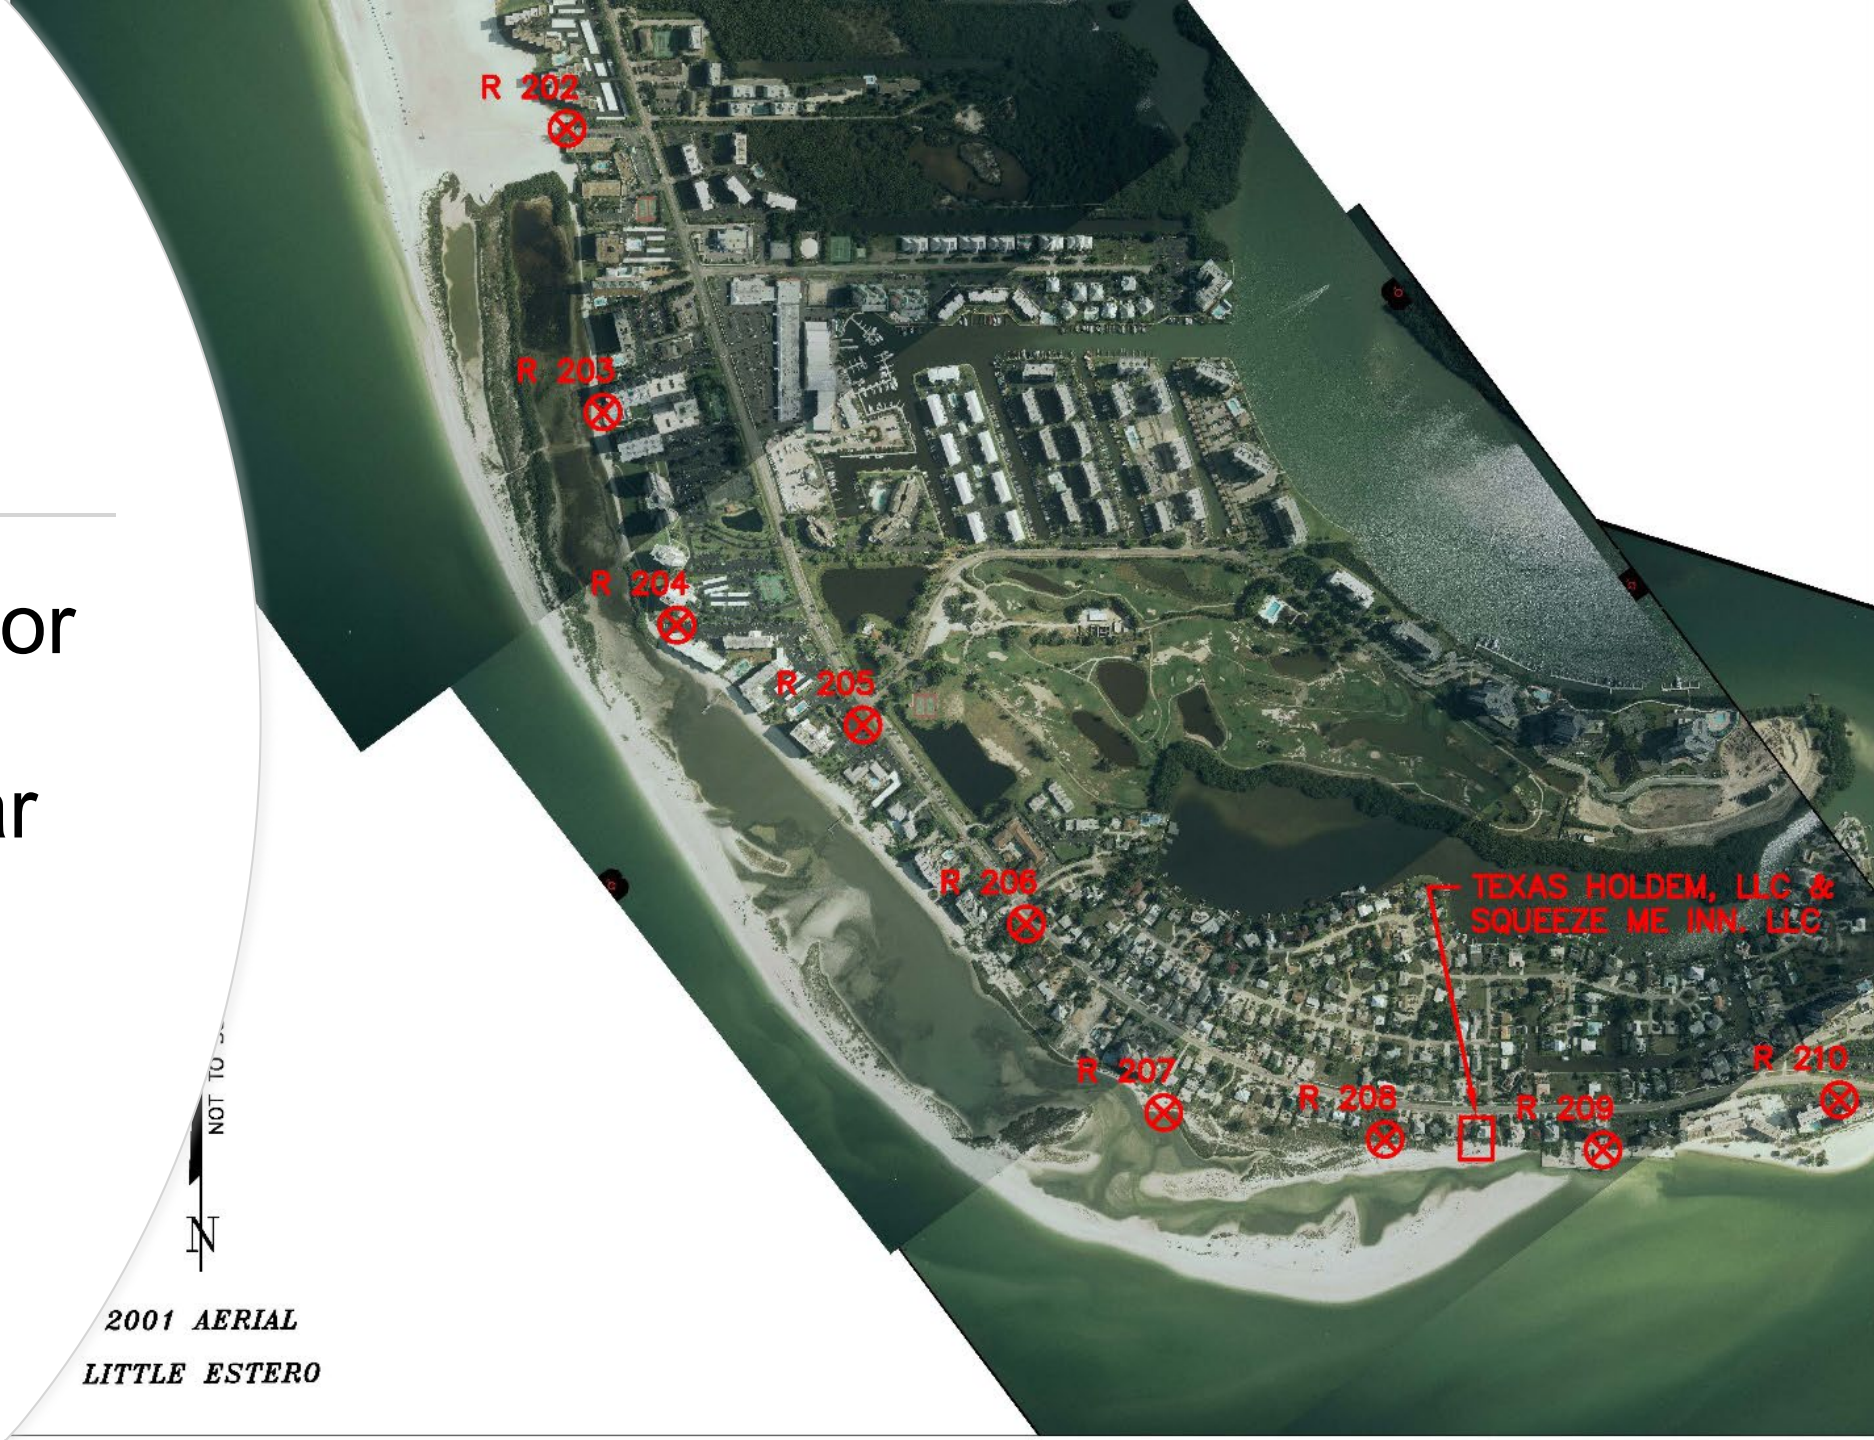
2001 AERIAL
LITTLE ESTERO

2001

Immediately prior
to southern
attachment near
R209.

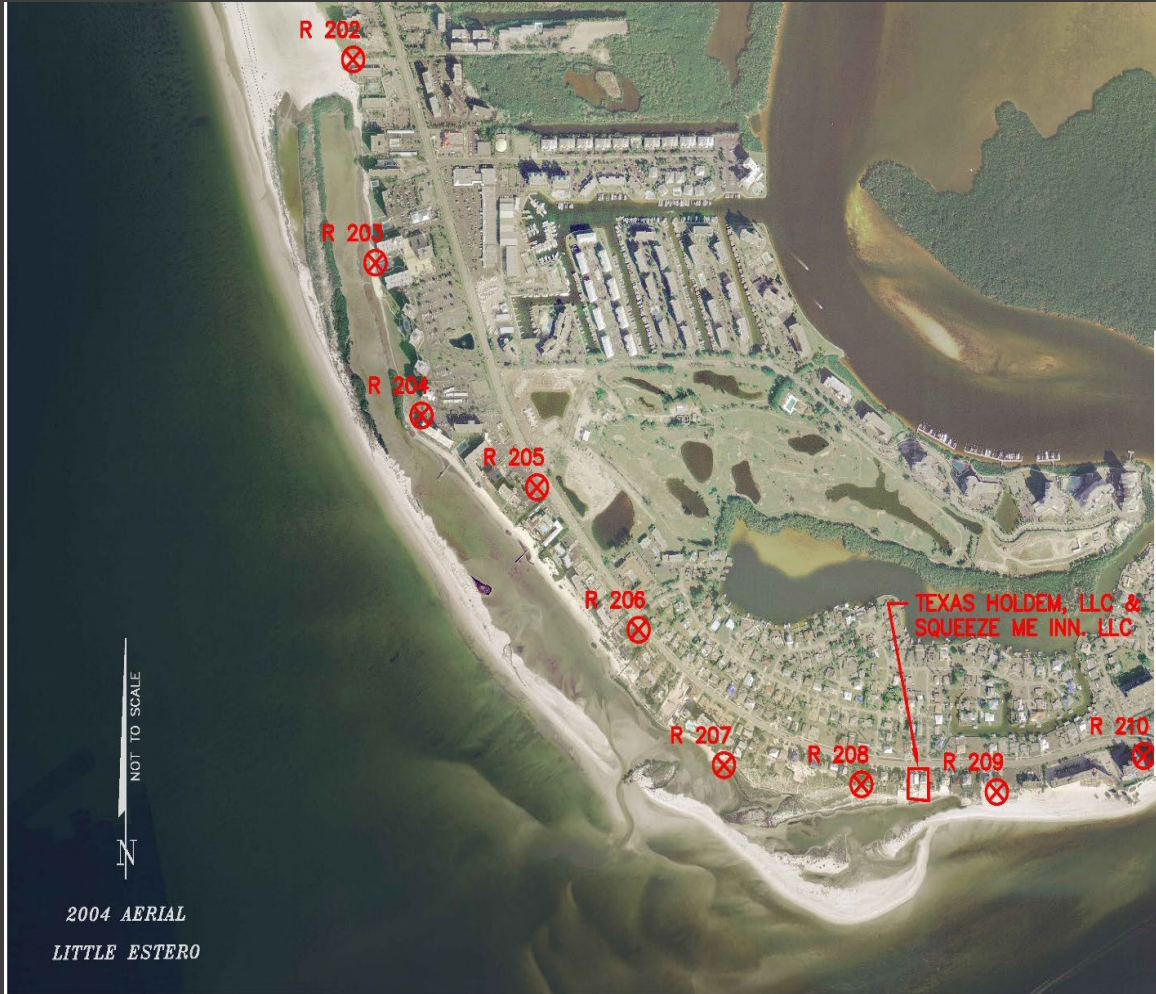
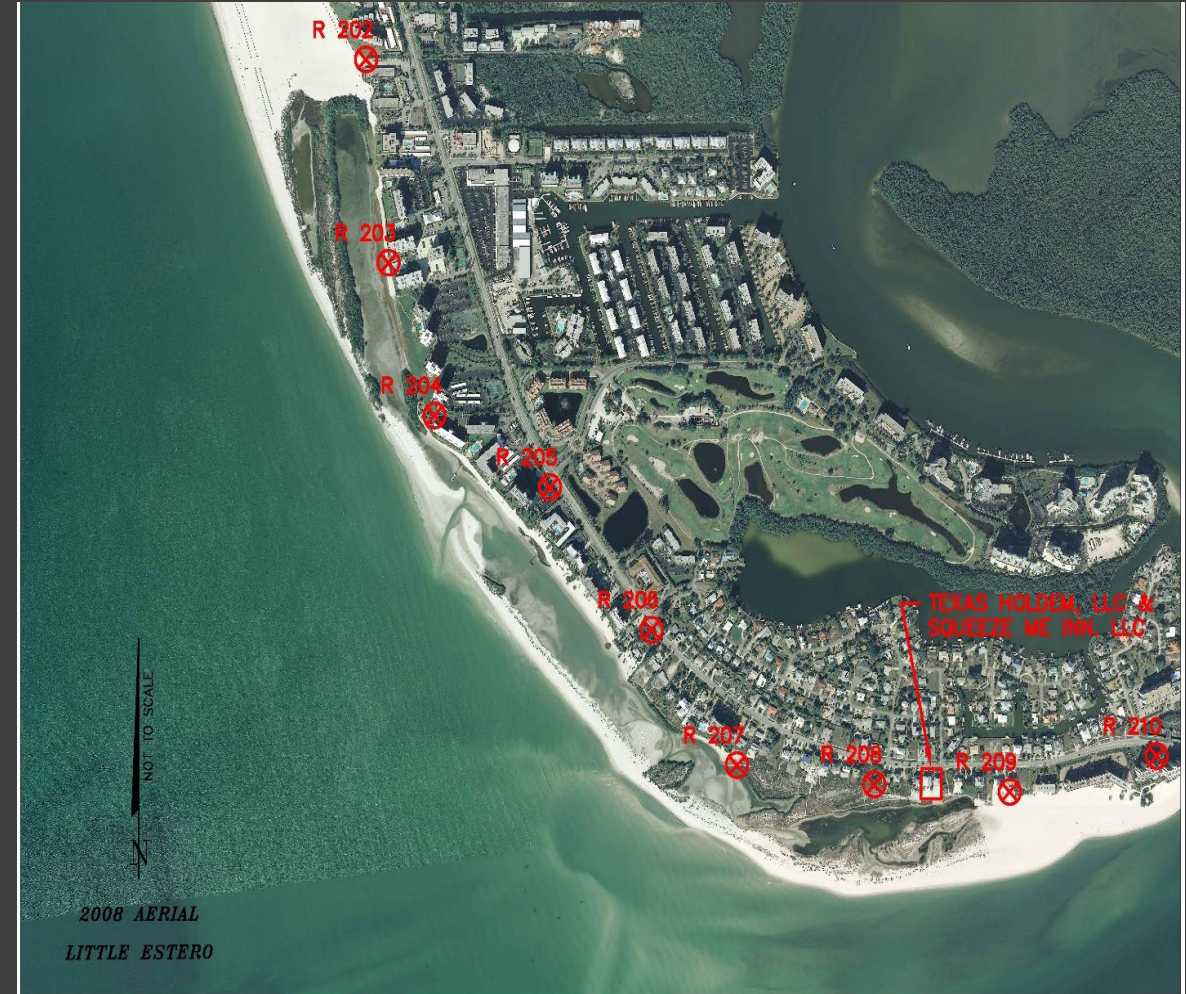
2005 Post-Hurricane Charley.

2008 Landward migration.
