The Morphological Evolution of Little Estero Island

Ralph R. Clark, P.E.

Office of Resilience and Coastal Protection

Feb. 2, 2023

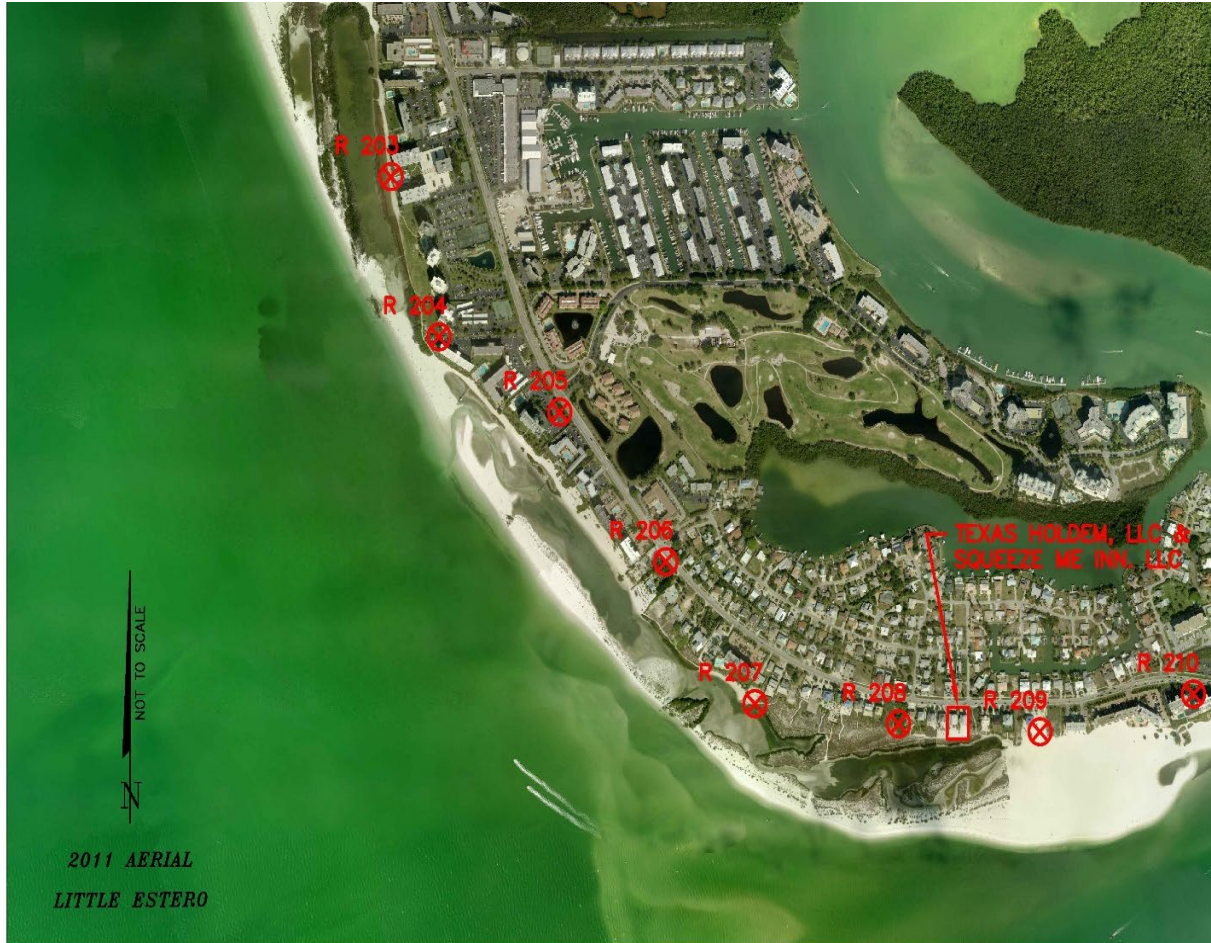
2011

Lagoon truncation.

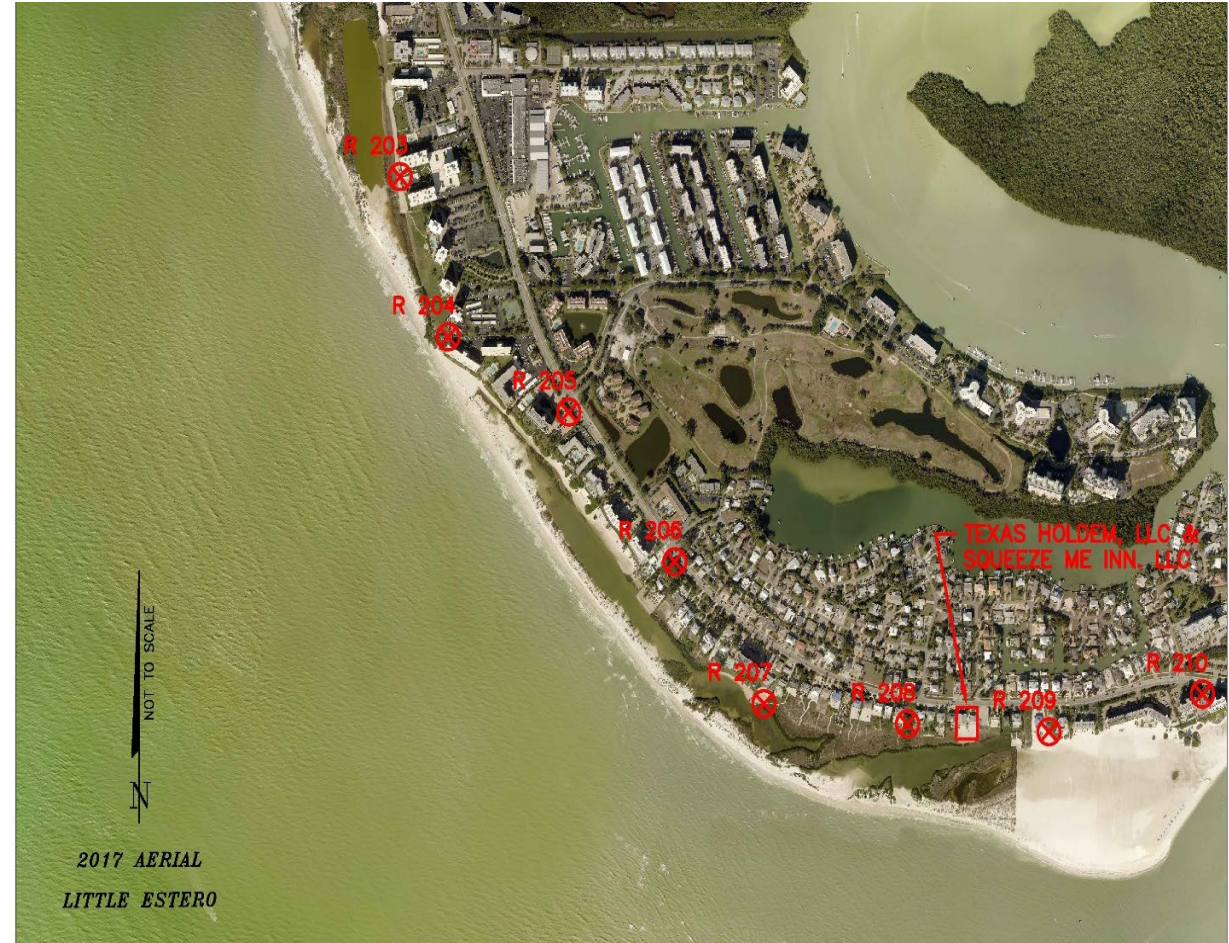
2017

Landward island migration.

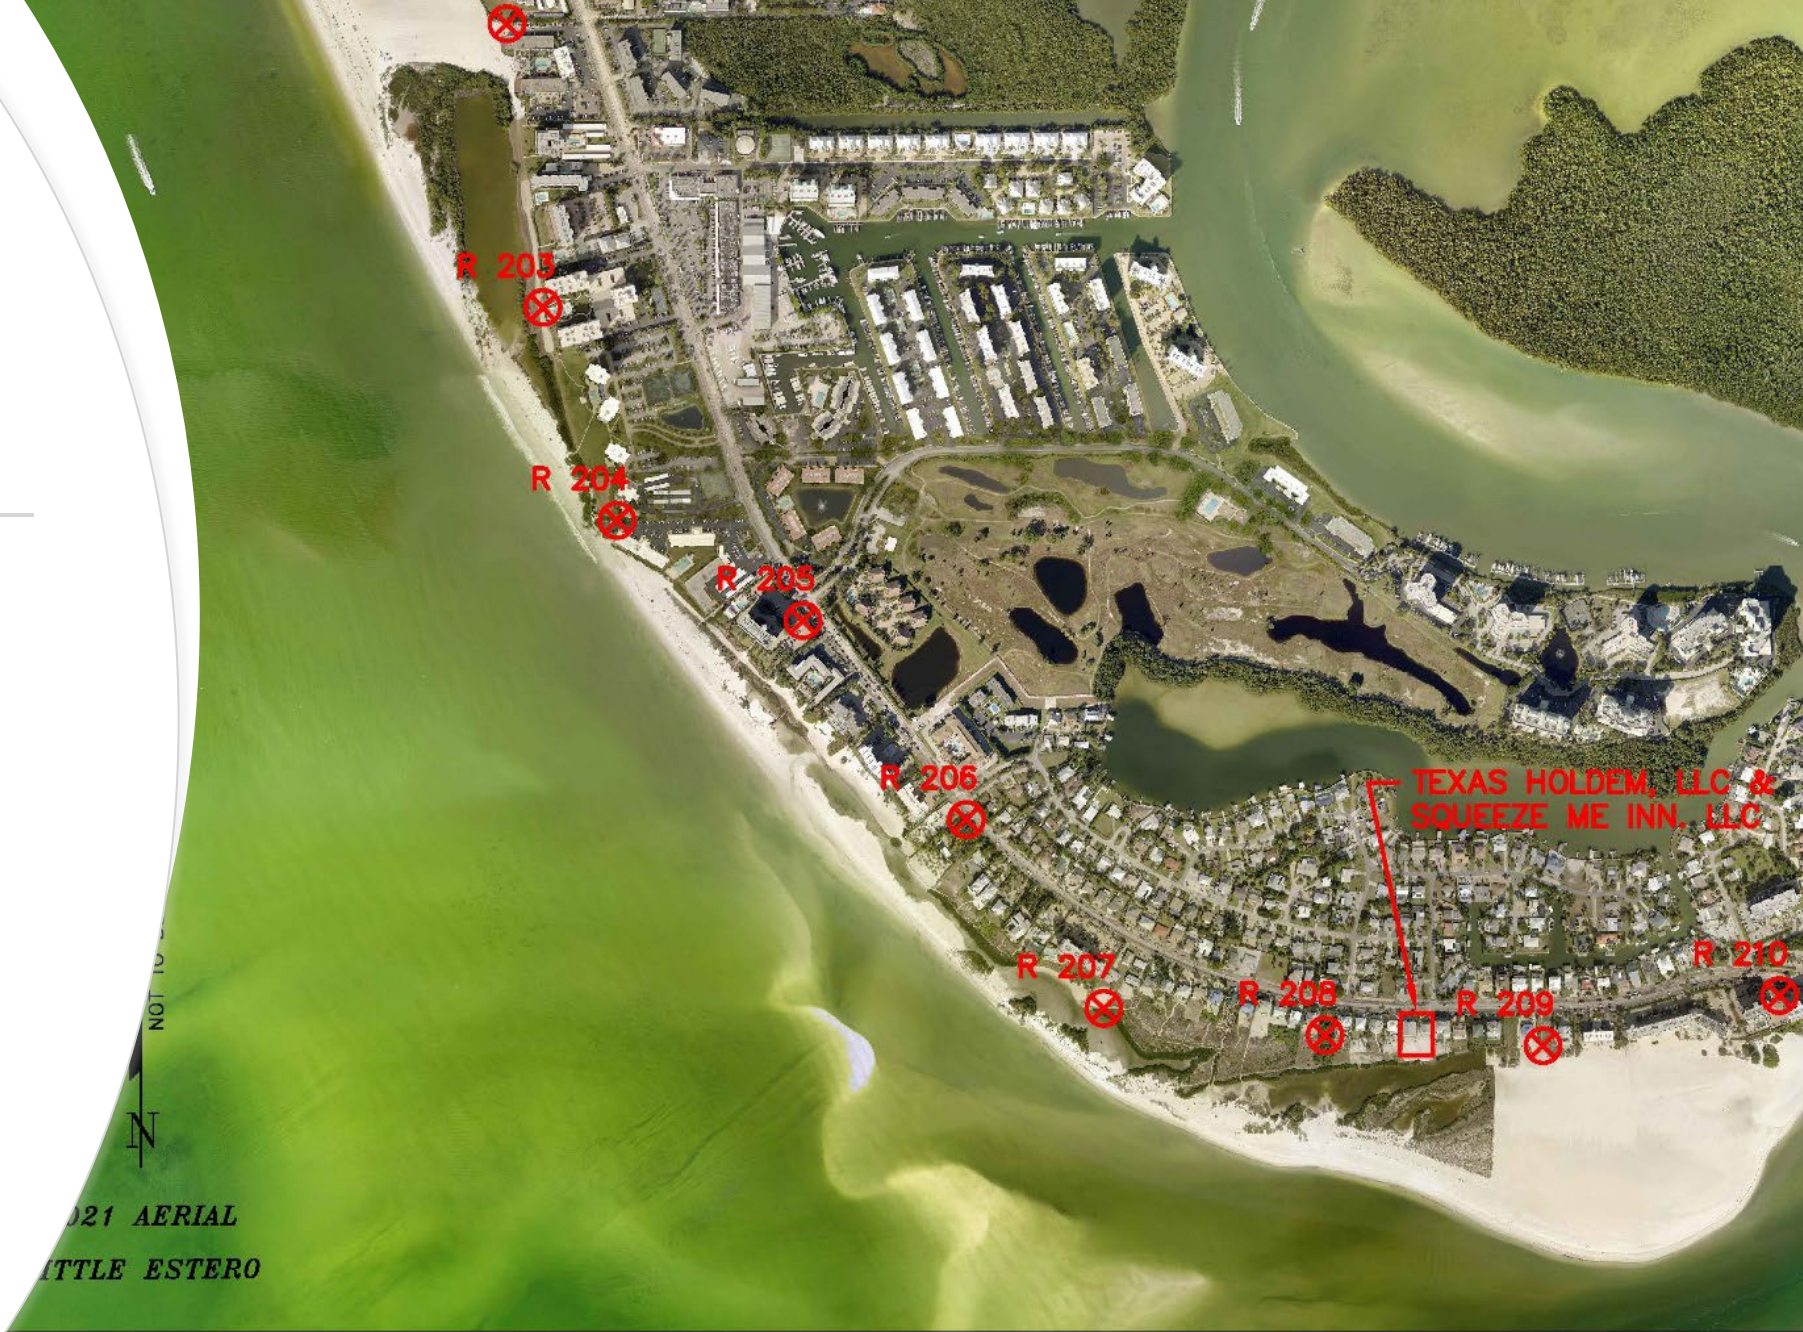
2021
pre-lan

Little Estero
Island and
lagoon
becomes
narrow.
