Captiva Island Coastal Impacts from Hurricane Ian and the Path to Recovery

FSBPA 2023 National Conference on Beach Preservation Technology

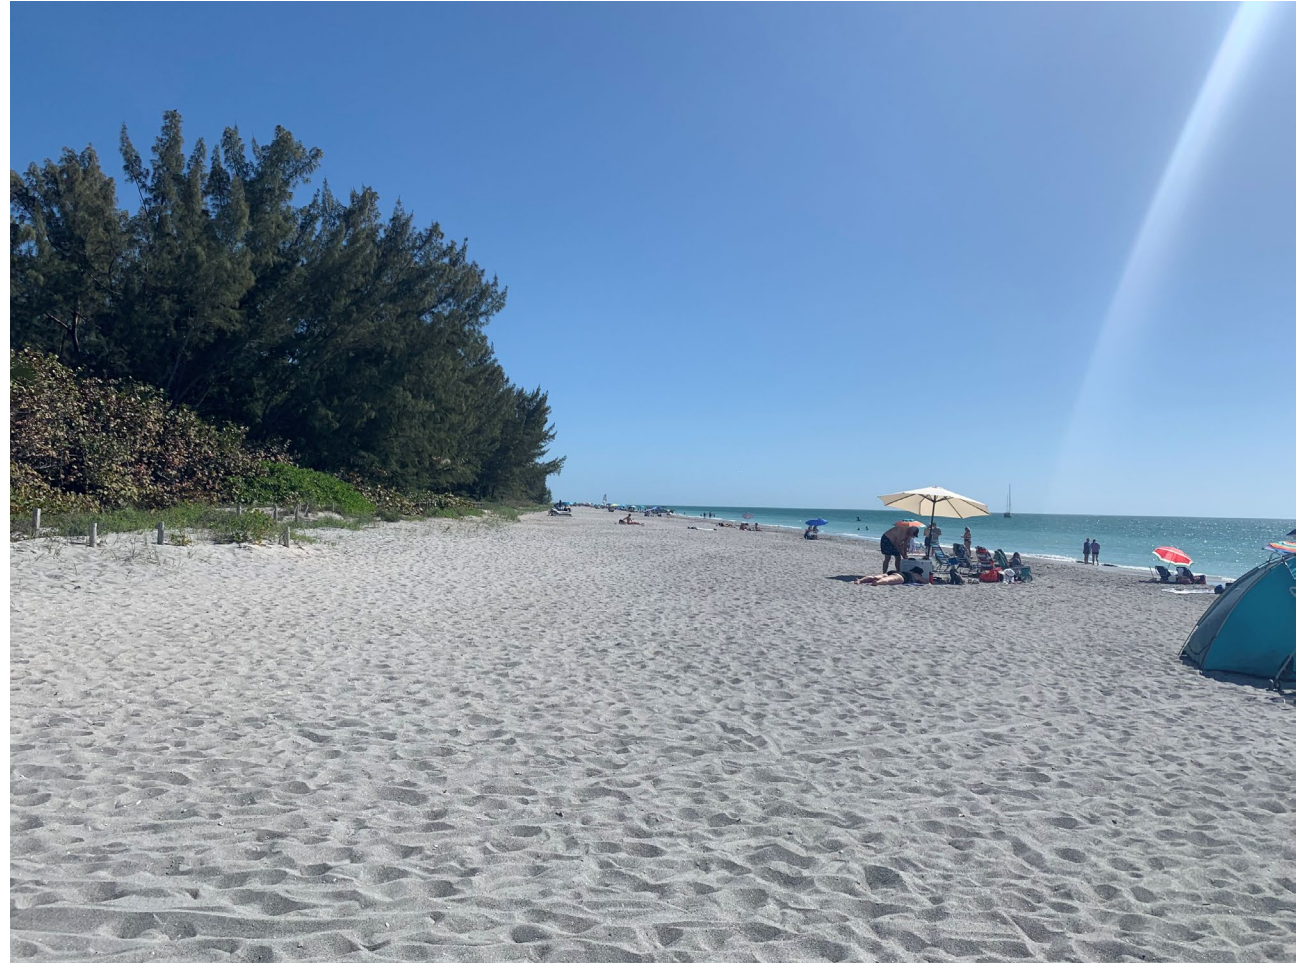
CAPTIVA PROGRAM HISTORY

- ▶ 1981 – 655,000 c.y. at South Seas Resort
 - ▶ Redfish Pass Groin
- ▶ 1988 – 1.6 Million c.y.
 - ▶ Blind Pass Groin
- ▶ 1996 – 821,000 c.y.
- ▶ 2006 – 1,017,000 c.y.
 - ▶ Redfish Pass Groin
- ▶ 2008 – 99,000 c.y.
- ▶ 2013 – 740,000 c.y.
- ▶ 2021 – 845,600 c.y.

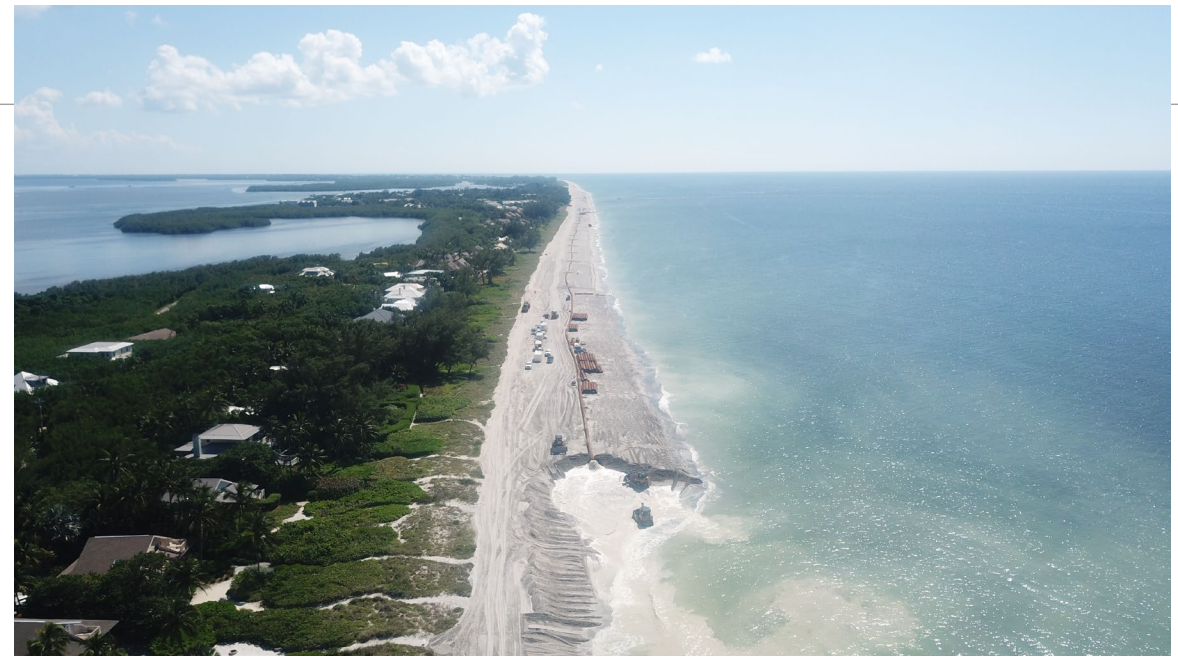
2021 PROJECT RECAP

- ▶ Entire wide island beach renourished
 - ▶ Island-wide dune constructed
- ▶ Designed to address background erosion and traditional hotspot areas
- ▶ Higher and wider beach to account for sea level rise
- ▶ Constructed between September 1, 2021 and November 9, 2021
- ▶ Fill template with minimal impacts pre-lan

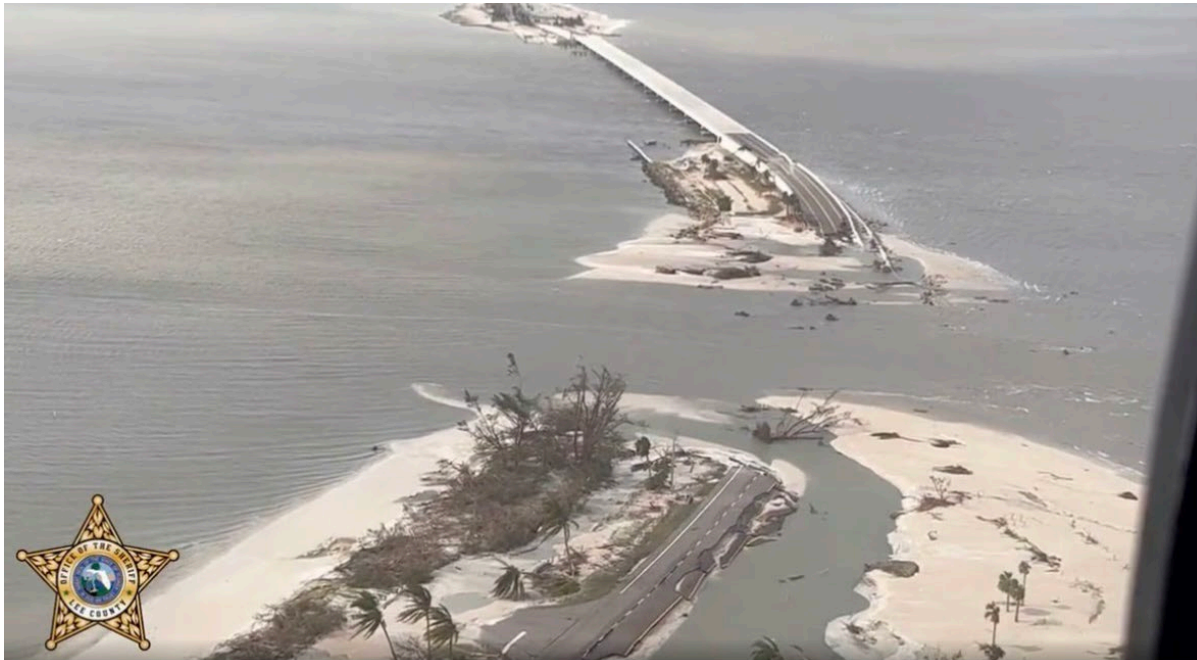
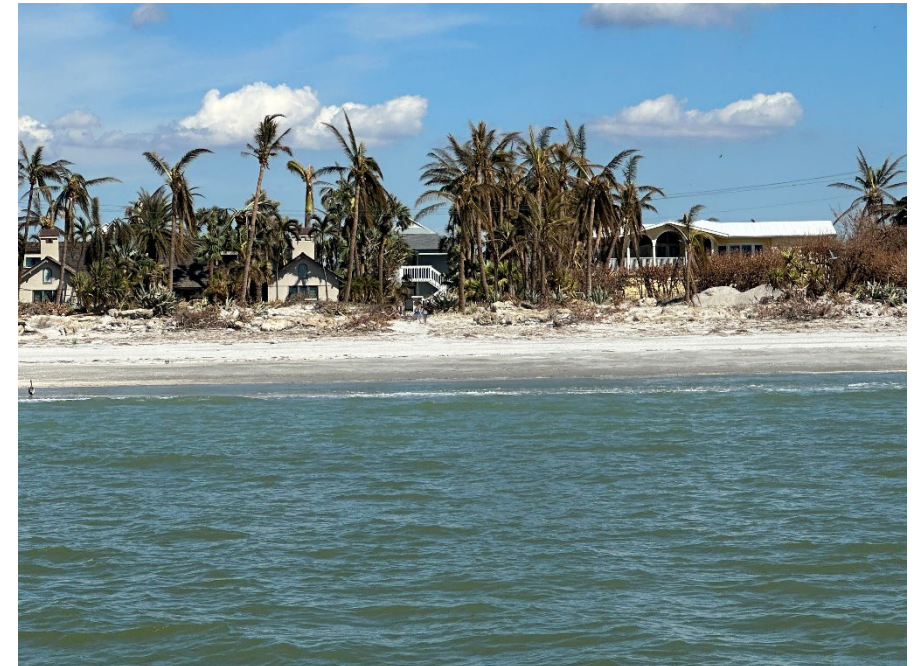
SAND OVERWASH

- ▶ Challenge: Clearing the roadway while remediating debris to salvage as much sand as possible.
- ▶ Solution: Lee County DOT stepped in and cleared the roadways as efficiently as possible. The sand was cleared of debris and returned to the dune area.
- ▶ Challenge: Overwash sand on private property.
- ▶ Solution: Communication to property owners on how to obtain a permit from FDEP to return the sand to the beach.

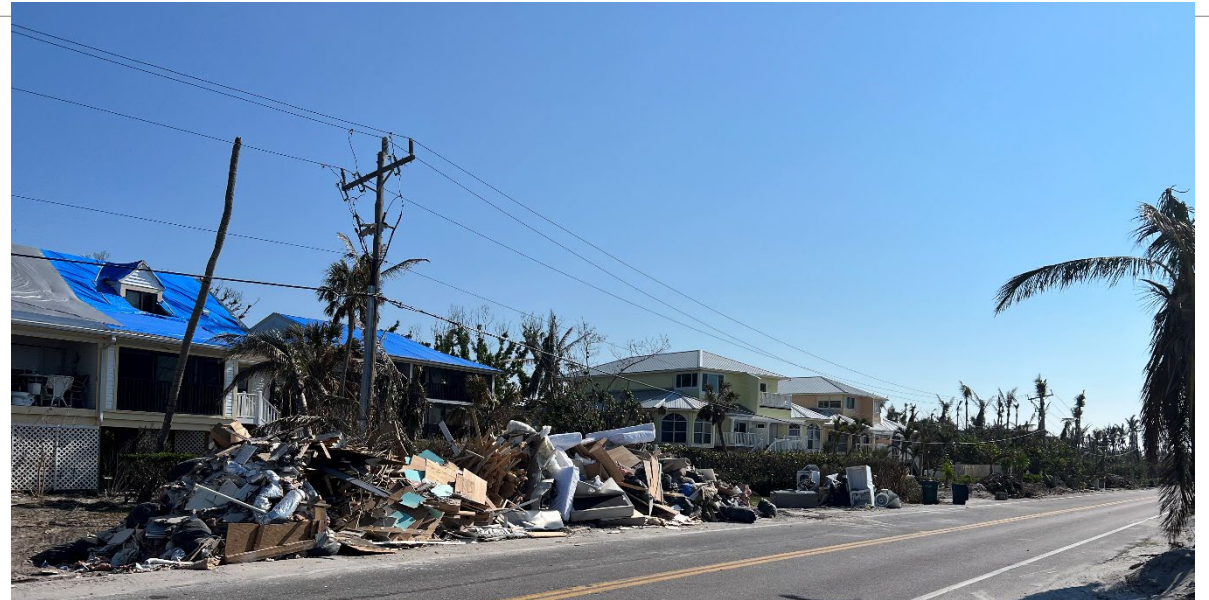
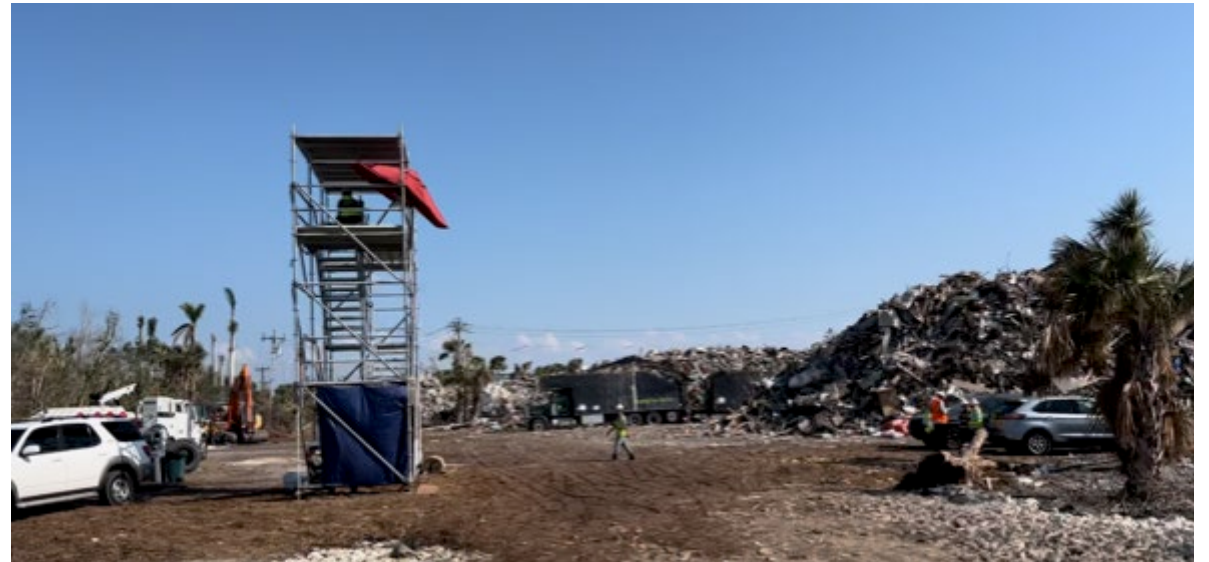
PHASE 1 – VISUAL ASSESSMENT

- ▶ 5 days after passage (October 3, 2022)
- ▶ Lack of accessible waterfront infrastructure
- ▶ Utilized functioning ramp in Charlotte County
 - ▶ Thanks Lee and Charlotte Counties for the collaboration 😊
- ▶ CEPD, SCCF, and Corps staff

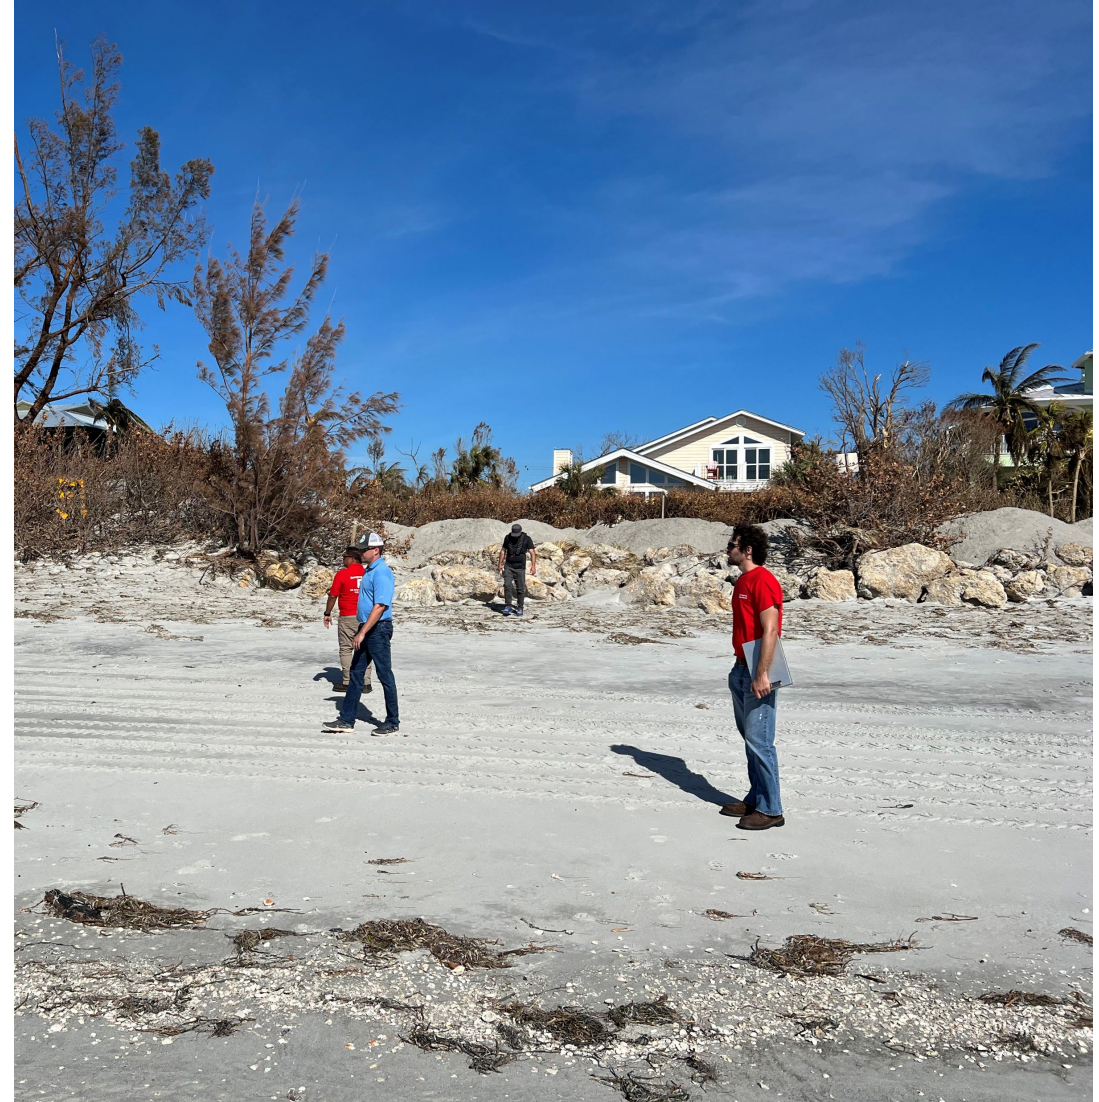
PHASE 1 – VISUAL ASSESSMENT

- ▶ Beach width and volume changes
- ▶ General observations:
 - ▶ Volume loss
 - ▶ Beach width loss
 - ▶ Beach elevation lowered
 - ▶ Sand bars
 - ▶ Dune impacts
 - ▶ Loss of vegetation
 - ▶ More losses mid- and south-end of Island

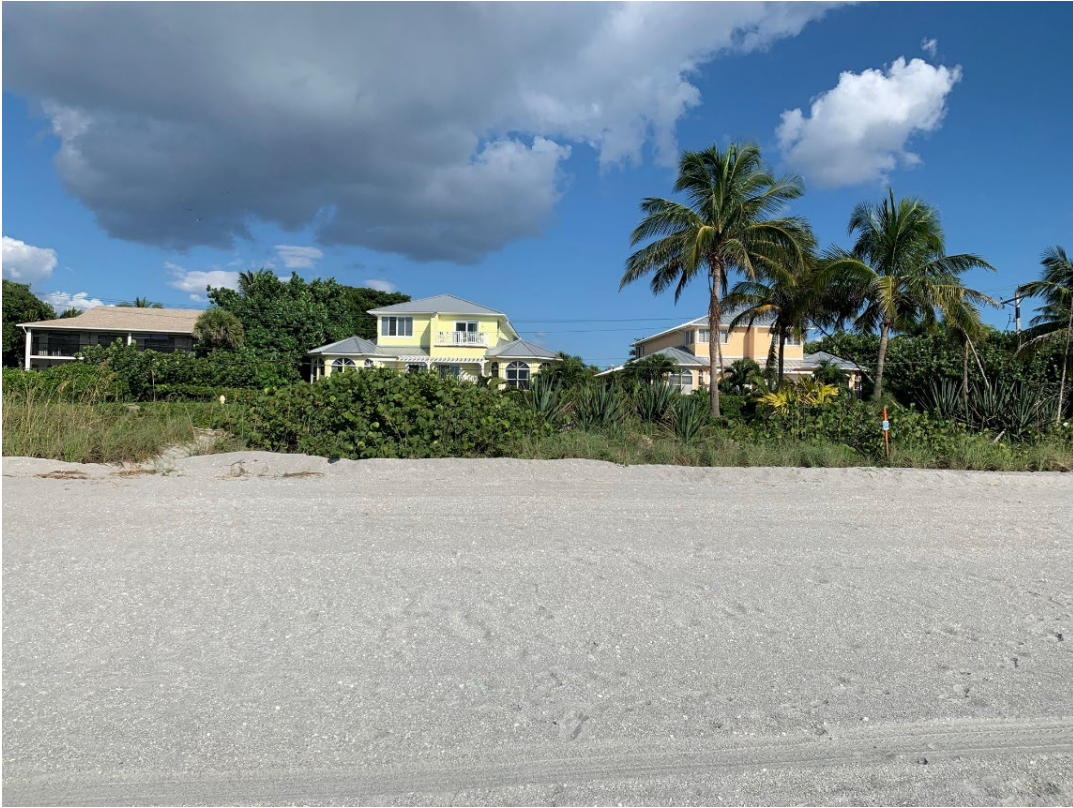
October 2021

BEACH PERFORMANCE

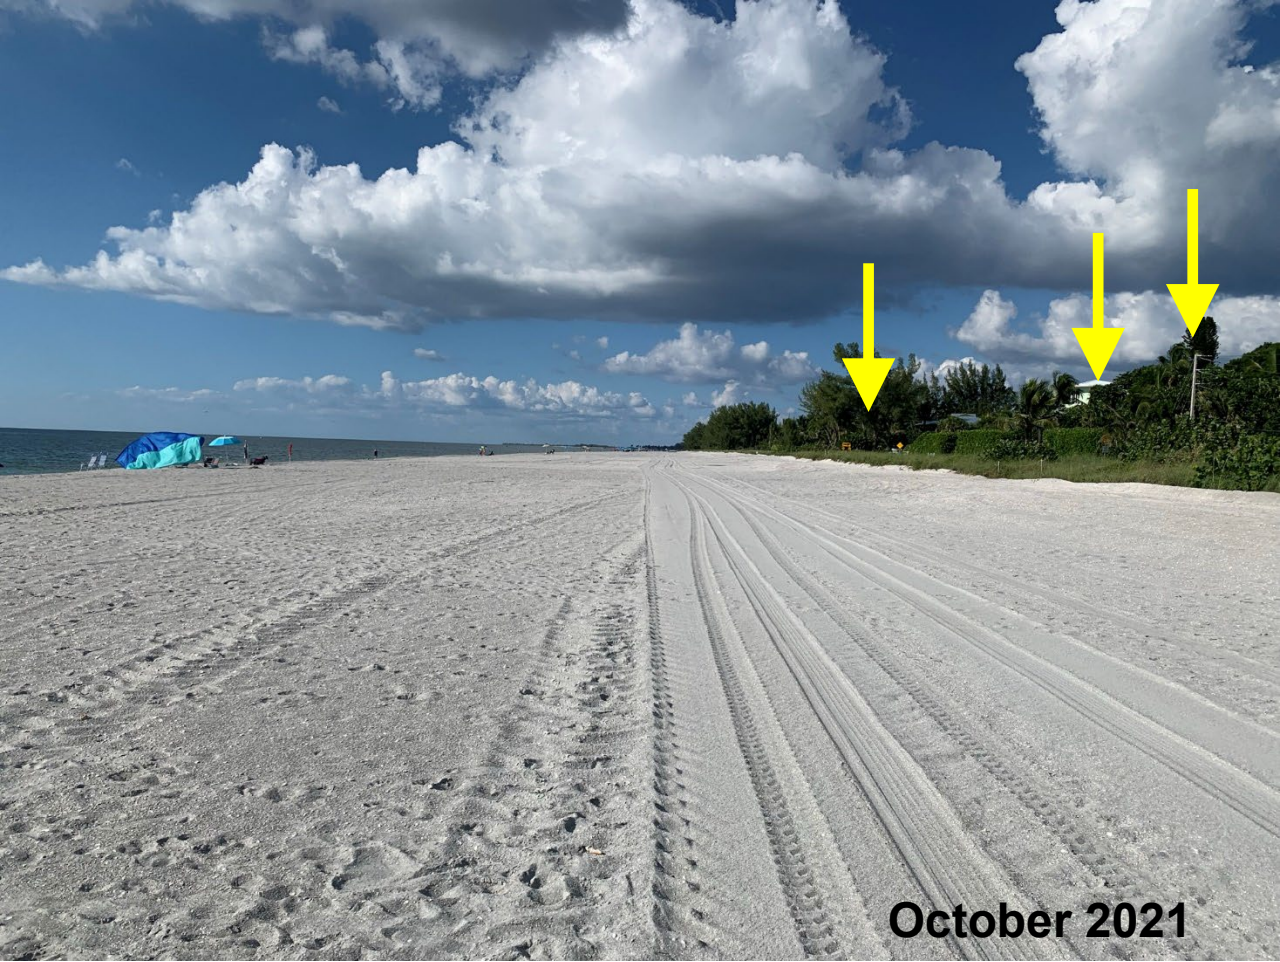
October 2021

BEACH PERFORMANCE

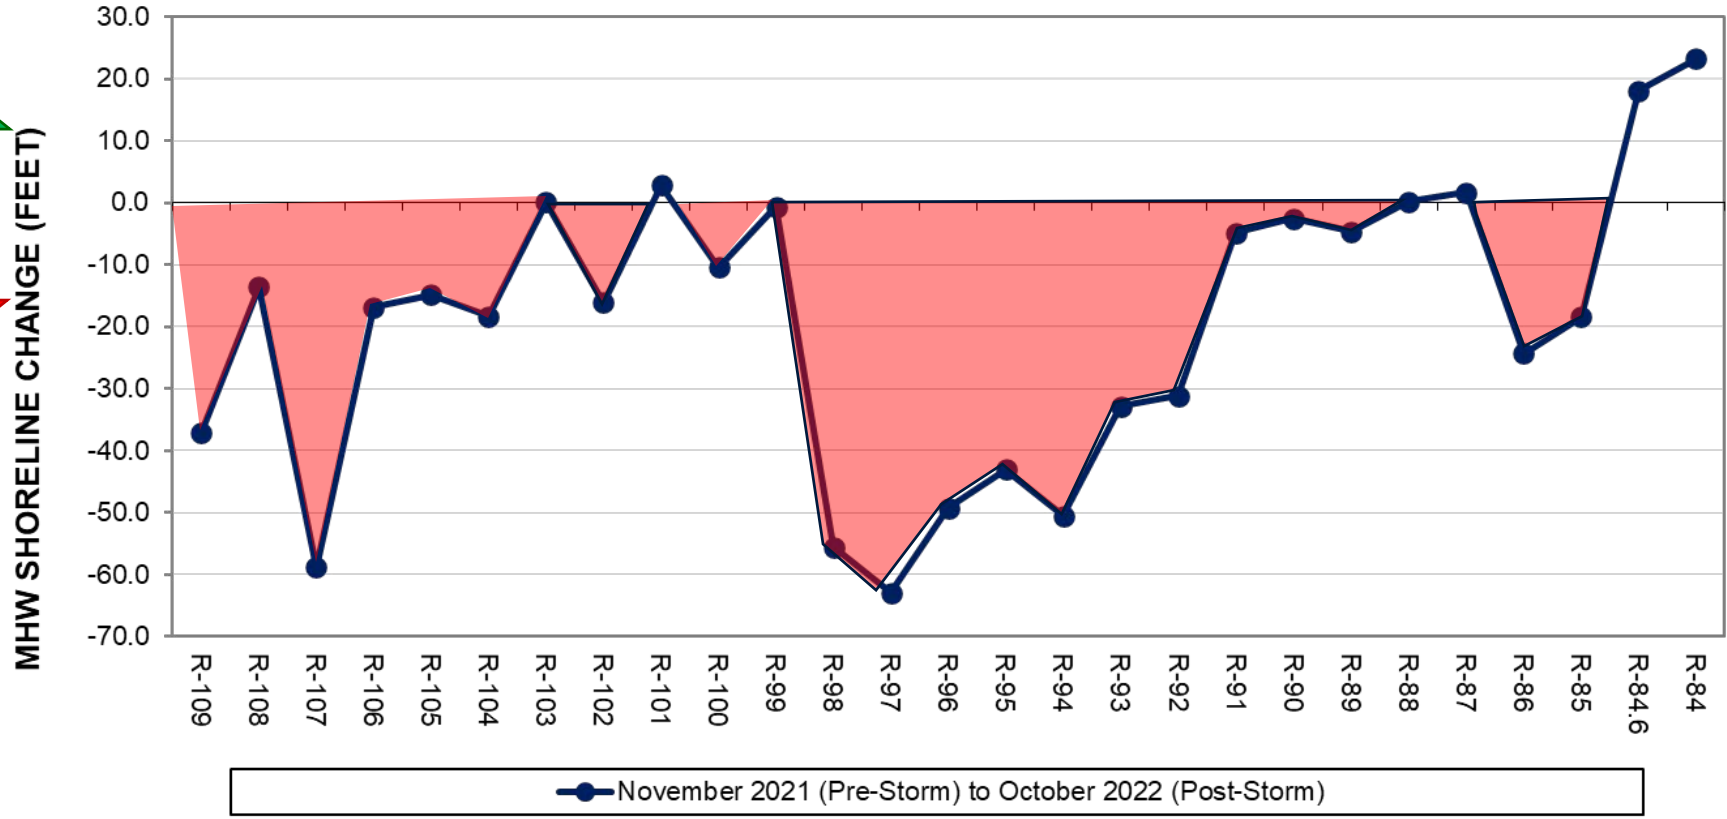
SHORELINE CHANGE

- ▶ MHW = 0.28 ft-NAVD
- ▶ Avg. loss = -19.3 ft
- ▶ Largest loss of 58.8 ft at R-107

FDEP R-Monuments

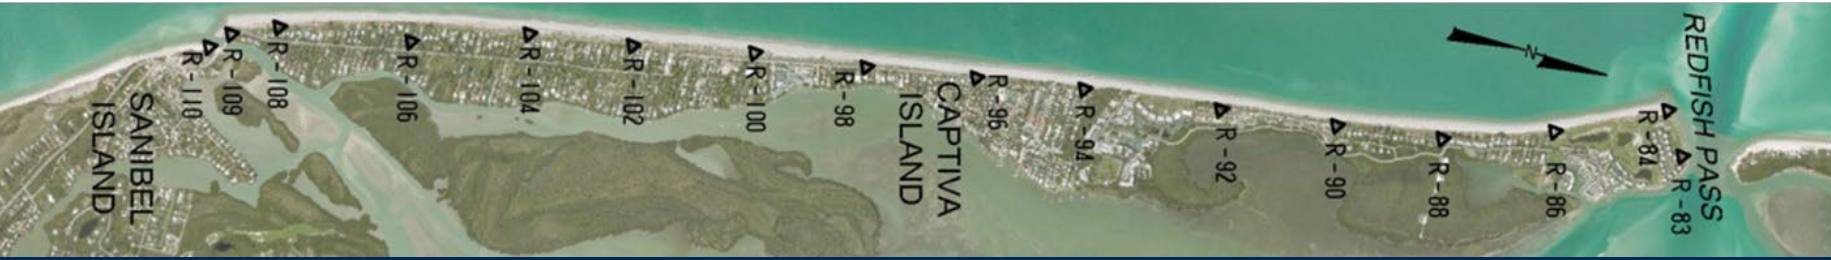
VOLUME CHANGE

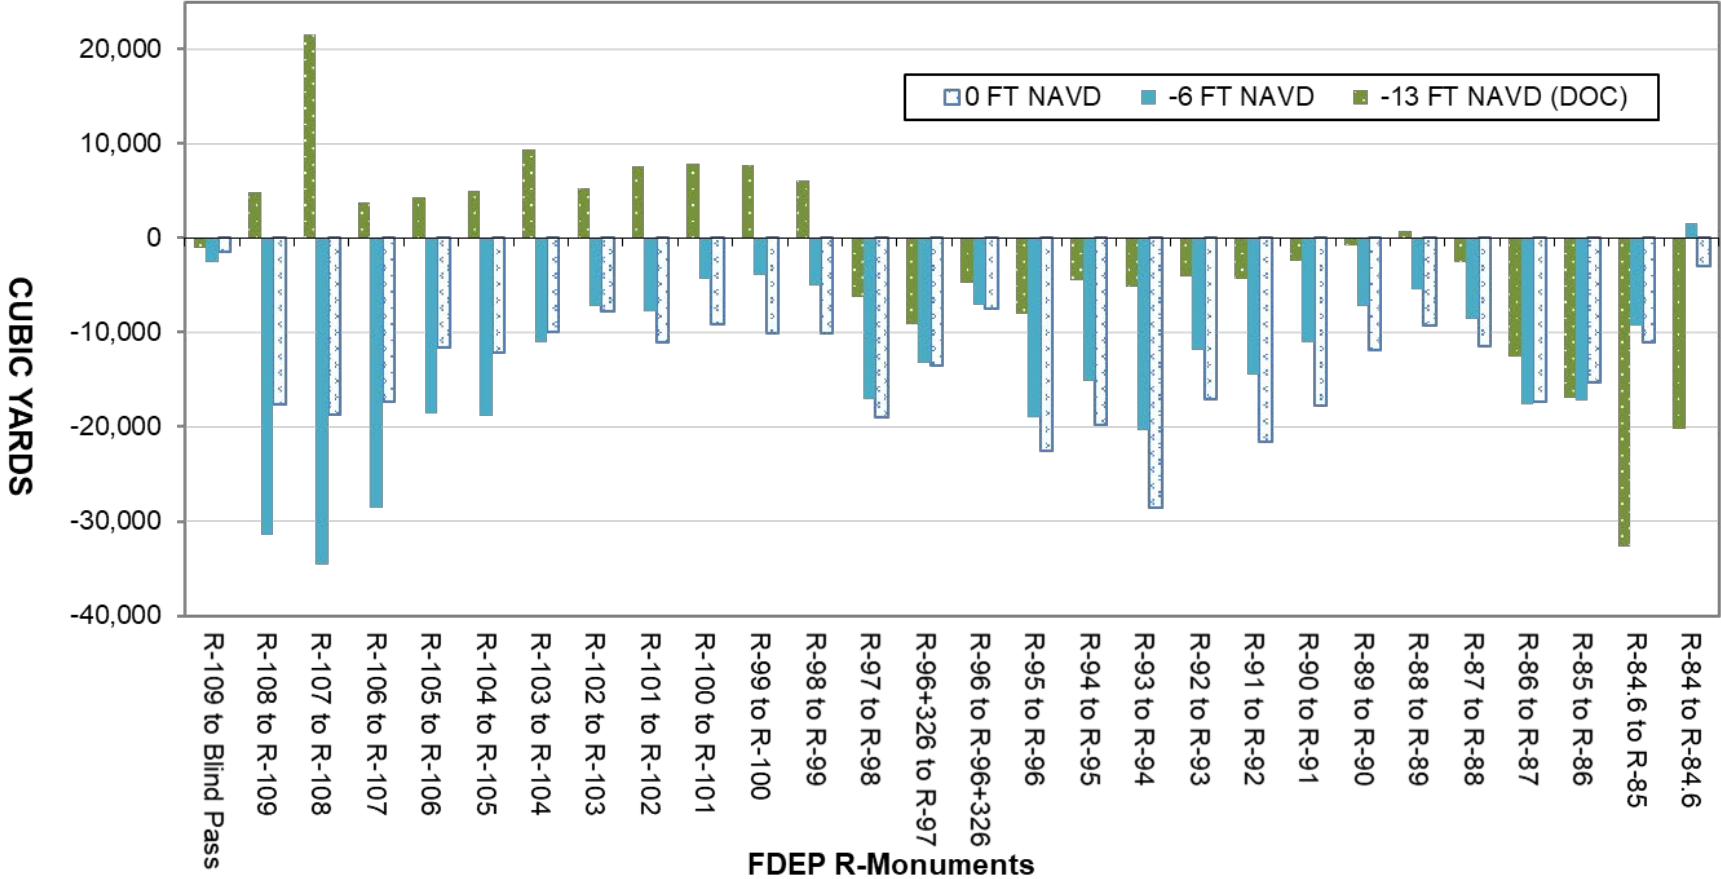
- ▶ Total beach profile volume change (most landward point of dune to depth of closure at -13 ft-NAVD):
 - ▶ -51,700 CY
- ▶ Volume lost above MHW (+0.28 ft-NAVD):
 - ▶ -377,700 CY
- ▶ Total volume lost under 2021 construction template:
 - ▶ 505,900 CY

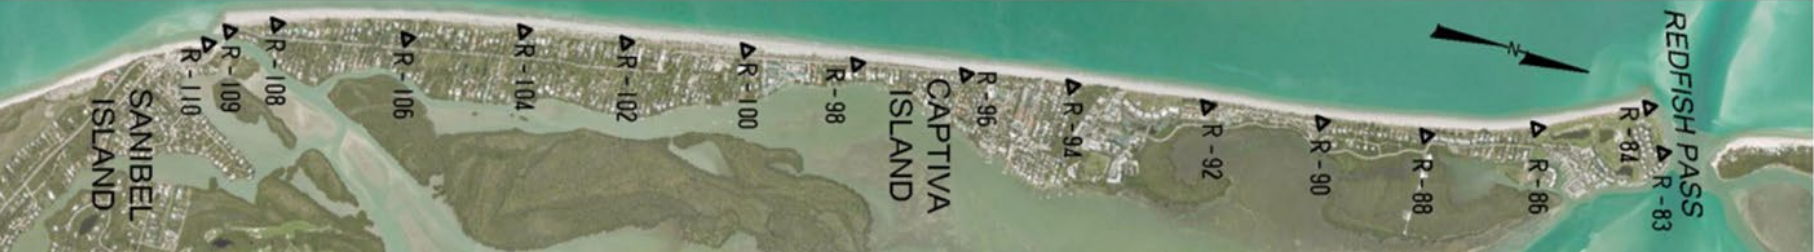
VOLUME CHANGE

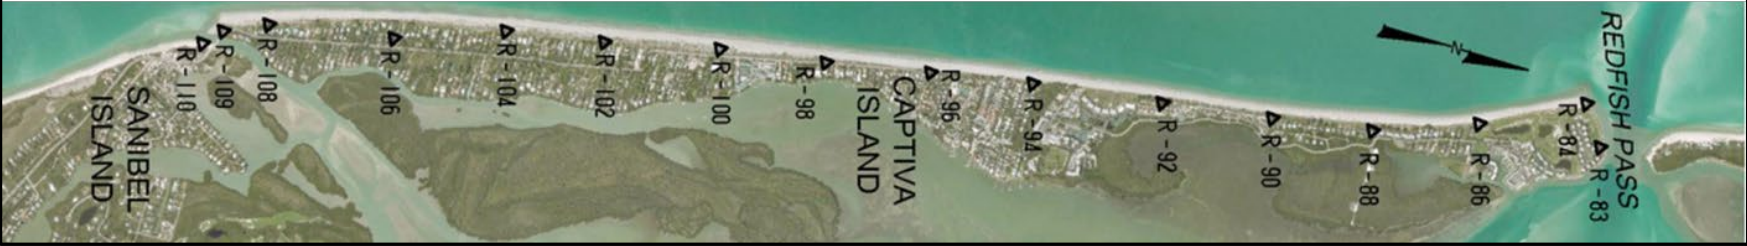
VOLUME CHANGE
