Analysis of Morphological Change at Ponte Vedra, FL caused by Hurricane Ian Using Drone Imagery and RTK GPS Surveys

Copeland Cromwell¹, Peter Adams^{1,2}, Matheus de Assis Bose¹, Orlando Cordero², Andrew Ortega³, and Christine Angelini^{2,4}

University of Florida, Department of Geological Sciences¹

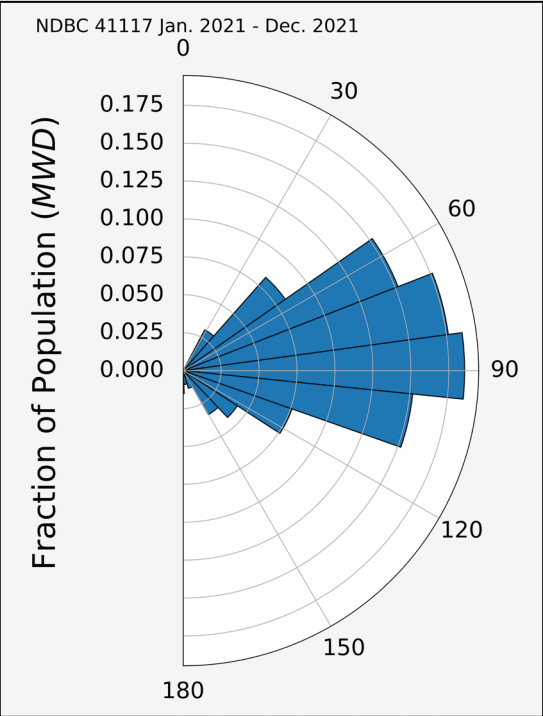
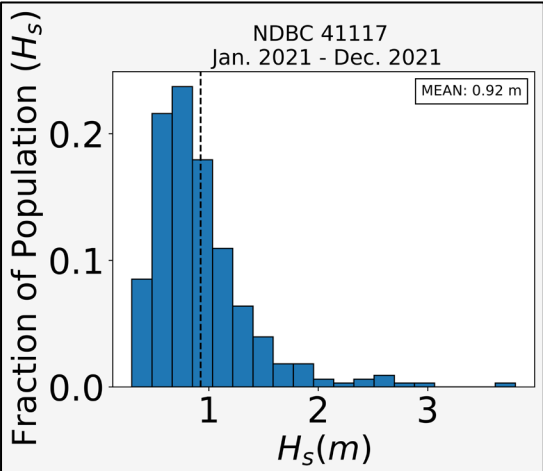
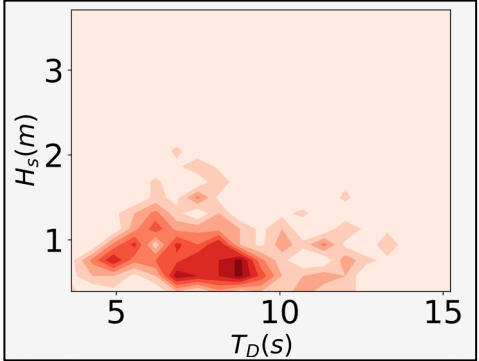
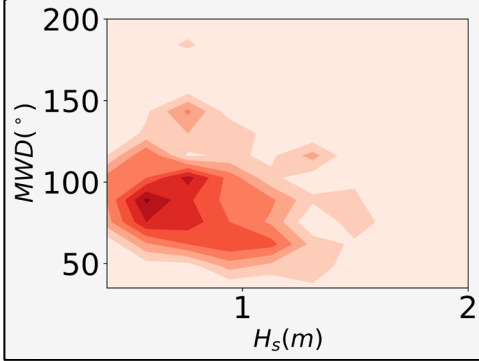
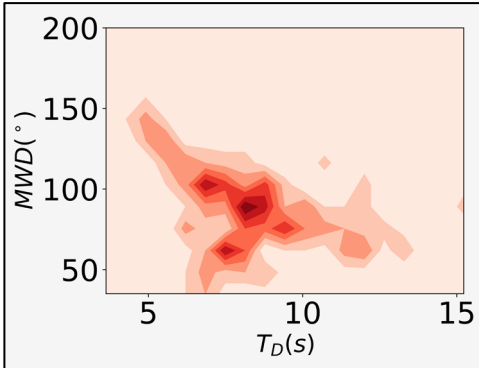
Waves at South Ponte Vedra Beach typically arrive from the northeast indicating a southern littoral drift.

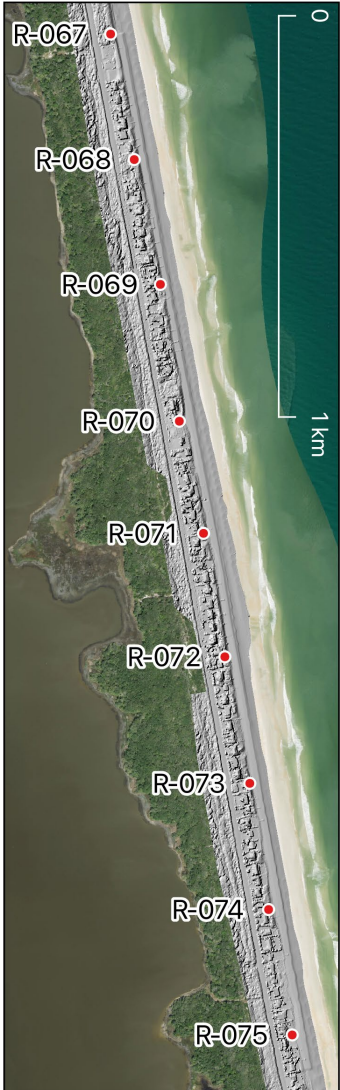
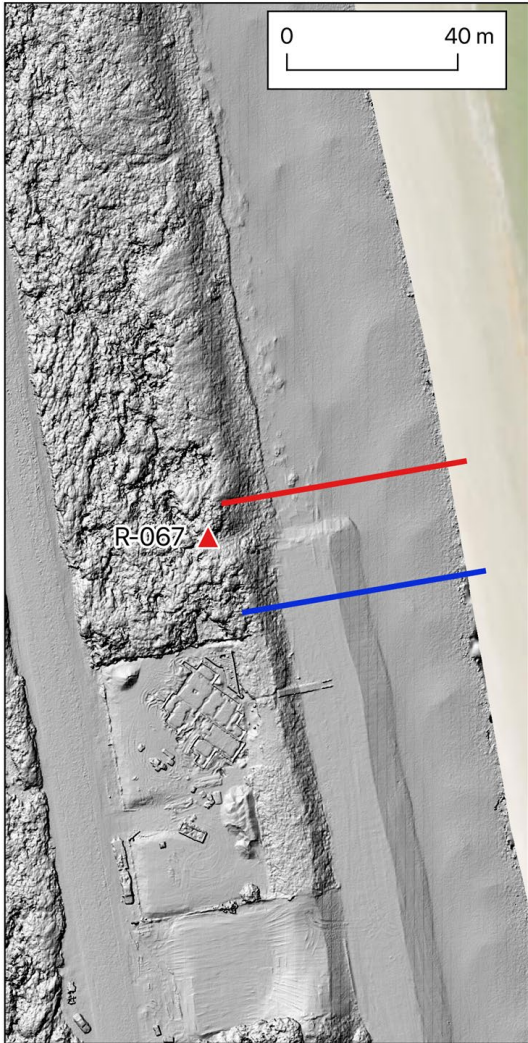
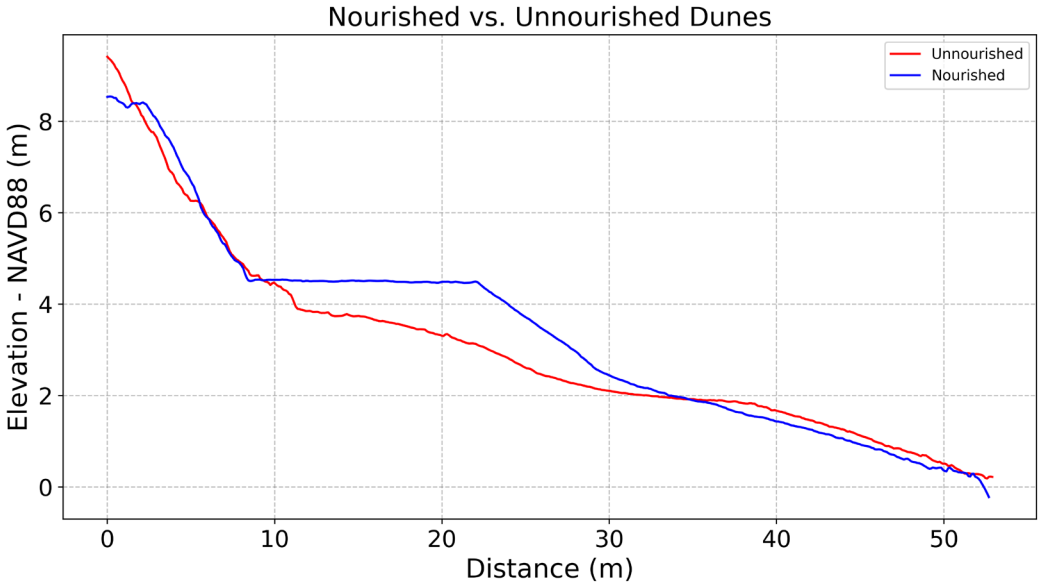
South Ponte Vedra Beach has undergone dune nourishments (restorations) to protect local infrastructure and residences.

- Nourishments in 2021 and 2022 added ~500,000 cubic yards of sediment over 18 km alongshore.
- The South Ponte Vedra Beach Study area was part of this nourishment with dune nourishment occurring between coastal

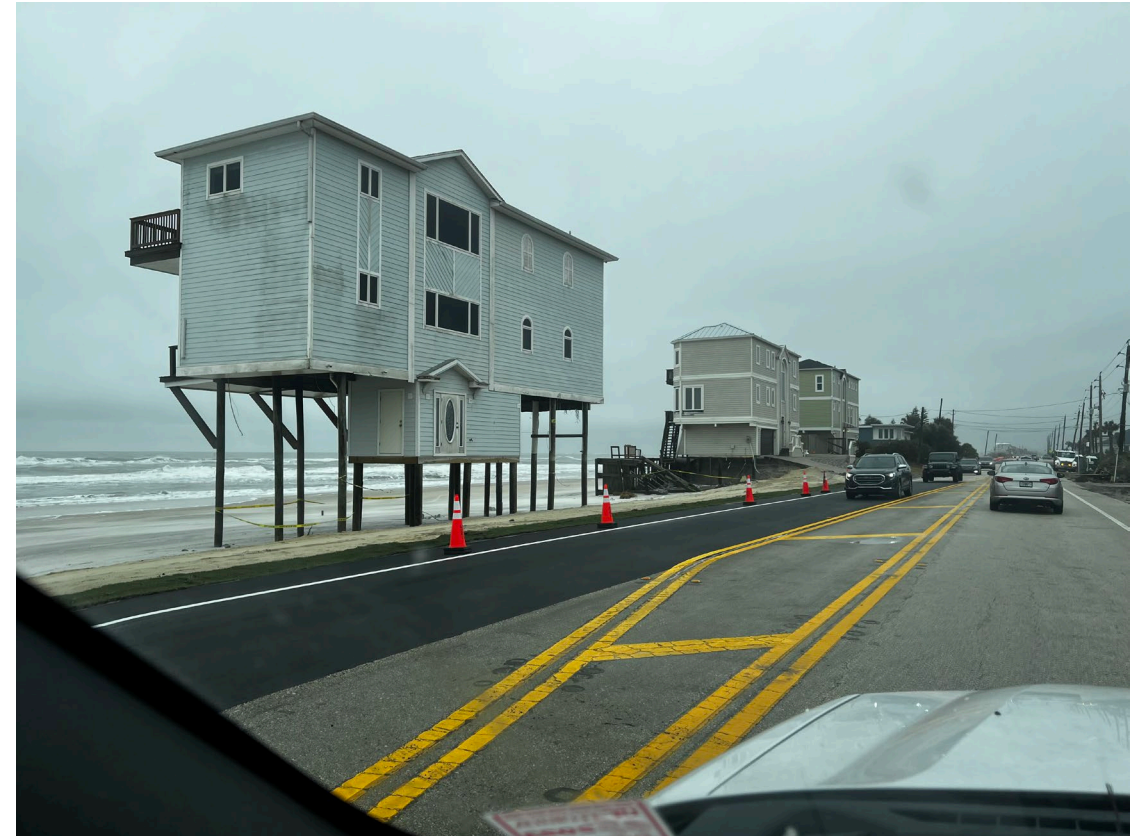
Recent storms have driven significant morphologic change at South Ponte Vedra Beach necessitating accurate monitoring of beach and dune morphology.

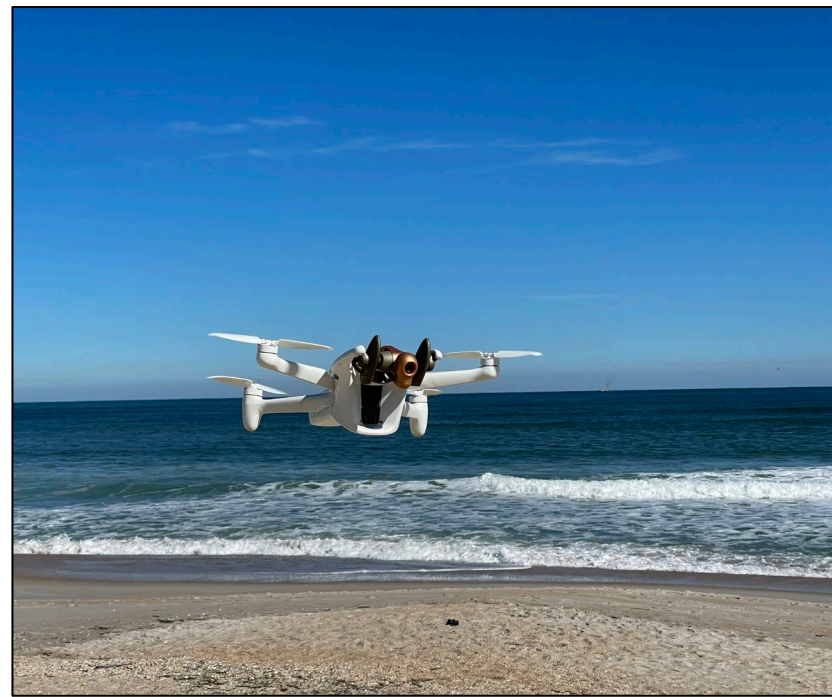
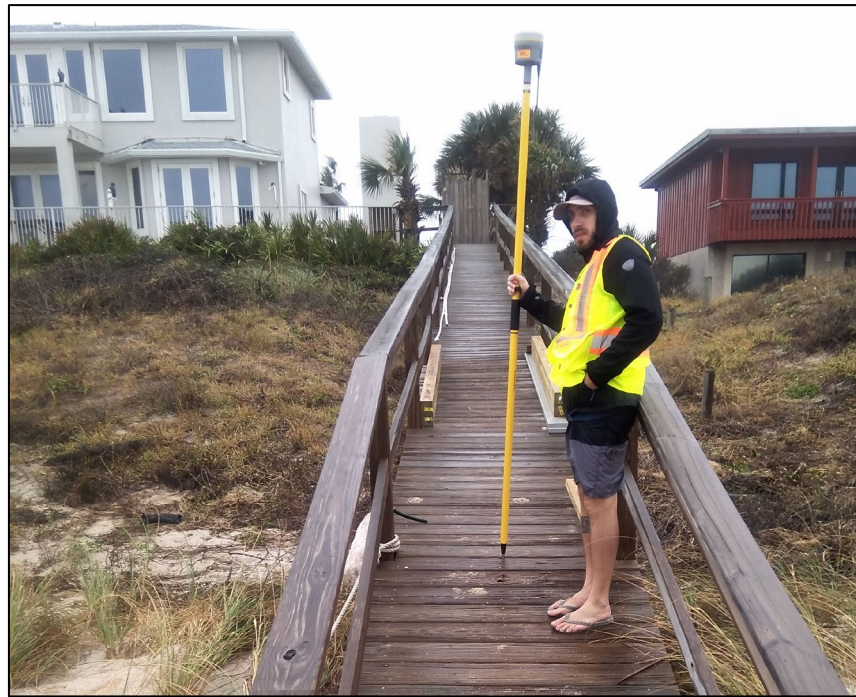
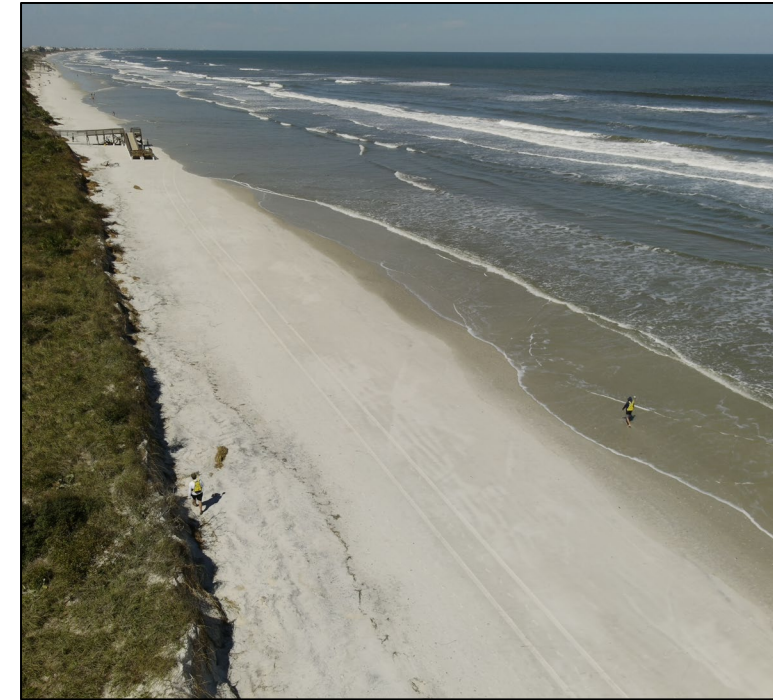
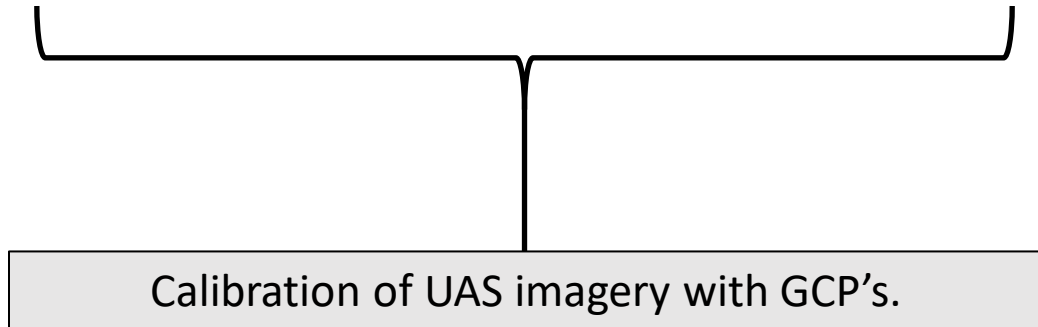
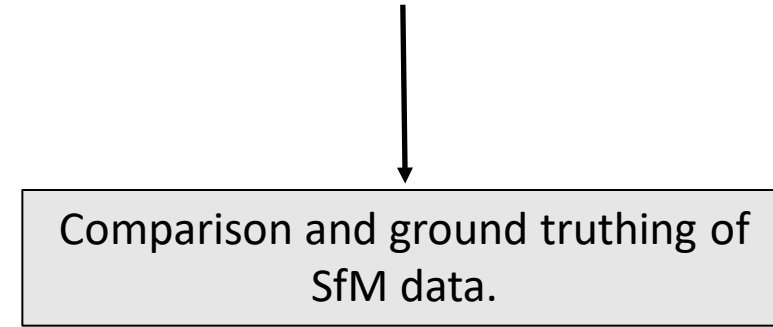
Drone imagery and SfM coupled with RTK surveys provide a reliable method of surveying storm damage and the recovery processes of beaches and dunes.

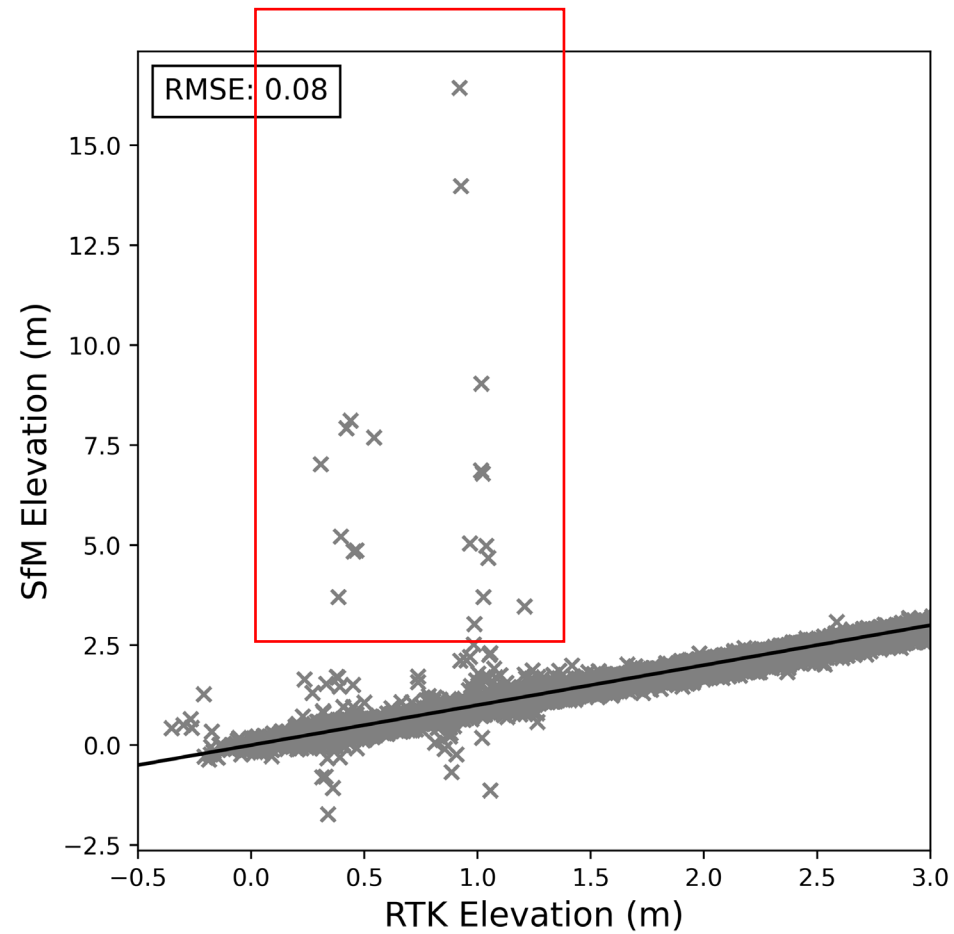
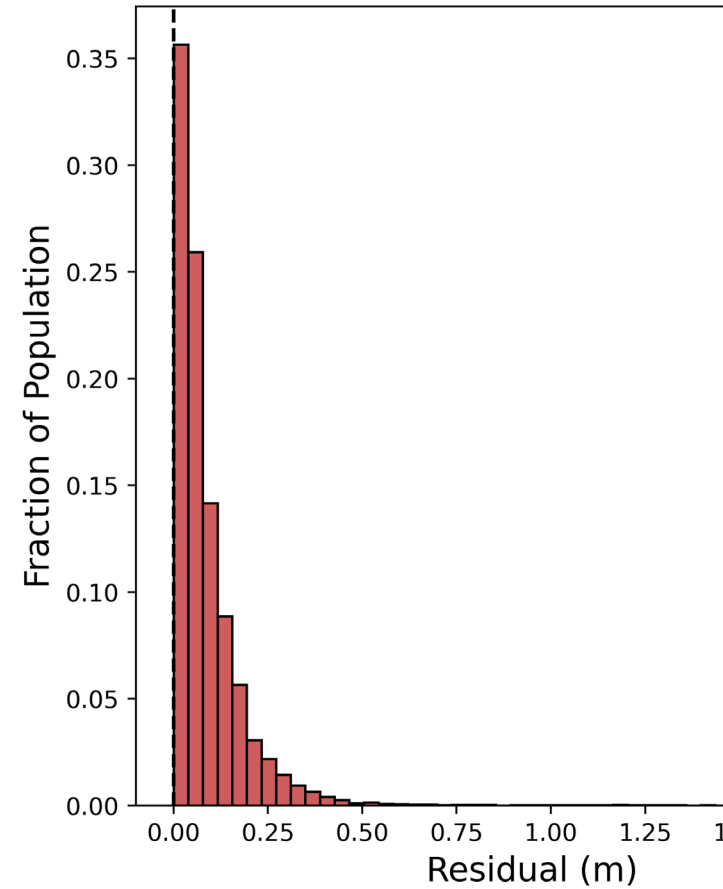
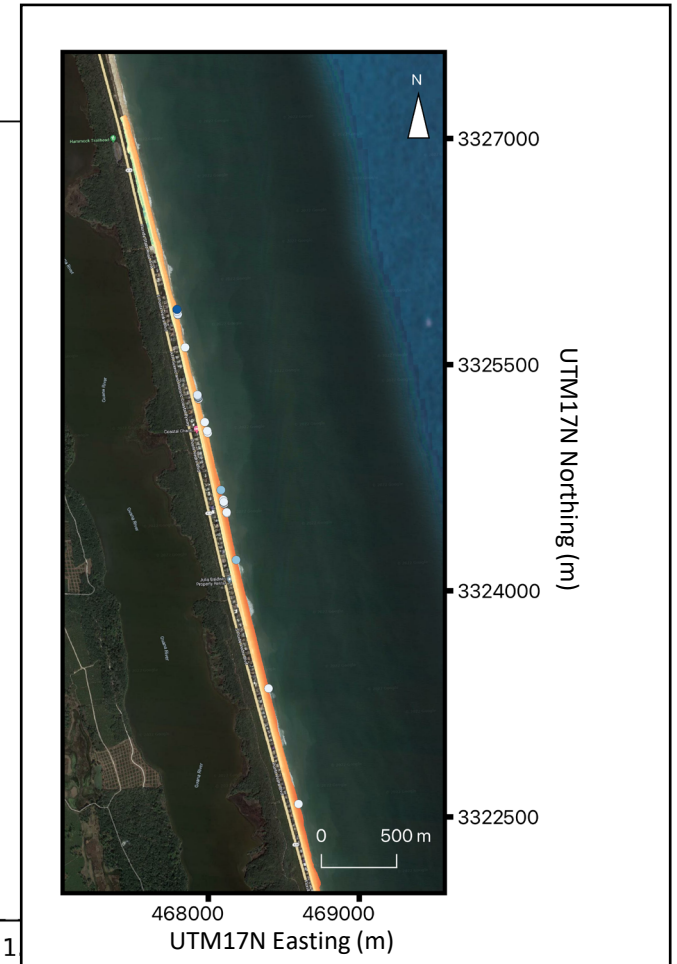
SfM provides elevations consistent with RTK surveys with error being largely confined to regions of wave activity.

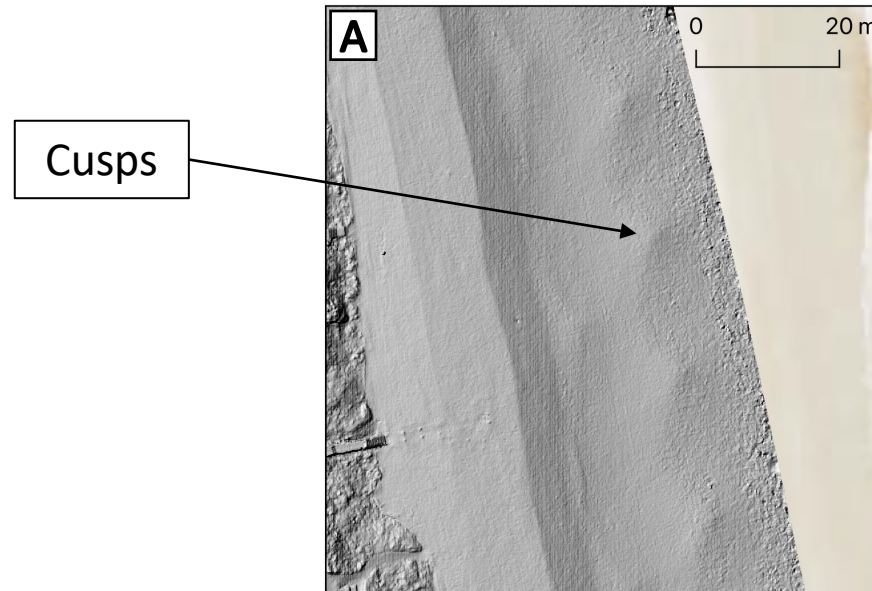
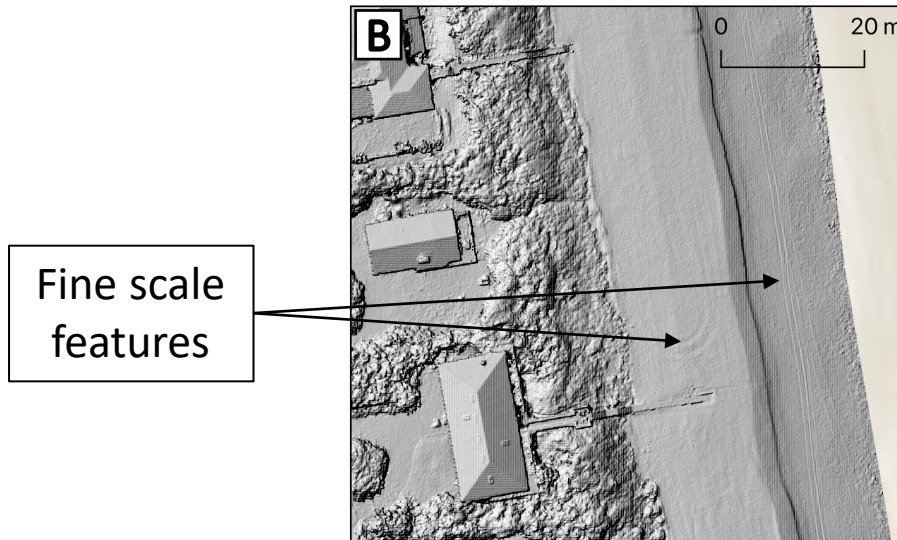
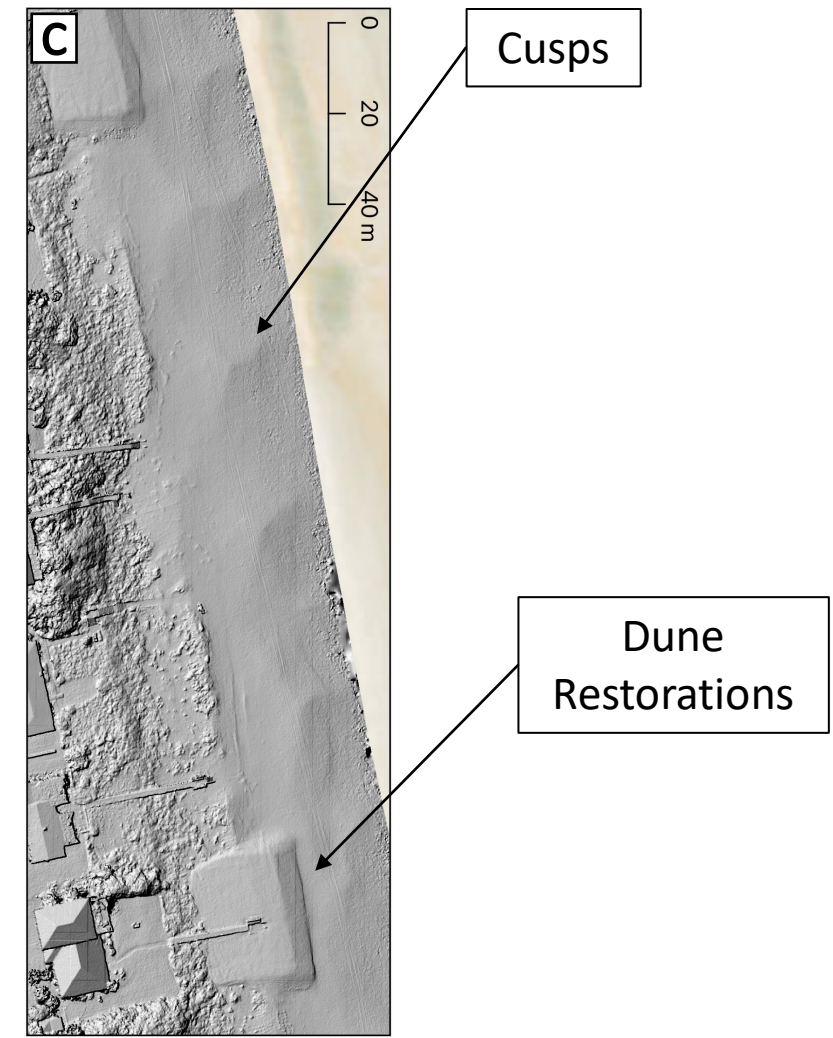
SfM allows for kilometer-scale coastal surveys while retaining decimeter-scale accuracy.

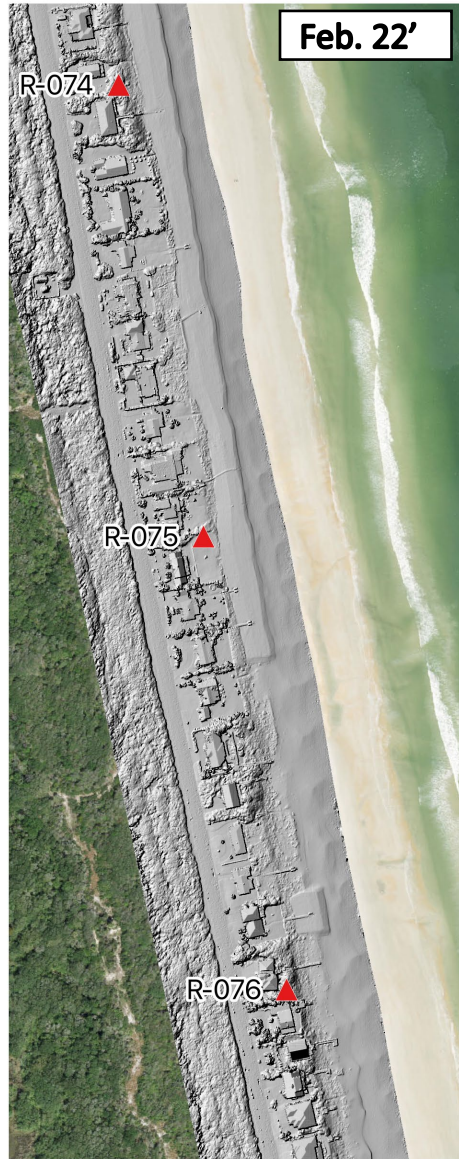
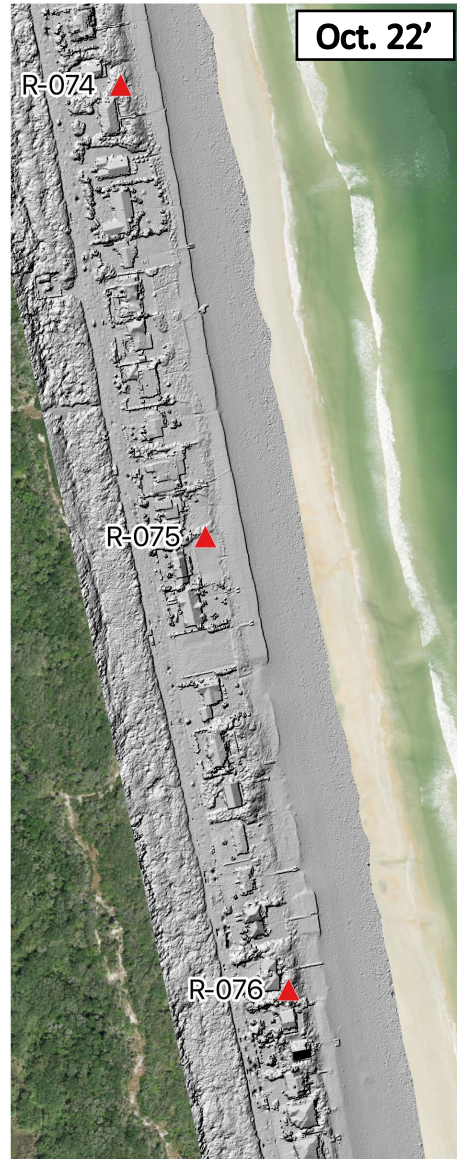
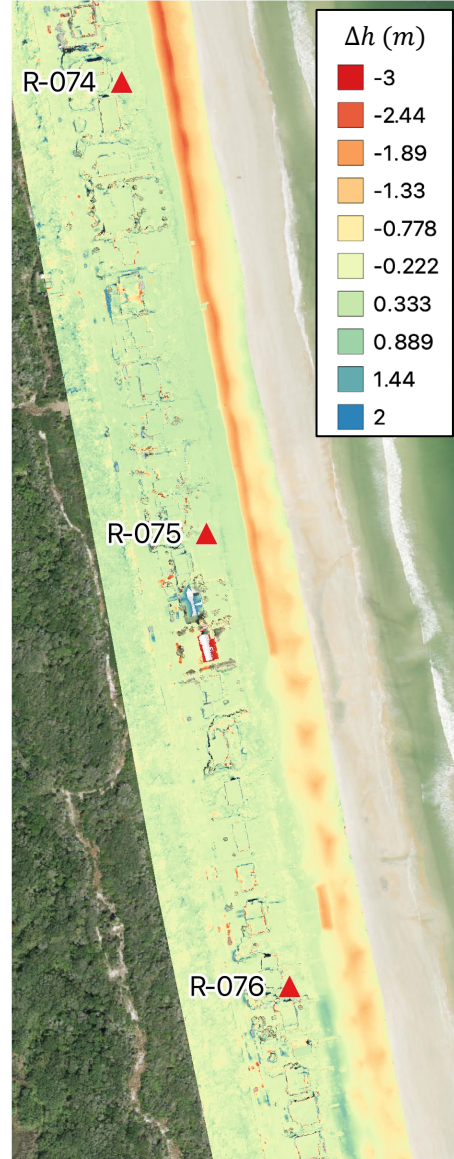
Hurricane Ian caused significant morphologic change – removing sediment from restored dunes and beach cusps.

- Near Ranger Markers 74 and 75, significant alteration of restored dunes is observed following Hurricane Ian.
- Most of this alteration is focused on the restored dune segment of the beach.
- Between Range Markers 75 and 76, continuous restoration was not conducted.
- Morphological change appears centered on cusped features.

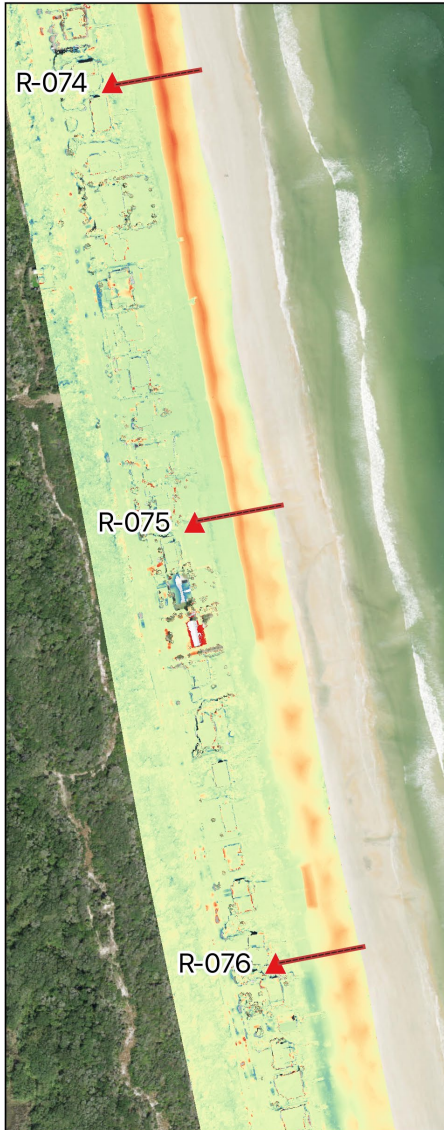
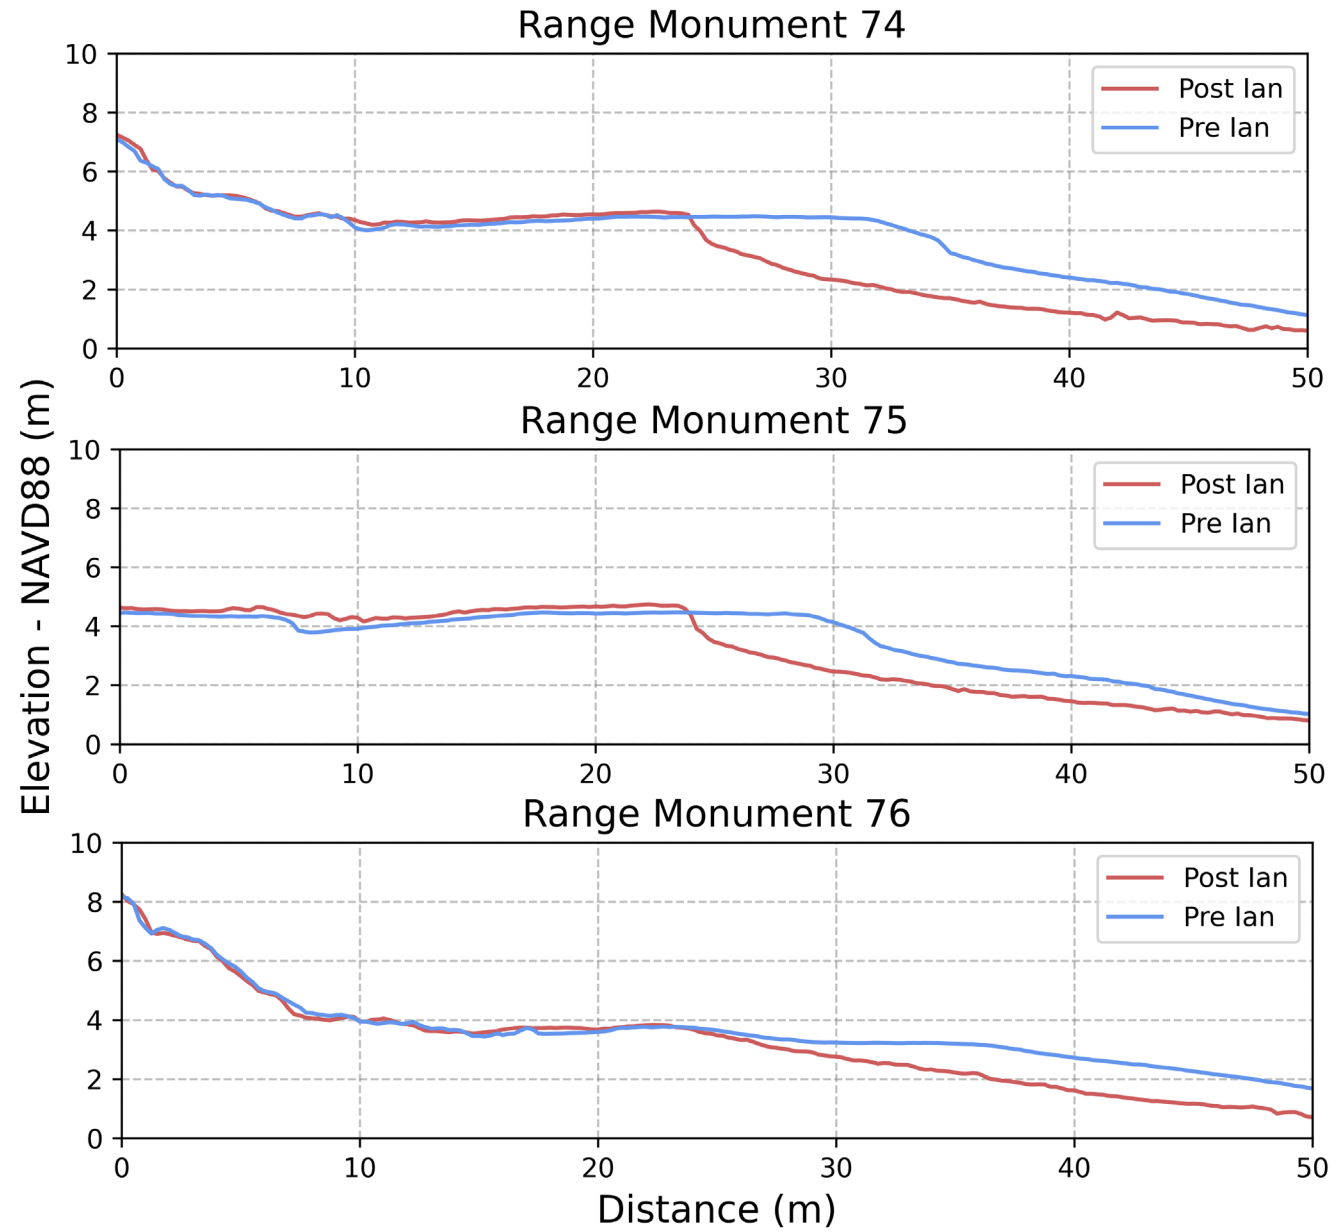
Transects show significant sediment loss following Hurricane Ian, and retreat of the restored dunes.

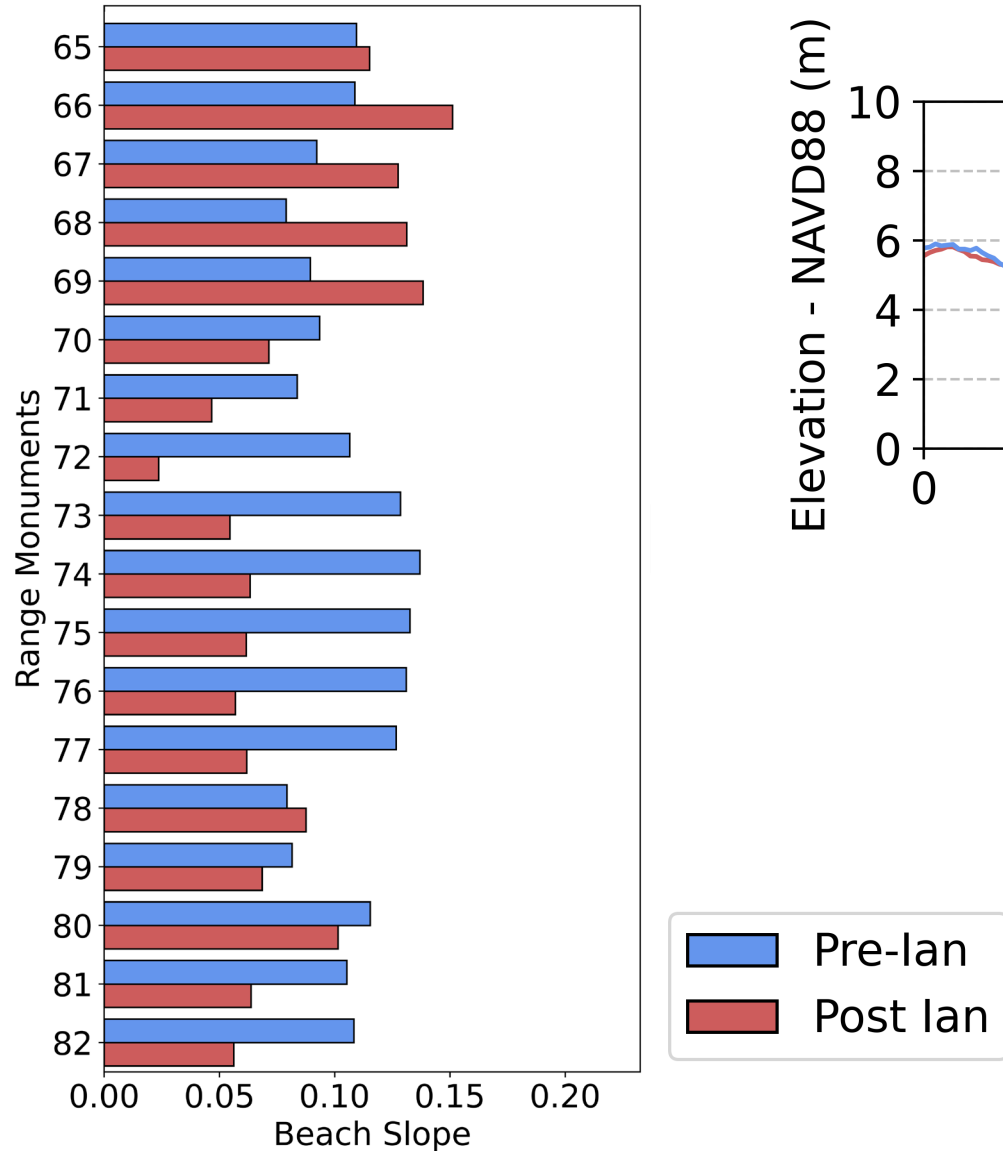
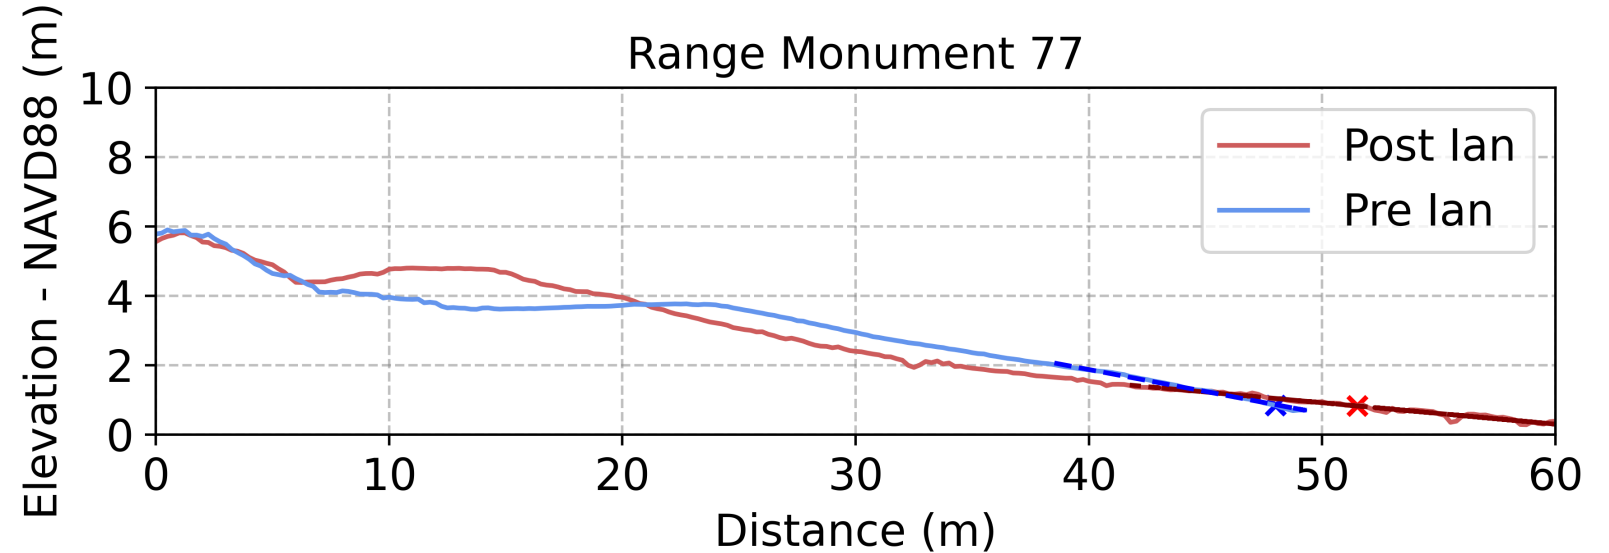
Following Hurricane Ian, mean beach elevation and foreshore slope decreased.

- Ordinary least squares regressions were performed on transects to determine slope.
 - We use the shoreline surrounding the MHW elevation to determine slope.
- After Hurricane Ian, the mean beach foreshore slope flattened by ~ 0.03 .

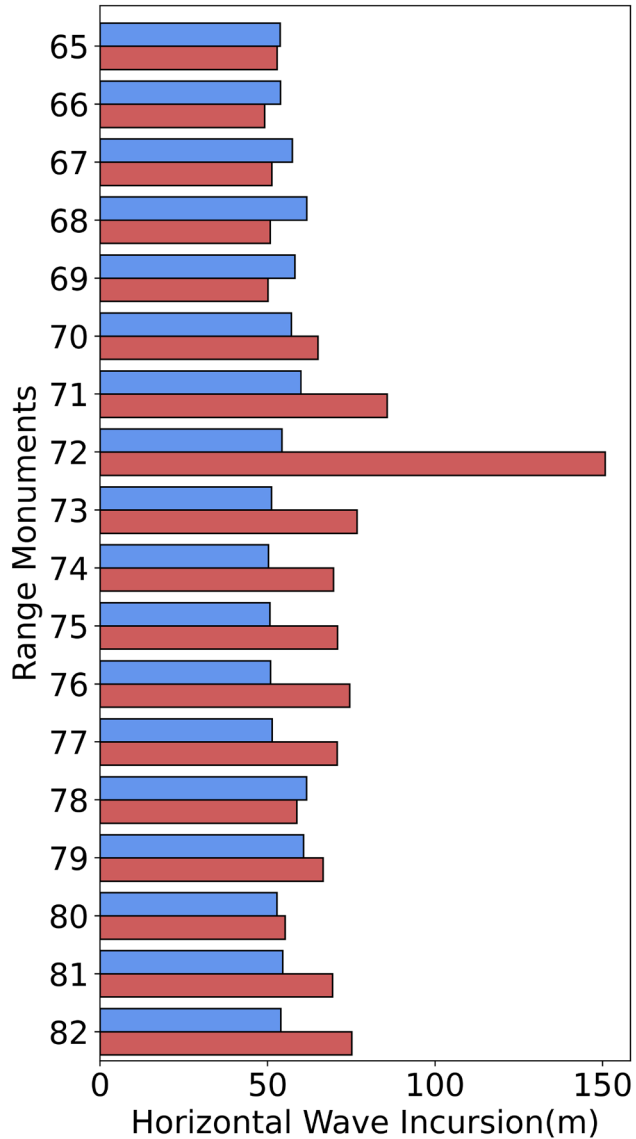
Empirical relationships from Stockdon et al., (2006) indicate horizontal wave incursion increased as a result of morphological change from Hurricane Ian.

$$R_2 = 1.1 \left[0.35\beta_f(H_oL_o)^{\frac{1}{2}} + \frac{[H_oL_o(0.563\beta_f^2 + 0.004)]^{\frac{1}{2}}}{2} \right]$$

$$HWI = \left[\frac{R_2}{\beta_f} \right]$$

- Empirical relationships can be used to assess potential wave runup and incursion.
- As a result of foreshore flattening, wave runup decreases and horizontal incursion increases.
- Beaches should be more readily subjected to inundation during future storms or high water levels.

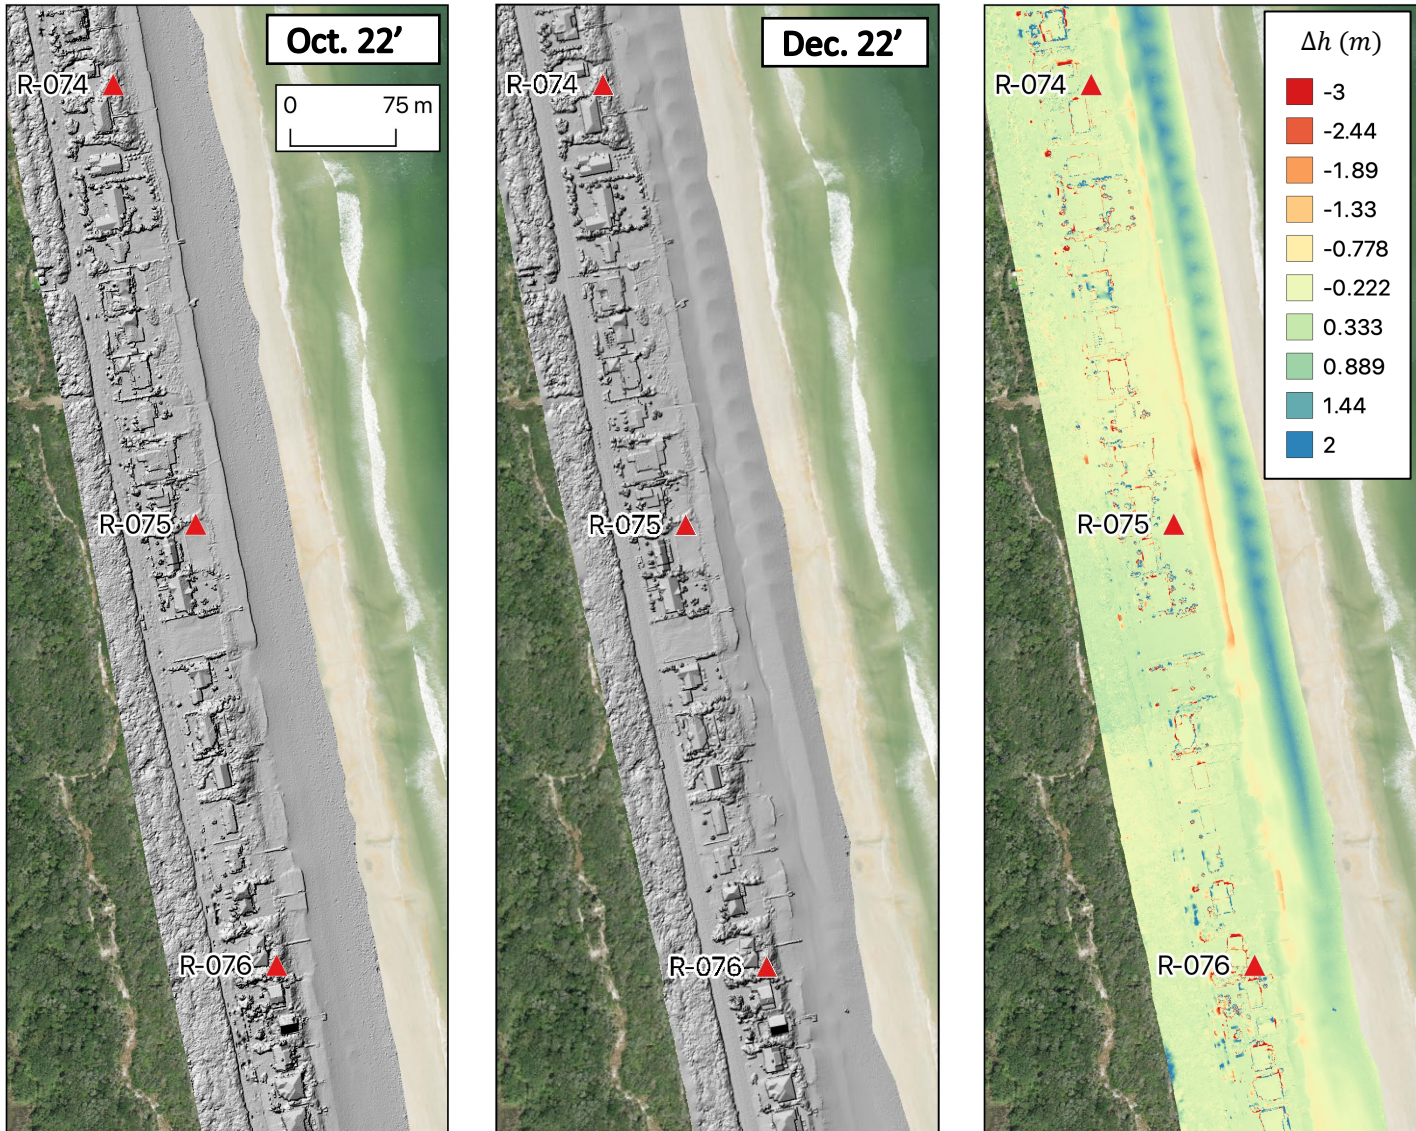
Hurricane Nicole did not remove sediment from restored dunes but resulted in aggradation on the foreshore leading to cusp formation.

- Beaches did not erode during Hurricane Nicole, but instead accreted sediment on the foreshore.
- Only minor dune retreat and sediment removal occurred following Hurricane Nicole.
- This is a significantly different morphologic response when compared to Hurricane Ian.

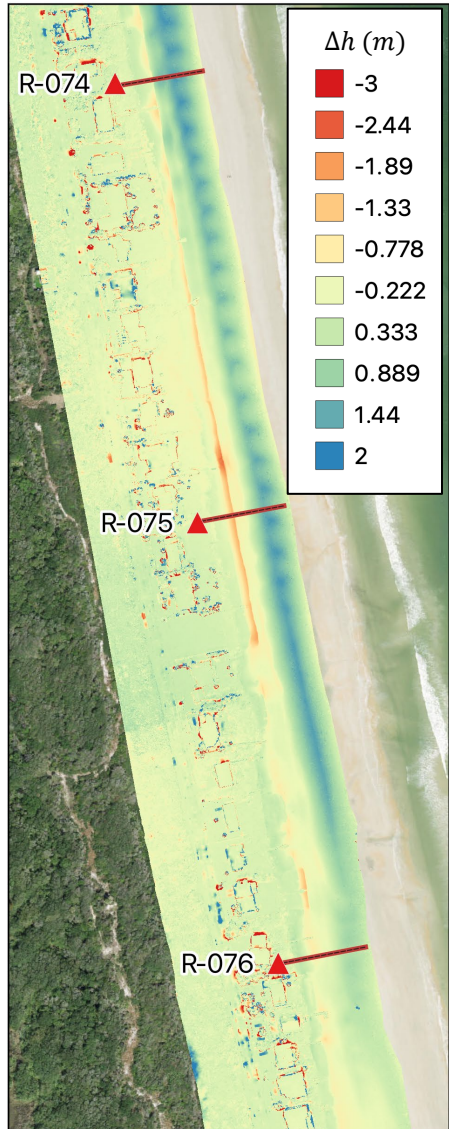
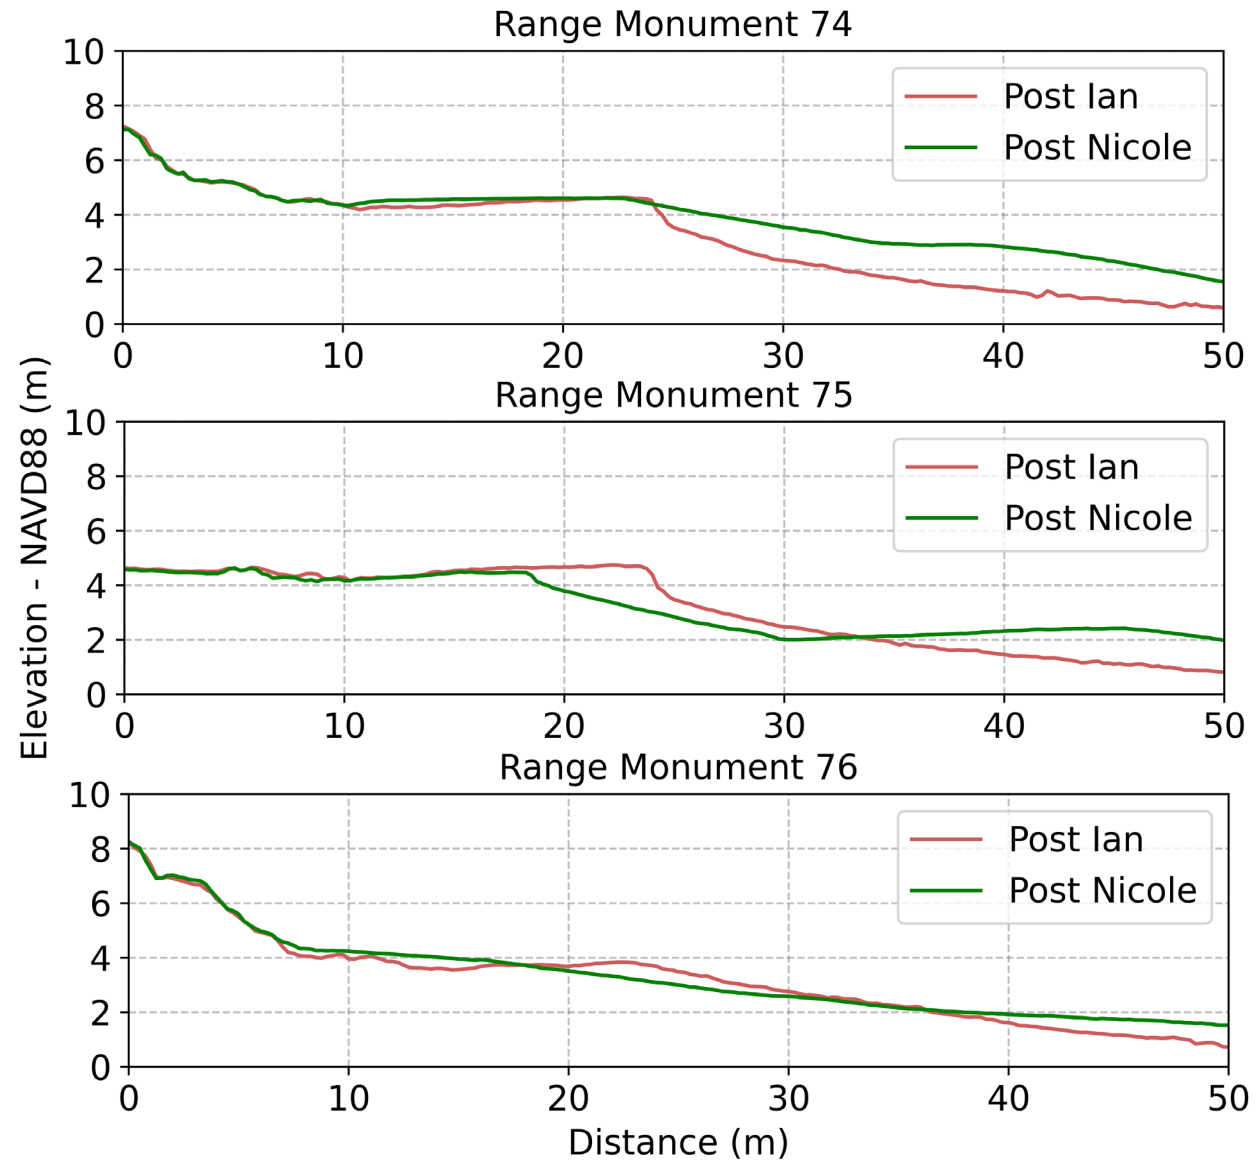
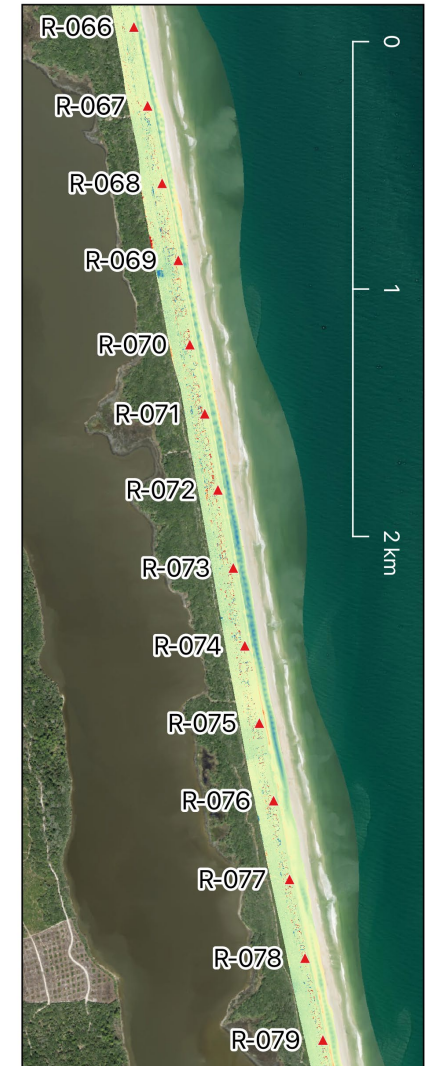
Surveys following Hurricane Nicole indicate that dune crests were eroded, and that aggradation was prevalent on the foreshore.

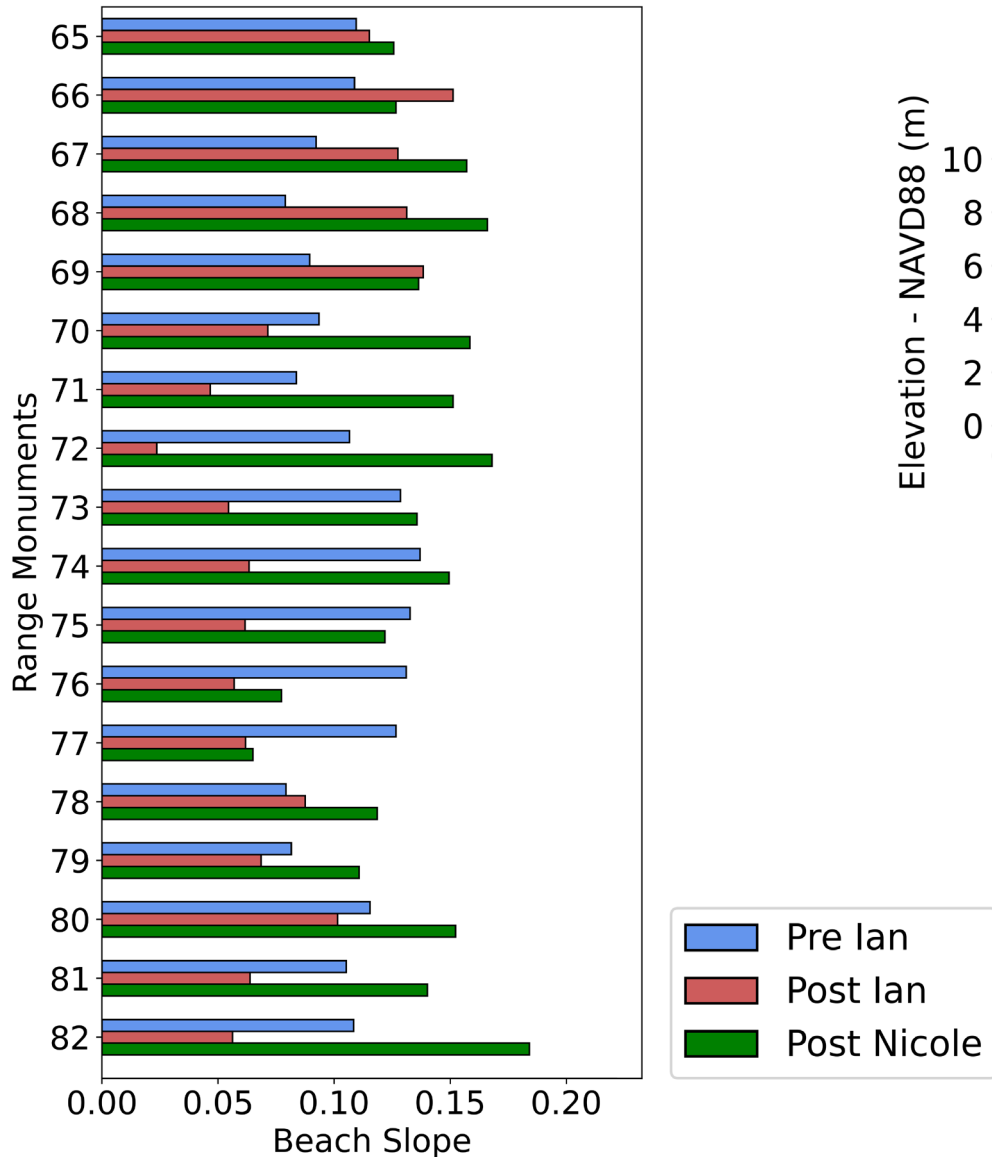
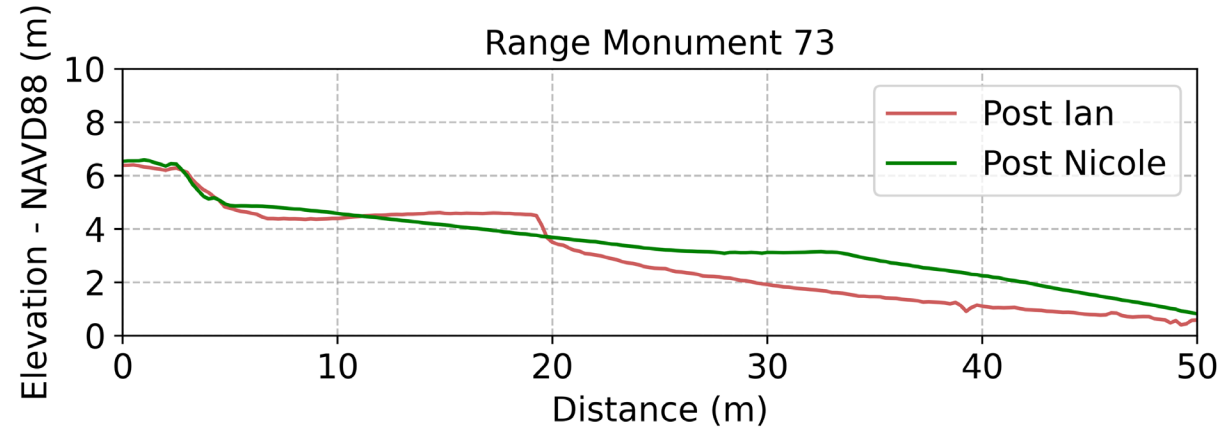
Foreshore aggradation following Hurricane Nicole, led to foreshore beach steepening exceeding beach steepness from prior to Hurricane Ian.

- Seaward migration of nourished dune sediment, resulted in a steepening of the beach.
- This is a significant deviation from morphological change following Hurricane Ian.
