Analysis of Morphological Change at Ponte Vedra, FL caused by Hurricane Ian Using Drone Imagery and RTK GPS Surveys

Copeland Cromwell¹, Peter Adams^{1,2}, Matheus de Assis Bose¹, Orlando Cordero², Andrew Ortega³, and Christine Angelini^{2,4}

University of Florida, Department of Geological Sciences¹

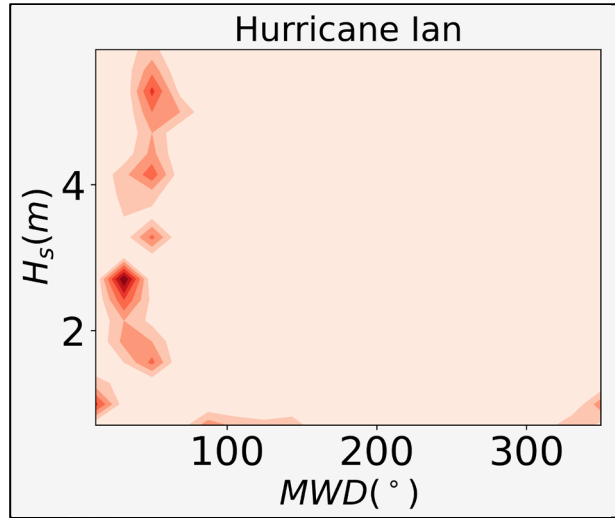
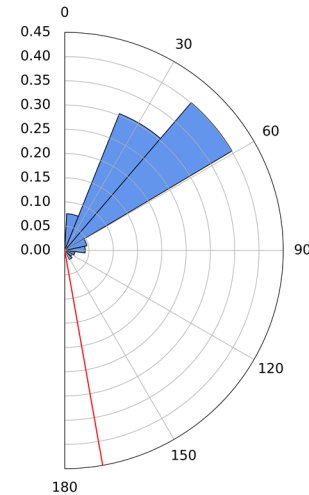
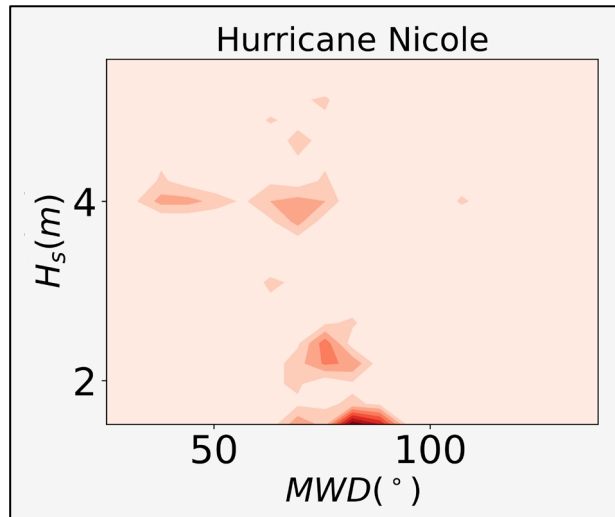
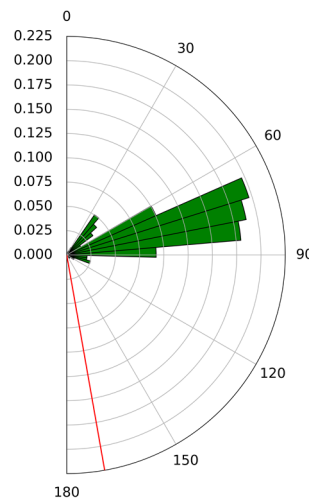
Morphologic responses may have resulted from differences in wave directions associated with Hurricane Ian and Nicole

- Wave directions from the five days surrounding Hurricanes Ian and Nicole, show significant differences.
- Wave directions associated with Hurricane Ian, are from the N-NE.
- Wave directions associated with Hurricane Nicole, are from the NE.
