- 1. Brief History of the Sand Key Project
- 2. Discussion on Offshore Monitoring Profiles
- 3. Calculations of Sediment Transport Rates
- 4. Possible Explanation on Observed Changes
- 5. Conclusion

#### Pinellas County Shore Protection Project

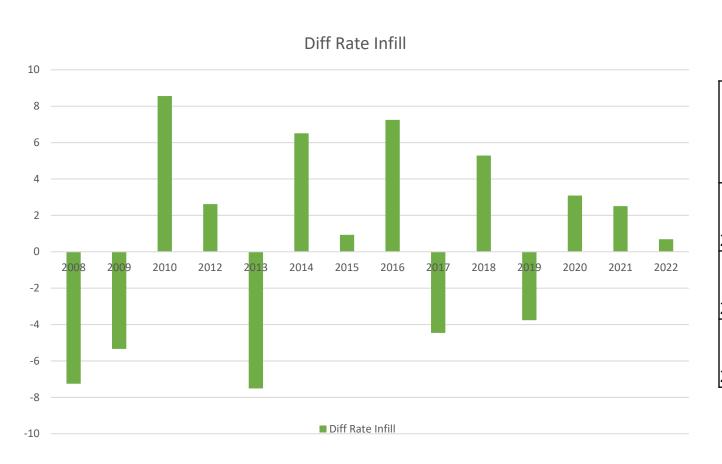
Rate CY/ft)		
-7.25		
-5.34		
8.56		
2.62		
-7.51		
6.51		
0.93		
7.25		
-4.46		
5.29		
-3.76		
3.09		
2.51		
0.69

Volume Infilling		Volume/Year	Volume/per
	(CY)	Years	Per Cell	foot/Year
2008-2022	4879.7658	14	348.5547	1.17
2015-2022	3160.8251	7	451.5464429	1.515714286
2019-2022	1873.8539	3	624.6179667	2.096666667

- 2000-2006 positive infill likely due to side sloughing
- Roughly 4 years after renourishment projects, the largest infilling rates occurred (2006, 2012)

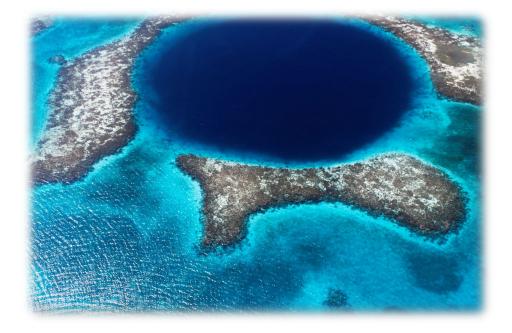
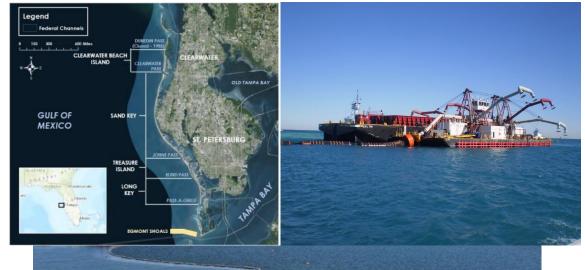
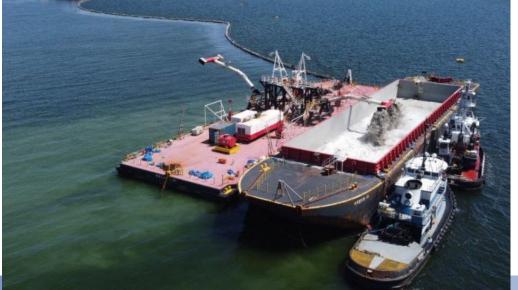
- The 1998-1999 Sand Key Project took sand from Egmont Shoals
- Used Spider Barge Technique
- Unlikely dredge would come up to the project area since sand is being barged from Egmont Key BA

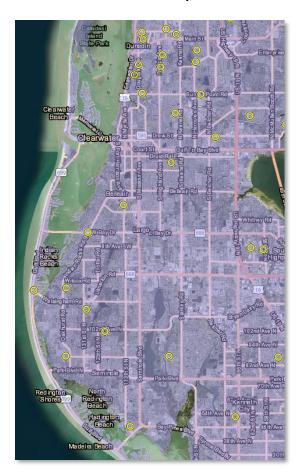
Upland Pinellas Considered Area III where cover collapse sinkholes are dominate and can vary in size
