### Repetitive Renourishments - Do Subsequent Renourishment Projects Last Longer?

## Repetitive Renourishments – Do Subsequent Renourishment Projects Last Longer?

# Using Drones for Aerial Mapping of Nearshore Habitats and Comparison with Current Methods

# John's Pass - Inlet Management Plan

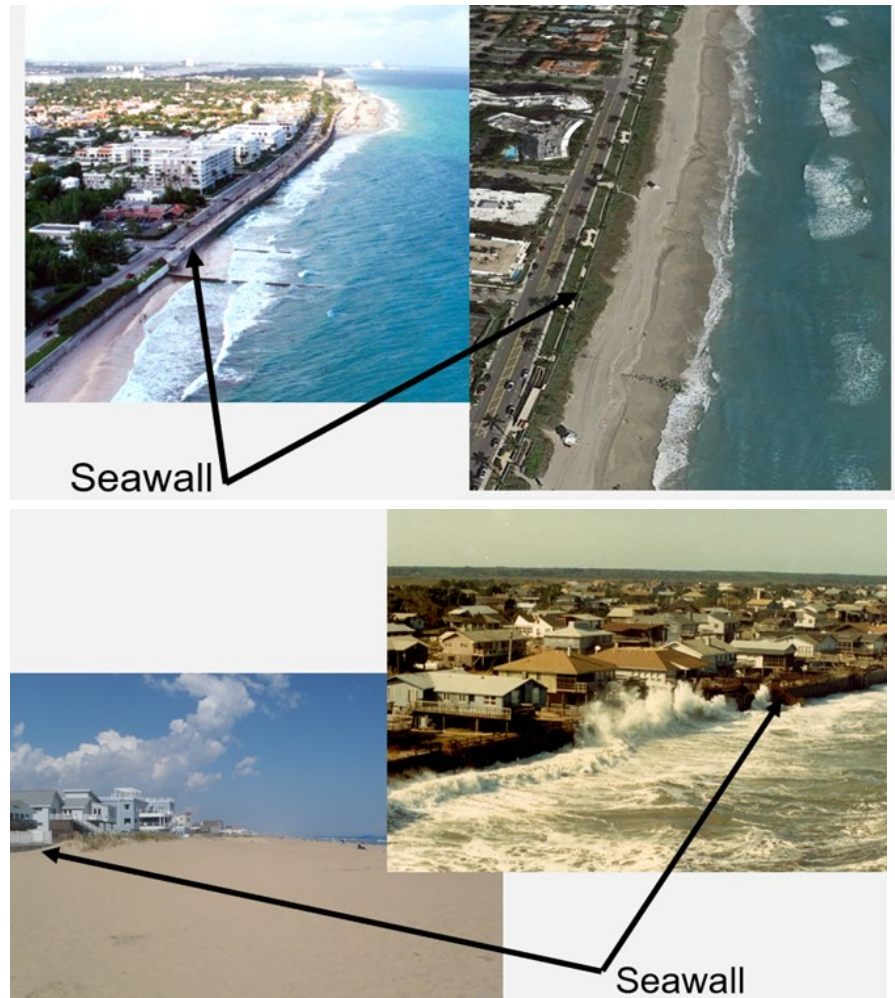
*Figure 4. Multiple renourishments developed robust dunes and sandbars in areas that were historically fronted by seawalls.*

One of the commonalities seen in assessing the performance of each of the study areas is that significantly more sand is within the project area after multiple renourishments than the initial project placed. While the renourishments are triggered and necessary based on the loss of sand from the project area, the coastal system naturally becomes more robust and resilient with each renourishment event. Most often, the initial project intent is to provide public beach to communities that have minimal recreational beach or no beach at all. These case studies demonstrate that following the initial project, beach dunes develop or become more robust and the offshore sandbar becomes more developed (Figure 4).

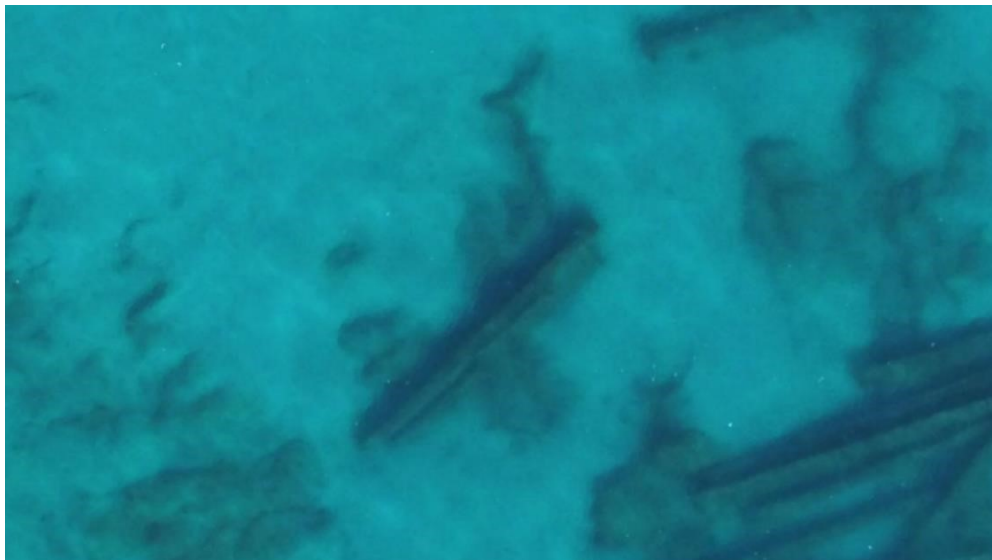
1a

Figure 1. Portion of artificial reef overlaying a natural reef offshore Martin County, Florida: a) DJI inspire drone image (4 in./pixel); b) manned aircraft image (6 in./pixel).

Drone imagery was collected over a 77-acre area of seafloor offshore Martin County, Florida 33 days after the manned aerials. One 24-min flight with the drone was sufficient for image acquisition. The drone imagery achieved a GSD of 4 in./pixel resolution (**Figure 1a**), while manned was 6 in./pixel (**Figure 1b**). Horizontal accuracy for the drone was  $\pm 3$  ft. As GCPs were not deployed, embedded GPS coordinates were used for orthorectification.

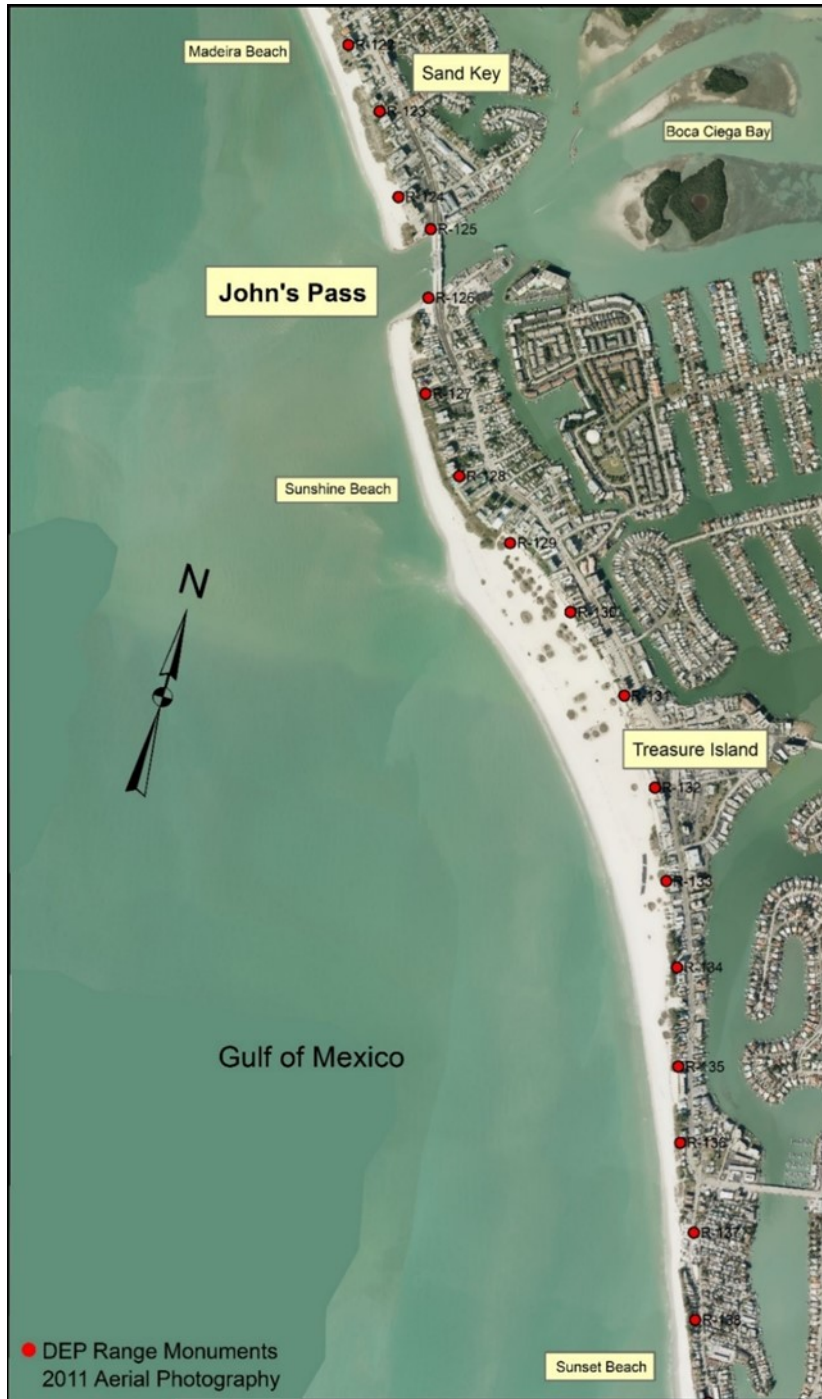
**Figure 1.** John's Pass in Pinellas County, FL. (2011 aerial photo by Southwest Florida Water Management District [SWFWMD])

In 1848, a severe hurricane opened and created John's Pass, which was named for a local fisherman and citrus grower, John Levique. For the two-inlet system (John's Pass and Blind Pass) connecting Boca Ciega Bay to the Gulf of Mexico, John's Pass has been the hydraulically dominant inlet, transporting between 70 and 80 percent of the tidal prism that flows into and out of Boca Ciega Bay. This tidal dominance has likely resulted in the hydraulic stability and geomorphological stability of the inlet, as John's Pass has not experienced any significant migration in its location since opening. Natural fluctuations in shoreline position along southern Sand Key and northern Treasure Island have been observed in the historical record of aerial photography, beach profiles, and shoreline surveys (Figure 2).

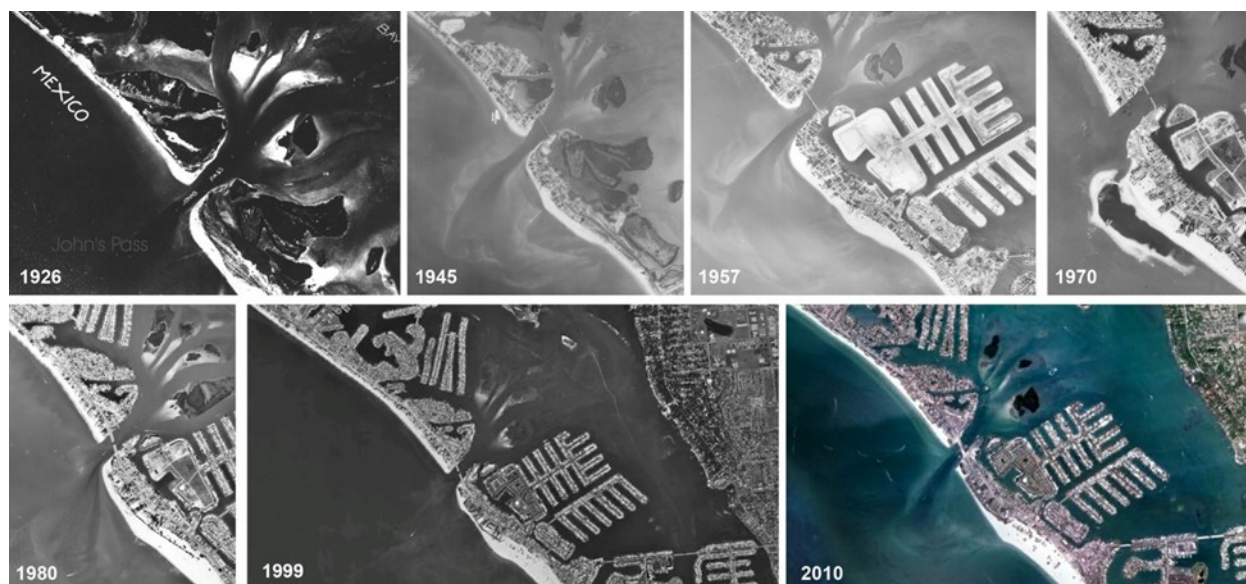
**Figure 2.** Historical aerial photos of John's Pass from 1926 to 2010. (Wang 2016).

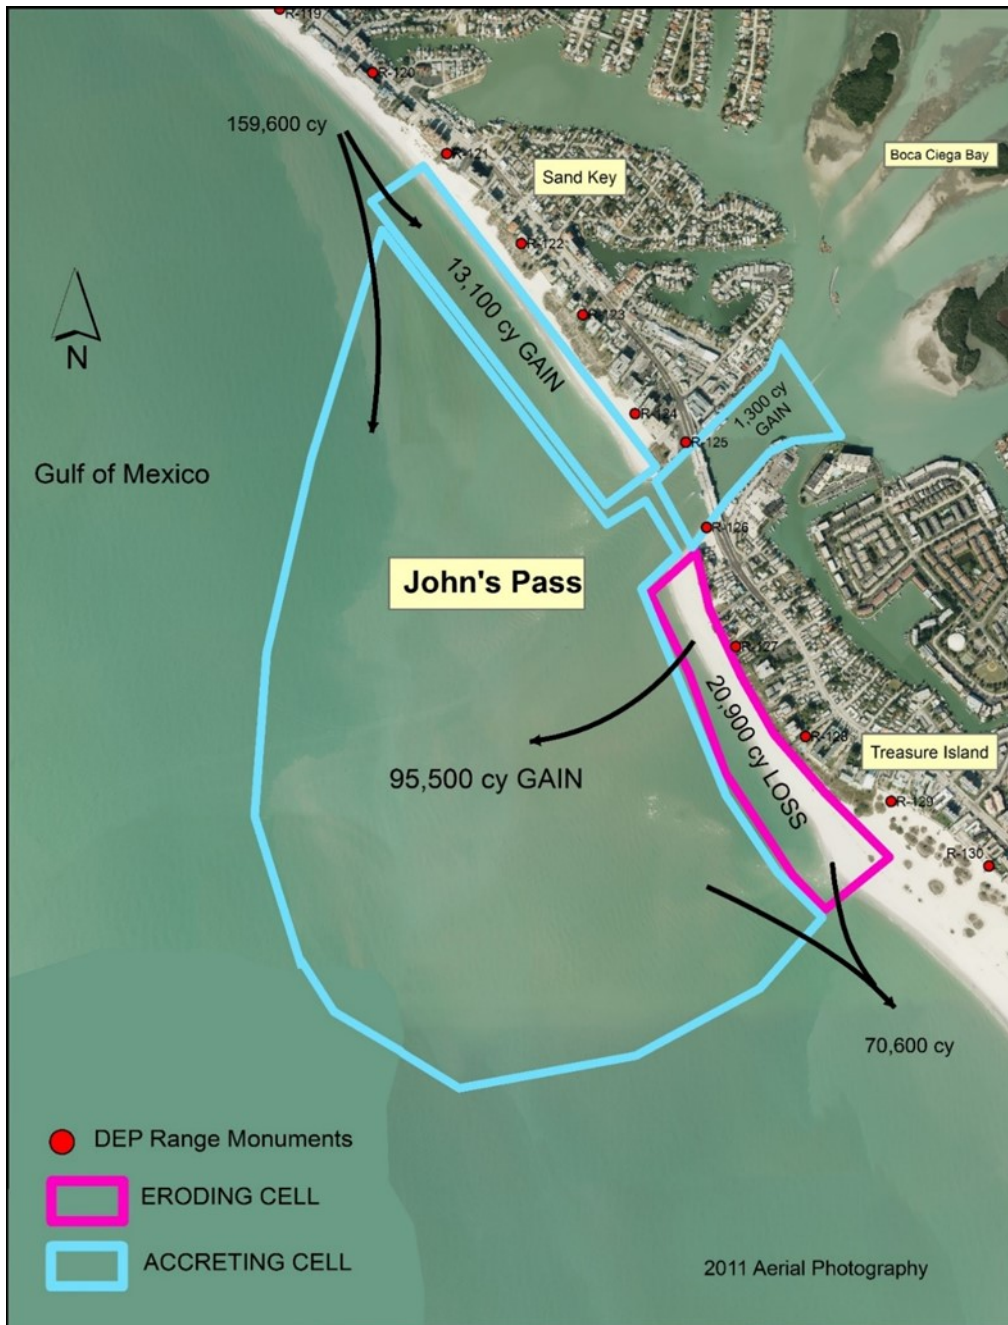
**Figure 4.** Annualized sediment budget at John's Pass based on field data collected from October 2010 to June 2014 (Wang et al., 2016). The 2011 aerial photo is courtesy of SWFWMD.

The modeling analysis for the John's Pass study included seven design alternatives, including baseline conditions, dredging of the northern portion of the ebb shoal, dredging the south bypass bars, re-dredging of 198,000 cubic yards from the navigation channel and side borrow area, extending the southern jetty or extending both jetties, and finally dredging the main channel. Both the field data and modeling work of these alternatives contributed to the development of the sediment budgets for both passes. The inlet management study for John's Pass conducted an updated hydrographic survey of the inlet system in 2014 (Figure 3) to compare with a prior survey from 2010, and developed a sediment budget using the methodology described by Rosati (2005). The sediment budget established bypass objectives for the southern shoreline (Figure 4). The northern shoreline adjacent to the pass is accreting and is not designated critically eroded.
