**GREENER GRASS ON THE OTHER SIDE: SHARING THE SUCCESSES AND
LESSONS LEARNED FROM THE LONGBOAT KEY, FLORIDA SEAGRASS
MITIGATION PROJECT**

THIRTY MONTH POST-CONSTRUCTION SURVIVAL ASSESSMENT

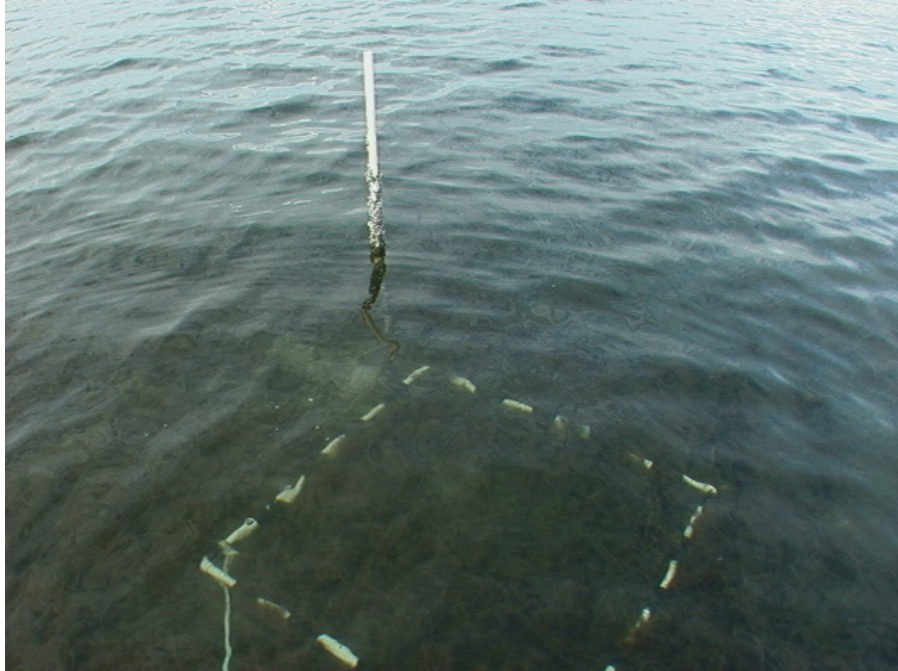
Photograph 1. Randomized grid samples (1m² quadrats) were used to survey seagrass coverage at each receiver site.

CPE used randomized grid samples (1m^2 quadrats) to survey each receiver site (Photograph 1) (pursuant to Permit No. 58-01637883-002 Seagrass Mitigation Plan [Attachment B] Page 6 of 15). The quadrat method is more suitable for seagrasses that propagate by long runners and do not form a clearly radial growth pattern (e.g., shoal grass) especially after the onset of growth and coalescence (Fonseca, 1993).

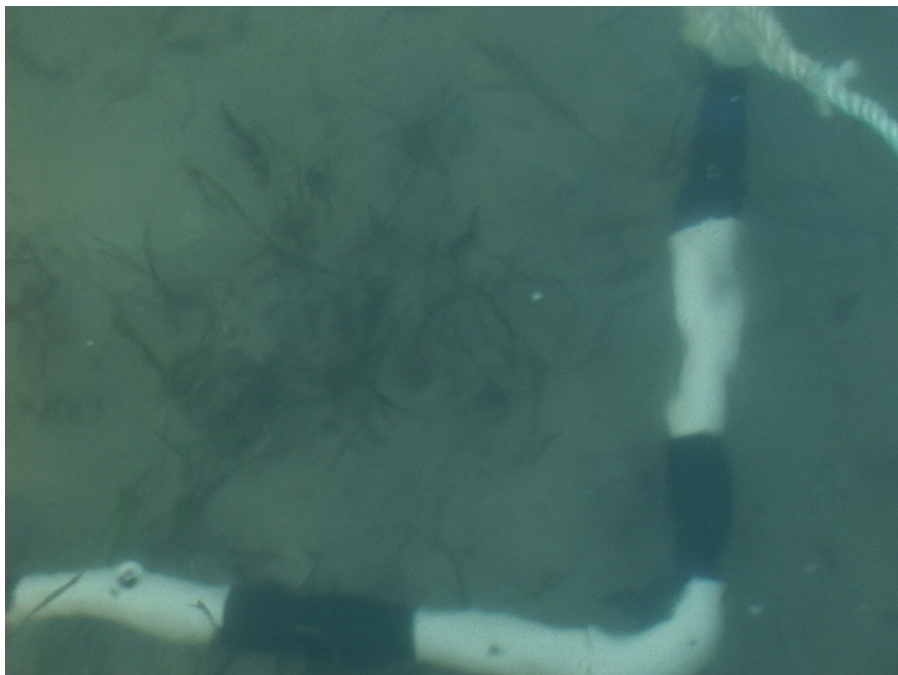
Photograph 2. A sample within the Durante Offshore Site is shown above.

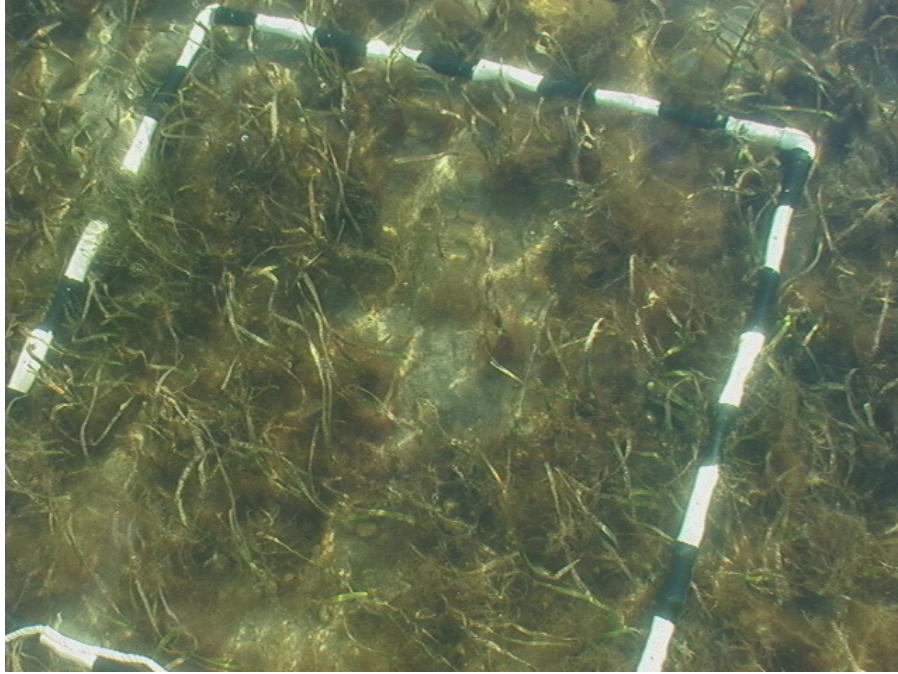
Photograph 3. Many of the transplants have coalesced within the Double Propeller Scar Receiver Site.

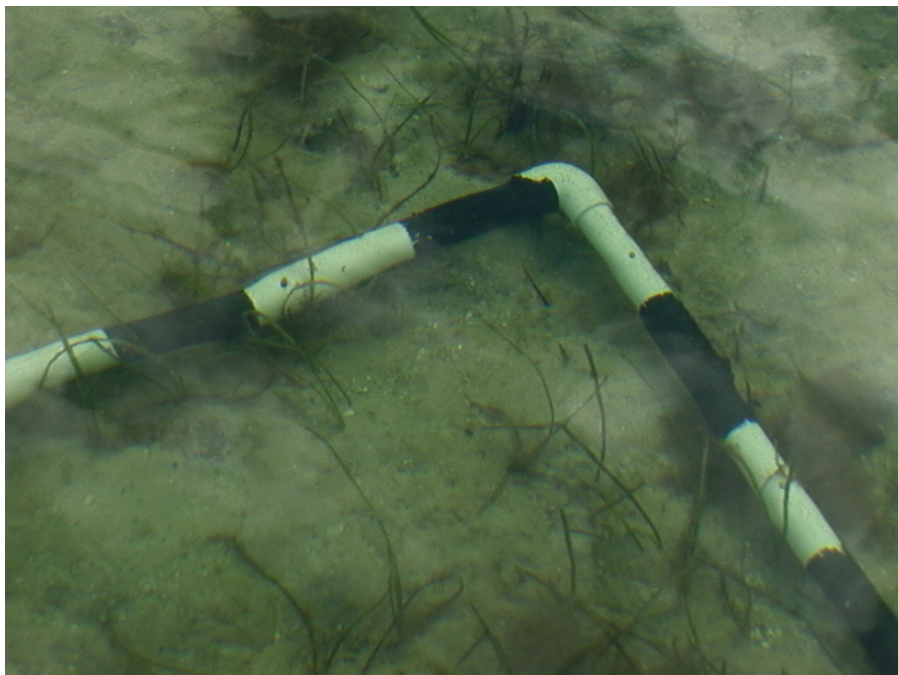
Photograph 4. Coquina Site 2 was the only site to yield an increase in seagrass during the thirty month survey.

Eighteen random 1m^2 quadrats were used to survey 5% of the receiver site (potential experimental error of 5.6%). CMT originally planted 236, 8-inch diameter (0.0324m^2) plugs within a 356m^2 area at Coquina Site 2. The total maximum area covered by transplanted seagrass at the time of planting was 8m^2 , which was a maximum of 2.15% of the receiver area. An average of 1.8% cover of seagrass was calculated from the percent cover assessed in the 18 quadrats. The overall area covered with seagrass increased from 0.6m^2 , recorded during the twenty-four month assessment, to 6.3m^2 during the thirty month (December 2005) assessment (Photograph 4). Calculated survivability was approximately 50%.

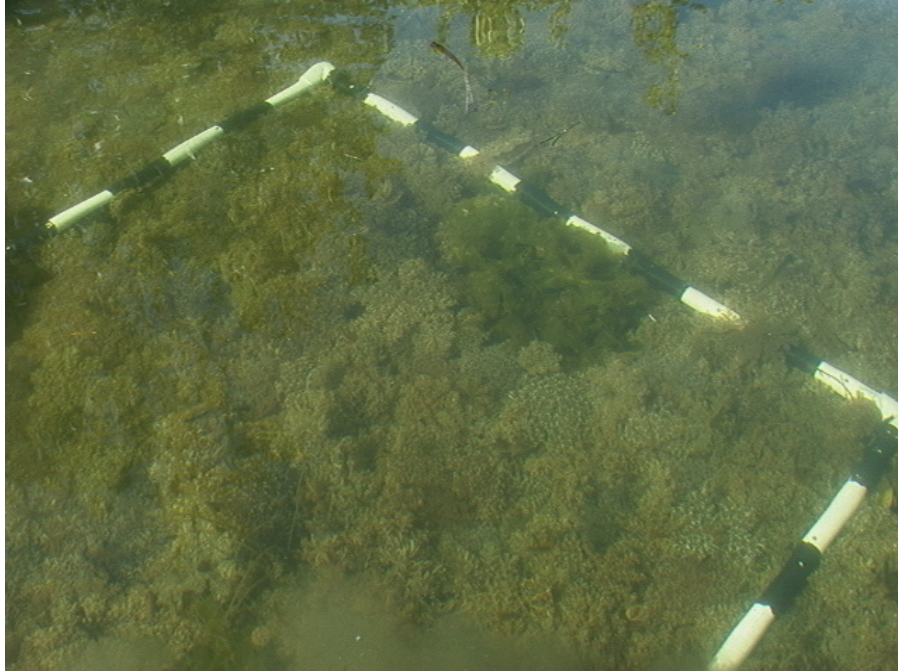
Photograph 5. Dense clusters of the mangrove upside-down jelly (*Cassiopea xamachana*) had formed “carpets” covering seagrass within portions of the Coquina Tidal Creek.
