MORPHOLOGICAL CHANGES AT THE 32nd STREET BREAKWATER
PROJECT
MIAMI BEACH, FLORIDA

Jannek Cederberg, M. Sc.
R. Harvey Sasso, P.E.
Coastal Systems International, Inc.
464 South Dixie Highway
Coral Gables, Florida 33146

Abstract

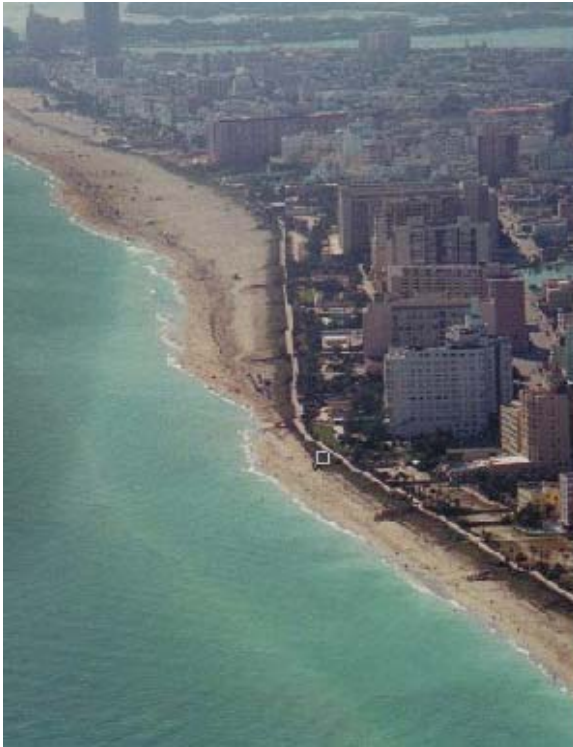
FIGURE 2

In 2000, Coastal Systems conducted an analysis of the 32nd Street Hot Spot. Following the analysis, shoreline stabilization consisting of 3 shoreline attached breakwater serving as headlands were recommended to reduce the continuing erosion experienced and stabilize the shoreline. The analysis showed that the shoreline orientation changes abruptly at the 32nd Street resulting in high erosion rates. As the beach in this area eroded at higher rates compared to the adjacent areas, the nourishment frequency of the area was dictated by the erosion rates at the 32nd Street. The narrow pre-construction beach along with the accretional beach further south is illustrated in Figure 2, which shows the conditions in 1996.

Pre-construction Conditions 1996

Several nourishment projects have been performed over the years without stabilizing the 32nd Street area. As the aerial photo from 1996 illustrates in Figure 2, the area needed further stabilization. Figure 4 illustrates a photo of the area in 2004. The difference between the pre- and post conditions are evident as the beach at and north of the breakwaters are significantly wider.

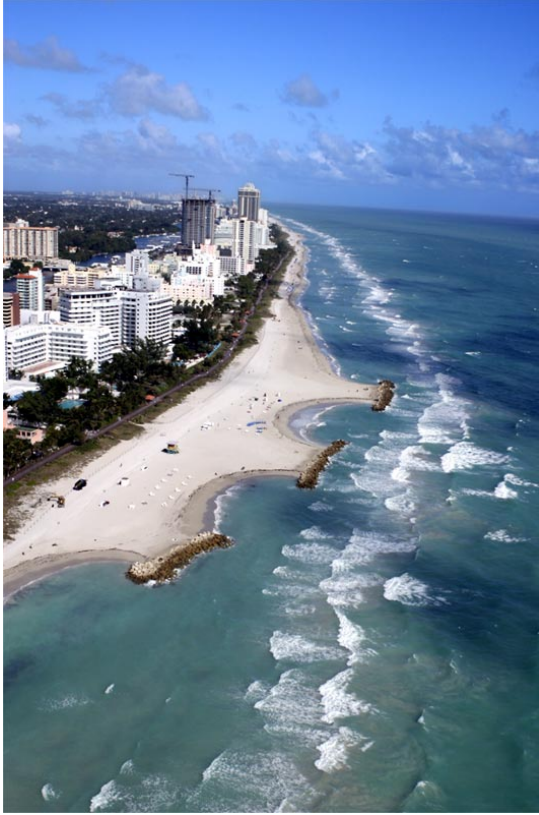
FIGURE 4

2004 Aerial of the 32nd Street Breakwaters
