The Juno Beach Shore Protection Project and Oyster Reef Restoration in the Loxahatchee River

(or... Making Lemonade out of Lemon-Sized Rocks)

Permit History

Let's Build a Beach!

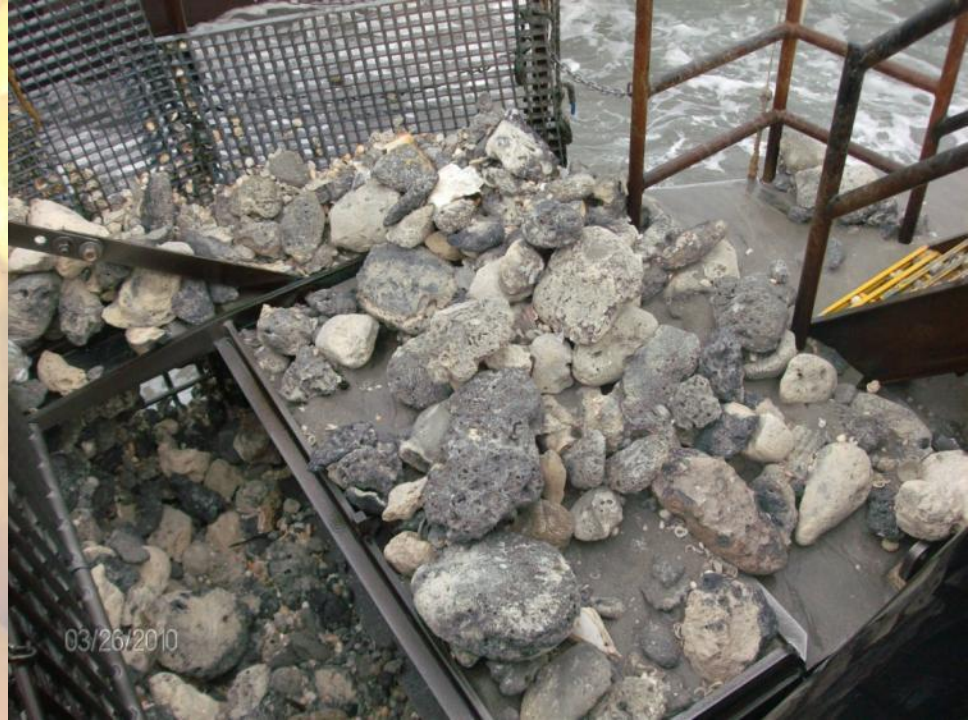
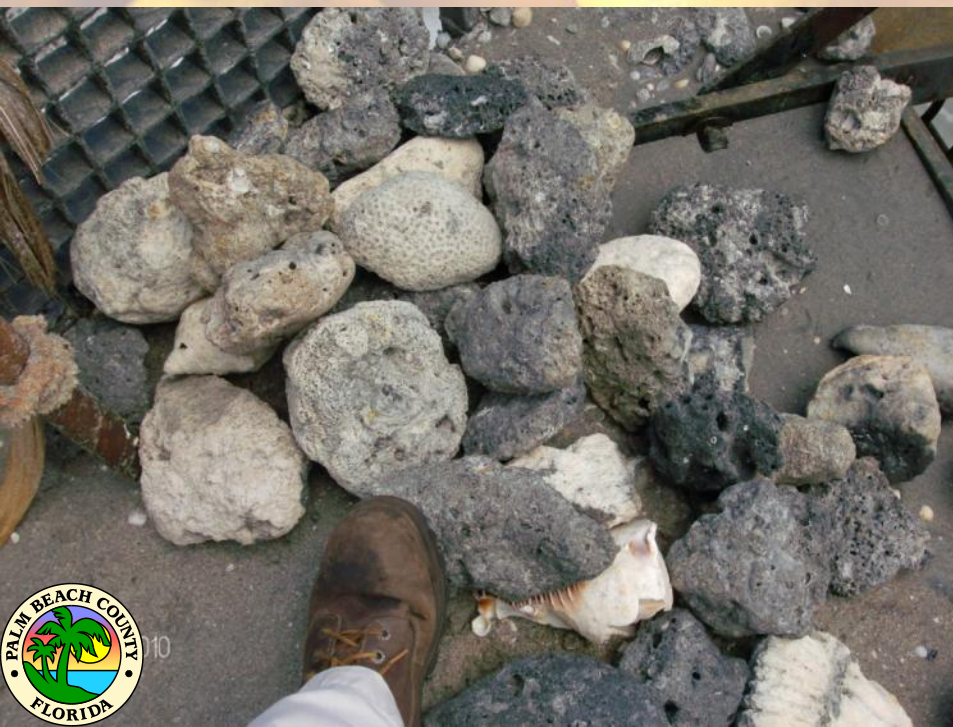
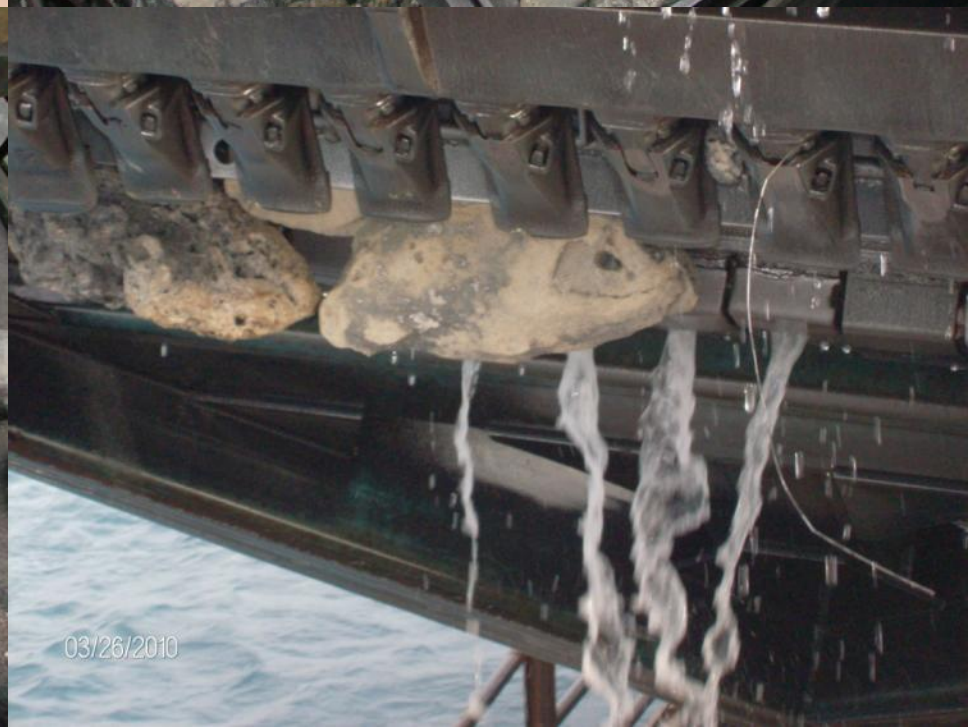
With the very first load, it became apparent that the geotechnical reports did not tell the whole story of what was in the borrow area...

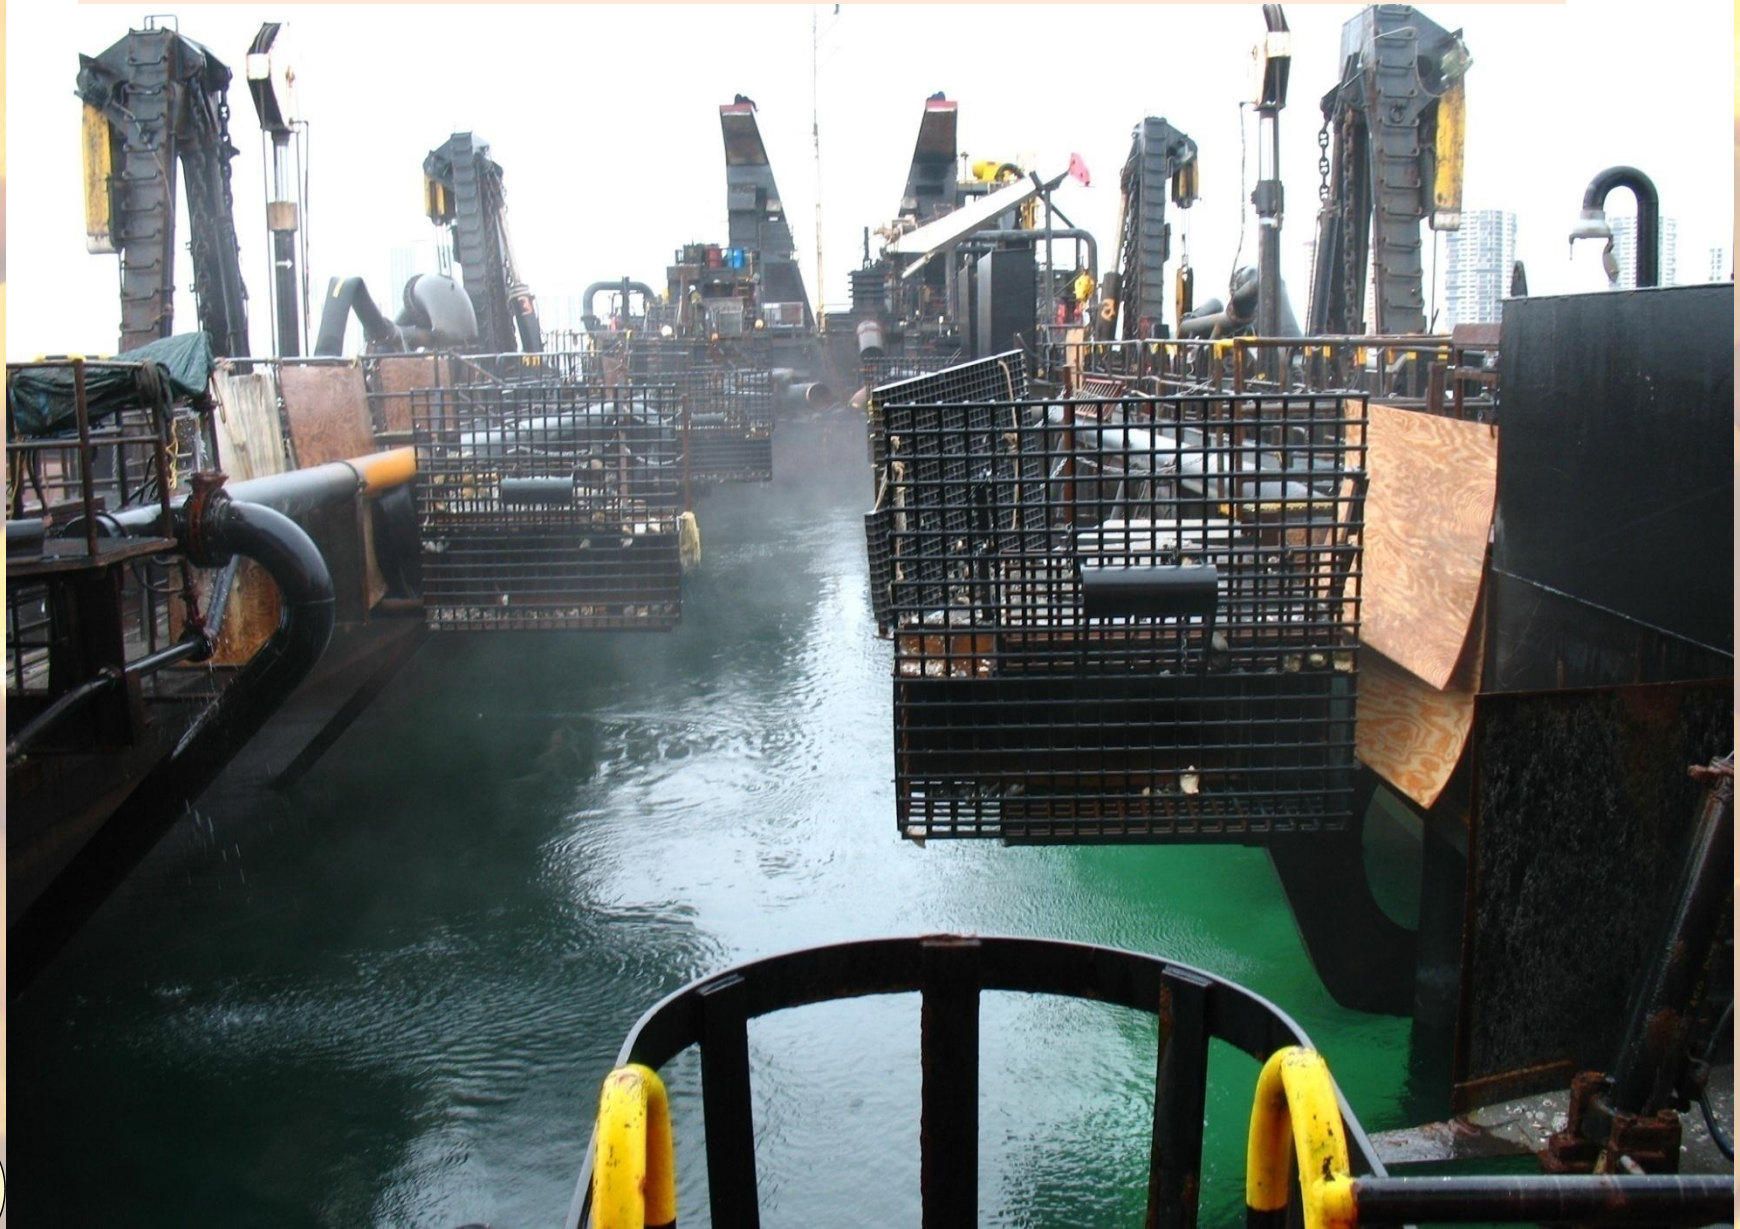
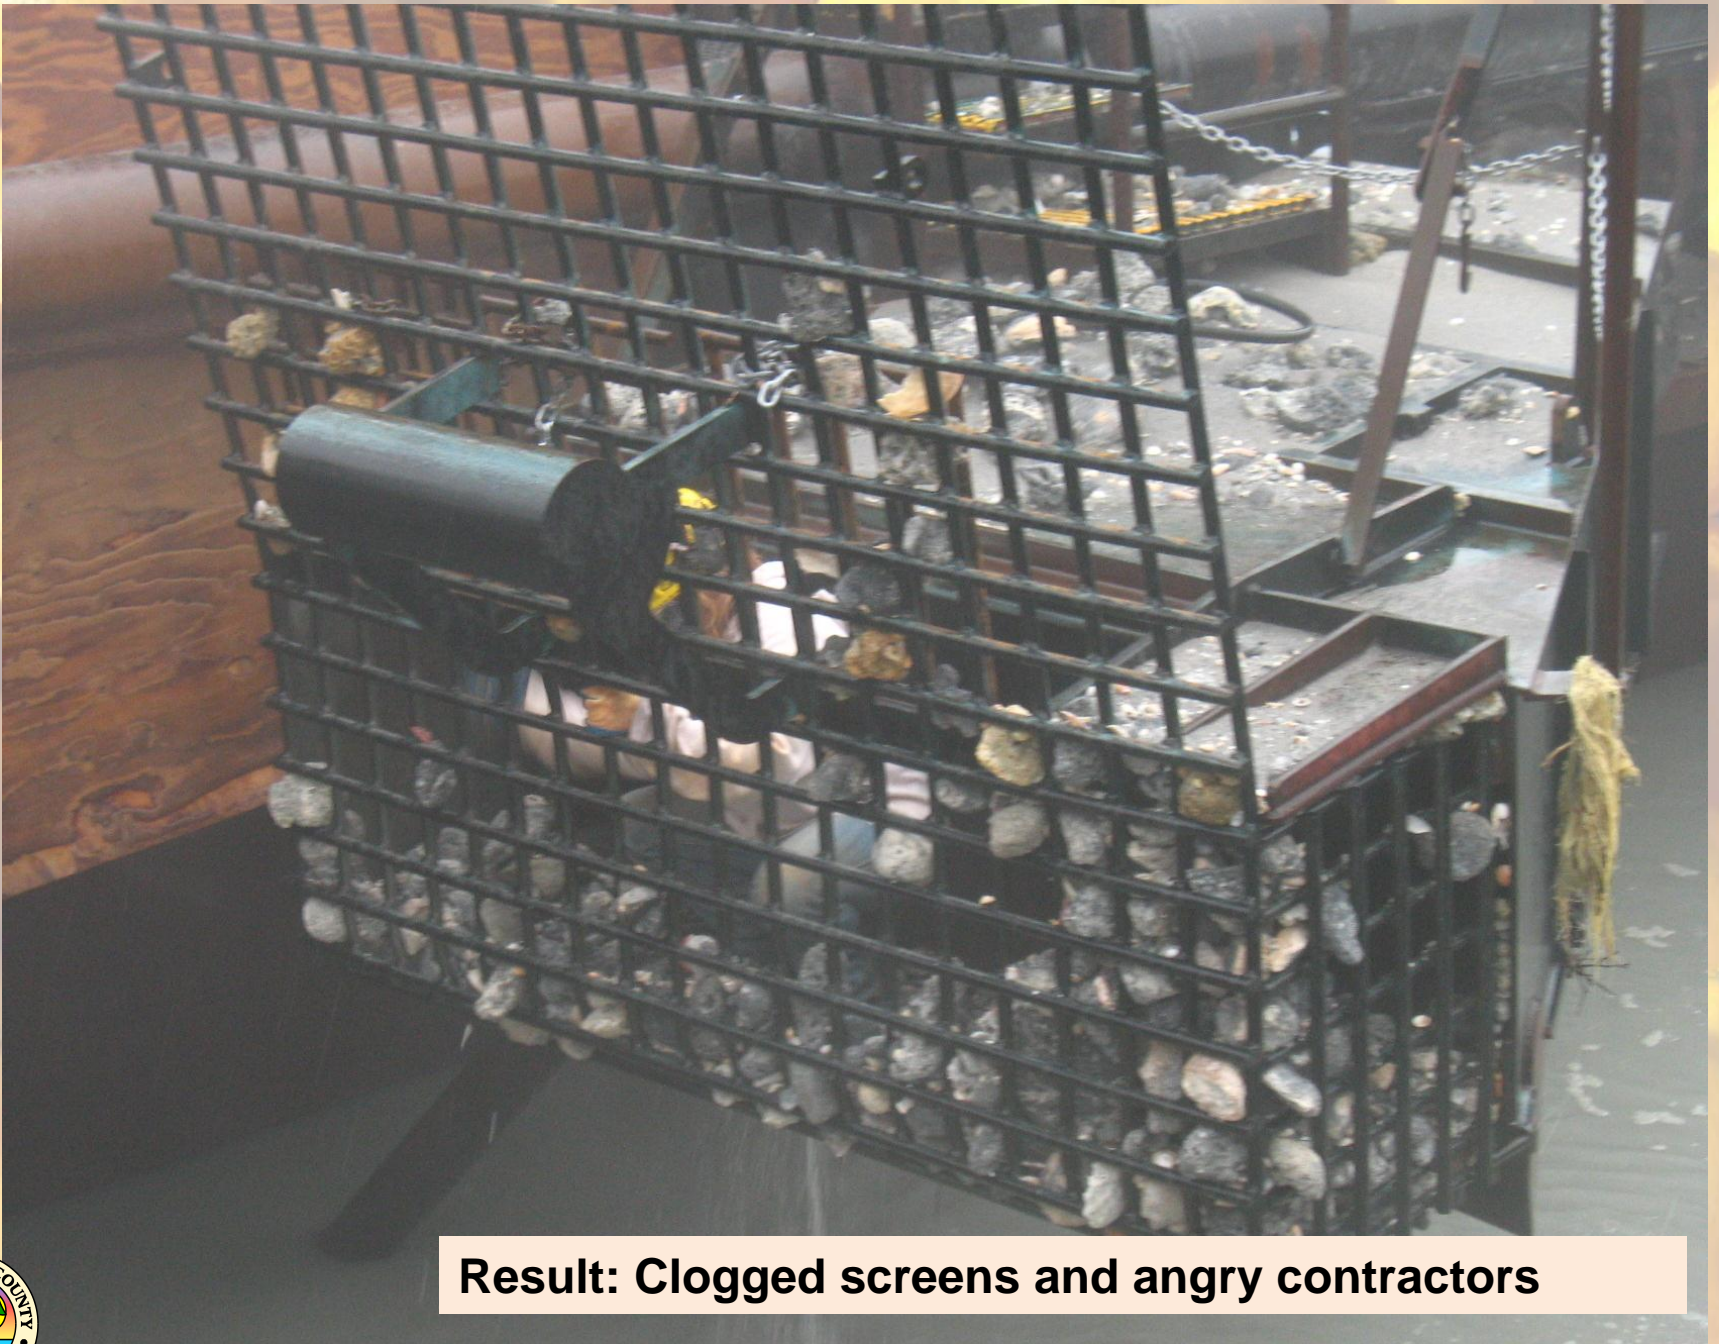
2) Add'l Screening on the Dredge...

Result: Clogged screens and angry contractors

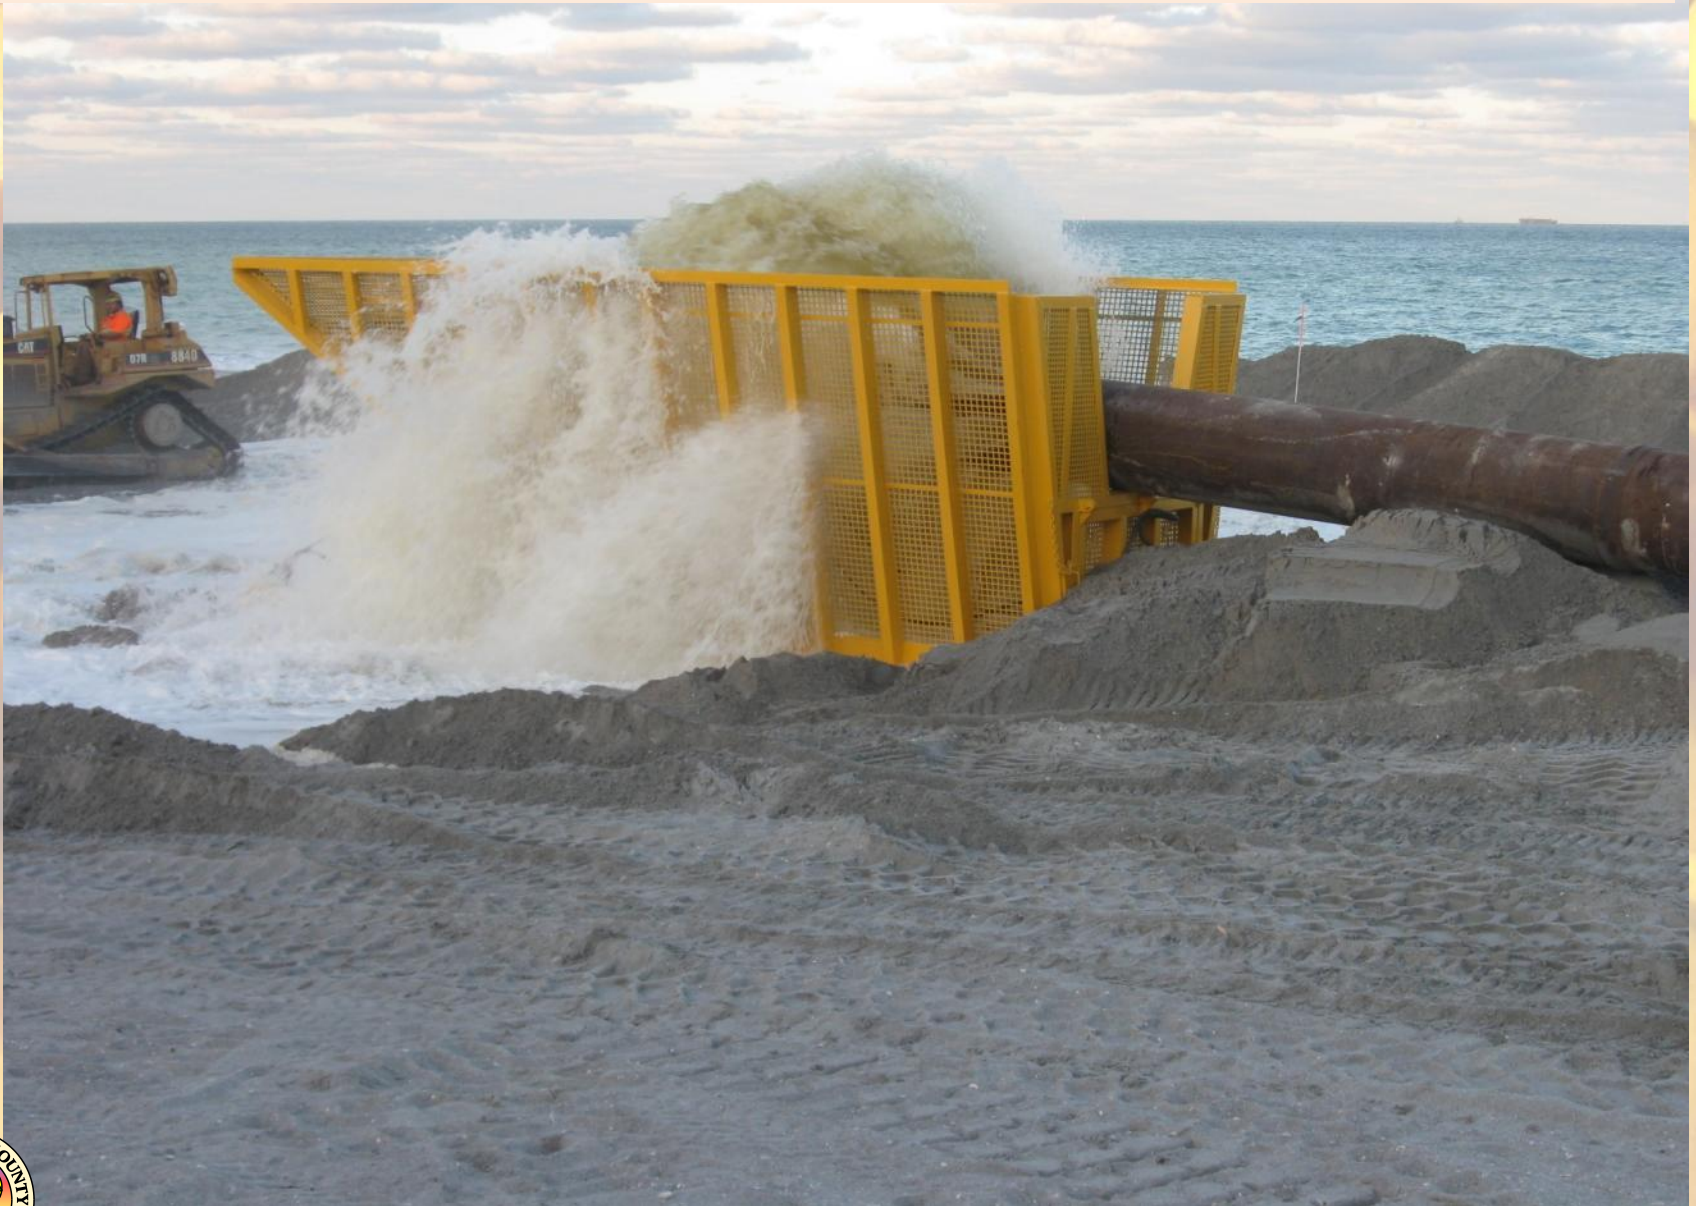
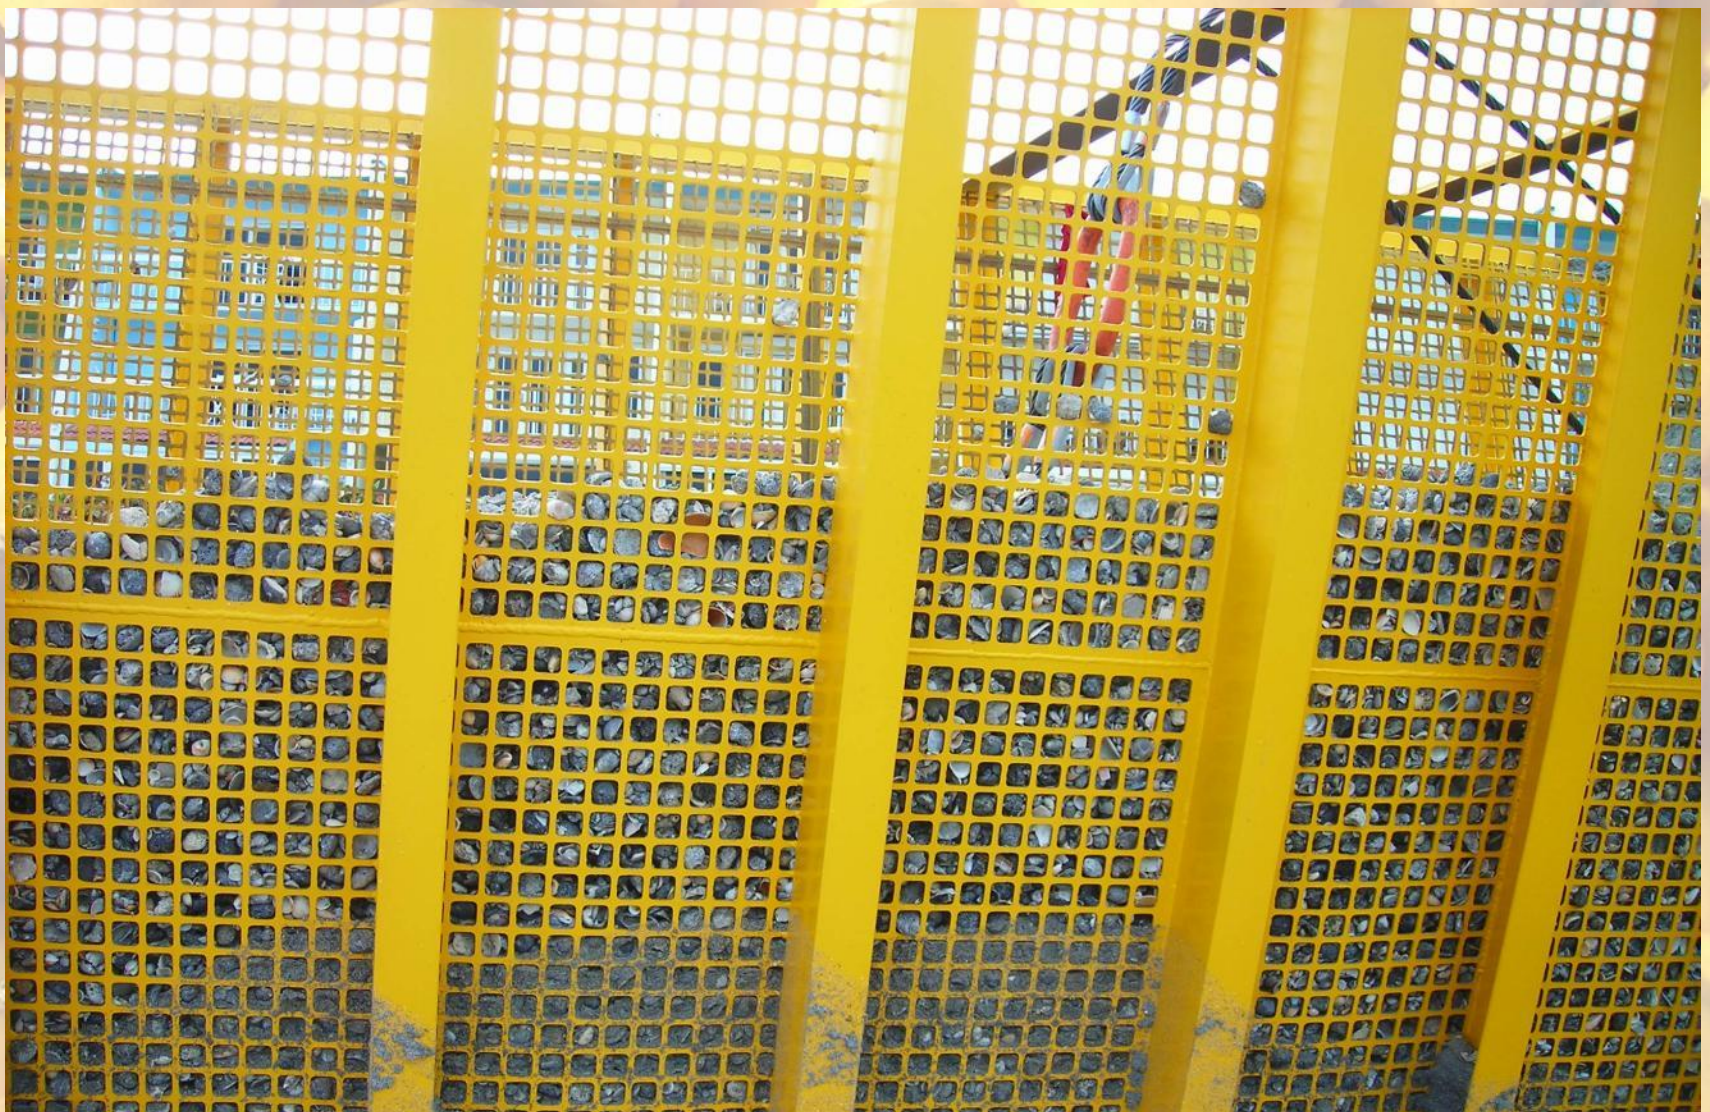
3) Add screens at end of discharge pipe

**Result: Clogged boxes, backed up discharge pipes, and...
angry contractors**

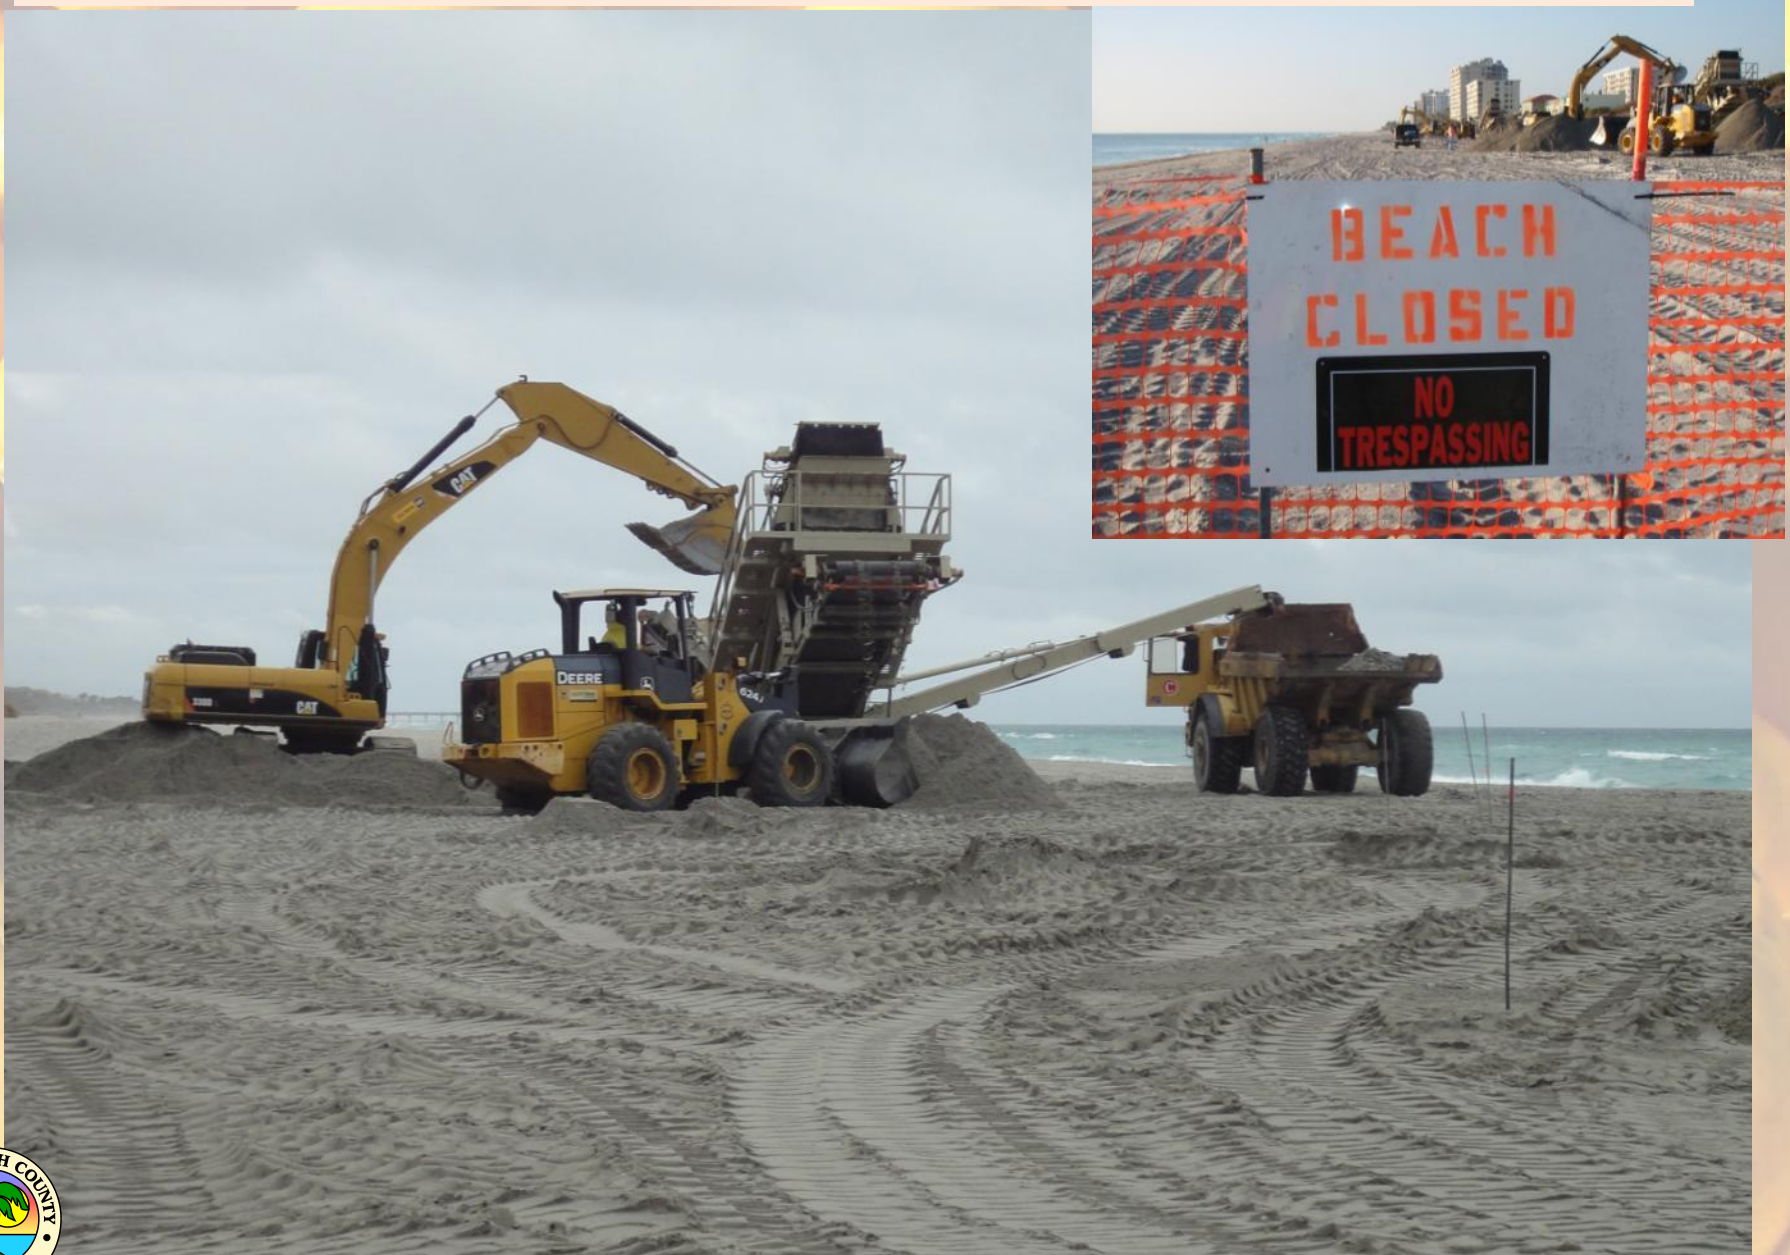
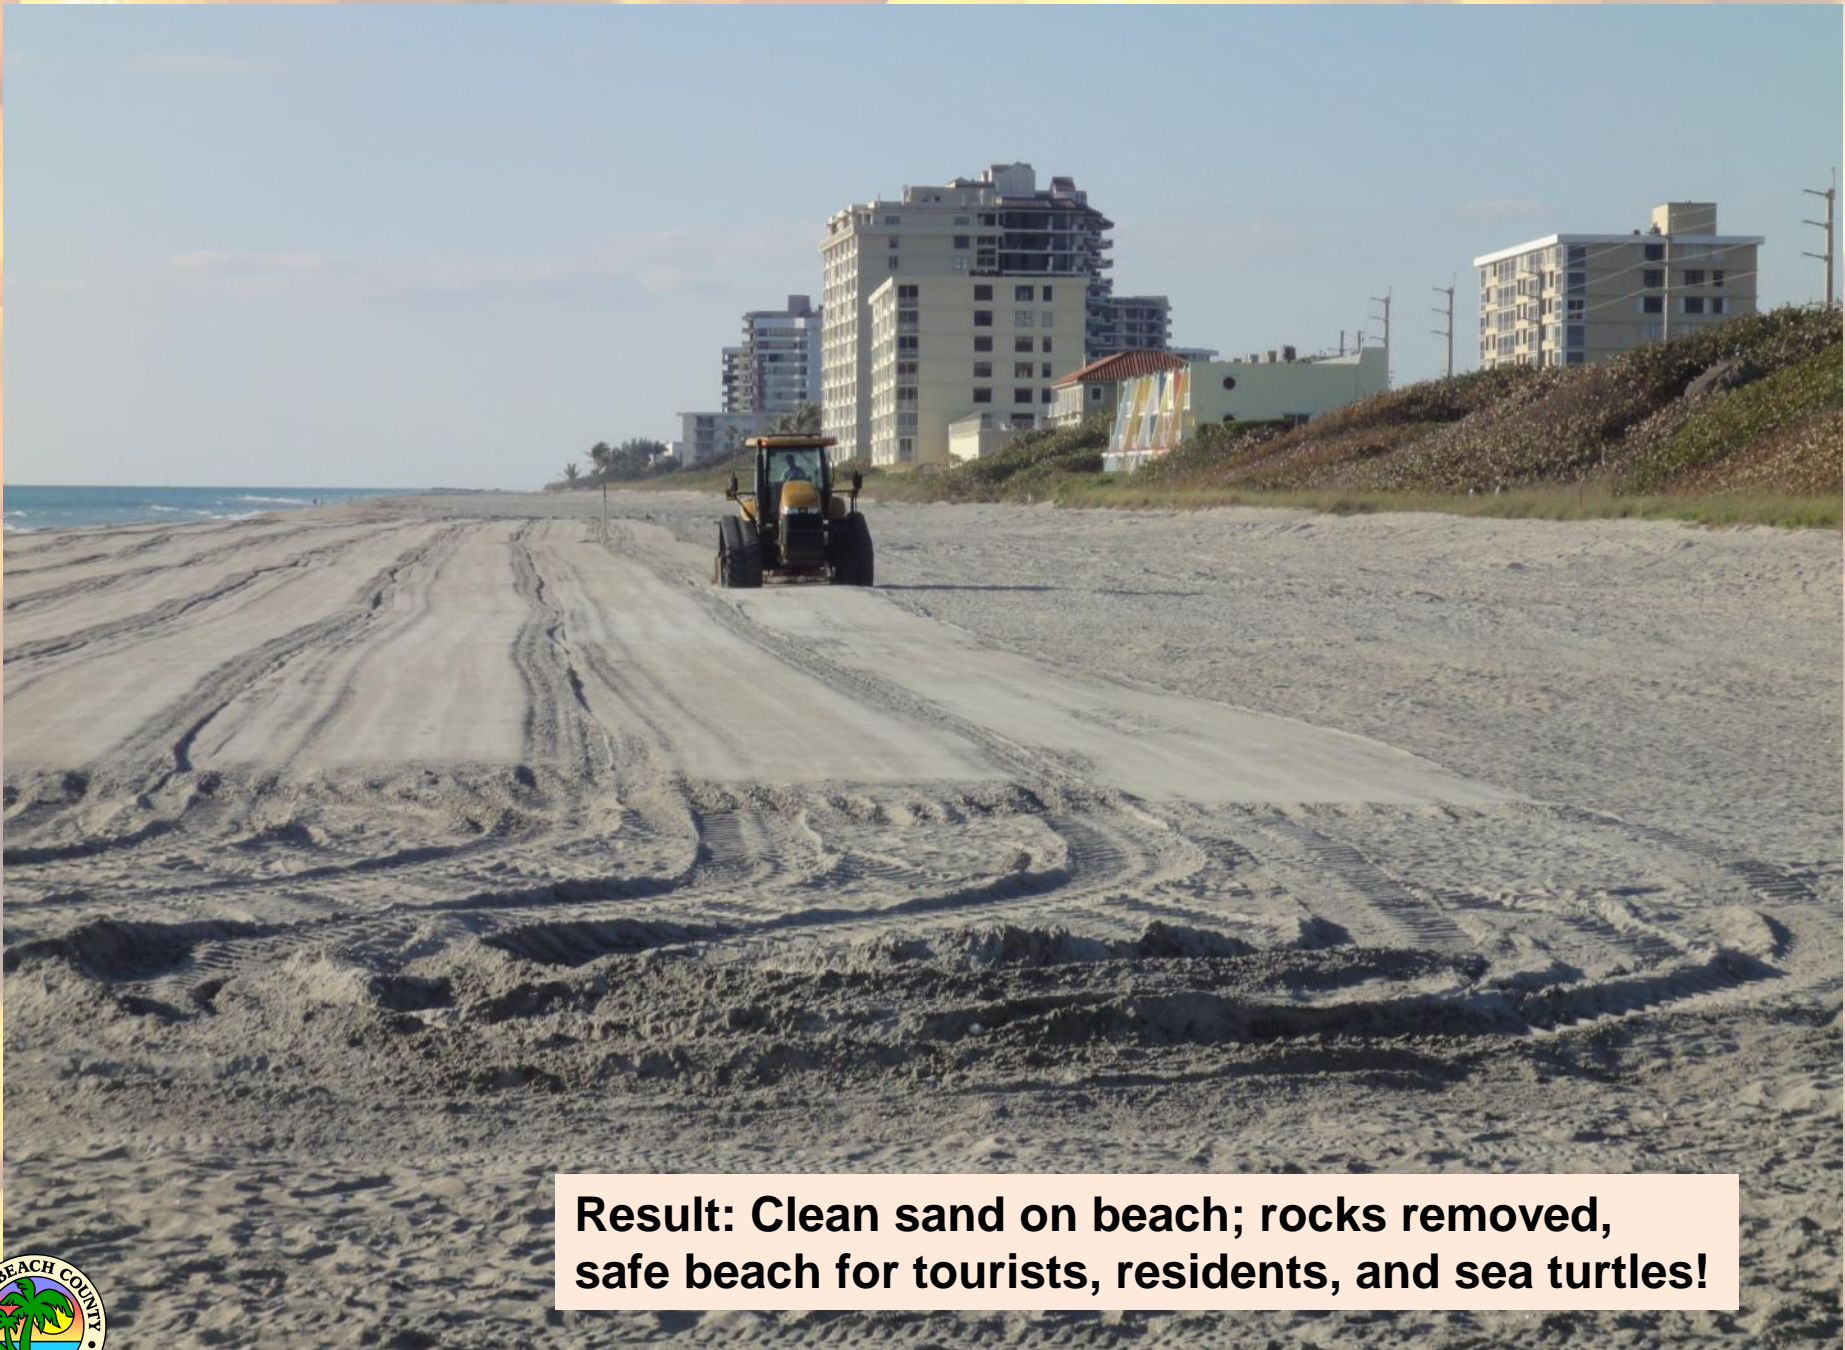
4) Post construction screening of fill...

Result: Clean sand on beach; rocks removed, safe beach for tourists, residents, and sea turtles!

- **Construction Dates: 3/15 – 4/30/2010**
- **Dry berm screened to 5' depth**
- **Volume of fill screened = 211,000 yd³**
- **Total rock screened from beach = 6457 tons**
- **Cost ~ \$1,000,000**

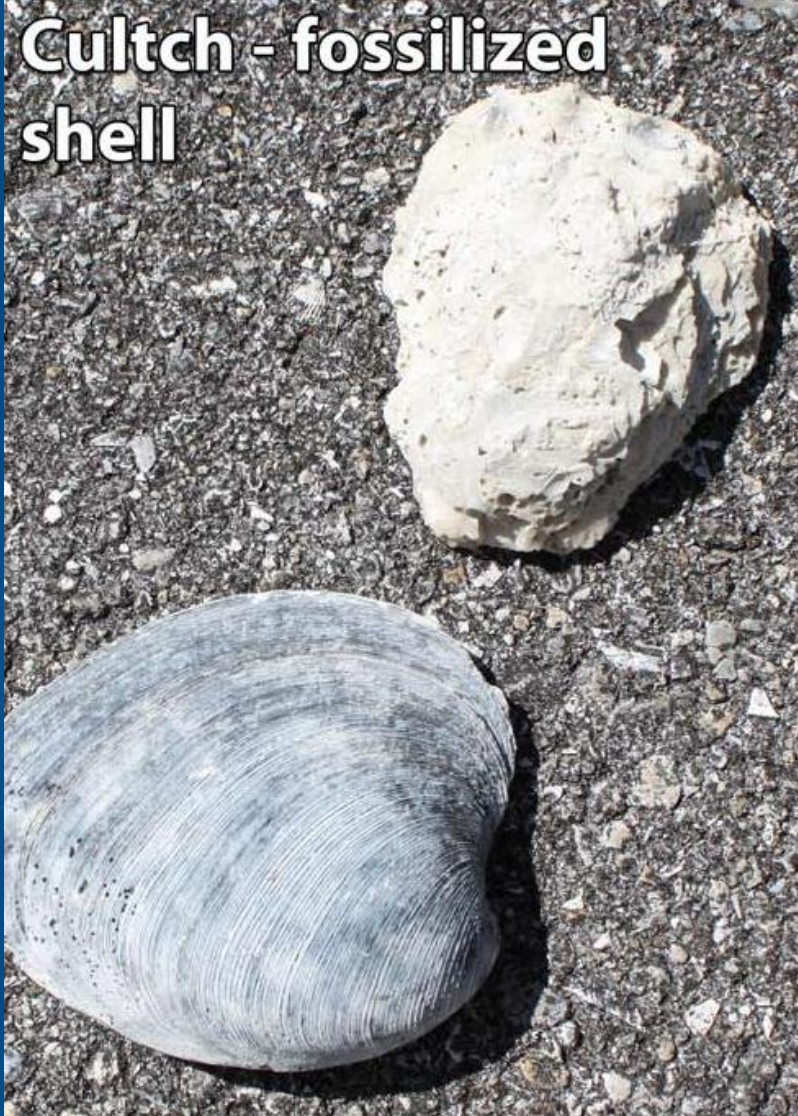
Cultch - fossilized shell
