The Collier County Beach Management Program Over Two Decades

Gary McAlpin, P.E., Coastal Zone Management Director, Collier County, FL

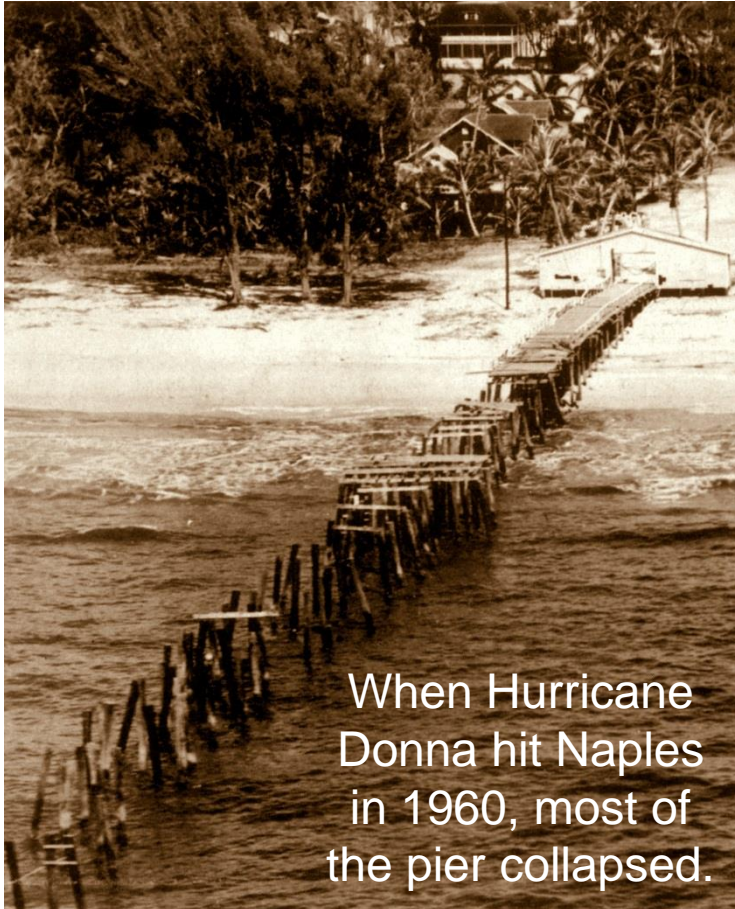
When Hurricane Donna hit Naples in 1960, most of the pier collapsed.

- First constructed in 1888:
 - Pier Street (12th Avenue S.)
 - Passengers and freight
 - Fishing
 - Post Office
- Hurricanes:
 - 1910: rebuilt and extended 100'
 - 1926: severe damage
 - 1935: "Labor Day" hurricane
 - 1944: complete rebuild
 - 1960: Hurricane Donna
- Renovated most recently in 2015

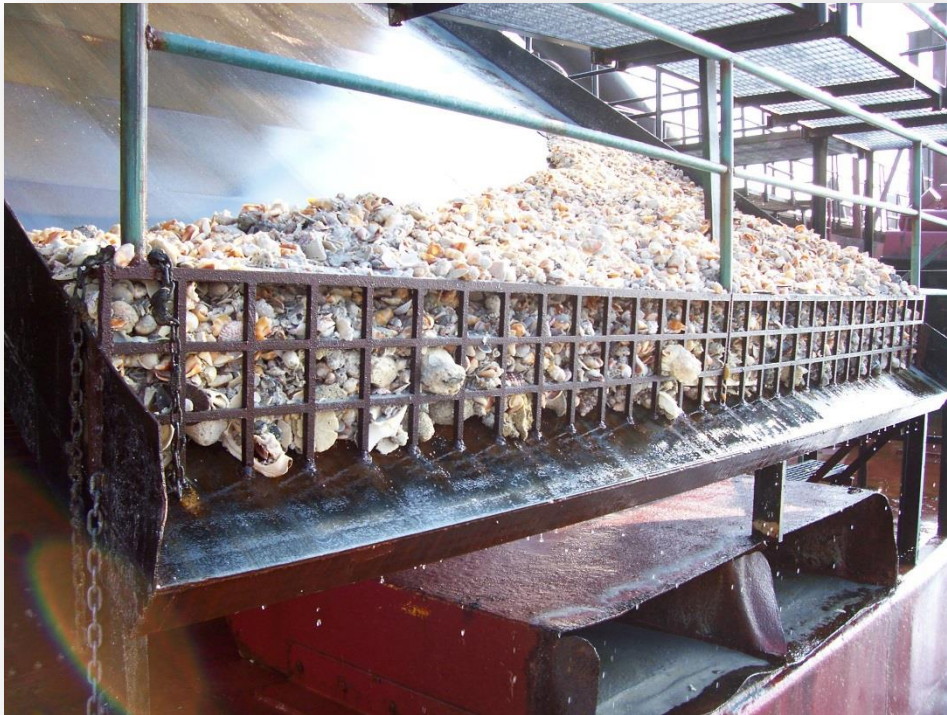
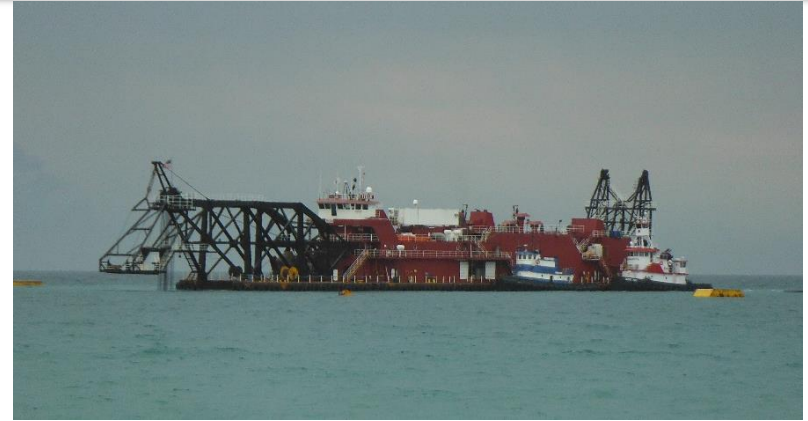
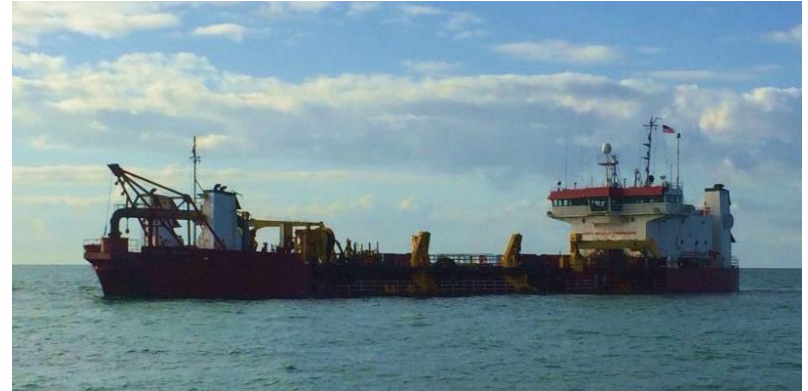
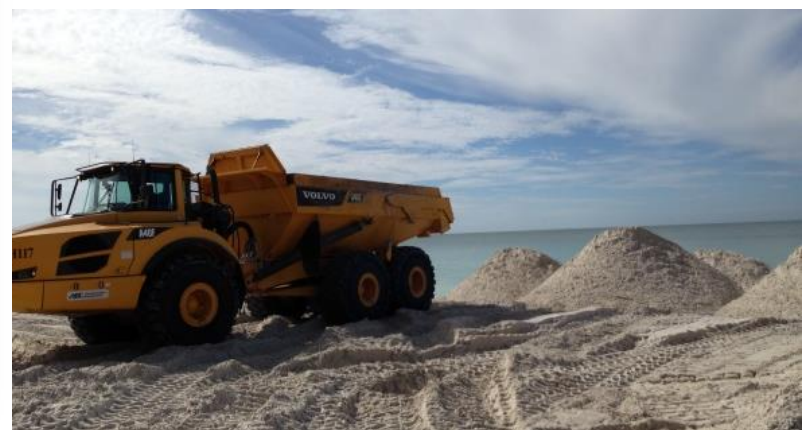
- Cutterhead Dredge and Scow (1996)
- Hopper Dredge with Screening (2006)
- Truck Haul (2013-14)
- Truck Haul / Fluidization (2016)

- **1996 – Initial Project**
 - 1.2 M cy
 - Borrow Areas NBII A+B, BA 6 (cutterhead and scow)
 - Vanderbilt, Park Shore, Naples
- **2006 – Renourishment**
 - 670,000 cy
 - Borrow Area T1 (hopper)
 - 3 extended segments
 - 1.09 ac artificial reef
 - Biological monitoring
- **2013-14 – Renourishment**
 - 235,000 cy (truck haul) + 40,000 cy Doctors Pass (dredge disposal)
 - Truck haul (Immokalee Mine)
 - Placement areas based on need
 - Biological monitoring

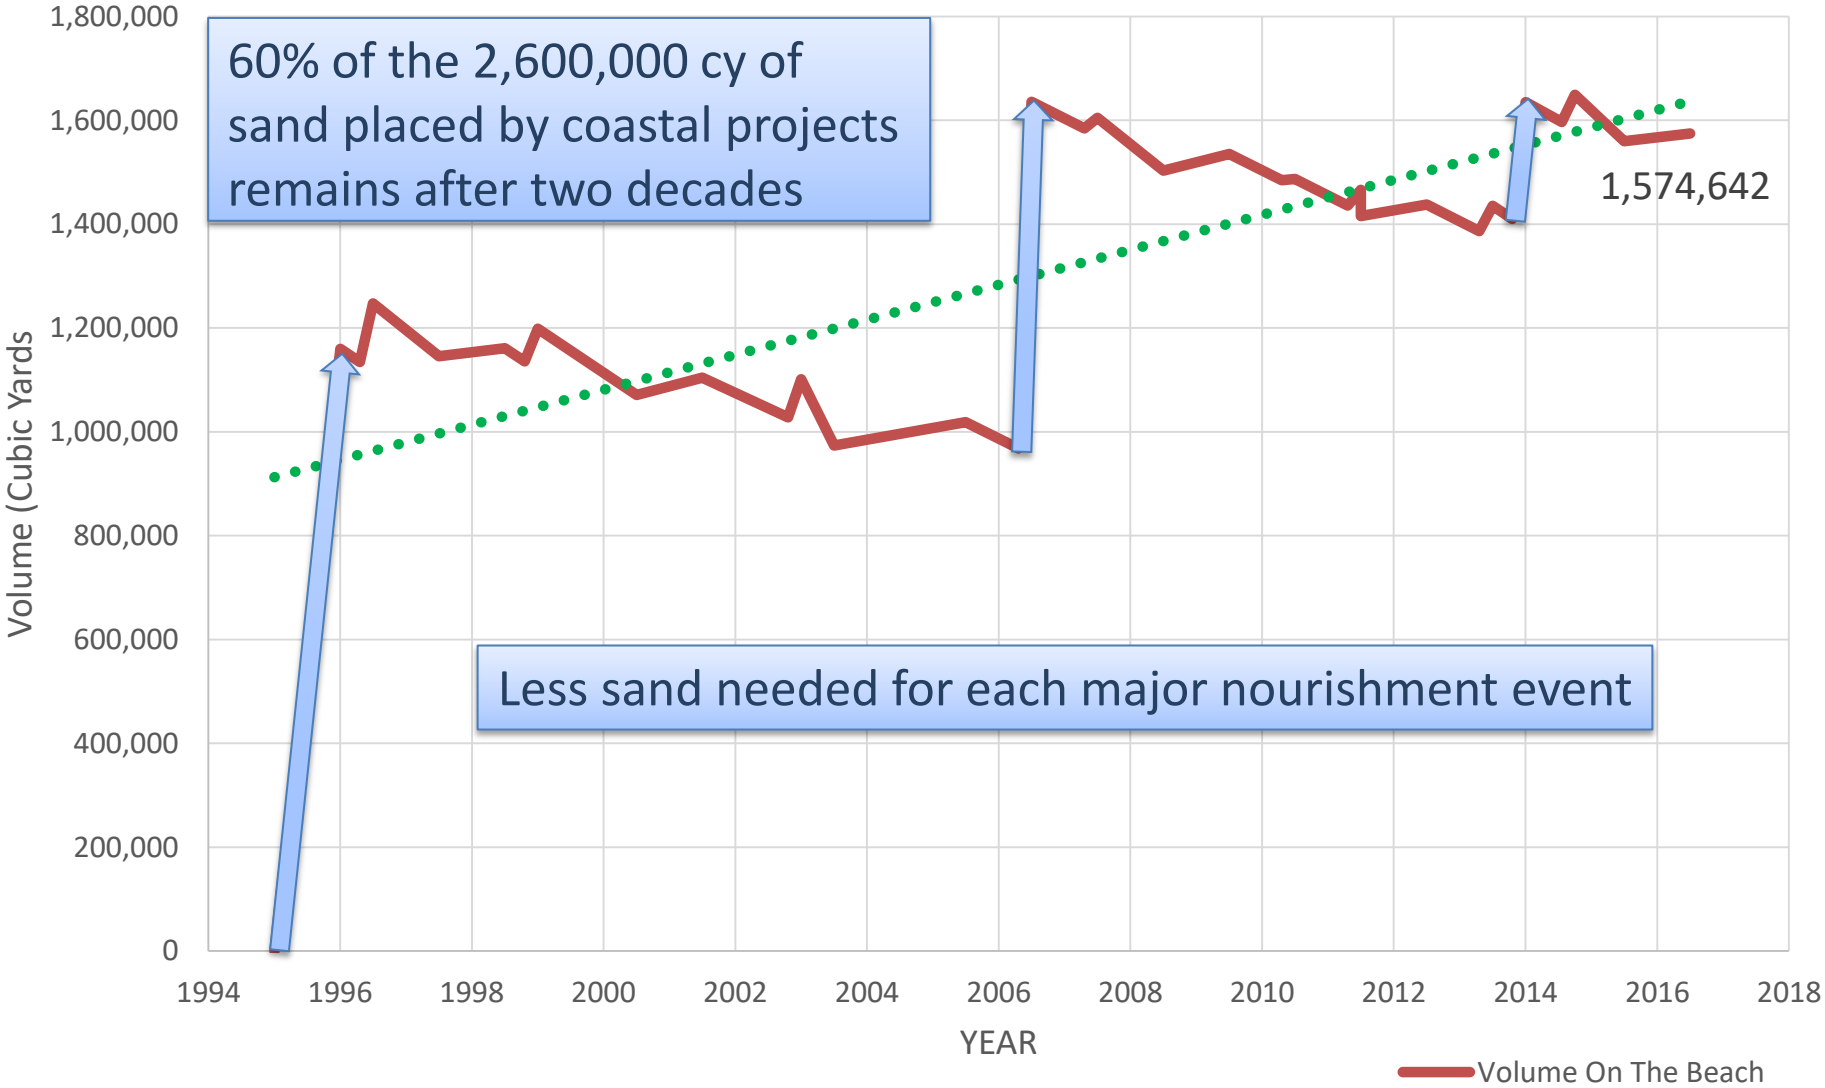
Collier County Beach Nourishment Project (North County)

60% of the 2,600,000 cy of sand placed by coastal projects remains after two decades

Less sand needed for each major nourishment event

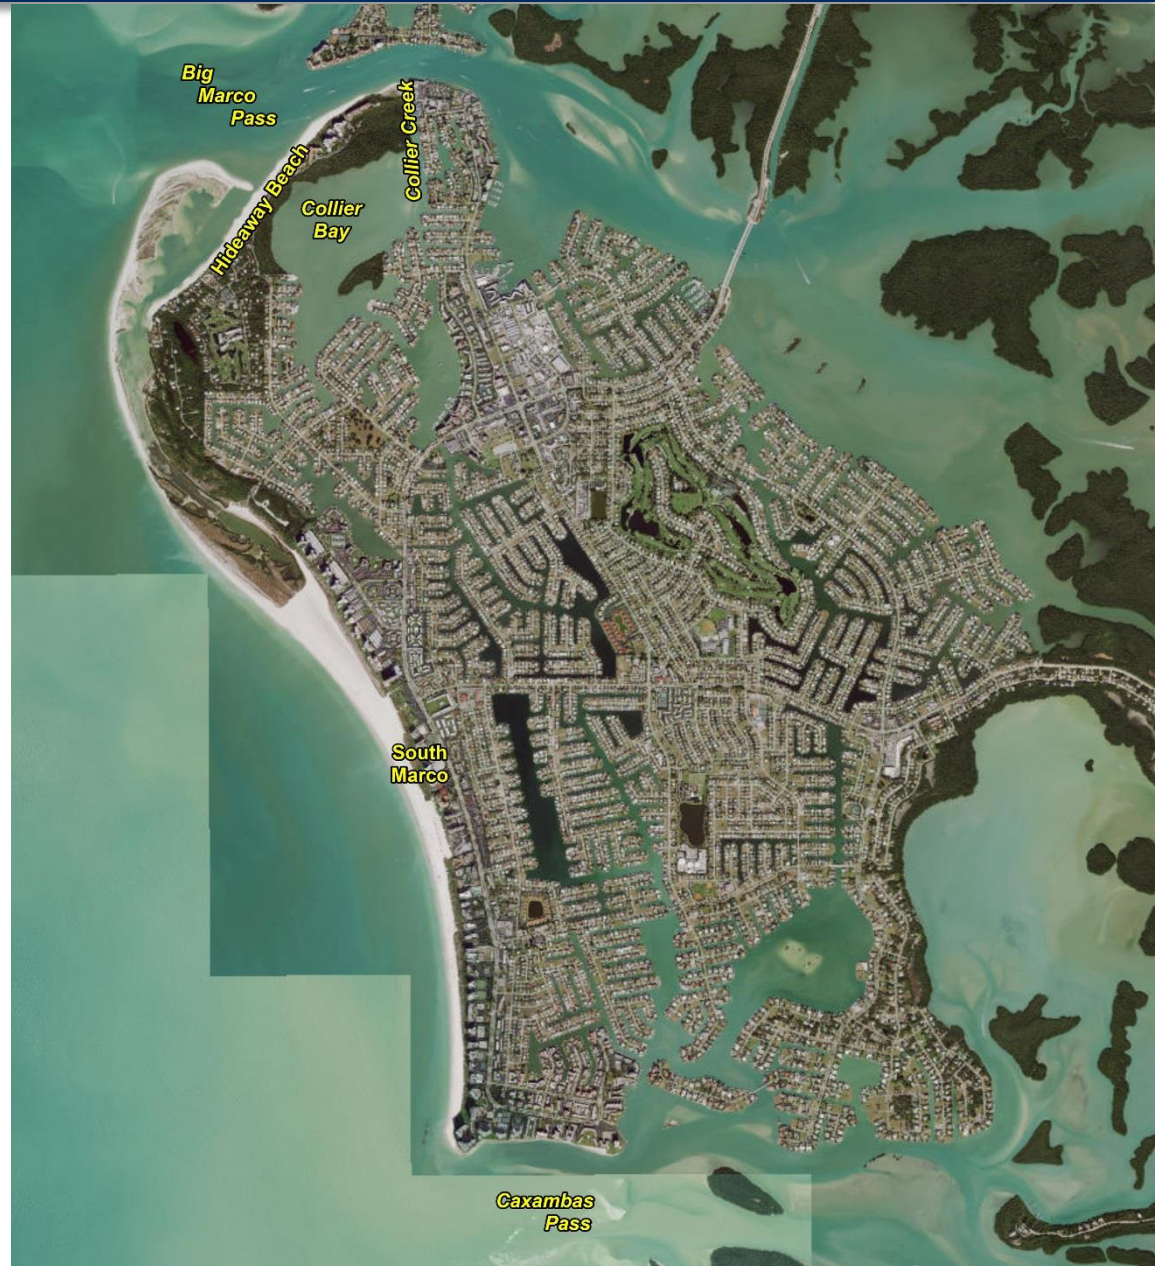
- Collier Creek
 - Navigation dredging

- Hideaway Beach
 - Big Marco Pass
 - Collier Creek

- Tigertail Beach
 - Natural Park Area

- Central Marco
 - Beach Grading

- South Marco
 - Caxambas Pass
 - 2016 Truck Haul

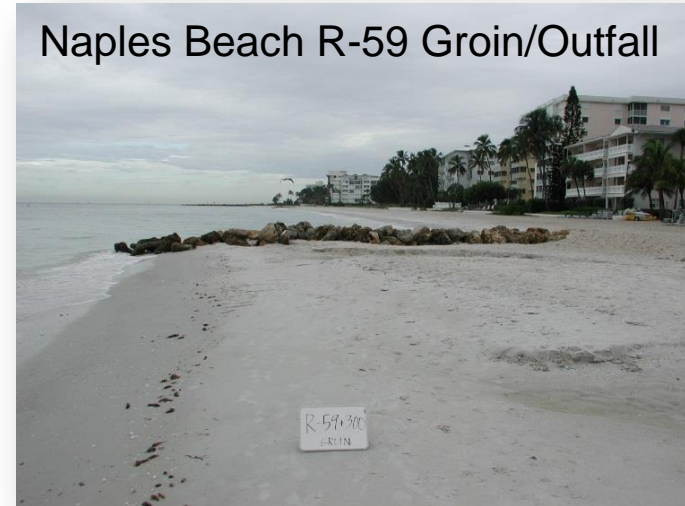
Naples Beach R-59 Groin/Outfall

Photographs of Collier County Beaches from 2003
7-Years after Initial Construction

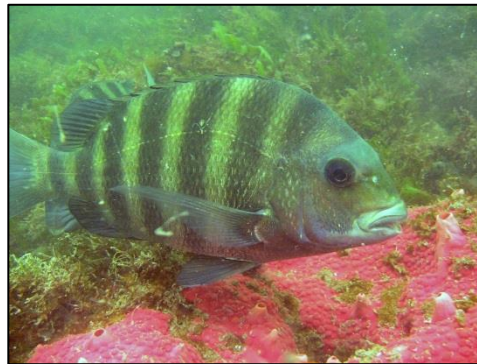
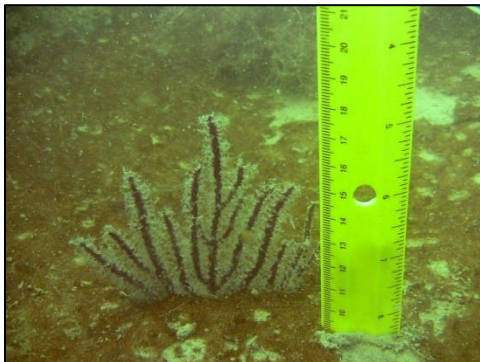
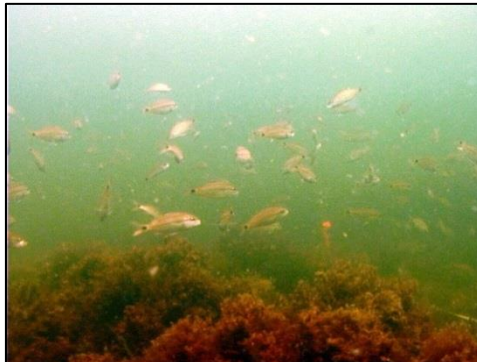
- Over 500 acres of nearshore hardbottom
- Approximately 500 – 1,000 feet from shoreline
- Water depths 11 - 18 feet
- Low relief (1 ft average to 3 ft maximum)
- Sidescan and diver delineated edge

— 2015 DIVER DELINEATED HARDBOTTOM

— 2013 DIVER DELINEATED HARDBOTTOM

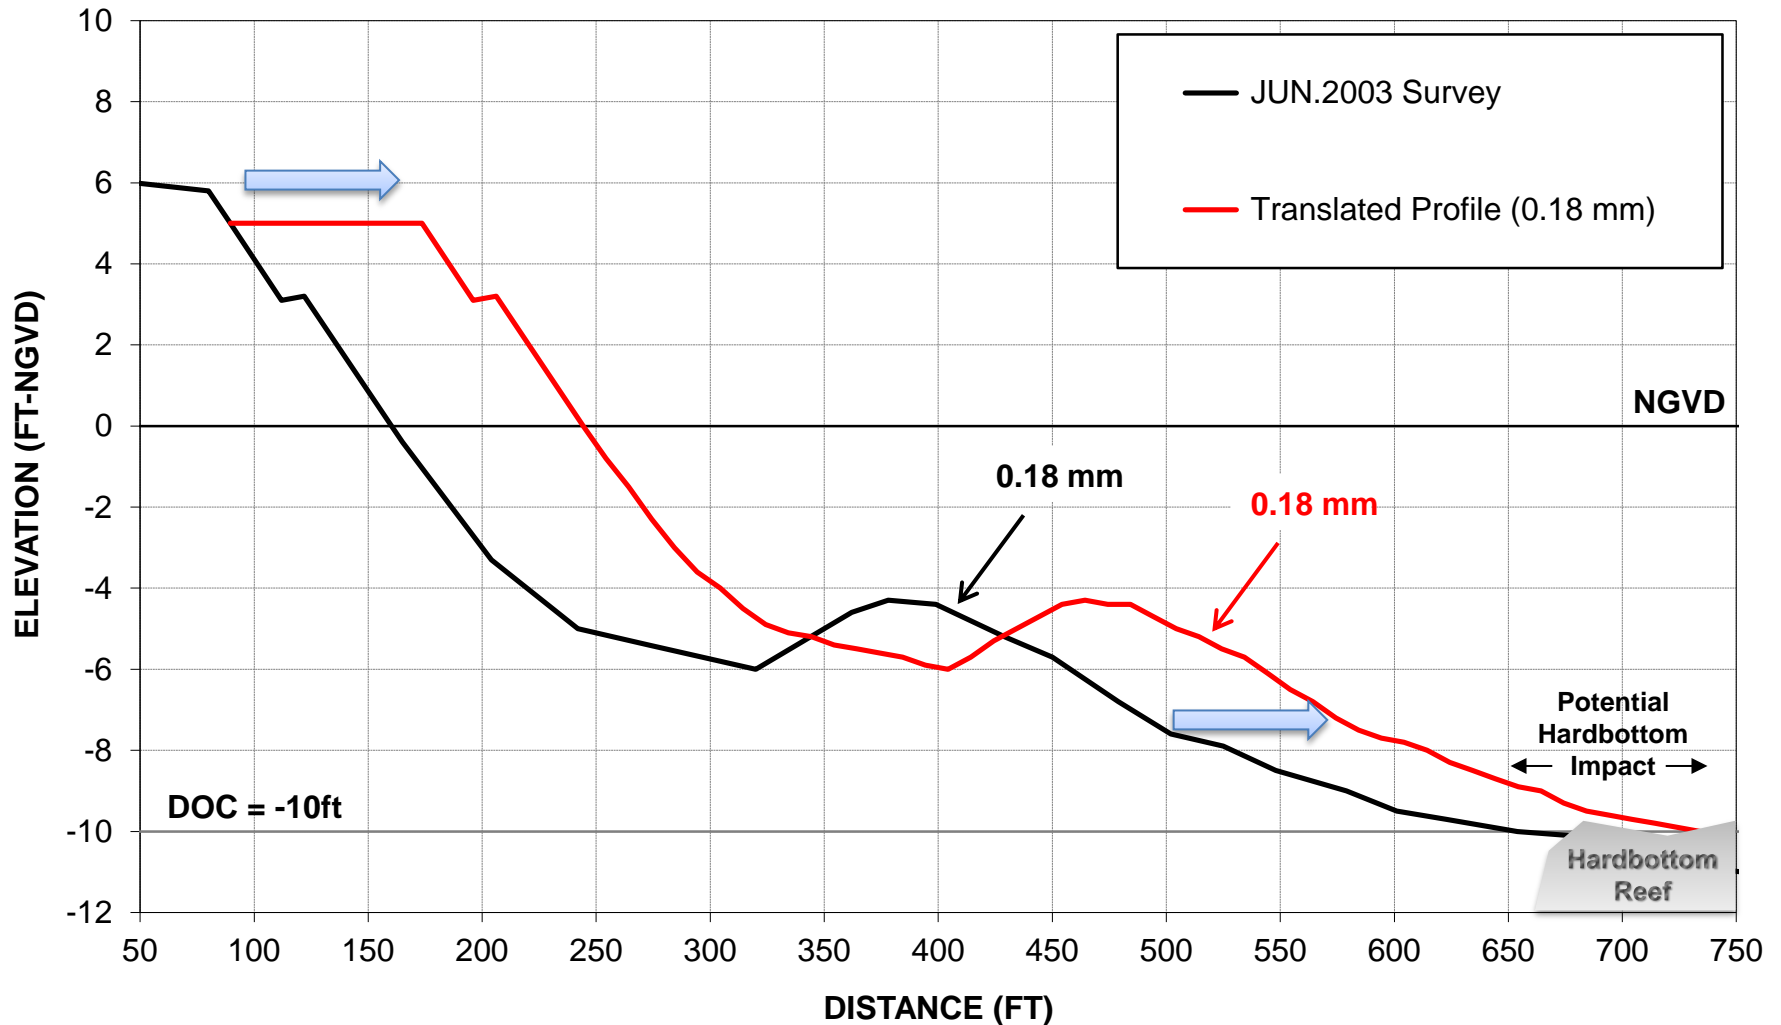
PARK SHORE BEACH PROFILE R-52 Translated Profile Equilibration

Based on CEM (2000) Method: Equation V-4-5, EM 1110-2-1100, Part V, Chapter 4 - BEACH FILL DESIGN, pg. V-4-35.

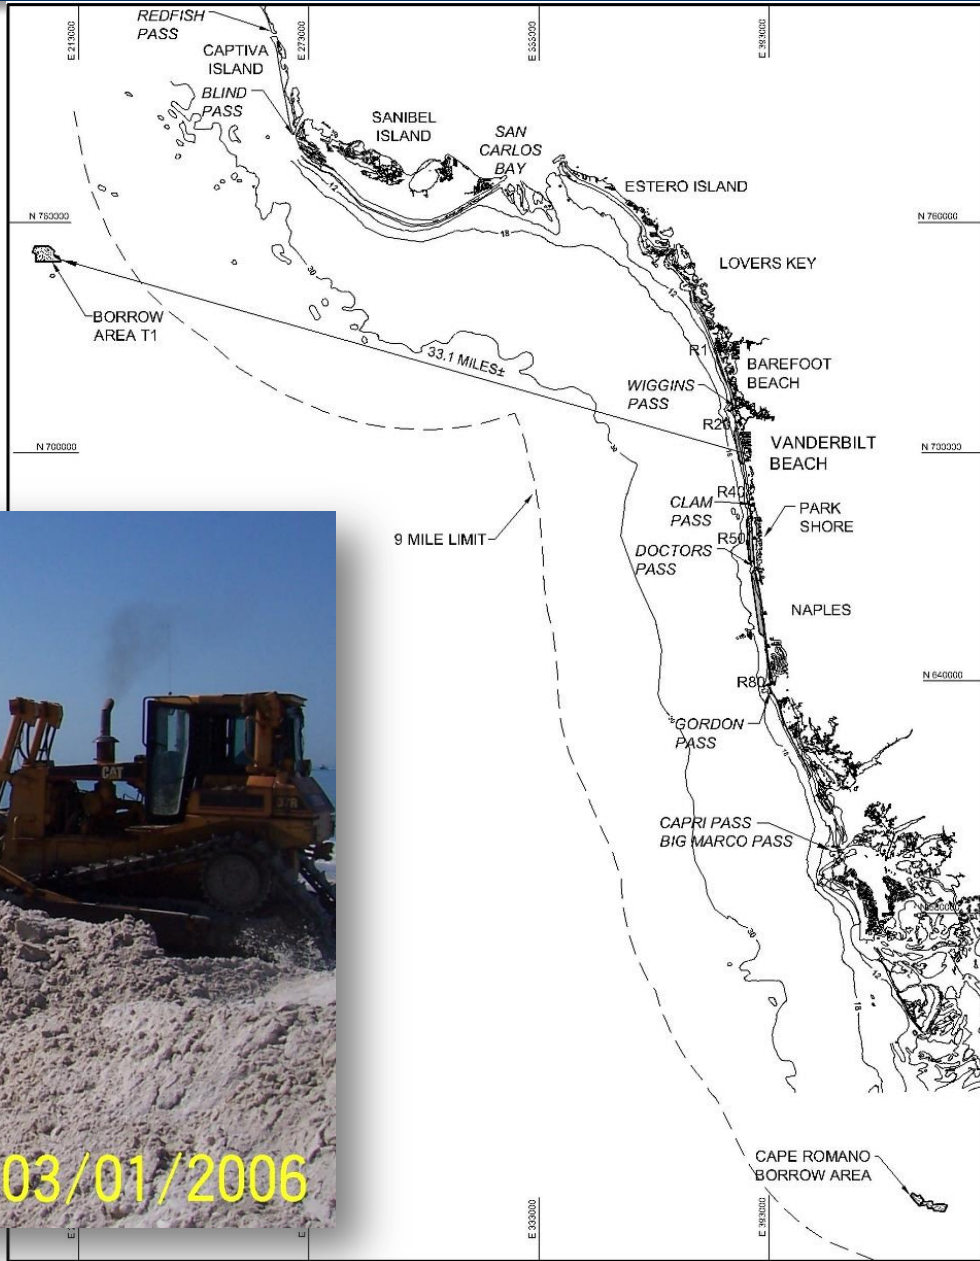
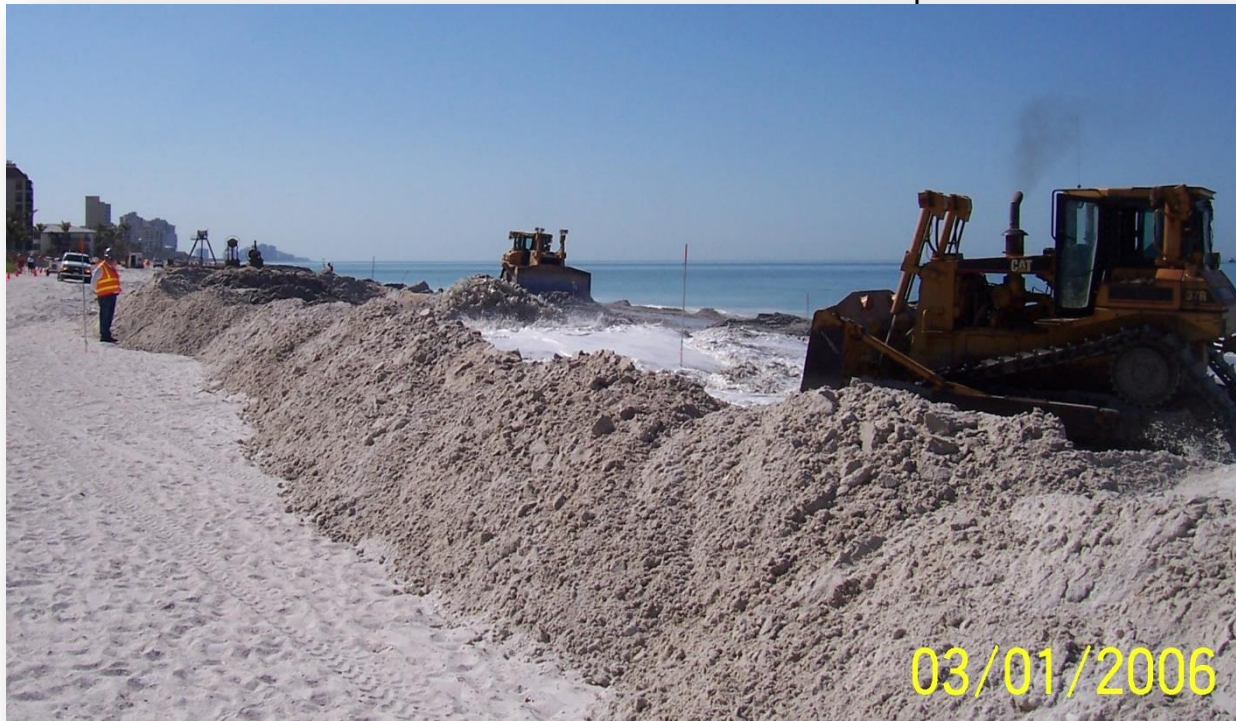
- Borrow Area T1
- Over 30 miles away
- MMS lease
- High quality material (0.33 mm)
- Screening on hopper dredges

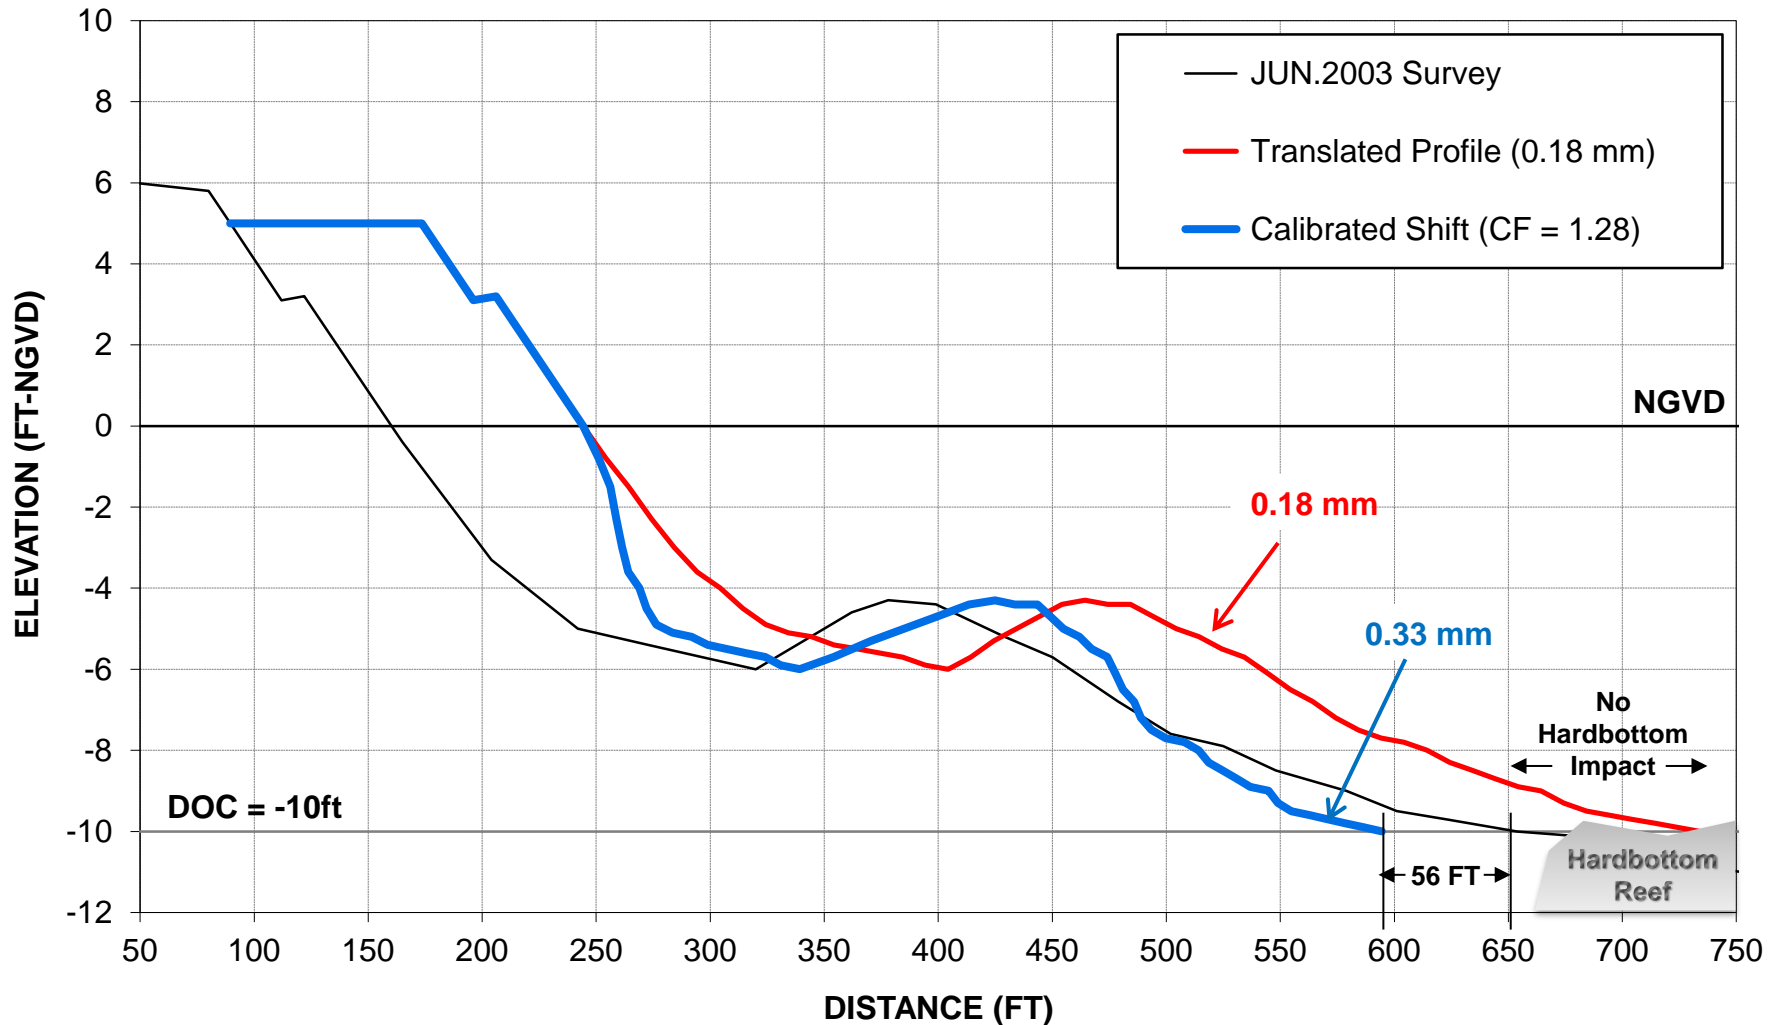
PARK SHORE BEACH PROFILE R-52 Predicted Profile Equilibration

Based on CEM (2000) Method: Equation V-4-5, EM 1110-2-1100, Part V, Chapter 4 - BEACH FILL DESIGN, pg. V-4-35.

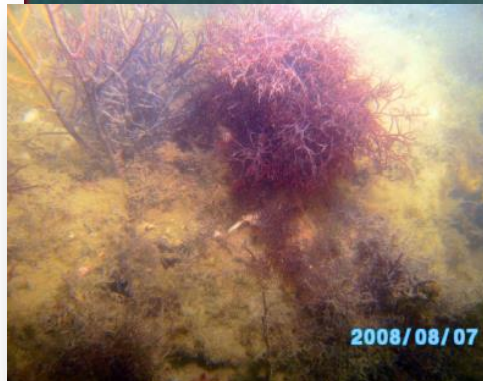
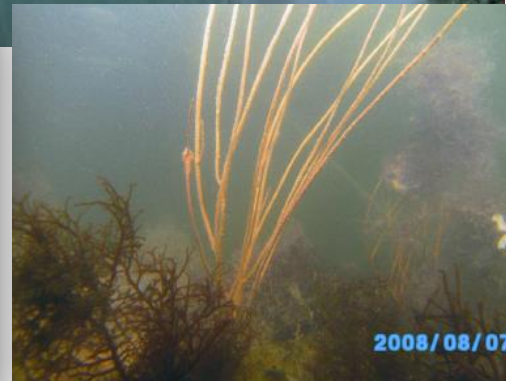
- 1.09 acre artificial reef required for potential impacts to hardbottom
- Built in Feb./March 2007
- 3-4 ft limestone boulders
- Located 1000 ft from shoreline
- Between 3rd and 4th Ave N. in Naples
- Water depths 10 to 14 ft
- Biological monitoring demonstrated mitigation success within 2 years
- **Biological monitoring also confirmed no impacts to nearshore hardbottom**
