BLIND PASS MAINTENANCE DREDGING PROJECT

Kris Thoenke¹, Michael Poff¹, Robert Neal², Steve Boutelle²

FEBRUARY 2010

THE PROJECT

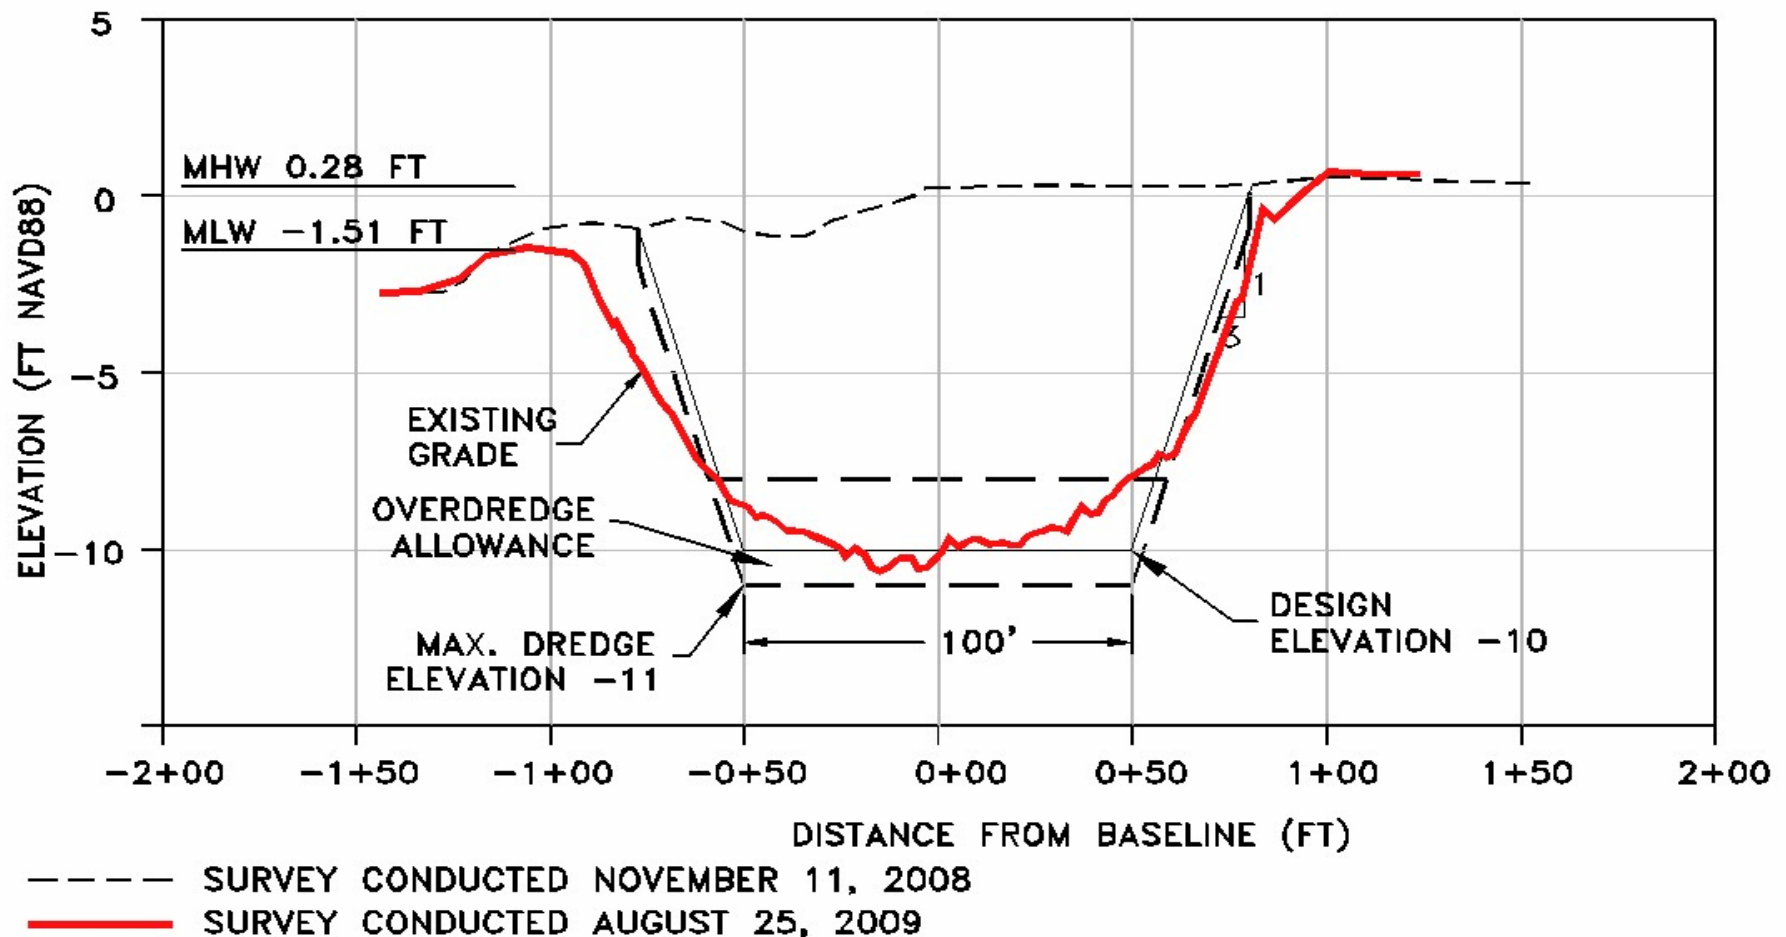
Sub 1 Stn 14+00

SUBAREA 1

STATION 14+00

- SURVEY CONDUCTED NOVEMBER 11, 2008
- SURVEY CONDUCTED AUGUST 25, 2009

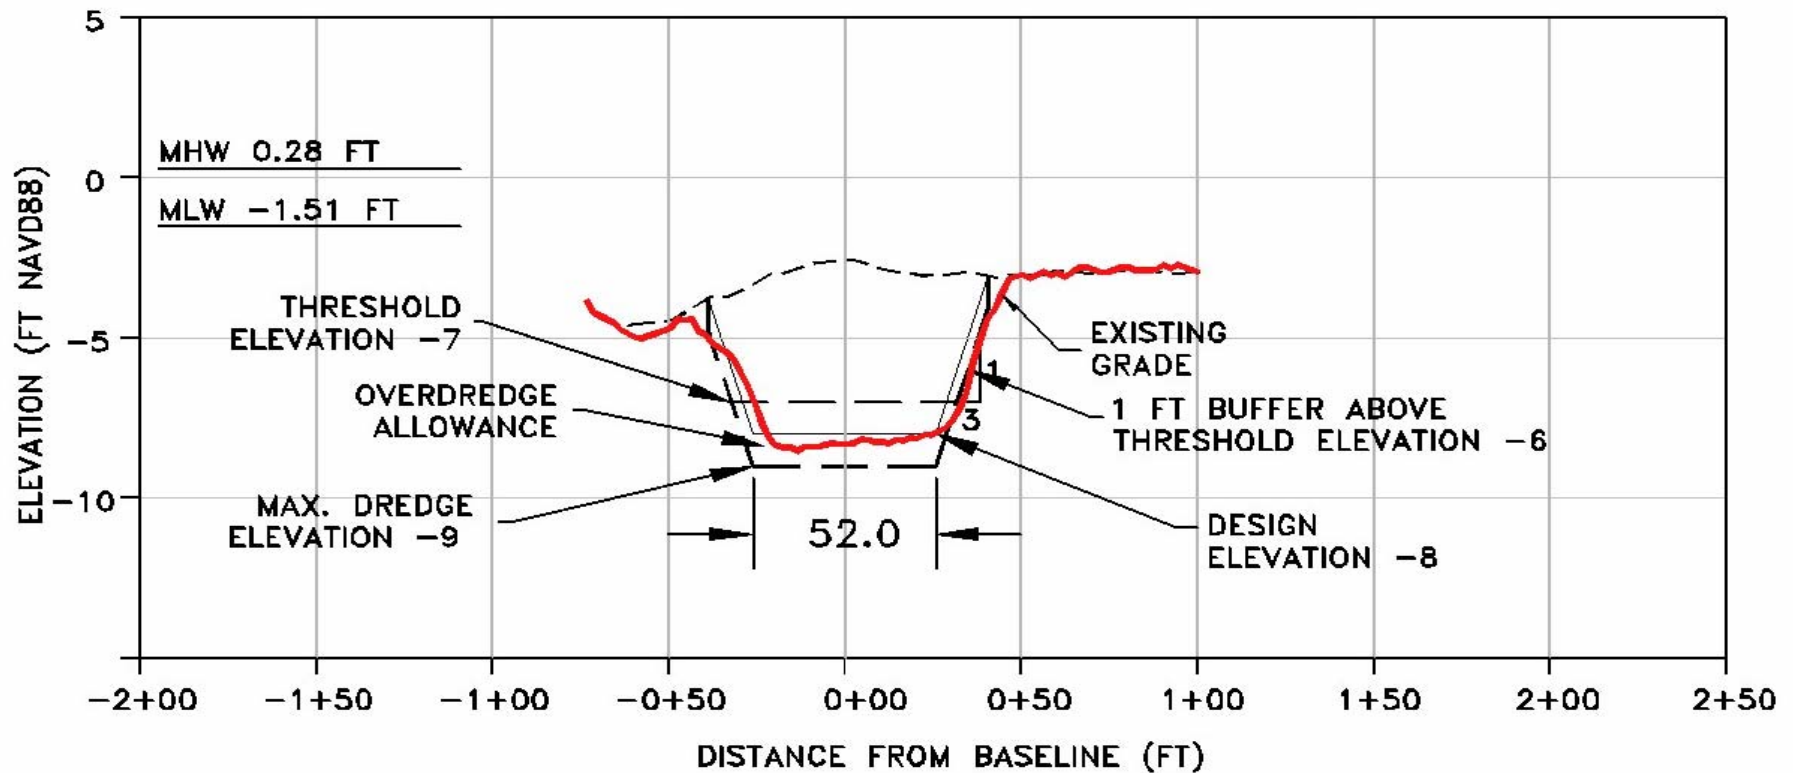
Sub 7 Stn 35+16

SUBAREA 7

STATION 35+16

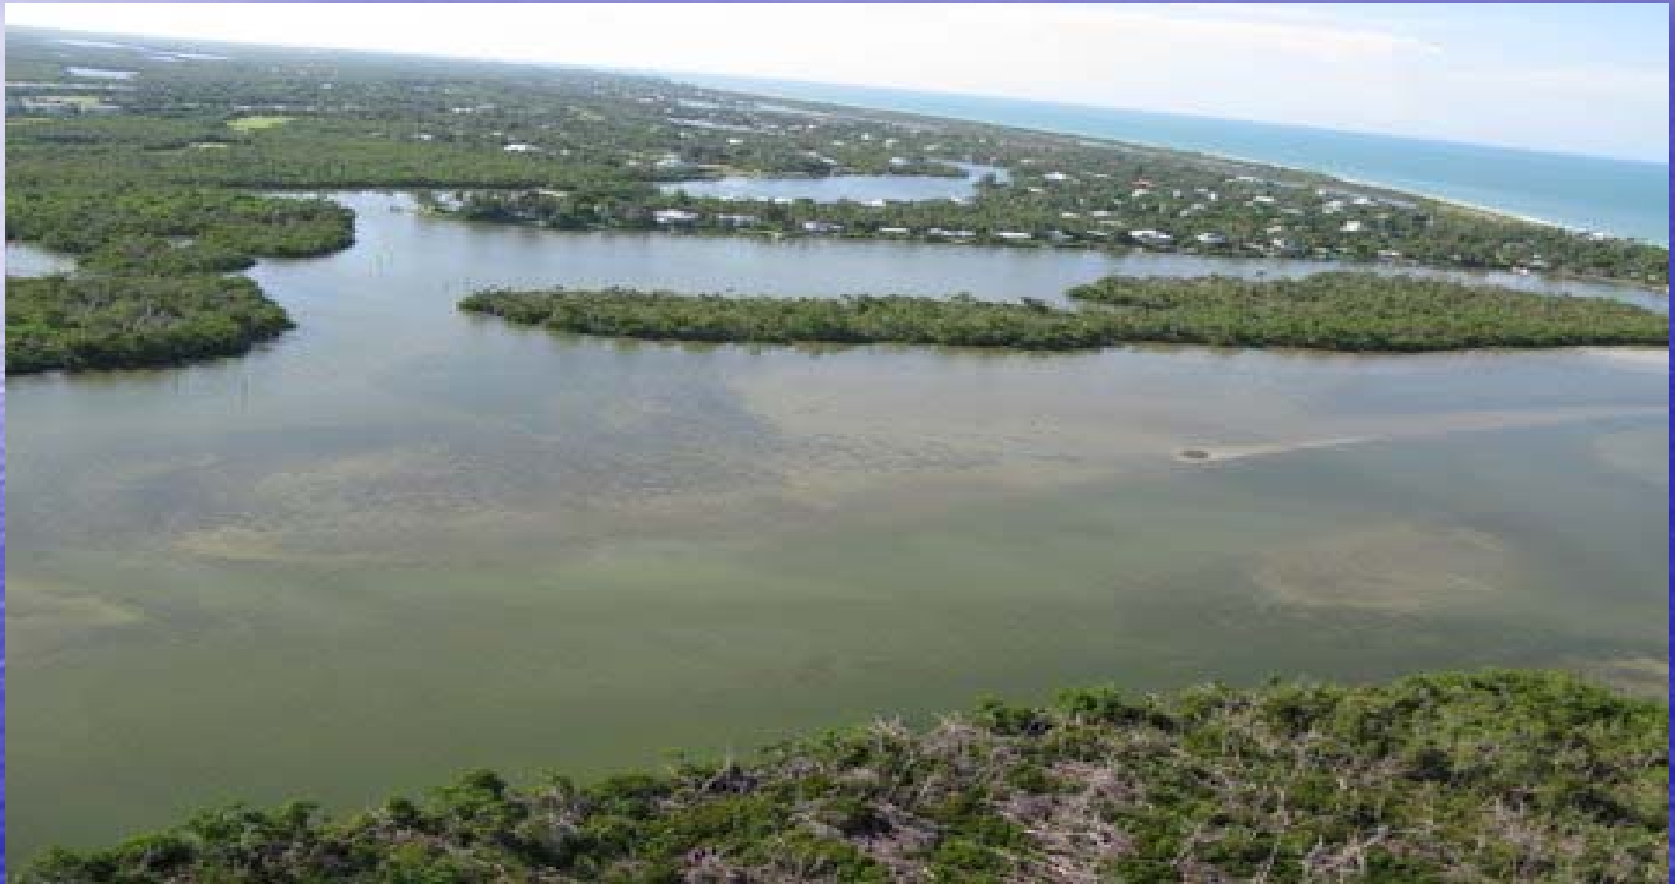
PRE-CONSTRUCTION: October 2008

- Secondary Impacts to Seagrasses Adjacent to Channel
 - To determine if shoaling or scour is impacting seagrasses within a 500' buffer of the dredge footprint
 - Map edge of seagrass beds prior to construction and annually for 5 years after
 - Conduct qualitative and quantitative sampling

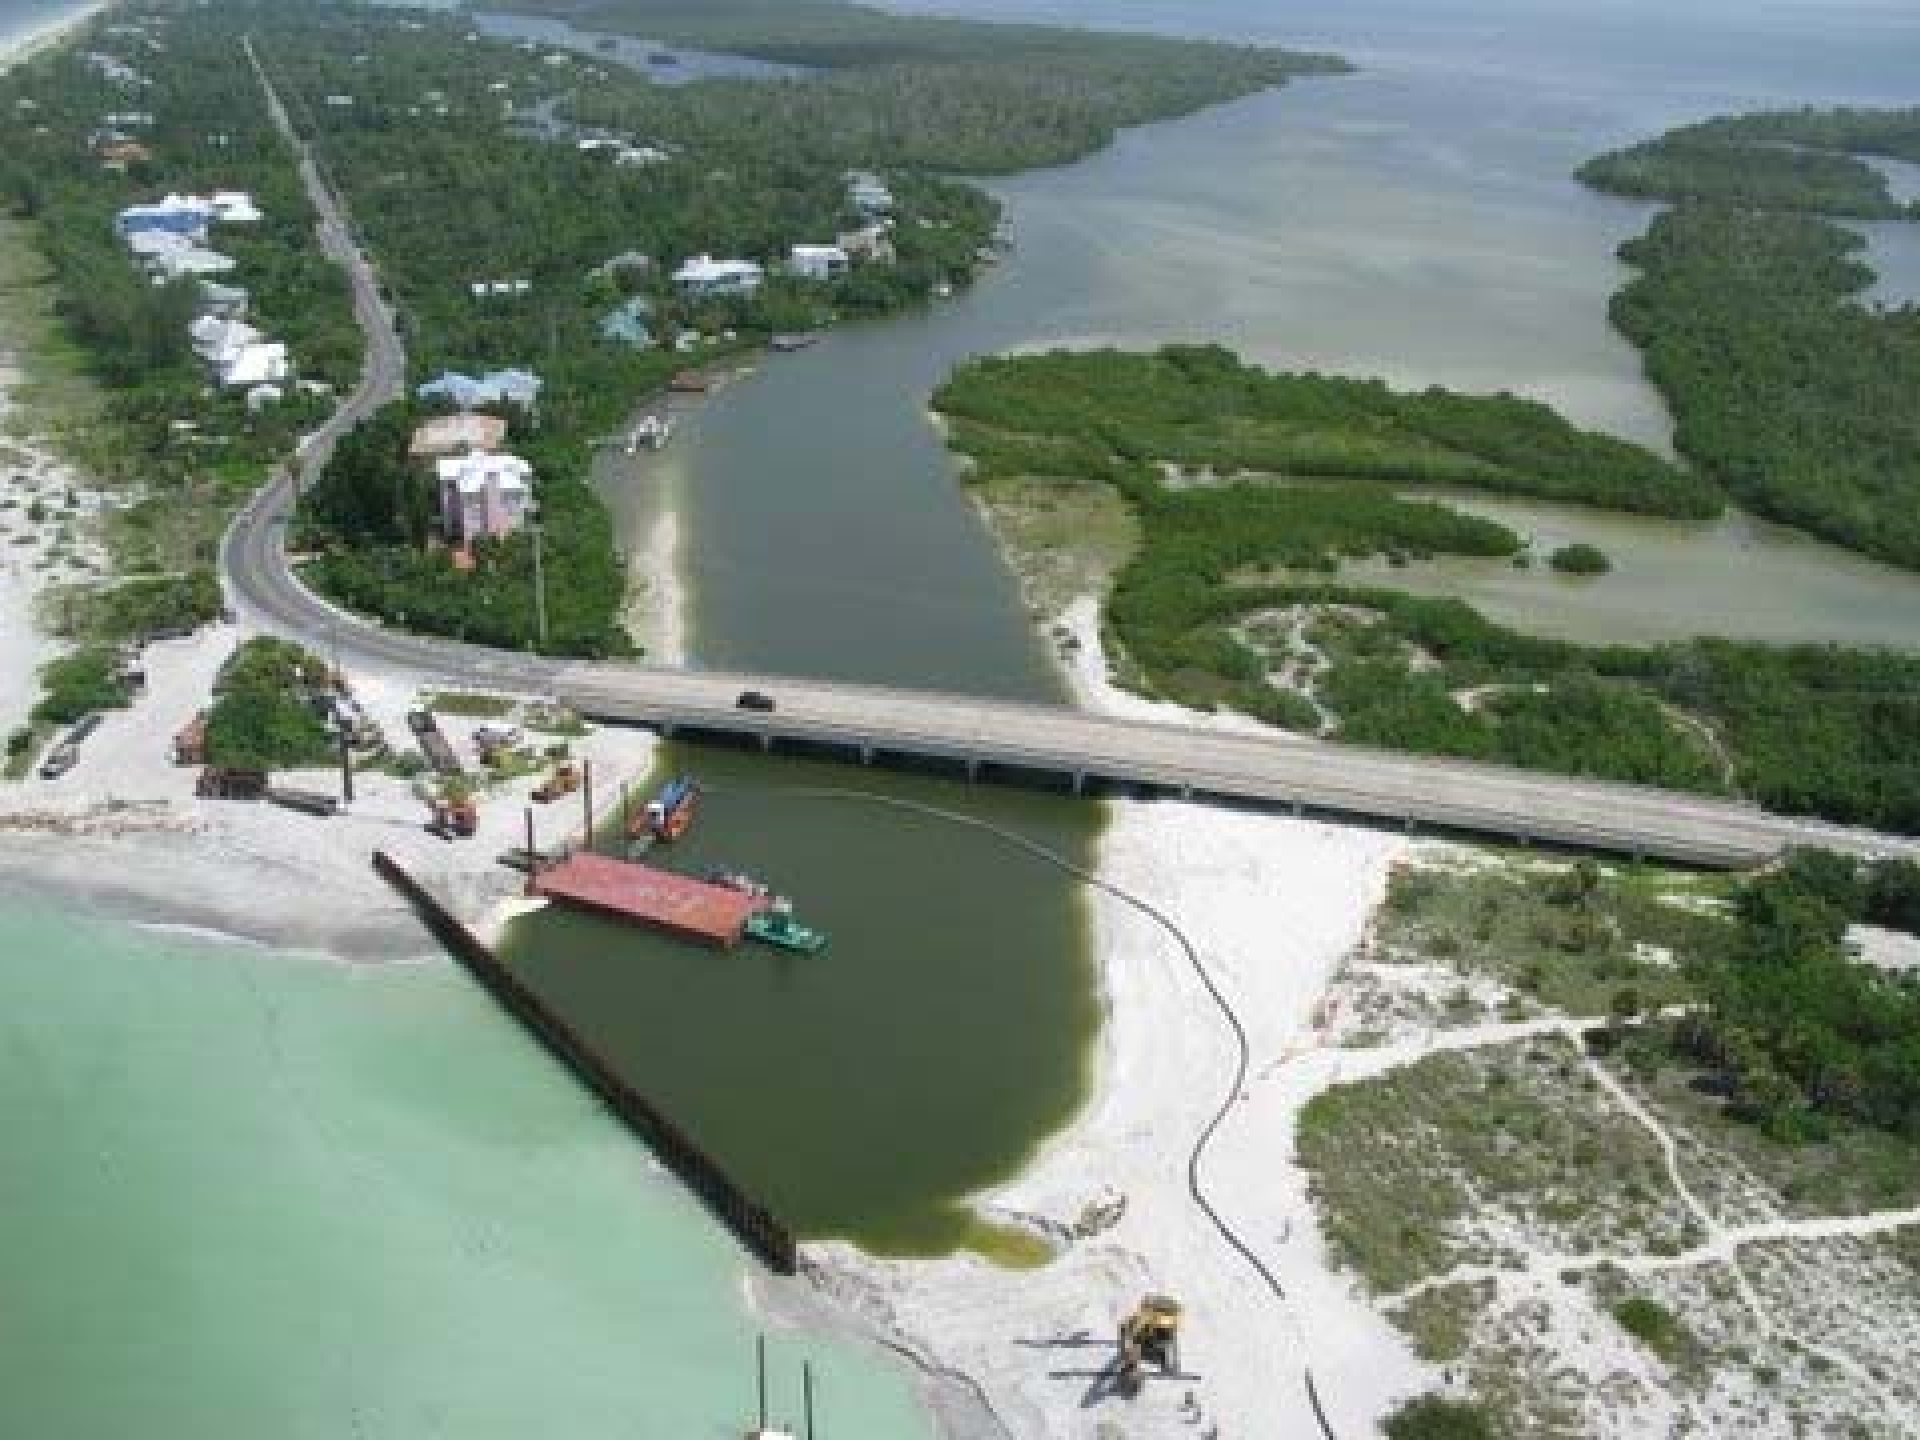
- WATER CLARITY IMPROVED – Positive sign for seagrass survival
- SEDIMENT CHANGES – Hypothesis was that the fine sand that was dominant in the areas of seagrasses (especially the large seagrass areas - III and IV) would be washed out when tidal connection was re-established.
- Observed a layer of coarser sand was transported into and deposited over the seagrasses
