UPHAM BEACH STABILIZATION PROJECT

BOUSSINESQ WAVE MODELING TO ADDRESS CONCERNS OF LOCAL SURFING COMMUNITY

Coastal Planning & Engineering, Inc.

FSBPA National Conference – February 2010 - Melbourne, FL

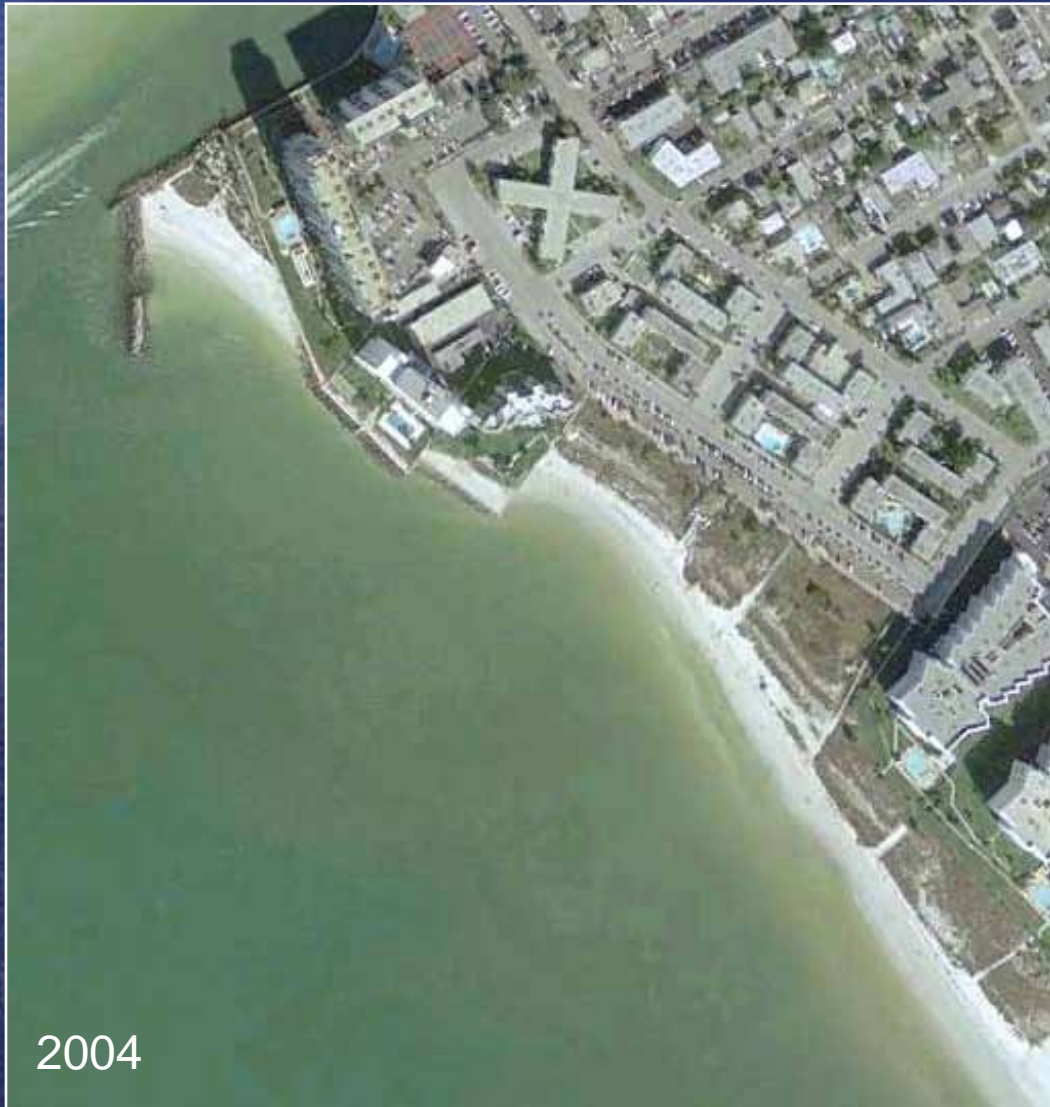
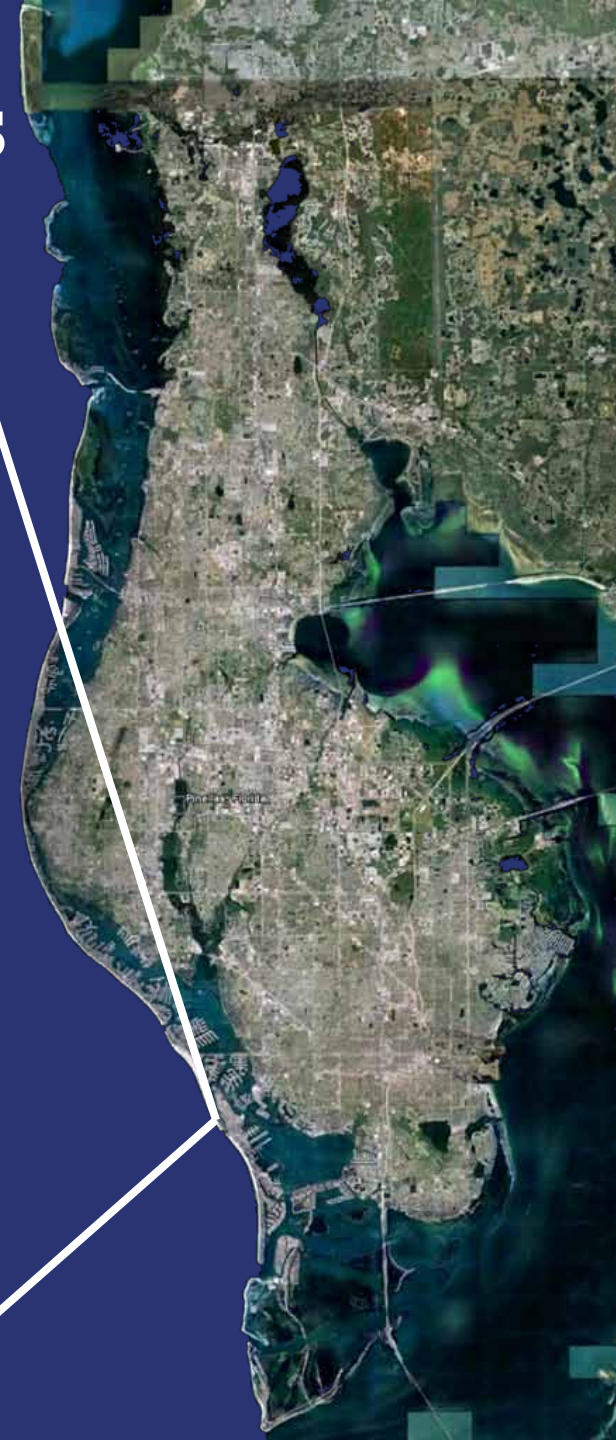
2004

Pre-nourishment, Pre-geotubes

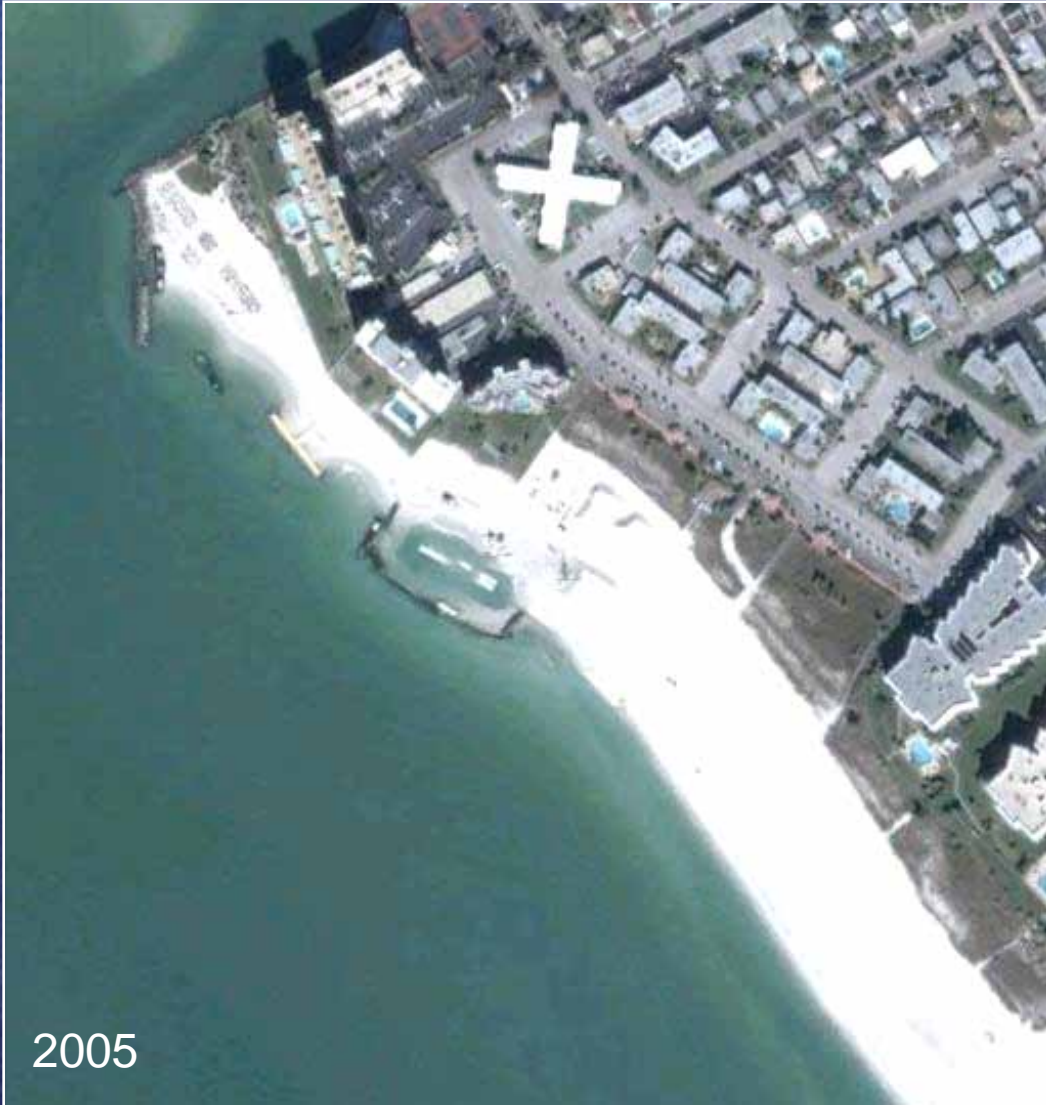
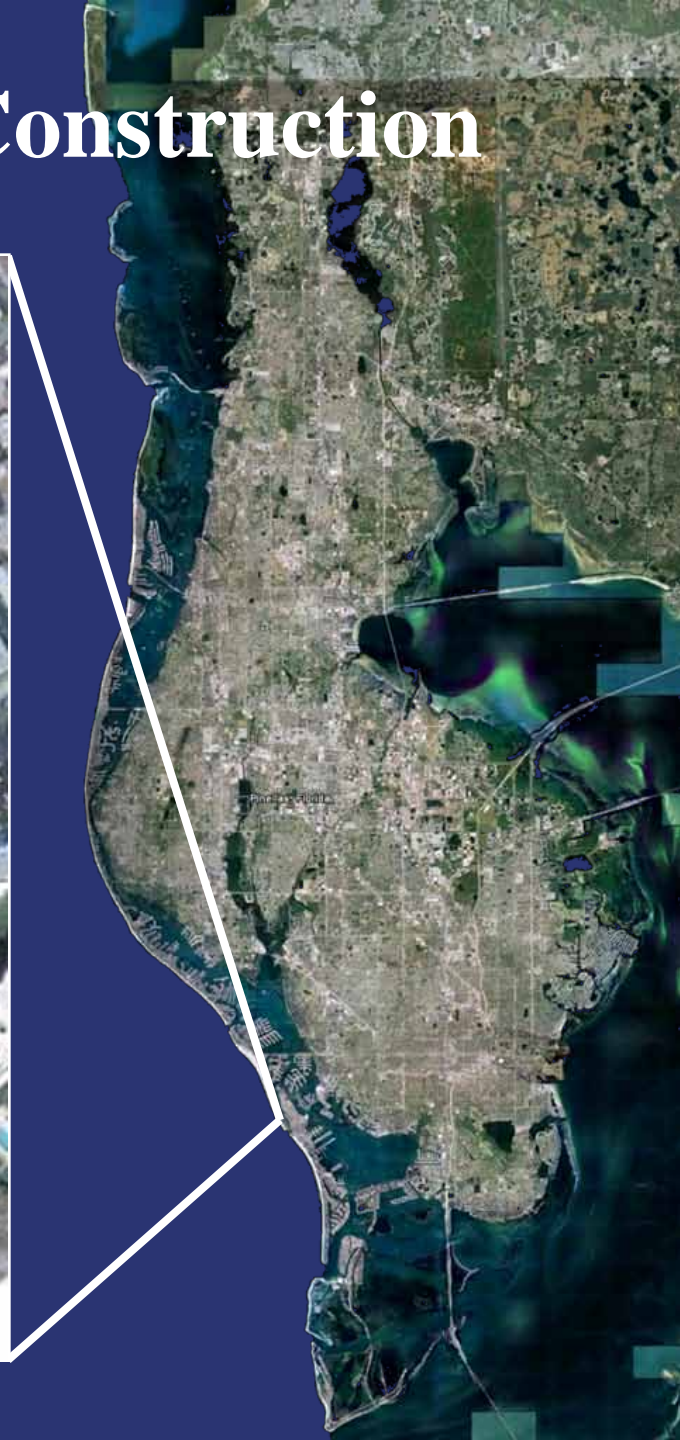
2005

Post-nourishment, Geotube Construction

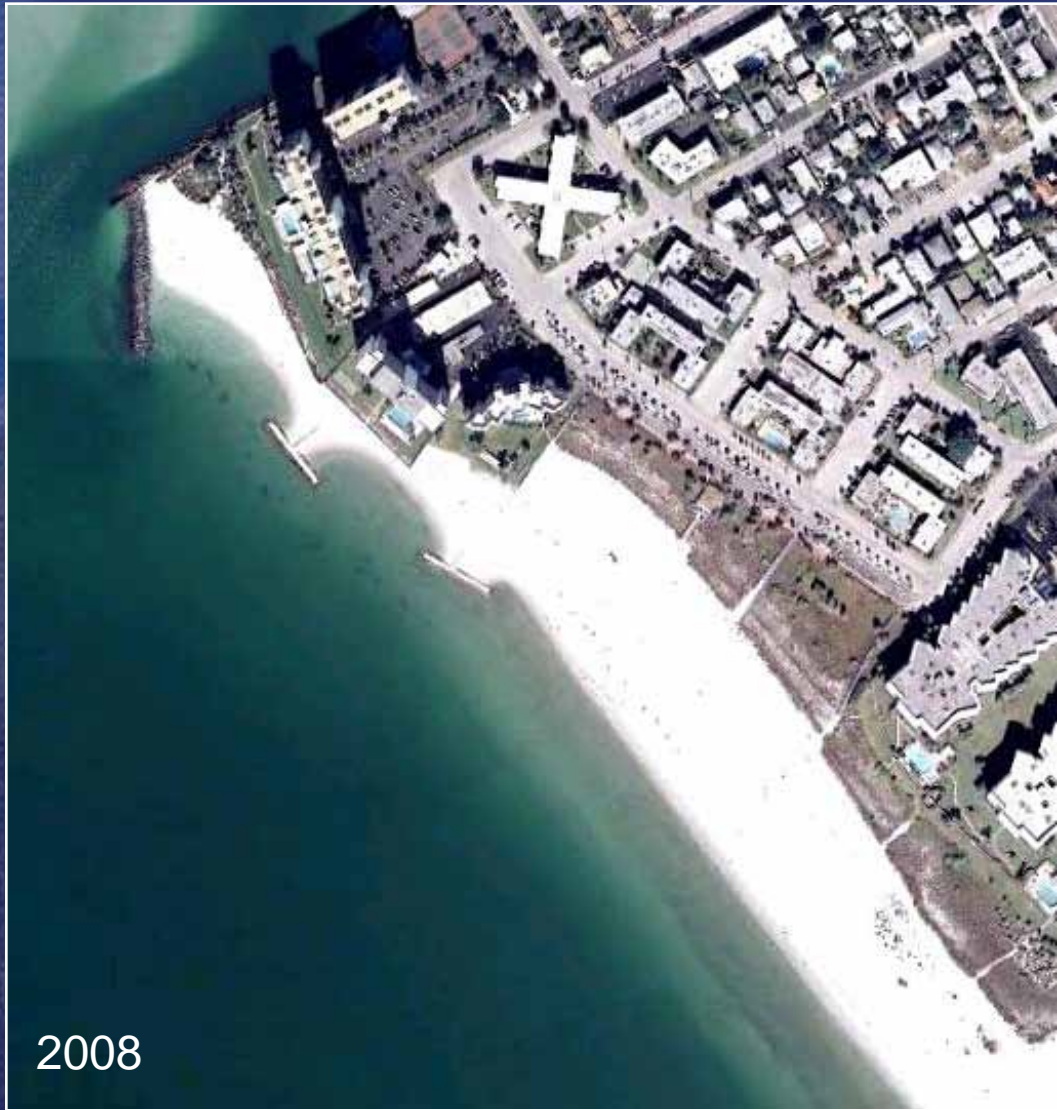
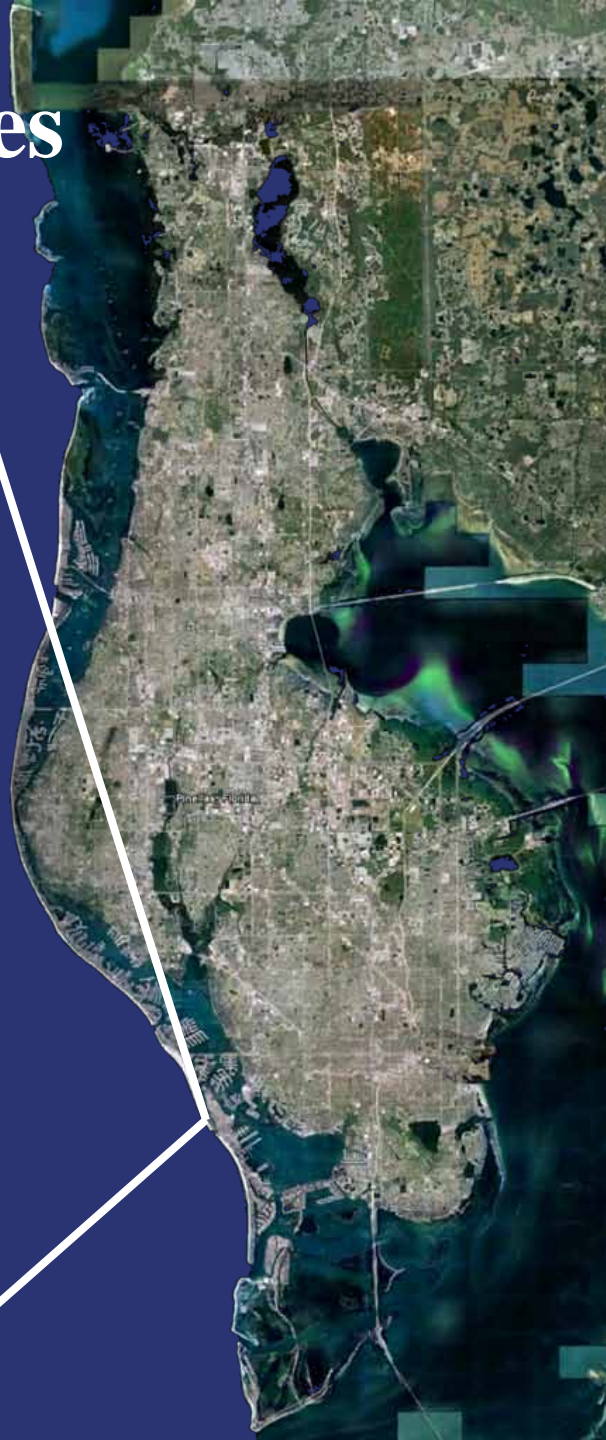
2008

Post-nourishment, Post-geotubes

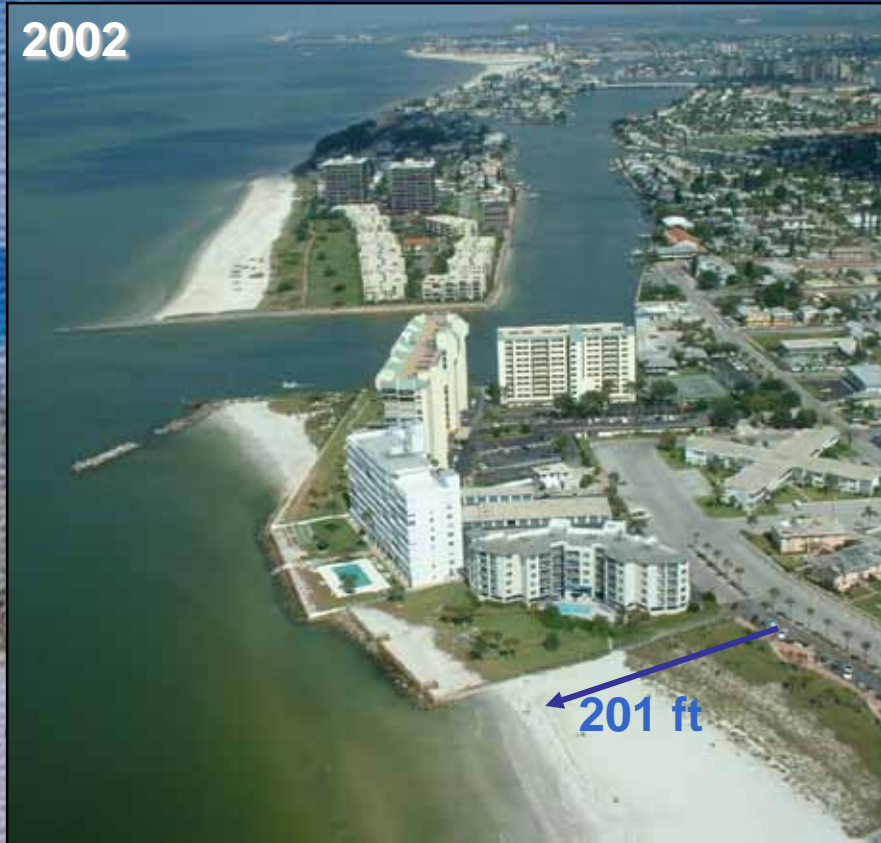
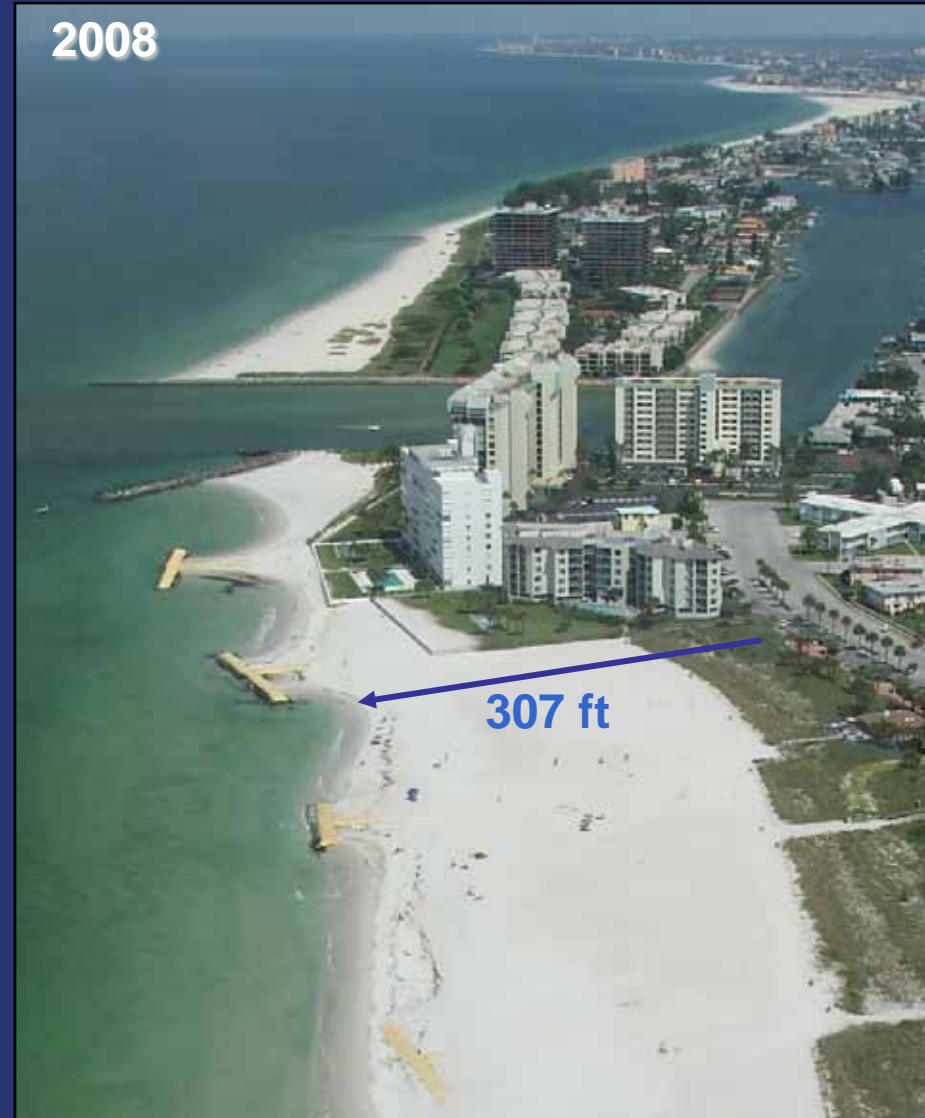
Each photo represents two years after nourishment

>100 ft wider beach!

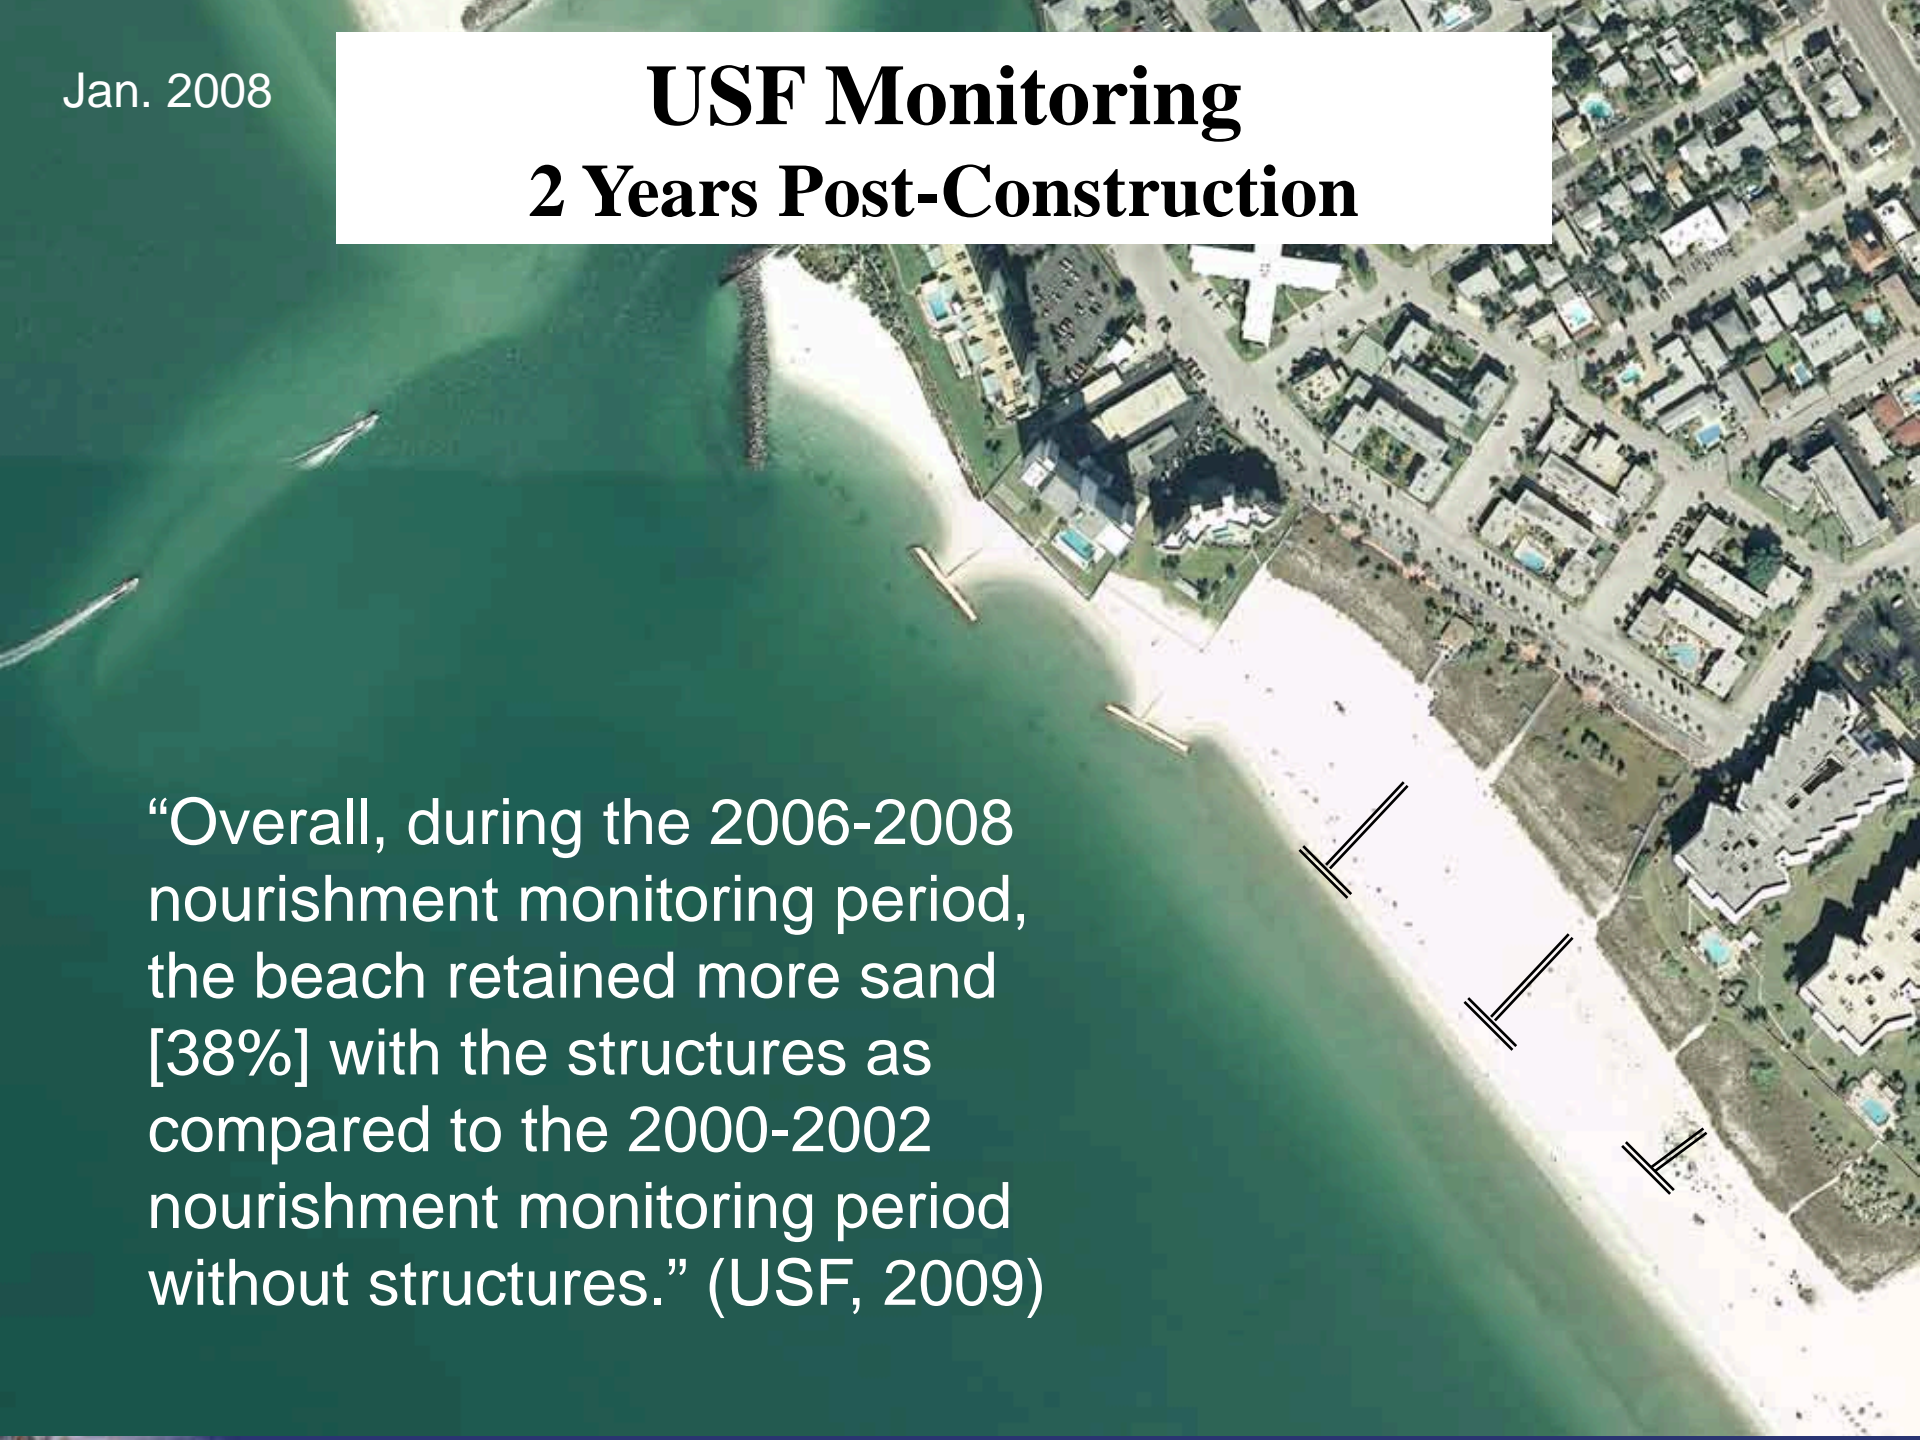
USF Monitoring 2 Years Post-Construction

“Overall, during the 2006-2008 nourishment monitoring period, the beach retained more sand [38%] with the structures as compared to the 2000-2002 nourishment monitoring period without structures.” (USF, 2009)

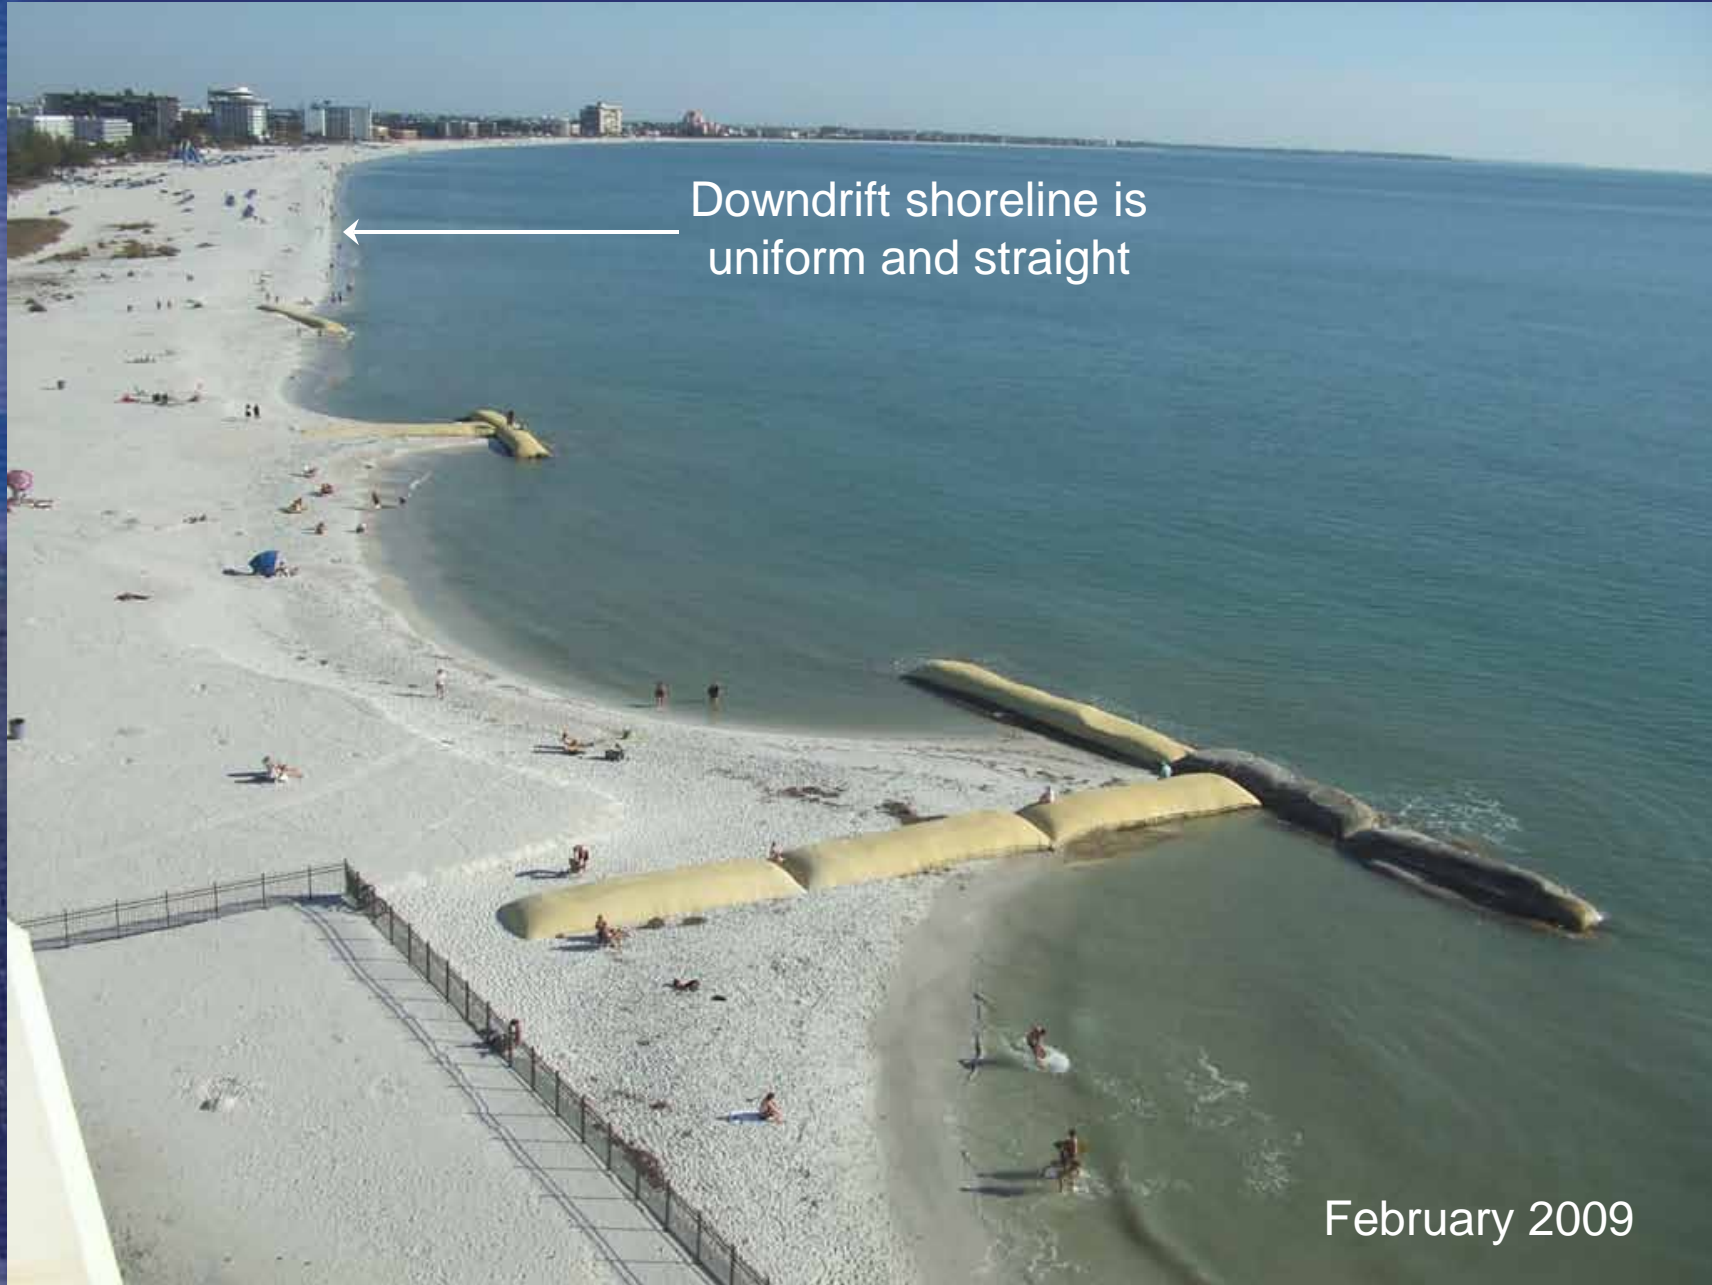
No Downdrift Impacts Observed

← Downdrift shoreline is uniform and straight

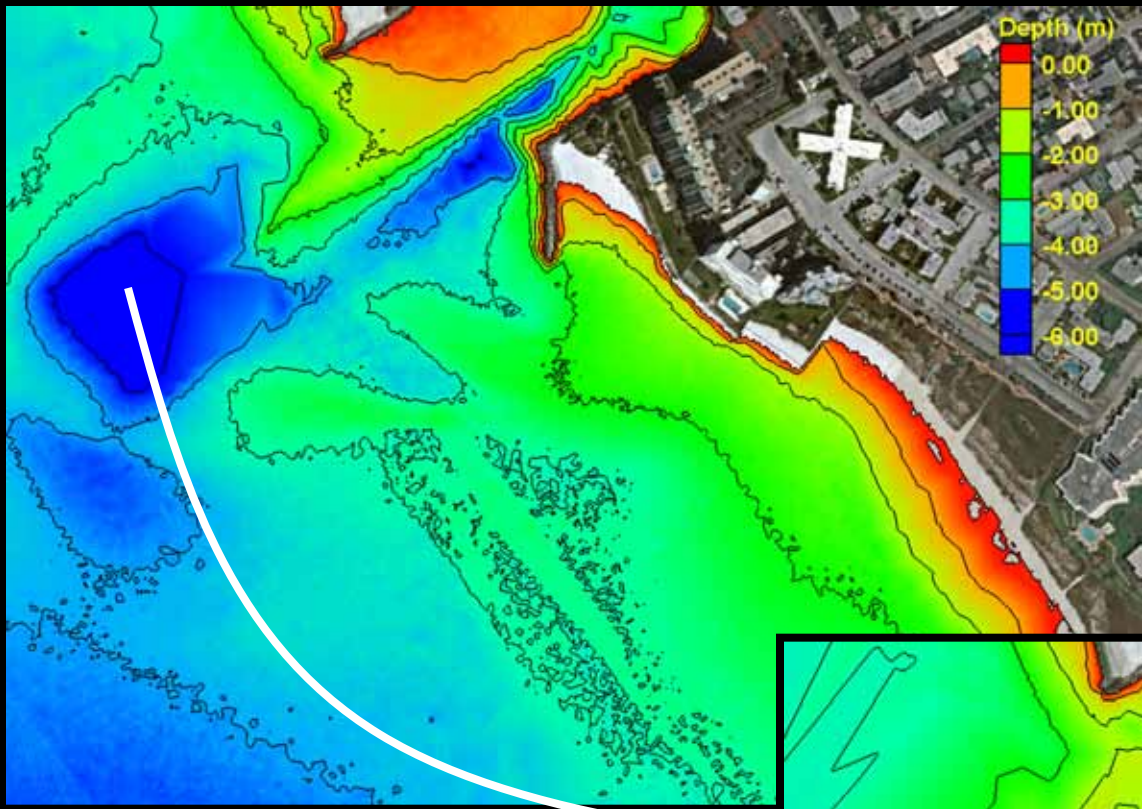
2004 Bathymetry
“Good Old Days”
(surfing)

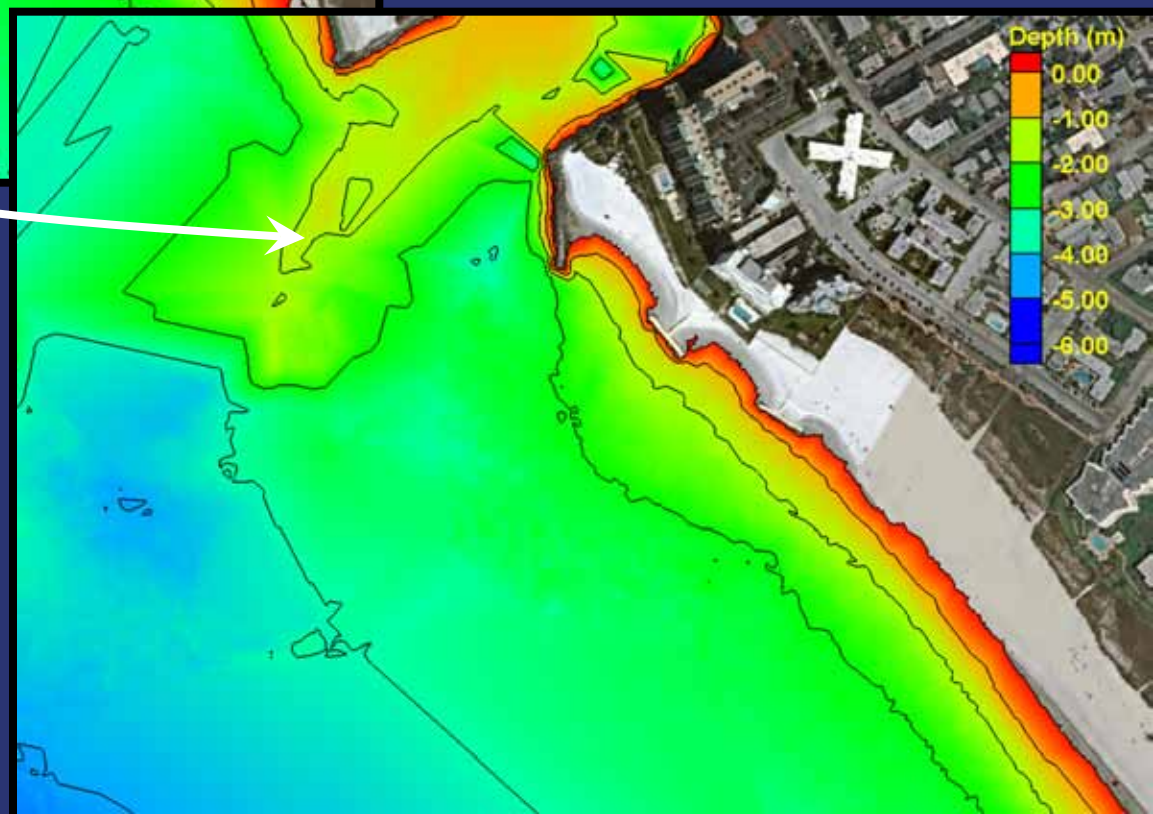
Growth of ebb shoal

2006 Bathymetry

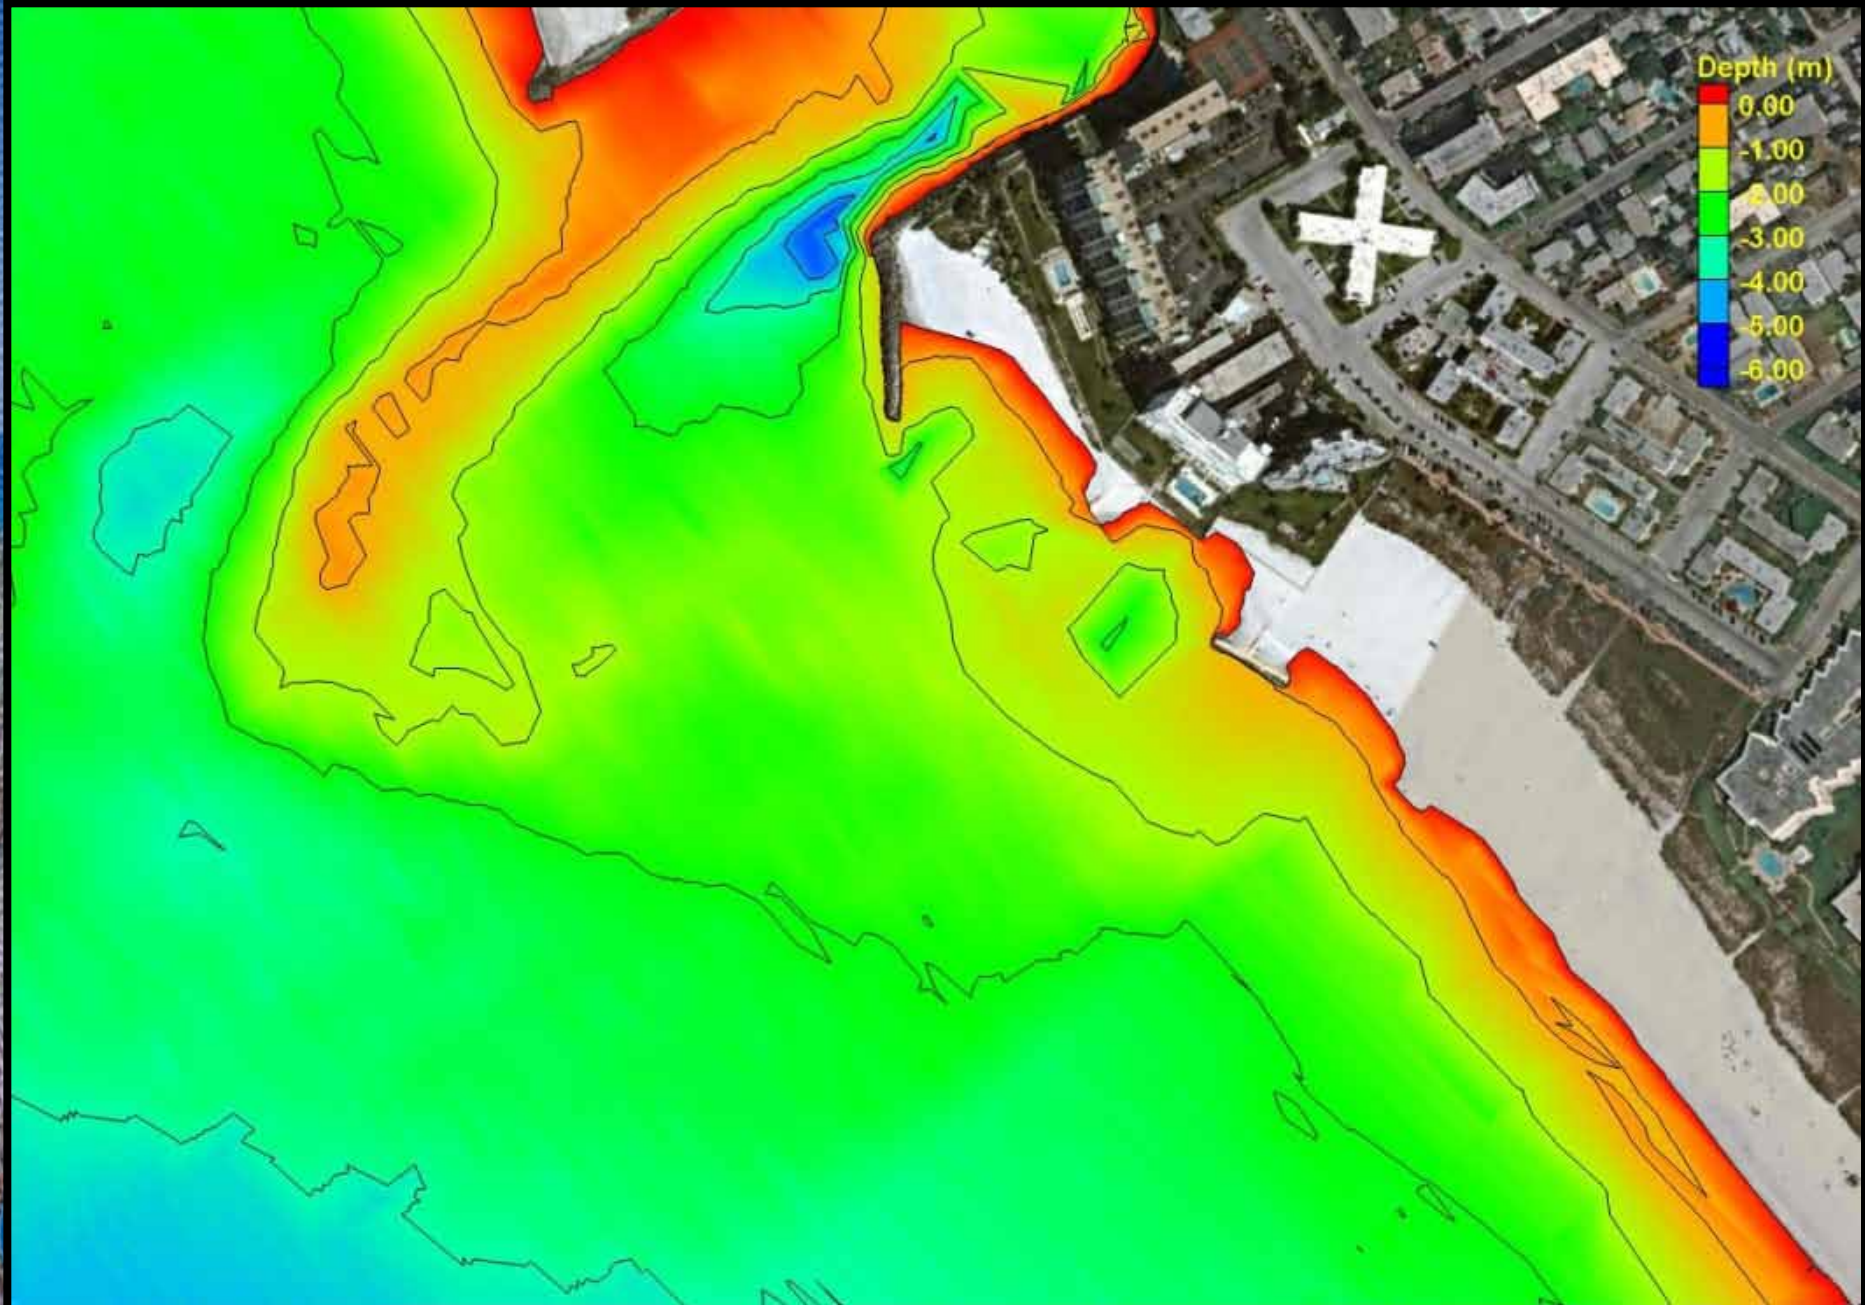
Existing Conditions for Model Runs (2009 Bathymetry)

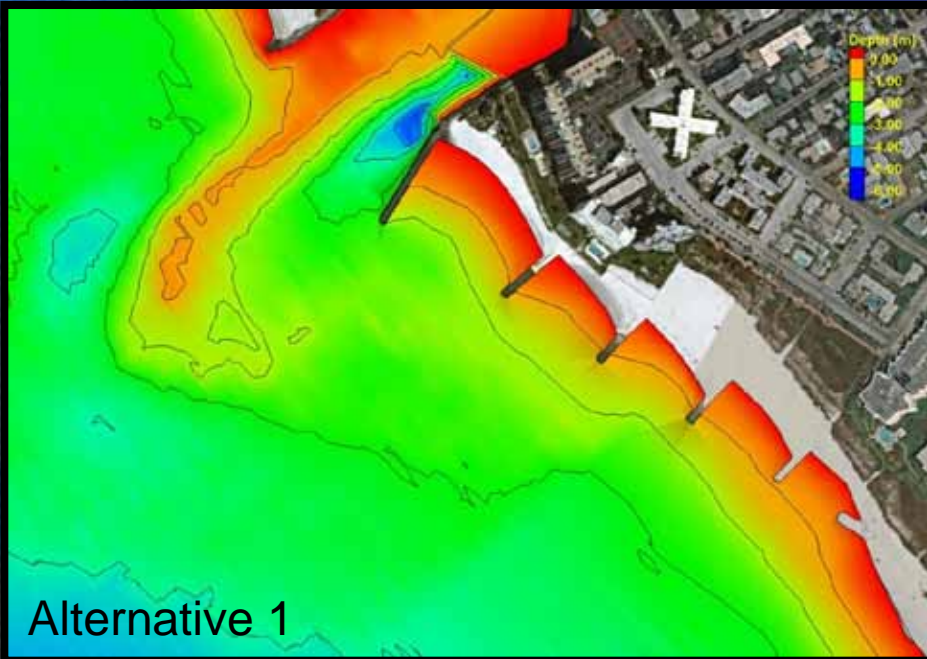
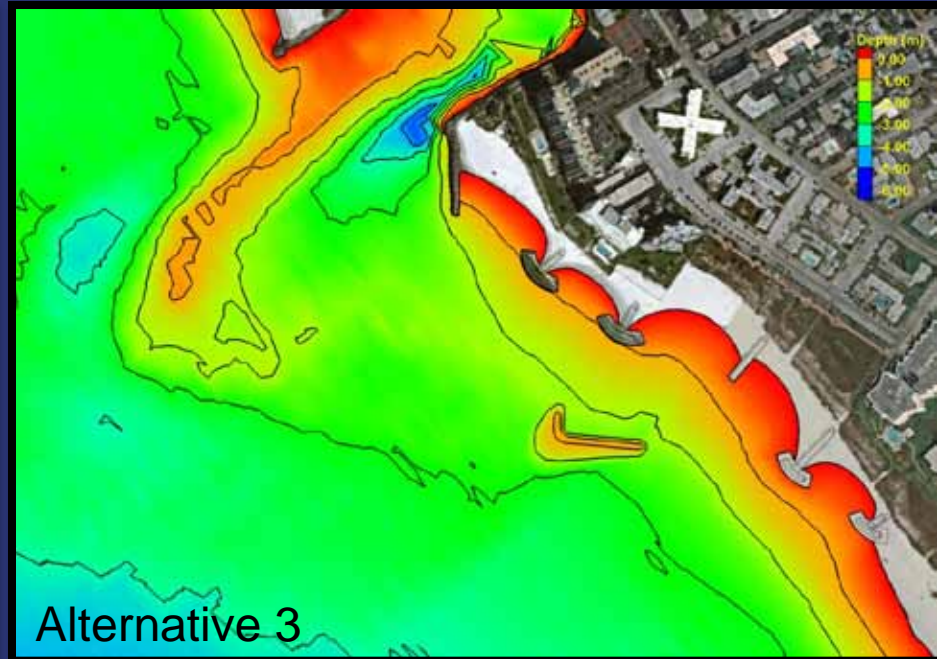
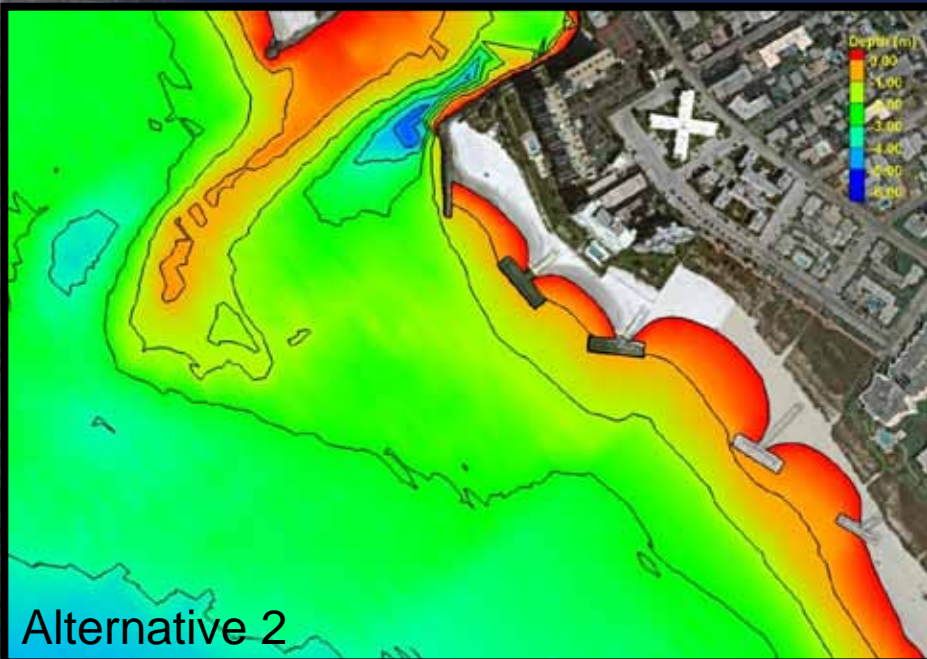
Alternatives Analysis with 2009 Bathymetry

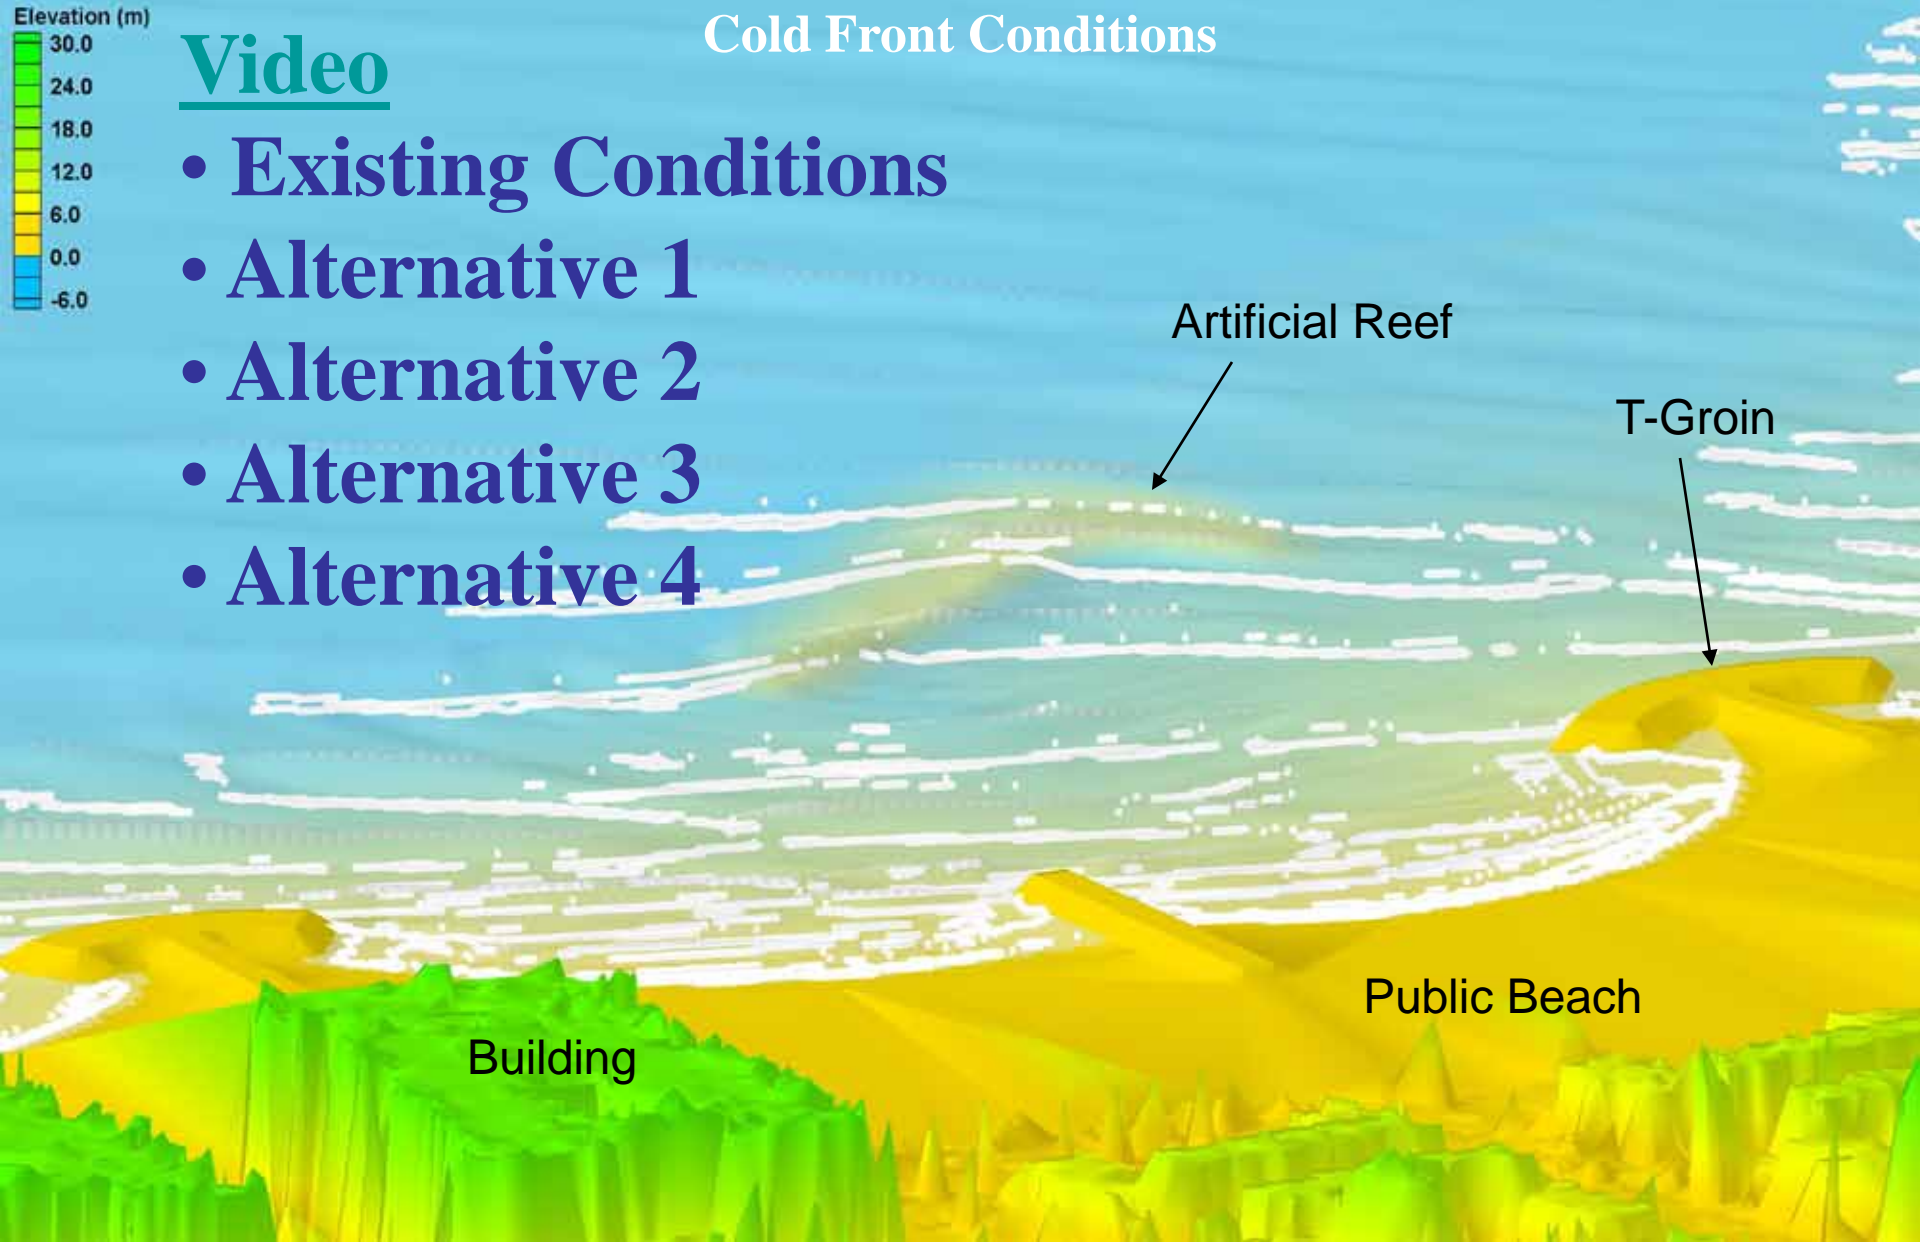
Example Model Simulations

Cold Front Conditions
