Initial Shoreline Response of an Open Coast Erosion Hot Spot to Permeable Adjustable Groins

Douglas W. Mann, P.E., D.CE.

Coastal Planning & Engineering, Inc.

National Conference on Beach Preservation Technology,
Jacksonville, Florida

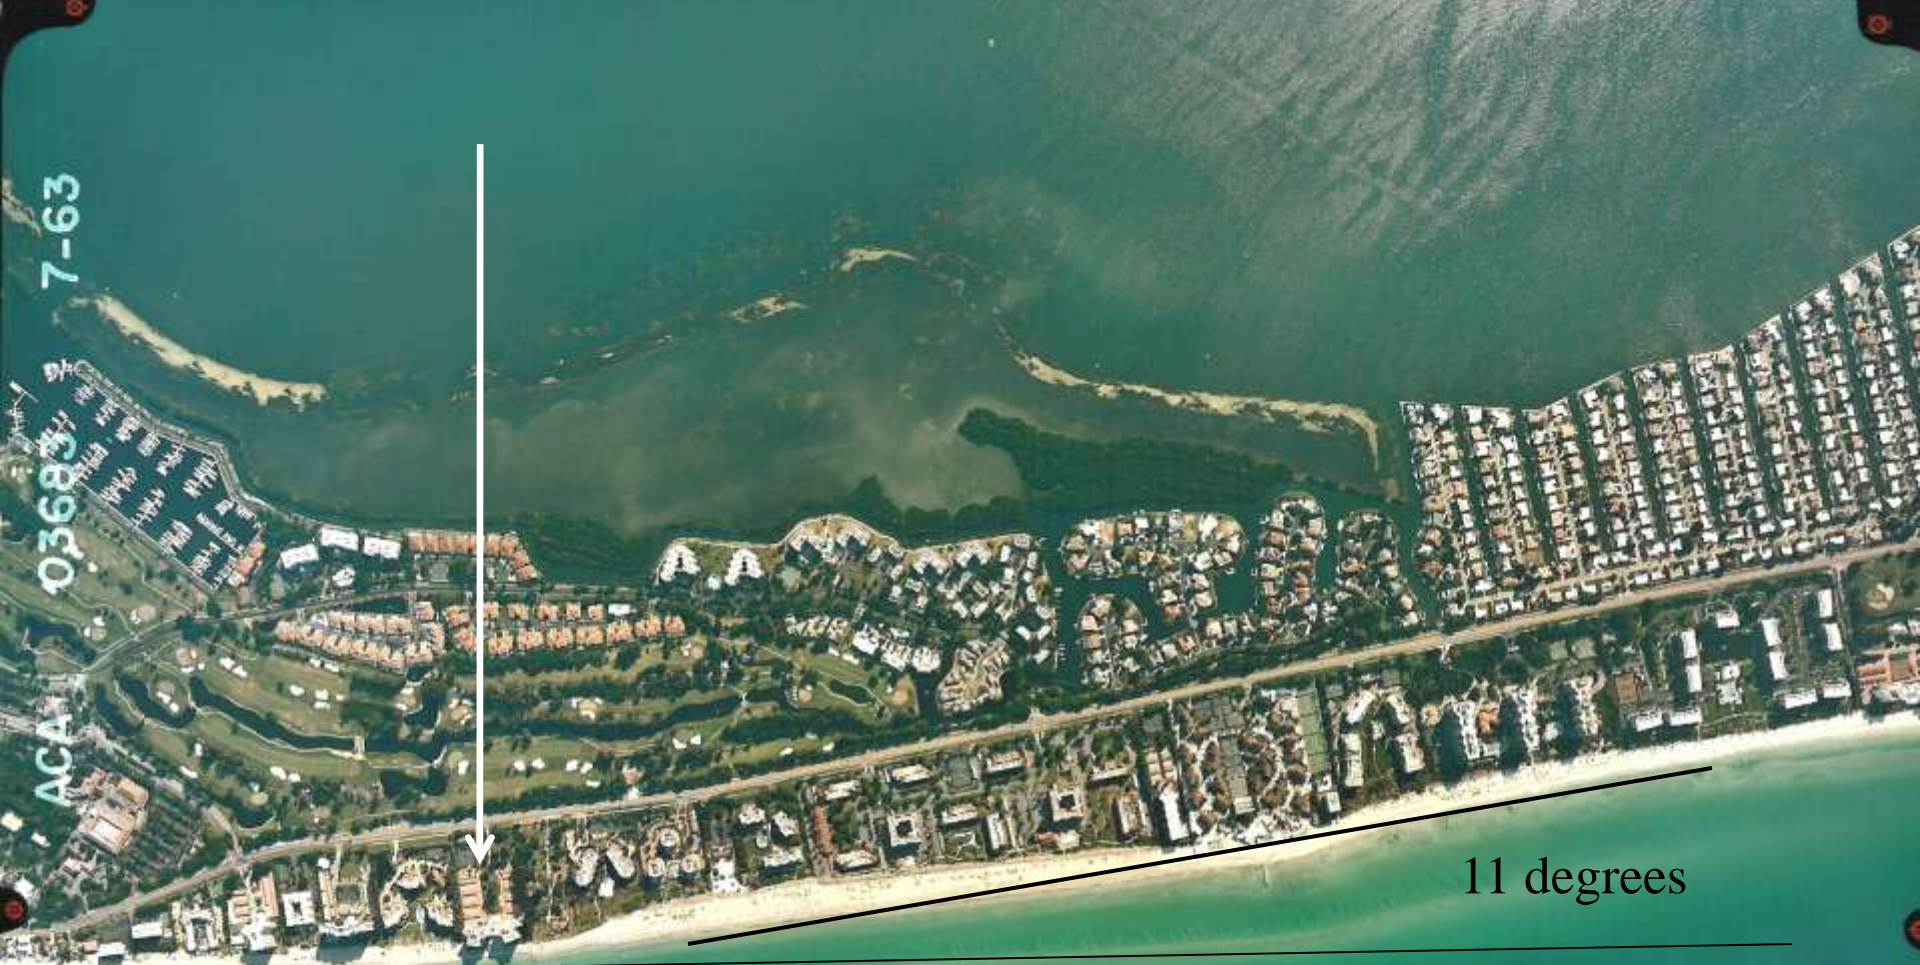
Net Transport = 50,000 to 90,000 cy/yr.

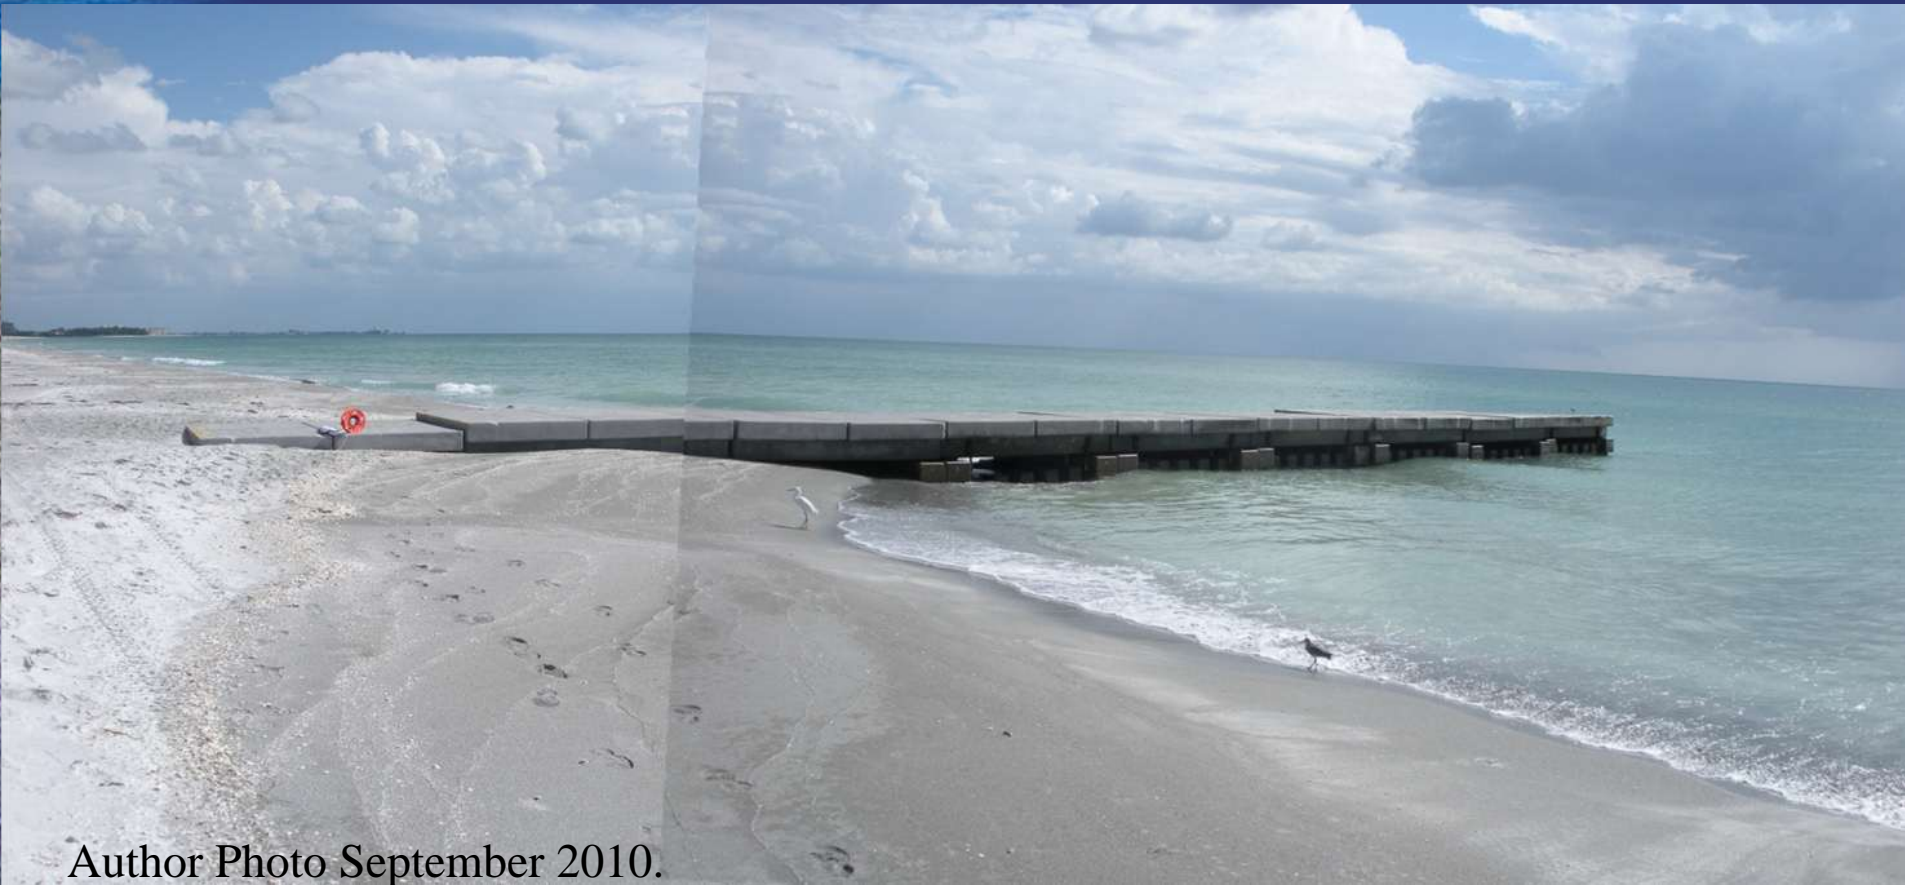
Permeable Groin (by S.M. Wood)

(constructed circa 1966, rebuilt 1994)

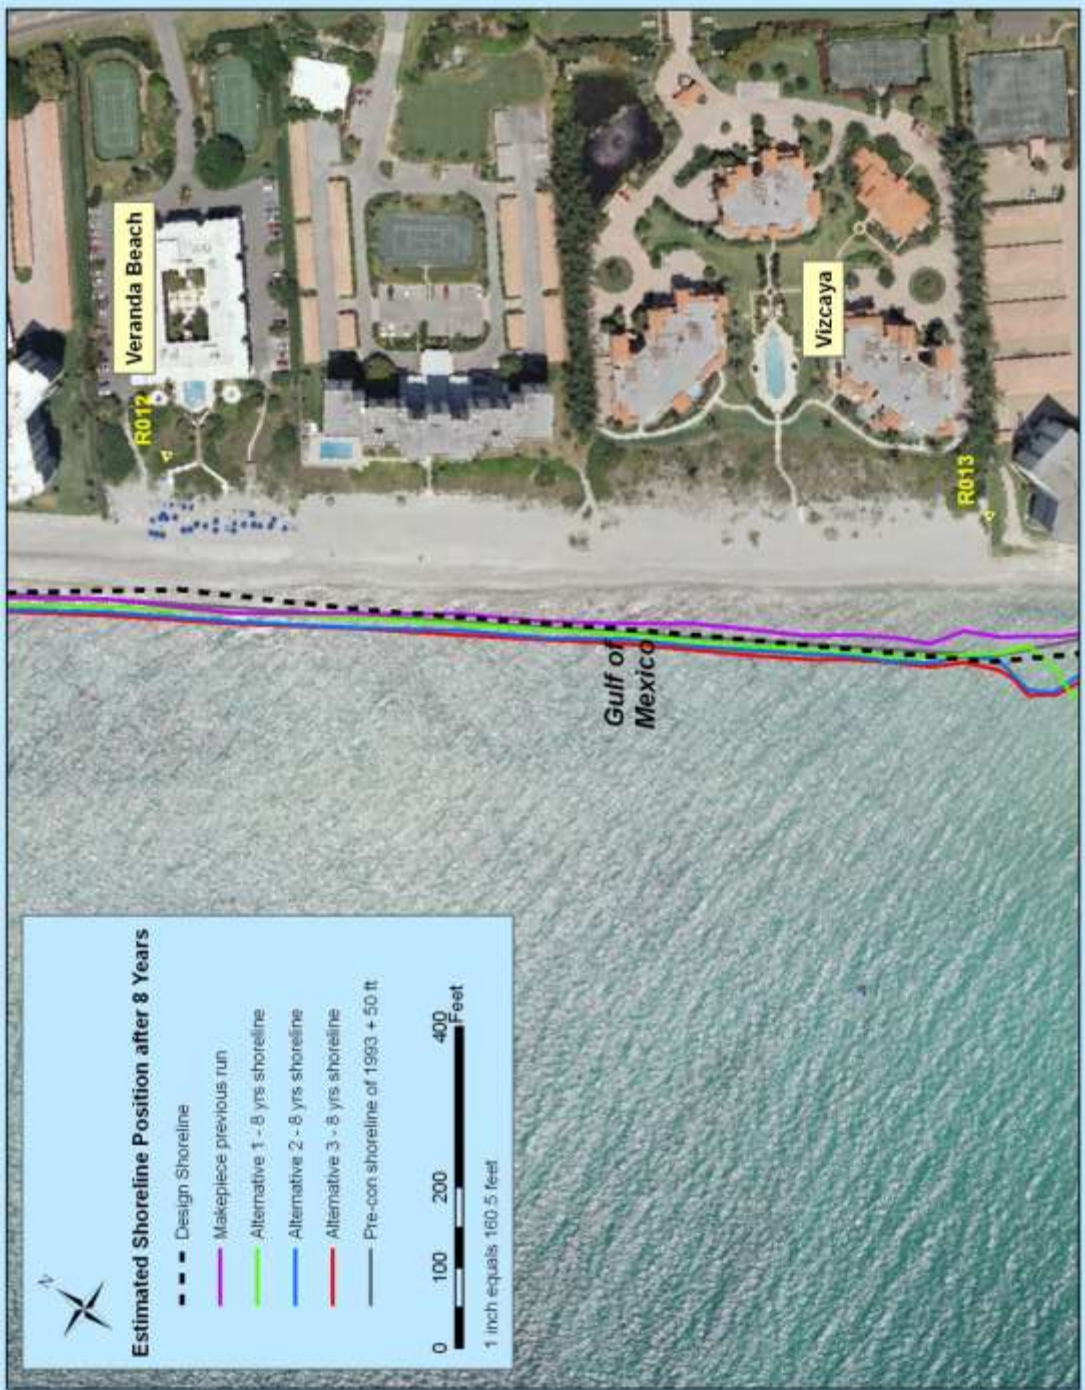
Estimated Shoreline Position after 8 Years

- Design Shoreline
- Makepiece previous run
- Alternative 1 - 8 yrs shoreline
- Alternative 2 - 8 yrs shoreline
- Alternative 3 - 8 yrs shoreline
- Pre-con shoreline of 1993 + 50 ft

- This effort lead to the conclusion that two Makepeace Wood type groins would be effective in conjunction with the Town's existing nourishment program.

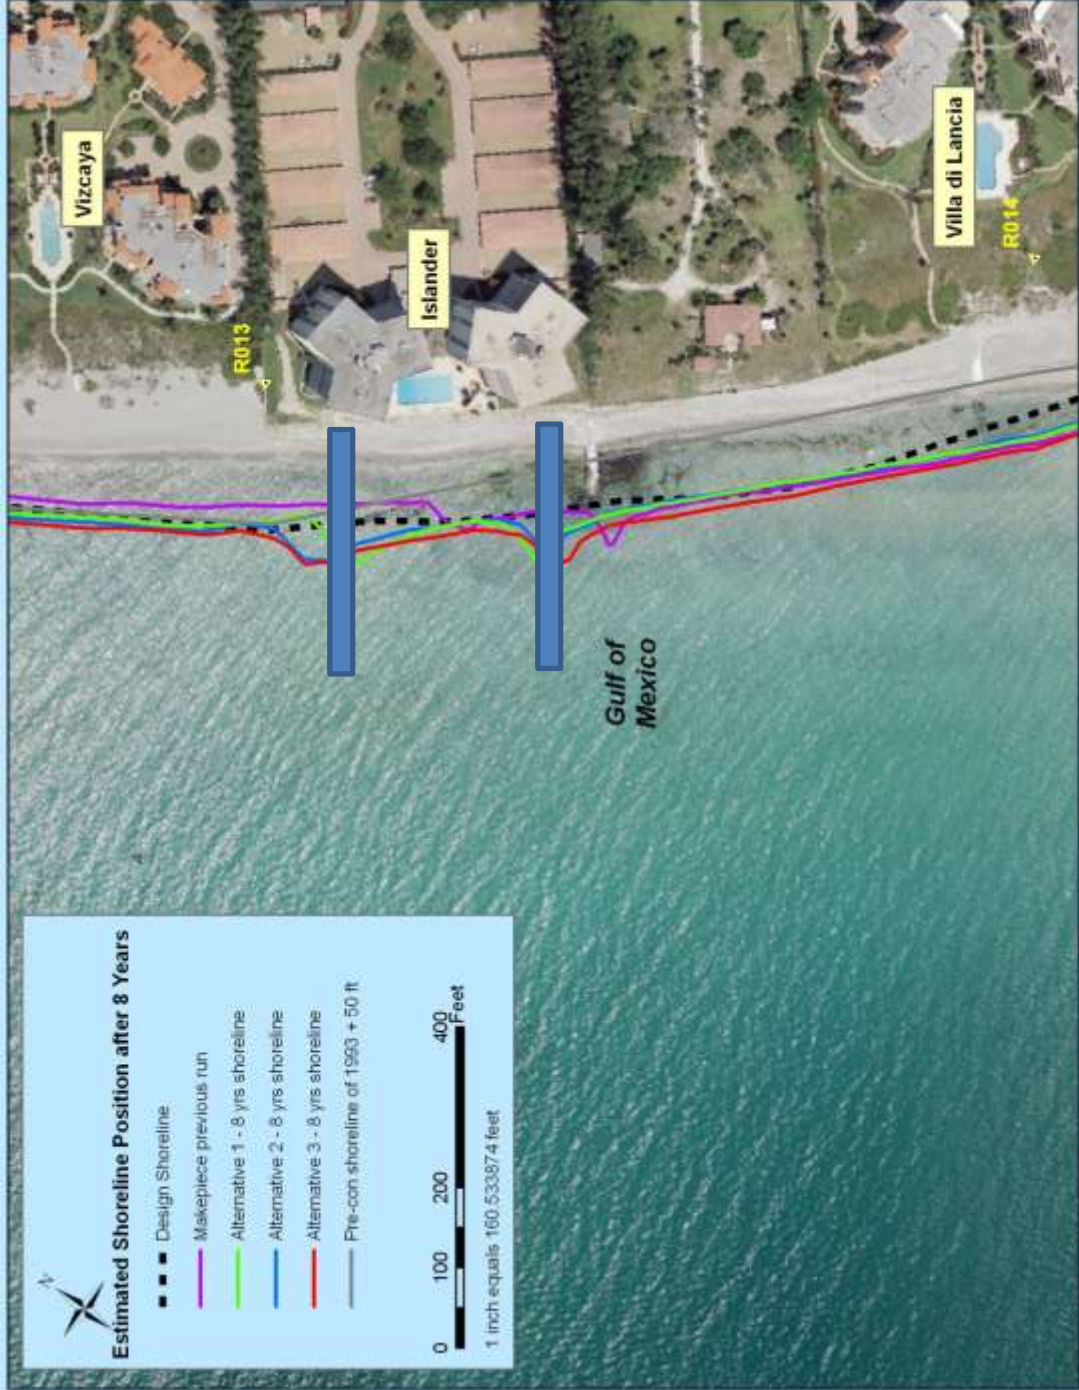
Estimated Shoreline Position after 8 Years

- ■ ■ Design Shoreline
- Makepiece previous run
- Alternative 1 - 8 yrs shoreline
- Alternative 2 - 8 yrs shoreline
- Alternative 3 - 8 yrs shoreline
- Pre-con shoreline of 1993 + 50 ft

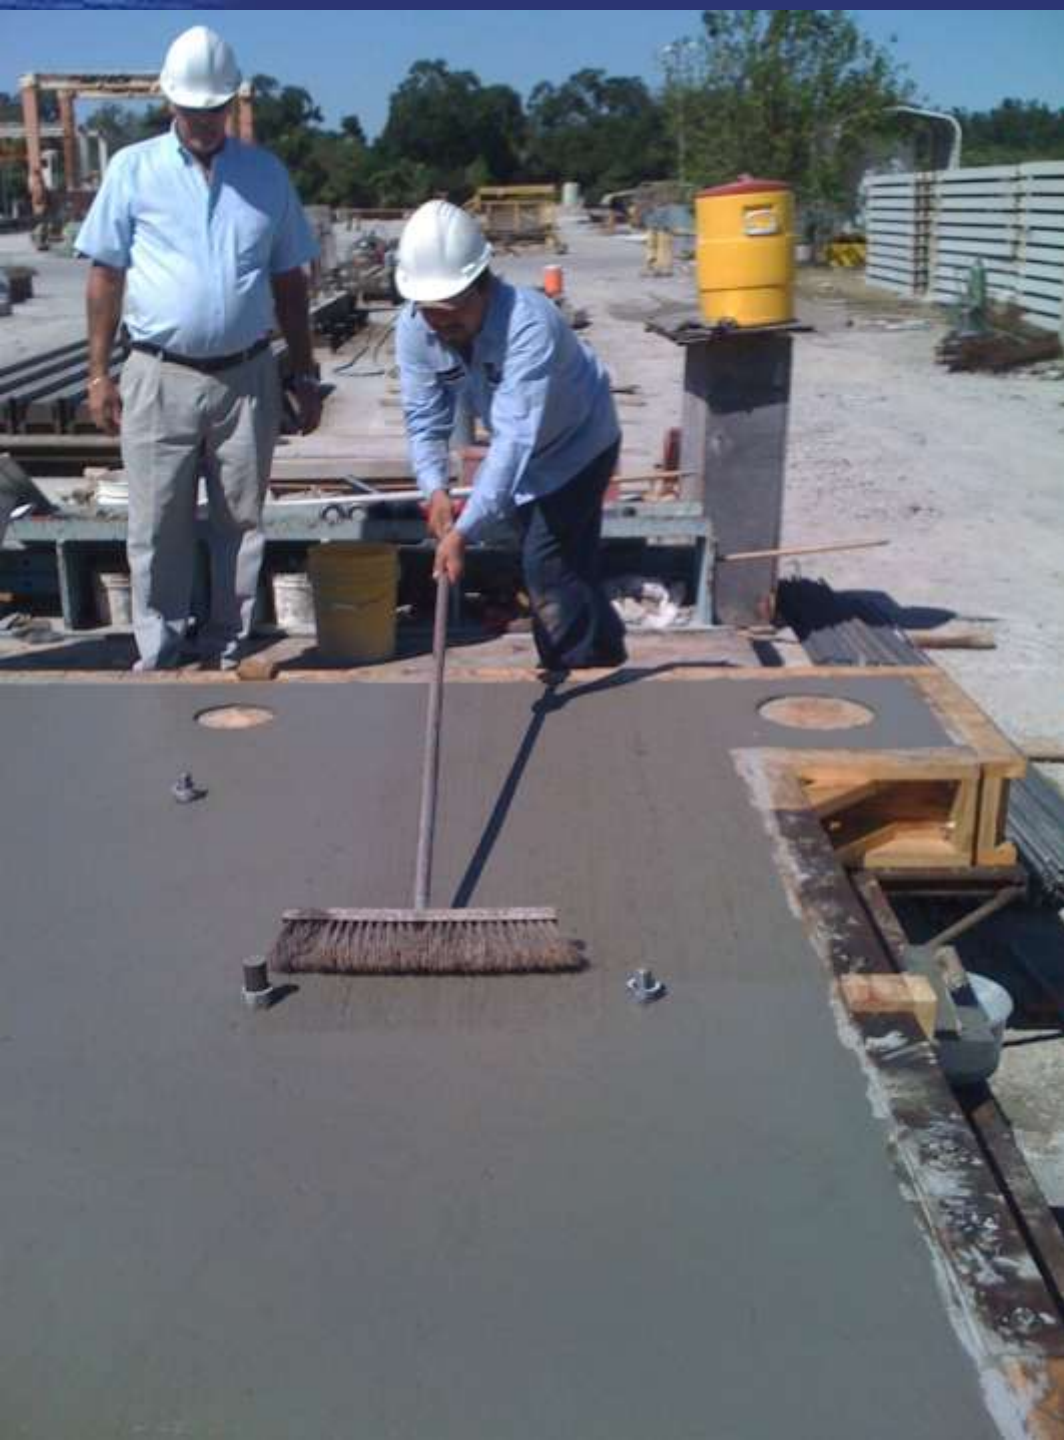
Groin deck slab.

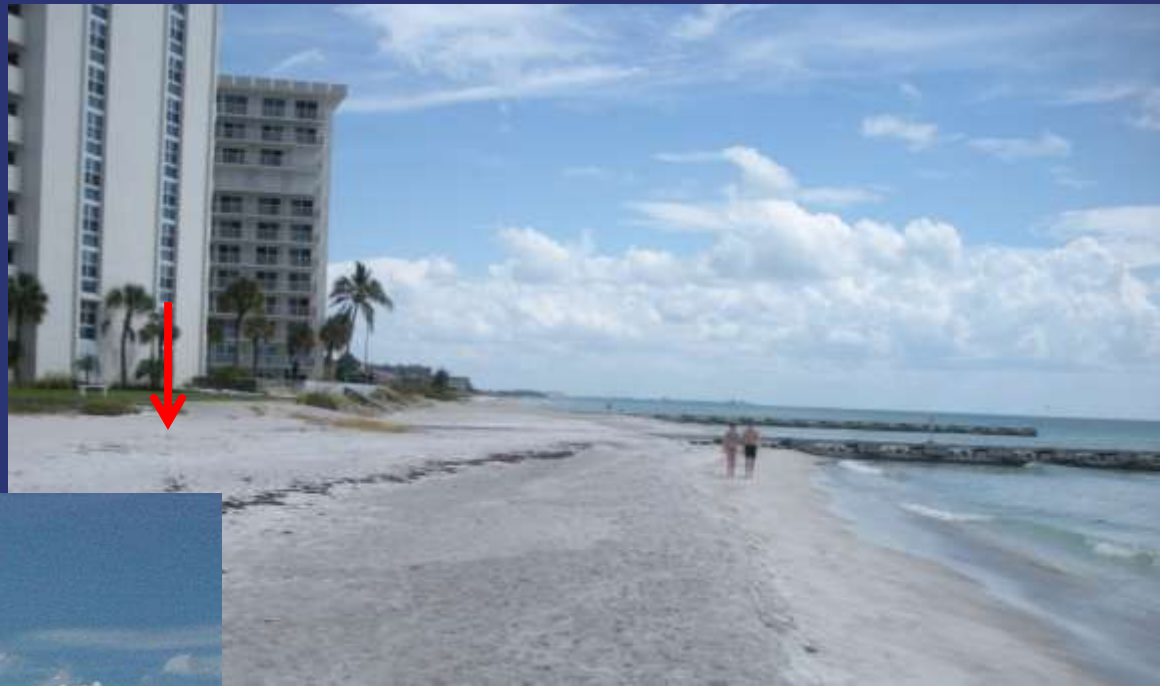
2010 (4 years post 2005/2006 nourishment)

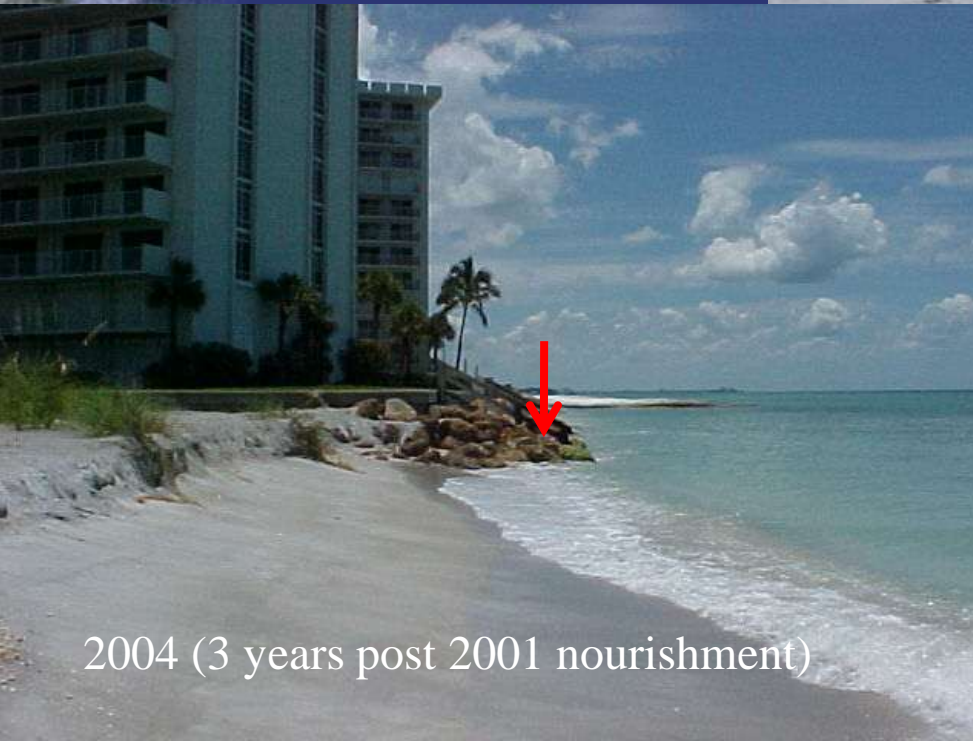
2004 (3 years post 2001 nourishment)

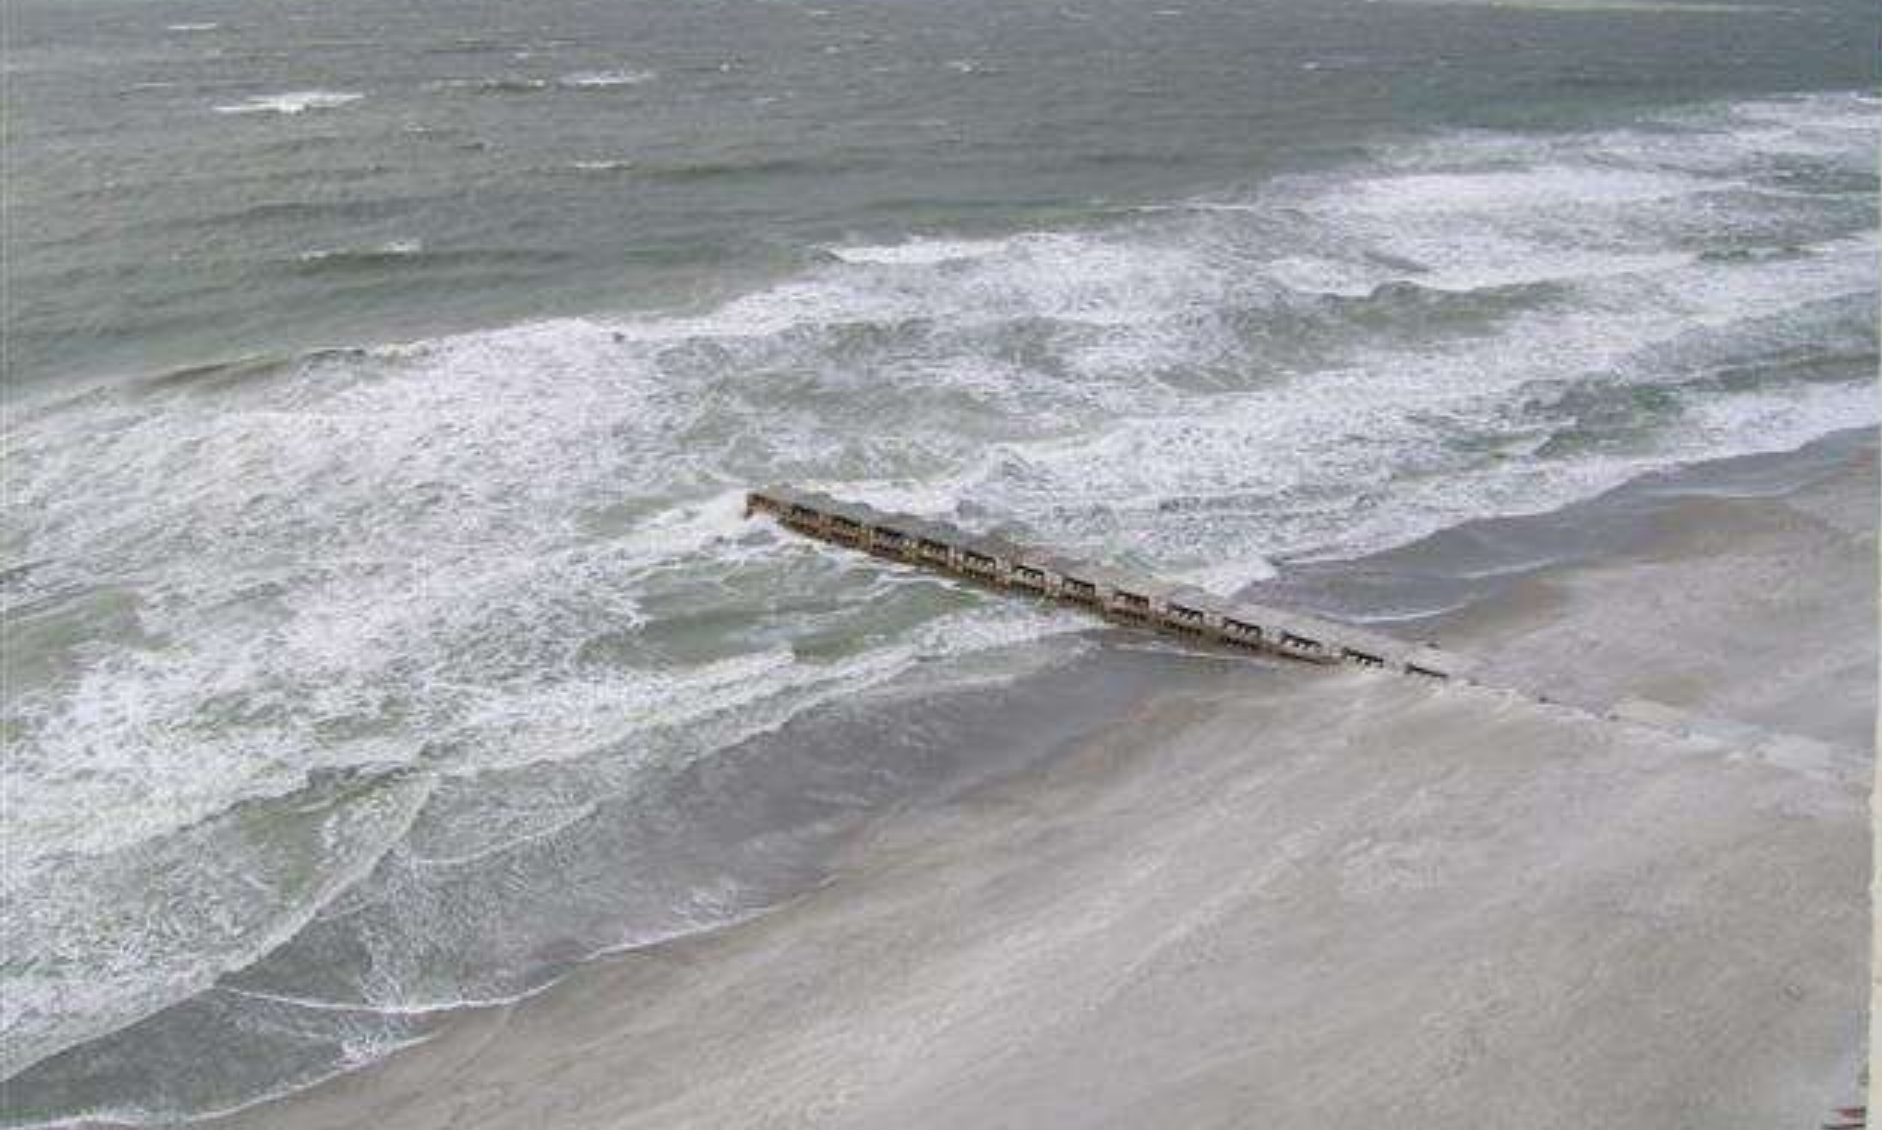
Storm Performance: Dec 13, 2010

Low Tide Condition. Photo Courtesy of LBK.
