Florida Department of Environmental Protection

Beach Nourishment & Nearshore Hardbottom

Danielle H. Irwin, Deputy Director
58th Annual FSBPA Conference
September 26, 2014

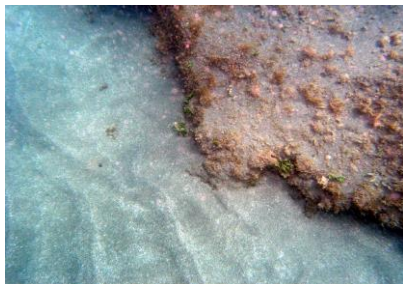
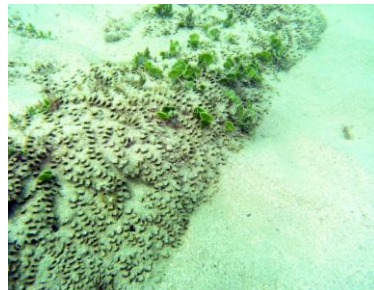
- Details of field protocol methodology
- Standardized monitoring techniques
 - Map and classify hardbottom
 - Conduct HB edge surveys
 - Establish and sample transects
 - Conduct video surveys
 - Conduct sediment monitoring
 - Sample quadrats
- More consistent data from all firms
