Numerical Modeling Analysis of the Katrina Cut Rubble Mound Structure

Gordon Thomson, PE, D.CE
Samantha Danchuk, PE, Ph.D.
Chris Day, PE
Mark Saunders, PE

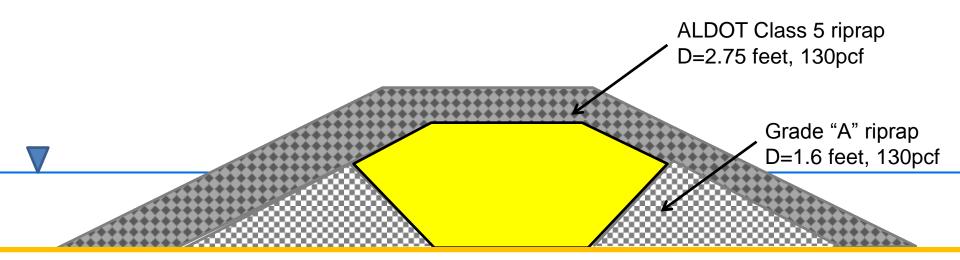
- Emergency barrier constructed during Deepwater
 Horizon Spill to limit oil flowing into Mississippi Sound
- Designed and constructed by Thompson Engineering under an emergency permit
- Rubblemound with sand core

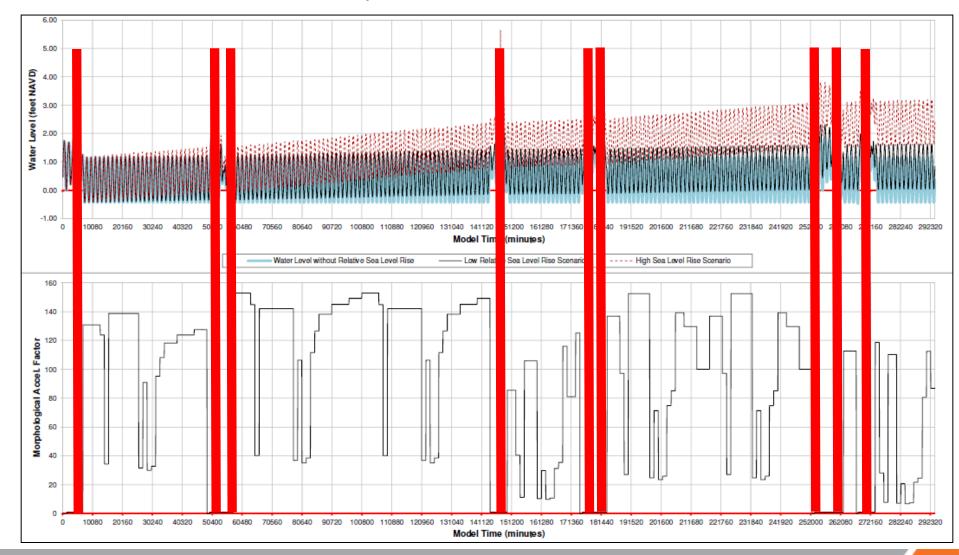
Morfac and storm history for 1917 to 1967

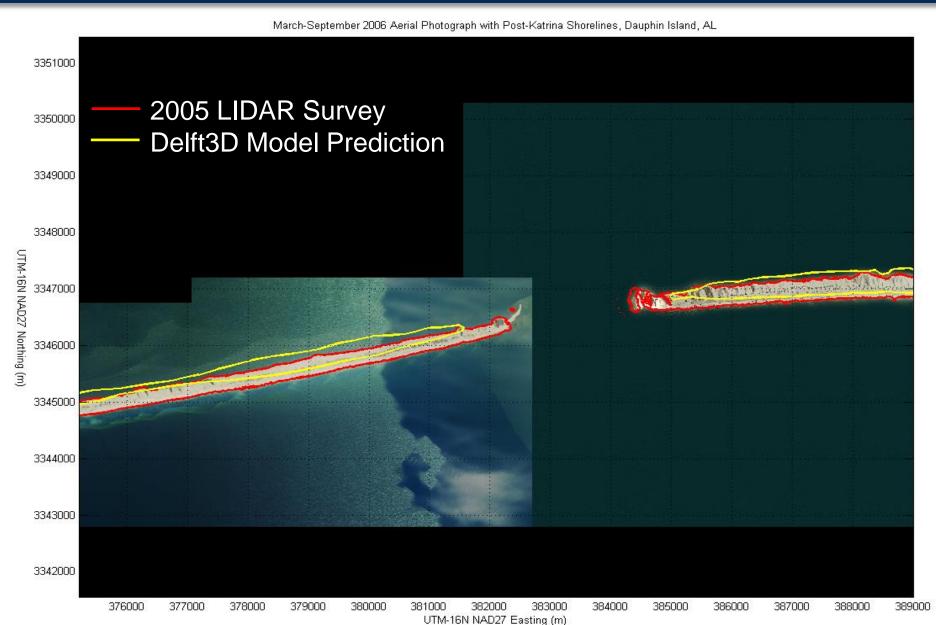
- Calibrated for storm response and long-term volumetric change
 - Repeated Katrina breach
 - 20 year calibration run
- Model verification using Hurricane Ivan and Hurricane Isaac
 - Shoreline and volume changes
 - Breach width

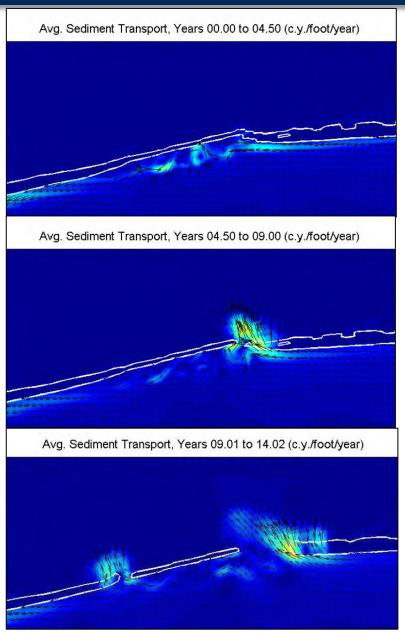
Structure promotes longshore transport initially

Breach forms in low lying area adjacent to structure

Structure is flanked, cross shore transport dominates

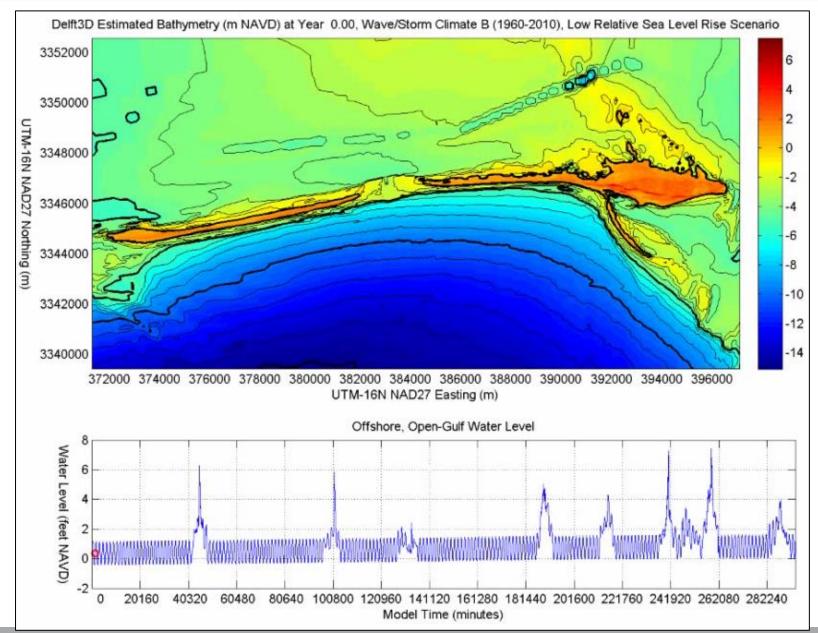
Model Results: Without Structure

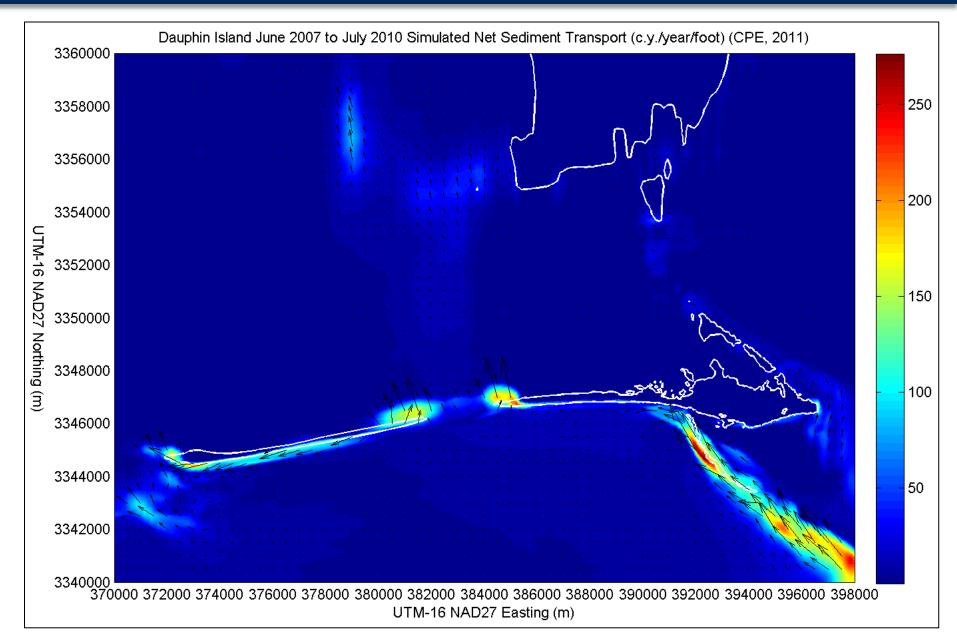
Model Results: Without Structure

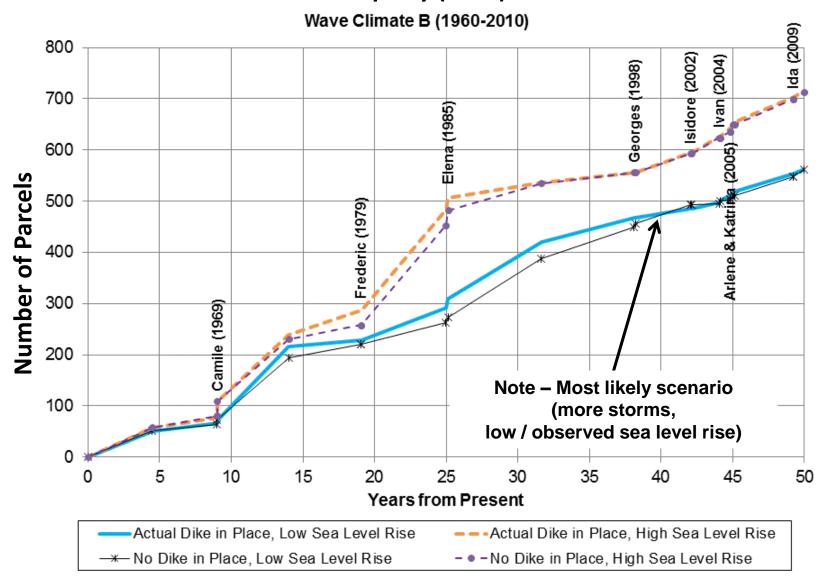
Private Property (Land) Loss

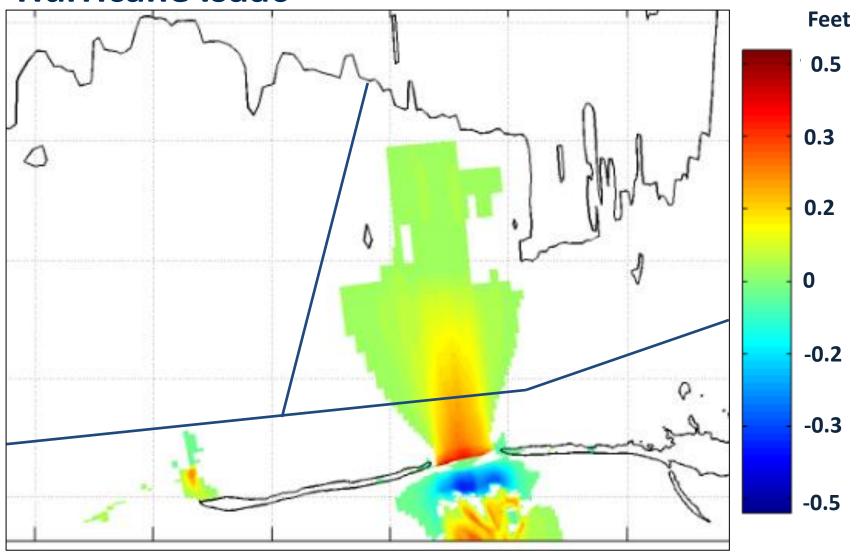
Hurricane Isaac
