# Sebastian Inlet

## South Shoreline Rehabilitation Project

**Presented by:**  
**Bryan D. Flynn, P.E.**  
**S. Marie Yarbrough, P.E.**

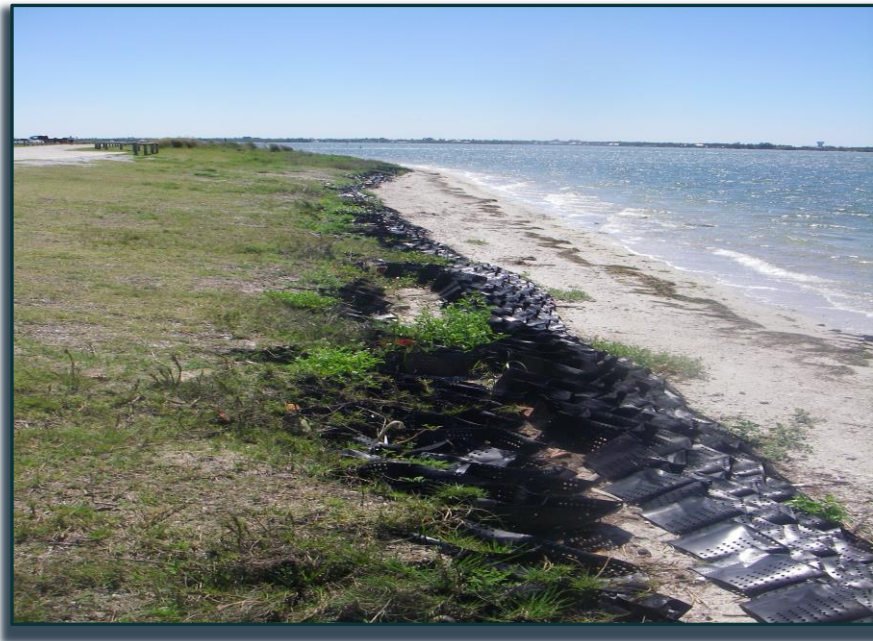
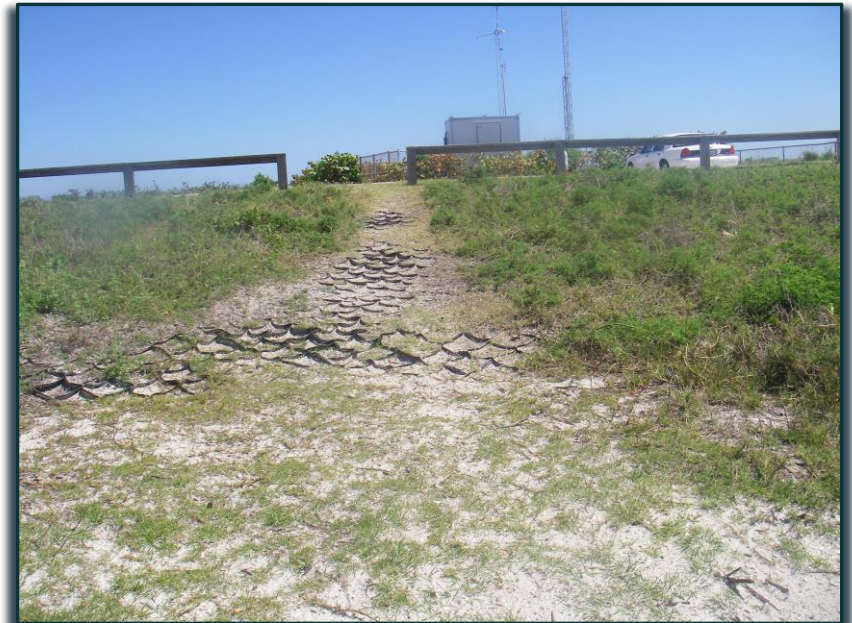
# History of Erosion at Coconut Point

- Coconut Point is a manmade peninsula
- Previous stabilization methods have had marginal success

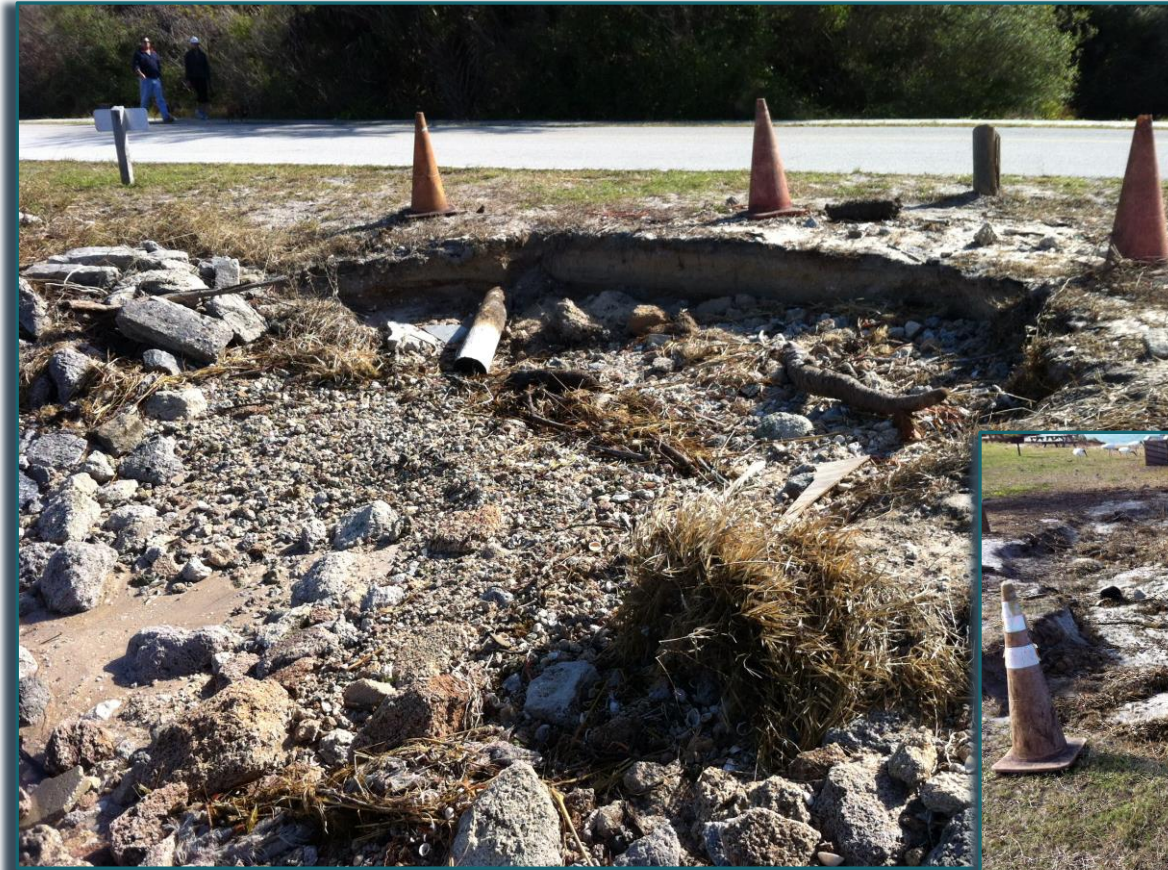
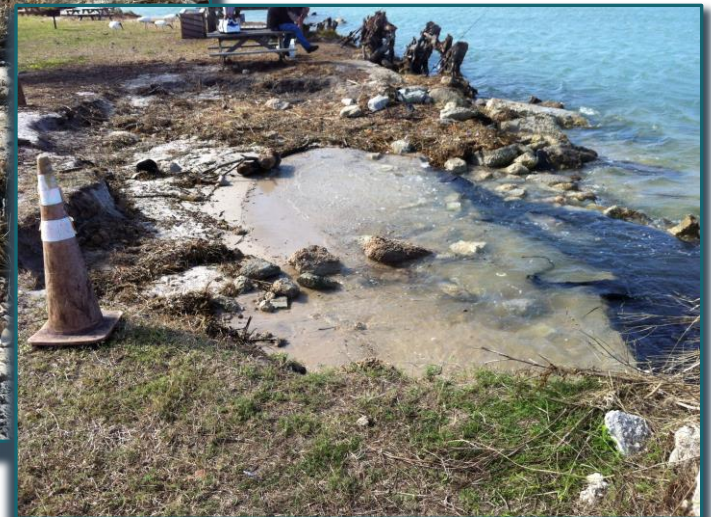
# Damage Threatening Infrastructure

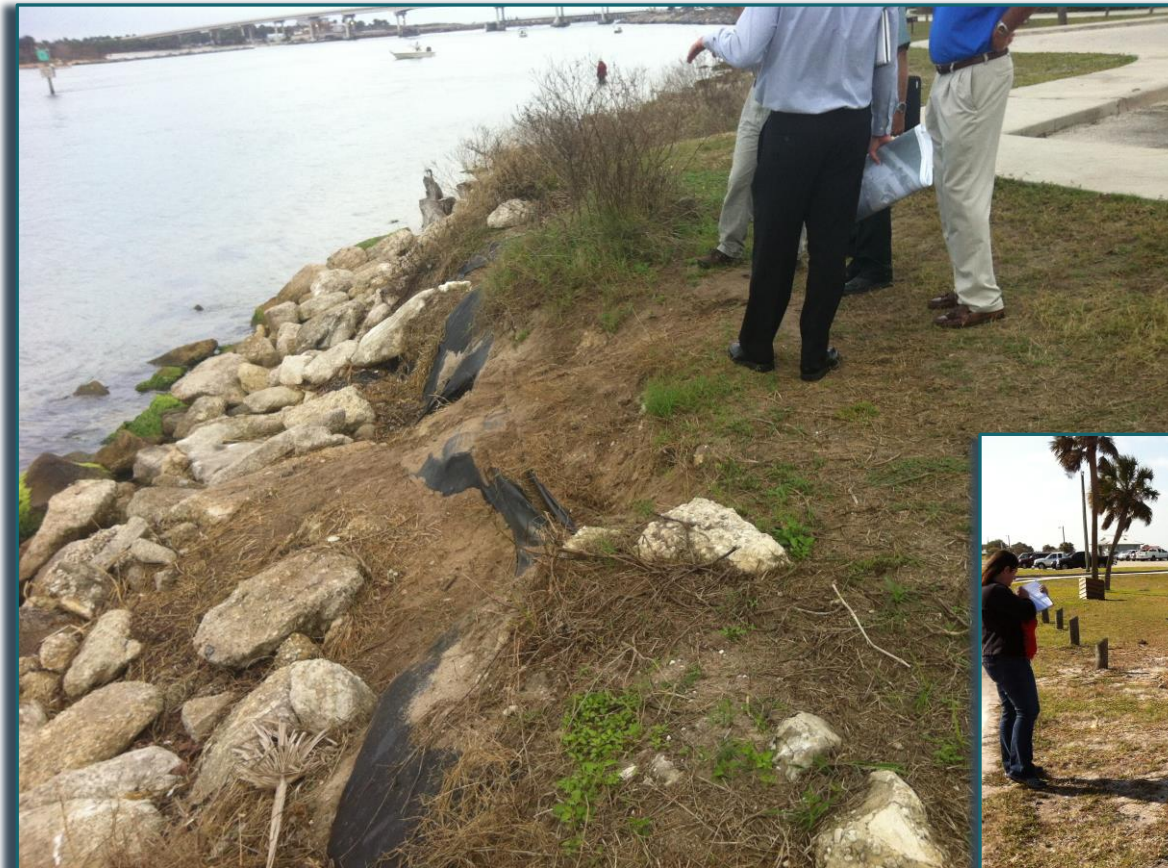
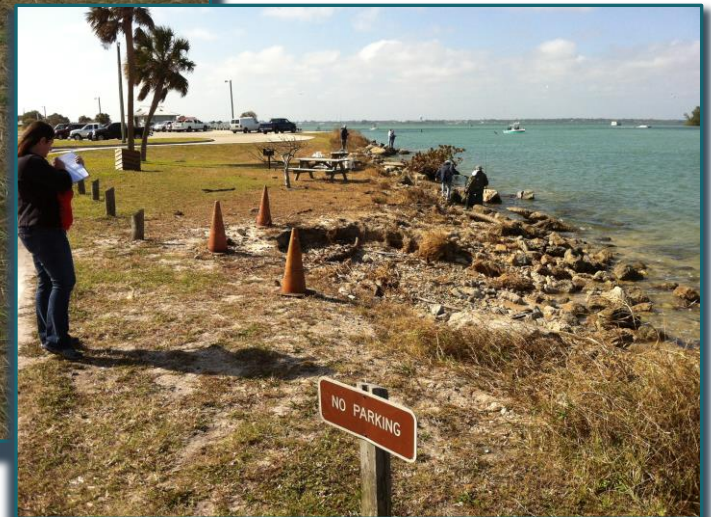
# Damage Threatening Infrastructure

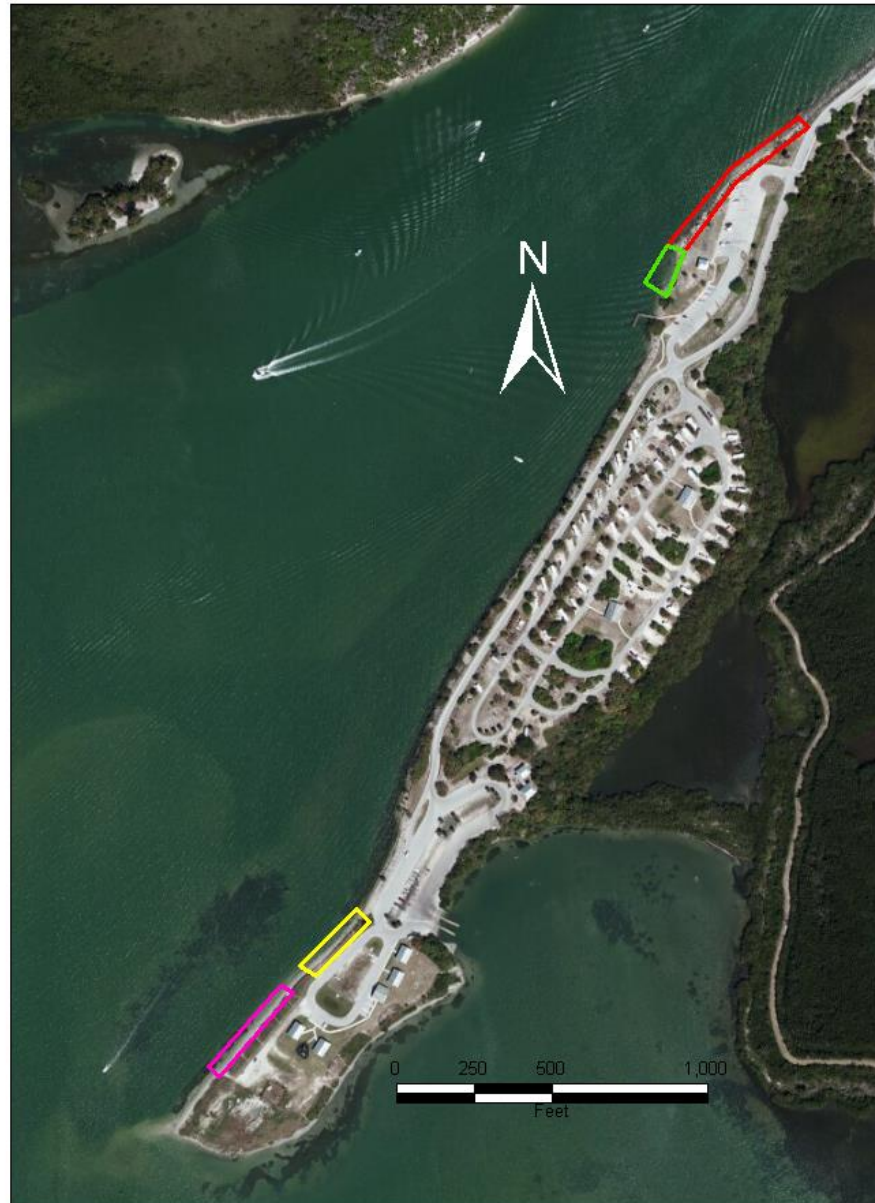
# Project Areas

-   Revetment Area
-

Beach Area
-   Launch Area
-   Walkway Area

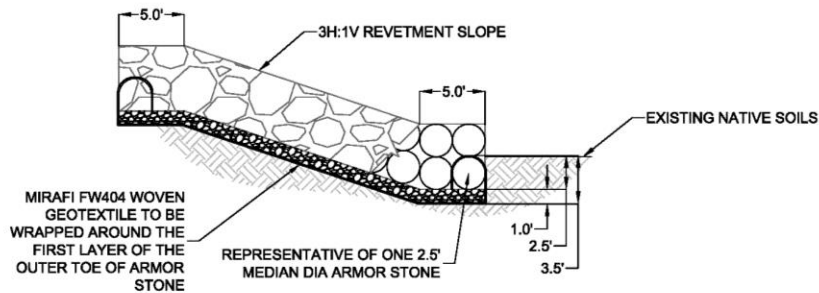
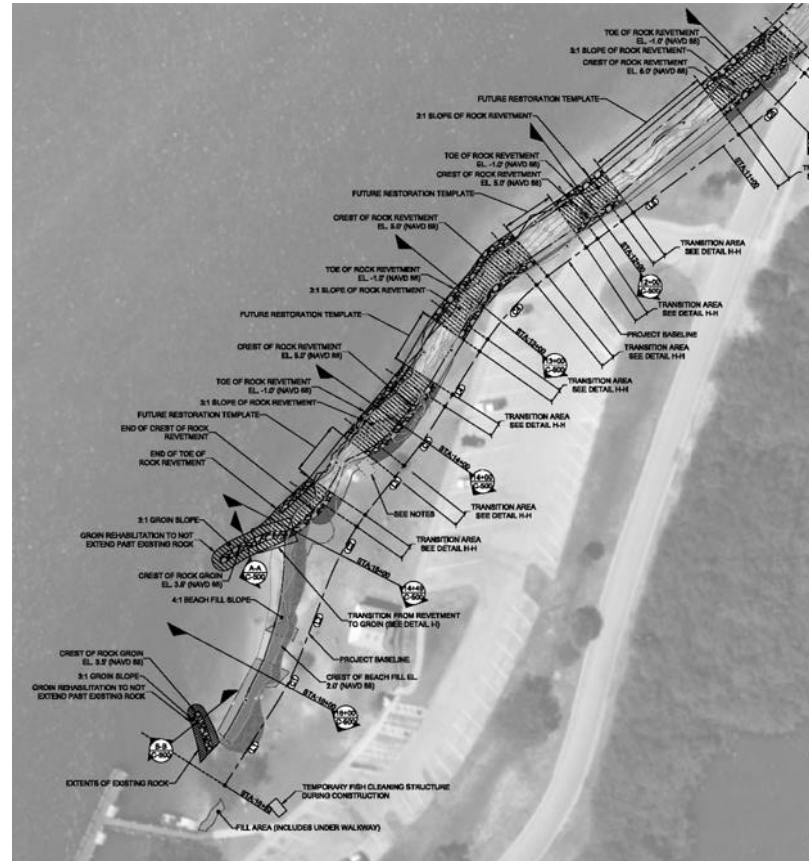
# Revetment Area Design Approach

- Land-based construction methods
- Earthwork
- Geosynthetic fabric
- Bedding stones
- Armor stones

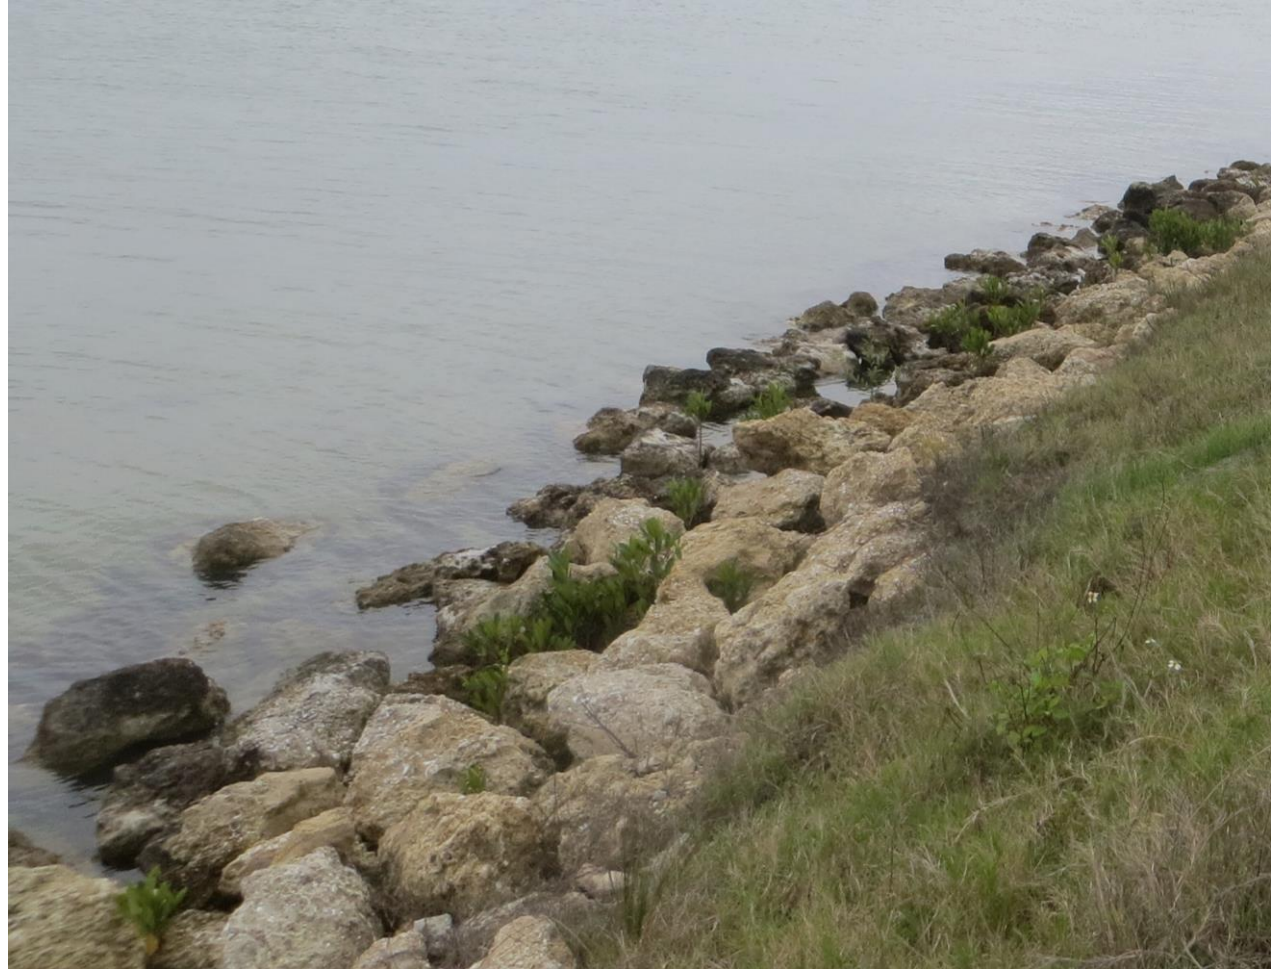
- Limestone revetment toe in the intertidal zone provides habitat for:
  - Natural recruitment of mangroves
  - Crabs
  - Invertebrates
  - Fish

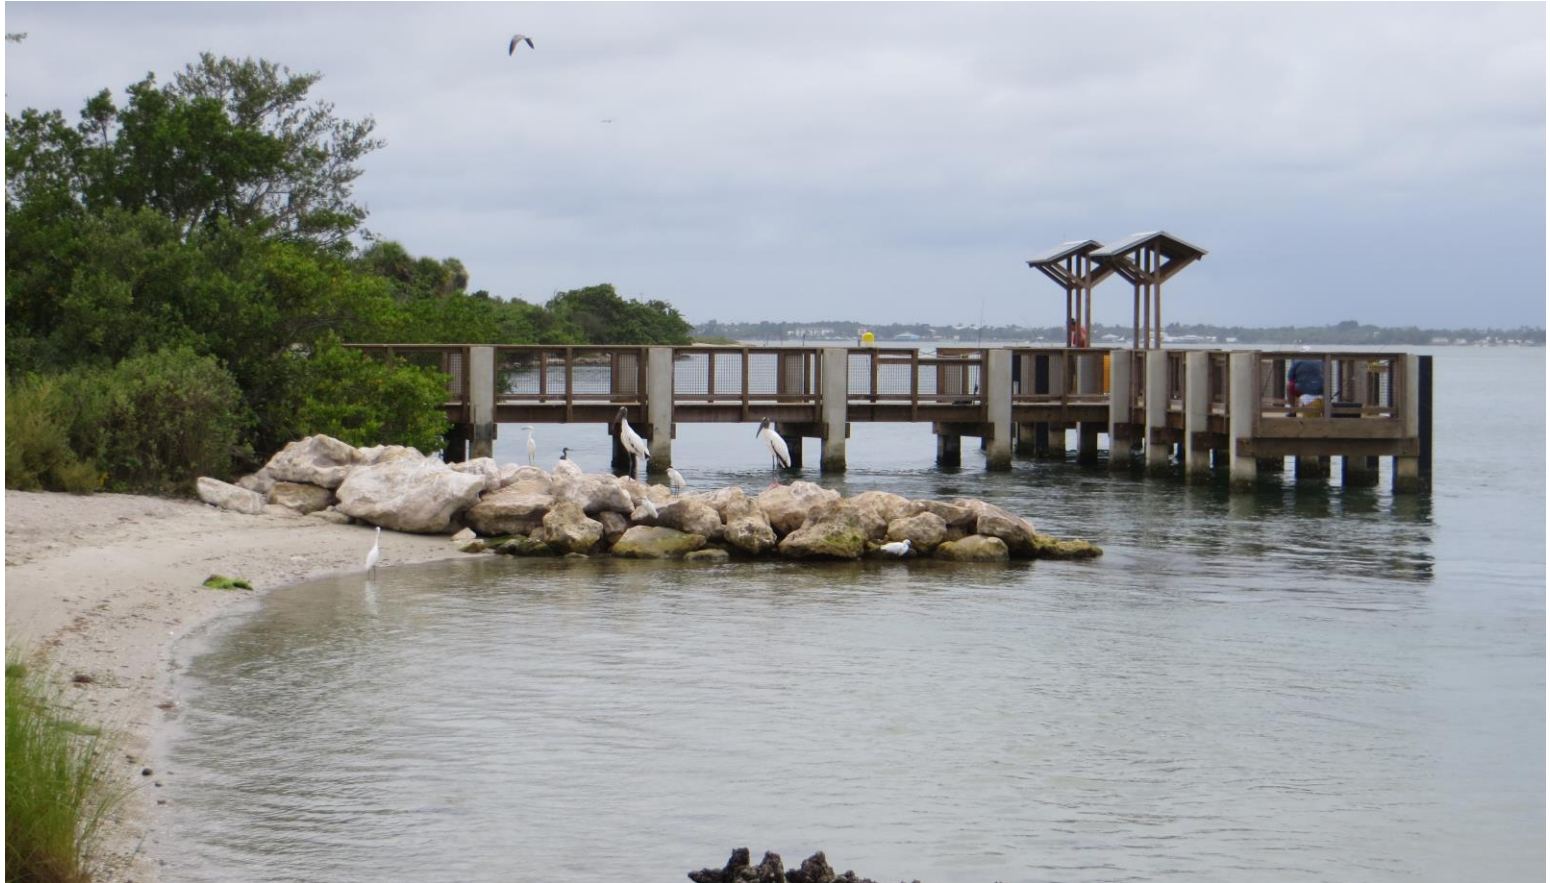
- Existing groins were augmented to provide enhanced protection against wave action while still providing a natural beach area

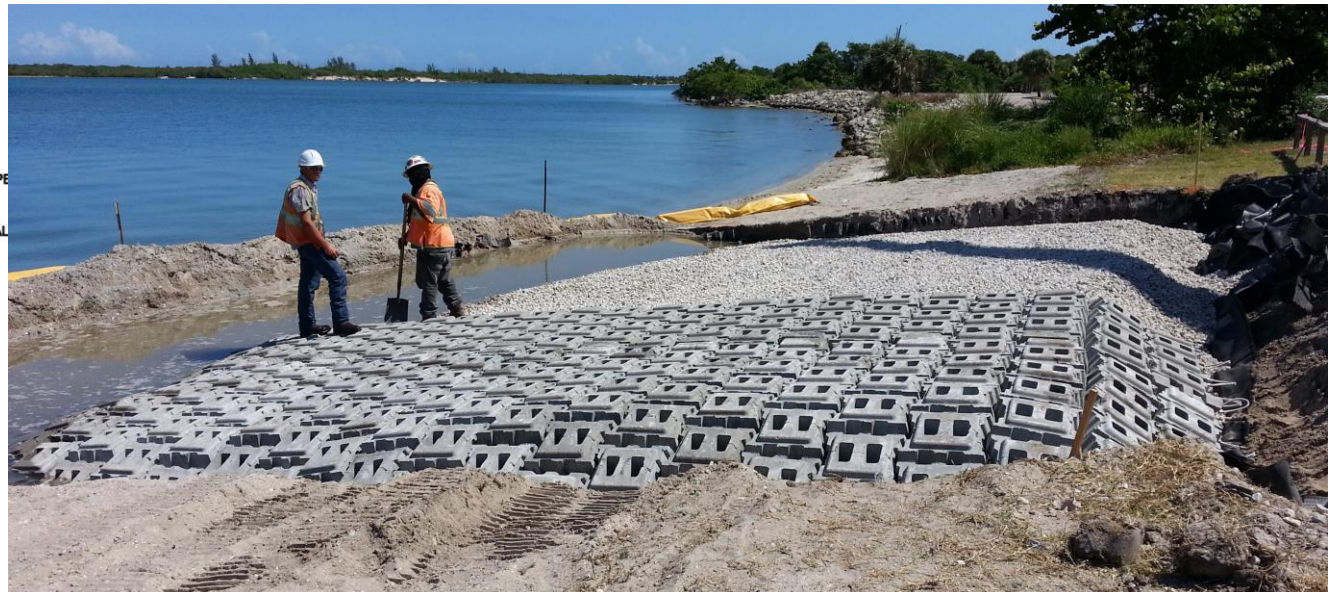
- Articulated block mattresses were installed in two areas

F-F: TYPICAL ARTICULATED CONCRETE BLOCK INSTALLATION CROSS SECTION

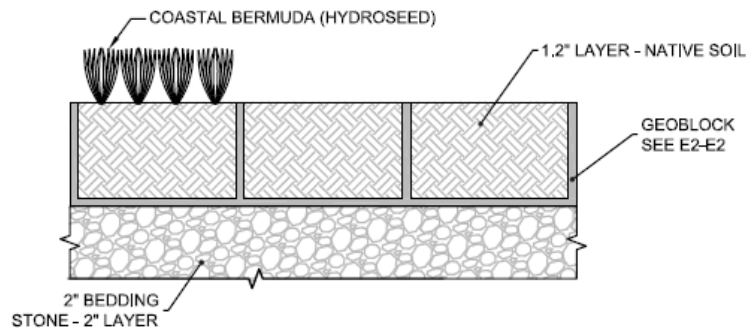
- Install geoblock in designated walkways
- Repair existing geoweb cellular confinement material

E1-E1: TYPICAL GEOBLOCK CROSS SECTION

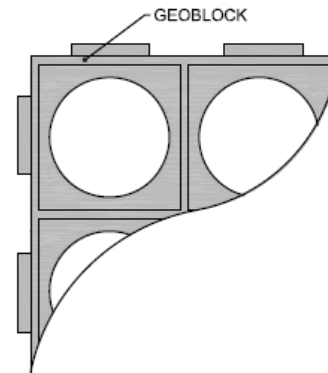
E2-E2: TYPICAL GEOBLOCK PLAN VIEW

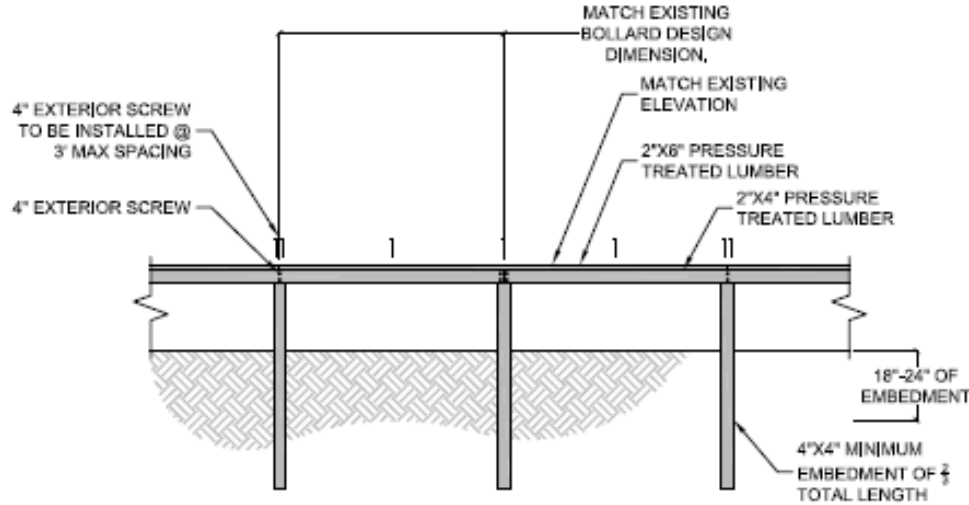
- Stabilization of designated access corridors with geoblock material containing native vegetation
- Installation of bollard fencing

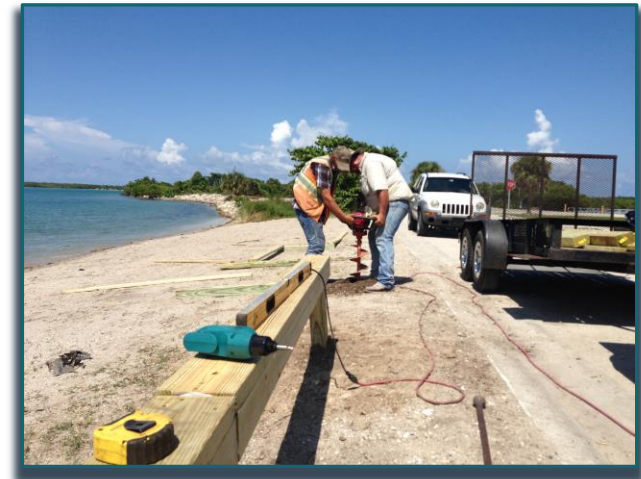
G-G: TYPICAL BOLLARD SECTION

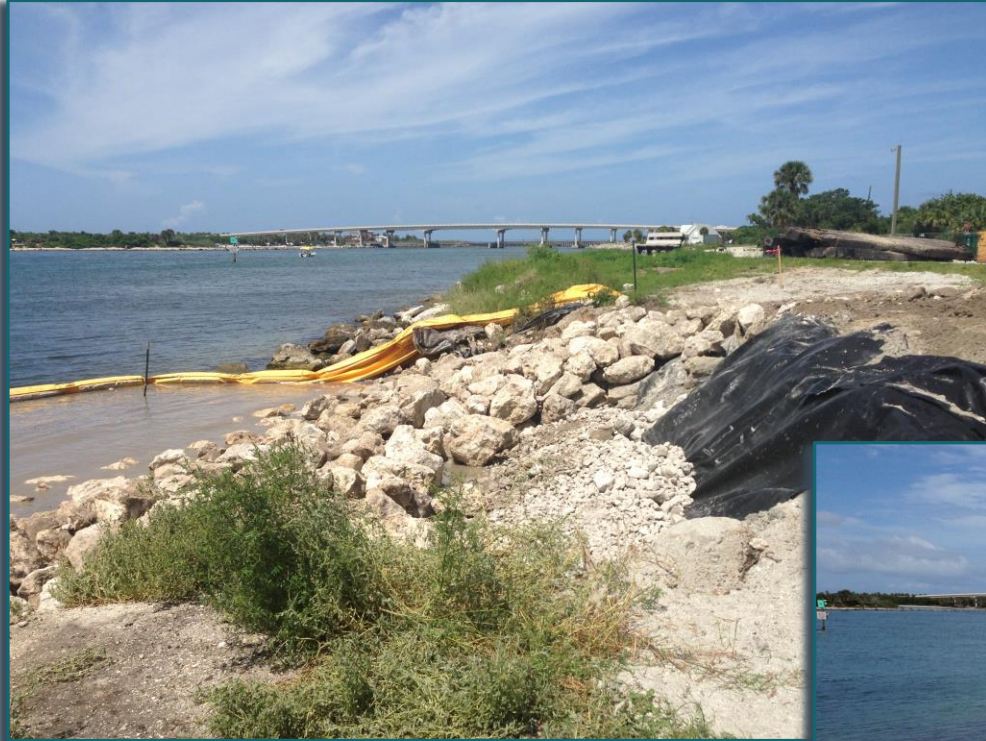
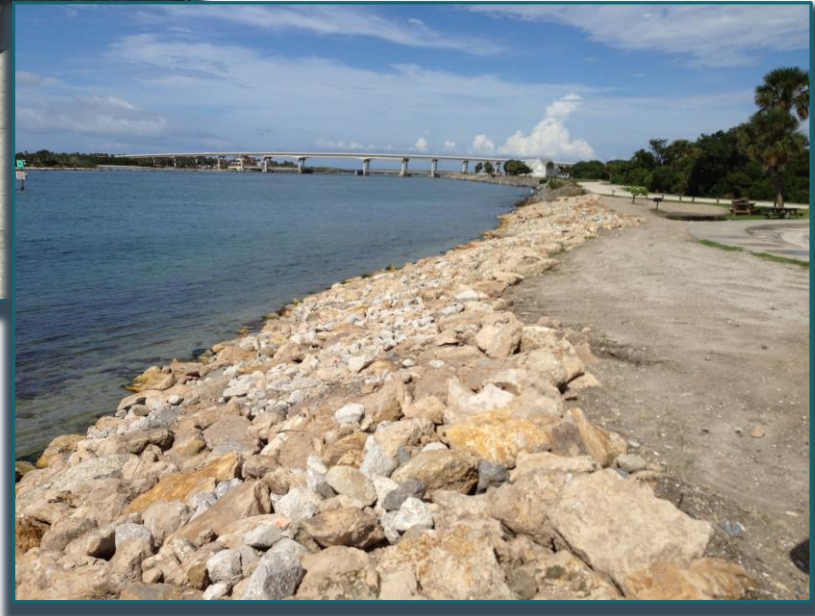
- Traditional armoring

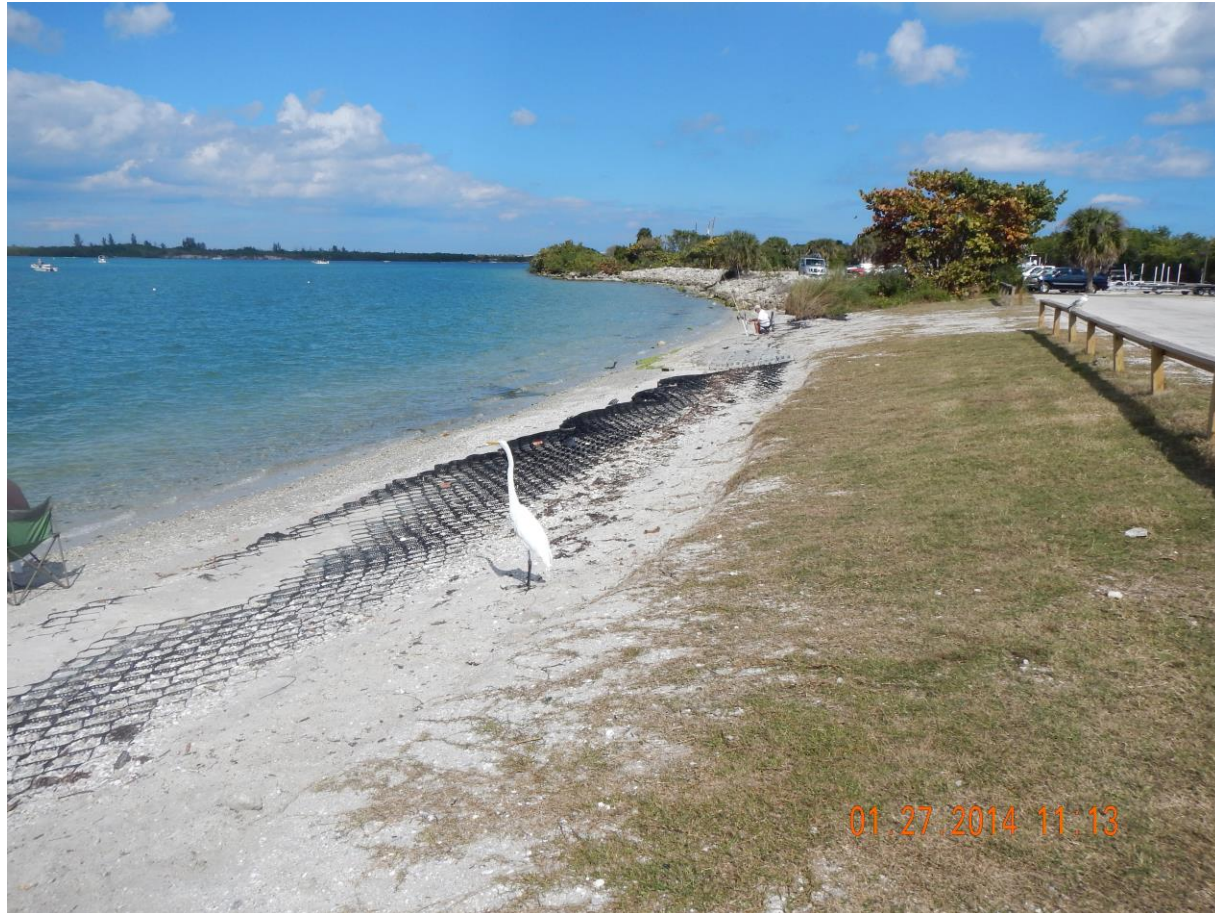
- Strong north winds uprooted many immature plantings
- High water levels due to a combination of high tides and storm surge scoured material covering the geoweb

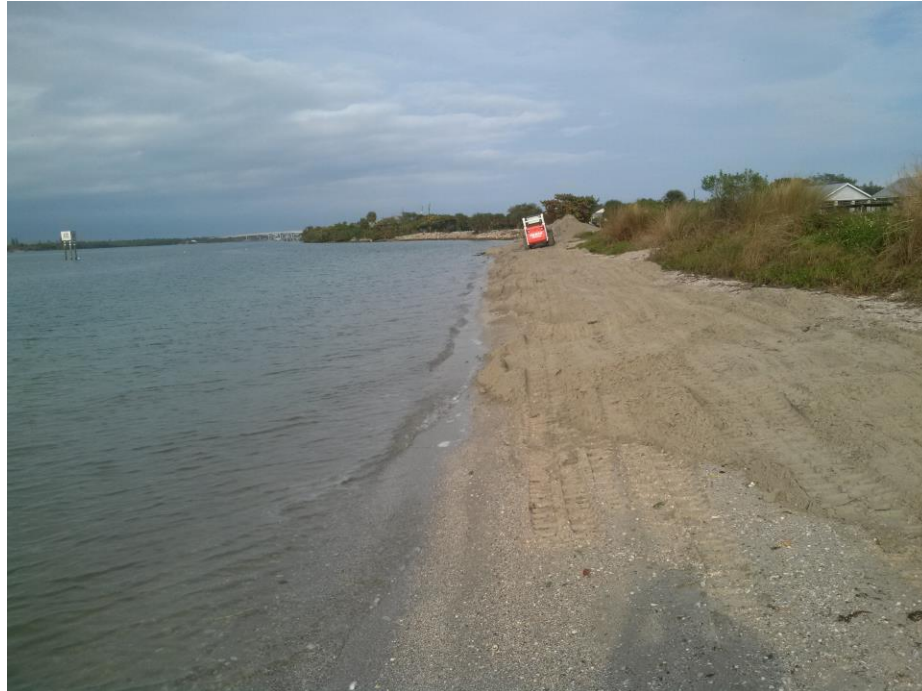
- Component of the comprehensive inlet management strategy
- Construction completed July 2011
- Provides short-term location for dewatering and storing up to 28,000 cubic yards of excavated sand
