Coastal Management Plan Development Fort Myers Beach, Florida

FSBPA Technical Conference

February 5, 2015

**COAST & HARBOR
ENGINEERING**

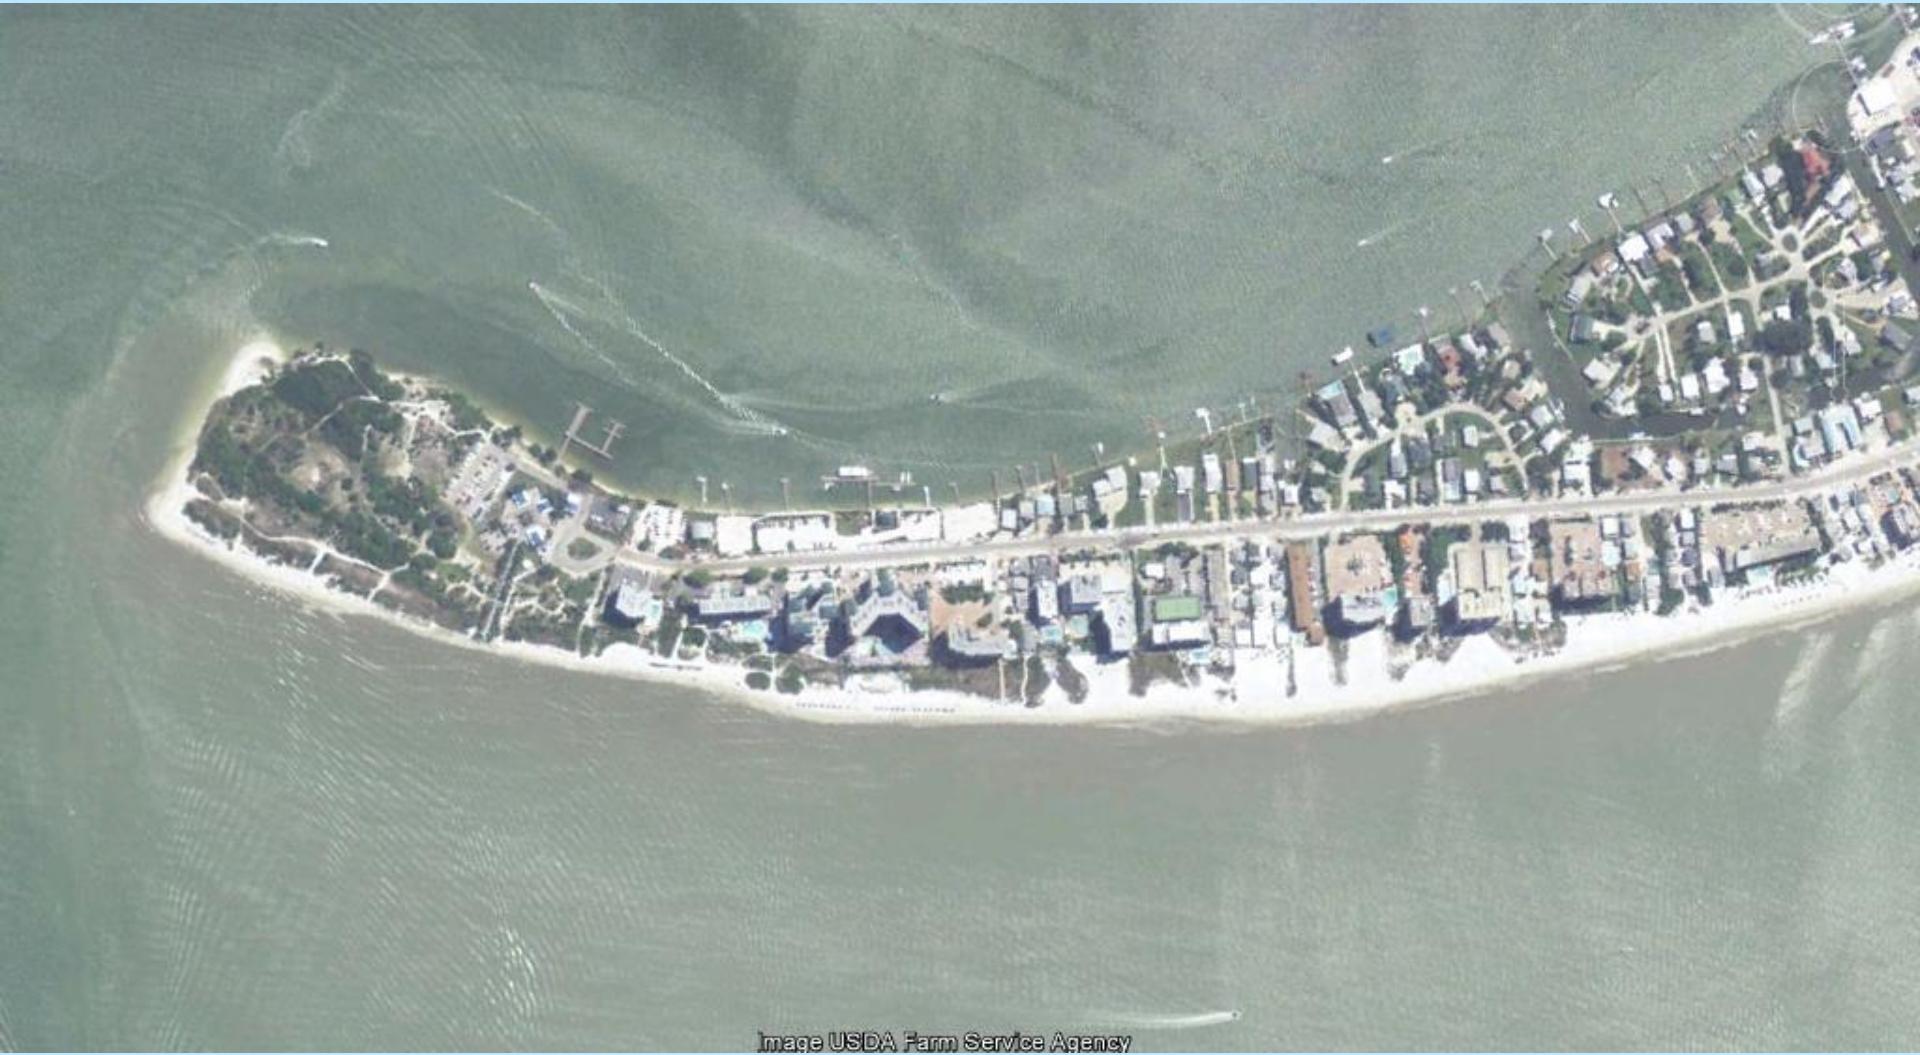
Pre-Nourishment Construction

2010-04

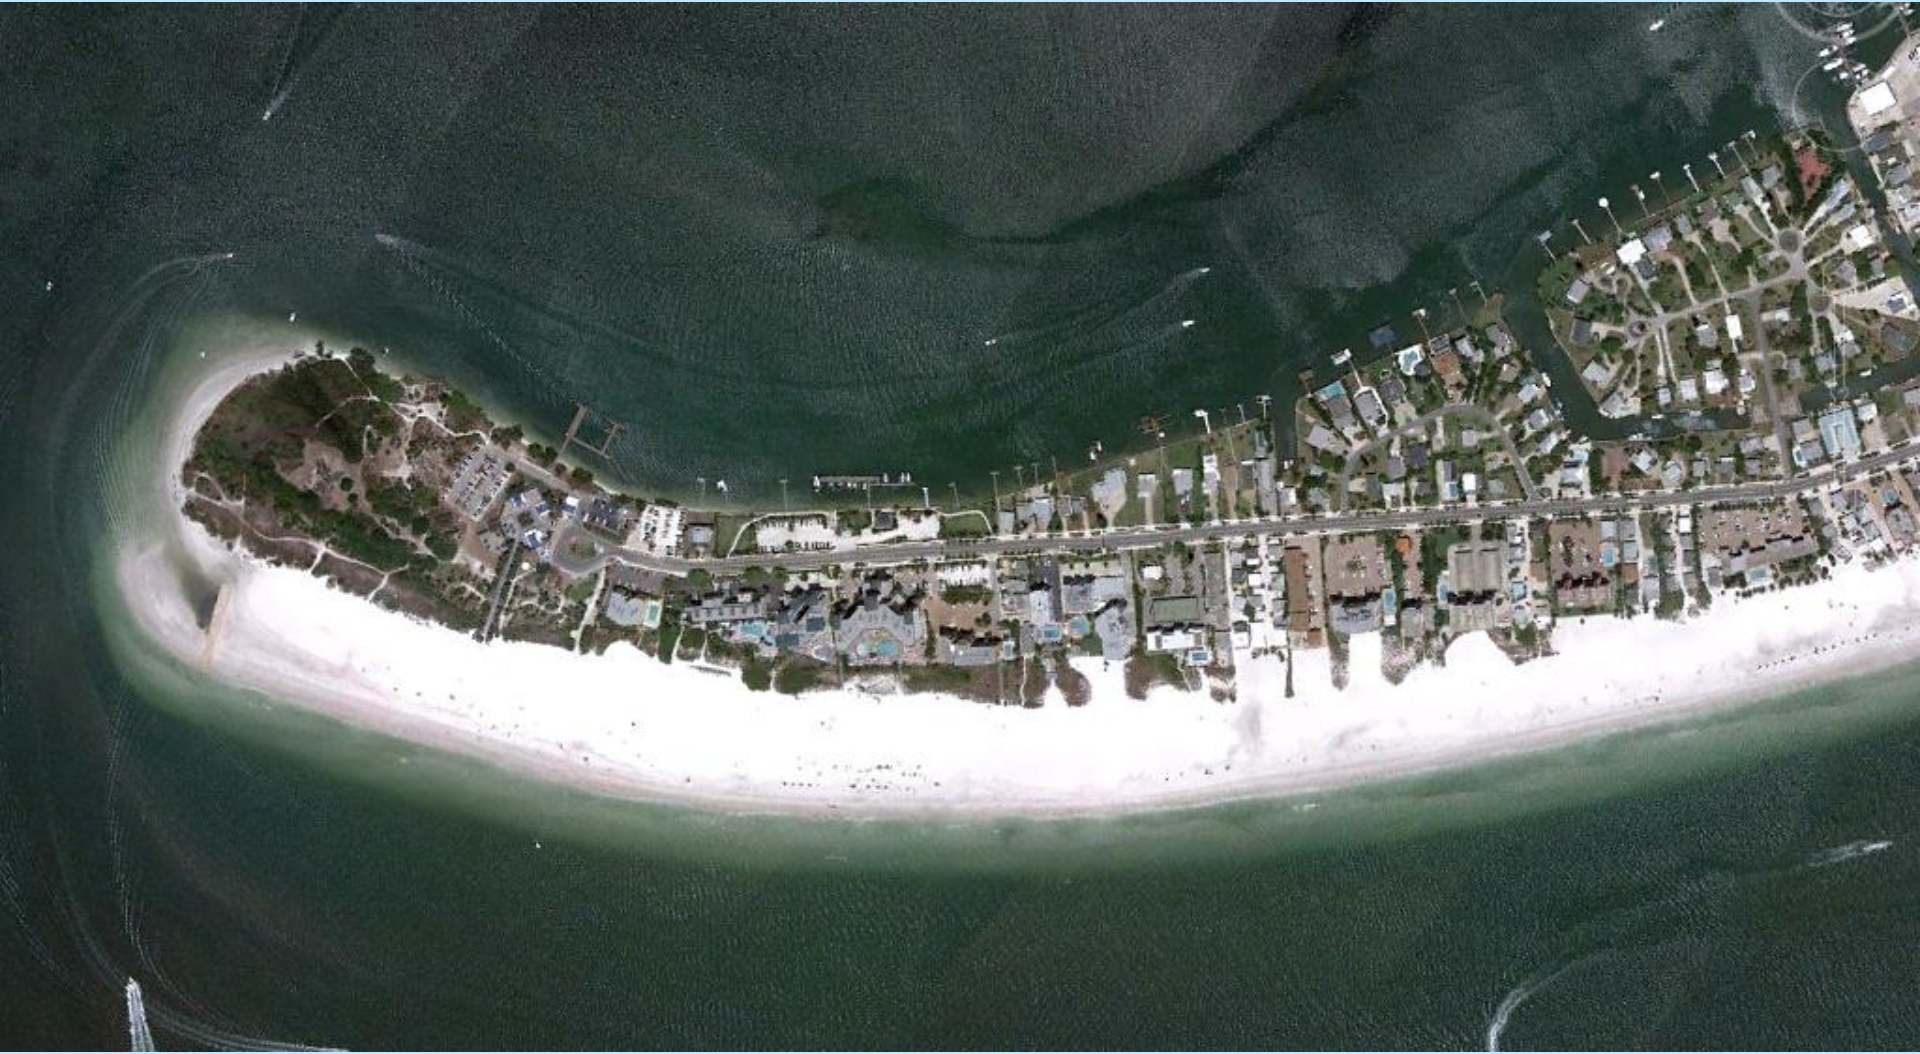
Post-Nourishment Construction

2012-04

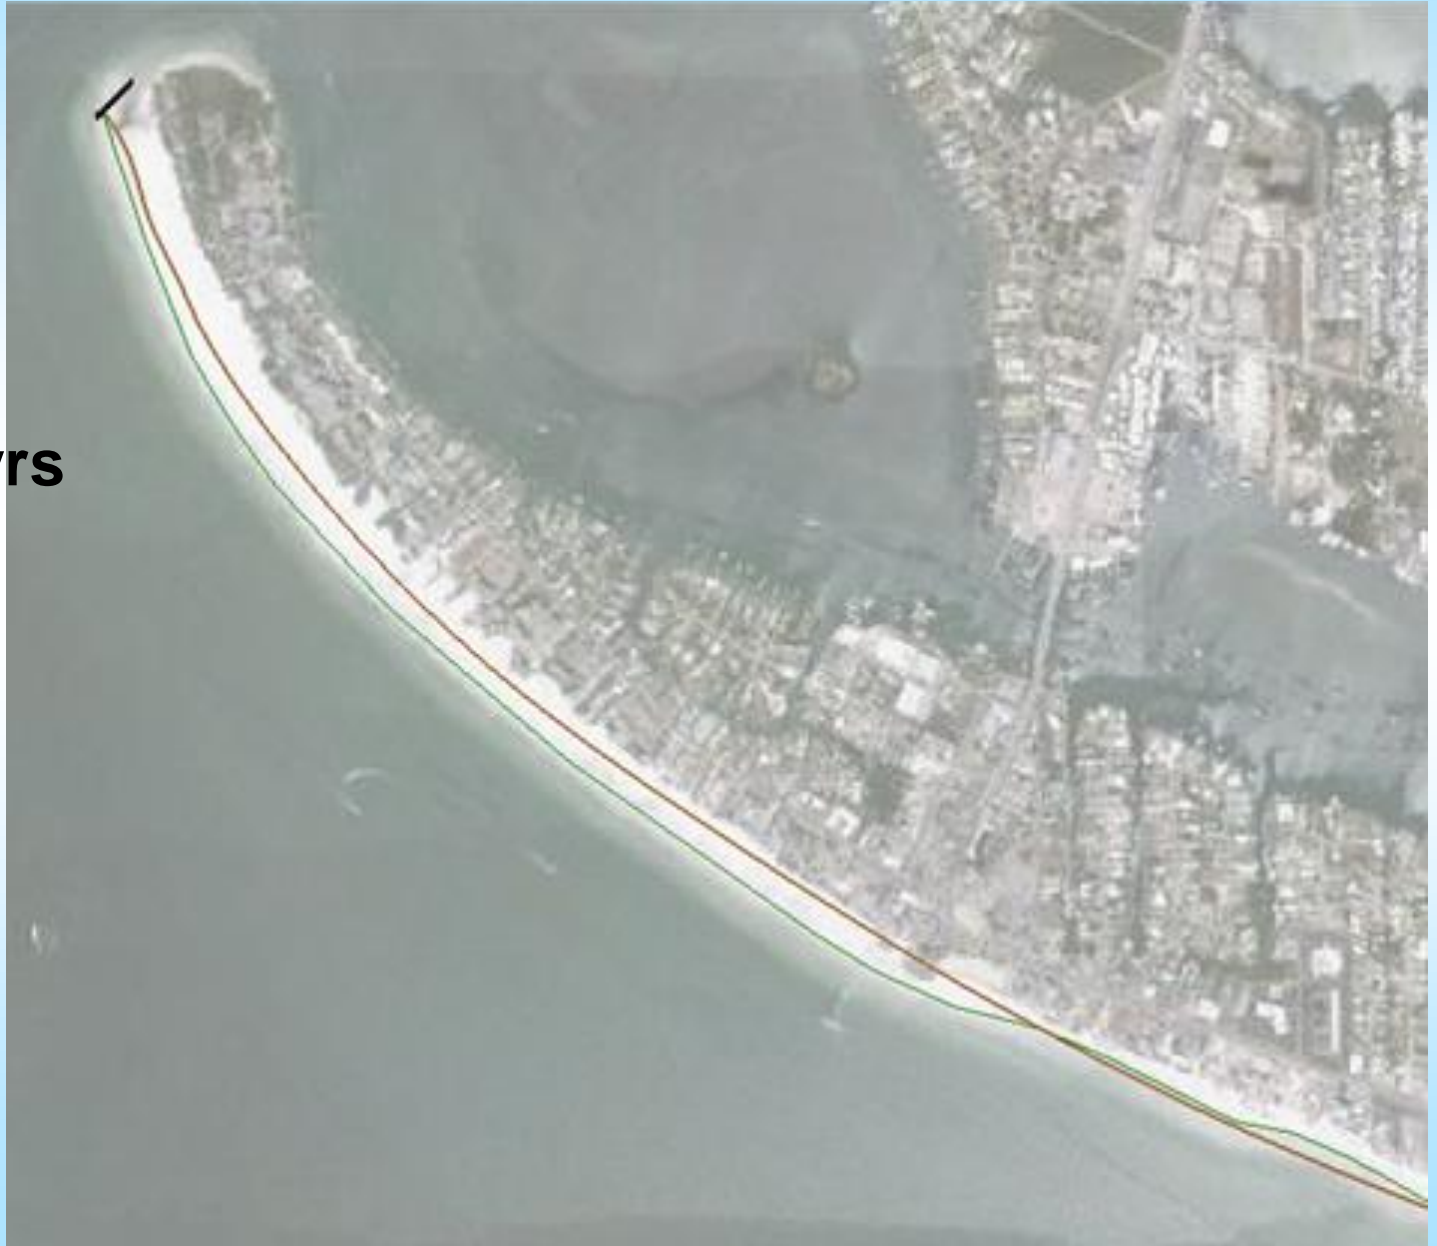
Alternatives Evaluation – Reach 1

Alt 1.1
Nourishment

In 8 years

Lifetime ~ 8 yrs

Alternative	Lifetime Estimate [yr]	Cost Estimate [M]
1.1 Beach Nourishment	8	\$4.6
1.2 Short Groin Field	12	\$4.4
1.3 Breakwater Field	14	\$10.0
2.1 Onshore Beach Nourishment	~20	\$2.5
2.2 Nearshore Nourishment	10	\$2.3
2.3 Offshore Nourishment	n/a	\$2.3
3.1 Breakwater Field	11	\$8.6
3.2 Onshore Beach Nourishment	12	\$2.8
3.3 Onshore Nourishment & Breakwater	15	\$14.7
3.4 Nearshore Beach Nourishment	6	\$2.6

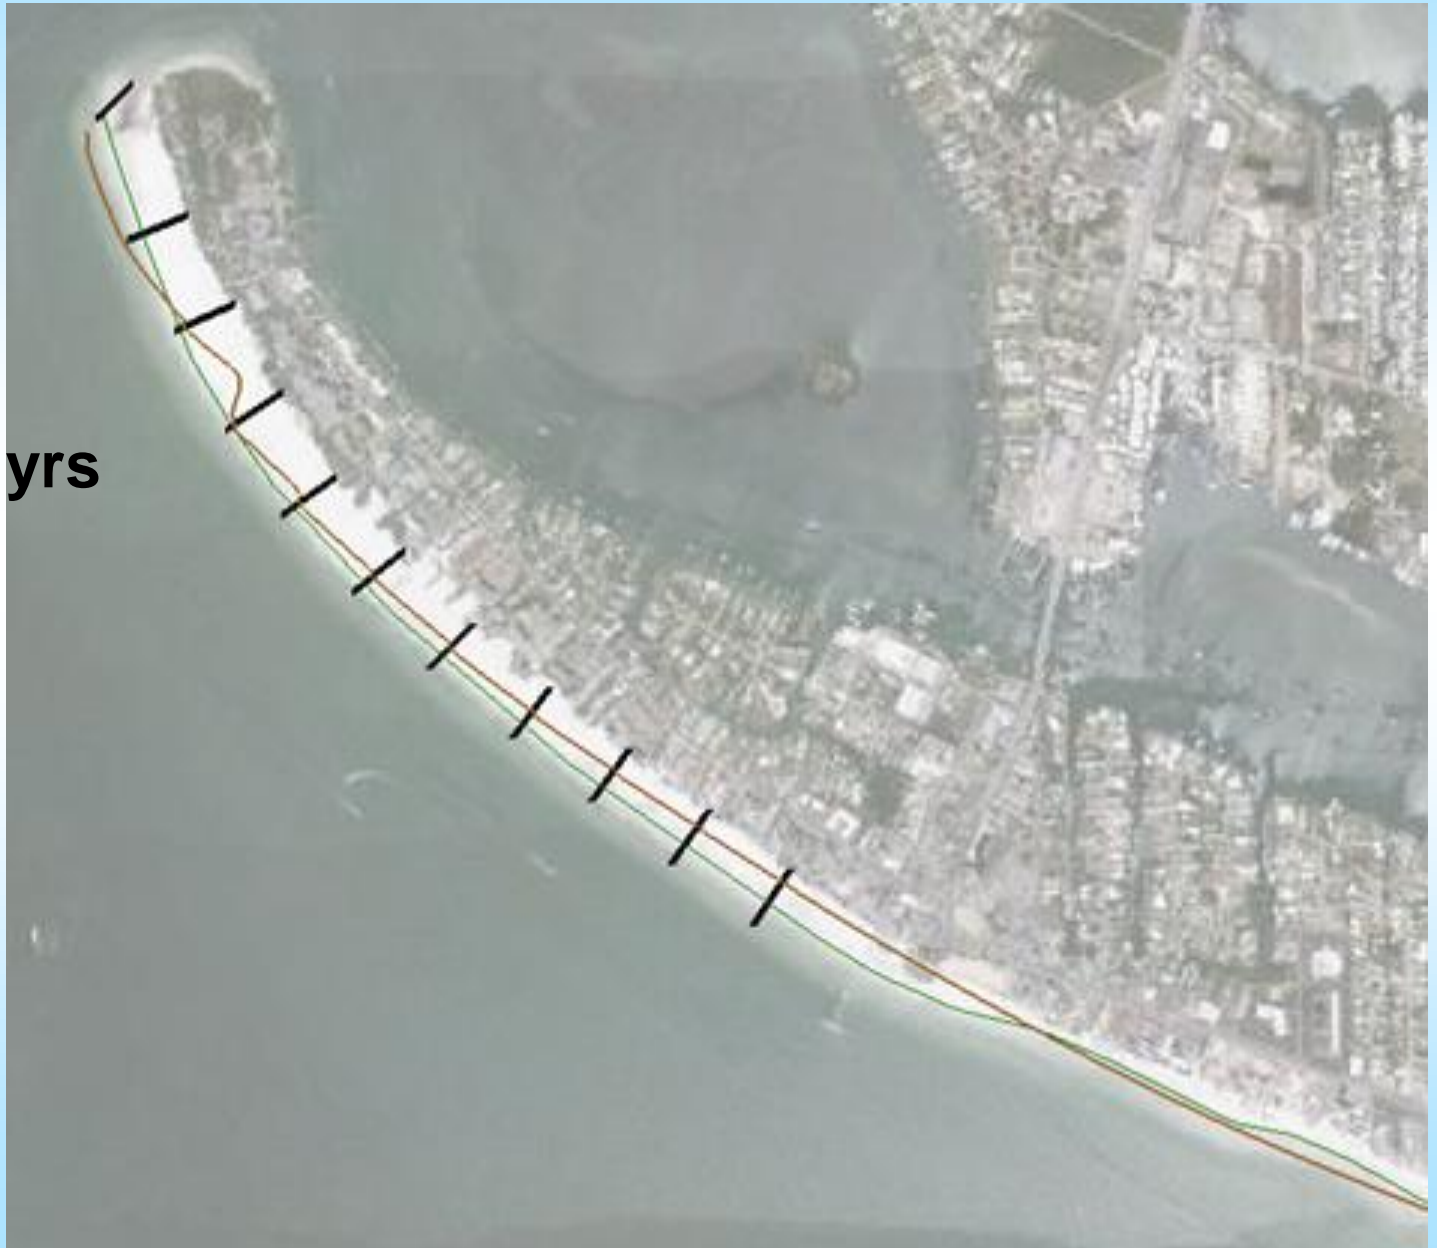
Alternatives Evaluation – Reach 1

Alt 1.2
Groins

In 8 years

Lifetime ~ 12 yrs

- Continue support of renourishment program
- Build Alt 1.2 short groins

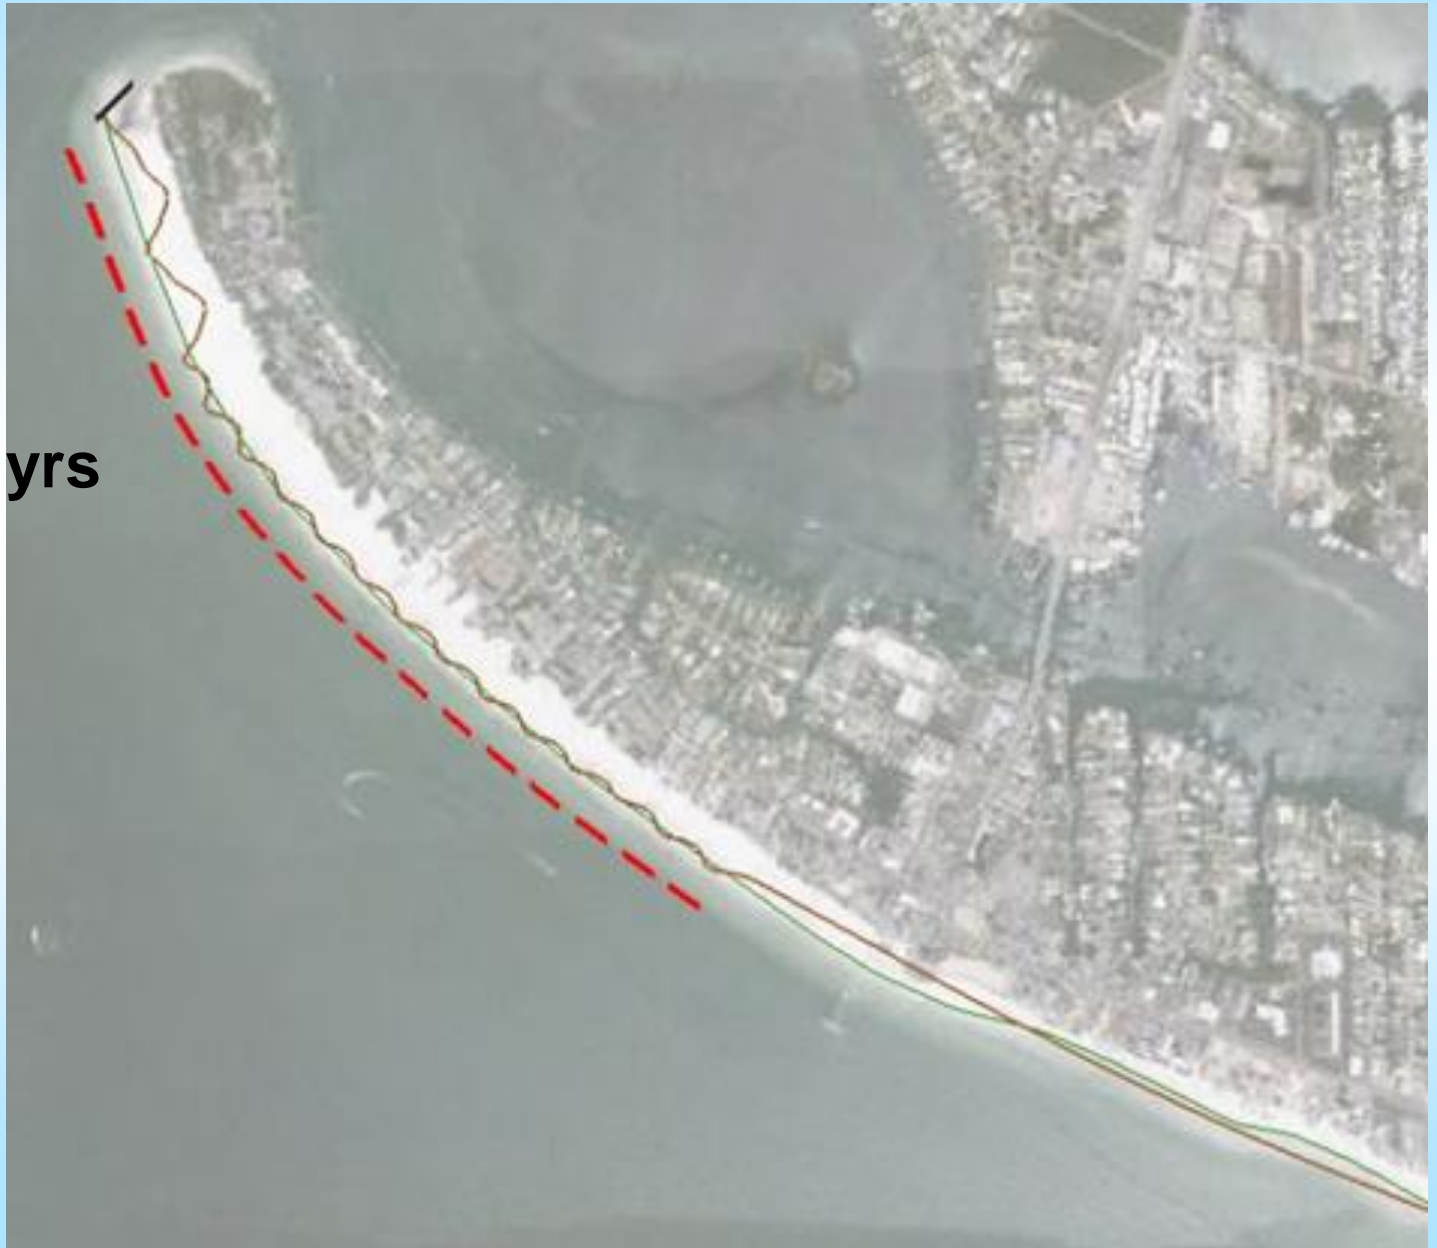
Alternatives Evaluation – Reach 1

Alt 1.3
Breakwaters

In 8 years

Lifetime ~ 14 yrs

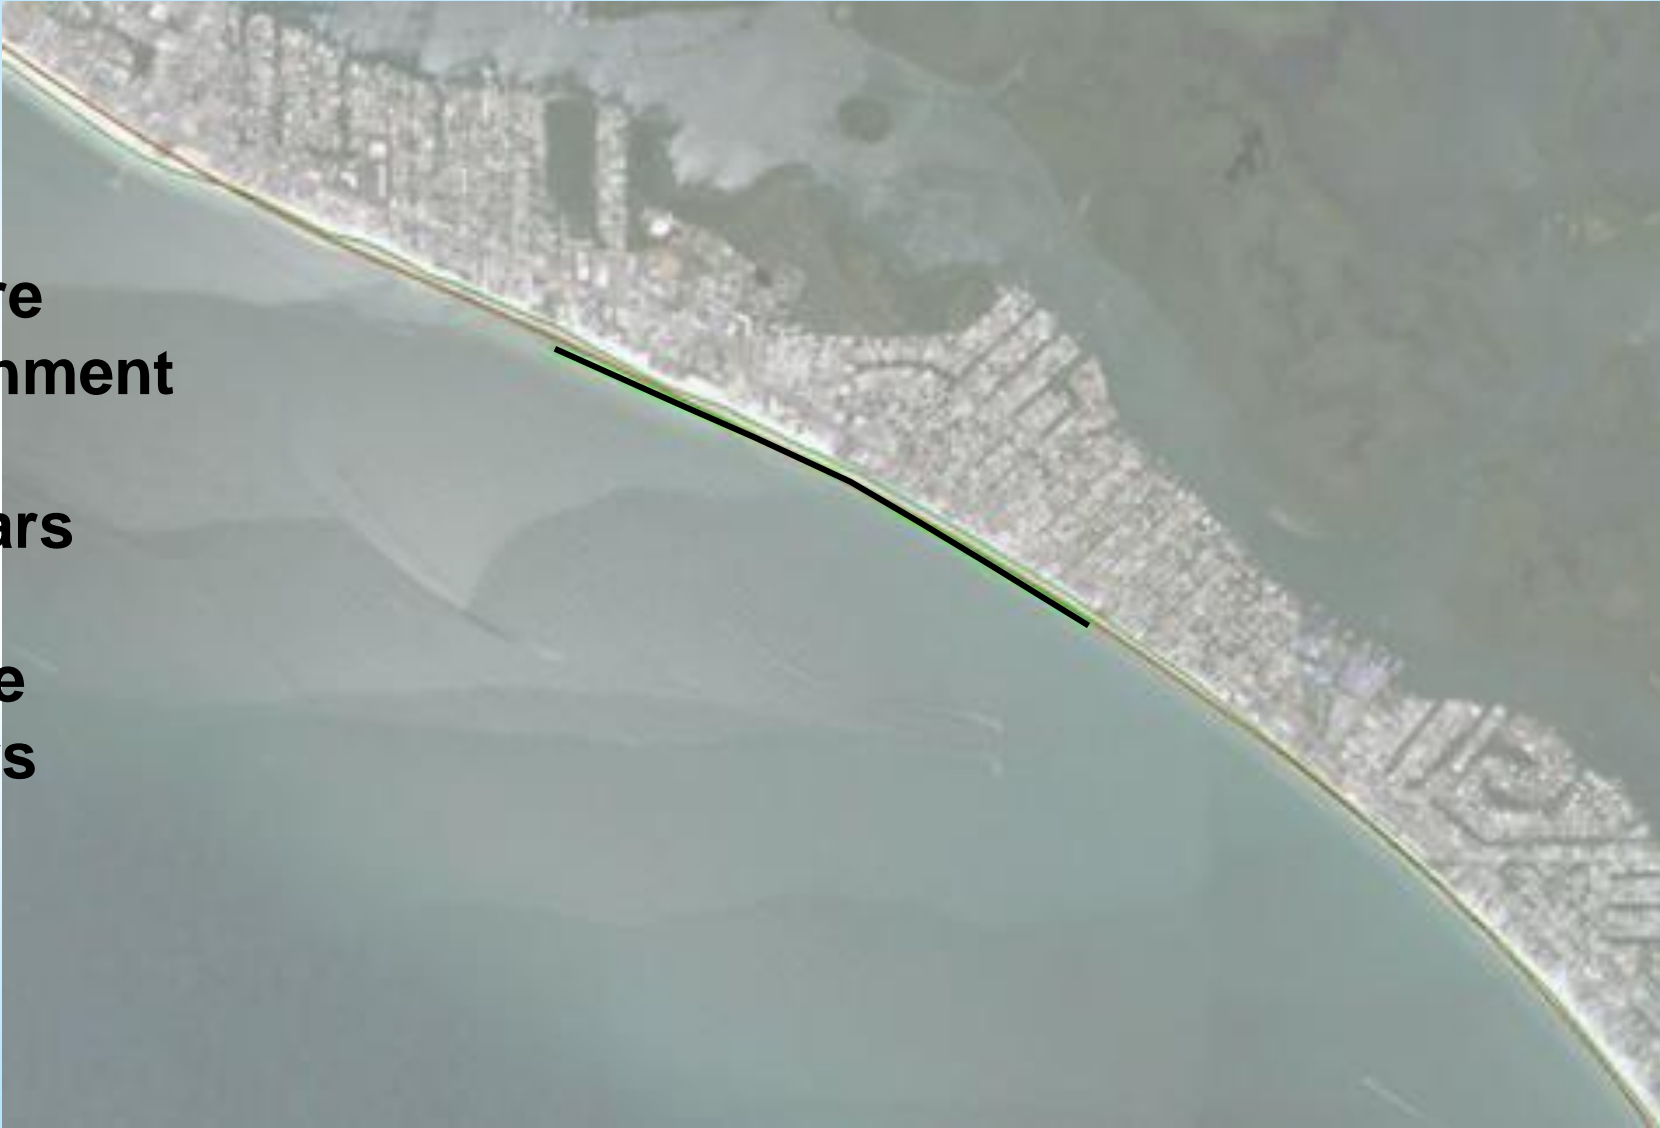
Alternatives Evaluation – Reach 2

Alt 2.1
Onshore
Nourishment

In 8 years

Lifetime
> 20 yrs
