# **Passive Dewatering**

## **A soft way to extend the life of beach nourishments**

**FSBPA Technical Conference  
for PDF print**

**February 6, 2015**

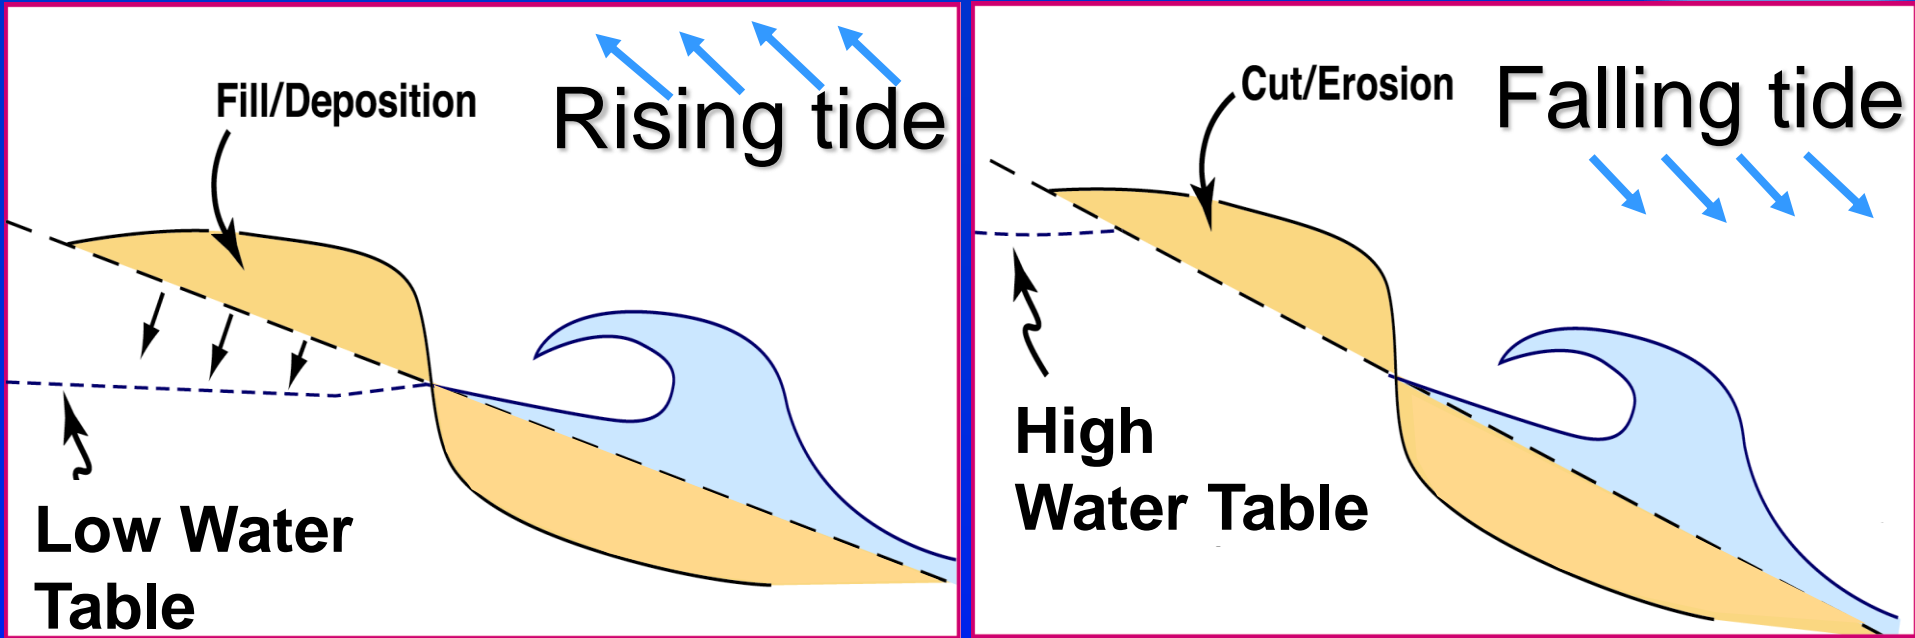
**Dry Beach = Accretion**

**Wet Beach = Erosion**

Semi-permeable and impermeable layers in a beach result  
in poor drainage → wet beach → erosion

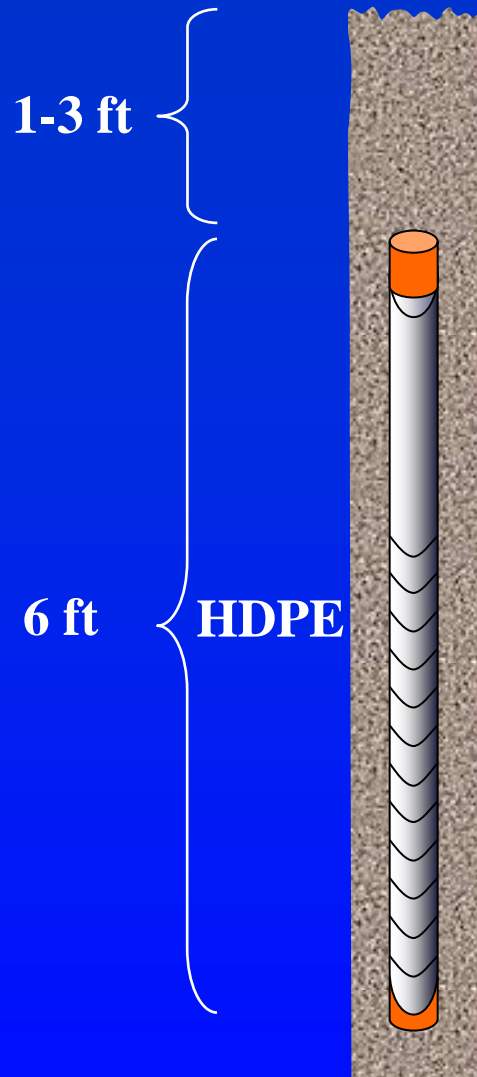
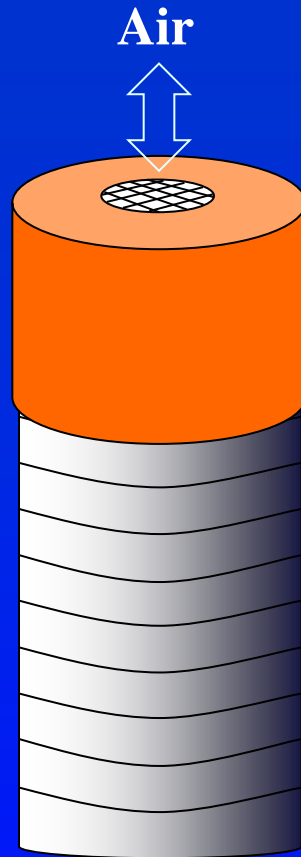
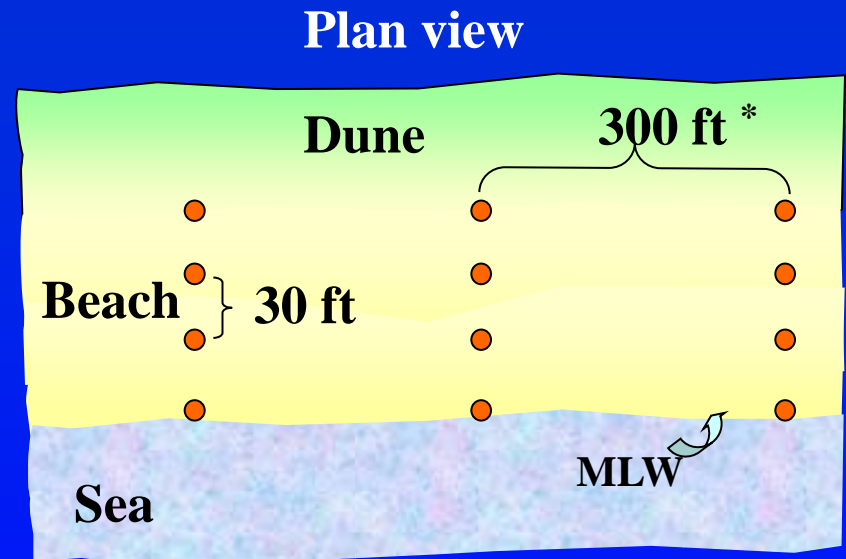
PEM is patented and designed to improve drainage of the beach

**NO PUMPS – NO POWER USED**

\* Every installation is tailor made

Diameter 2.5 inches

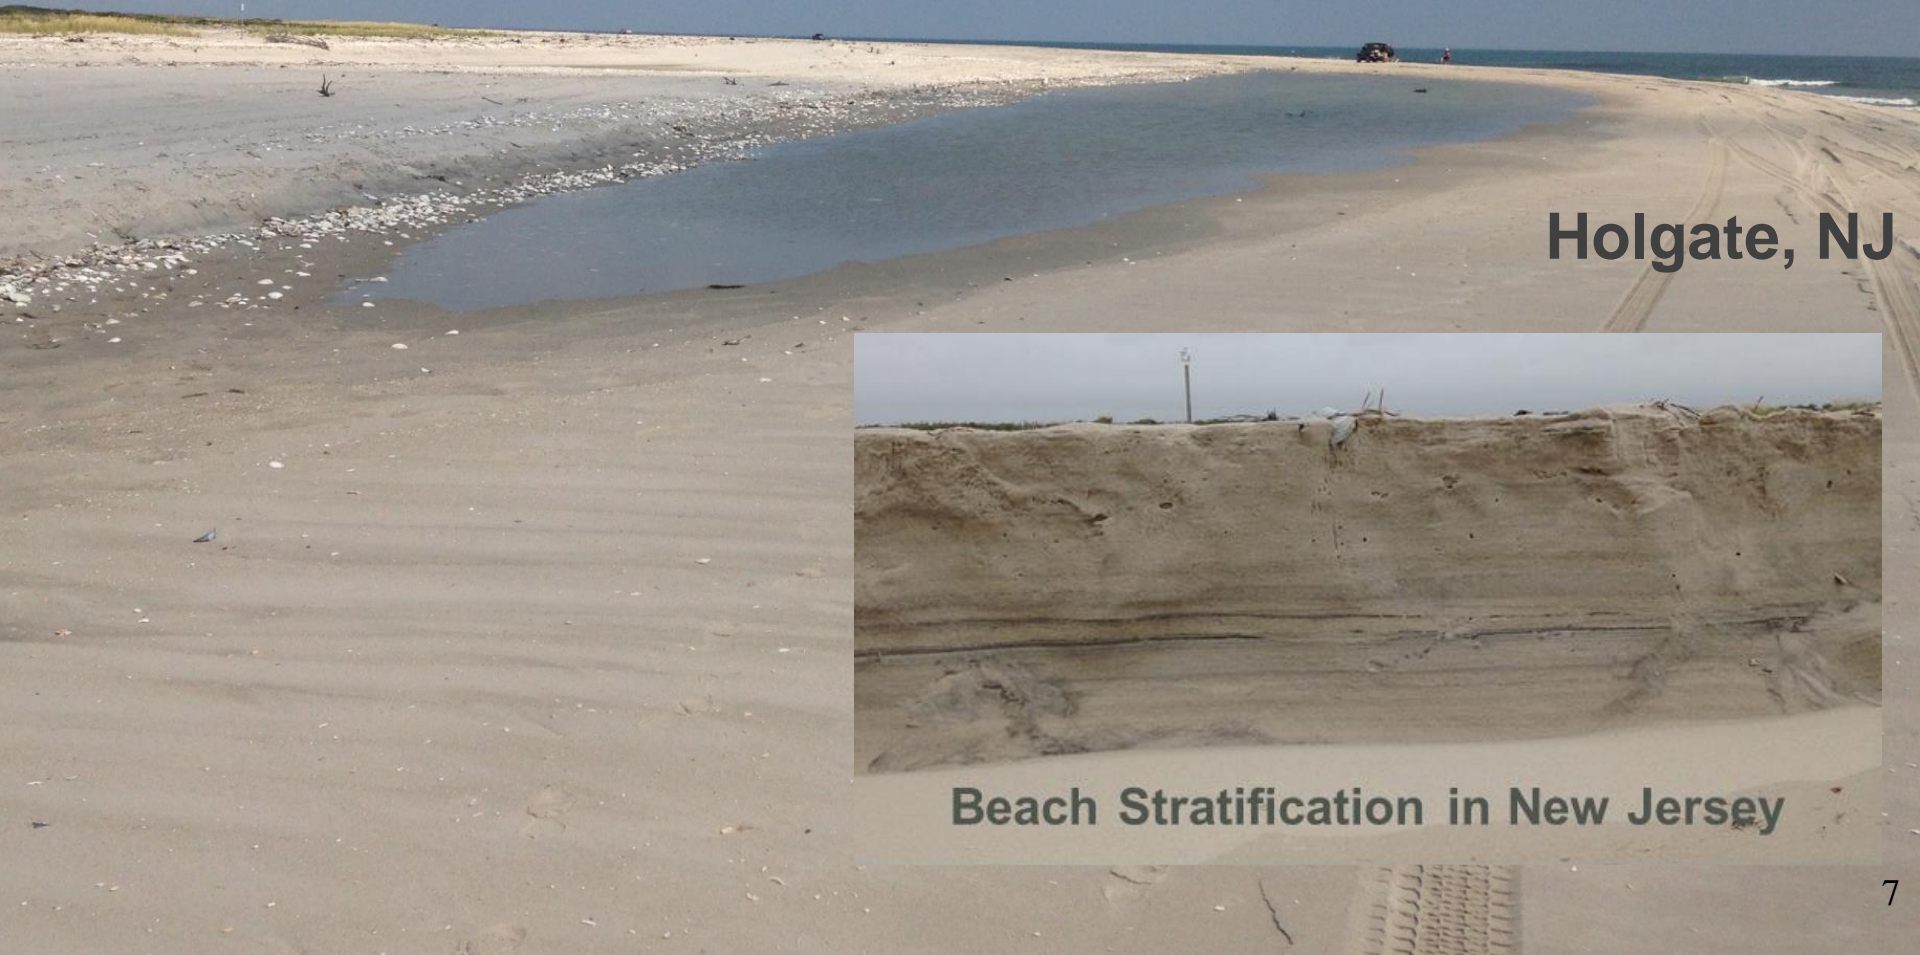
**Holgate, NJ**

A thin layer of impermeable clay is the most likely the culprit

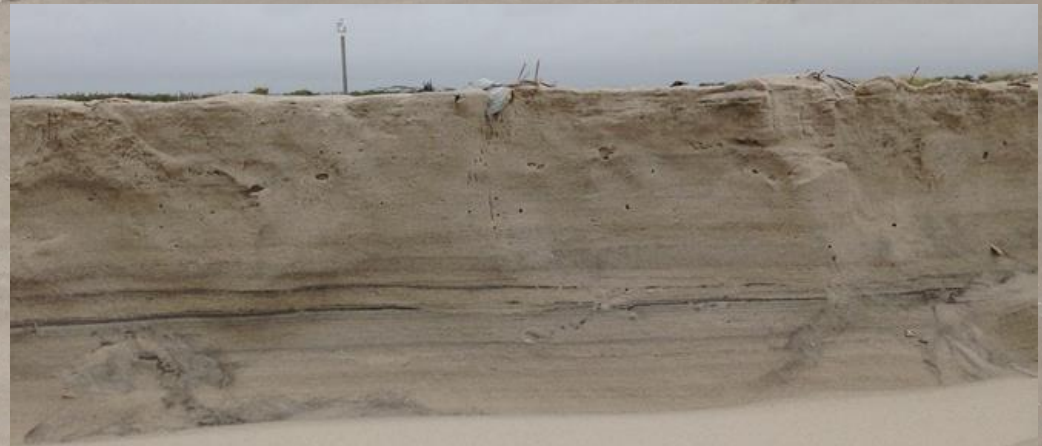
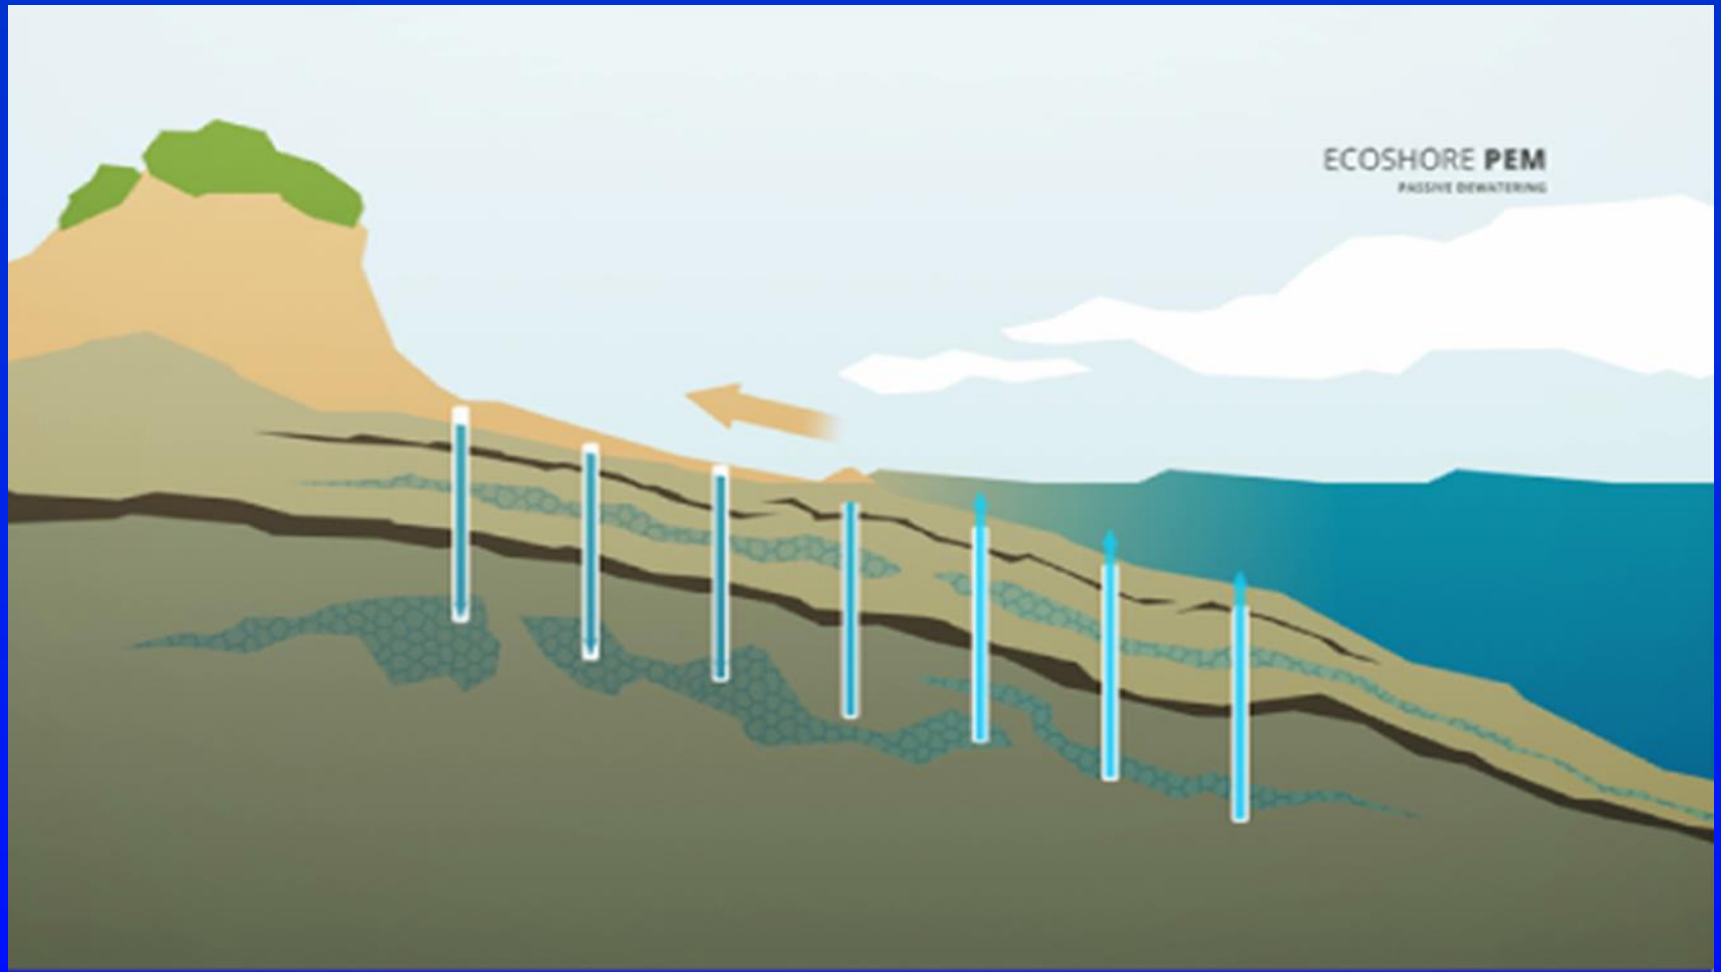
**Beach Stratification in New Jersey**

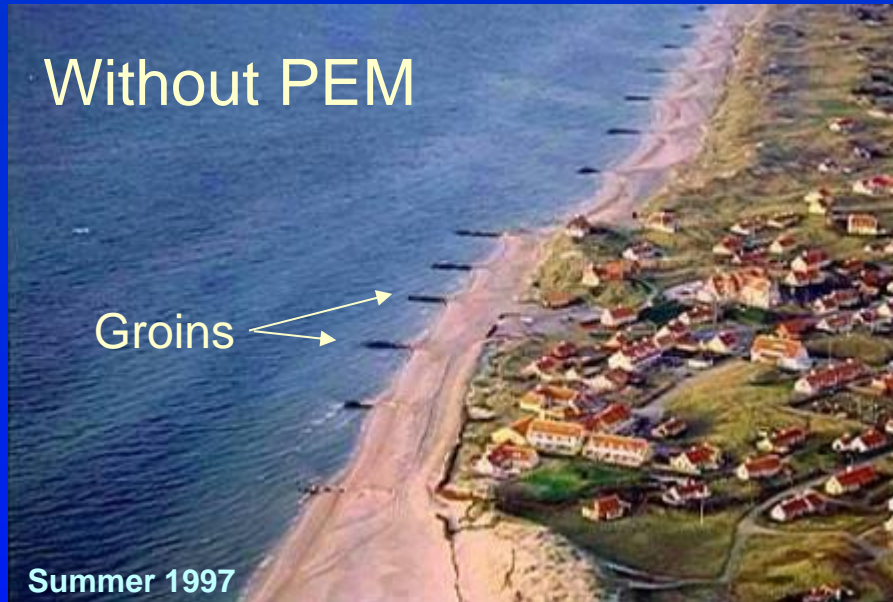
**Before PEM  
installation**

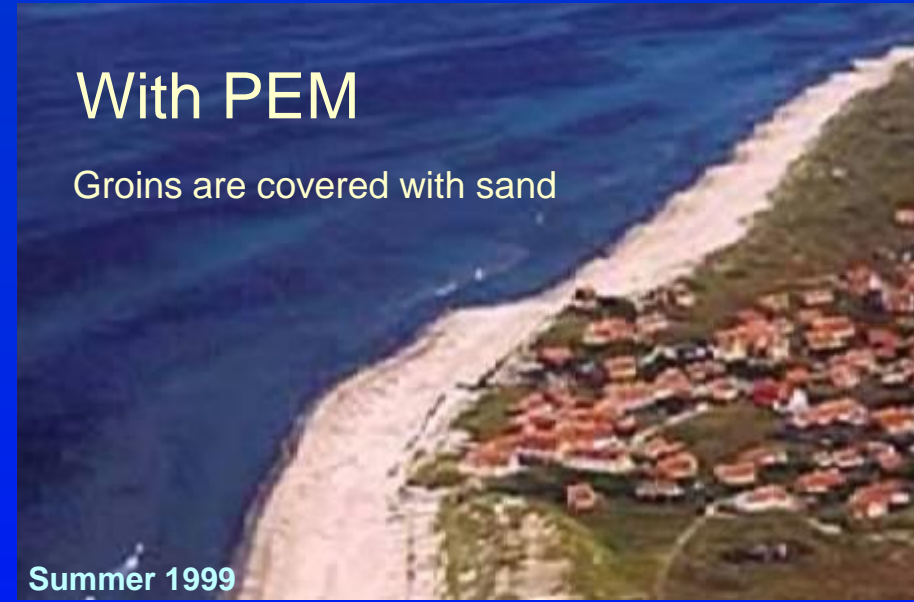
**18 months after  
PEM installation**

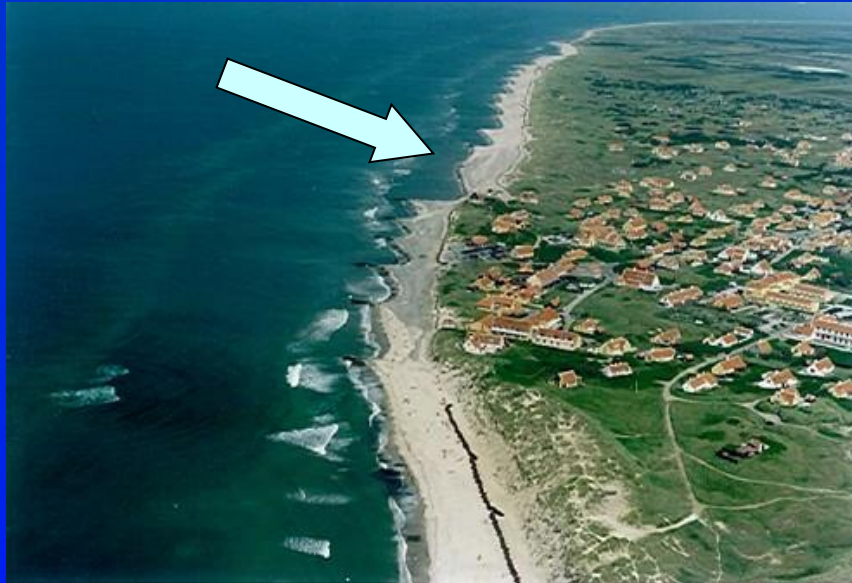
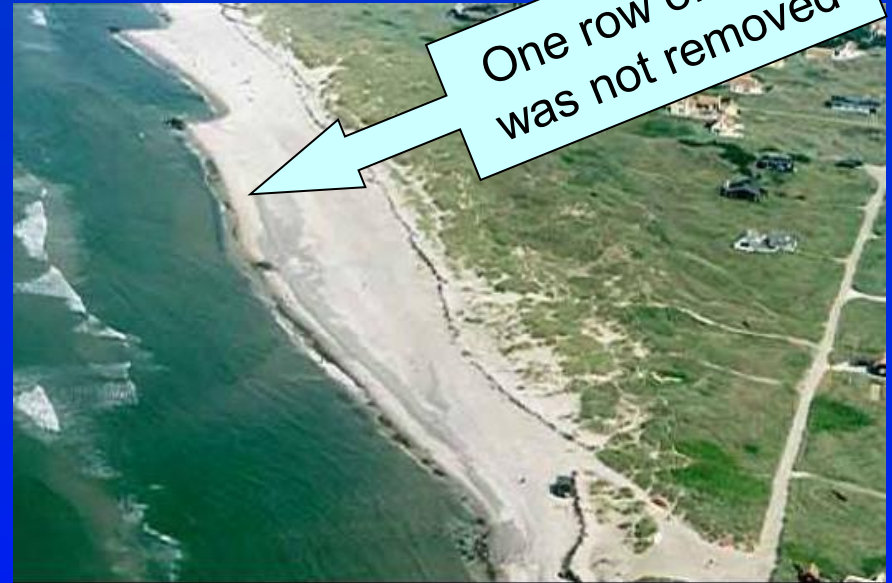
**July 2002**

**8 months after removal of the PEMs**

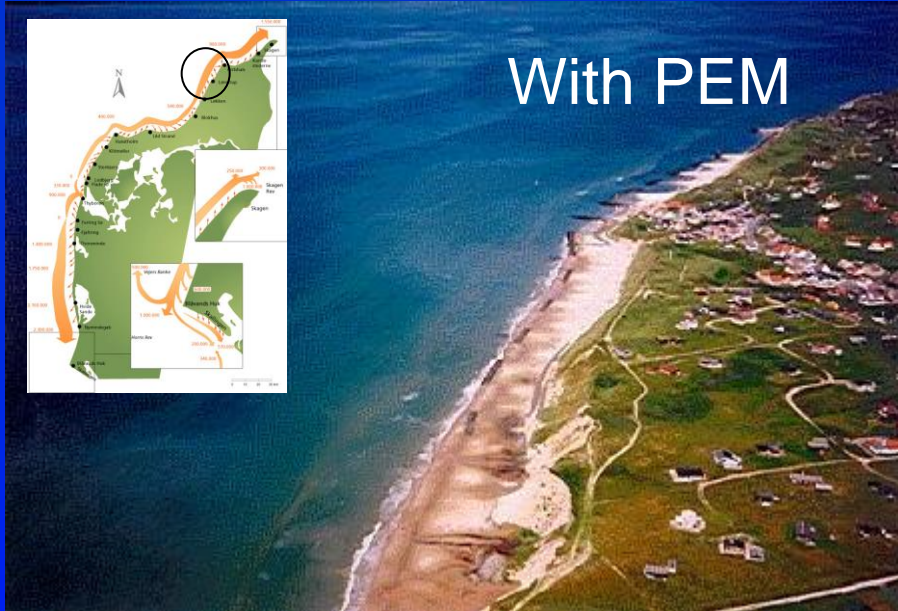
**PEM installed April 1999**  
**Photo summer 1999**

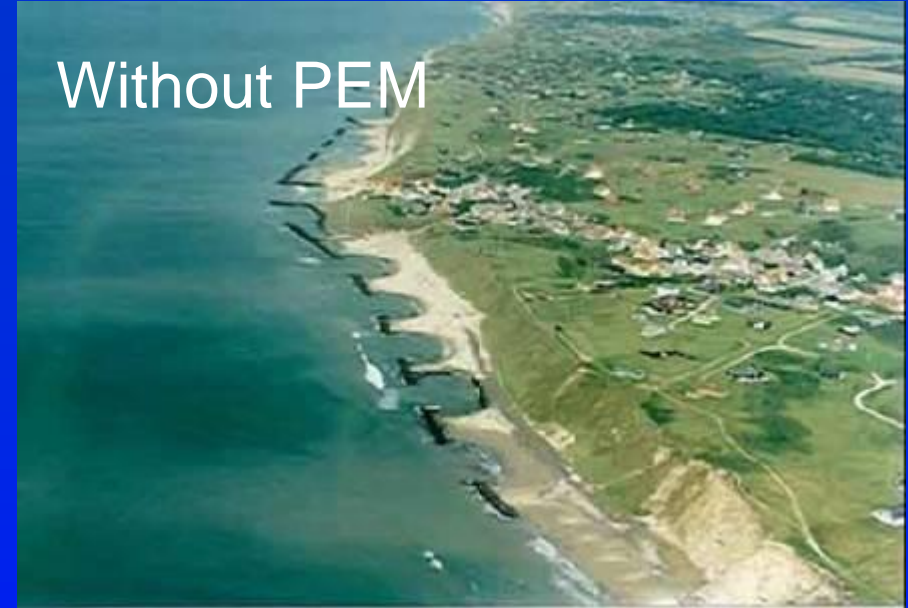
**PEM removed August 1999**  
**Photo summer 2002**

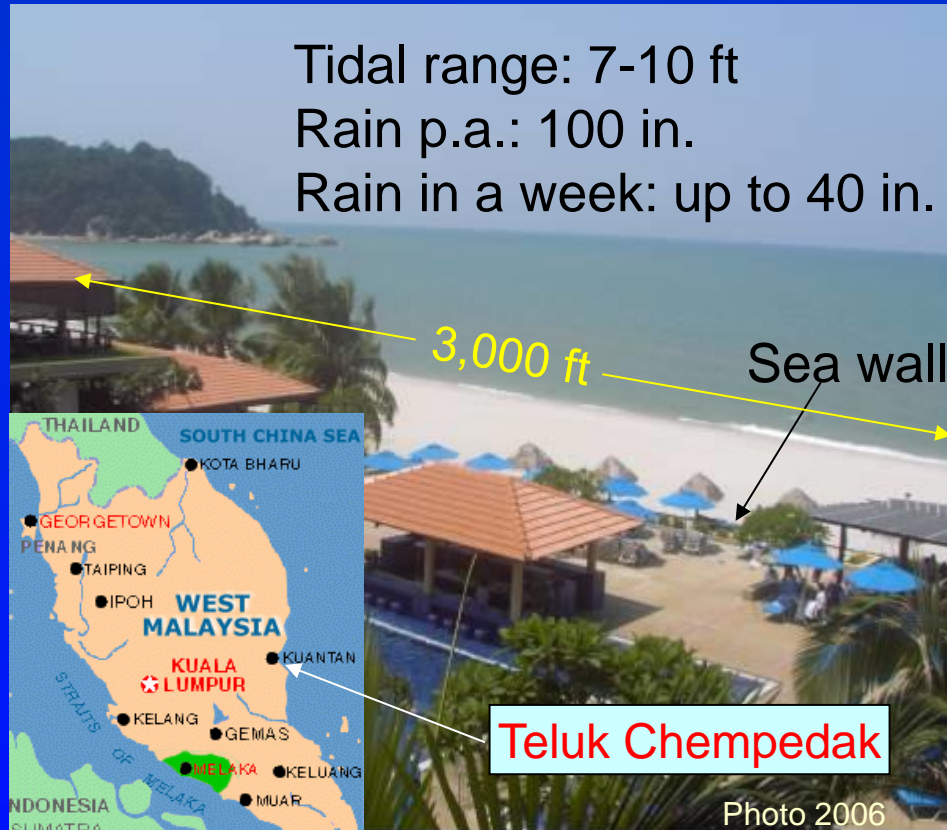
### Double layer of PEM

Tidal range: 7-10 ft  
Rain p.a.: 100 in.  
Rain in a week: up to 40 in.

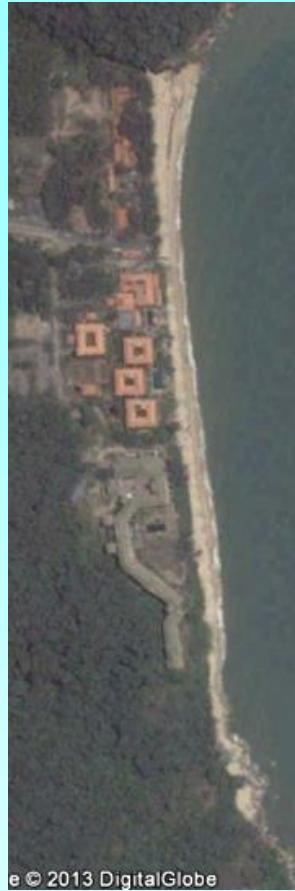
**2003**

**Pre-  
Nourishment**

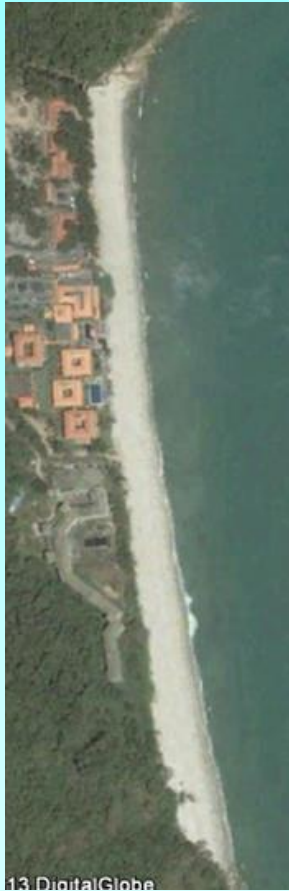
**2007**

**Post-  
Nourishment**

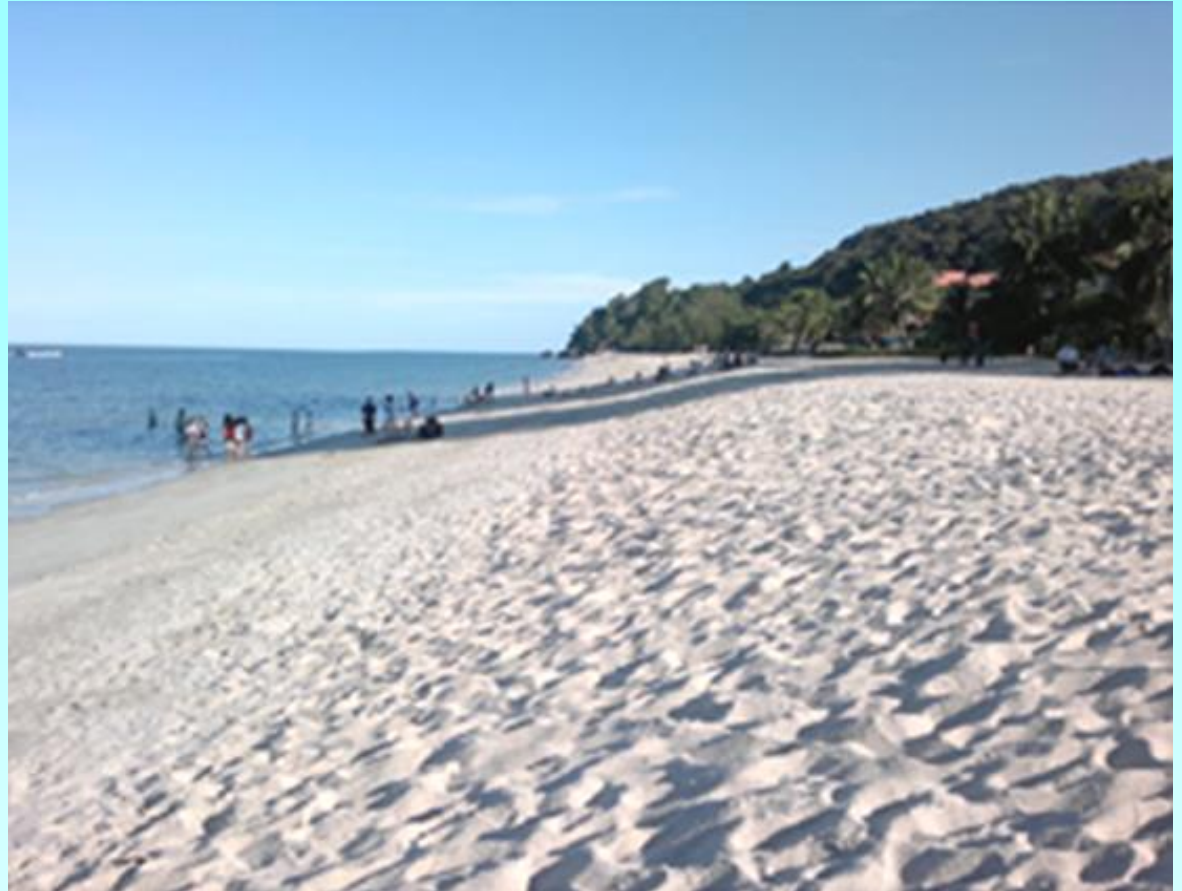
**July 2013**

**Elevated convex beach. This project demonstrates  
how to prolong the life of beach nourishments.**

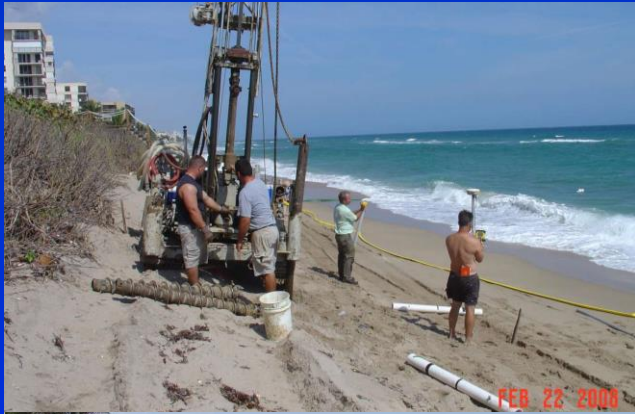
## Pre-PEM installation February 2008

- **Validate physics: Installed water wells/PEMs**
  - Very high groundwater level

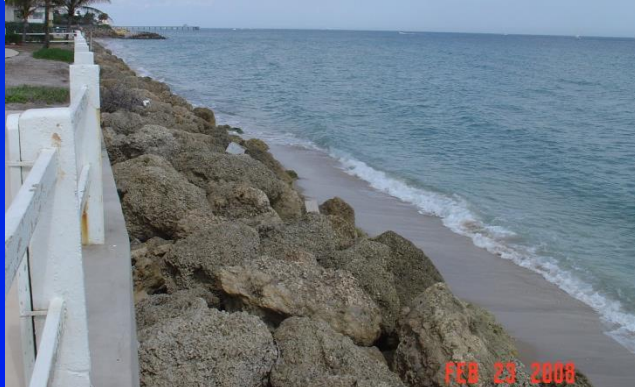
## PEM Installation in February 2008

- **Installation completed in 2 weeks**
- **90 PEMs installed with drill**
- **Very poor beach condition**
- **>50% of PEMs were reduced in size**

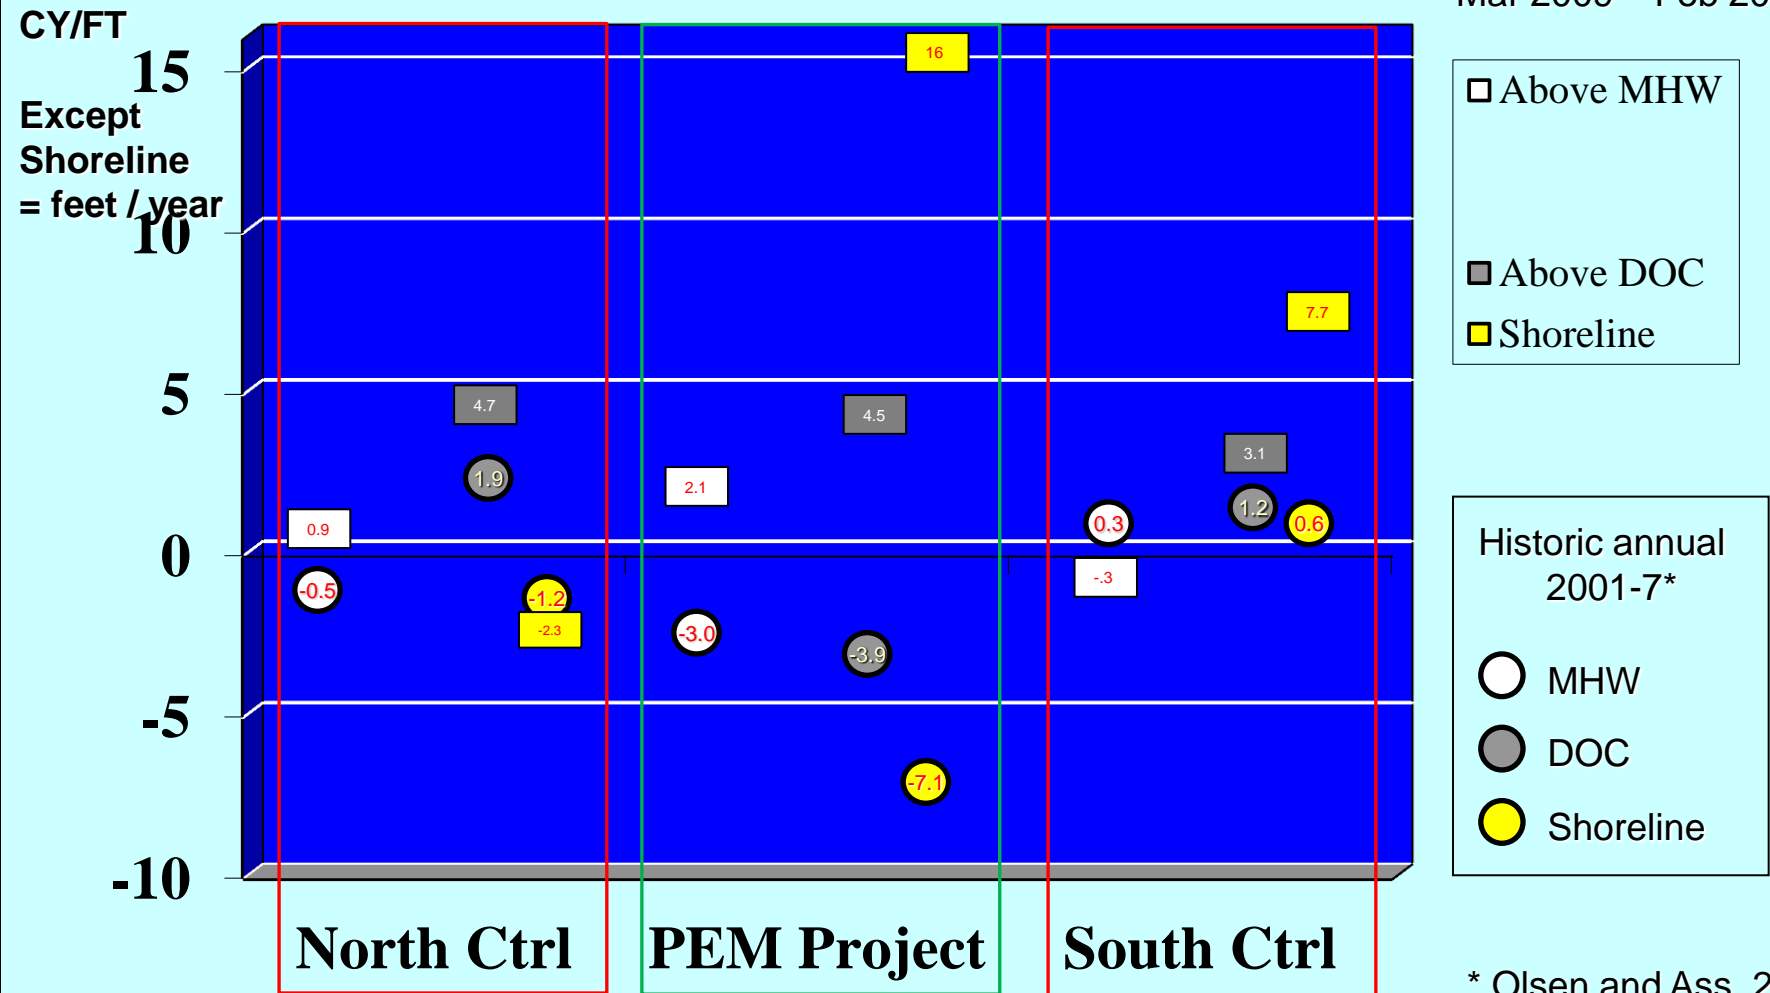
# 2<sup>nd</sup> year. No Nourishments. No storms.

Mar 2009 – Feb 2010

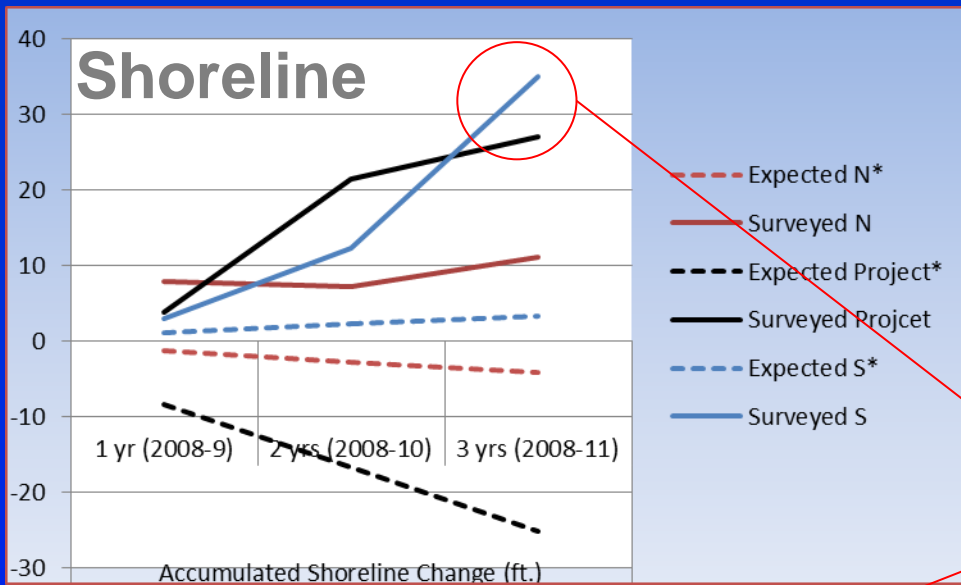
**Accumulated 3 year  
Comparative Results**

**How did the test areas expected  
performance\* compare to the surveyed  
results?**

**No down-drift erosion**

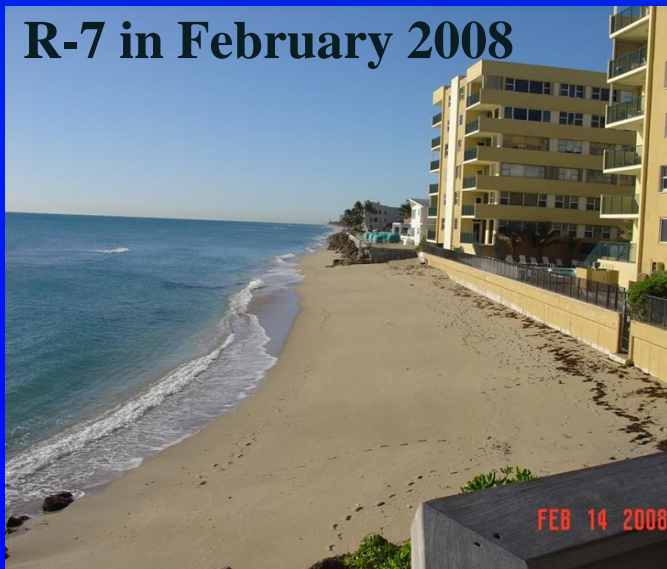
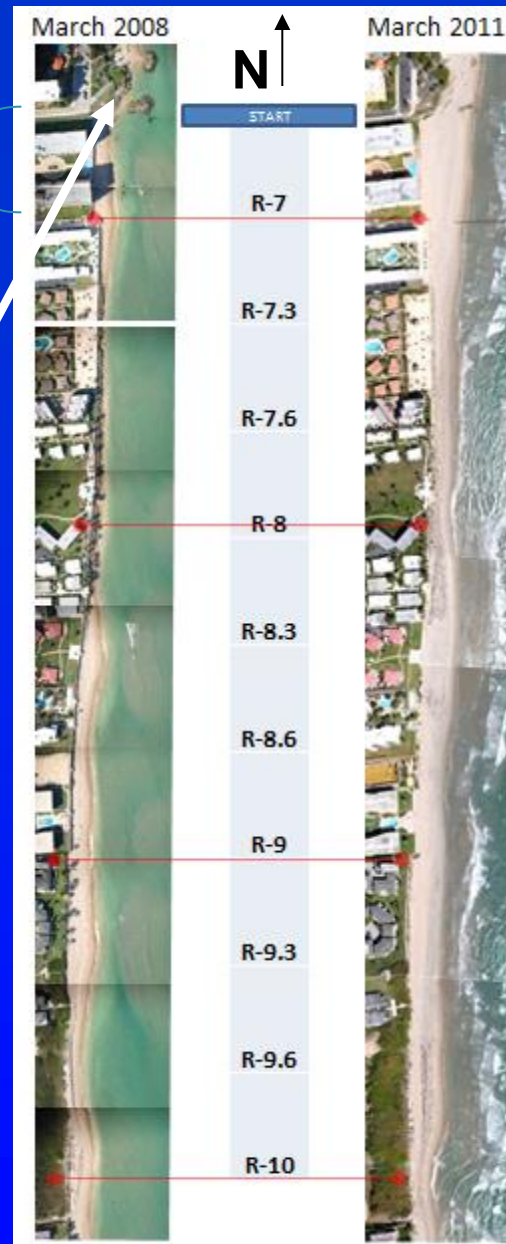
R-7 in February 2008

Photo comparison  
at low tide.

March 2011 was shot 1  
month after PEM removal.  
By then the sand had  
started to wash away

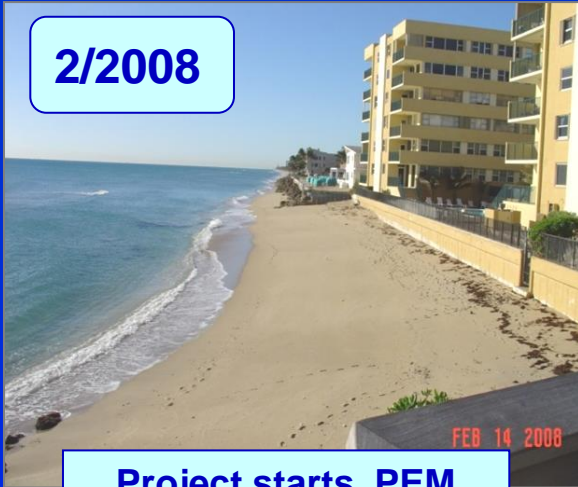
**2/2008**

**Project starts. PEM installed from R7 - R12**

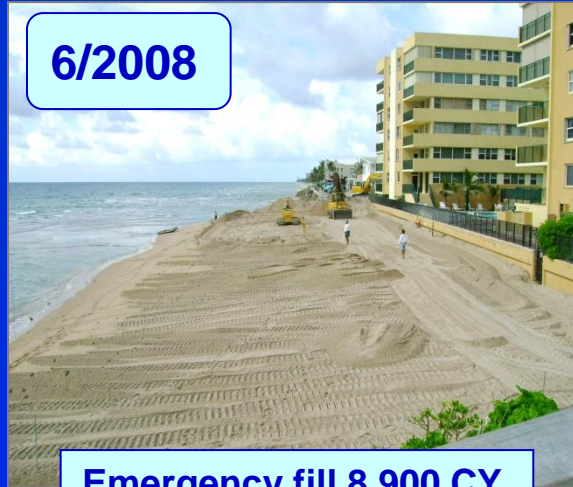
**6/2008**

**Emergency fill 8,900 CY at R7, on top of PEM**

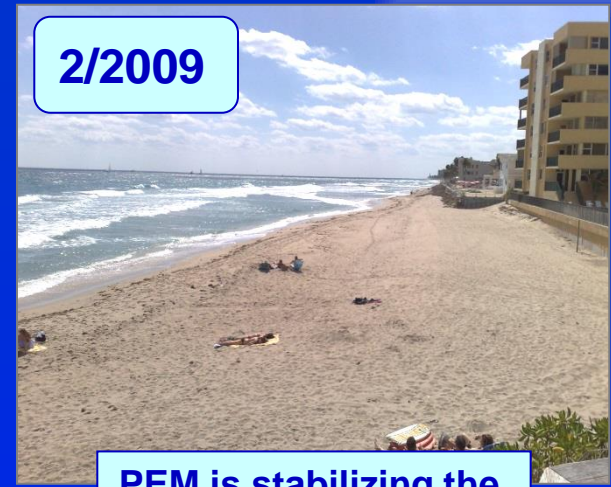
**2/2009**

**PEM is stabilizing the emergency fill at R7**

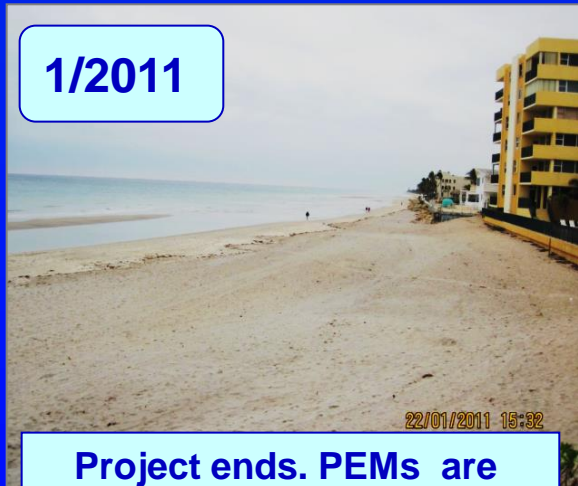
**1/2011**

**Project ends. PEMs are removed. The beach is wide**

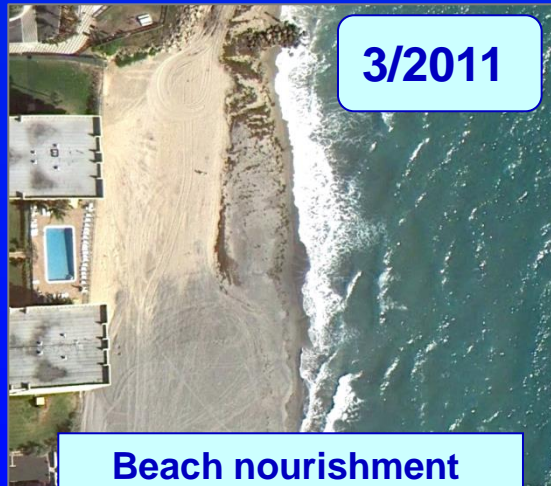
**3/2011**

**Beach nourishment 340,000 CY from R6 - 12**

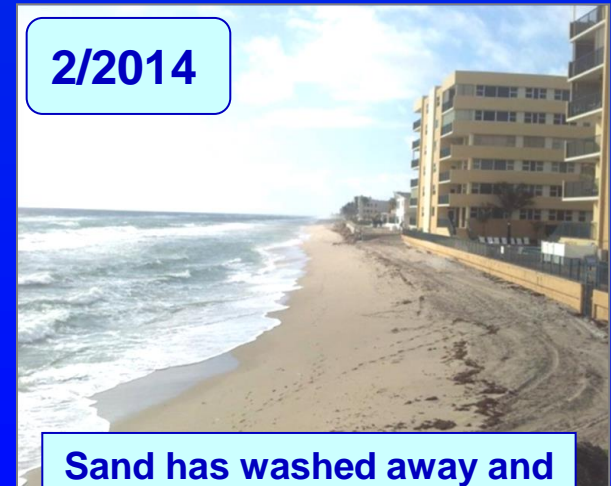
**2/2014**

**Sand has washed away and beach is back to 2008-level**
