JCP Environmental Monitoring – Making It Meaningful, A Case Study

CHARLOTTE COUNTY STUMP PASS EROSION CONTROL PROJECT
SEAGRASS MONITORING

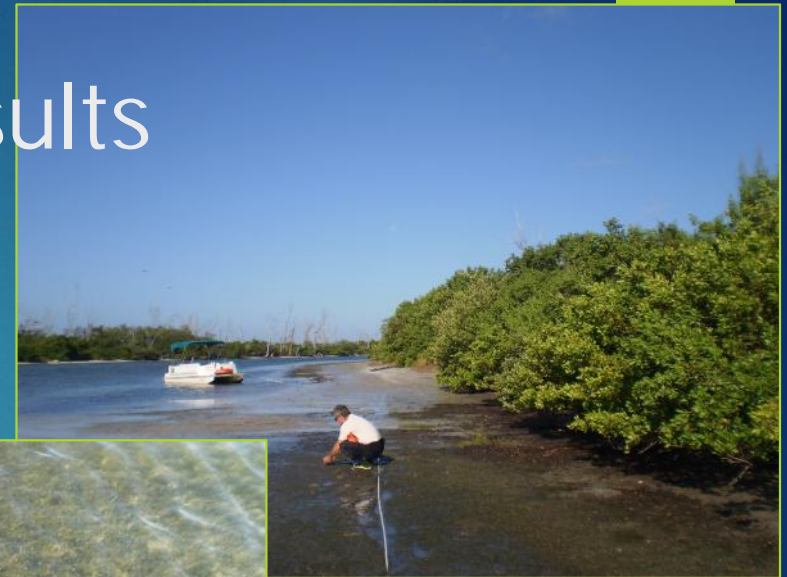
2006-2010 Monitoring Results

- ▶ Seagrass coverage and extent varied, as did frequency of occurrence, abundance, and density calculations based on field data.
- ▶ Water quality data varied among and between survey events.
- ▶ Turbidity measurements varied among and between survey events.
- ▶ Chlorophyll-a measurements varied among and between survey events.
- ▶ Transect L2, the most interior transect was also the most stable, exhibiting high coverage and extent of seagrasses during most surveys.
- ▶ Sediment characteristics tended towards sand along all transects except L2 over time.

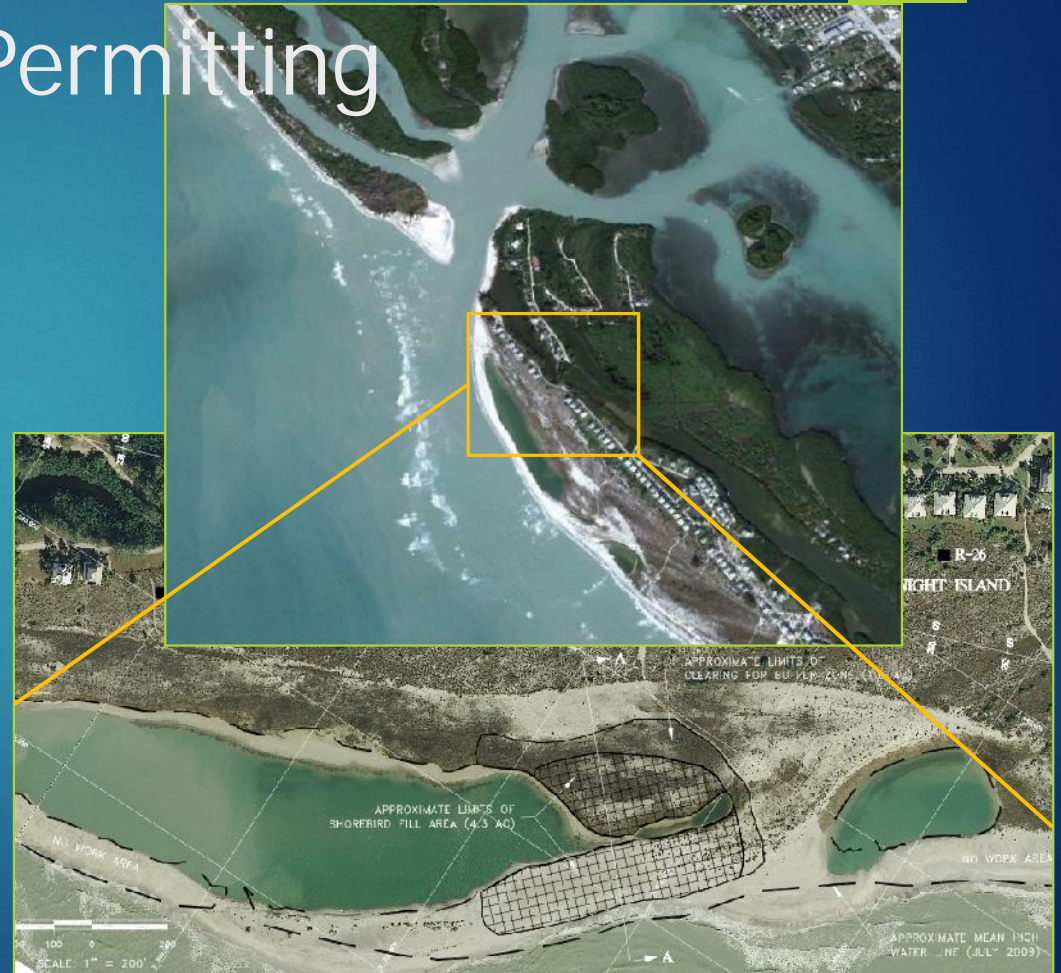
2010 Second Erosion Control Maintenance Event Permitting

- ▶ Environmental component to permitting for 2010 project was concentrated on shorebird nesting on Knight Island, associated mitigation.
- ▶ No documented seagrass impacts from project, 2003 Seagrass Protection Plan remained in effect.
- ▶ Four monitoring events associated with 2010 project followed 2003 Seagrass Protection Plan (XVIII – XXI).
- ▶ JCP permit modified with updated Seagrass Protection Plan in December 2012 and initiated in 2013.

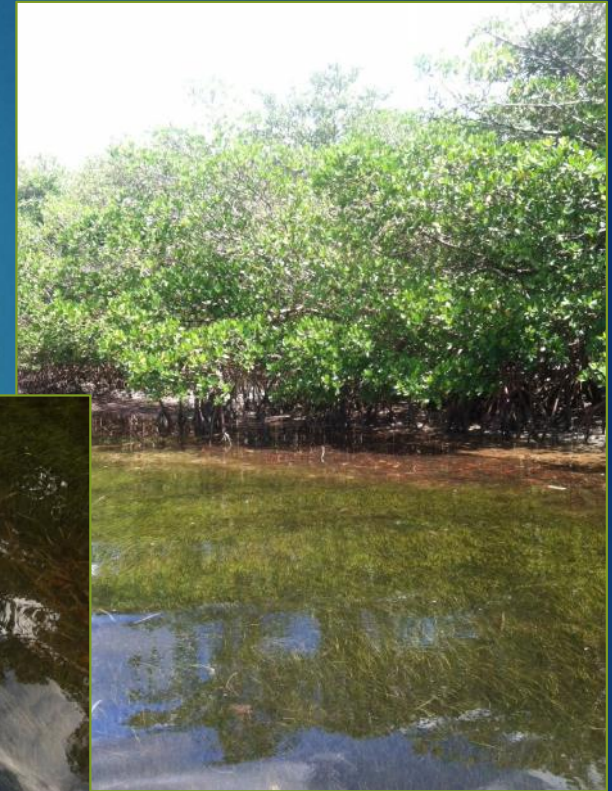
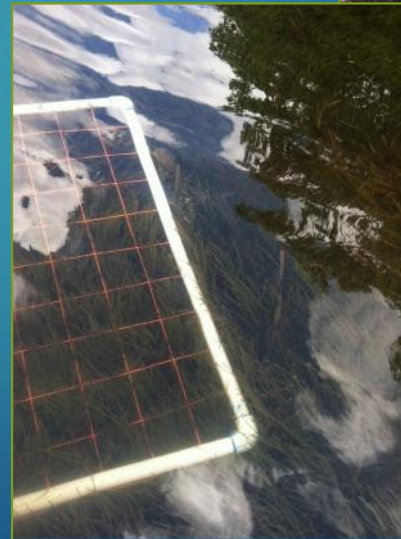
2012 Updated Seagrass Protection Plan

- ▶ Reduced biannual monitoring to annual event during mid-late season to begin SAV Survey XXII.
- ▶ Water quality data (temperature, pH, salinity, conductivity, DO, turbidity sample) collected only at Transect L1 deep end, rather than all seven transects.
- ▶ No light attenuation data.
- ▶ No chlorophyll-a data.
- ▶ Remainder of 2003 Plan remained intact:
 - ▶ 7 transects, monitoring stations every 20m.
 - ▶ Quadrat data and analyses.
