Wiggins Pass Straightening Implementation: Construction, Monitoring and Inlet Management

Stephen Keehn, PE and Tara D Brenner, PG, EI

CB&I Coastal Planning & Engineering, Inc.

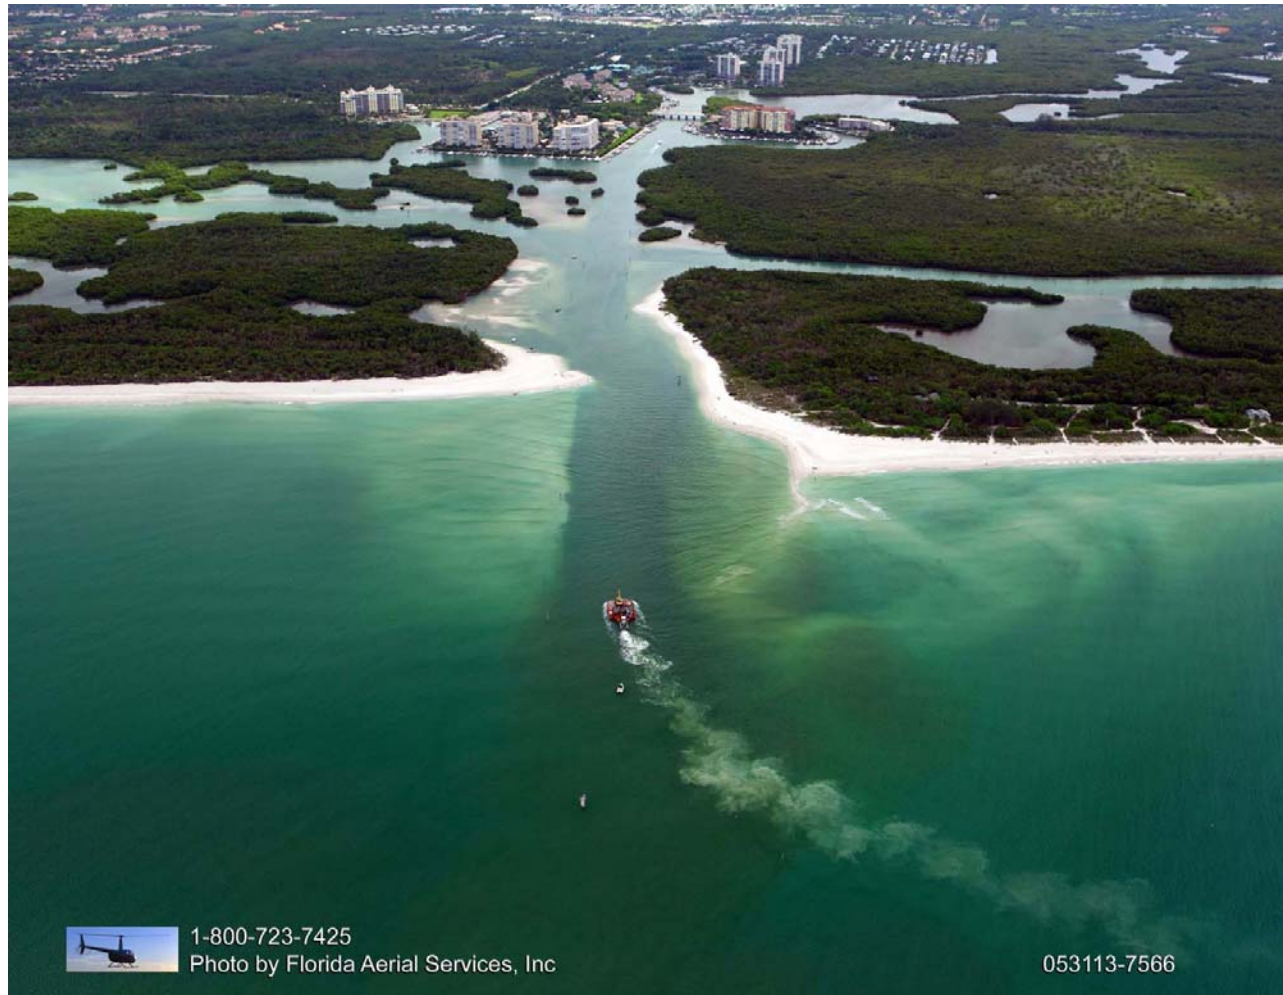
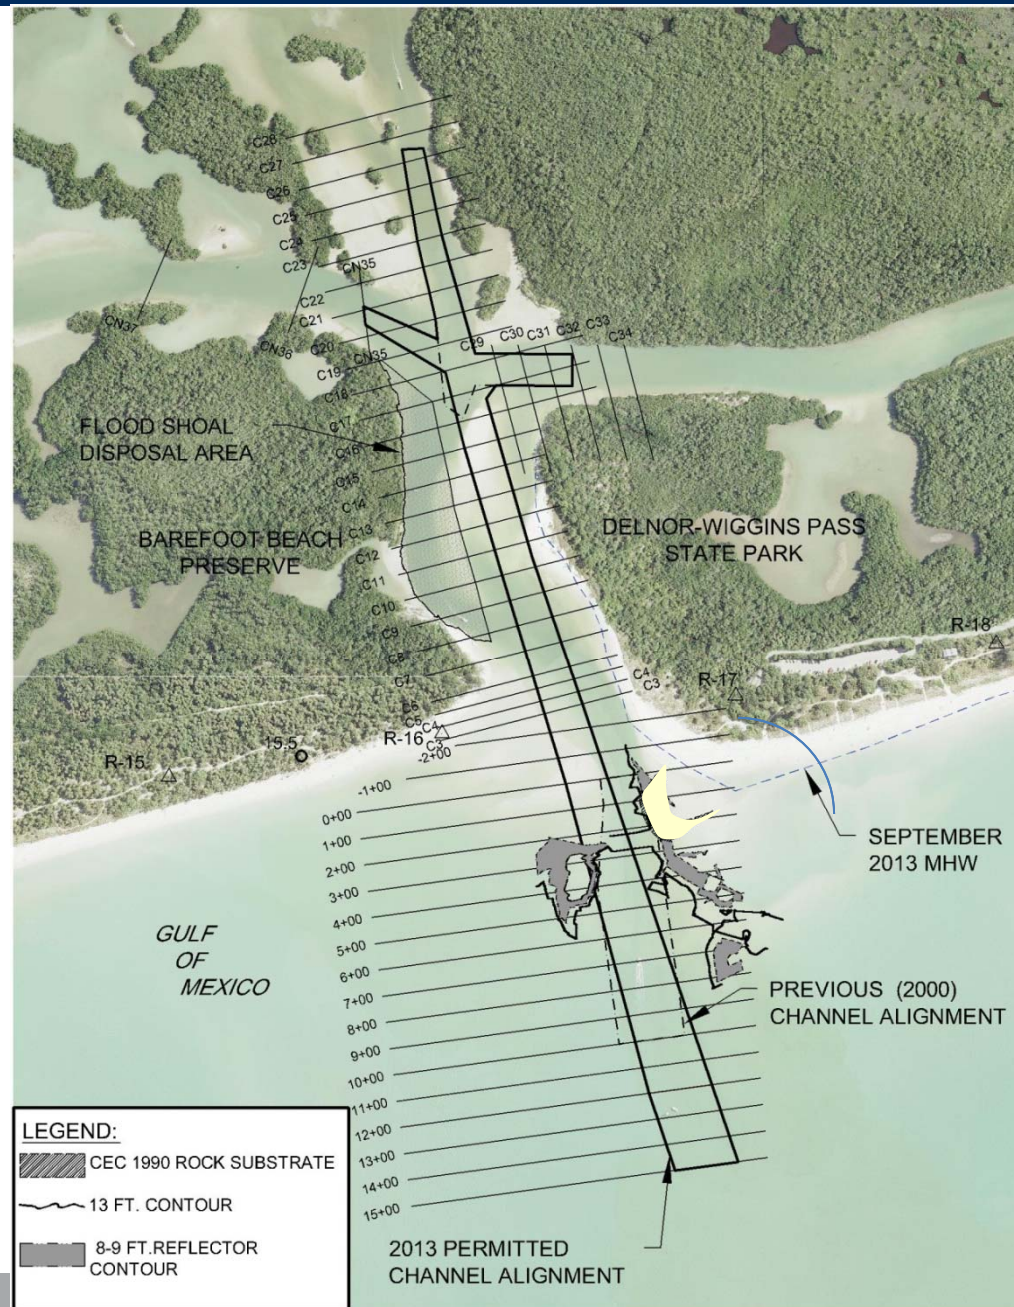
Post-Dredge Conditions May 2013

- After Land Phase

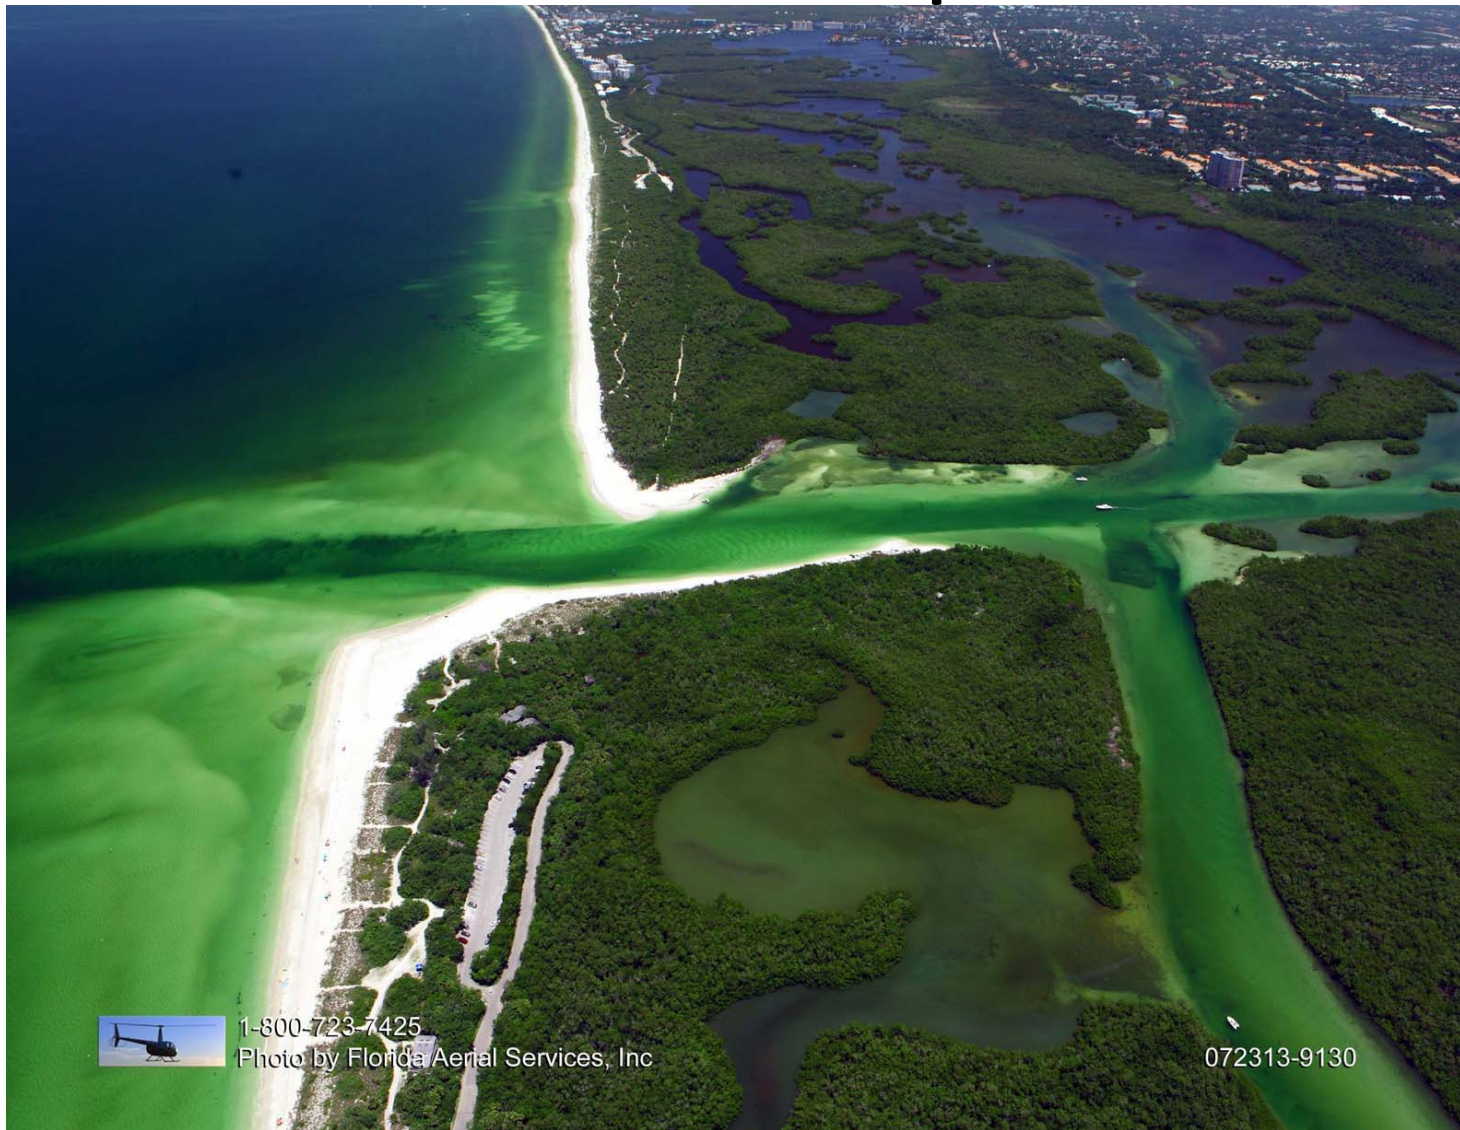
Dredge Conditions July 2013

After Clean Up Phase

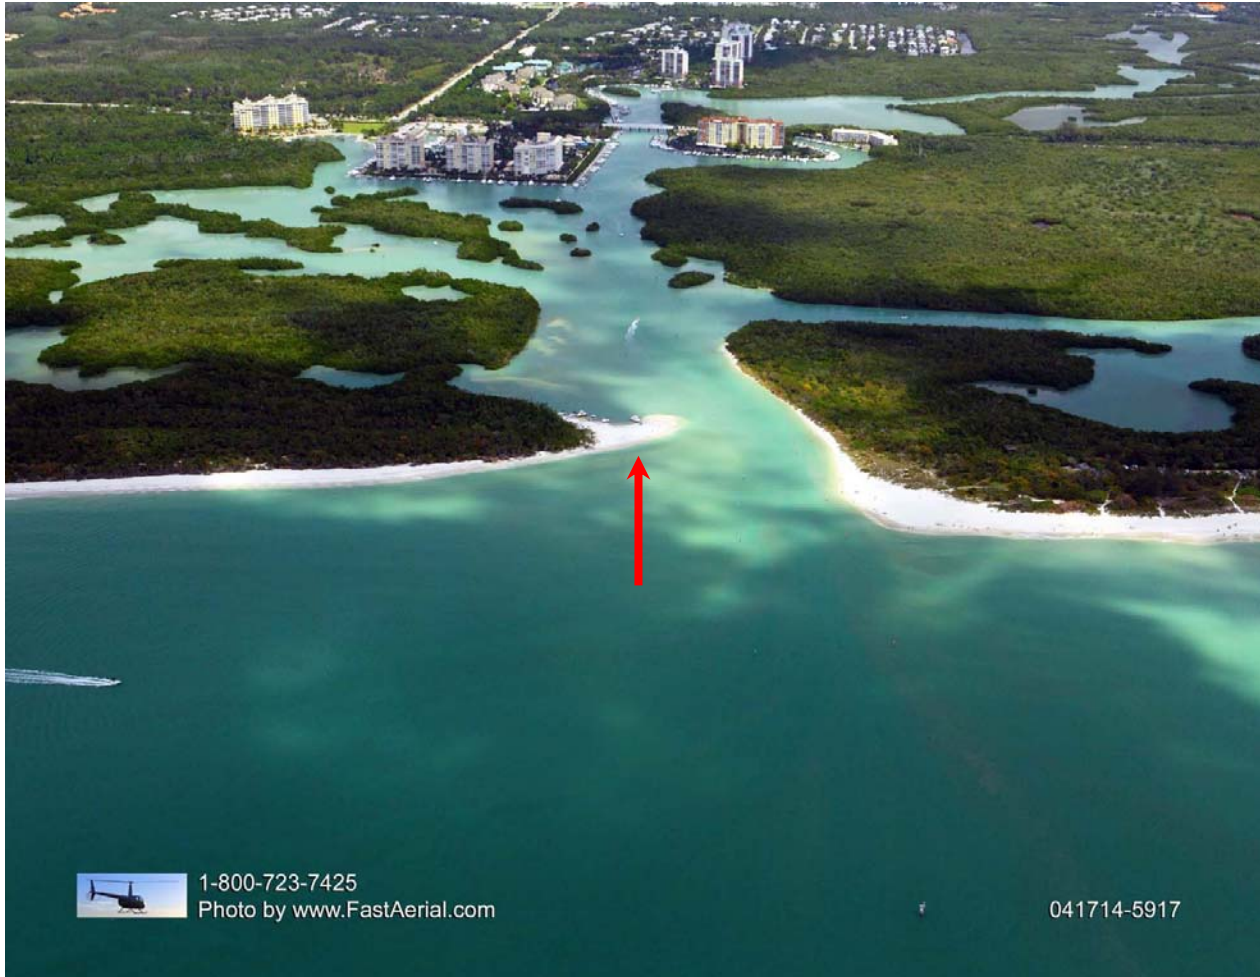
April 2014 Condition

Note: Barefoot Beach Sand spit forming in channel
Turbid waters make navigation more difficult

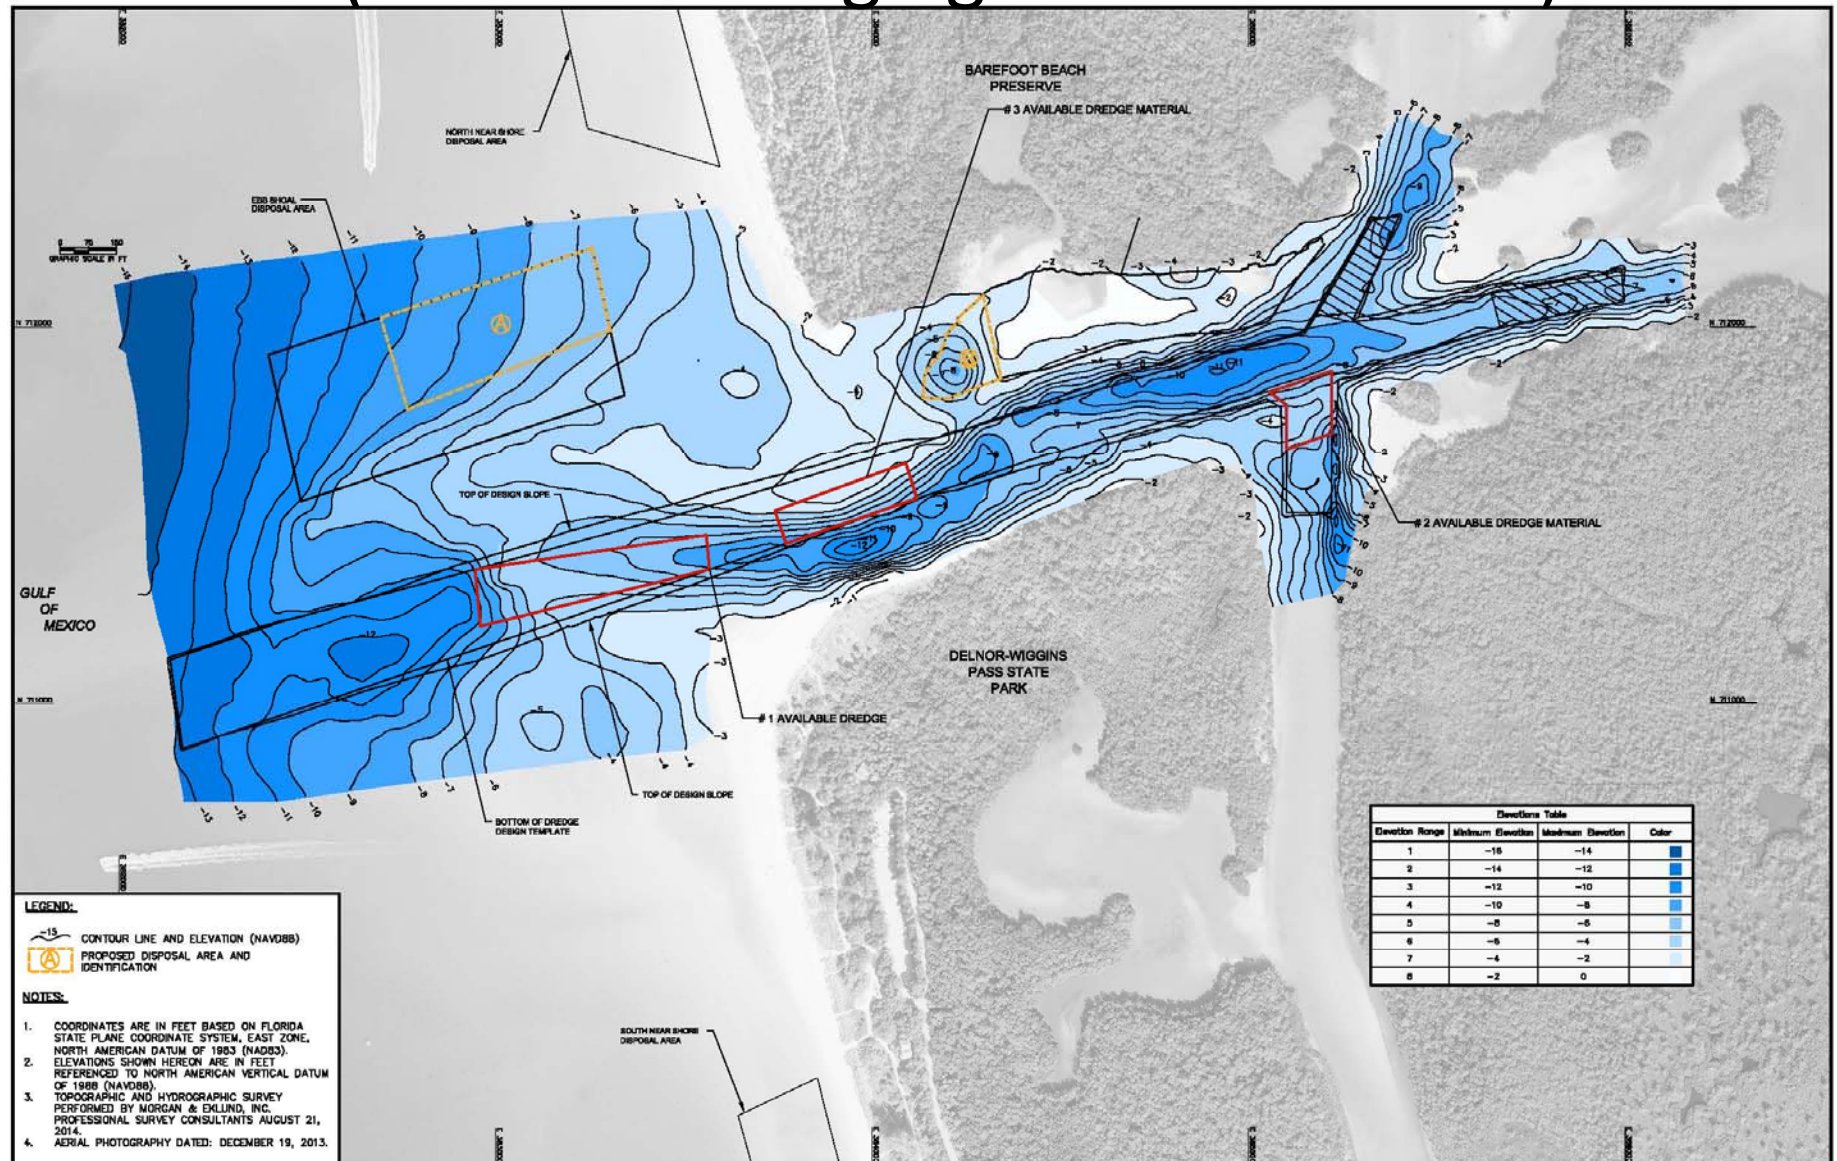
1-Year Monitoring Results

(intermin dredging locations in red)
