# Recent Applications and Advancements for the Strategic Use of Coastal Structures

Thomas P. Pierro, P.E., D.CE  
Director, CB&I

- FSBPA 2014 National Conference on Beach Preservation Technology, February 12-14, 2014 in Stuart, FL

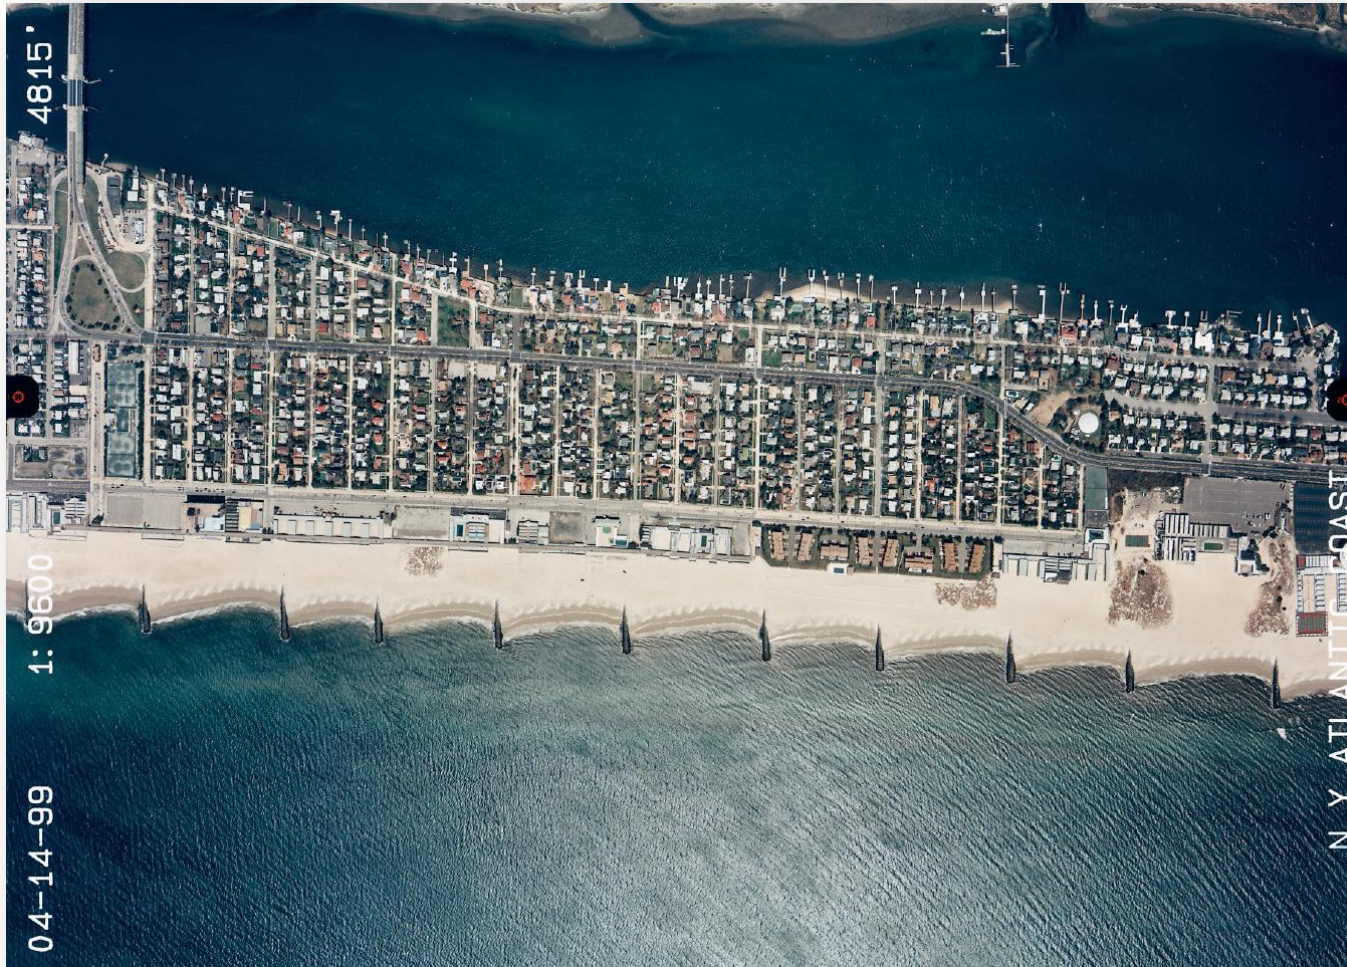
(1999) Groins built at Long Beach, NY  
Source: City of Long Beach

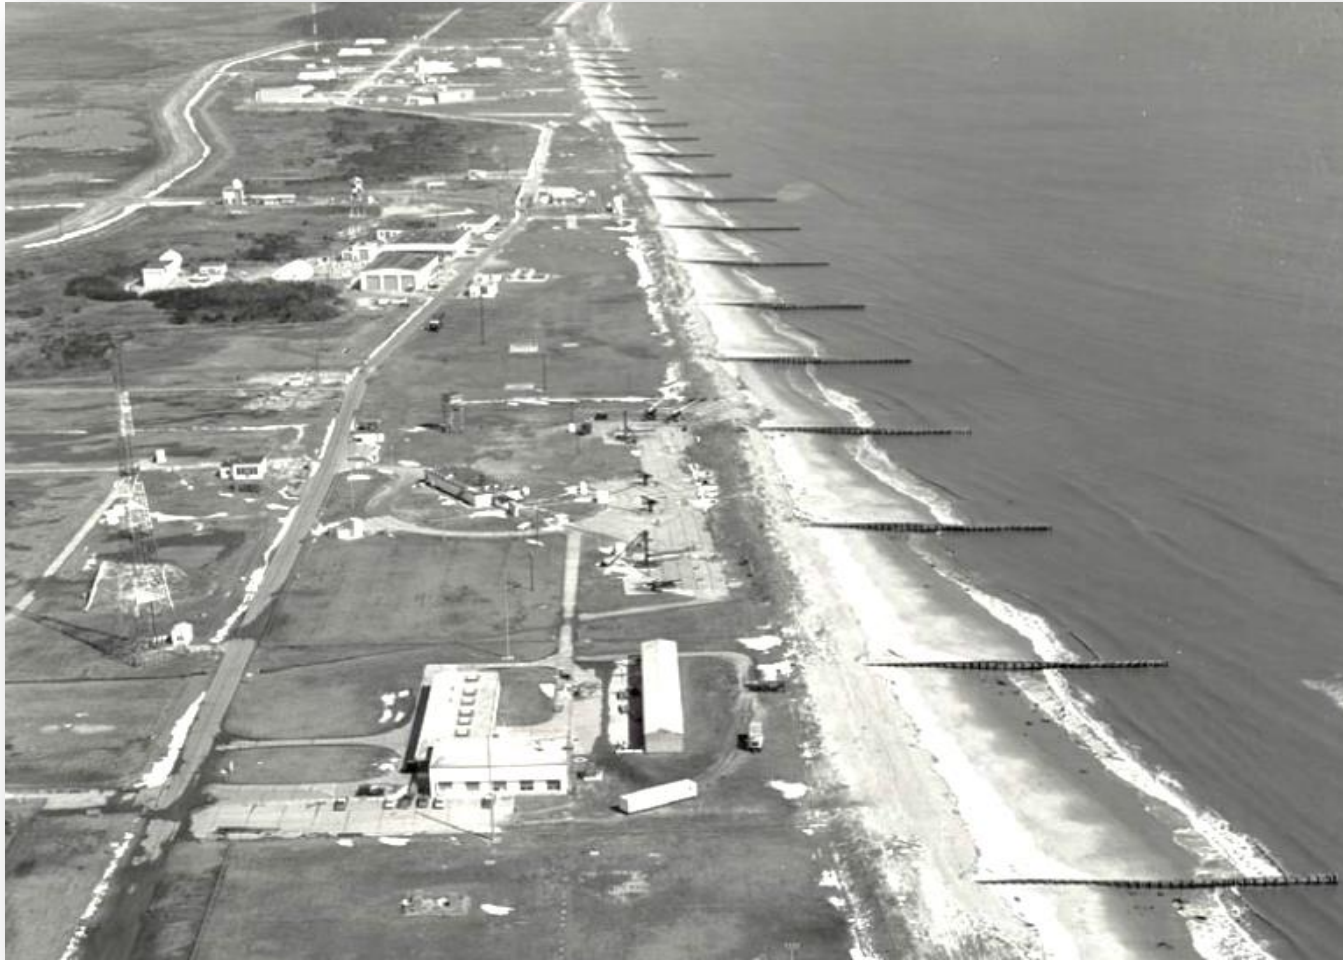
(1969) Groins built at Wallops Island, VA

Source: USACE, 2010; Storm Damage Reduction Project Design for Wallops Island, Virginia (p.11)

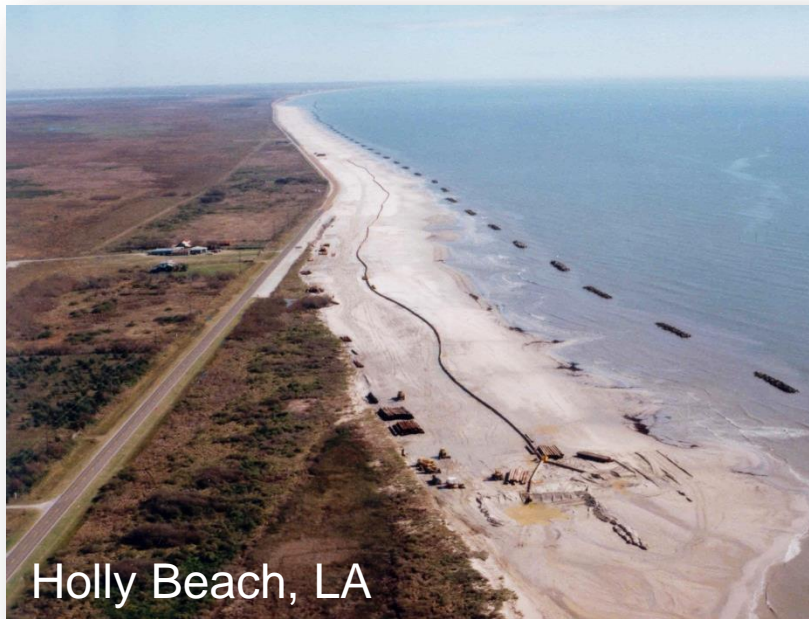
## Temporary Geotextile Tubes

Upham Beach  
January 31, 2014

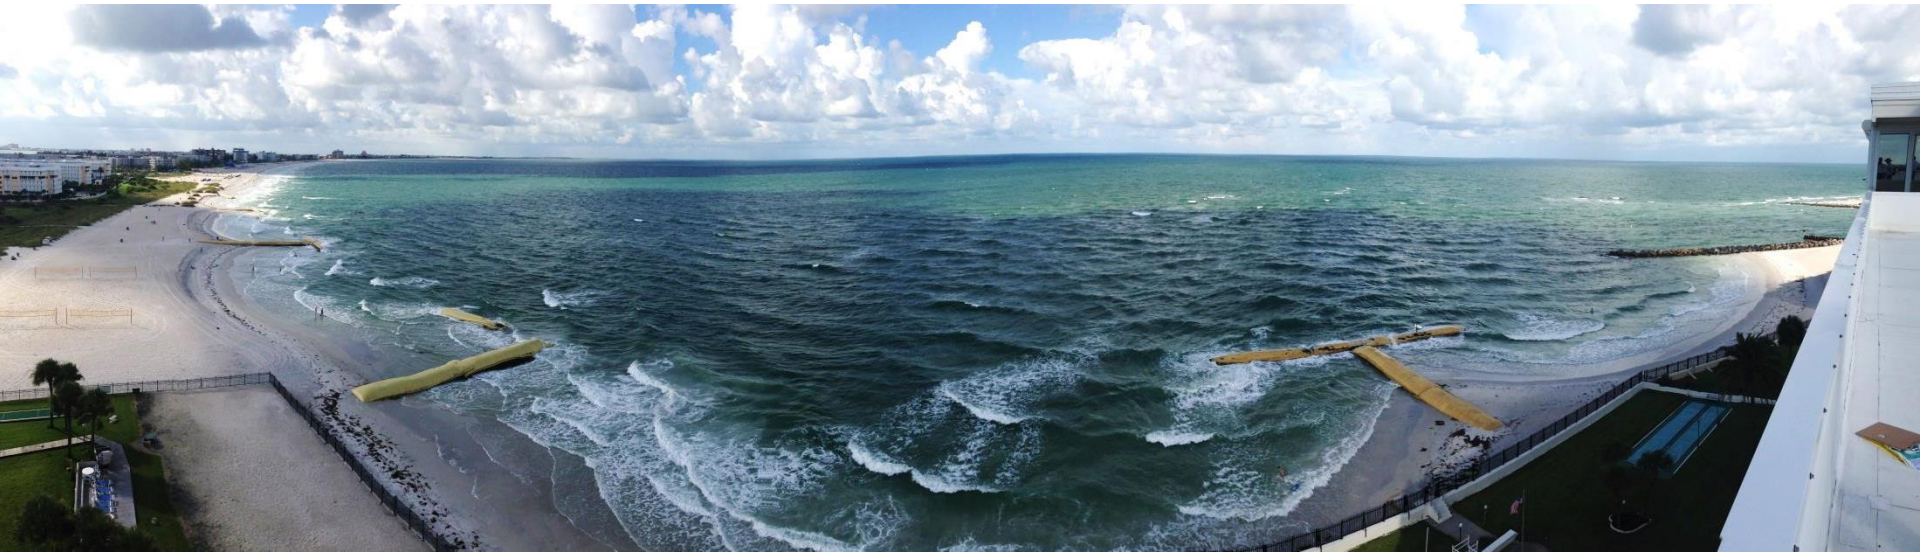
- July 16, 2014 – Before USACE 2014 project

- 4 years since previous (2010) fill project
- Groin T2 damaged
- Public beach stabilized

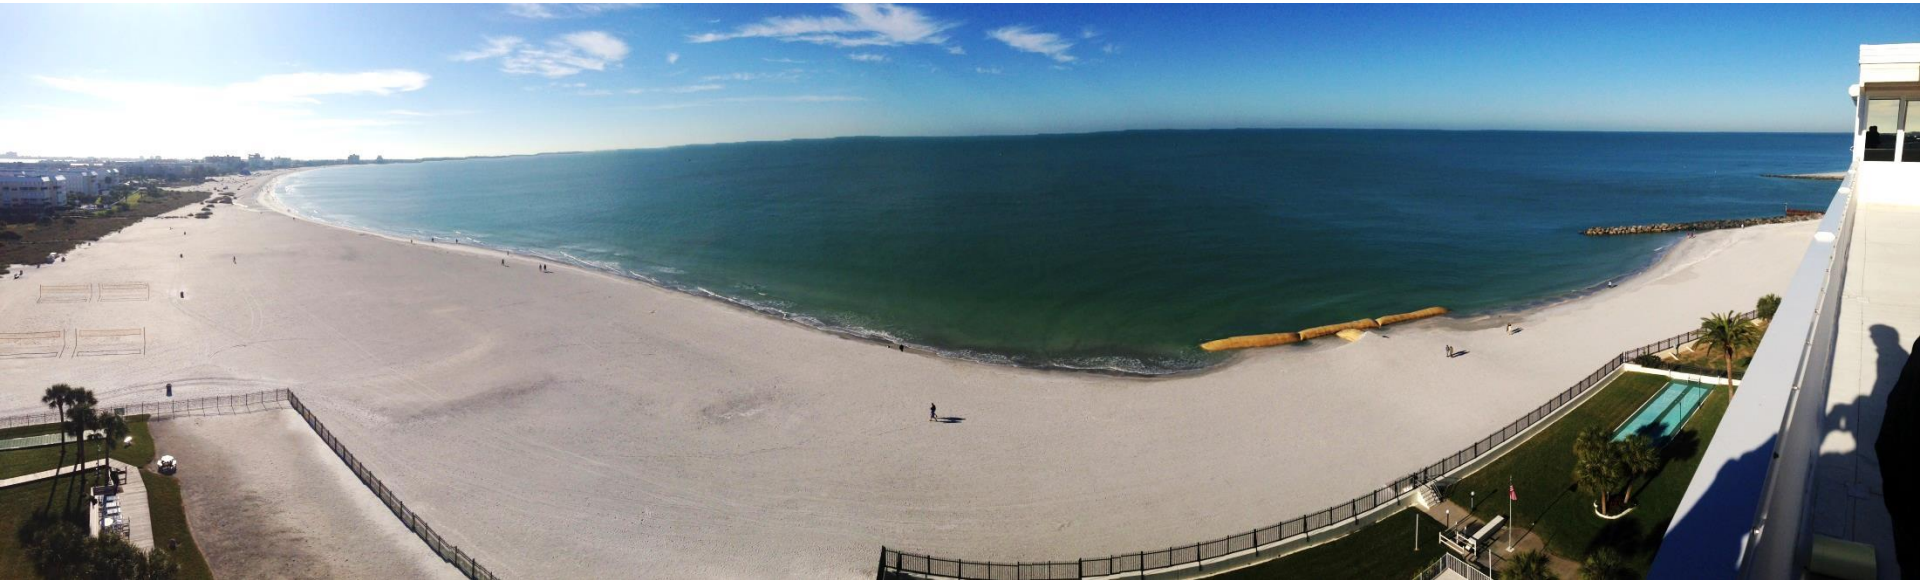
- January 29, 2015 – 5 months post fill from USACE 2014 project

- Fill placement August 2014
- 157,000 cubic yards
- Egmont Shoals East borrow area

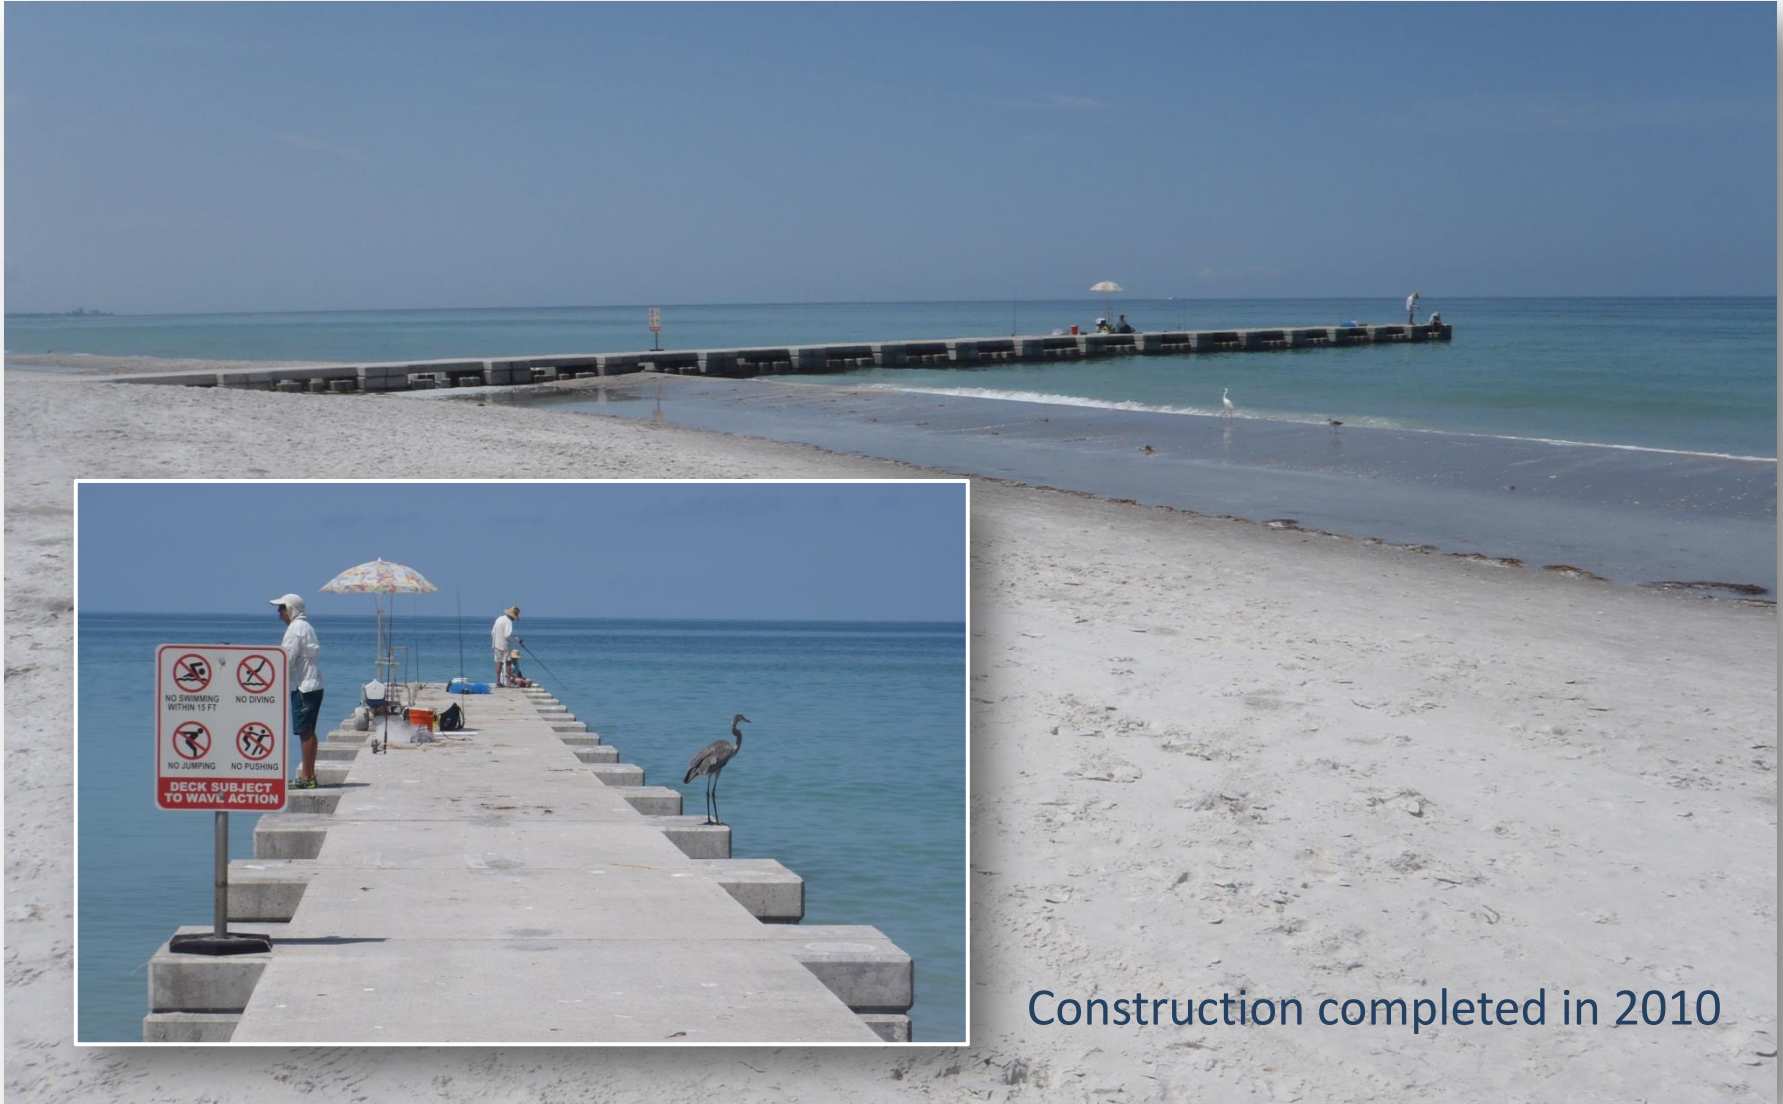
- Islander Club Condominium PAGs: July 2, 2012 – Post TS Debby

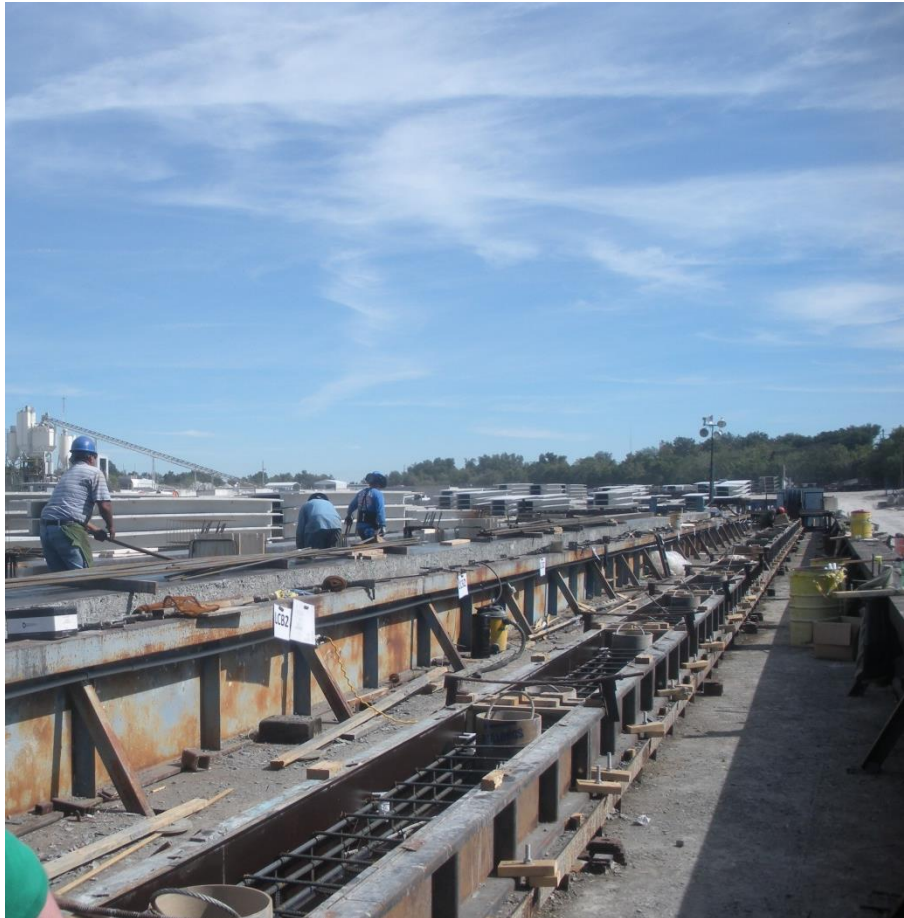
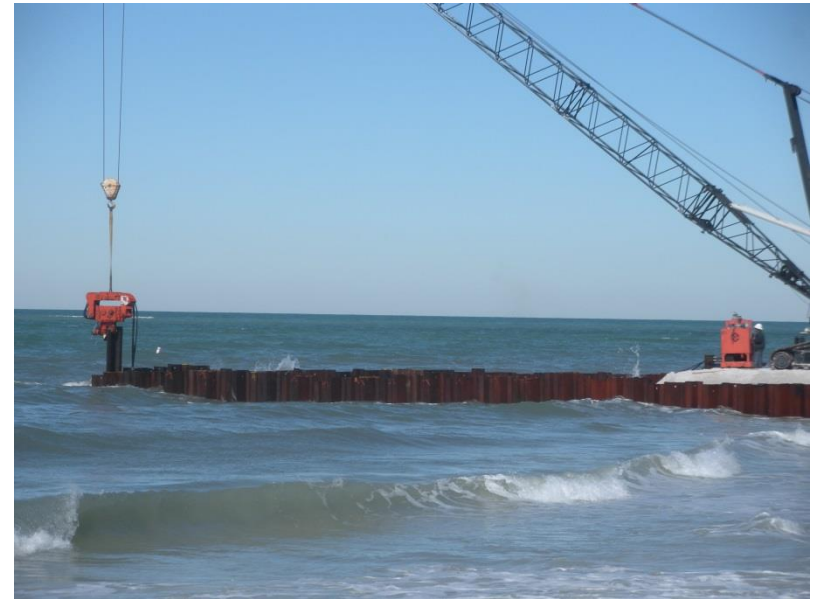
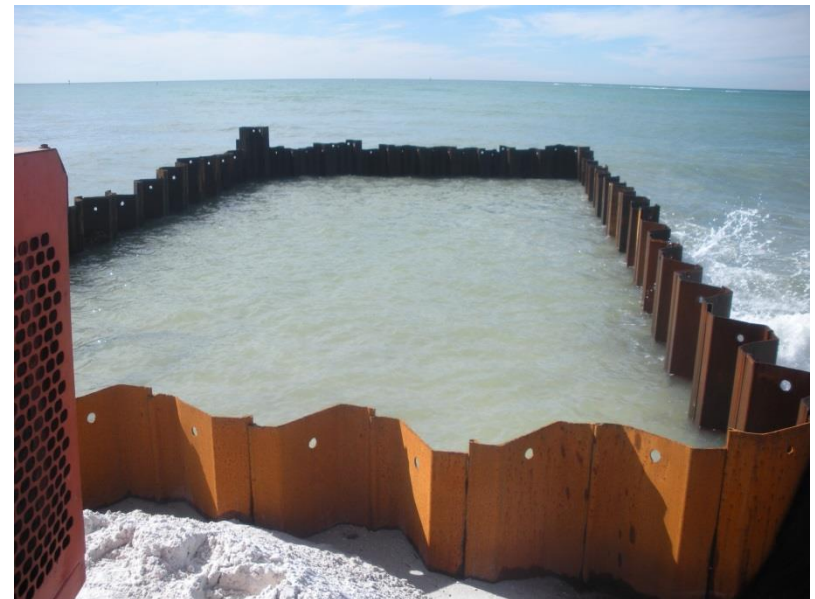
## North End PAGs Installation

- Precast Operation
- Temporary Cofferdam

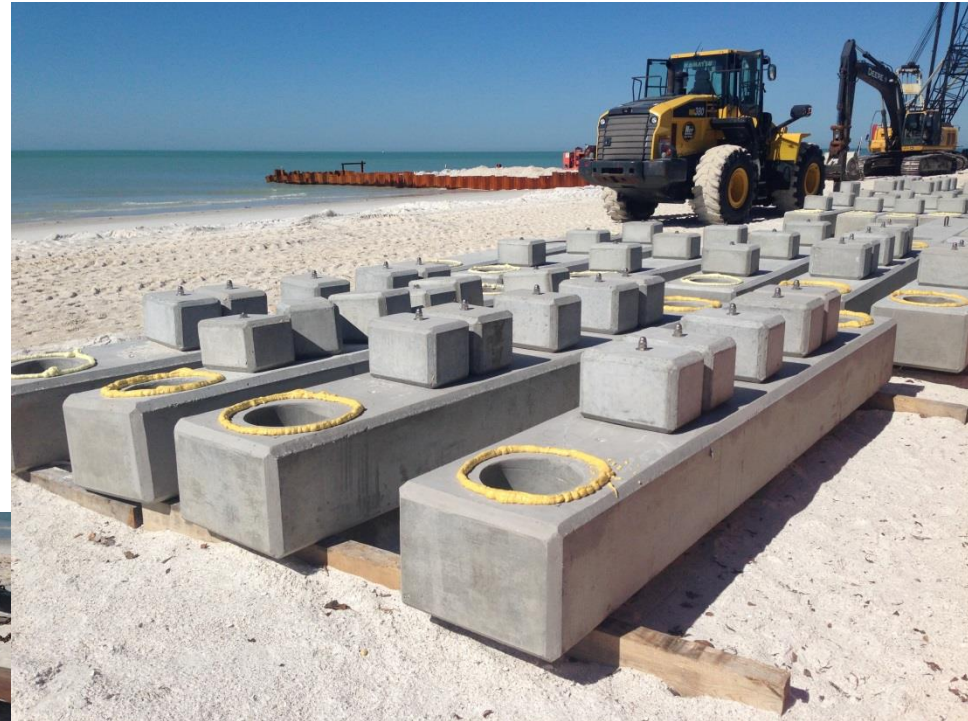
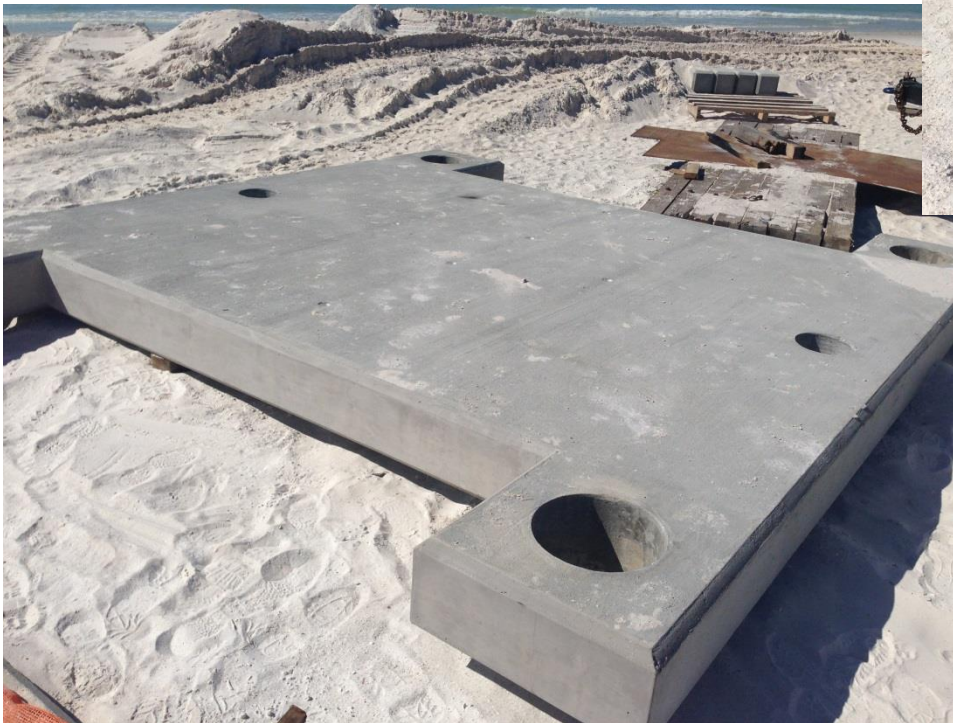
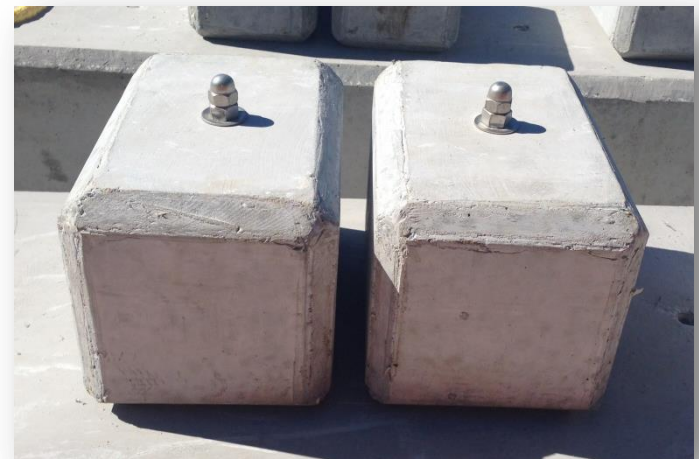
## North End PAGs Installation

### Precast Components:

- Deck Slabs
- Deck Supports
- Crib Beams
- Removable Elements

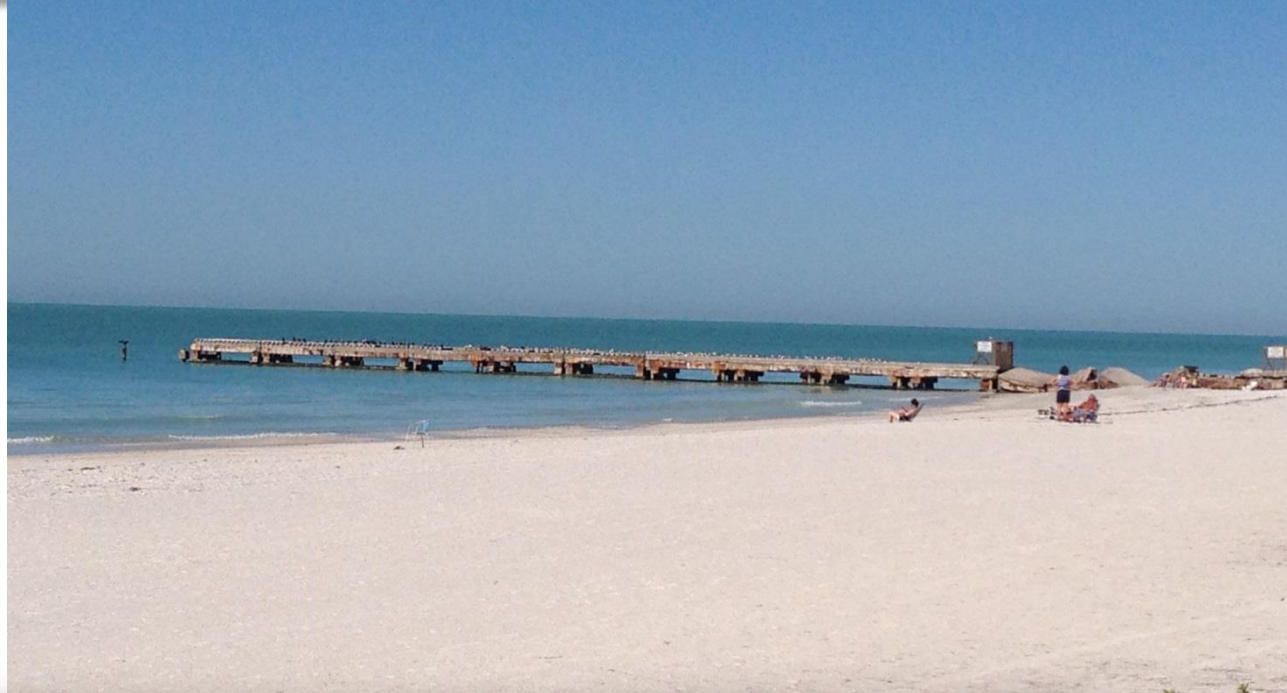
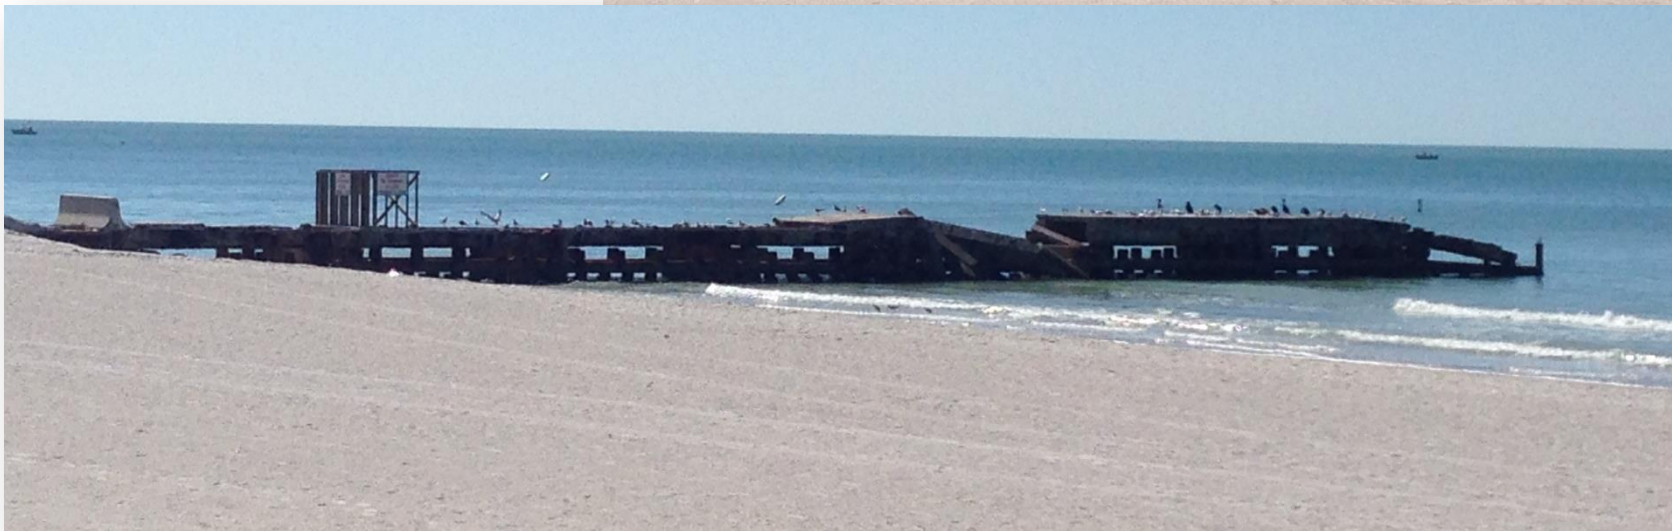
Cortez Beach:  
January 29, 2015

- Existing structures to be removed

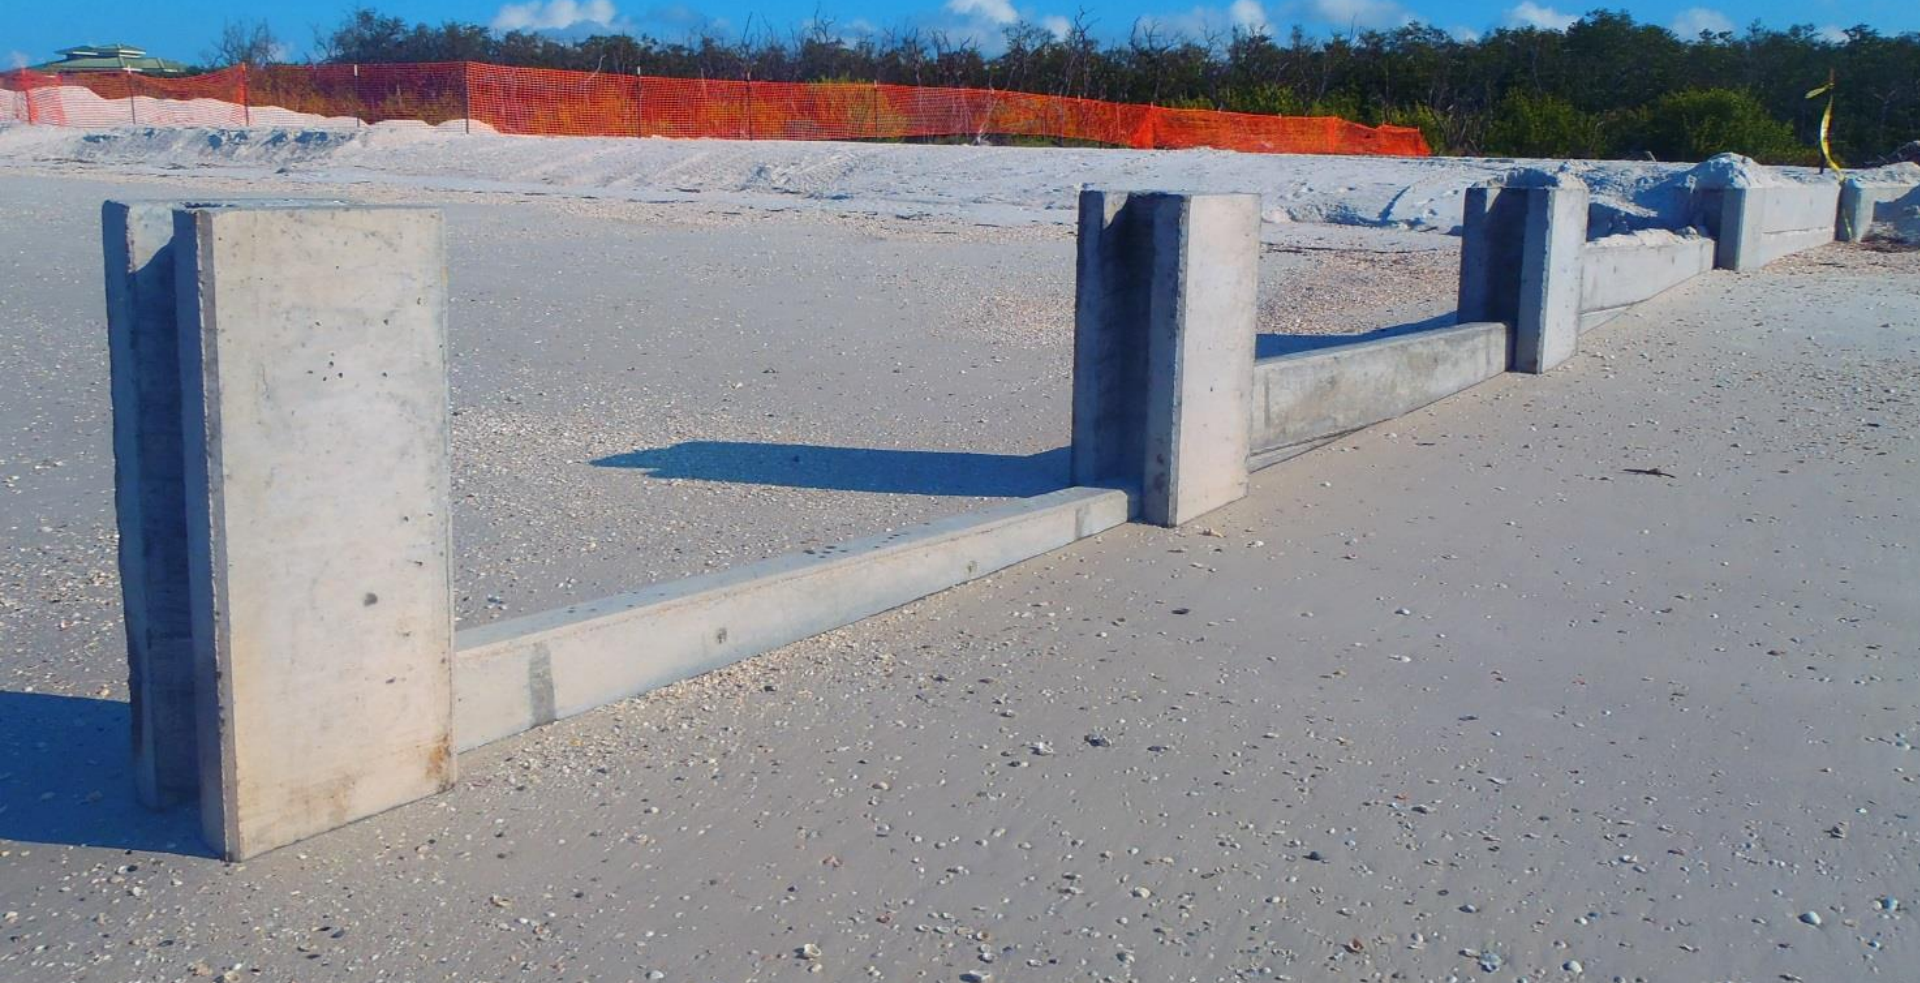
- Limited footprint
- Customizable lengths and adjustable
- Minimize sea turtle interactions
- Ease of construction (offsite concrete casting)

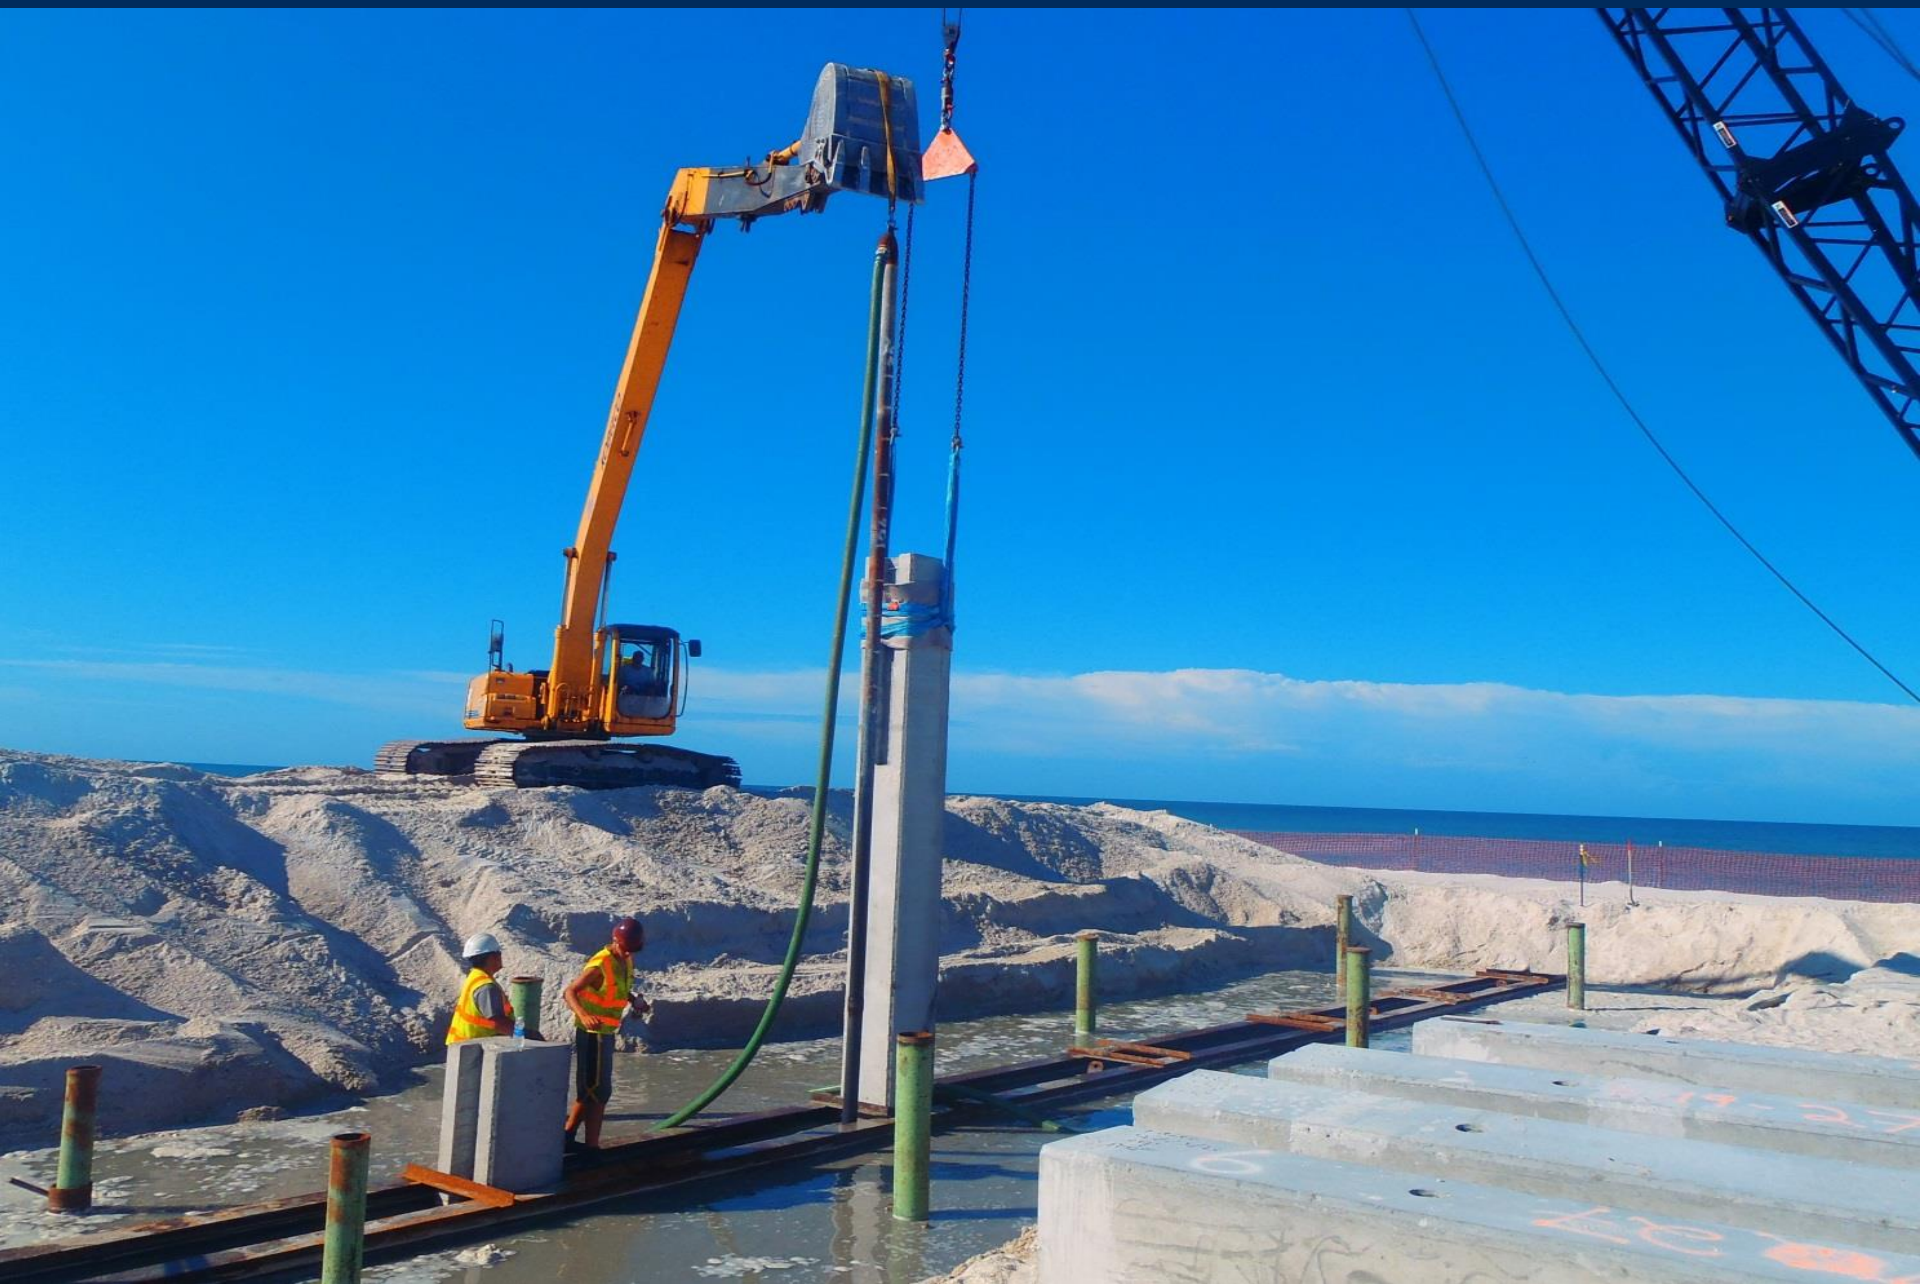
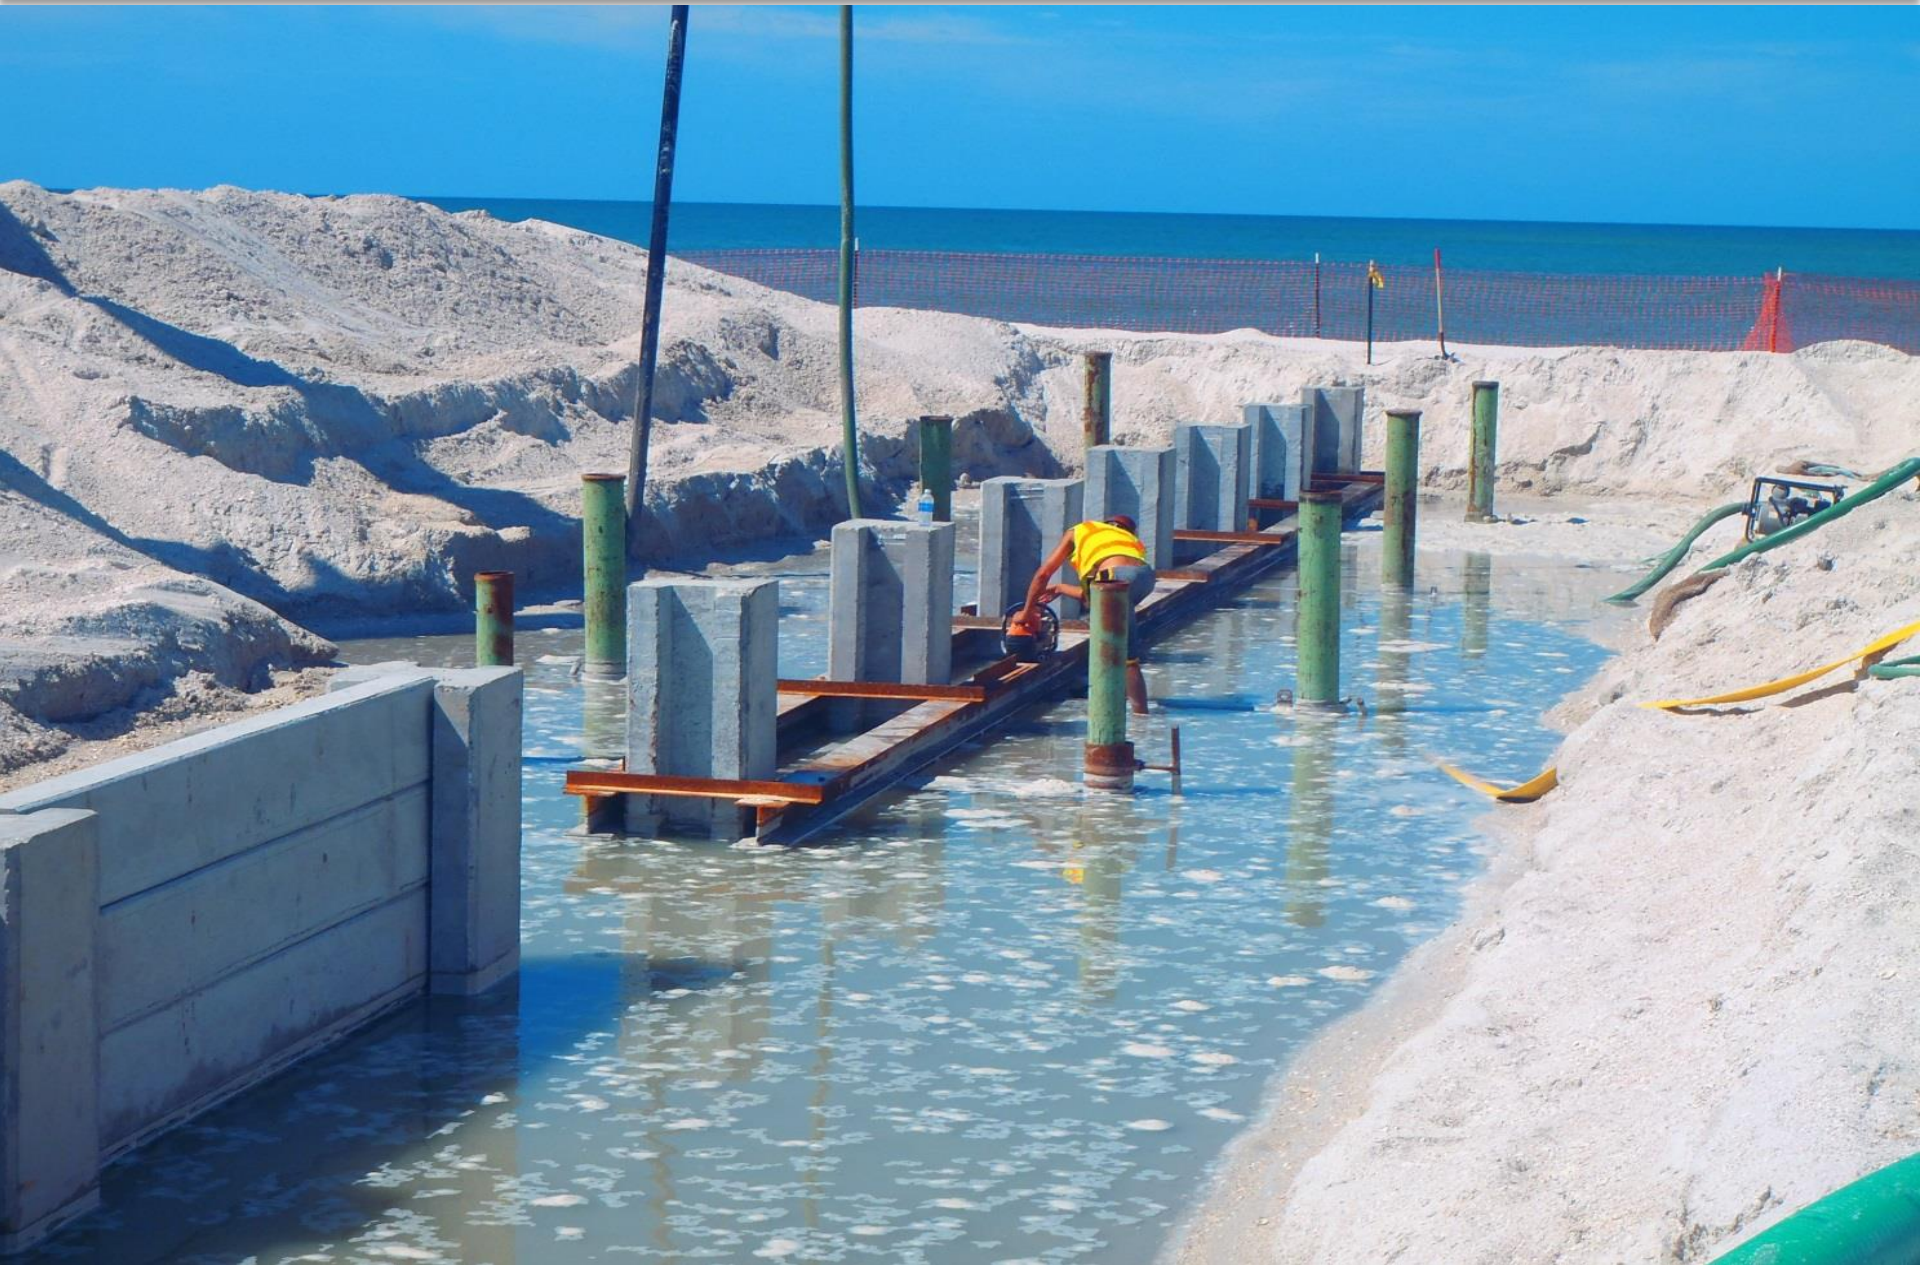
- 75,000 cubic yards from ebb shoal
- 600 ft long dune along the back of the new beach
- 7 king pile and panel groins to control the loss of sand

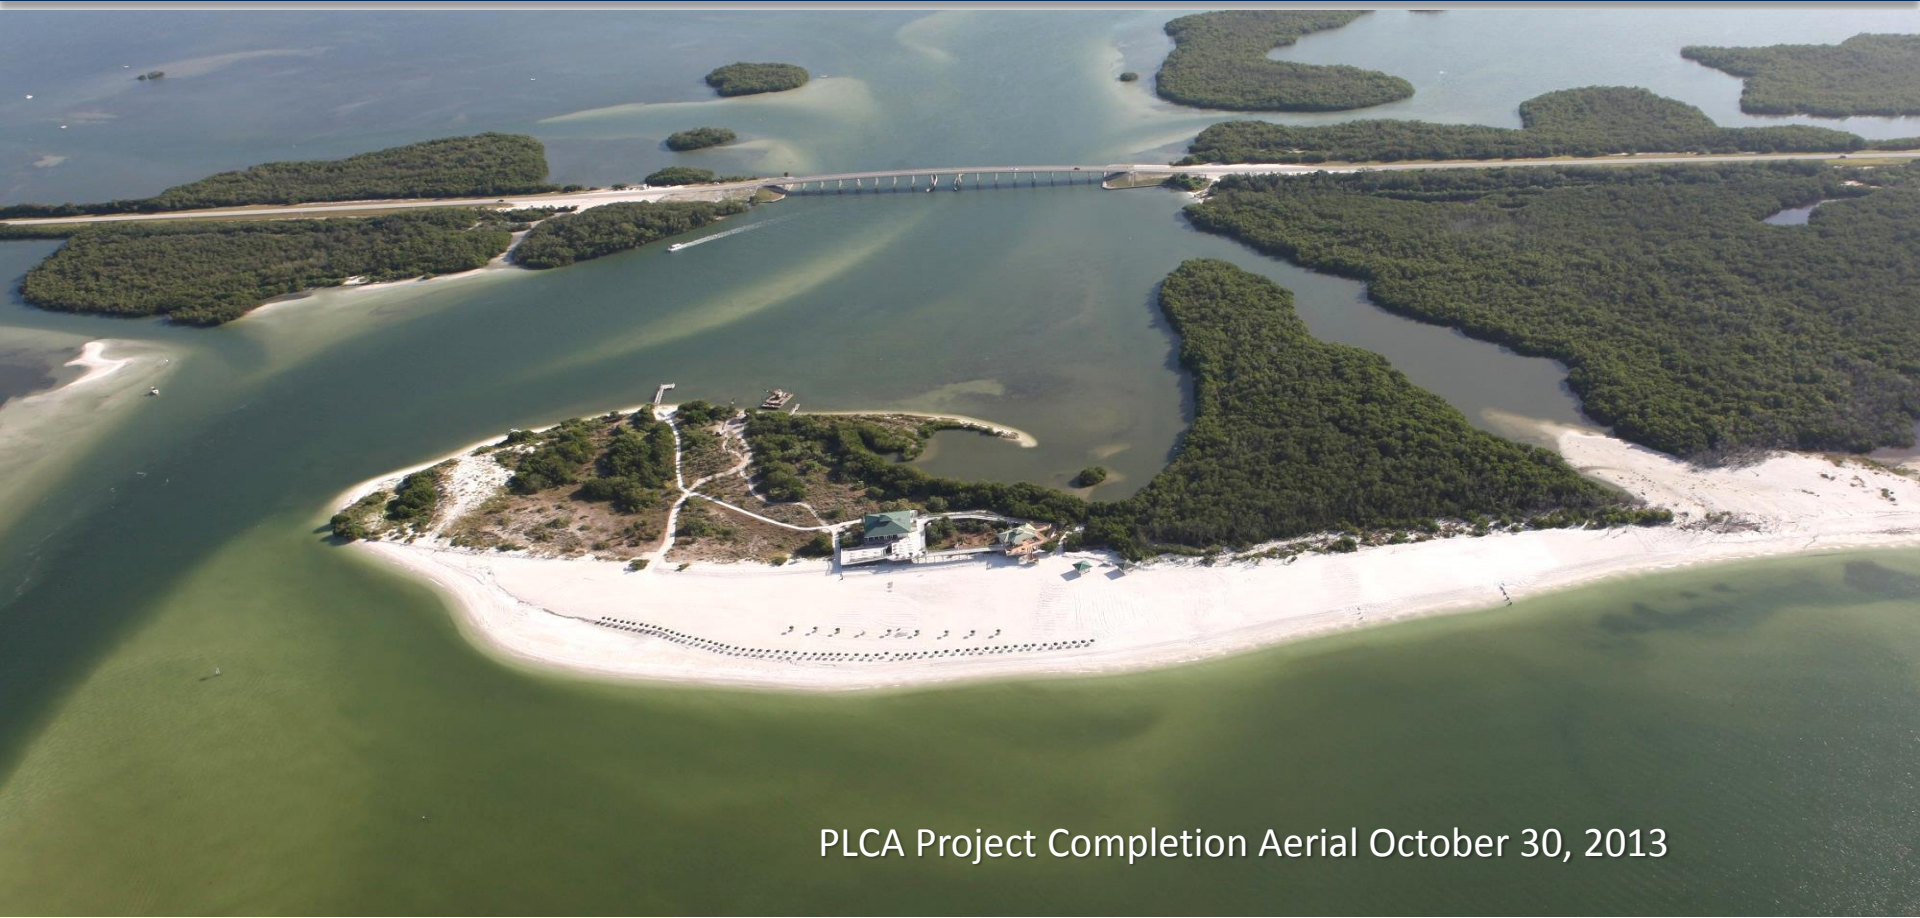
PLCA Project Completion Aerial October 30, 2013
