# Recent Applications and Advancements for the Strategic Use of Coastal Structures

Thomas P. Pierro, P.E., D.CE  
Director, CB&I

- FSBPA 2014 National Conference on Beach Preservation Technology, February 12-14, 2014 in Stuart, FL

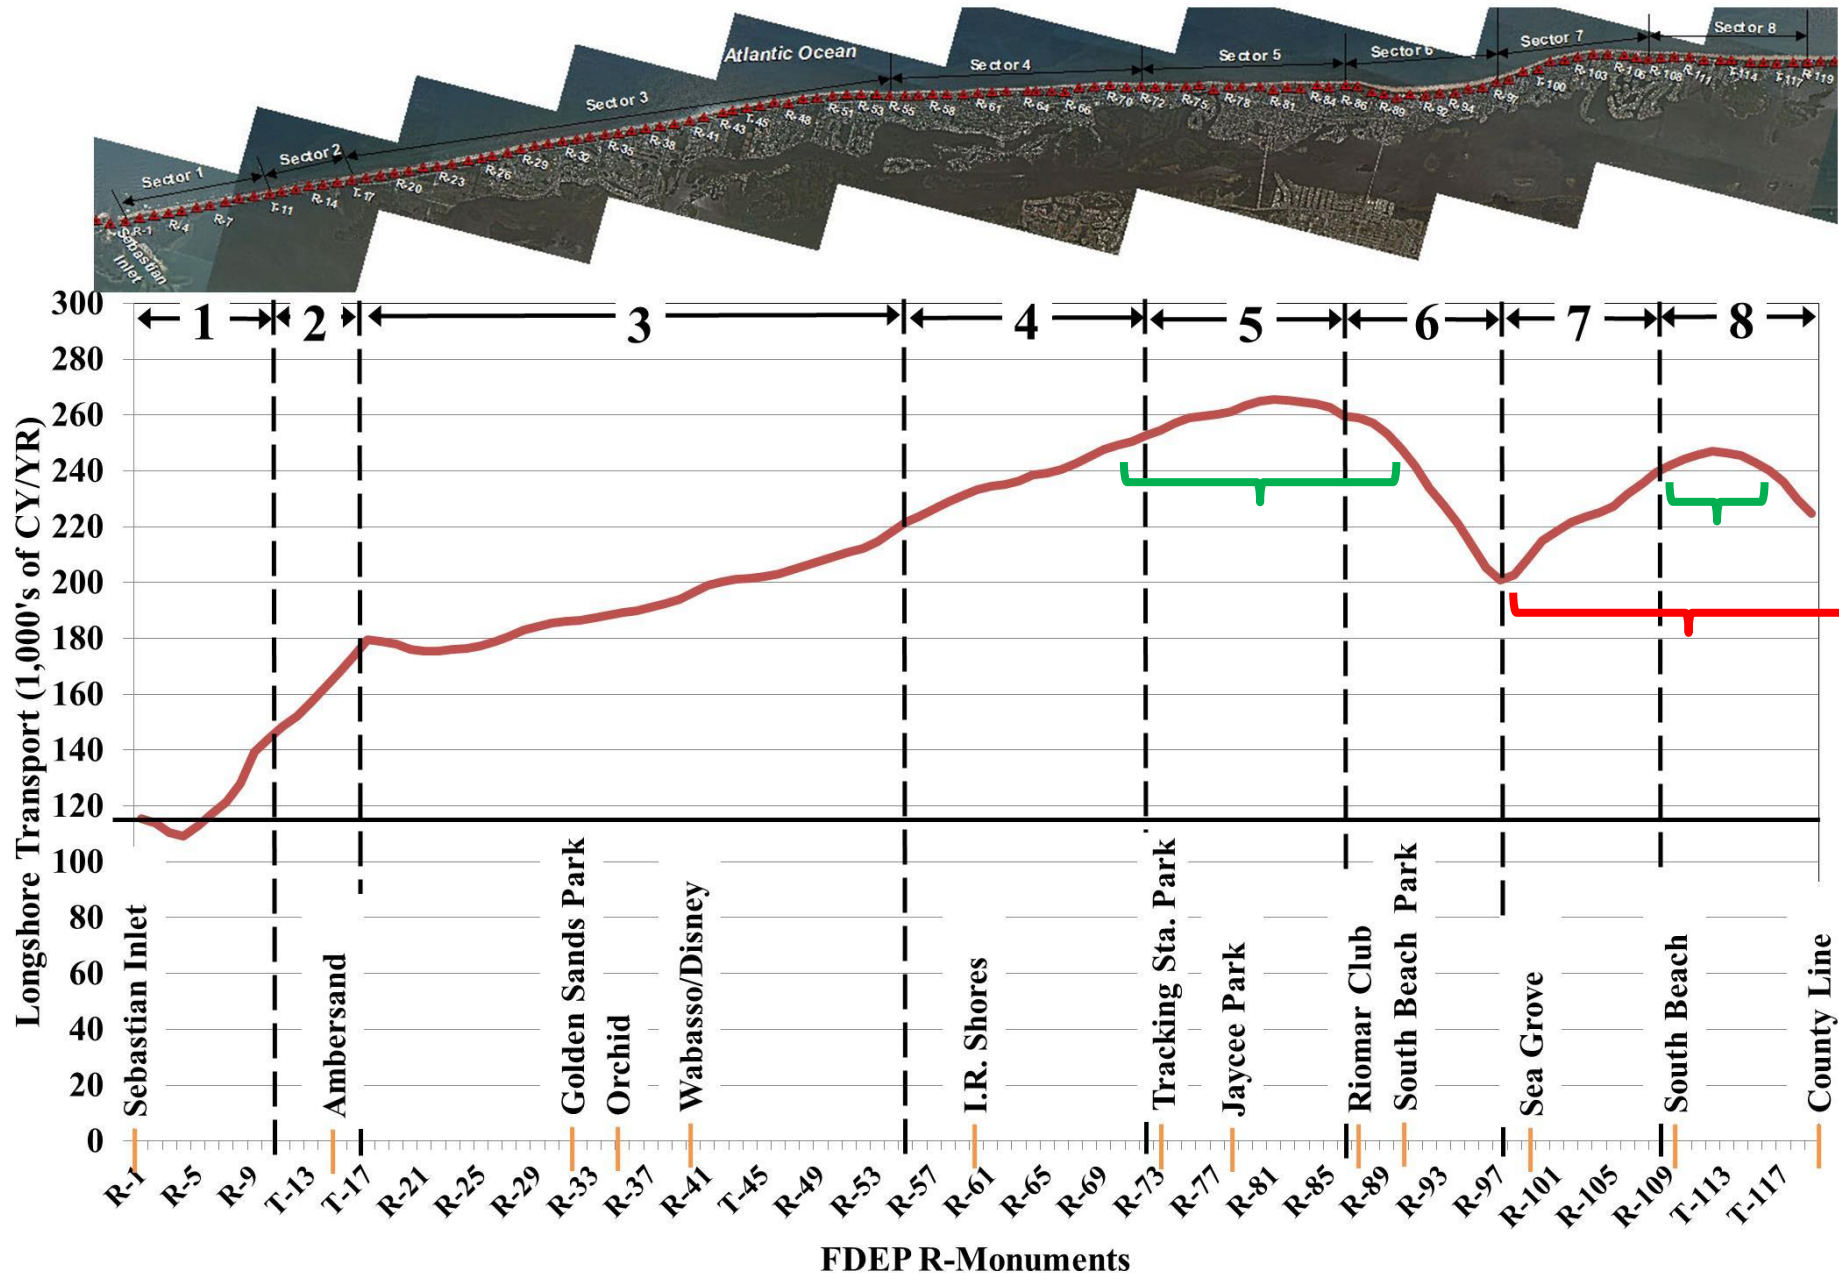
- Fill placement limited by presence of nearshore hardbottom
- Structural objectives:
  - Improve beach fill performance
  - Minimize downdrift impacts
  - Limit to areas deemed “critically eroded” by the State
- Littoral transport curve analysis
- Beach fill, groins & breakwaters considered
- Design optimized with Delft 3D modeling
