# Four Structurally Stabilized Resort & Public Beaches in the Caribbean

**Kevin Bodge**, Ph.D. P.E.  
Olsen Associates, Inc.  
Jacksonville, Florida

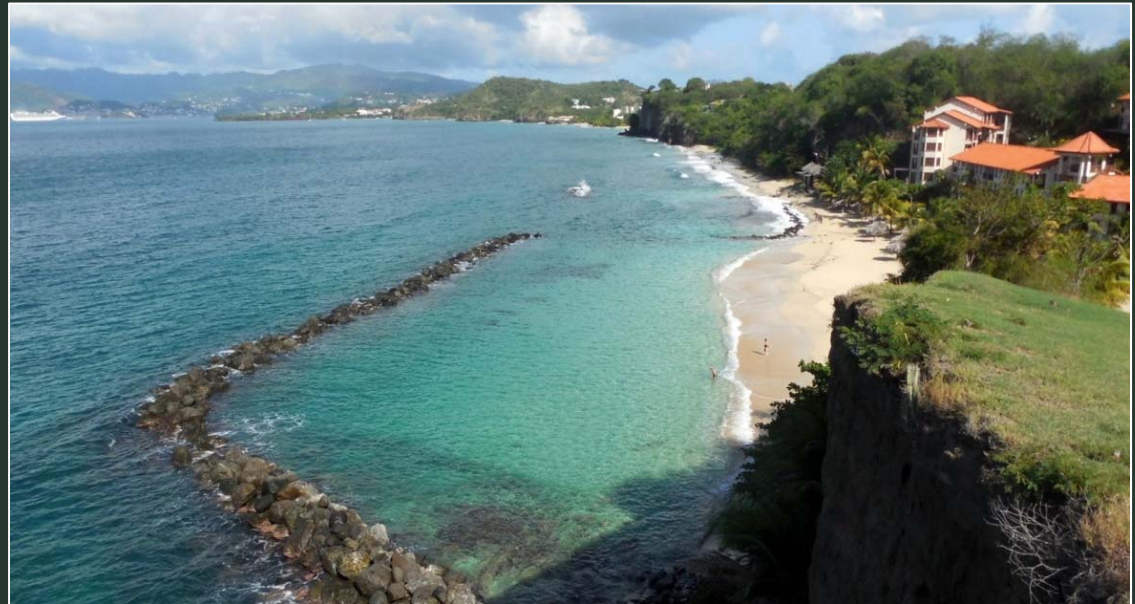
Pre-Project (Nov 2012)

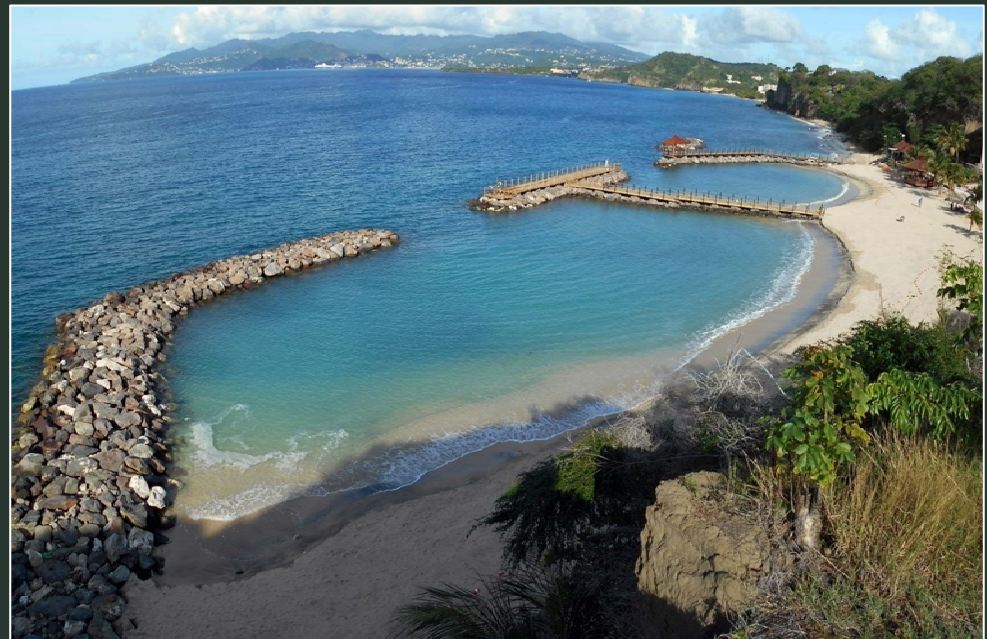
Post-Project (Dec 2013)

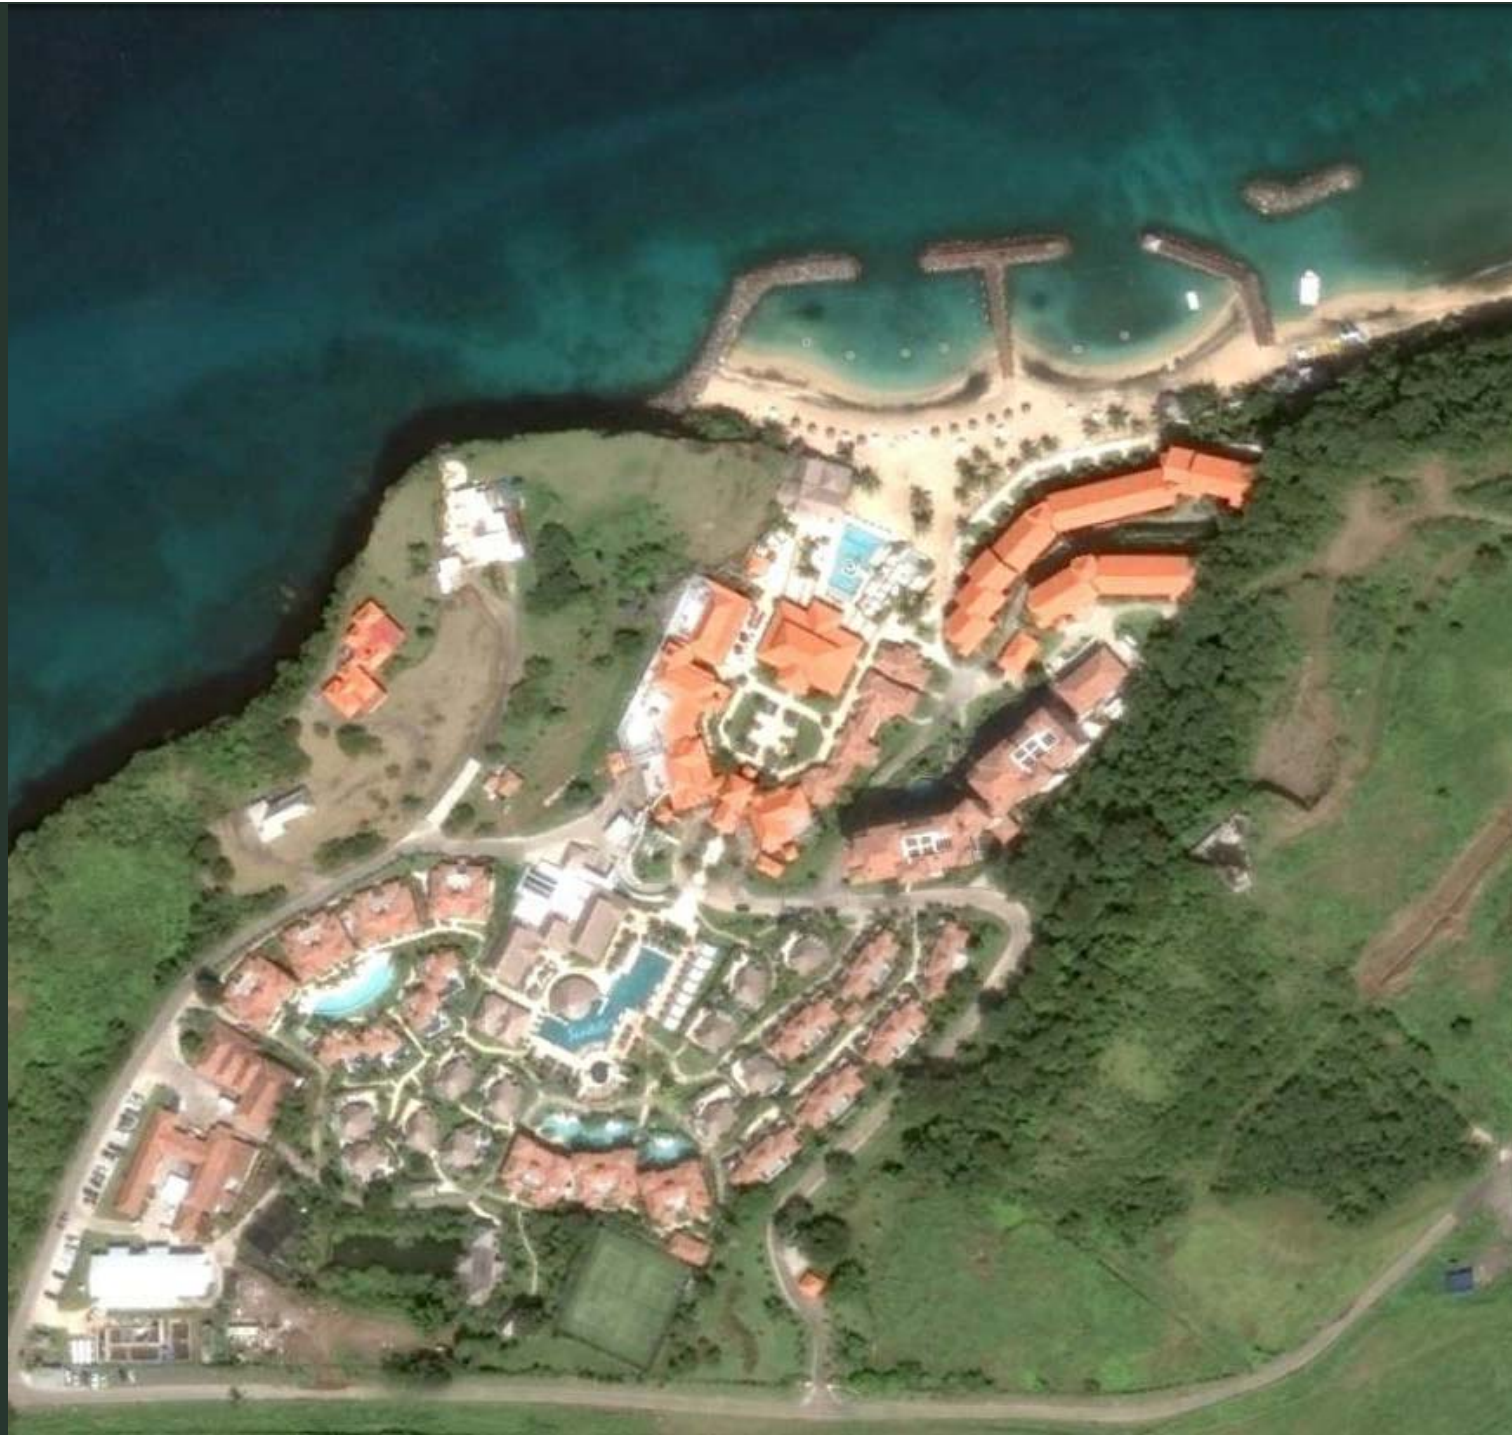
**GAP = 67'**  
**O/S = 135'**  
 $\gamma = 2.0$

**GAP = 75'**  
**O/S = 128'**  
 $\gamma = 1.7$

Noting that  
cells are  
underfilled,  
per plan.
