St. Lucie County South County Beach & Dune Restoration Project - Mitigation Reef

Lessons Learned

**2016 FSBPA
National Conference
on
Beach
Preservation
Technology**

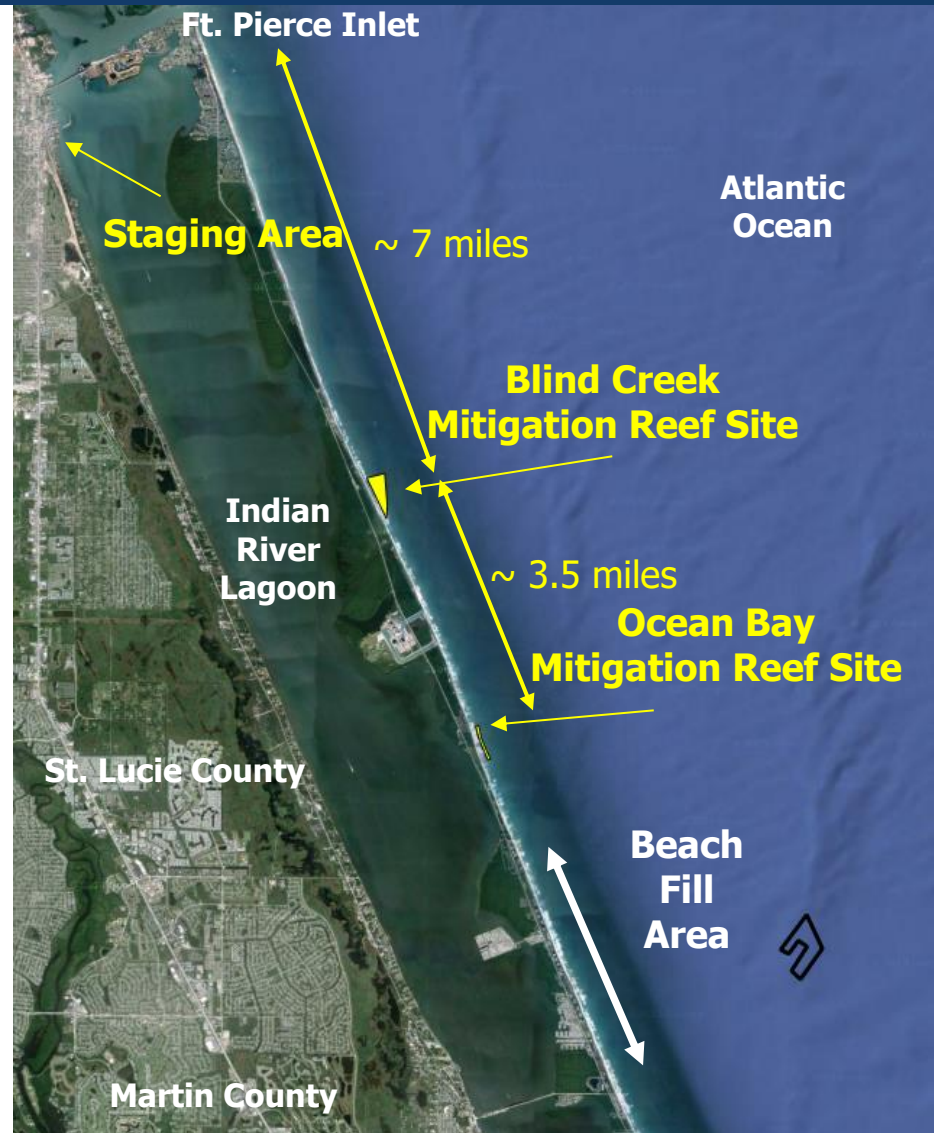
- R-98 to R-115 + 1,000 / Martin County Line

- Offset historical erosion
- Restore recreational beach
- Provide storm protection to upland properties, and
- Restore coastal habitat

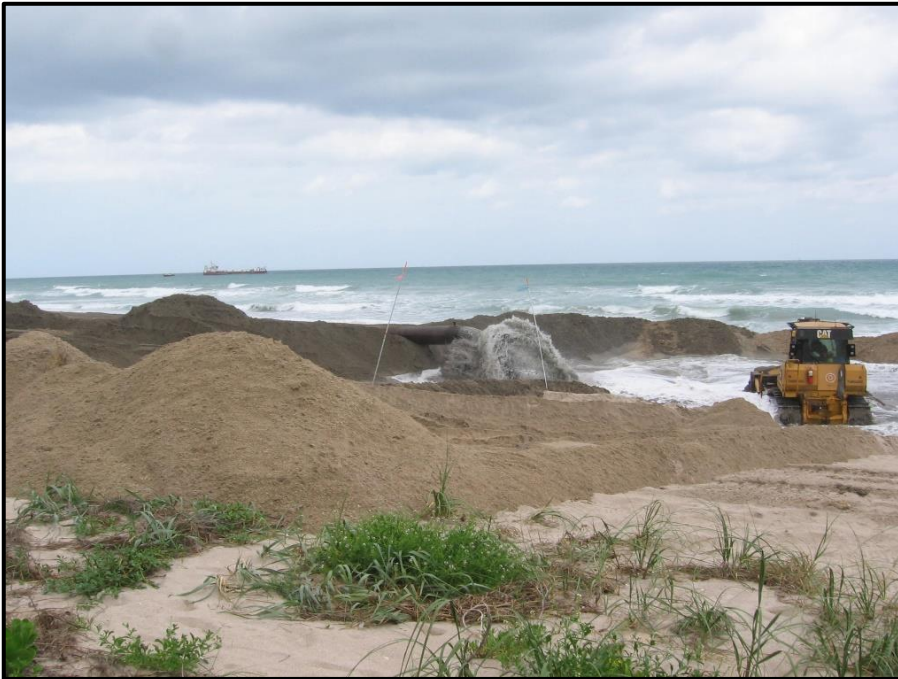
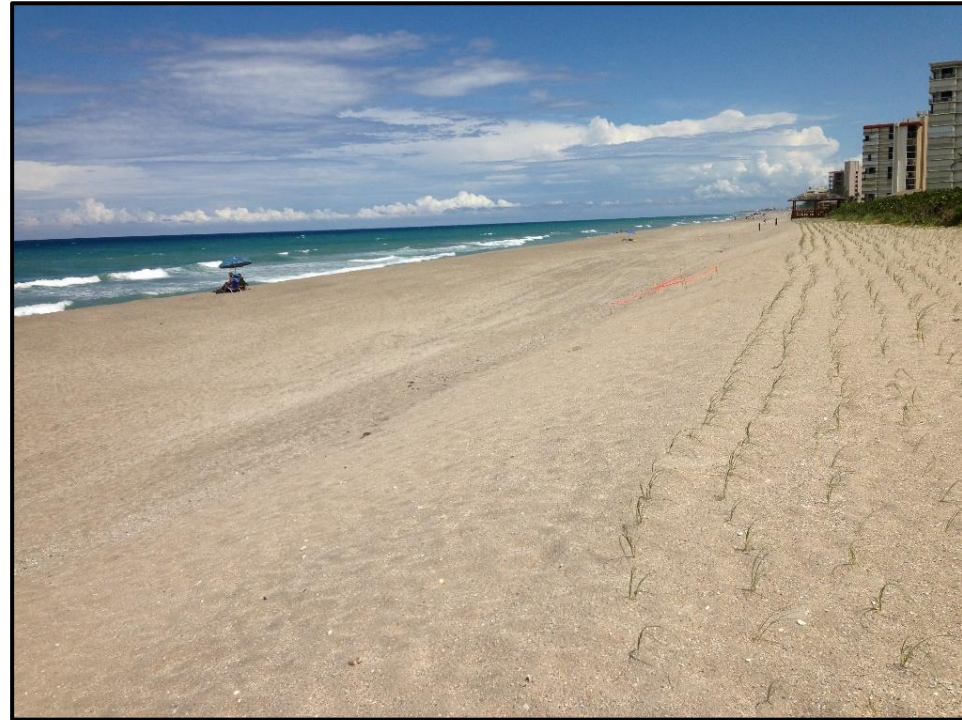
- Constructed
March to May 2013

- 635,164 cubic yards placed
over 3.3 miles of shoreline

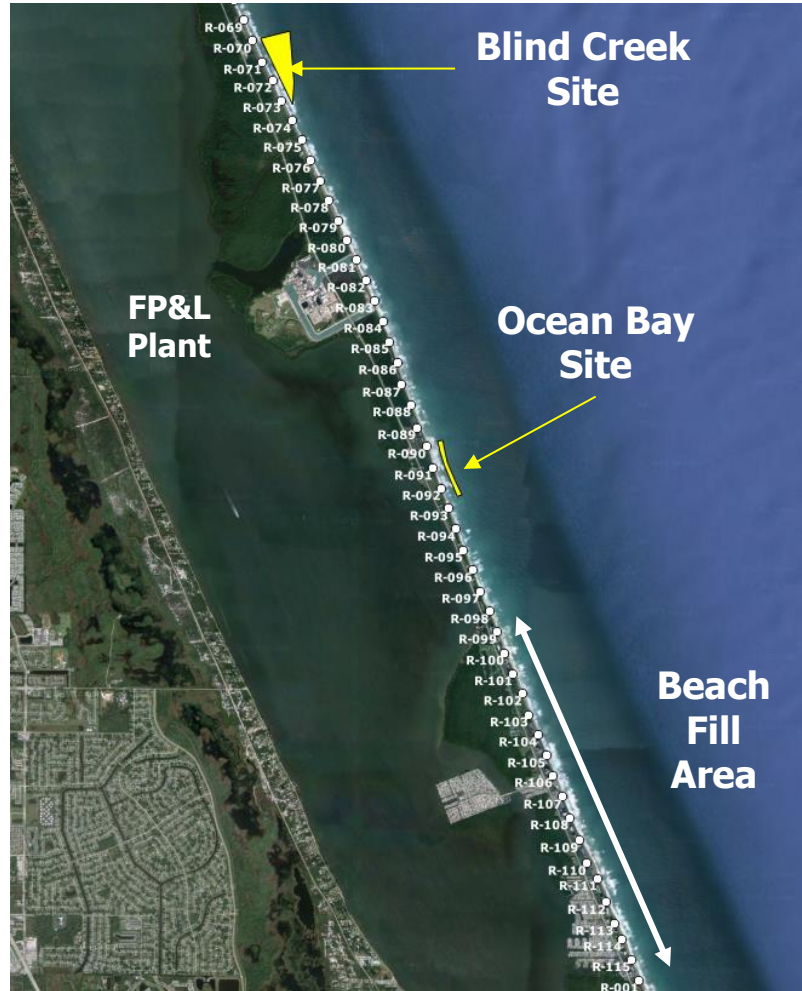
- Blind Creek site added (R-70 to R-73)
 - previously investigated by County for artificial reef program
 - » < 2 feet veneer
 - CTC-G.E.C. determined sand depth > 5 feet
- Geo-textile fabric
 - proposed to deter settlement

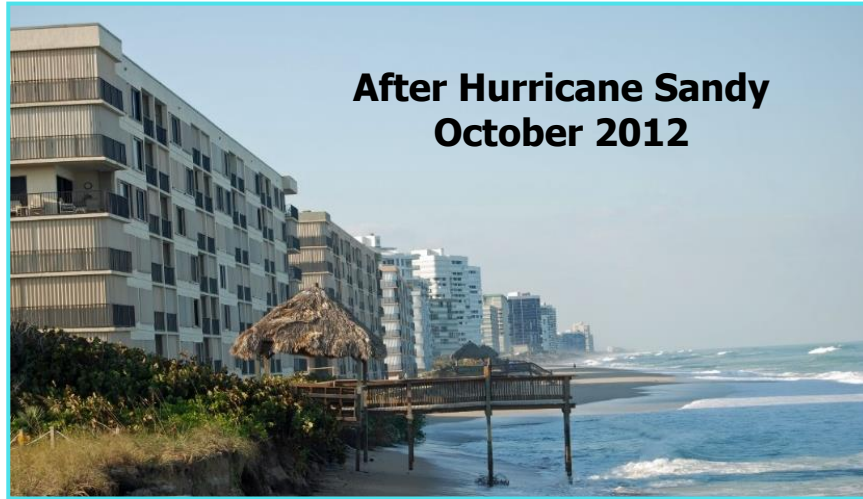
- October 5, 2012 survey depicted on construction plans
- Sand deposition \approx 2 feet
 - Attributed to Hurricane Sandy – changed water depths
- Filter cloth for all reef cells

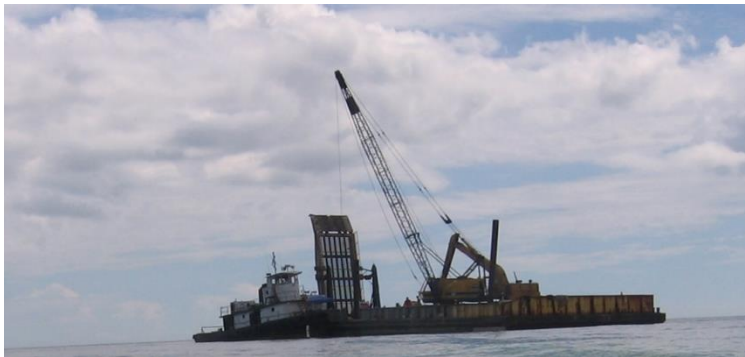
- Each Day:
 - Load rocks onto the barge at staging area and transport to reef
 - Locate next to target cell, lower welded frame w/ filter cloth into place w/ RTK guided crane
 - Rocks placed with long-arm excavator
 - Initially RTK on excavator used
 - Eventually diver assisted to position rocks
 - Completed ~ 0.35 acres over ~ 5 months

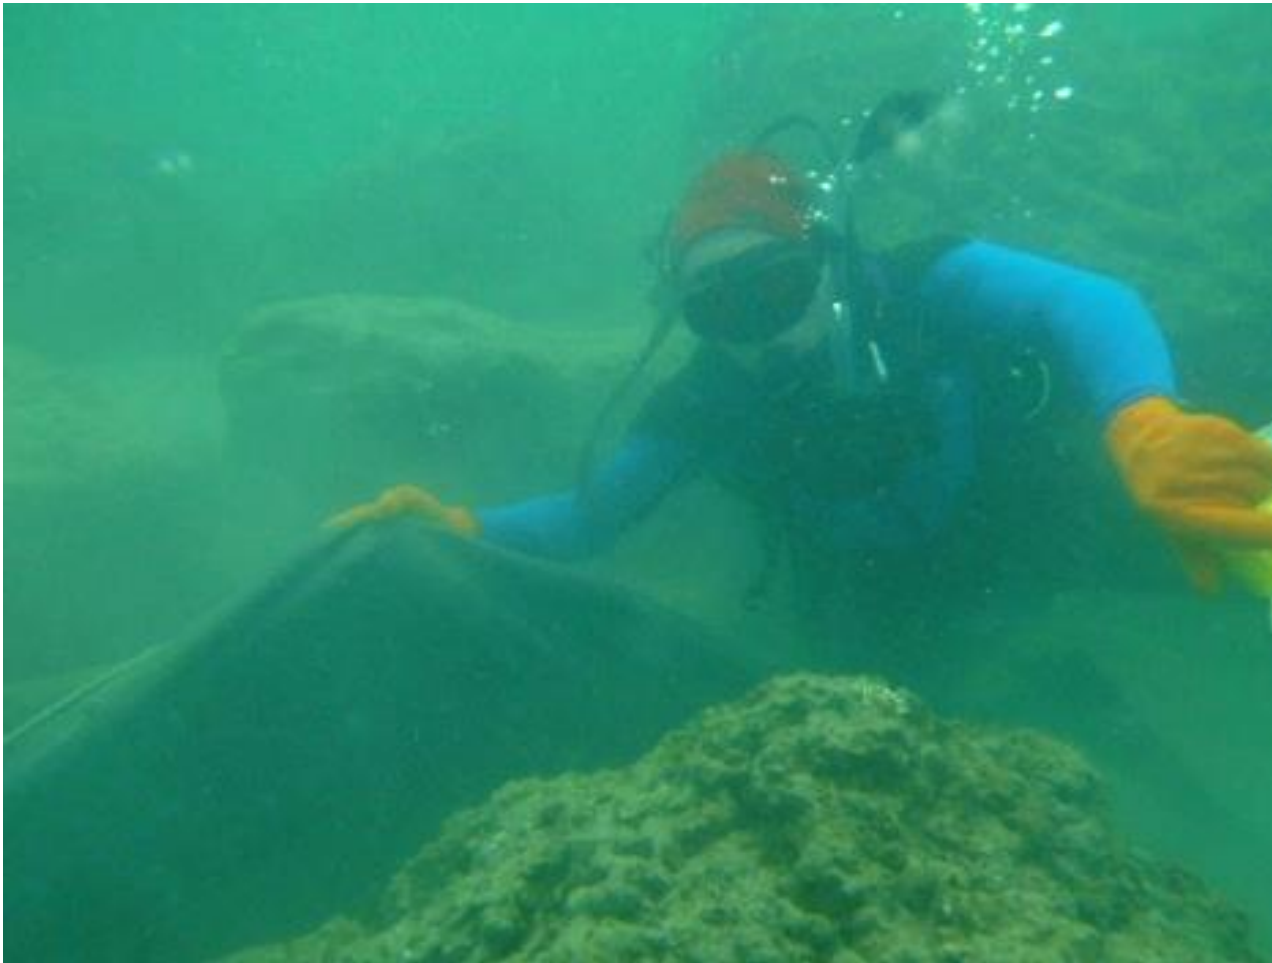
- Excessive spacing between rocks
 - Specs Required
 $1 \text{ ft} \leq \text{spacing} \leq 2 \text{ ft}$
- Filter cloth without rock
- Rocks not on filter cloth
- No remedy
- Insufficient Progress

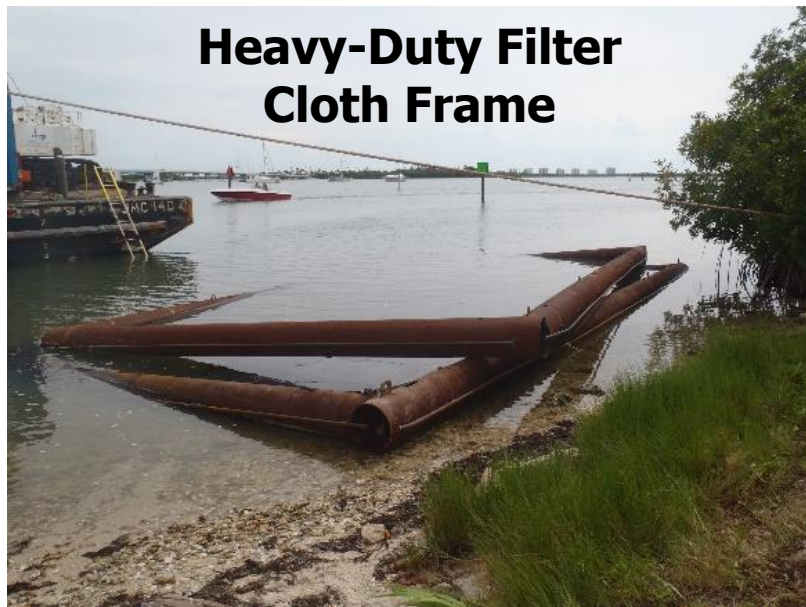
Heavy-Duty Filter Cloth Frame

- Every 3 – 4 days:
 - Load barge with approximately 500 tons of rock
- Each Day:
 - Transport divers/crew to reef site to meet barge
 - Locate target cell with RTK and place frame and filter cloth
 - Place rocks in water with crane – diver assisted
 - Remove frame and relocate barge
