The Value of Navigation Dredged Material to Ecosystem Restoration and Coastal Resiliency

Terri Jordan-Sellers & Eric Summa
USACE – Jacksonville District

National Conference on Beach Preservation
Technology – February 3, 2016

Miami Harbor GRR & EIS

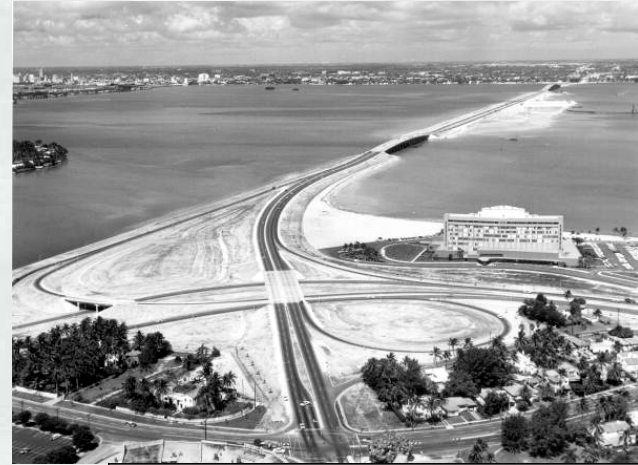
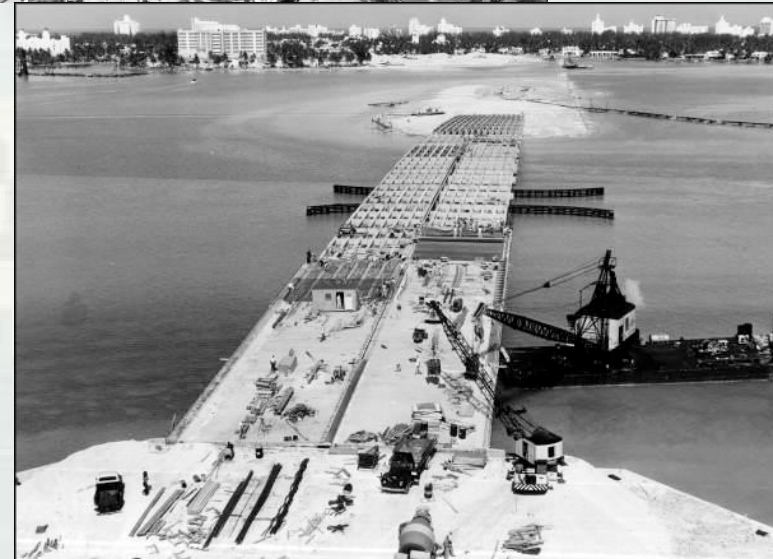
- Hole was dredged in Biscayne Bay circa 1959 as fill material for the Julia Tuttle Causeway from Miami to Miami Beach.
- Low sediment inflow in the Bay made it unlikely that the hole would repair itself to be able to support seagrass

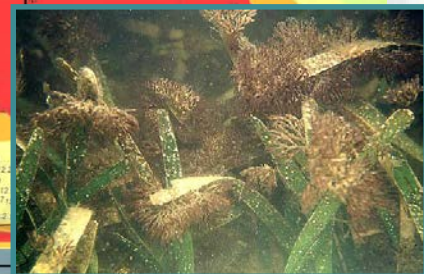
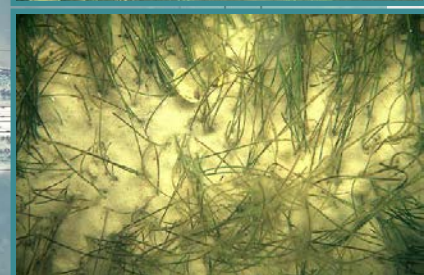
TYPICAL CROSS SECTION
JULIA TUTTLE MITIGATION AREA

- 31 acres available, Required to build 16.6 acres.
- Select fill cap (5 to 10% fines) to -4ft MLLW +/- 0.5ft
- "Design/Build" in the specifications

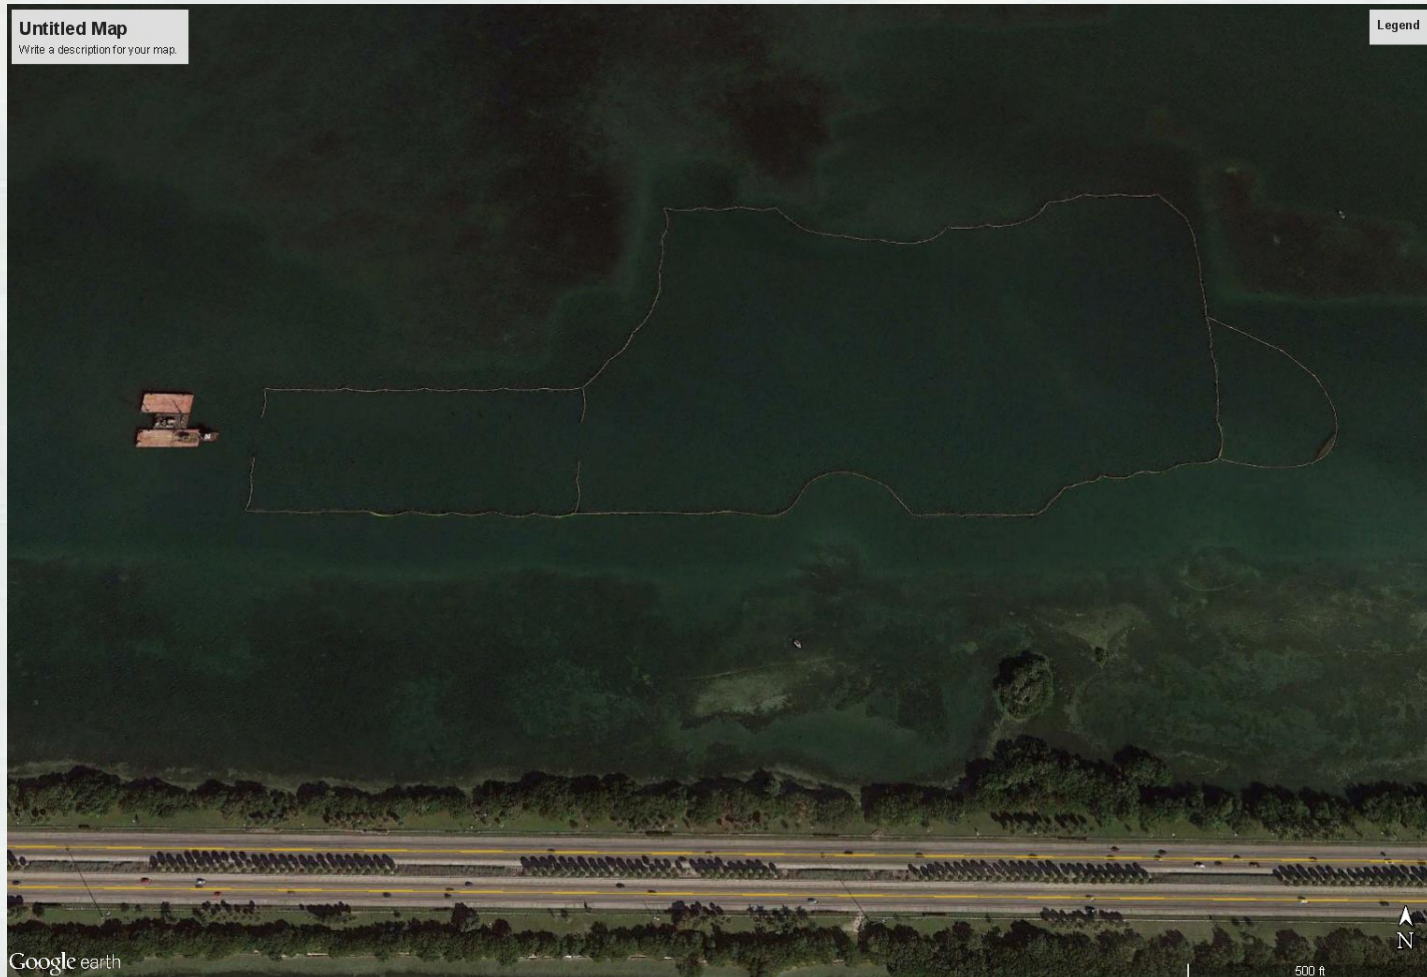
January 18, 2014 Google Earth Photo

- 560,000 CY of excavated dredged material placed in the JTMA hole to create 16.99 acres of seagrass habitat instead of placement in Ocean Dredged Material Disposal Site (~600 ft of water)
- 1,192 scow loads from Jan 8, 2014 to Oct 19, 2014.
- Loads limited to <1,000 CY/scow due to depth limitations accessing the site from the IWW.

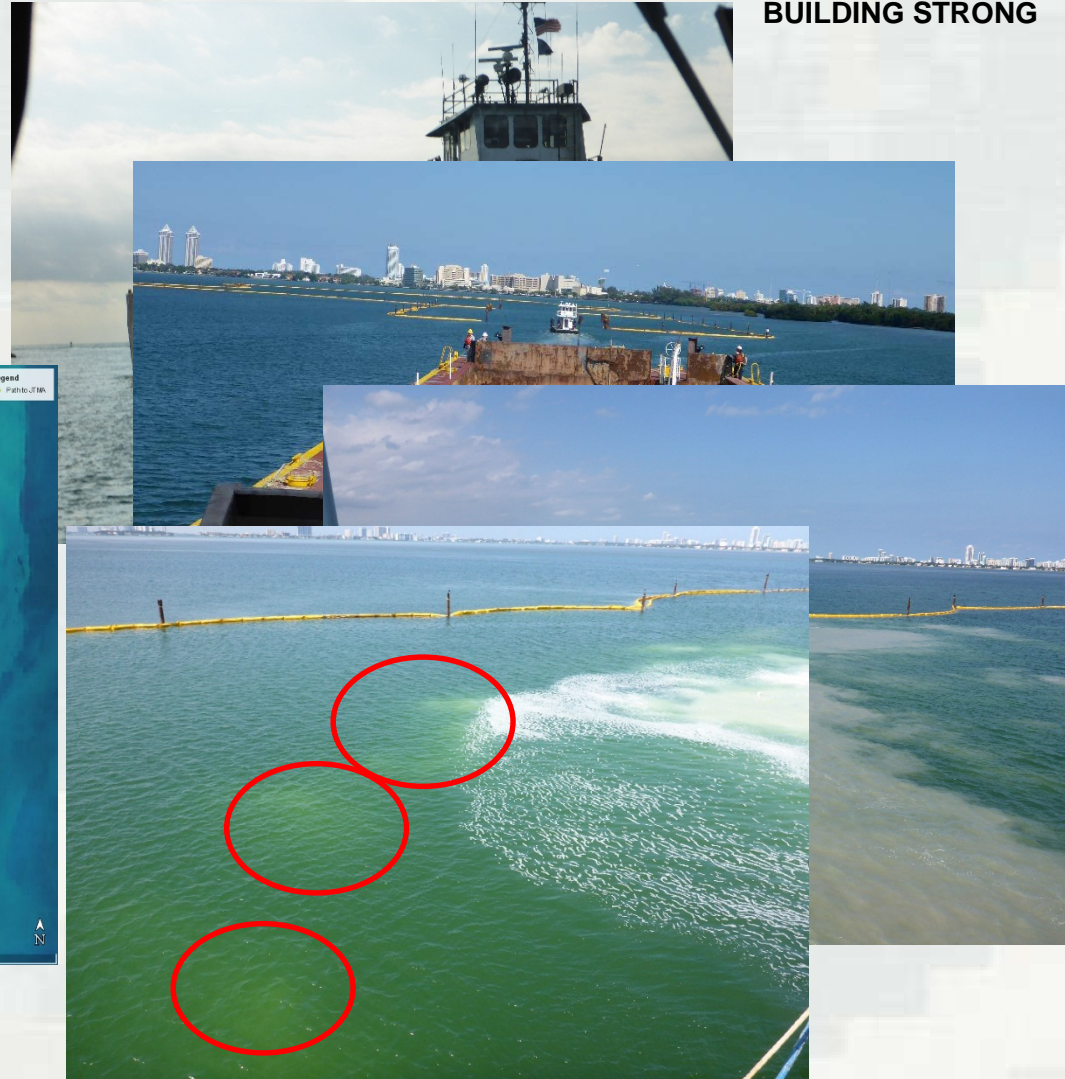
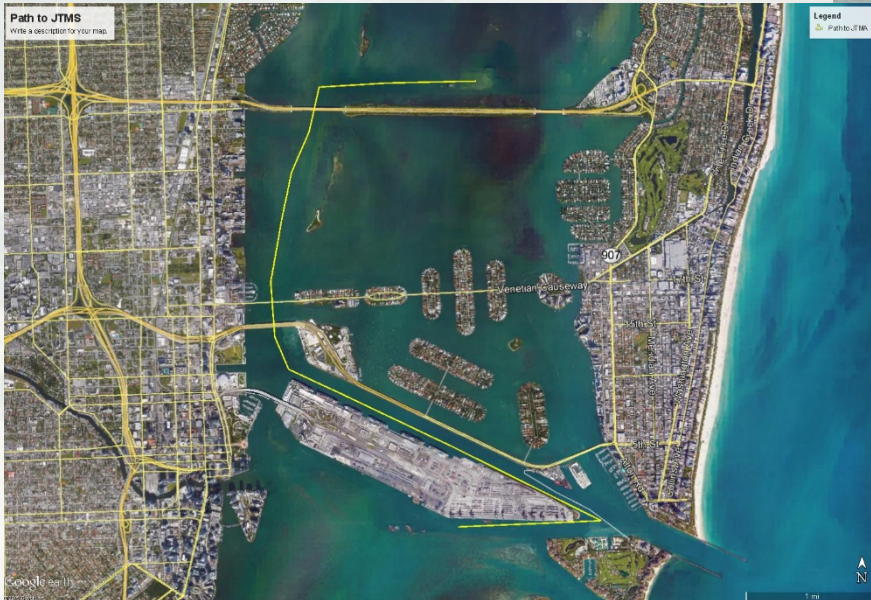
Transport & Placement

~5.0 mile one way trip
Through 3 bridges in the
Intracoastal
Waterway

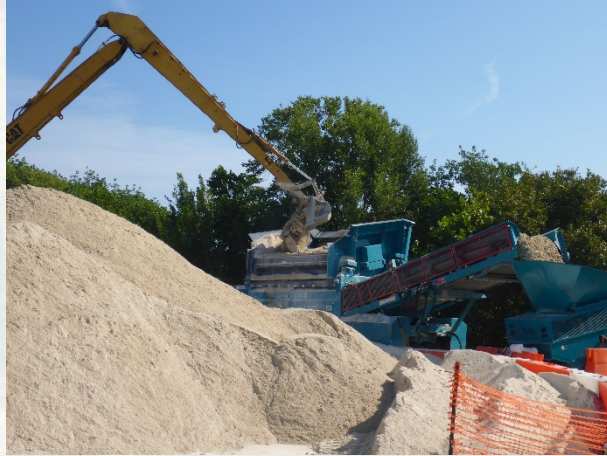
Mined Material <5% fines

Loaded on barges and
transported to the site

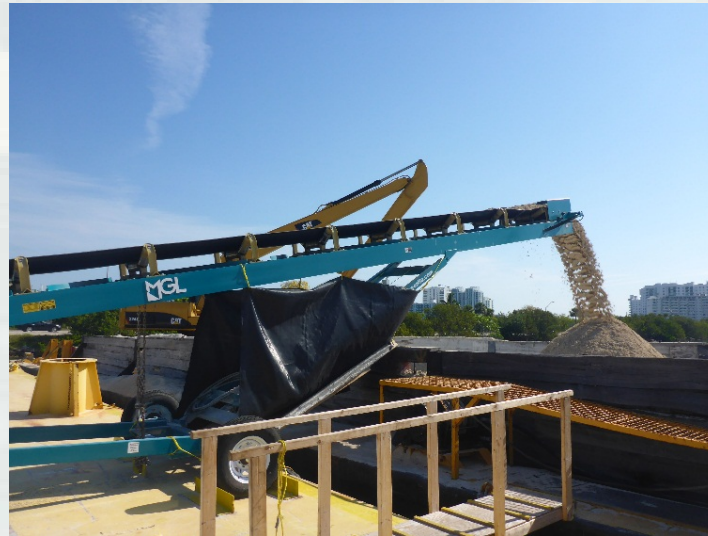
- 285 barge loads
- 114,425 tons
- 5,500 dump trucks
- CEMEX Krome Quarry in Miami

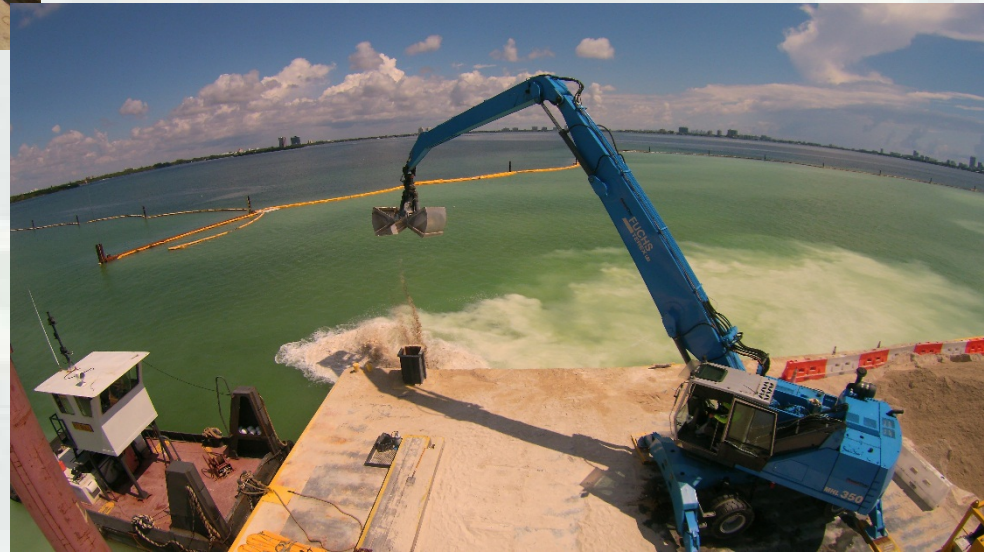
Dredged material was capped with 85,000 CY upland mined “select fill”

Load #1 placed Jan 8, 2015 and Load #285 was placed on July 7, 2015. 180 Days of active filling.

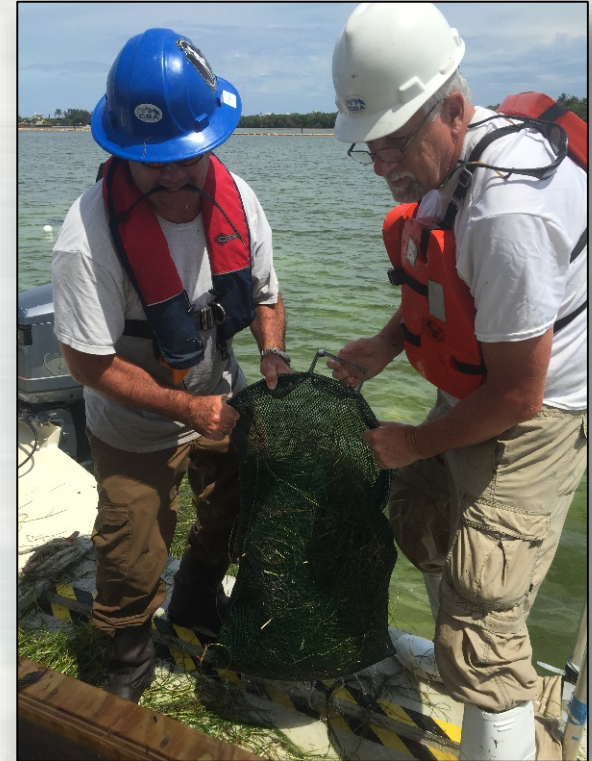
- 0.25 m² harvest plots
- ~ every 2 m along 100 m transects
- “Cookie cutters” used
- Stored *in situ* in large mesh bags

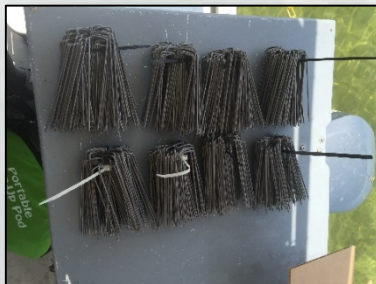
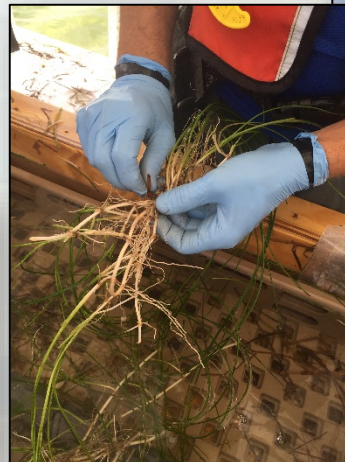
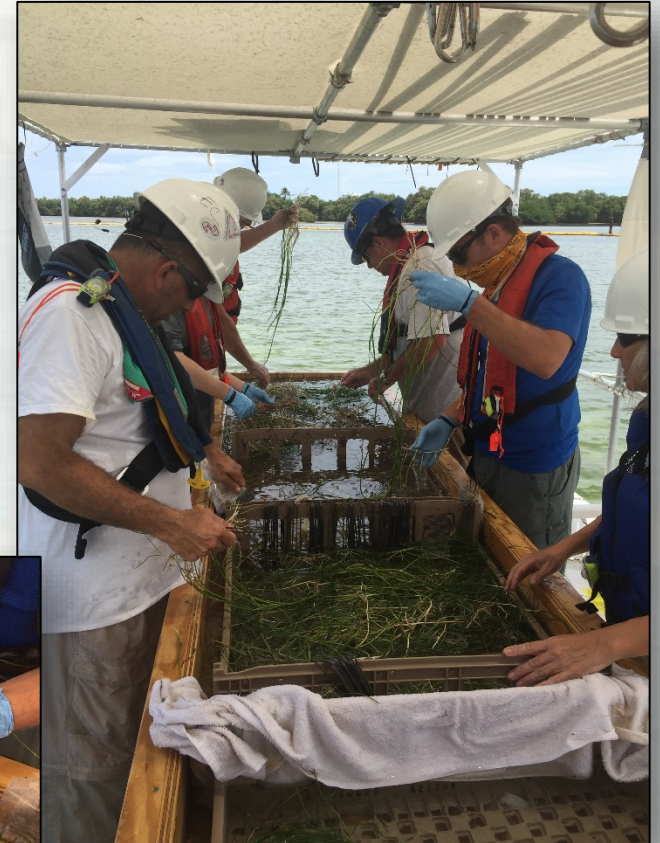
- Material sorted in flow-through table
- *Syringodium filiforme* (aerial and sediment rhizomes w/ apicals)
- Non-target seagrass discarded
- 4-5 rhizome apicals + staple = 1 PU
- QC checks on apical counts per planting tray (100 PU)
- Mean = 4.1 apicals PU⁻¹

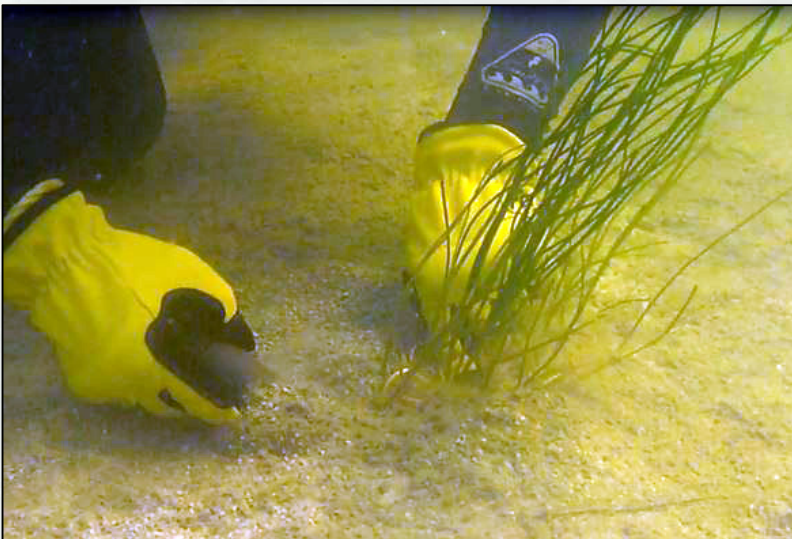
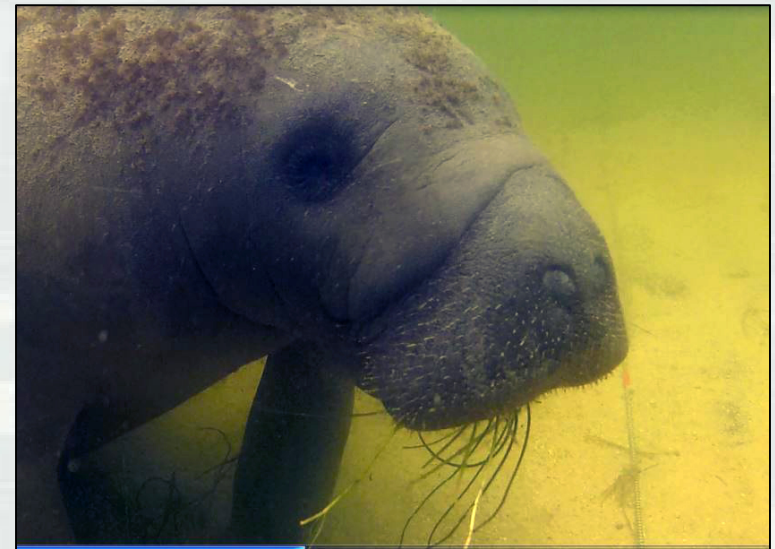
Planting

- Divers inserted 1 PU m⁻²
- PU Buried just beneath the sediment surface
- Manatees observed eating PUs

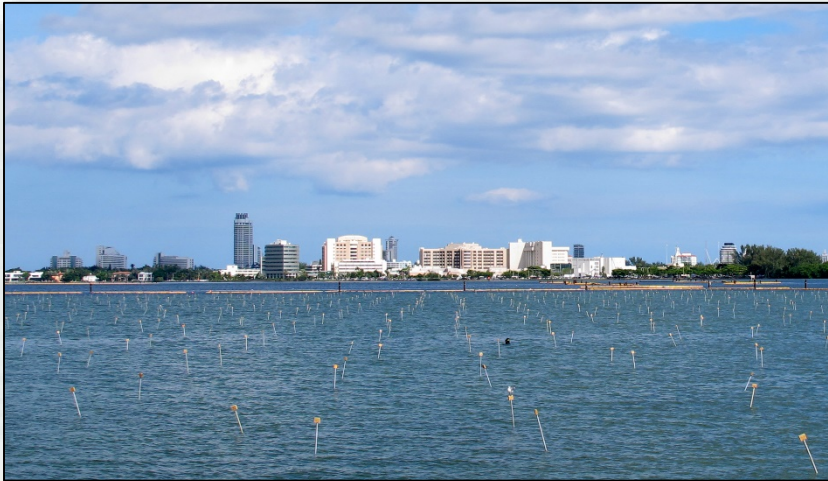
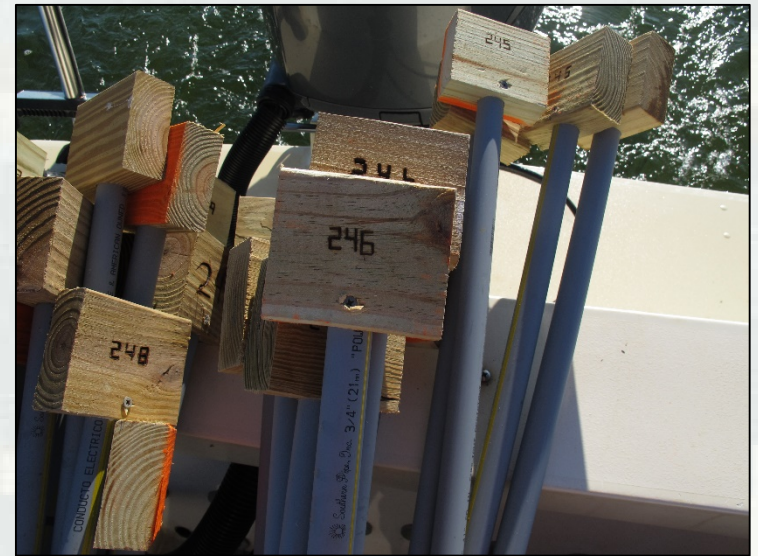
- Each bird stake marked by plot number
- 1,160 stakes (corners of planted plots)
- Roost ~0.3 m (1 ft.) above water surface (mean high tide)

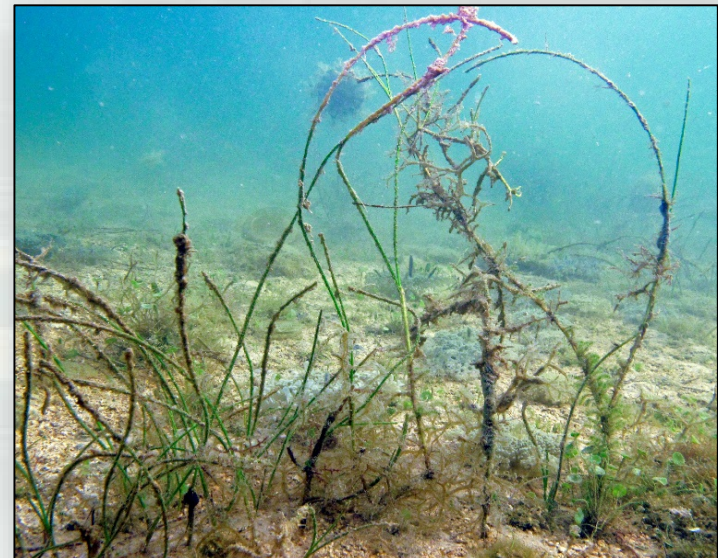
- Miami Harbor PUs – 97.6% survival
- USCG PUs – 98.2% survival
- Baseline USCG data
 - Mitigation Site: 1% Total Seagrass; 13.8% Macroalgae
 - Reference Site: 55.0% Total Seagrass; 1.0 % Macroalgae

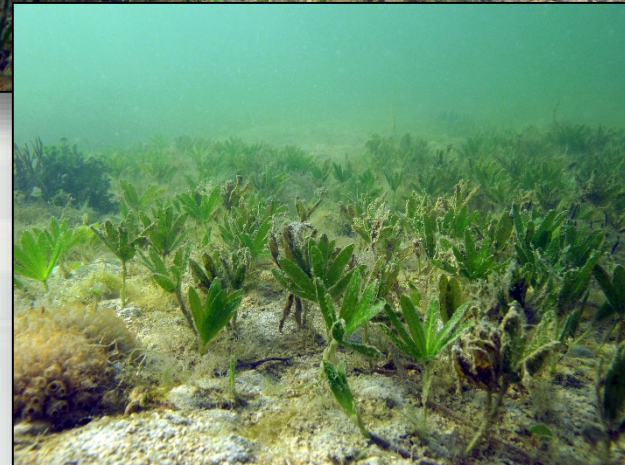
Macroalgae

- *Halimeda*
- *Batophora*
- *Caulerpa*
