FSBPA - February 2022

Krista Egan, P.E. Al Browder, Ph.D., P.E.

# The 2021 Longboat Key Beach Construction Season Part II (The Technical Side)

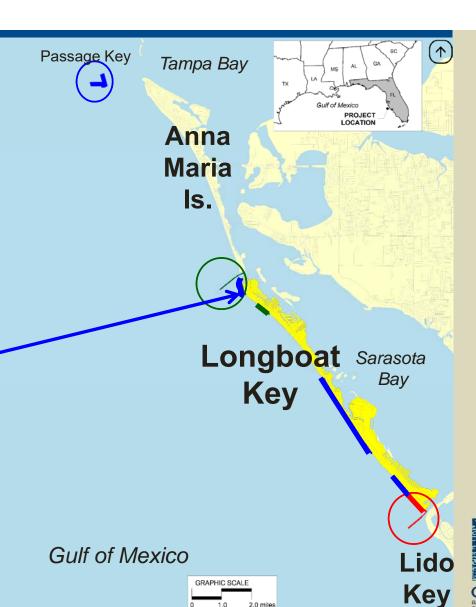
#### **Beach Nourishment**

Passage Key Inlet borrow area

# & North End Structural Stabilization

750K cy

4.4 mi shoreline (3 segments)

5 rock groins

Dune & mangrove habitat restoration

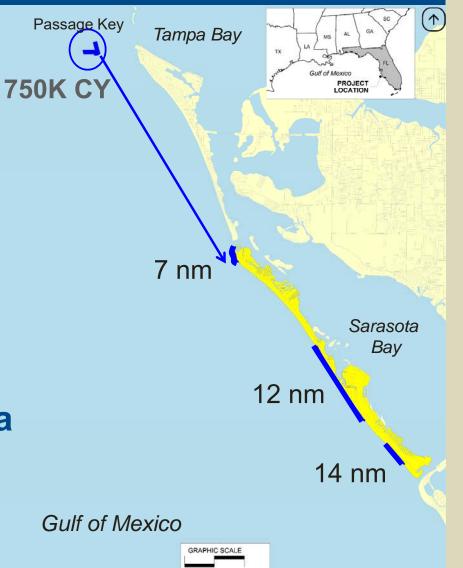
# PASSAGE KEY INLET SAND EXCAVATION & TRANSPORT

Water depths 6 - 25 ft

Option to use rehandling area

Limited dredging area

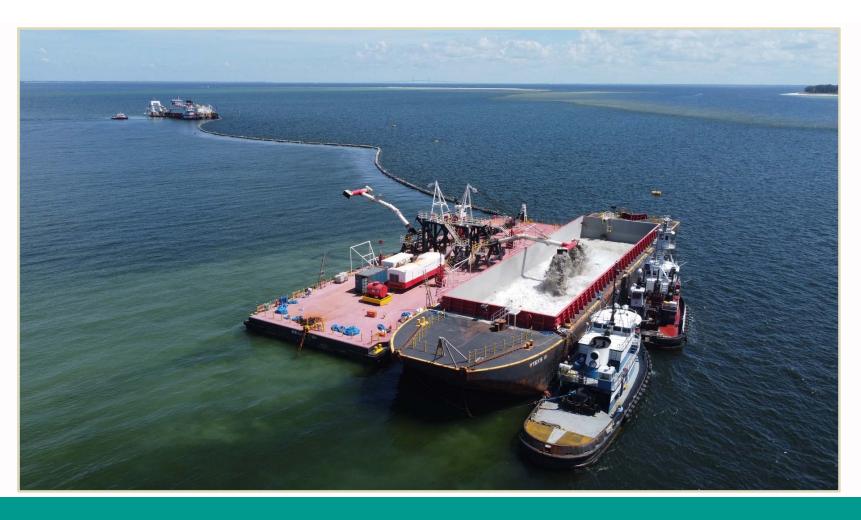
# BEACH NOURISHMENT — Passage Key Inlet

**Spider Barge**

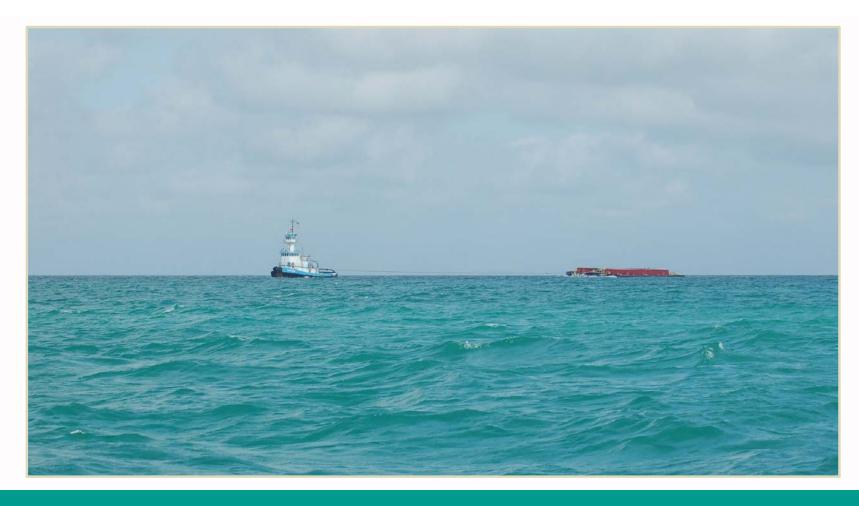
# BEACH NOURISHMENT - Passage Key Inlet

**Spider Barge**

Scows (4)

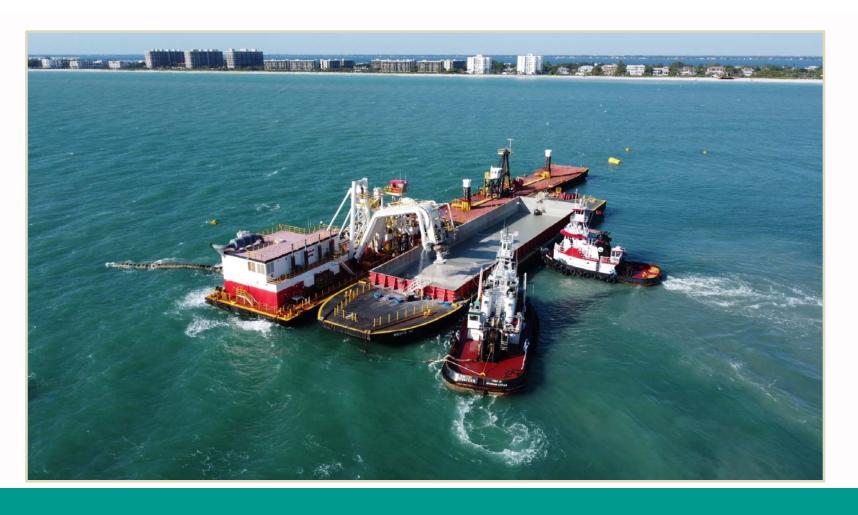
## BEACH NOURISHMENT — Passage Key Inlet

**Spider Barge**

Scows (4)

**Unloader**

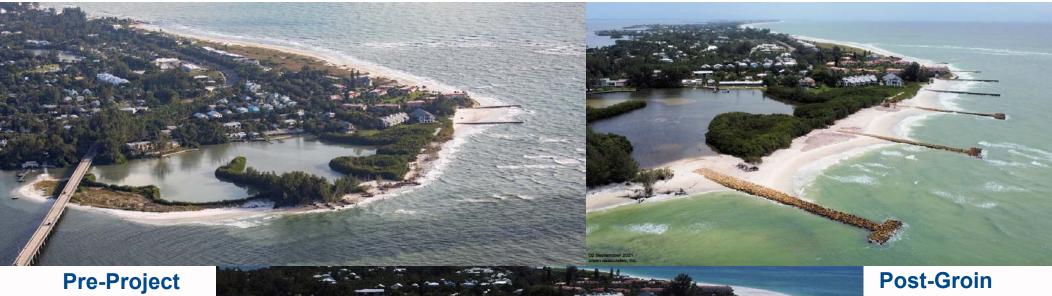
**ROCK GROINS – Order of Work**

**Groins +** Beach Fill

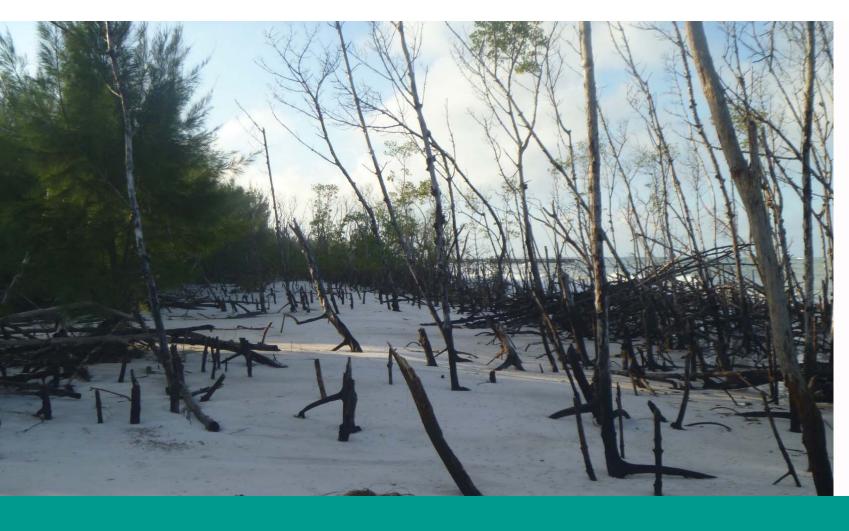
### **DUNE & MANGROVE RESTORATION**

Dead vegetation & Australian pine removal

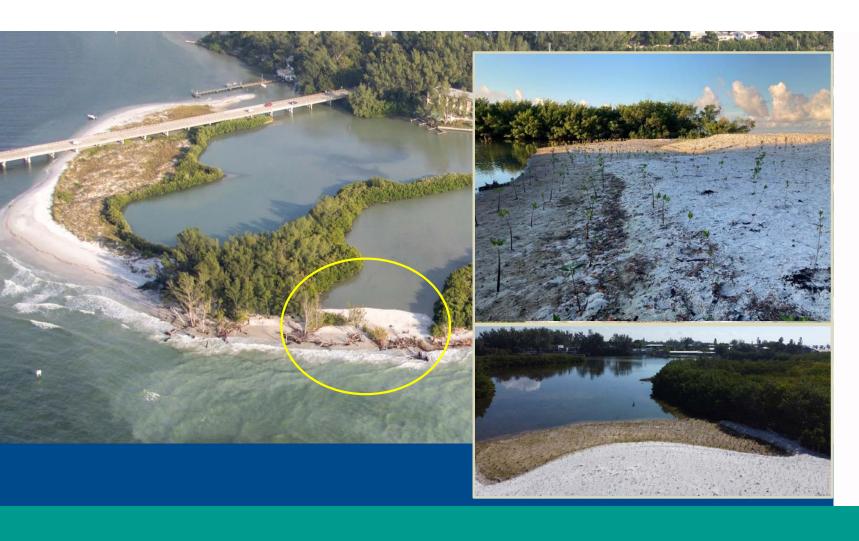
**DUNE & MANGROVE RESTORATION**

Dead vegetation & Australian pine removal

Mangrove fringe restoration 1K plants
