Sunset Beach Groin Study

APTIM: James Austin, P.E., Douglas Mann, P.E., BC.CE.,
Hithaishi Hewageegana, Ph.D.

Pinellas County: John Bishop, Ph.D.,
Zachary Westfall

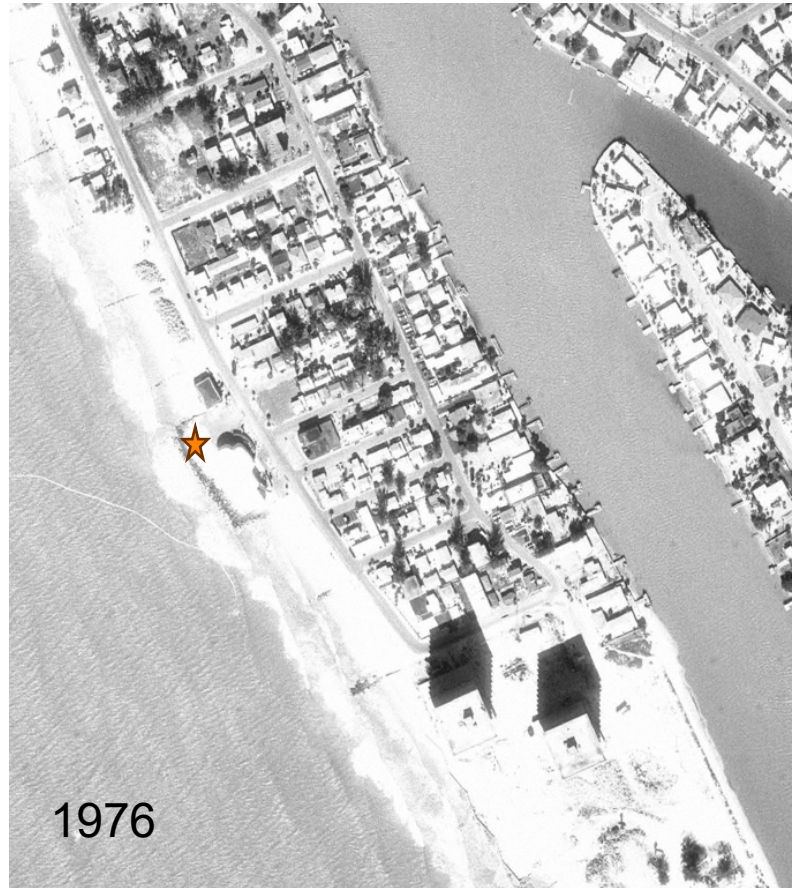
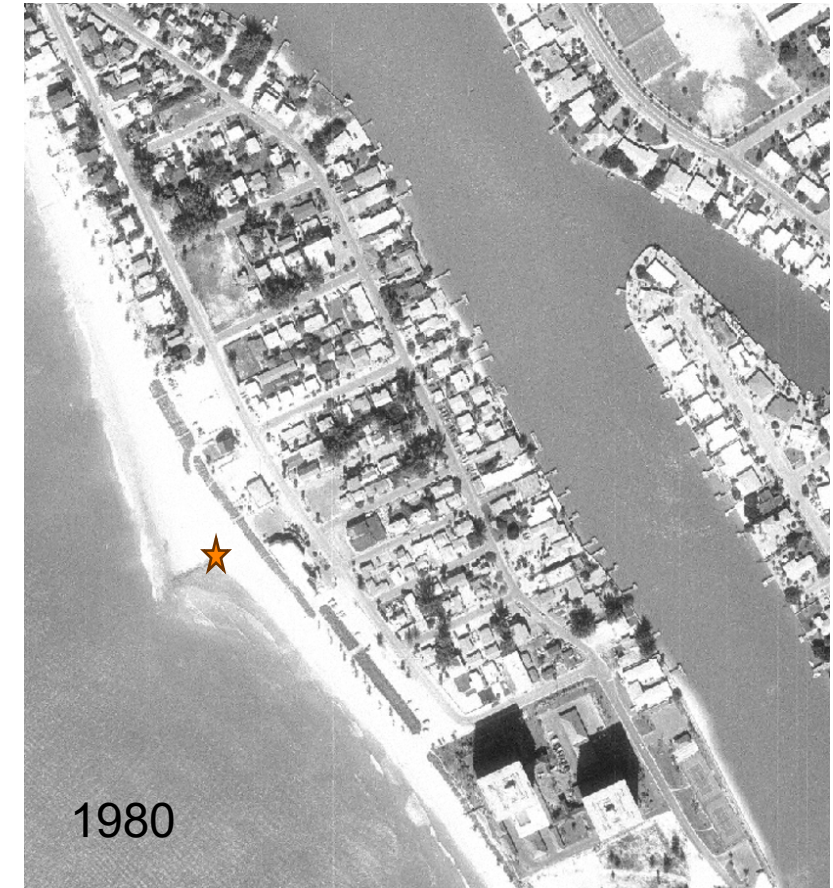
GROIN HISTORY

- Constructed in 1976
- Part of the Pinellas County Beach Erosion Control Project (USACE, 1968)

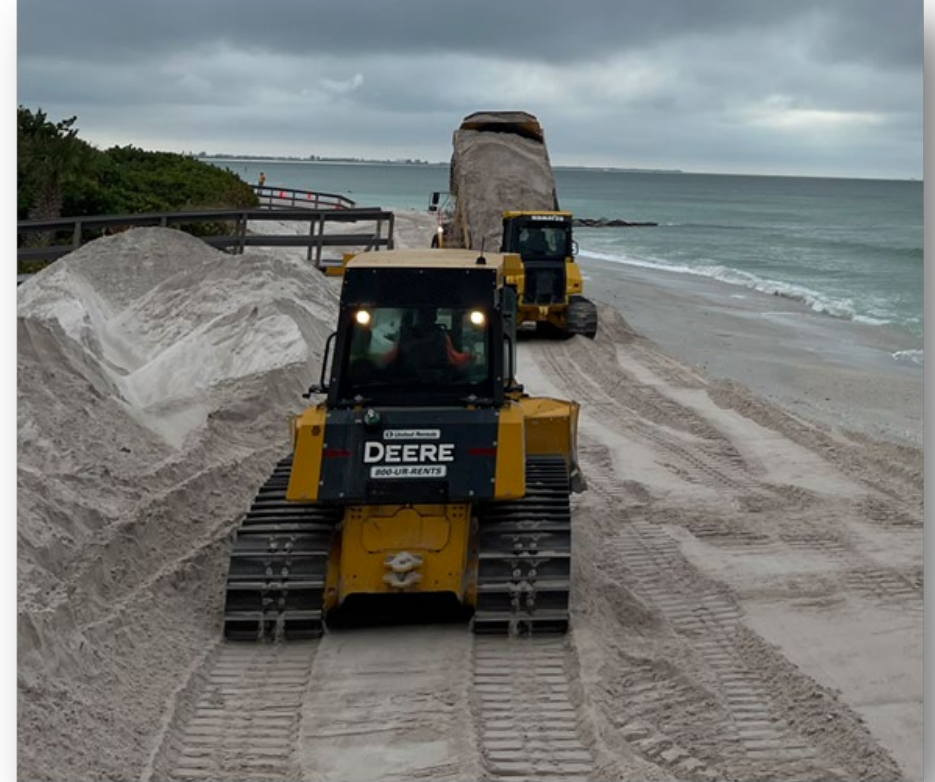
- USACE Project
 - 2018: 239,000 CY between R-136A to R-142
 - Current Period of participation ends in 2031
 - Feasibility study in progress to nourish TI over next 50 years
 - Pinellas County is the non-federal partner
- Countywide Emergency Dune Project
 - Winter 2023/24: 32,000 CY between R-137 to R-142

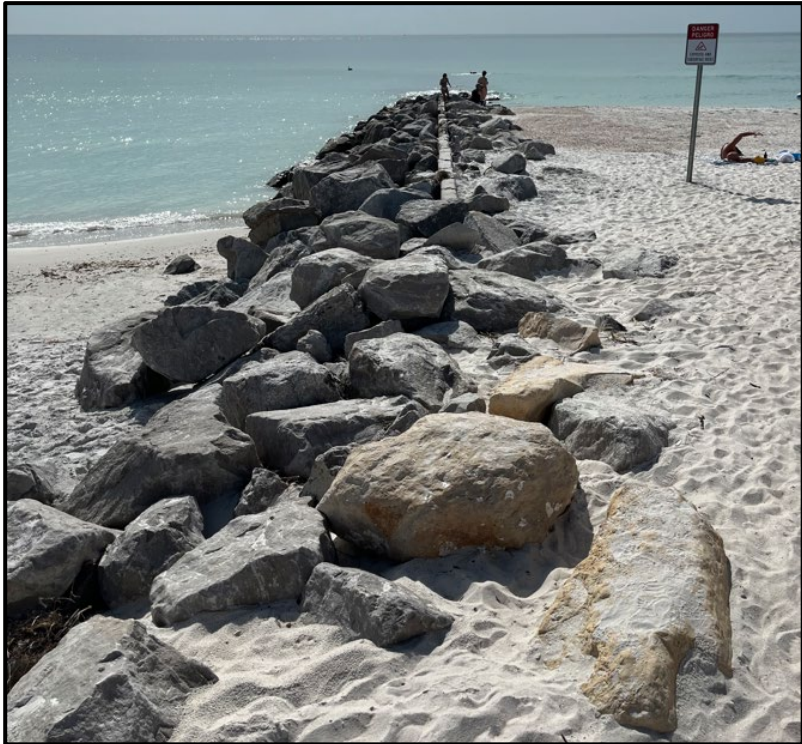
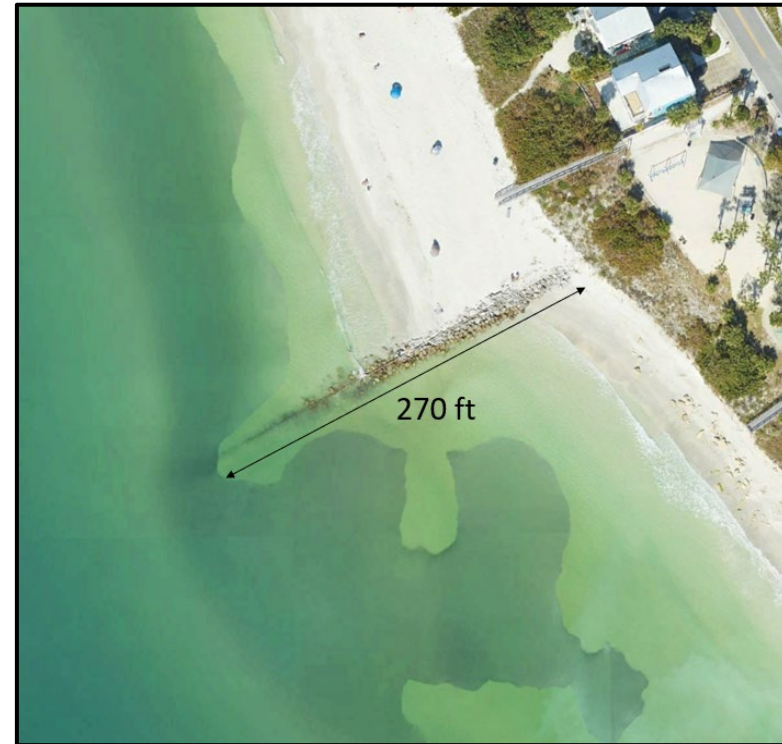
GROIN OBSERVATIONS

- Composed of granite armor stone and concrete sheet pile
- Approximately 270 feet of exposed groin
- Slopes into water and buried on the seaward end

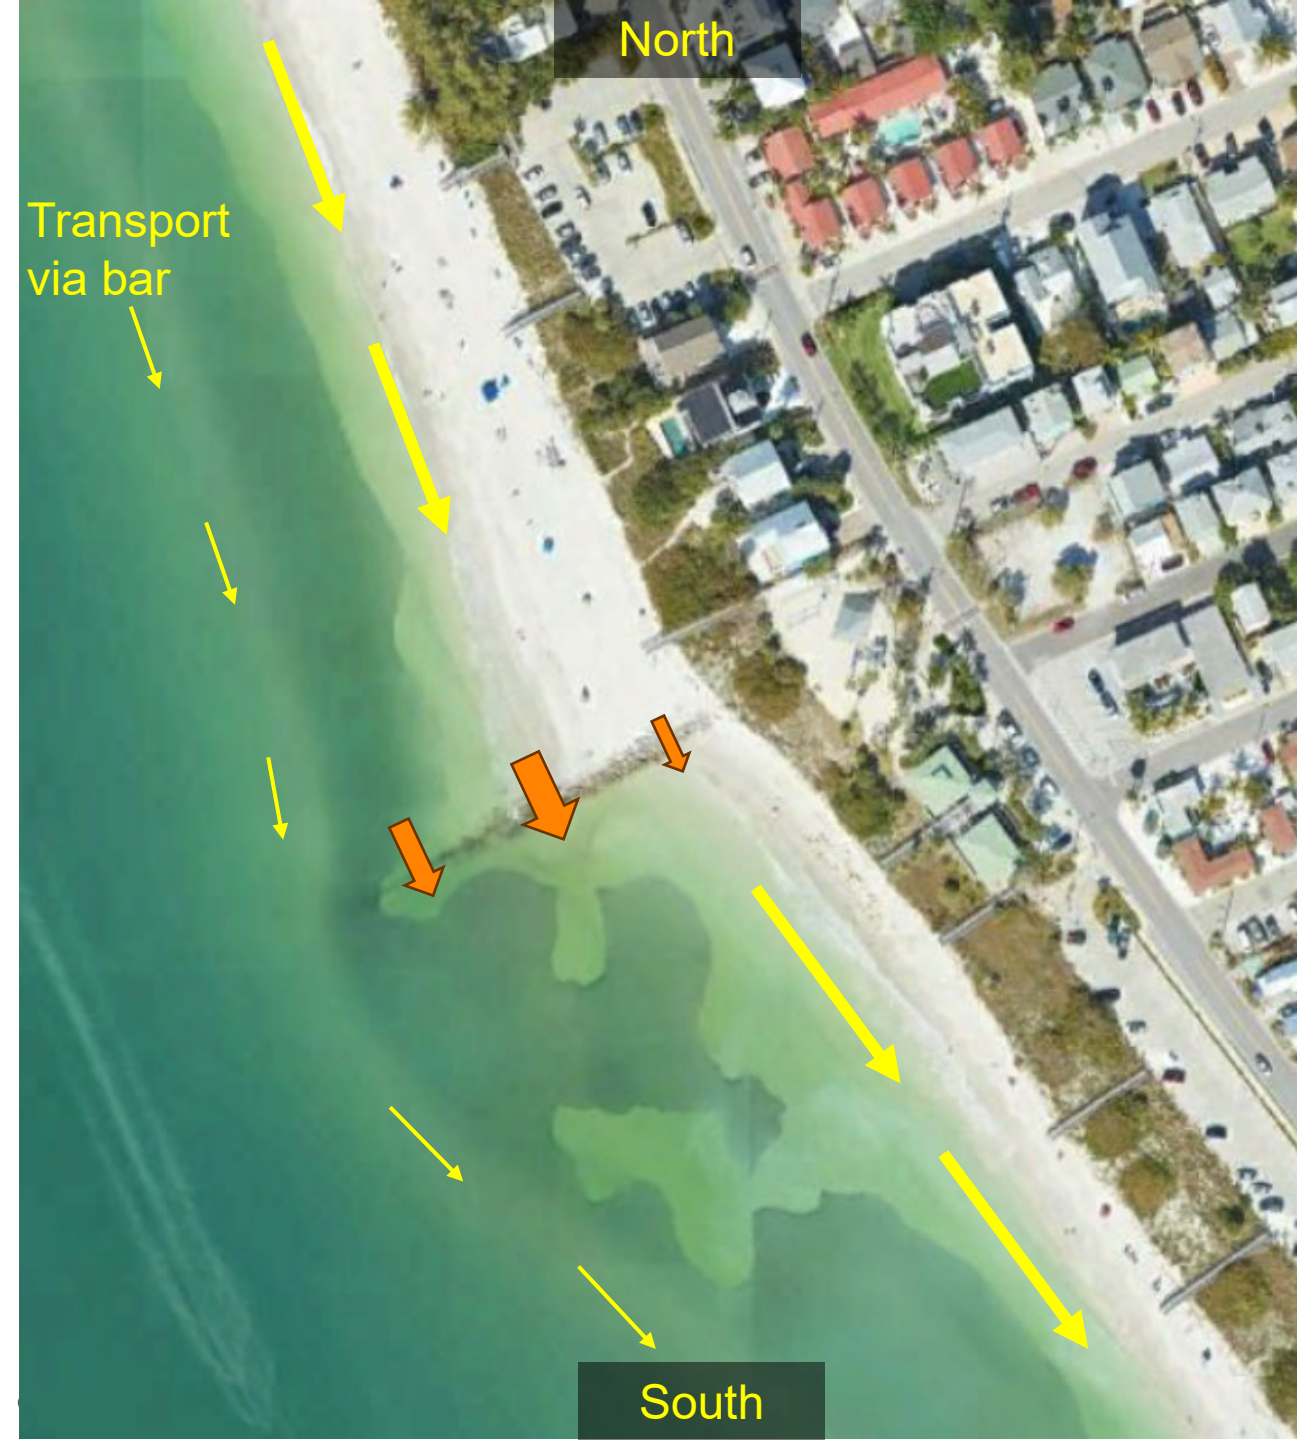
SEDIMENT TRANSPORTS

- Sediment moves north to south through the study area from wind driven waves and currents
- Majority of sediment transport at Sunset Beach assumed to occur at MHW line
- Small amount of transport occurs in the bar

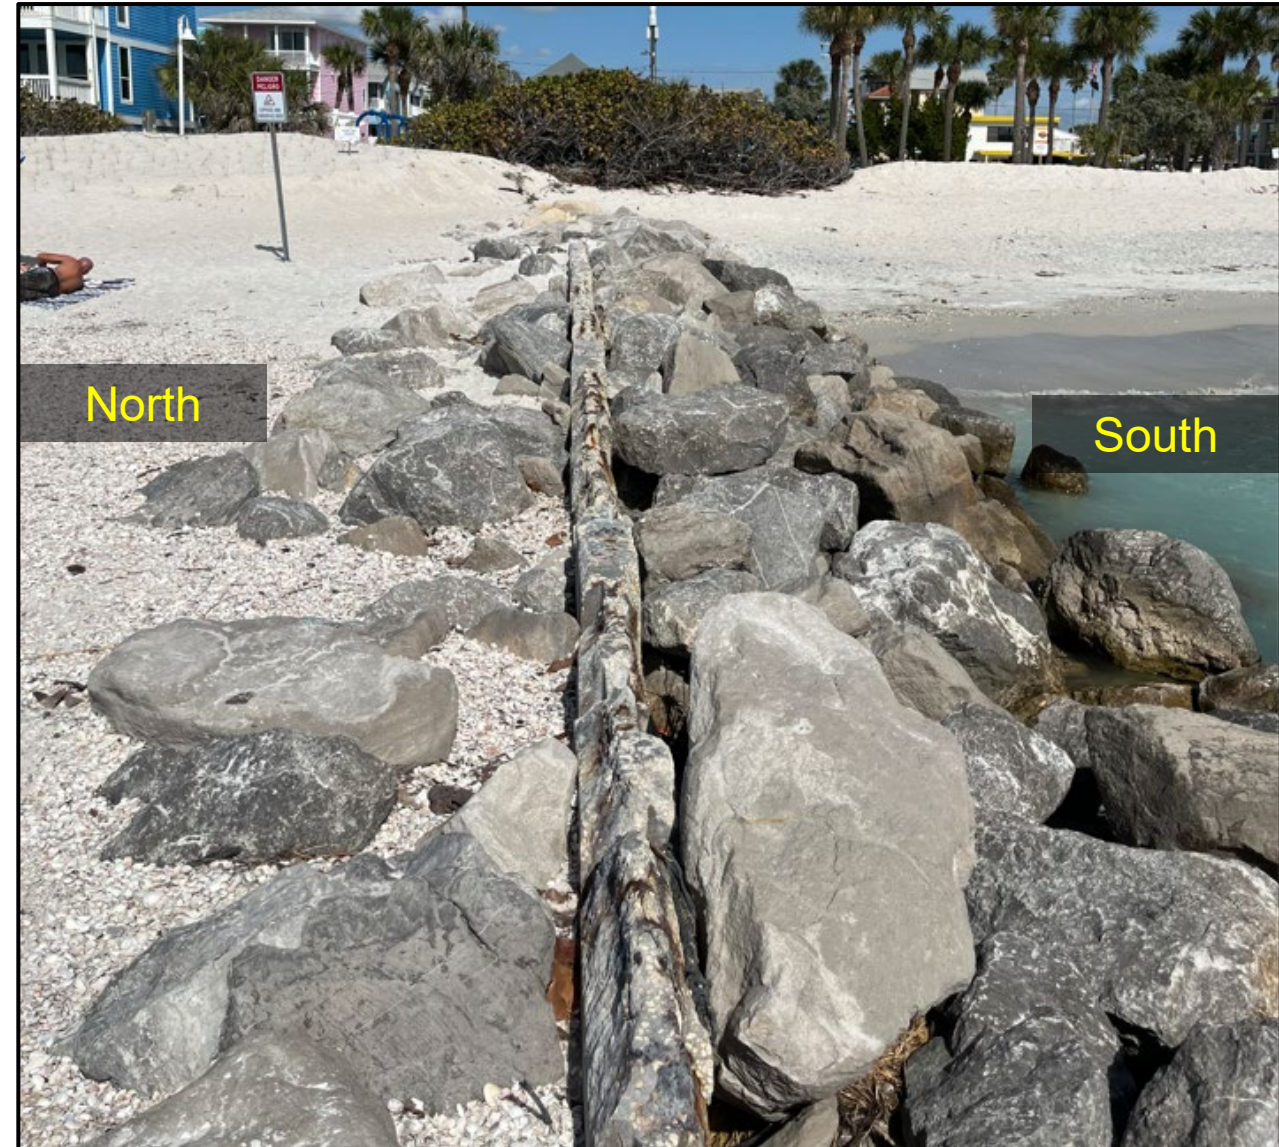
ENGINEERING CHALLENGES

- Structure is trapping sediment on the north side causing erosion to the south
- South side erosion is severe
- Beach nourishment alone has been inadequate

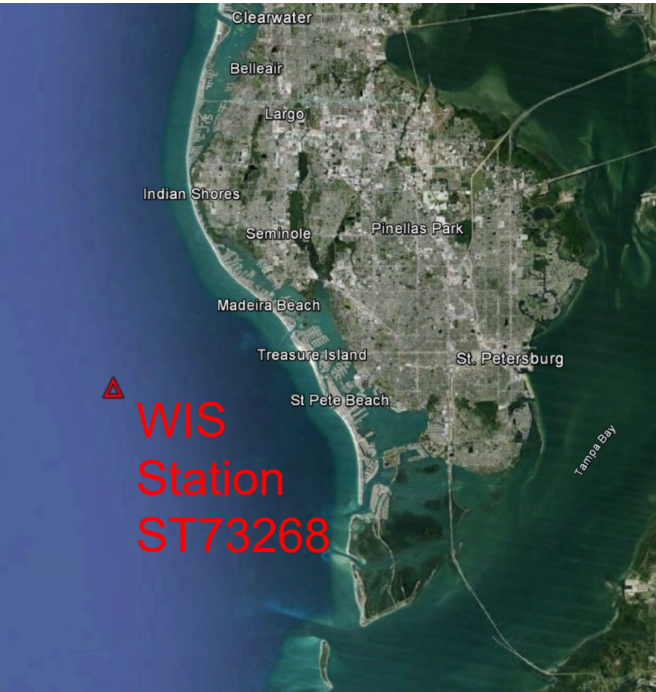
Wave Rose WIS Station ST73268
1980 to 2023. Units in feet

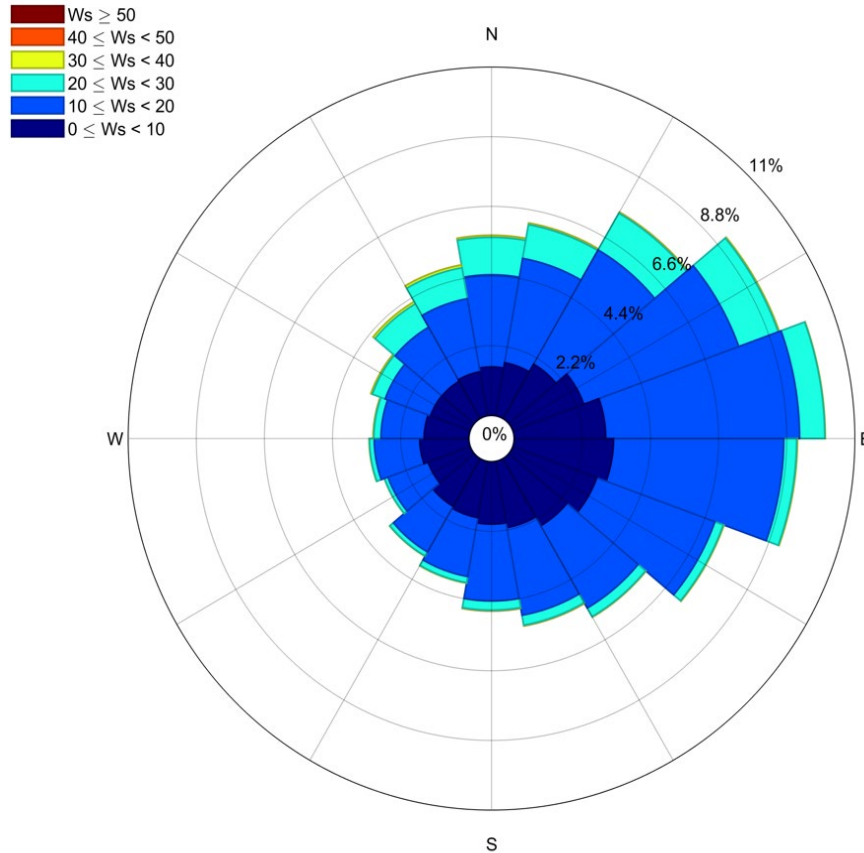
Wind Rose WIS Station ST73268
1980 to 2023. Units in miles per hour

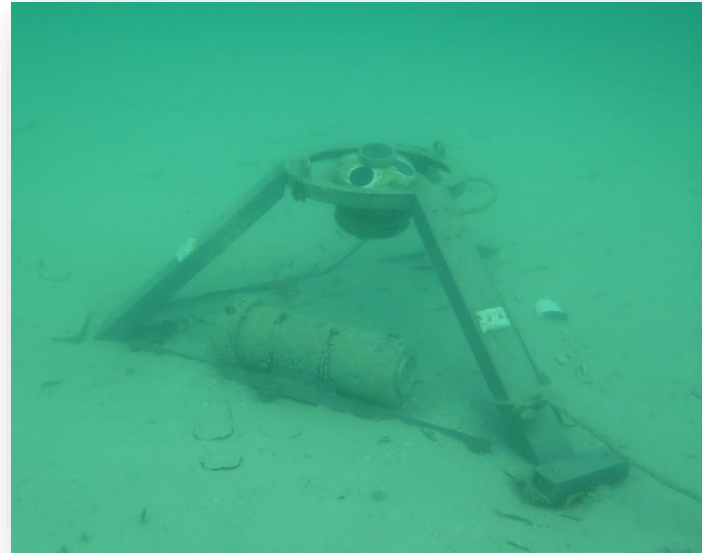
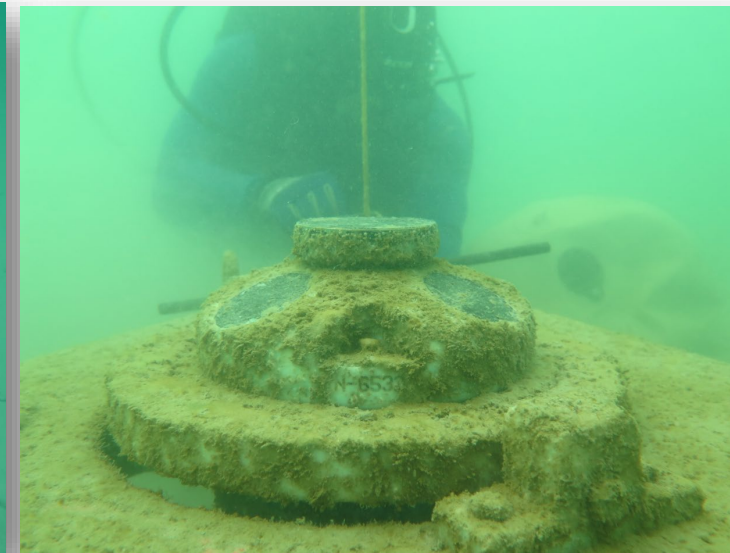
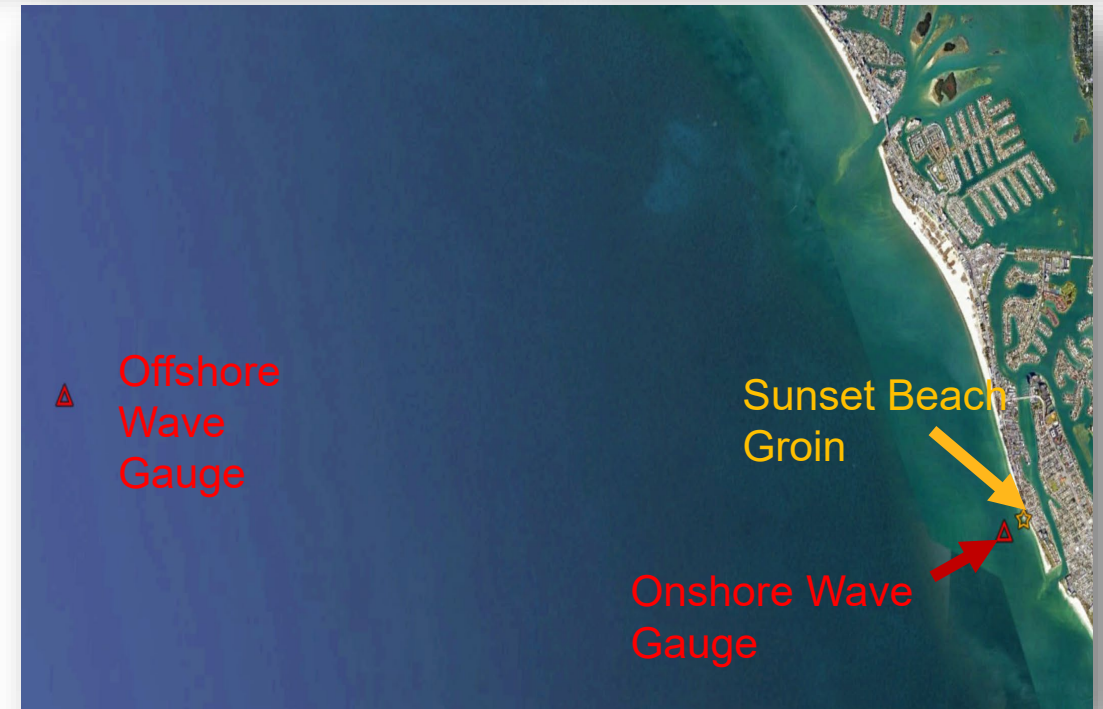
ADCP Deployment

- Two wave gauges were deployed by APTIM divers to measure currents and wave heights.
 - Offshore wave gauge depth = 32 ft
 - Onshore wave gauge depth = 15 ft

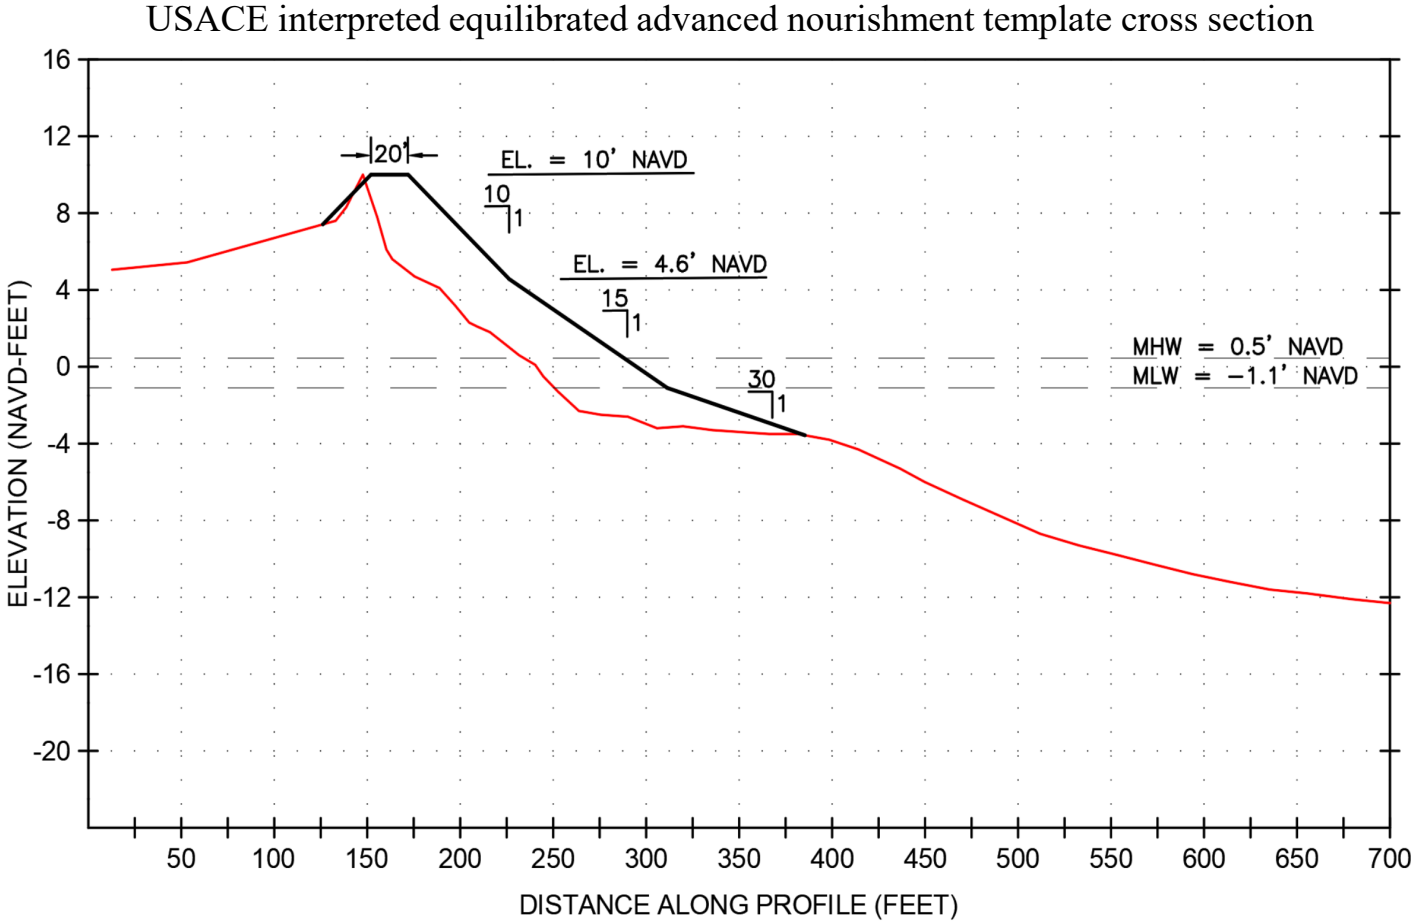
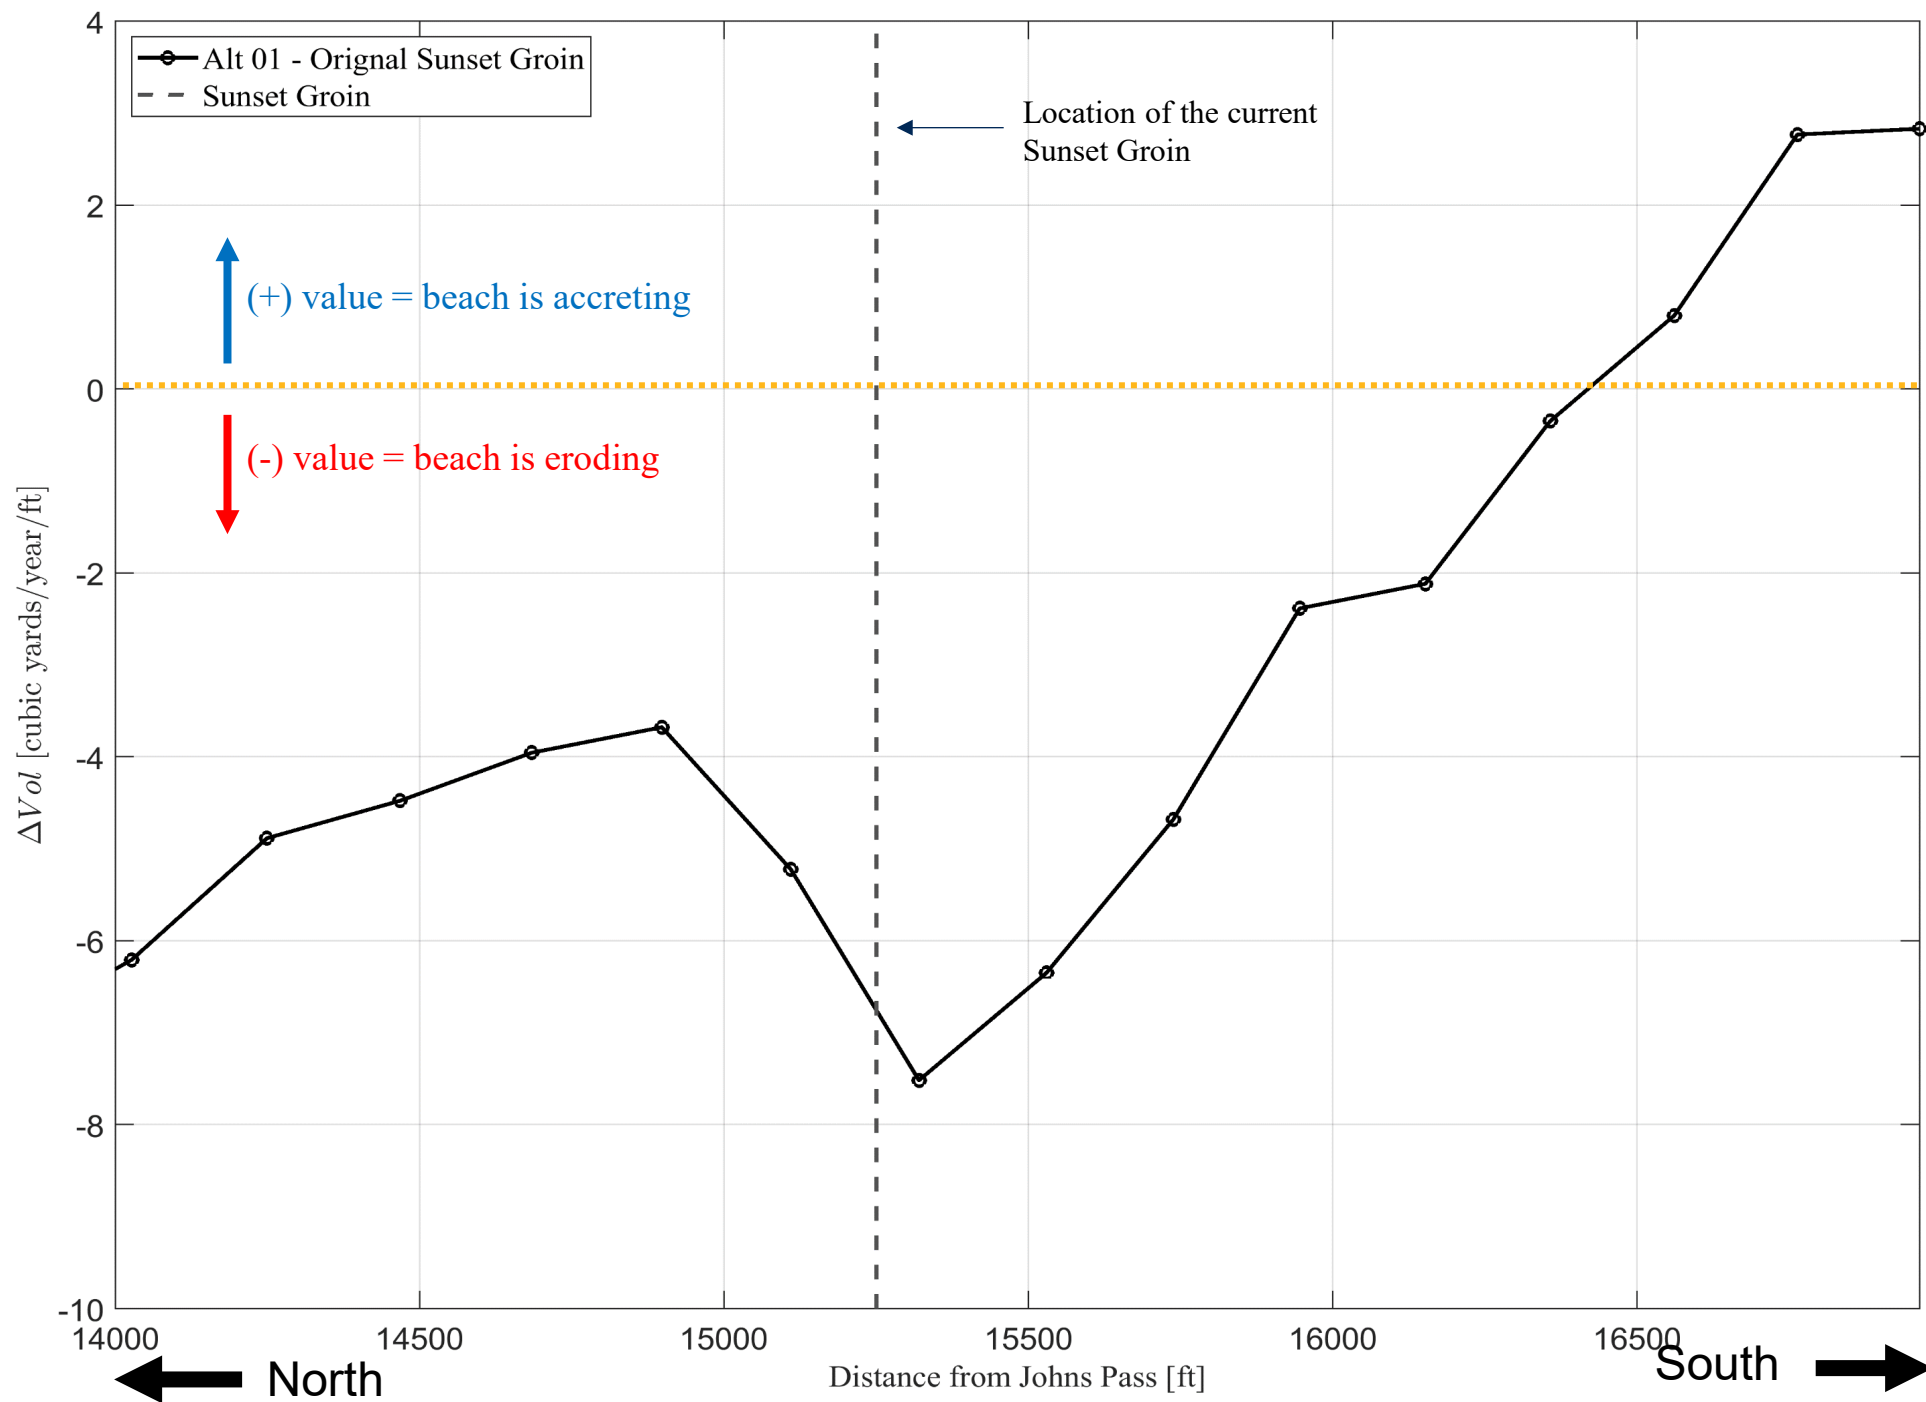
ALTERNATIVE 01 : NO ACTION

USACE Nourishment Template

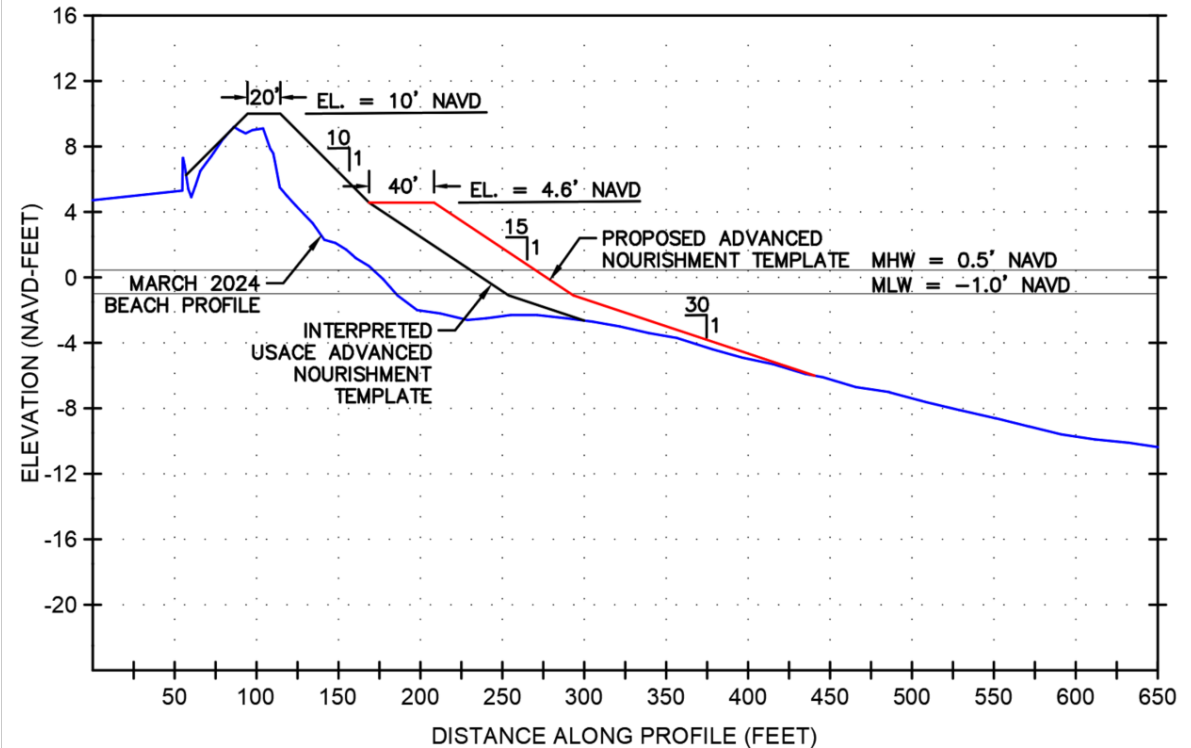
Increase Advanced Nourishment

- Increase the USACE nourishment to 53 CY/FT
- Compatible with federal shore protection design
- Can be implemented with federal project

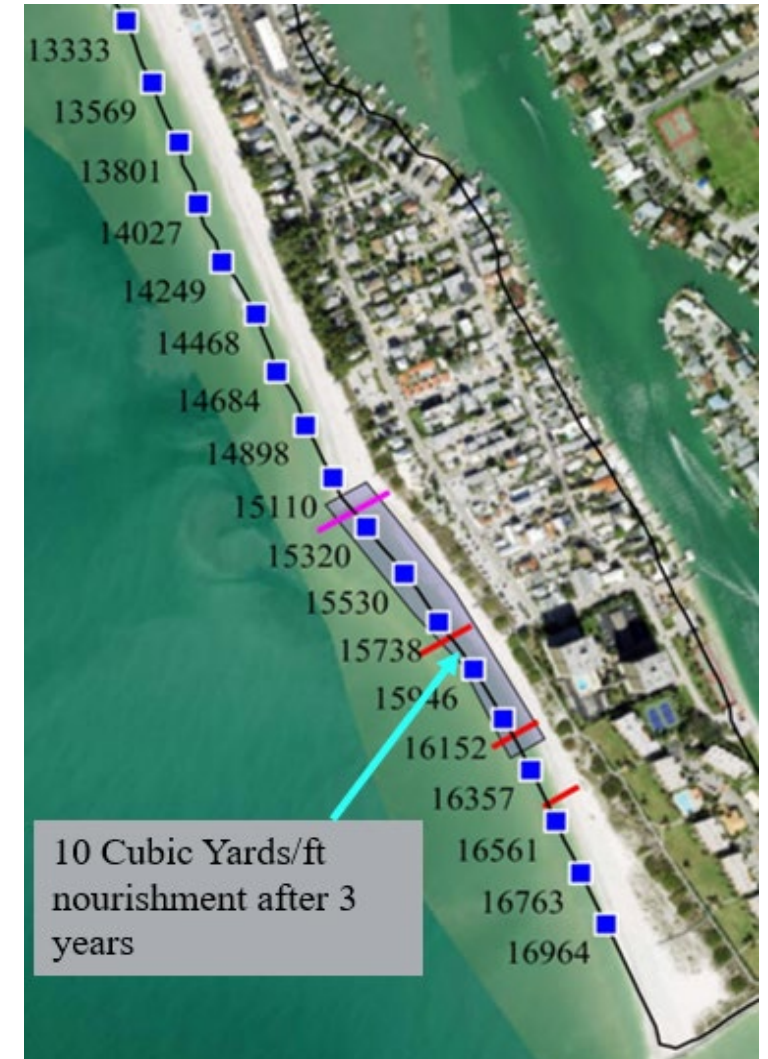
Interim Nourishment

- Perform interim truck haul nourishment of approximately 38,000 cy after 3 years
- On as needed basis
- Compatible with federal shore protection design
- Funding likely limited to State and local sources

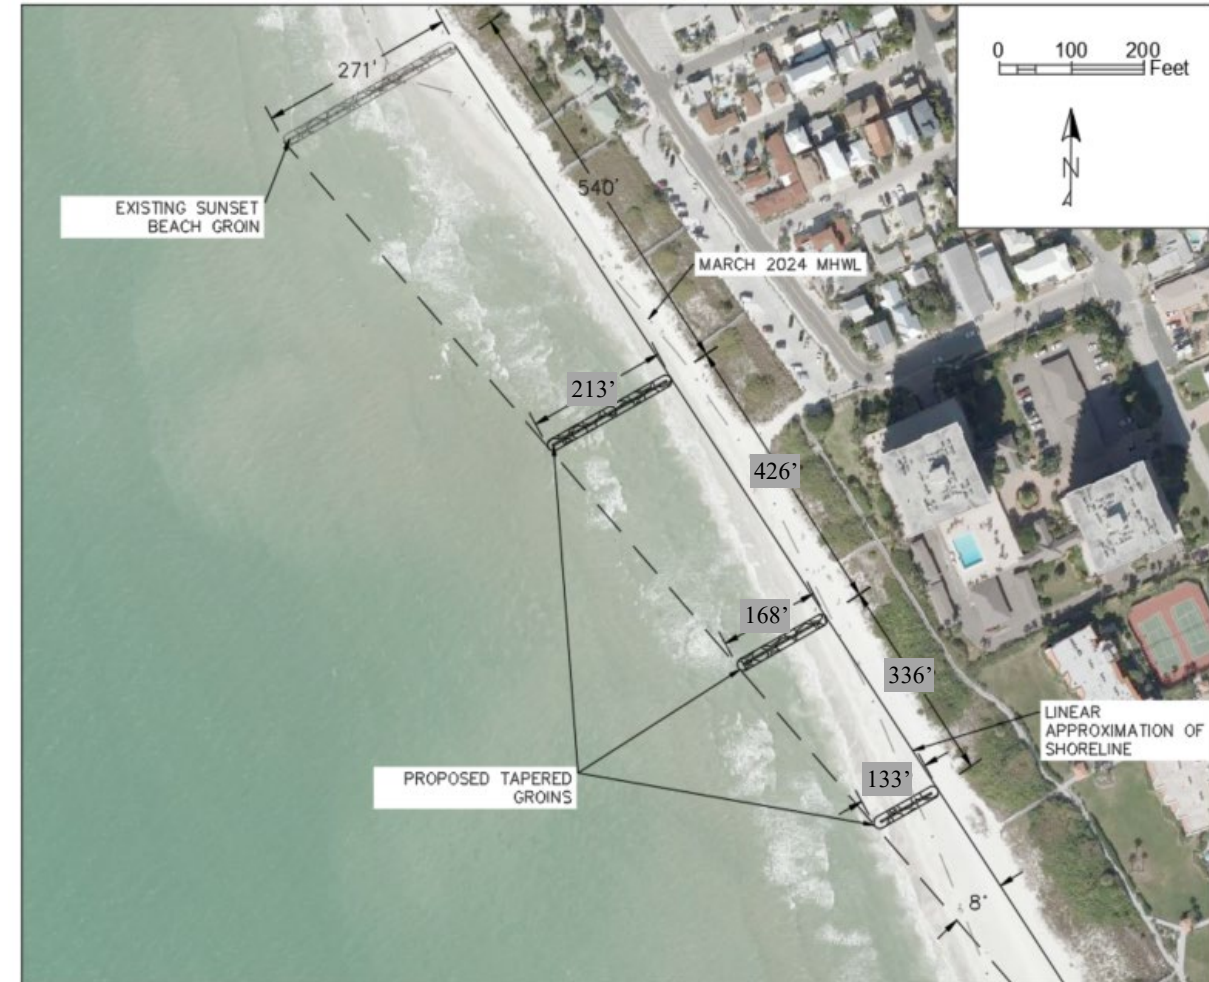
Tapered Groin Field

- Construct a tapered groin field south of the existing groin
- May be difficult to incorporate into the federal nourishment
- Further coordination with stakeholders is recommended
