IWW Maintenance Dredging Placement Into a Barrier Island Breach, Summer Haven, FL

Ian Heausler, P.E.
U.S. Army Corps of Engineers, Jacksonville District

Florida Shore & Beach Preservation Association
38th Annual National Conference on
Beach Preservation Technology

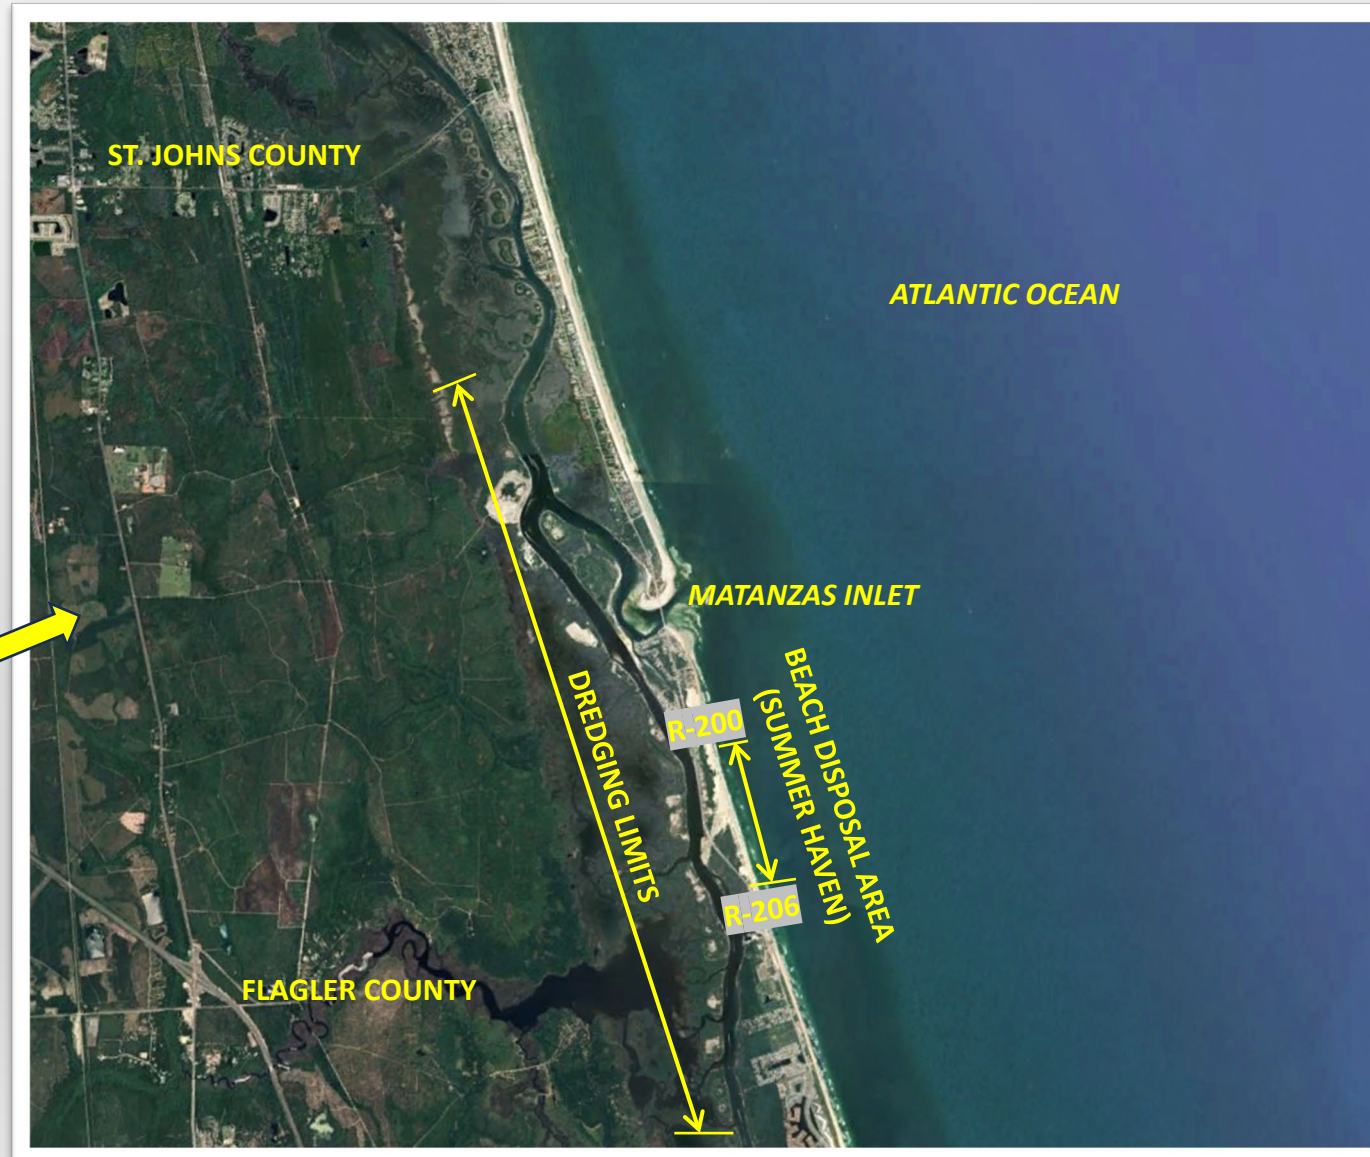
- Operations and Maintenance Navigation Project
- Dredging 378,000 CY from IWW in St. Johns and Flagler Counties
- Material transported hydraulically to Beach Disposal Area located in Summer Haven
- Disposal Area is approximately 6,100 feet between R-200 and R-206

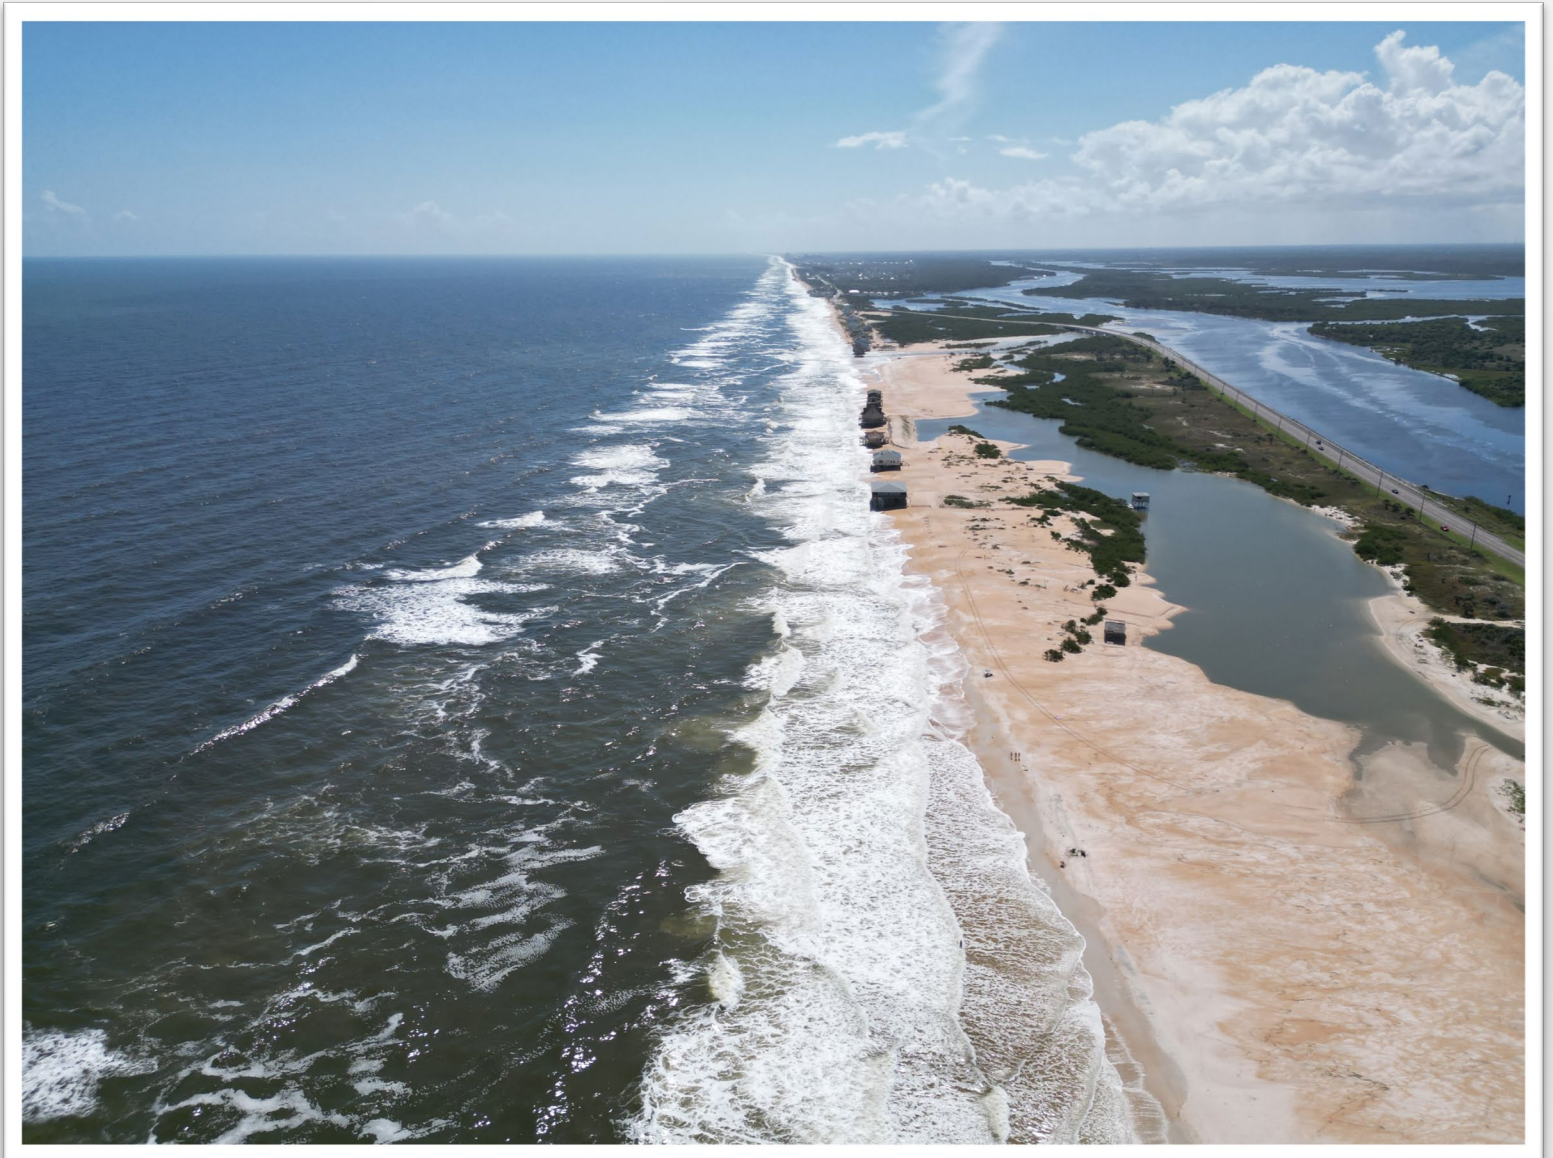
Disposal Area - Summer Haven

- Low lying barrier island
- Least cost disposal
- Chronic erosion
- Multiple abandoned structures
- A1A rerouted during the 1970's

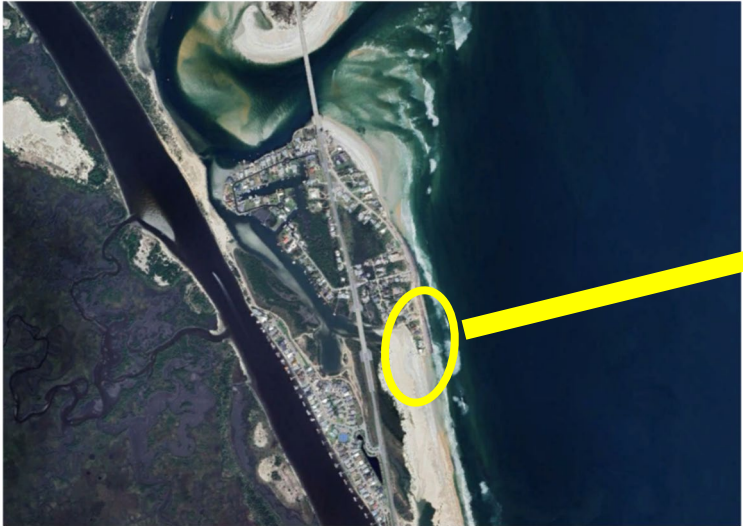
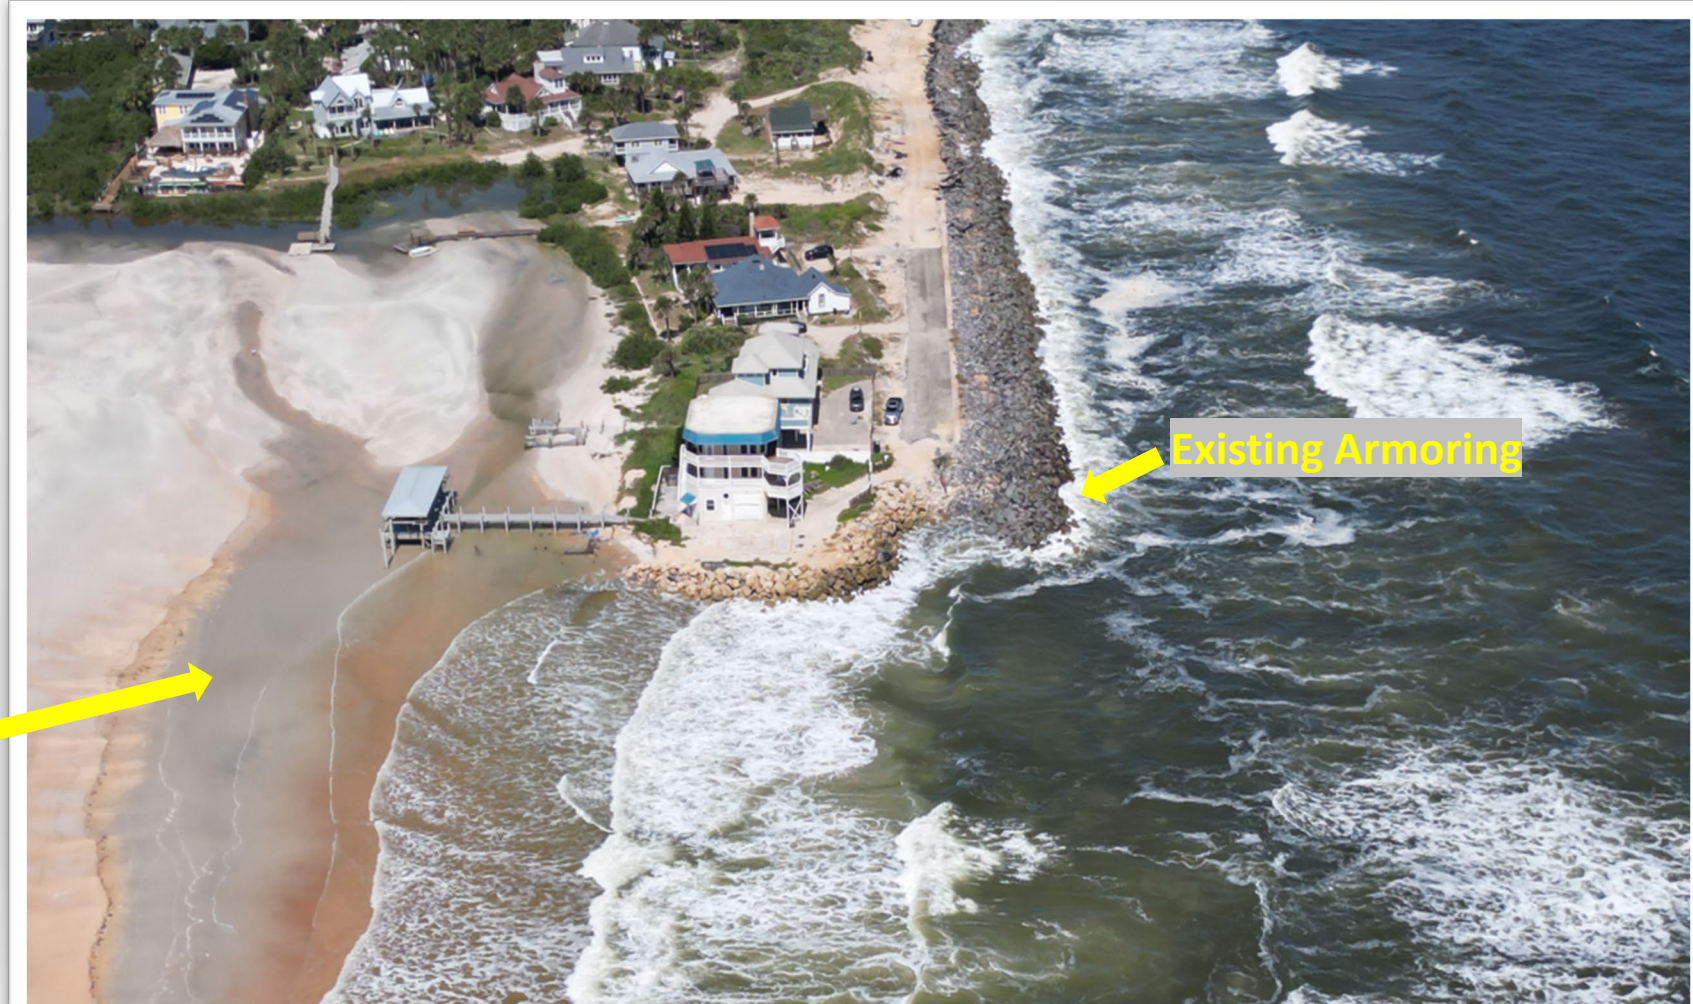
Disposal Area - Summer Haven

- Shoreline armoring located on the north end of Summer Haven.
- Armoring prevents sediment transport leading to erosion to the south.

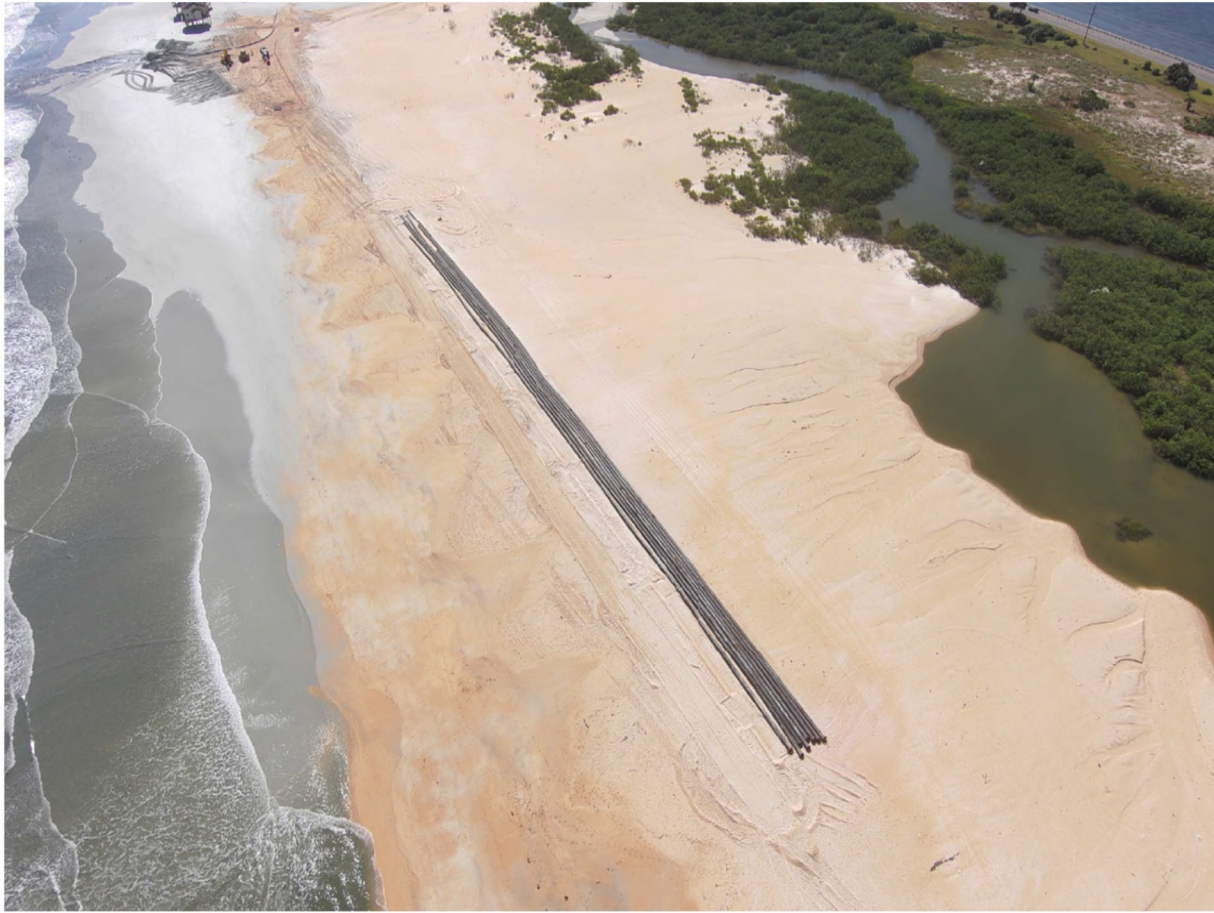
- Pipeline staging area adjacent to channel and Beach Disposal Area

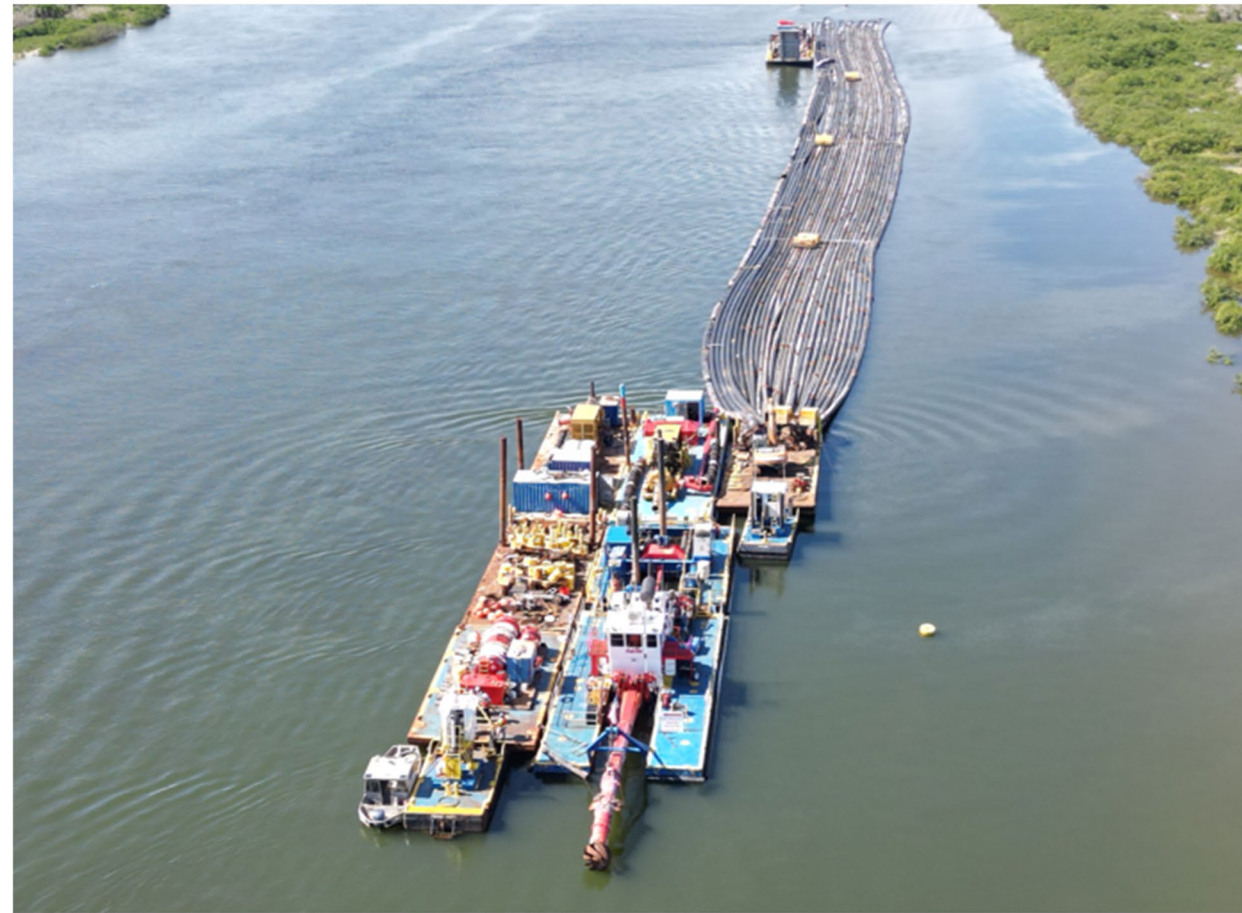
- Cutter Suction Dredge

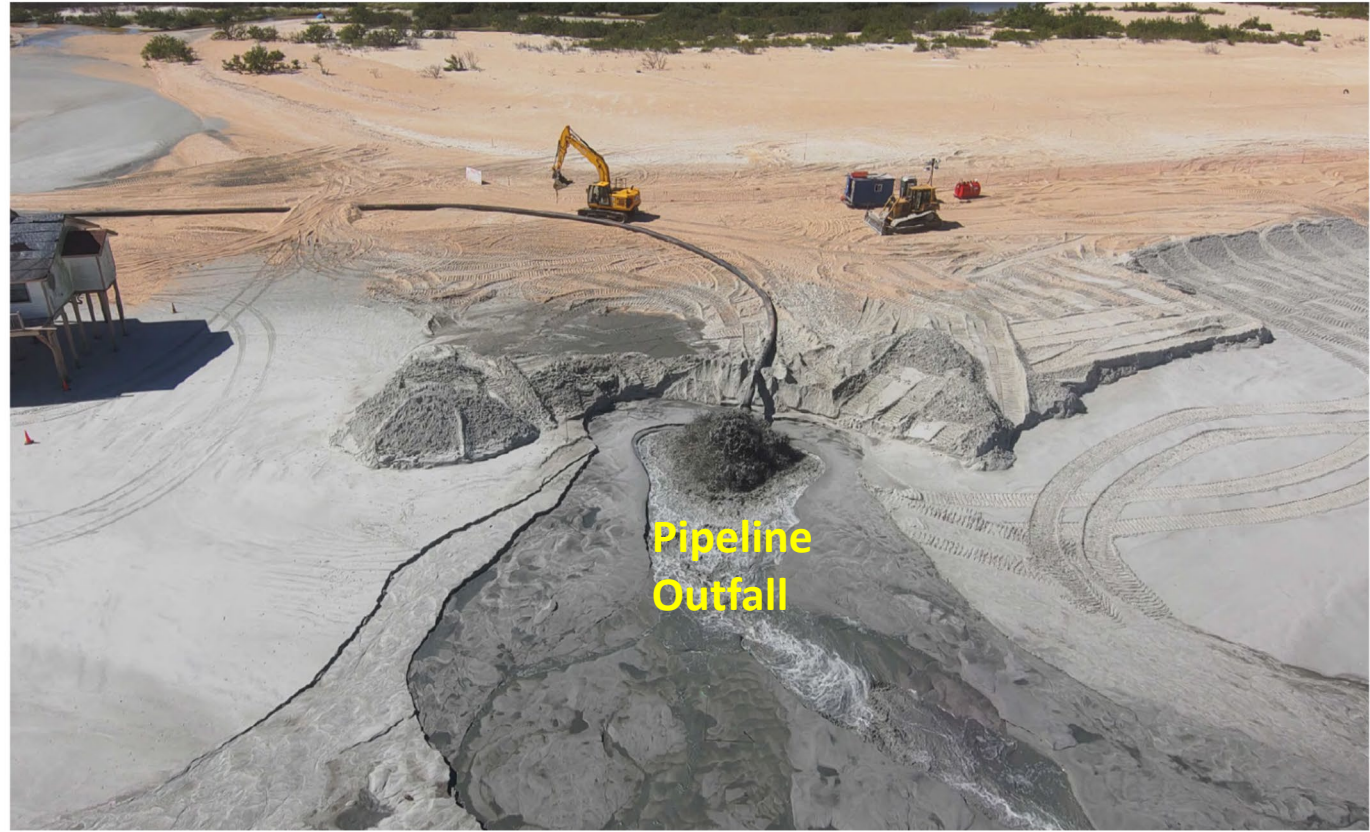
Existing Breach

- Located roughly between range monument R-204 and R-205
- 100 to 300 feet wide
- Pipeline corridor and staging area located adjacent to the breach

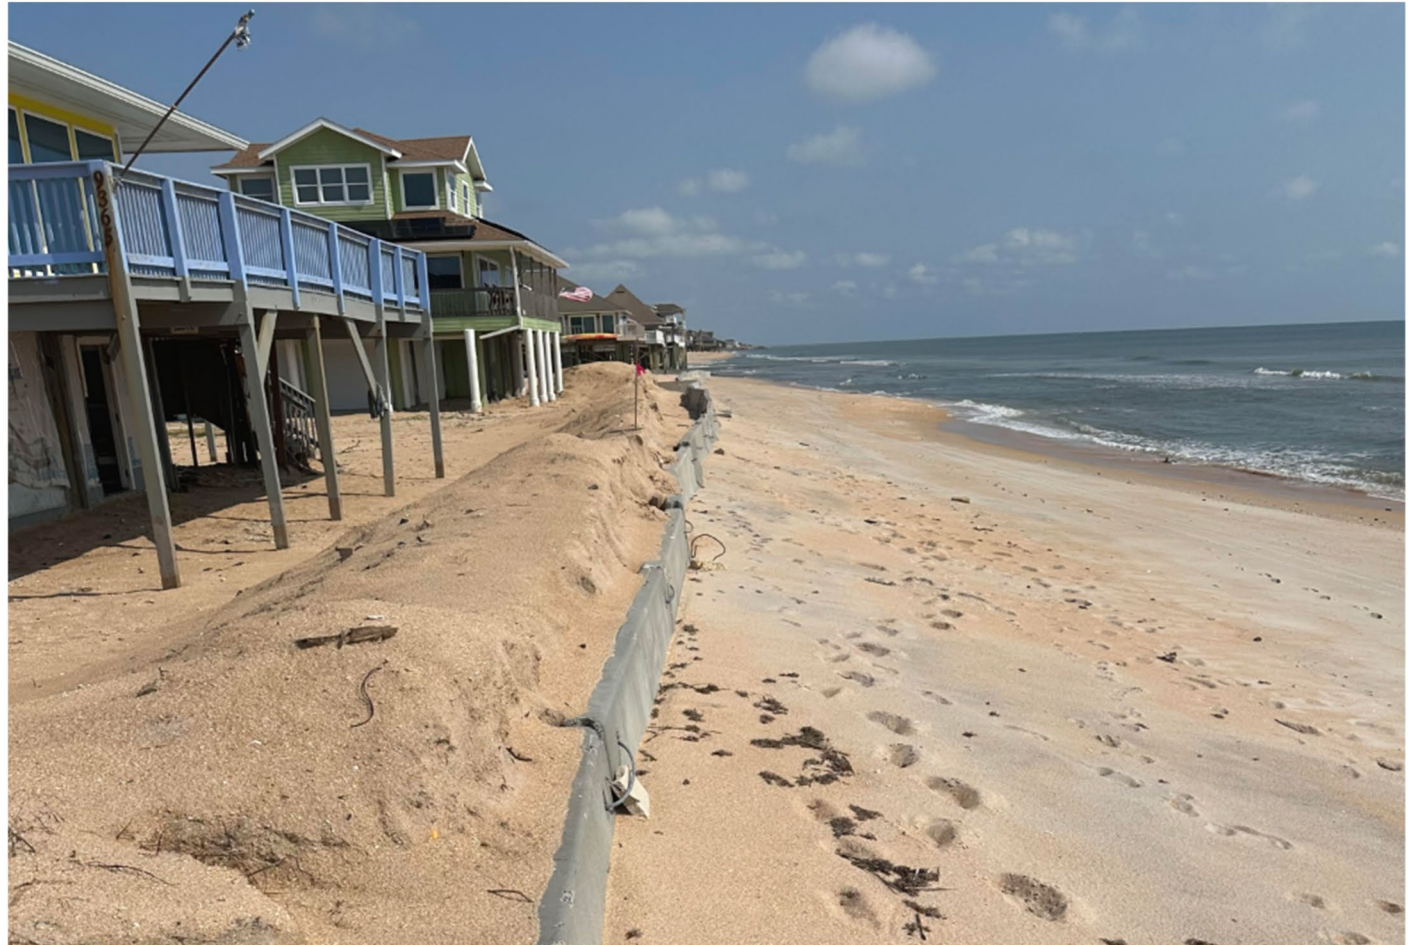
Typical Cross Section of Beach Disposal

SUMMER HAVEN - TYPICAL DISPOSAL SECTION - WESTERN R/W BELOW DUNE CREST

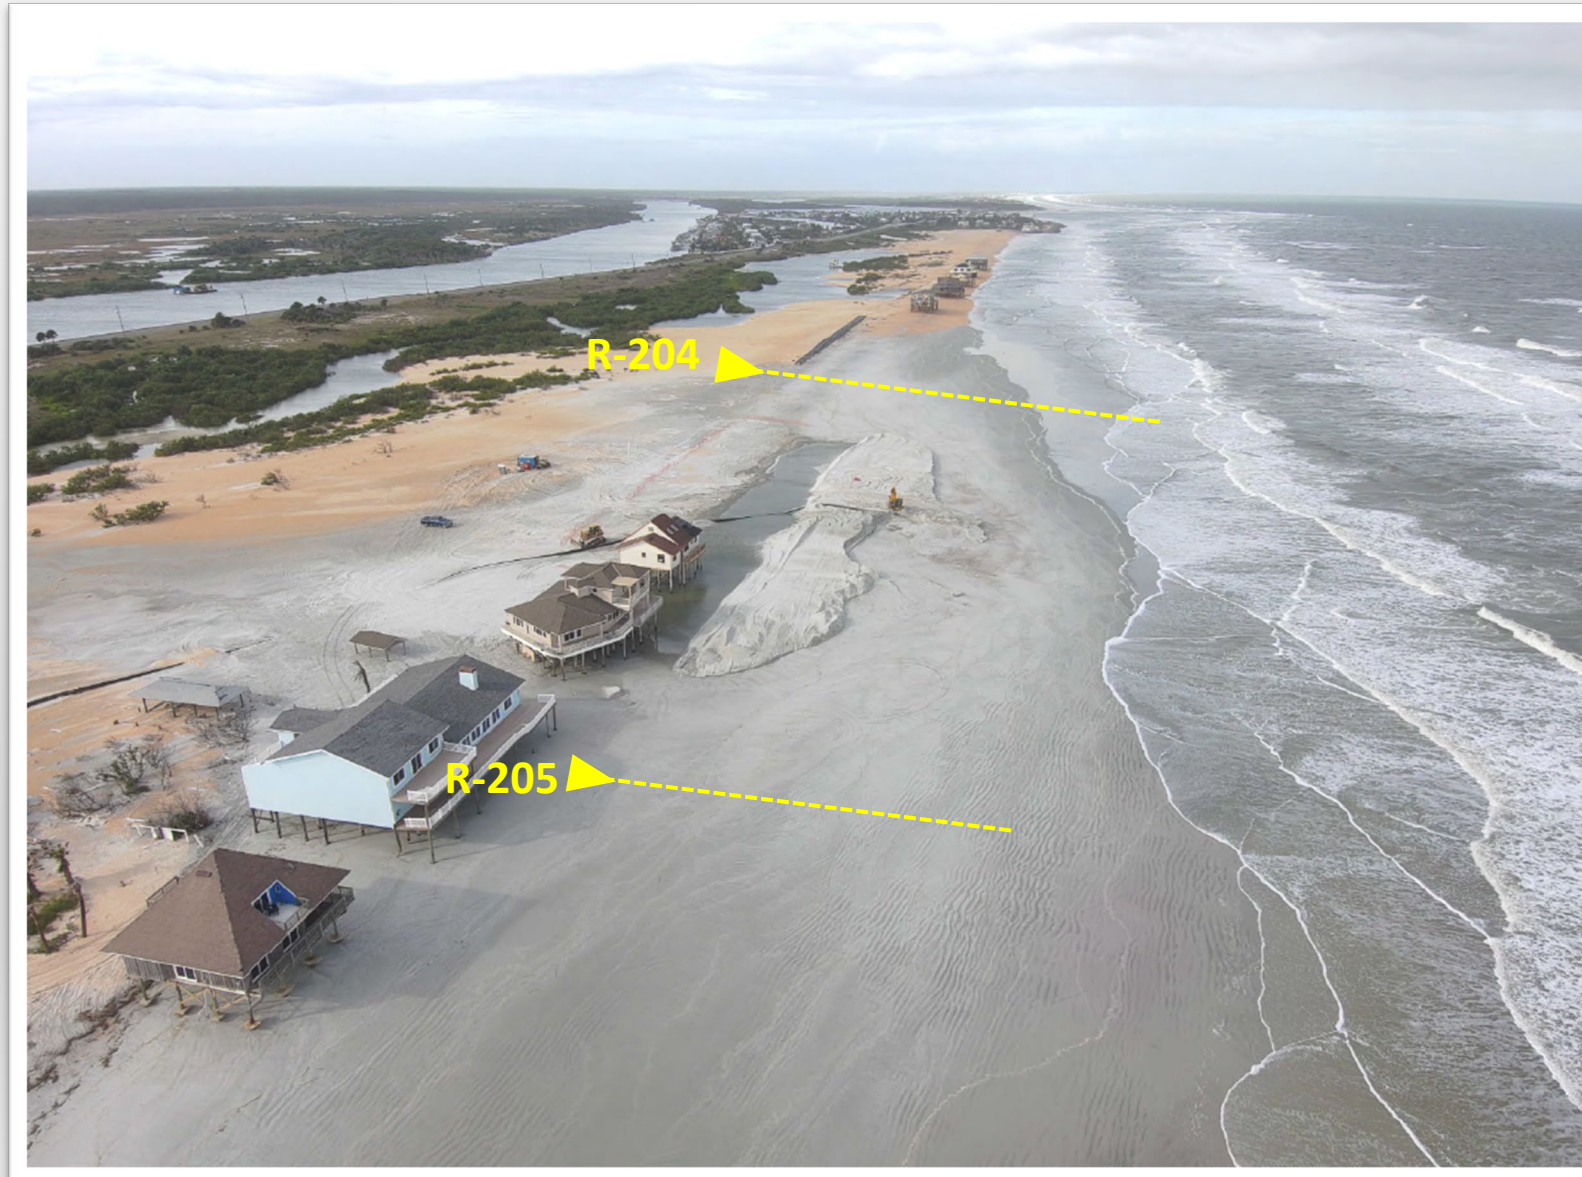
Sediment Transport Through Breach

- High propensity for material migrating through the breach landward towards the Summer Haven River
- Flood shoal at the confluence of the Summer Haven River and the IWW has impacted navigation
