IMPACTS OF HURRICANES DEBBY, HELENE AND MILTON ON ANNA MARIA ISLAND

38th Annual National Conference on Beach Preservation Technology February 2025, Panama City Beach, Florida

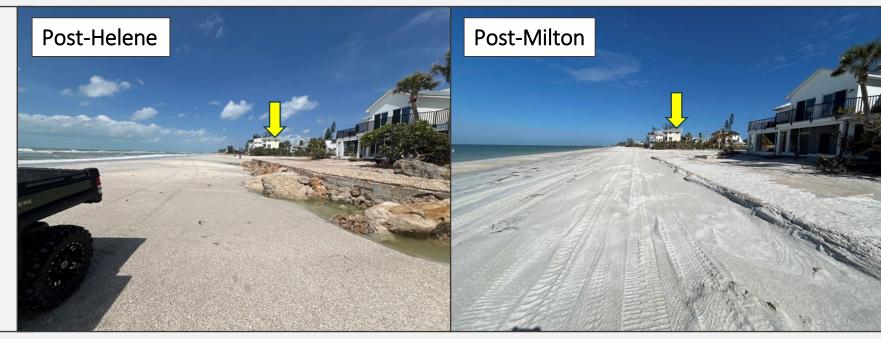
Cortez Beach, R-34, facing South

Pre-Helene/Milton
