Adaptive Restoration of Bird Island CWA: Stabilizing Shorelines for Long-Term Ecological Resilience

Ryan Watson, EIT

Florida Shore and Beach Preservation Association

2/5/2026

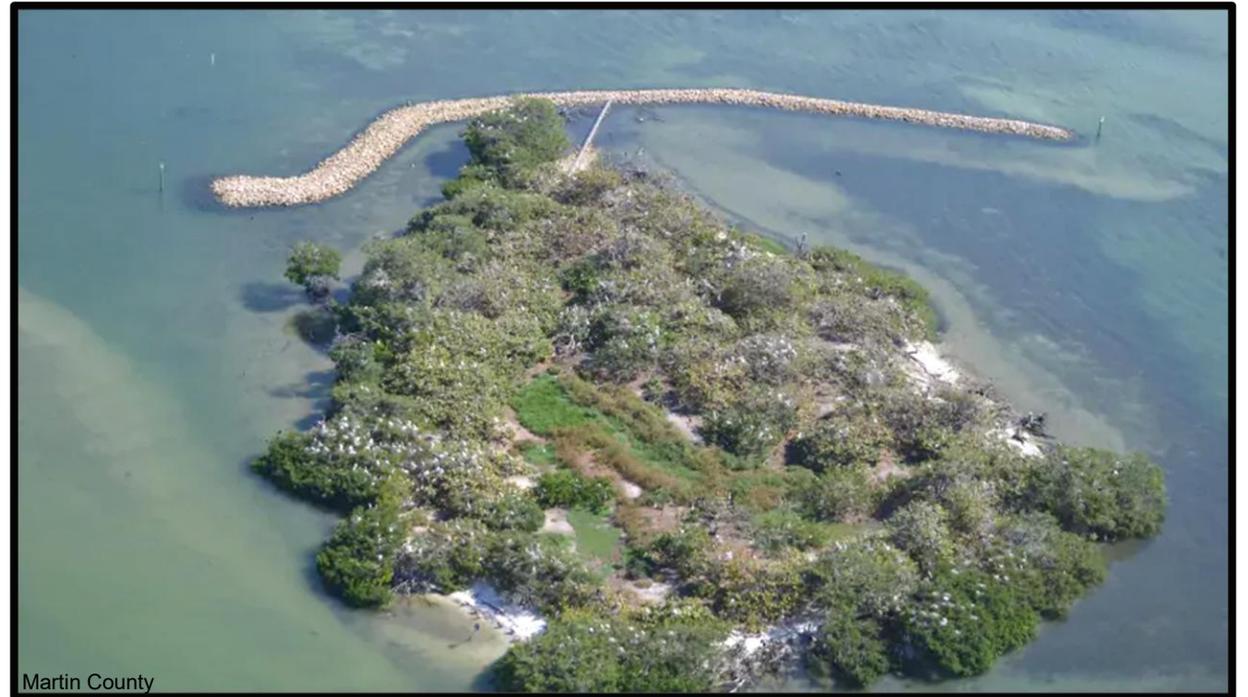
- Created in the 1940's during the dredging of the Atlantic Intracoastal Waterway
- Adopted for conservation under SIMP in 1990
- Designated as a CWA in 2014

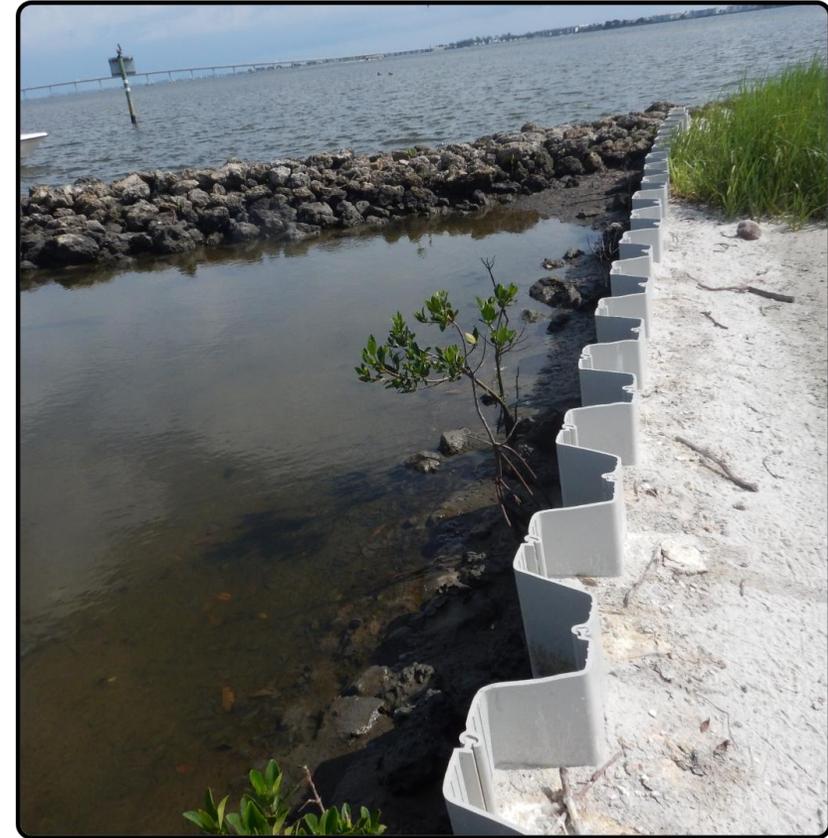
Implemented Projects

416 linear-ft Breakwater

- Riprap
- Protects north point

Small scale living shorelines

- Oyster Clutch
- Reef modules
- Riprap mangrove planters
- Planting efforts

- 31% area lost to erosion (2010, Ecological Associates)
- Modeling shows vulnerable north side of the island (2010, Adams Design)
- 416 linear-ft breakwater constructed with weir (2011, LES and Adams Design)
- Small scale living shoreline (2012-2021, BluStem)

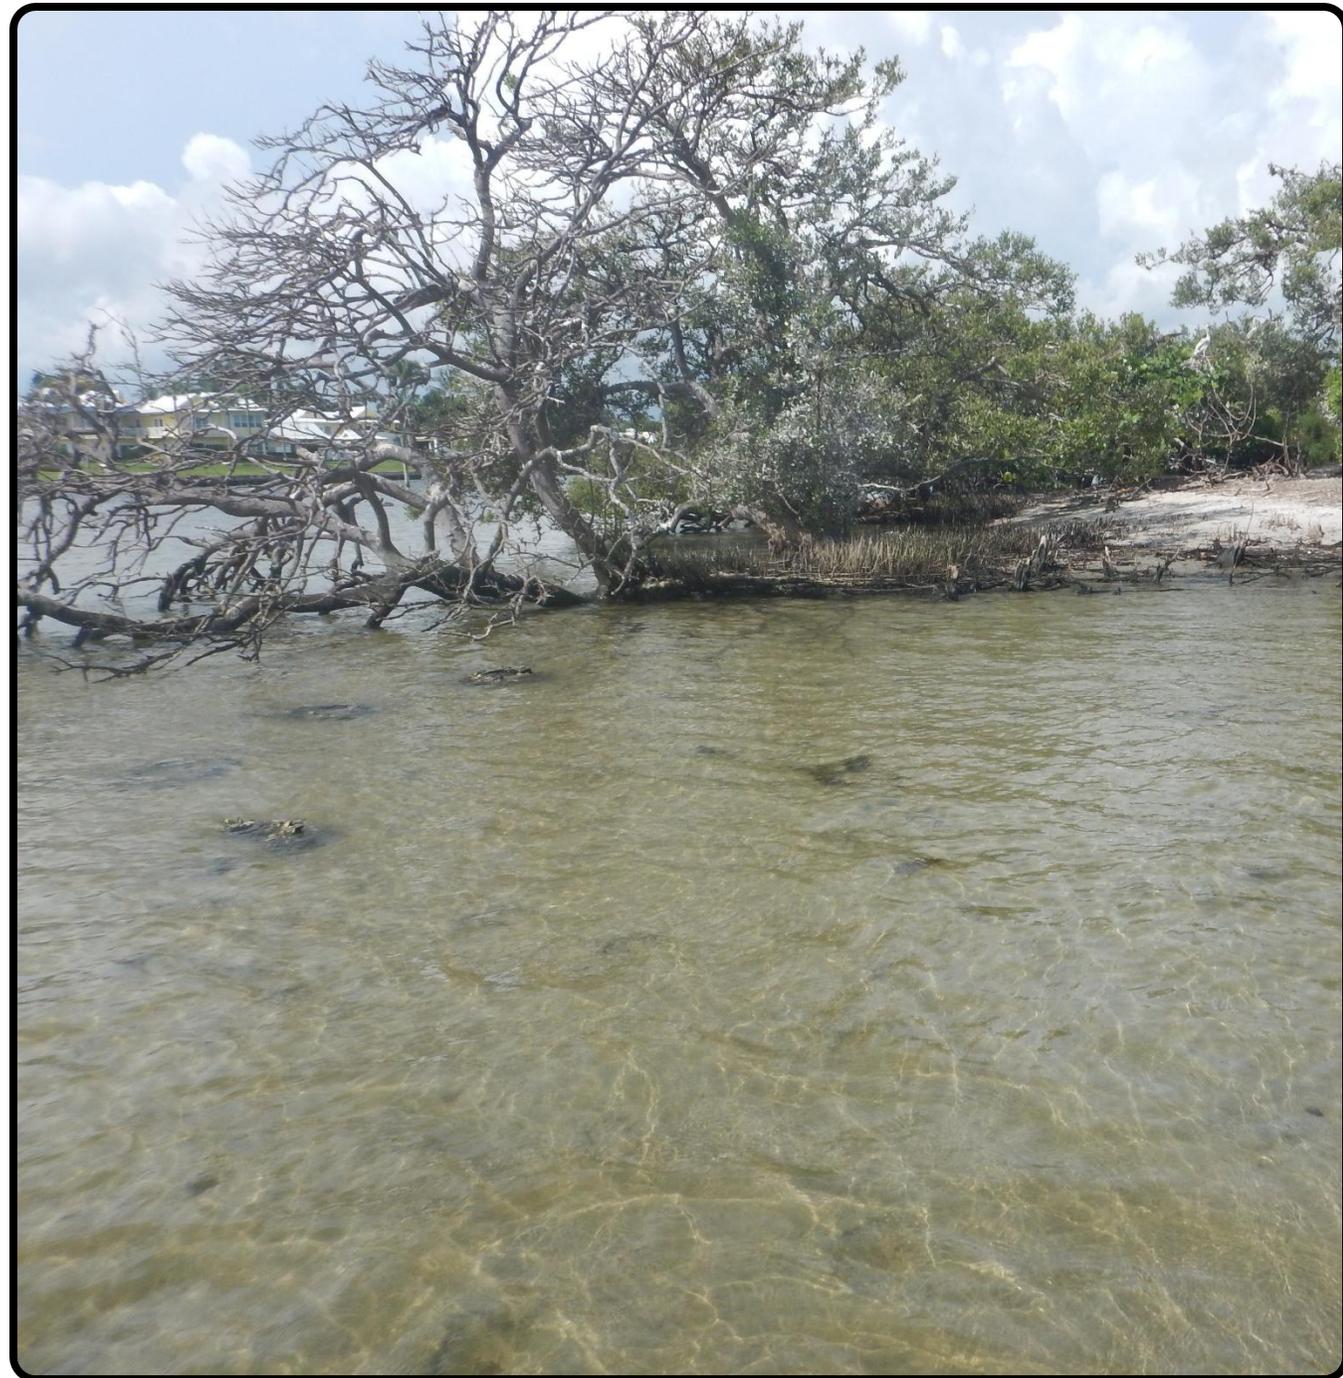
Post-Construction

- Additional 10% loss of land mass since breakwater installation
- Significant loss of mangrove trees
- Stantec to complete site evaluation and design alternatives

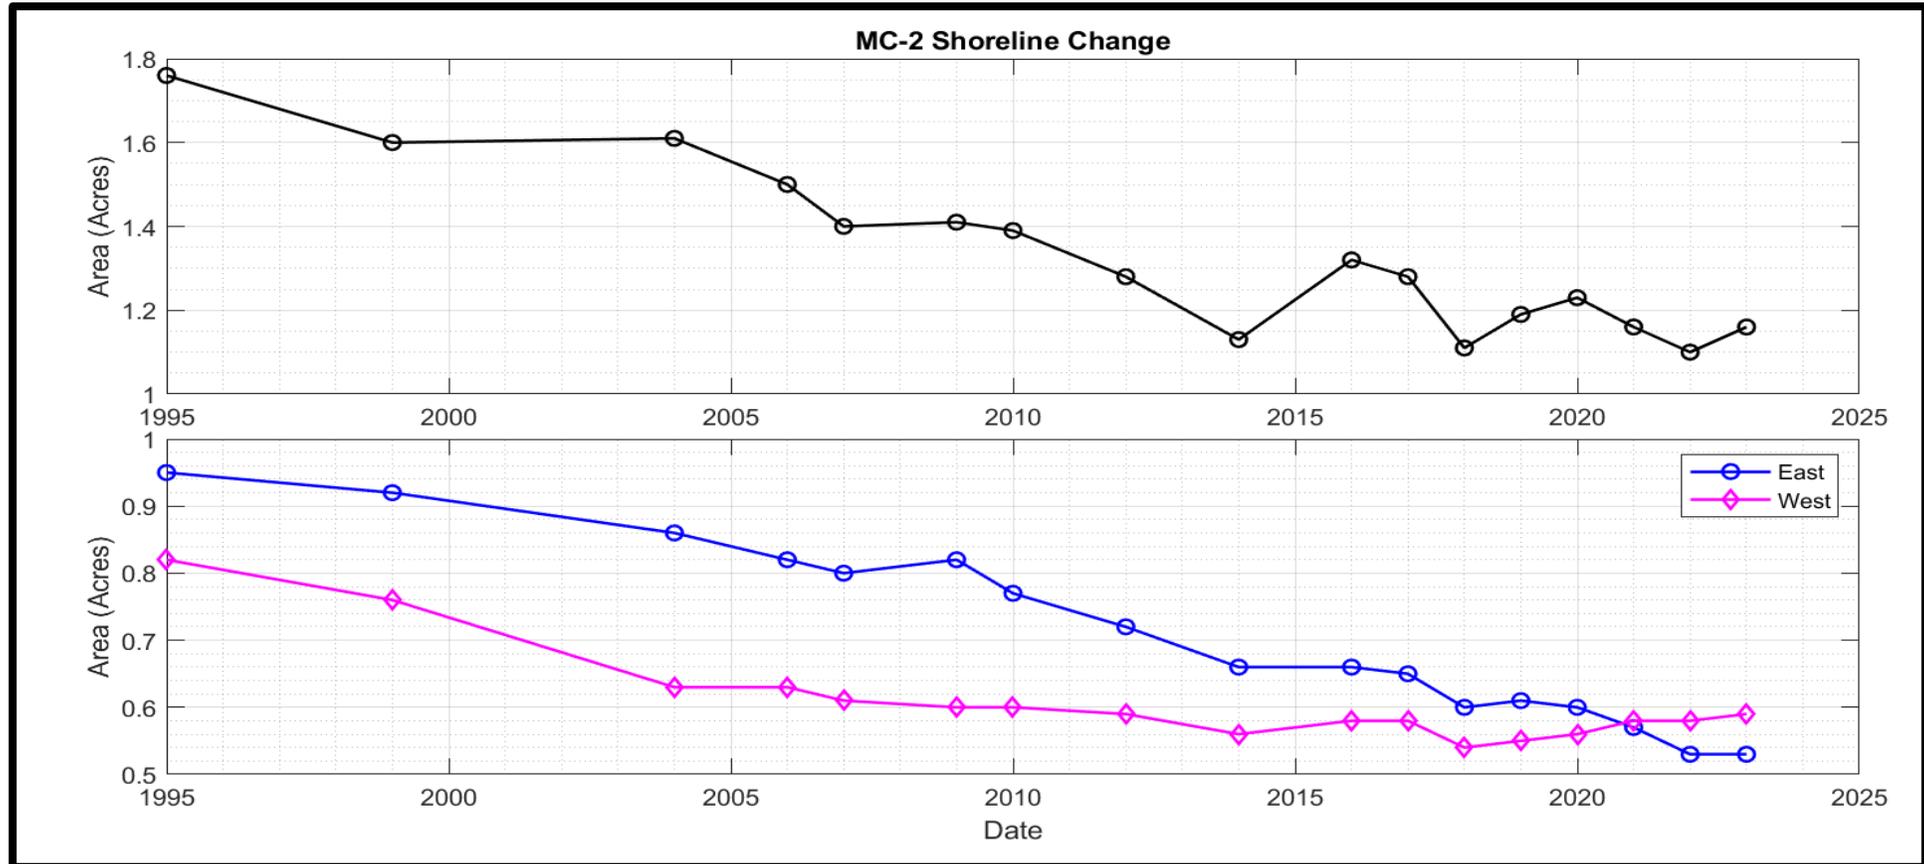
Shoreline Change Trends

Shoreline change of Bird Island CWA (MC-2) from 1995 to 2023 (top), and a comparison of the shoreline change of the east vs. west shorelines of the island (bottom).

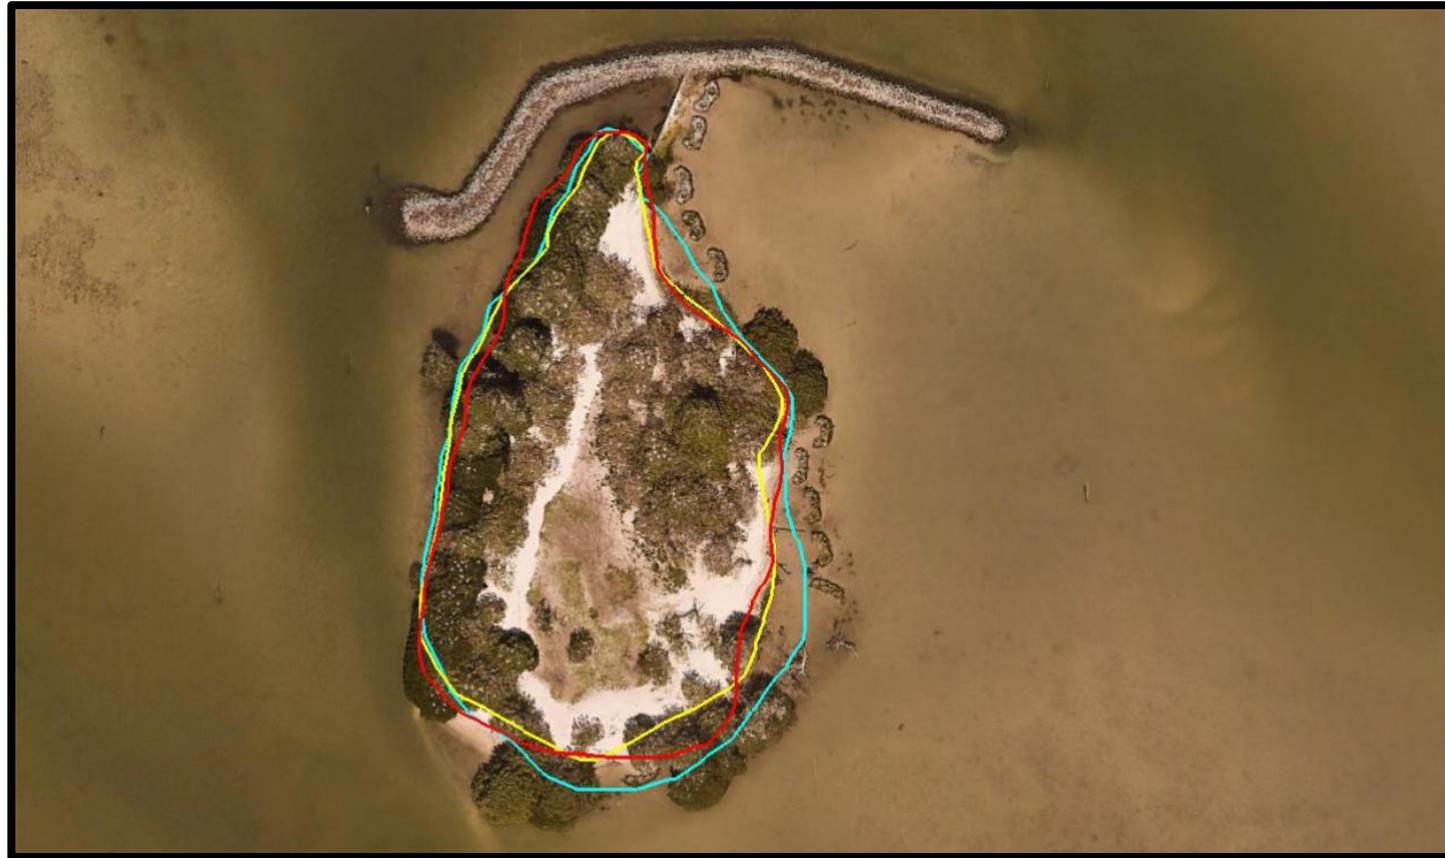
Shoreline Change Trends

Aerial comparison of shoreline change between the years 2012 (blue), 2018 (red), and 2023 (yellow).

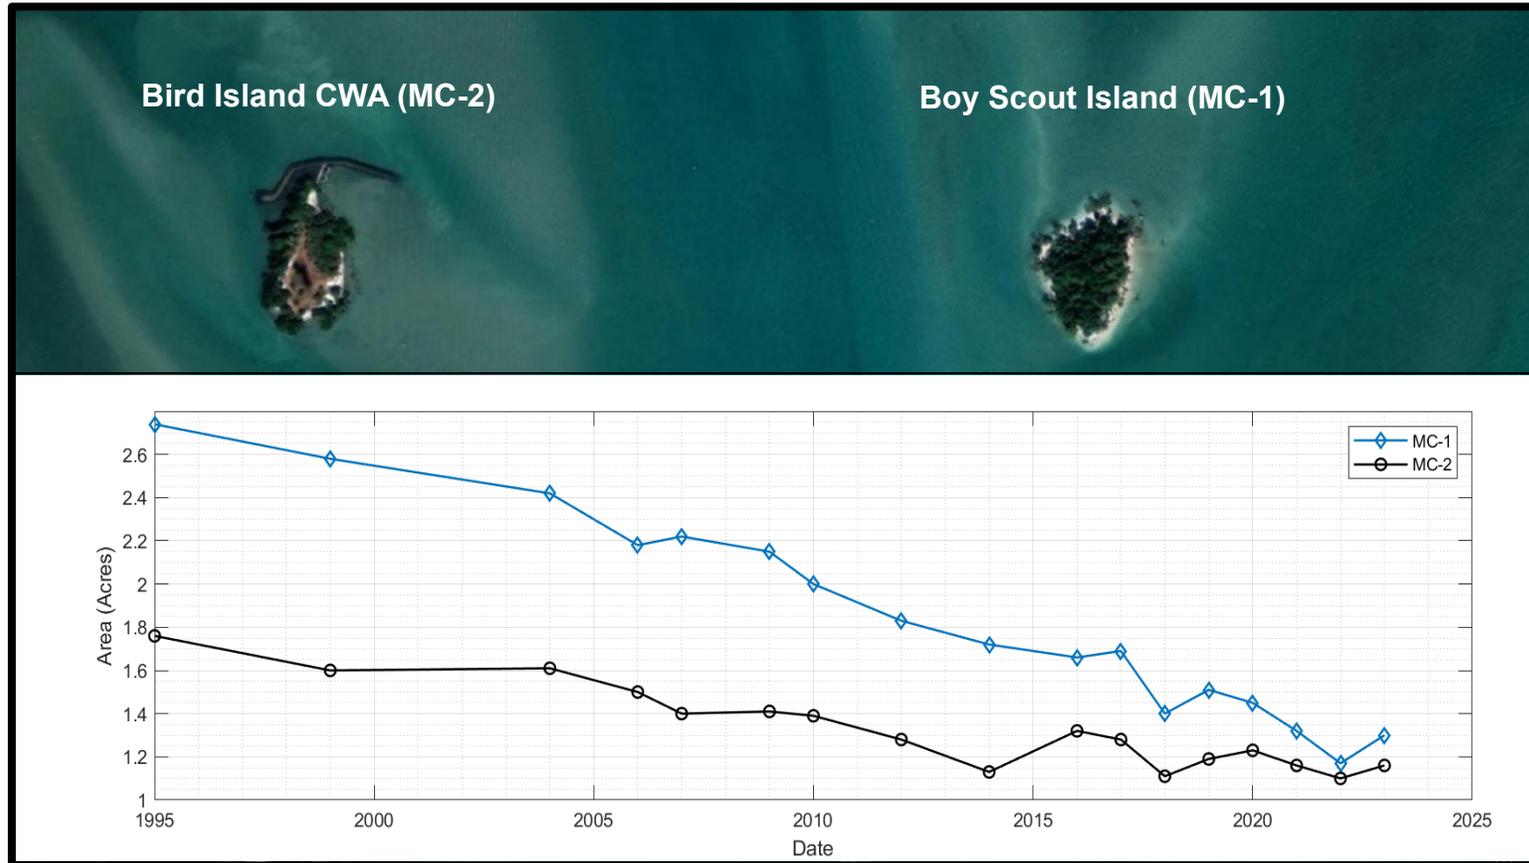
Shoreline Change Trends

Comparison of shoreline change rates for Boy Scout Island (MC-1) and Bird Island (MC-2) from 1995 to 2023. The Island areas, displayed in acres, are approximate and based on Google Earth Aerial Imagery.

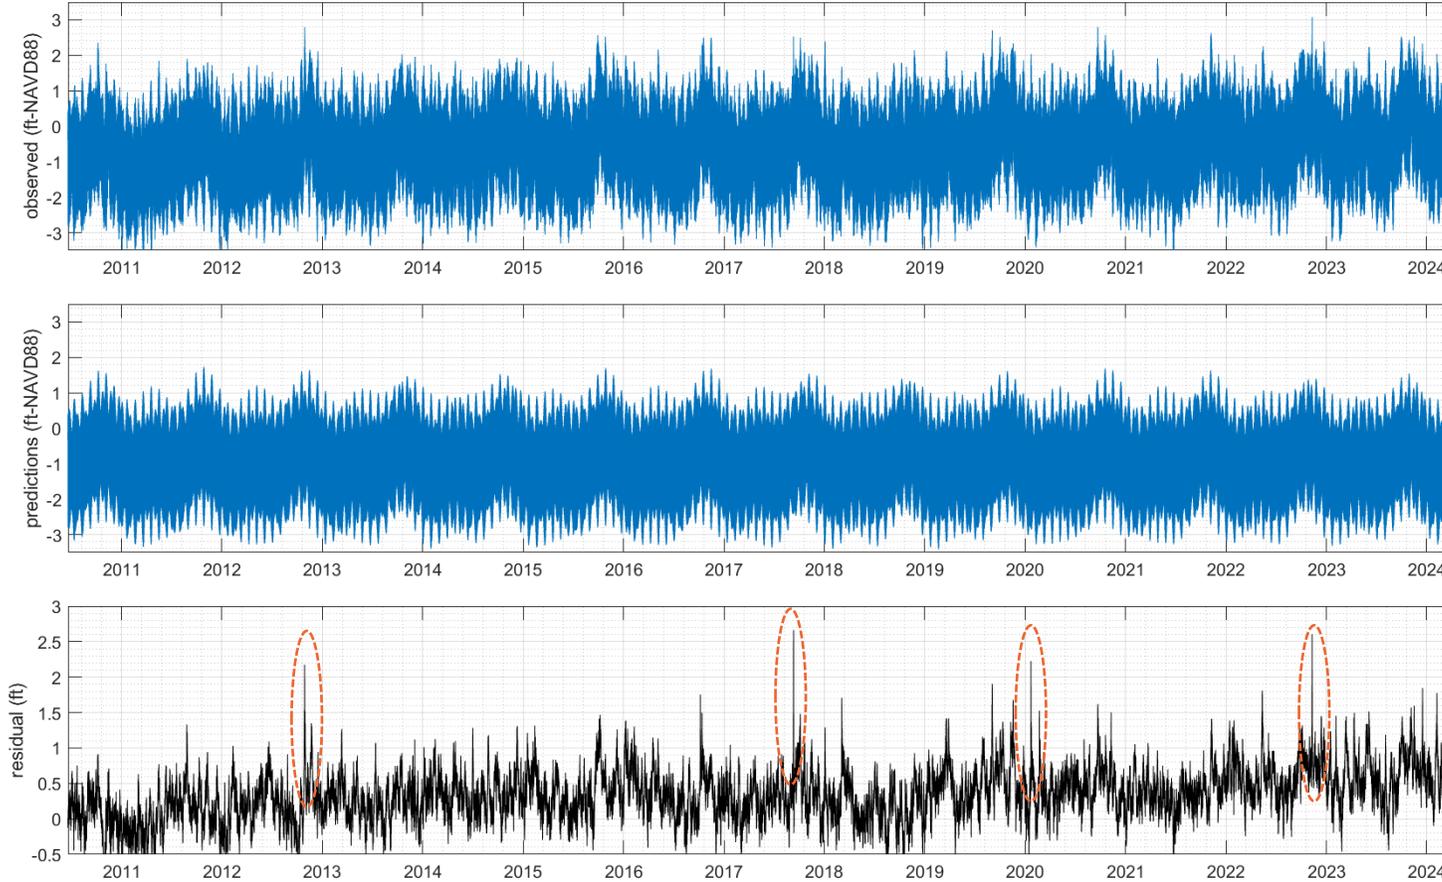
Extreme Water Levels

Comparison of observed tides (top) predicted (middle) and the tidal residual (bottom) for all records at the Lake Worth Pier Tide gauge (8722670). Storm events with tidal residual greater than 2 feet are circled in orange.

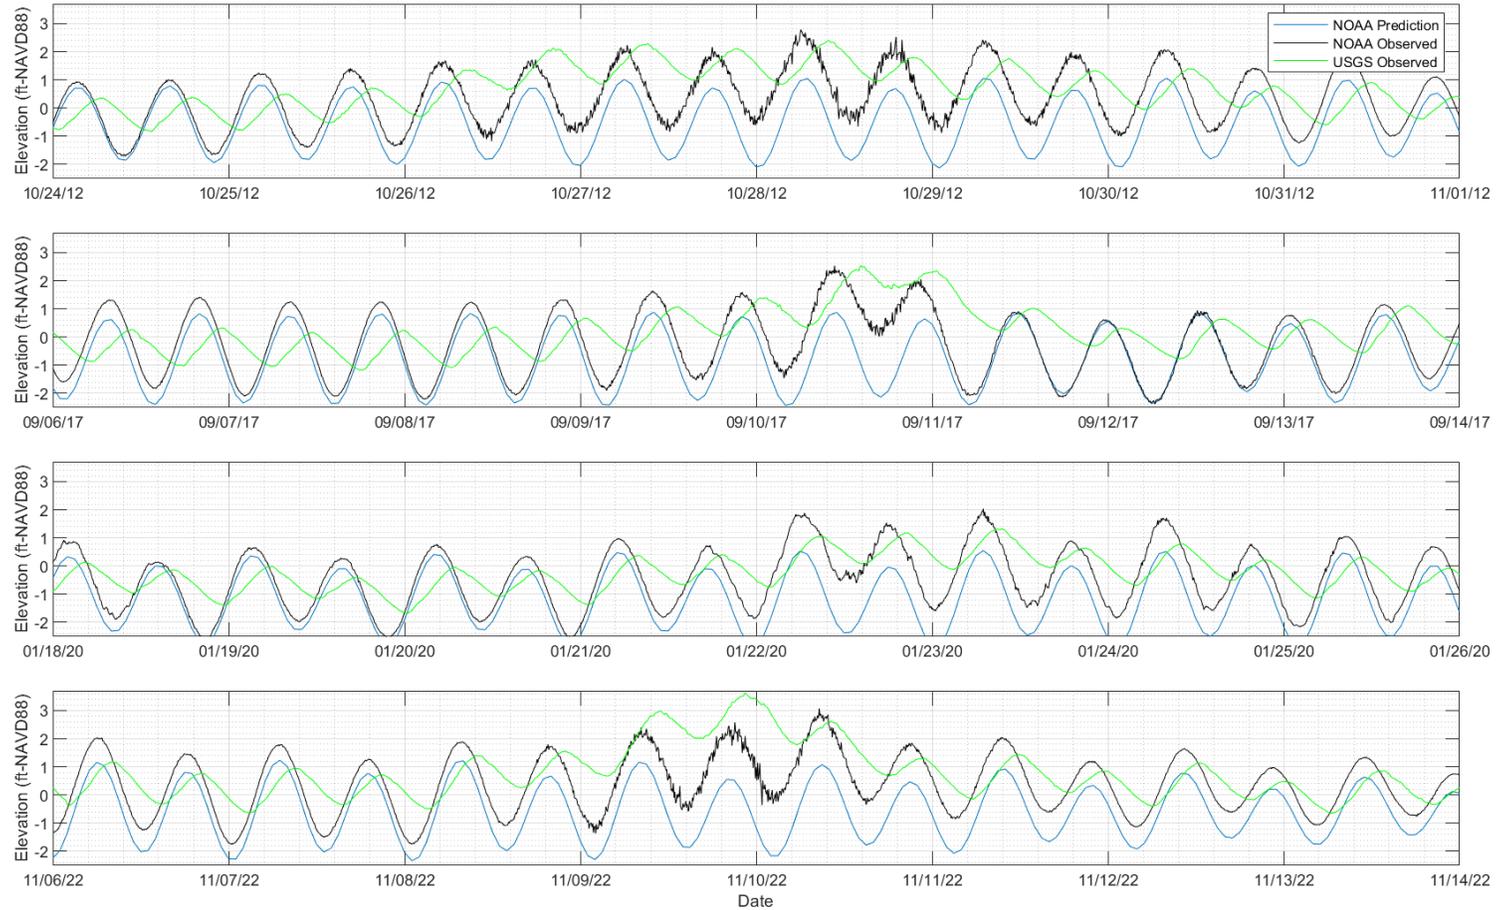
Extreme Water Levels

Comparison of water level observations (blue) and predictions (black) at Lake Worth Pier, to observations in St. Lucie River (green) during the four events identified.

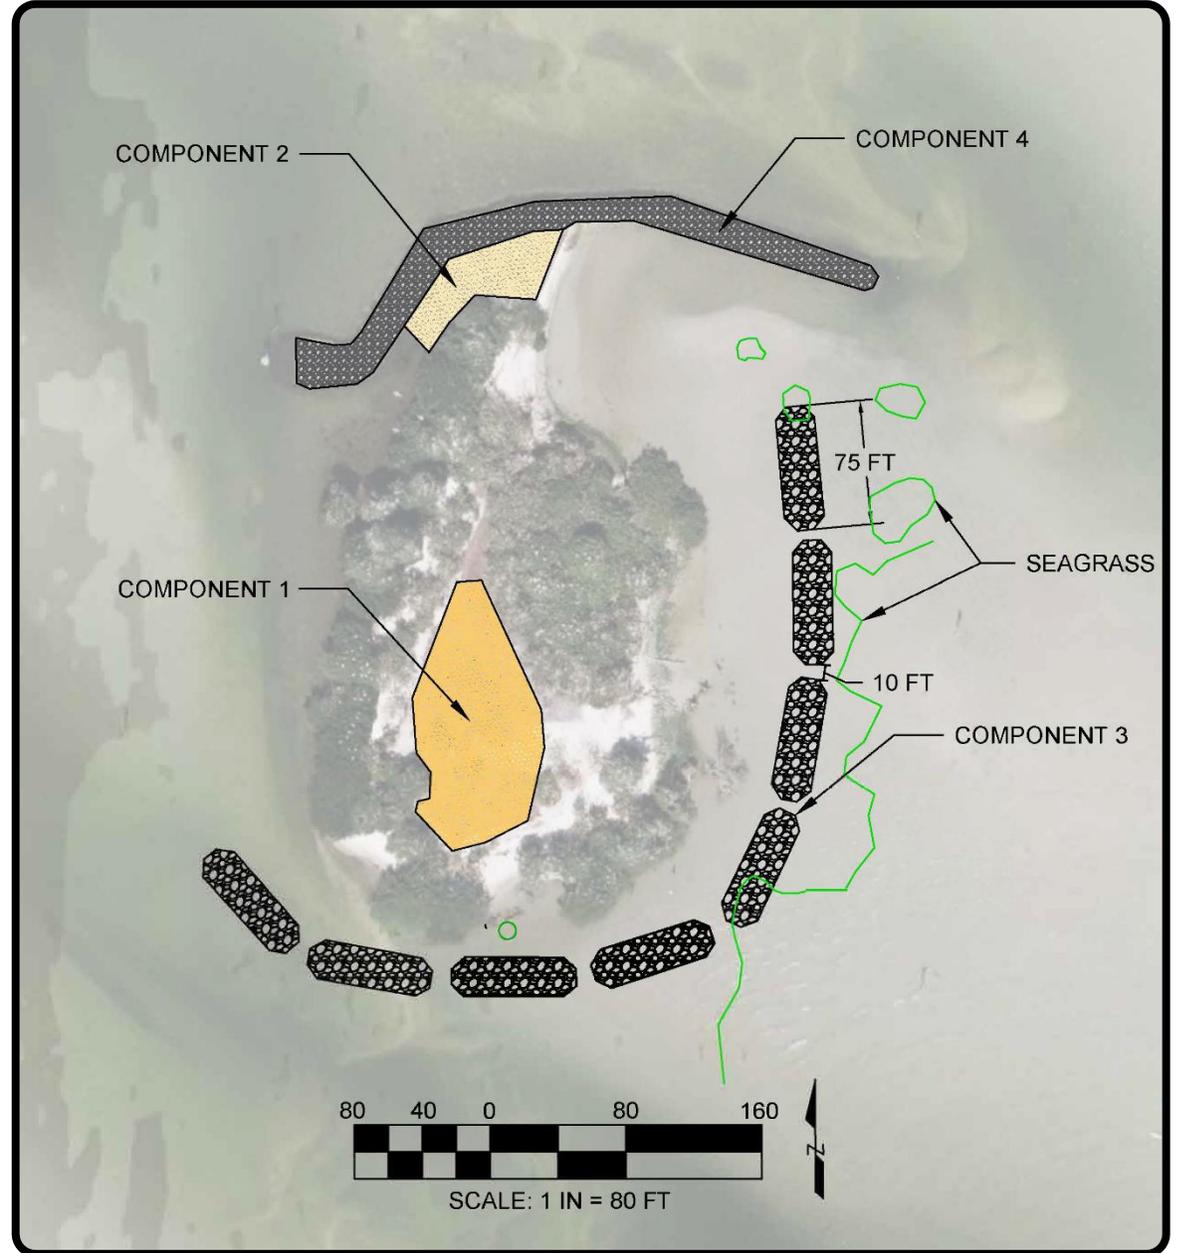
Proposed Design Alternatives

Component 1:

Increase Center Island Elevation

Component 2:

Restore North Point

Component 3:

Segmented Breakwaters

Component 4:

Increasing Elevation of Existing Breakwater

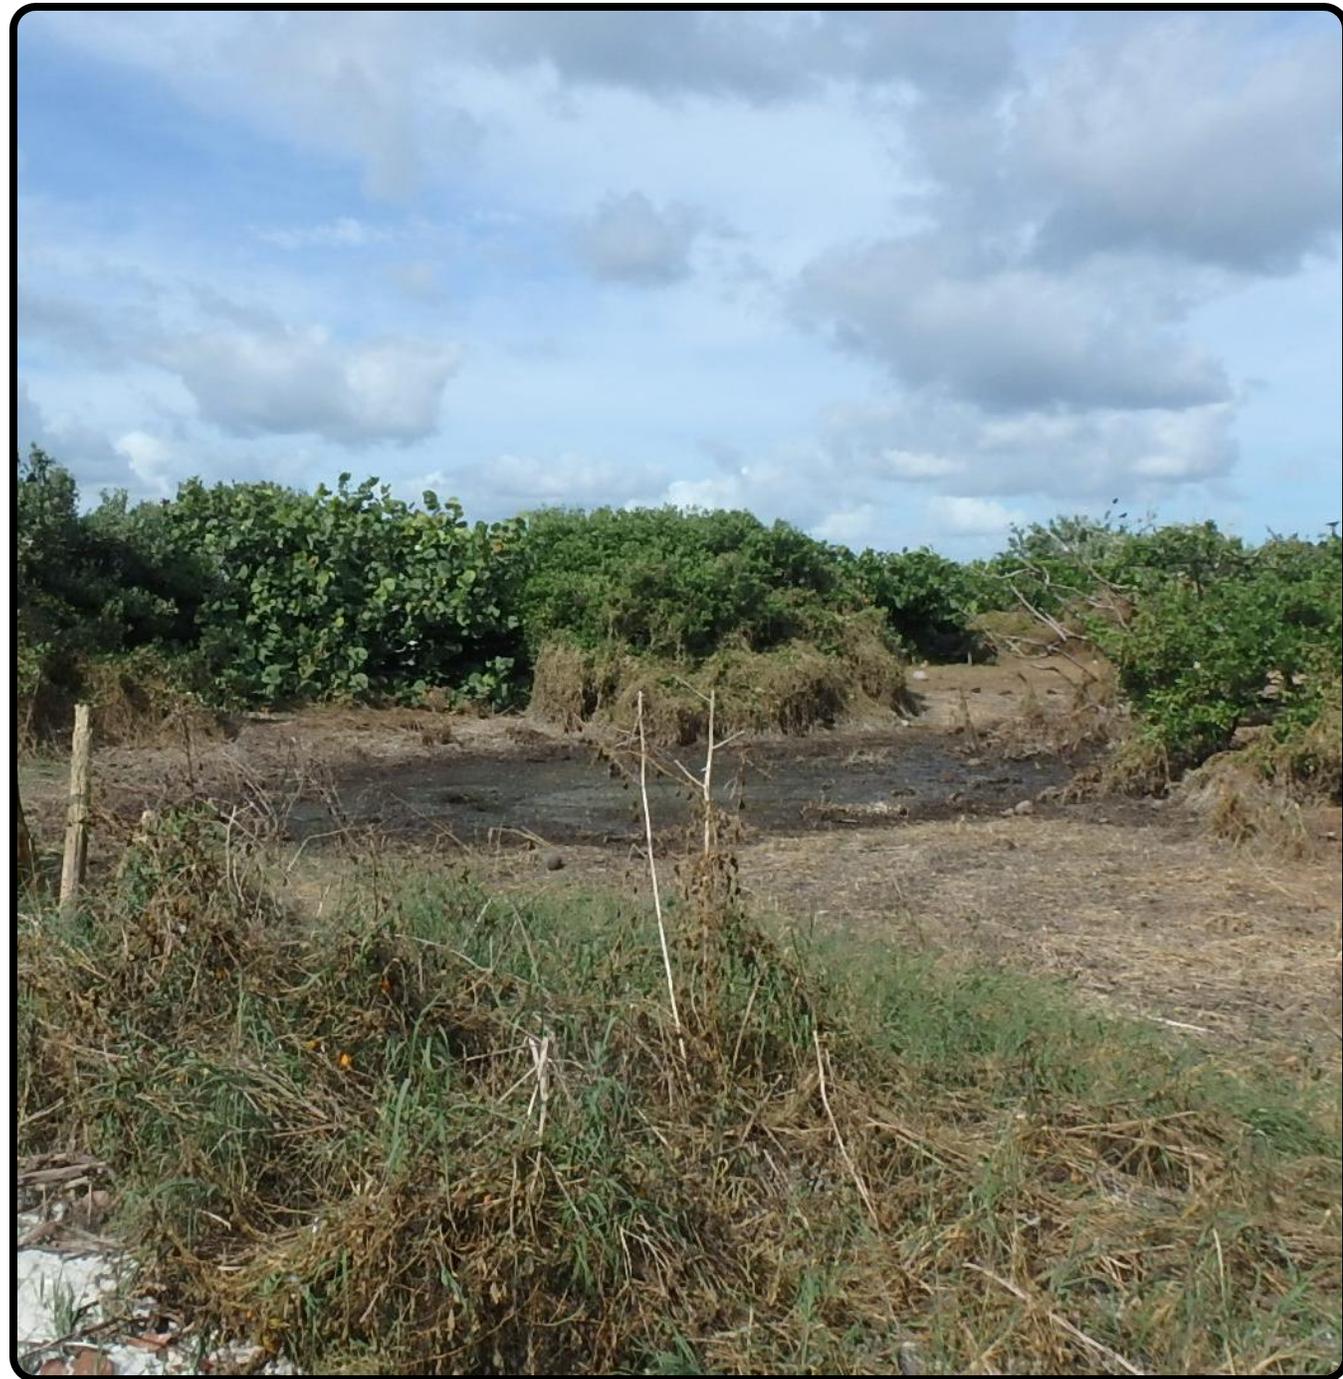
Component 1: Increase Center Island Elevation

- Raise center of island with beneficial dredge material
- Combat sea level rise
- Restore mangrove nesting habitat

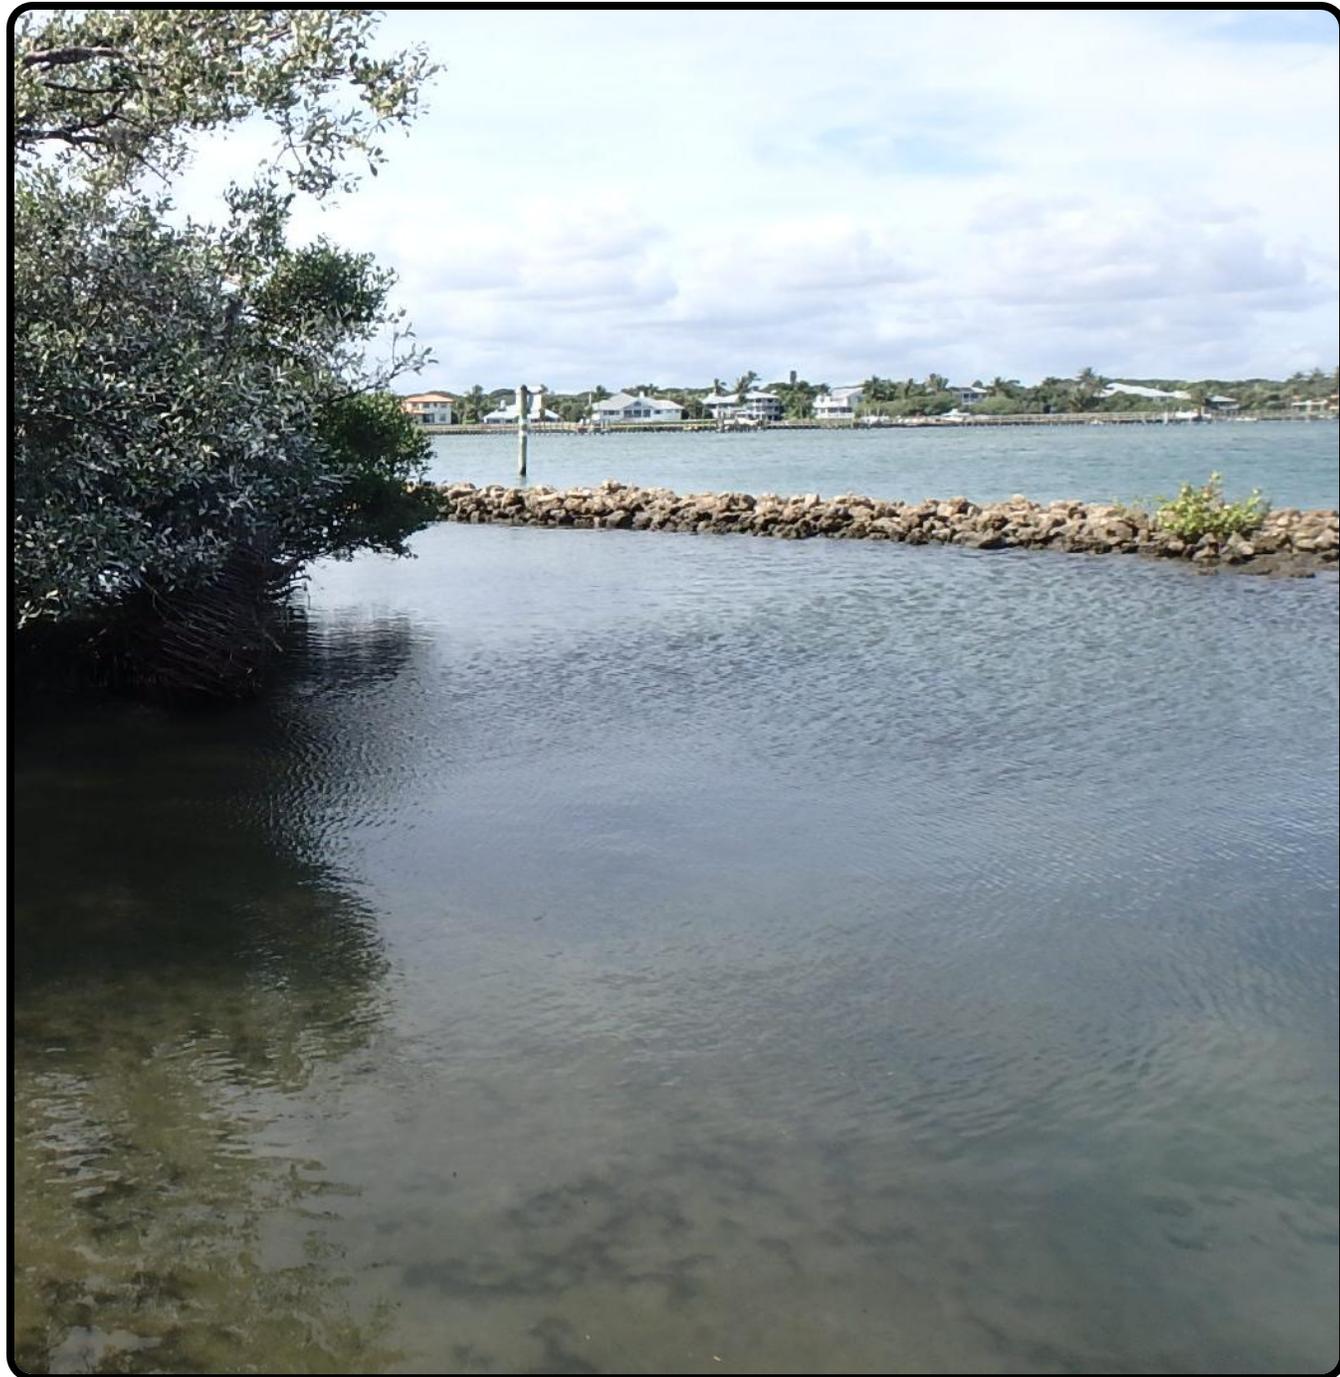
Component 2: Restore North Point

- Deep water area developed behind breakwater post-construction
- Lack of aquatic resources due to poor circulation and silty sediment
- Fill with beneficial dredged material to restore ecological function

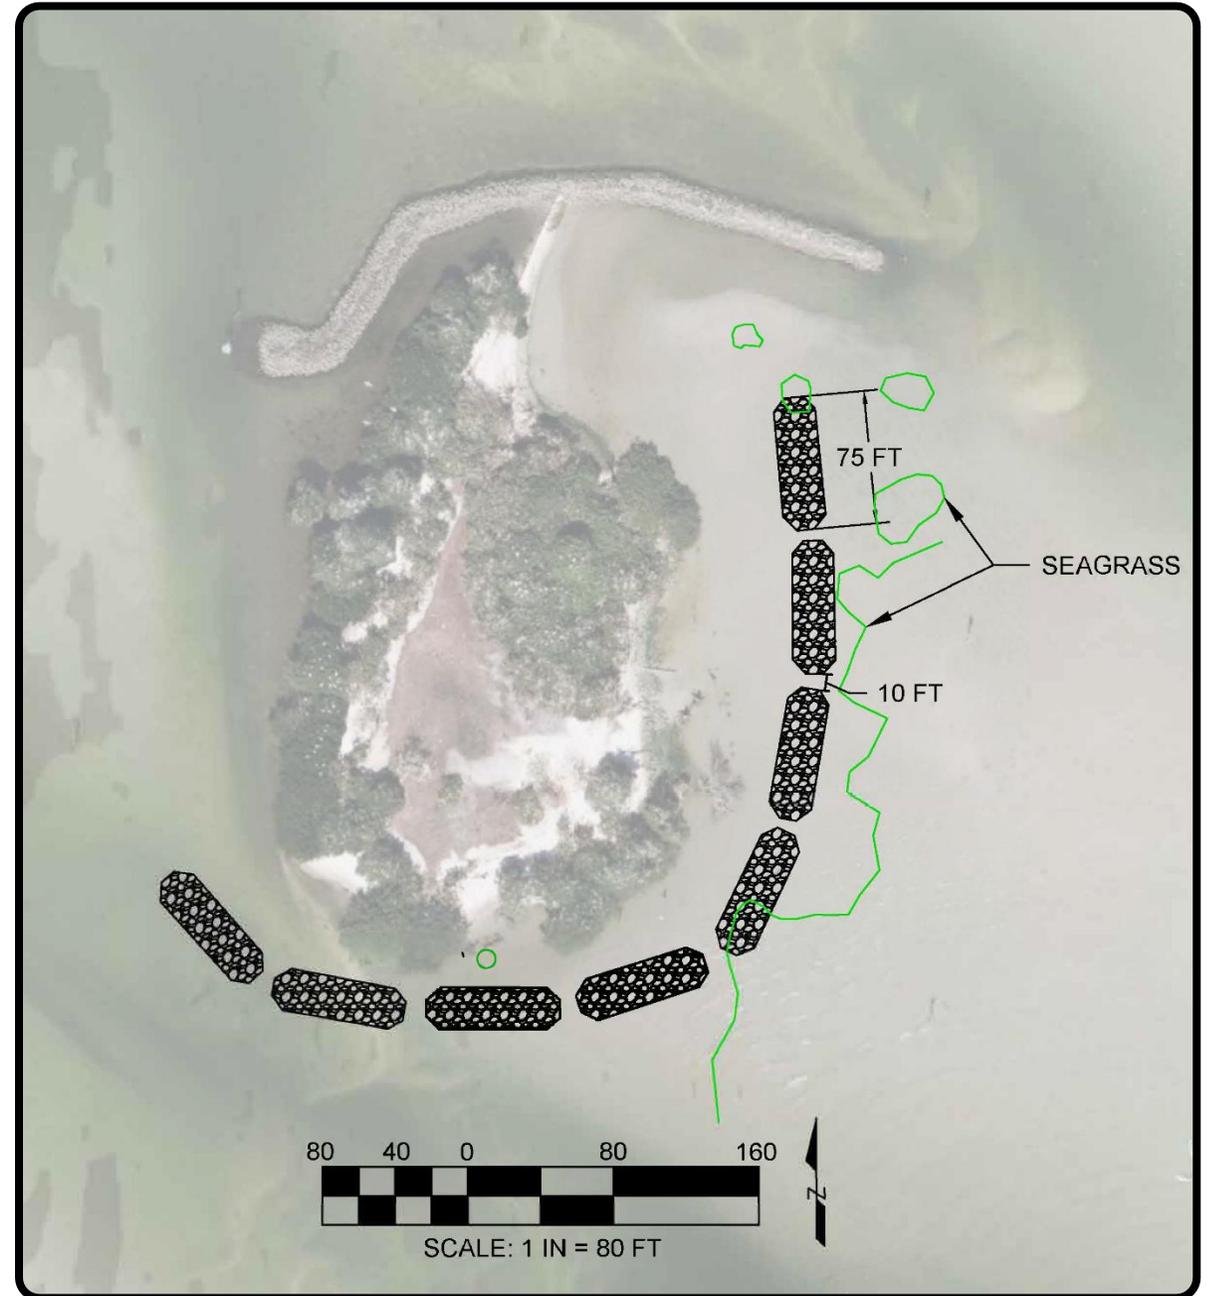
Component 3: Segmented Breakwaters

- Series of 8 Breakwaters
- Approximately 75 ft long
- 10 ft gaps for water circulation

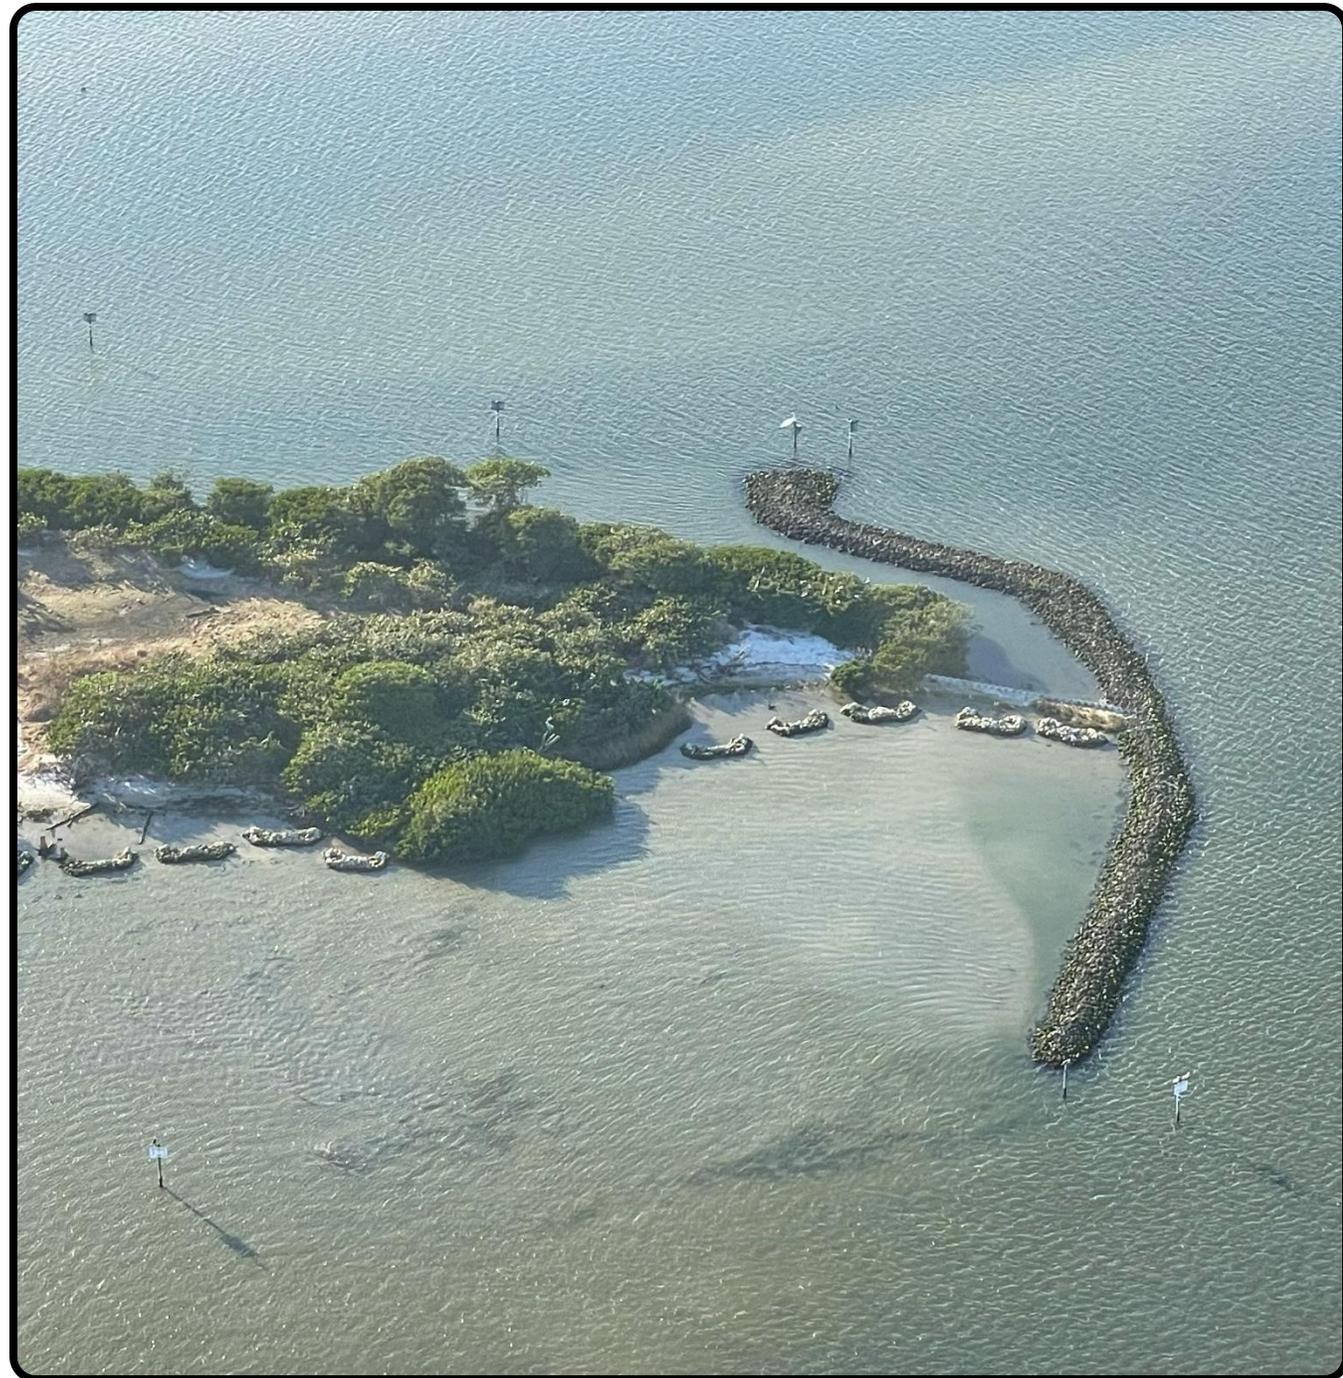
Component 4: Increasing Elevation of Existing Breakwater

- Use present storm data to plan proper elevation for future resilience
