Sebastian Inlet North Jetty Rehabilitation Project

The National Conference on Beach Preservation Technology - FSBPA 2026

Sebastian Inlet North Jetty

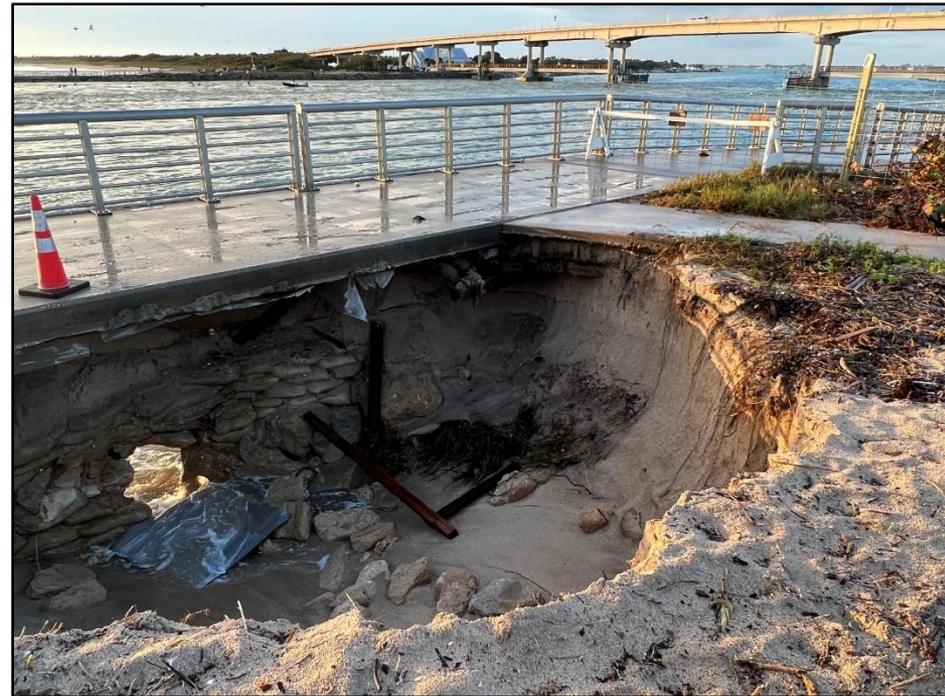
Erosion under the jetty's approach sidewalk after Hurricane Nicole 2022

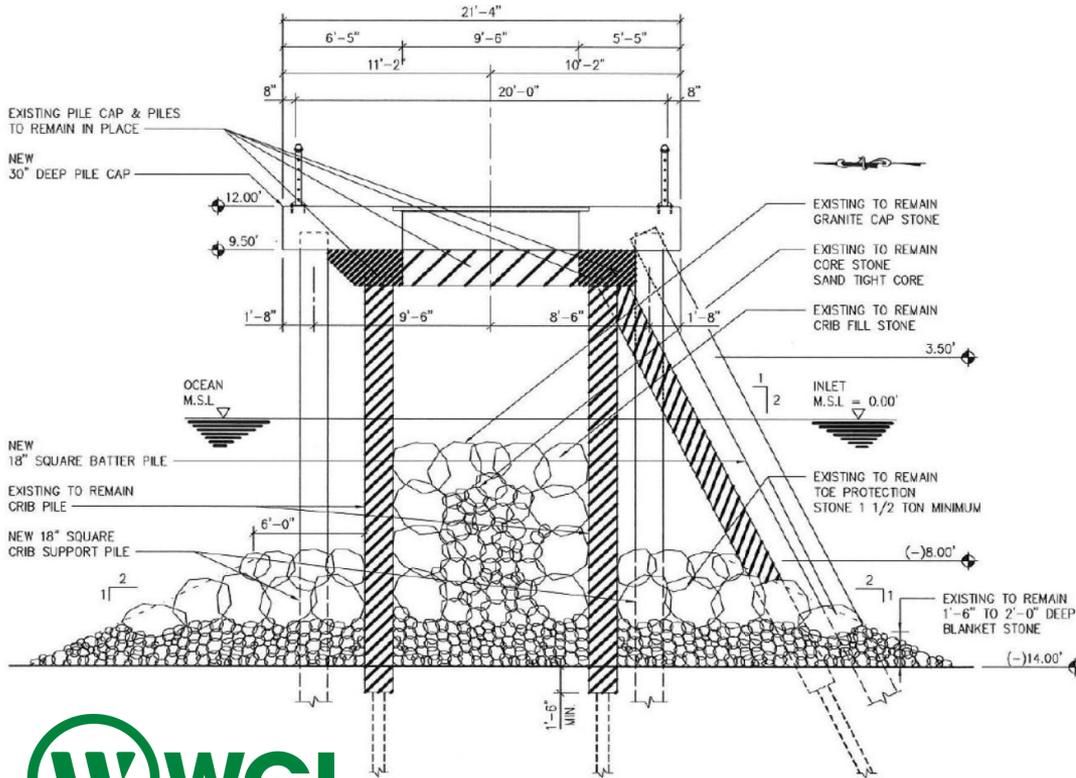
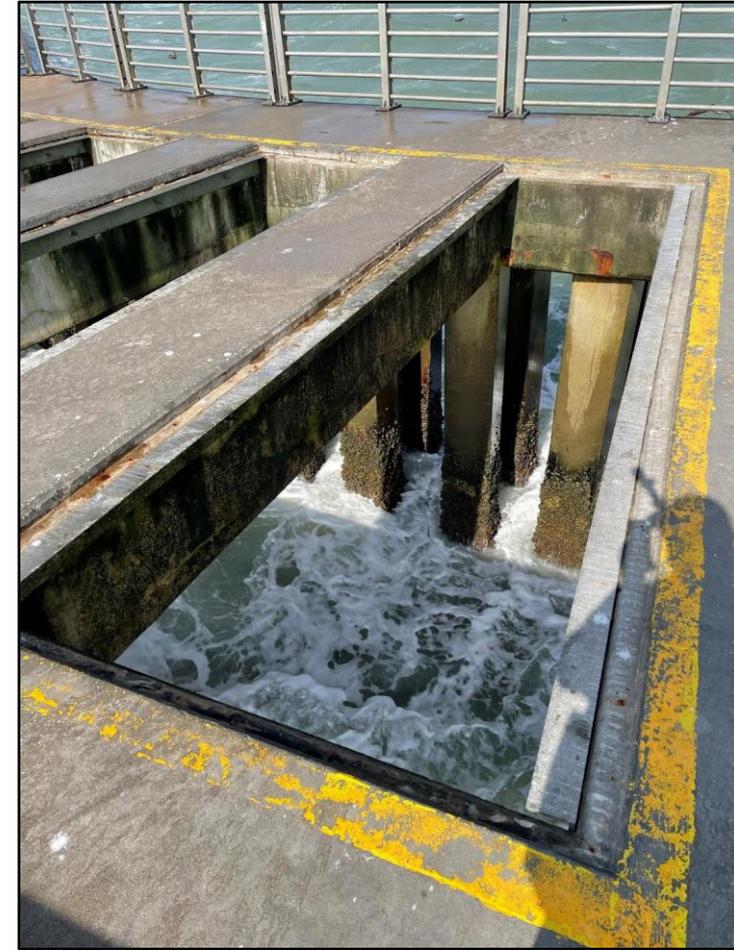
Typical North Jetty Cross Section

Bays 1-55

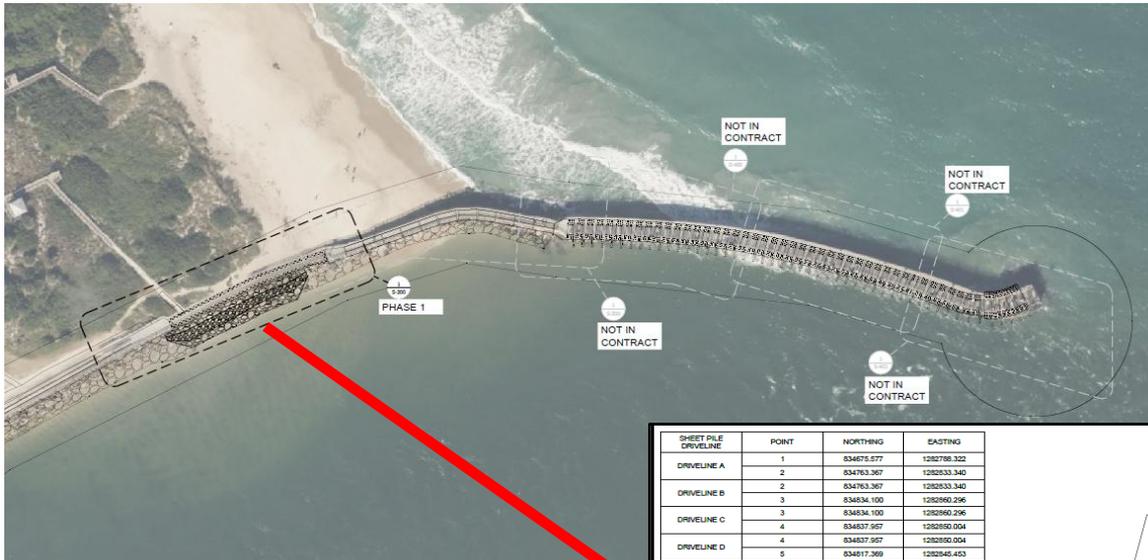
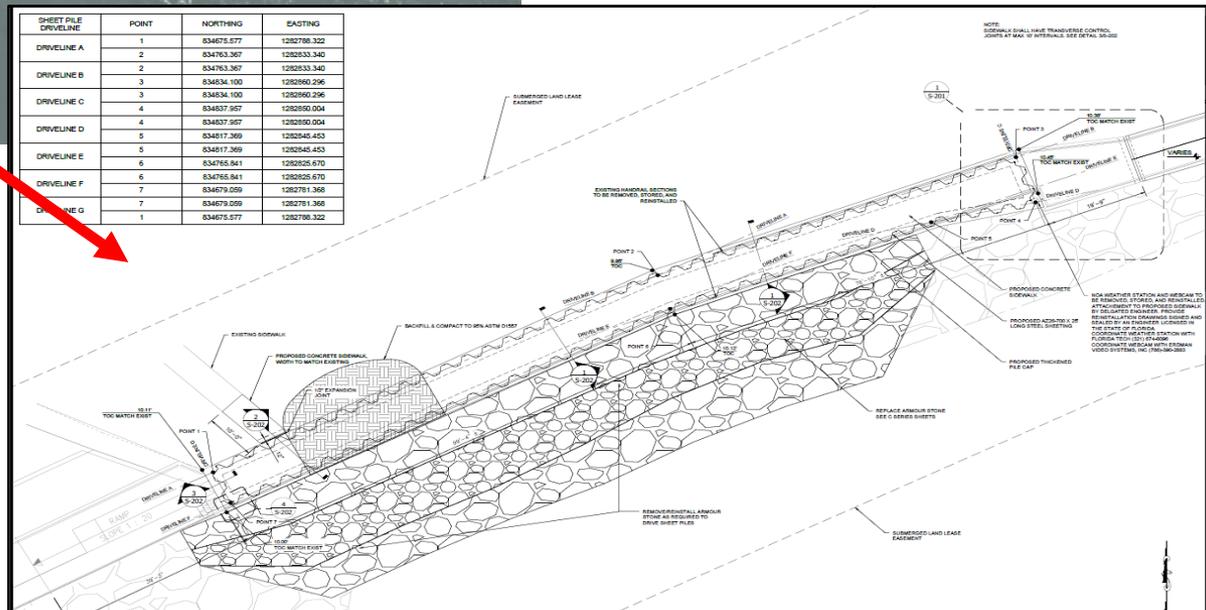
North Jetty Phase 1 Design

- ~ 440 LF of Seawall
- ~ 1,950 Tons – 48” – Granite Armor Stone
- Construct New Concrete Walkway

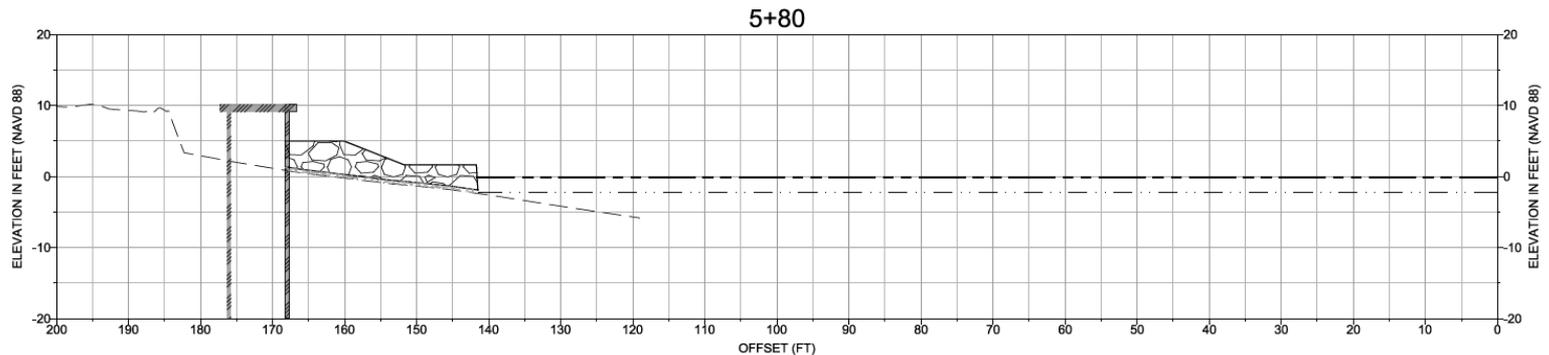
North Jetty Phase 1 Design

NEW SEA WALL CAP WITHIN 18"
OF EXISTING CONCRETE WALL

- The design called for installing sheet piles along the former sidewalk alignment and constructing a 30-ft-wide riprap structure.
- Surveys performed before and after removing the existing wall.

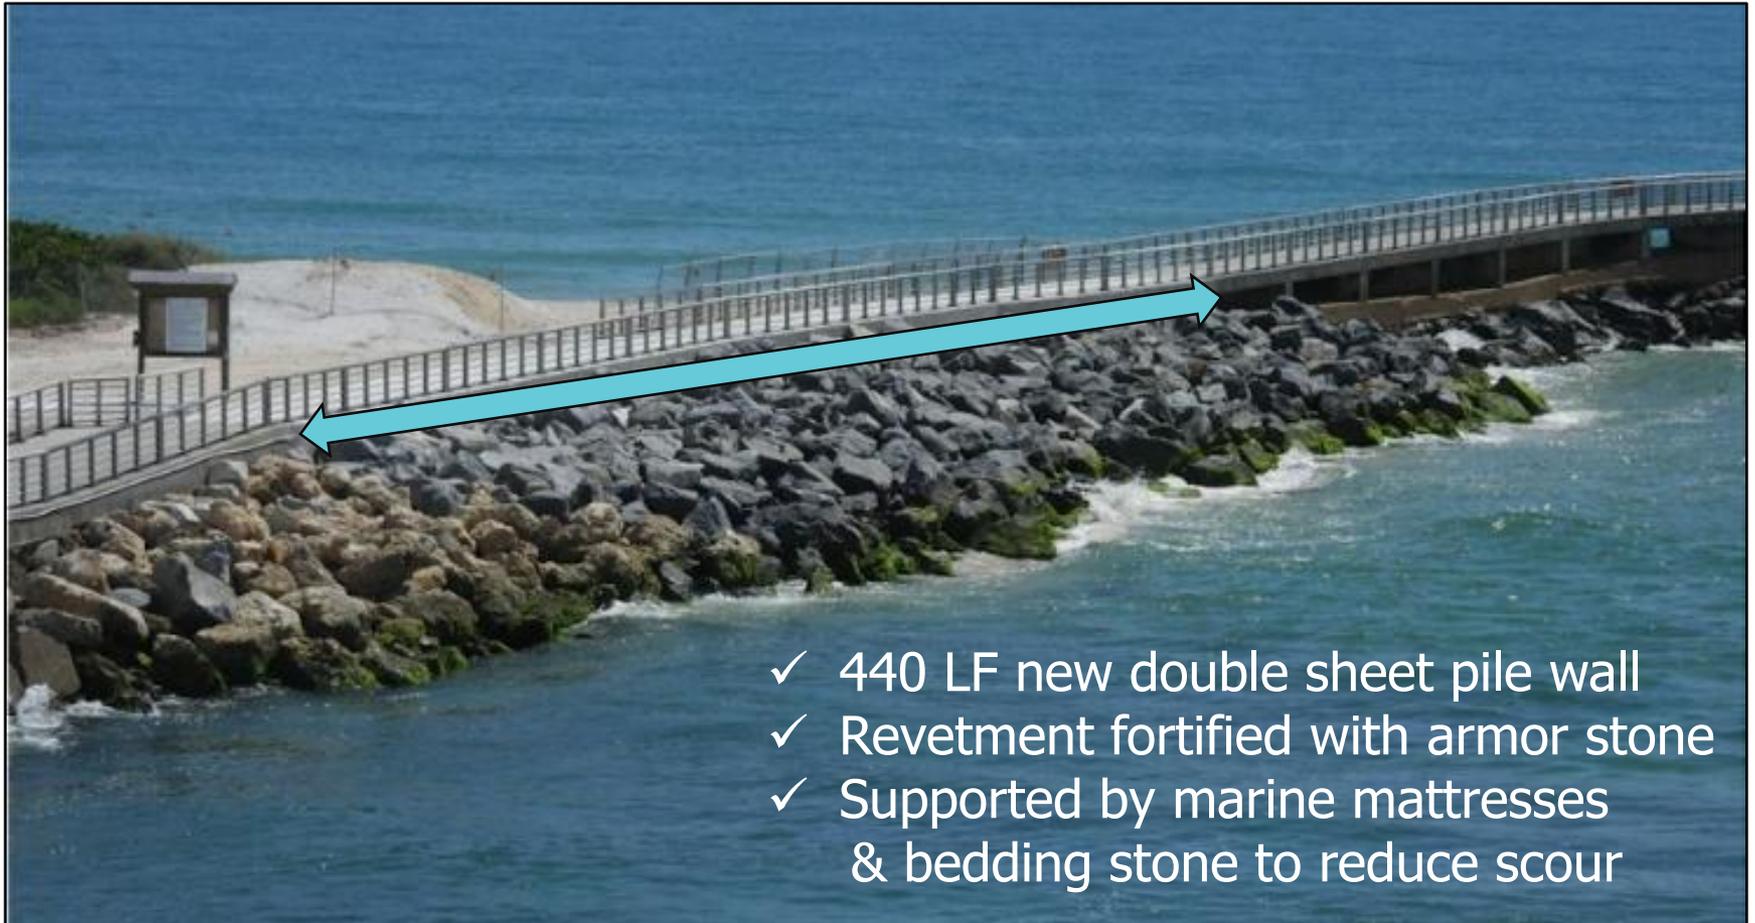
North Jetty Phase 1 Completed Reopened June 30, 2025

- ✓ 440 LF new double sheet pile wall
- ✓ Revetment fortified with armor stone
- ✓ Supported by marine mattresses & bedding stone to reduce scour
