Beach Erosion and Shore Protection along Placencia Peninsula, Belize

School of Geosciences

University of South Florida

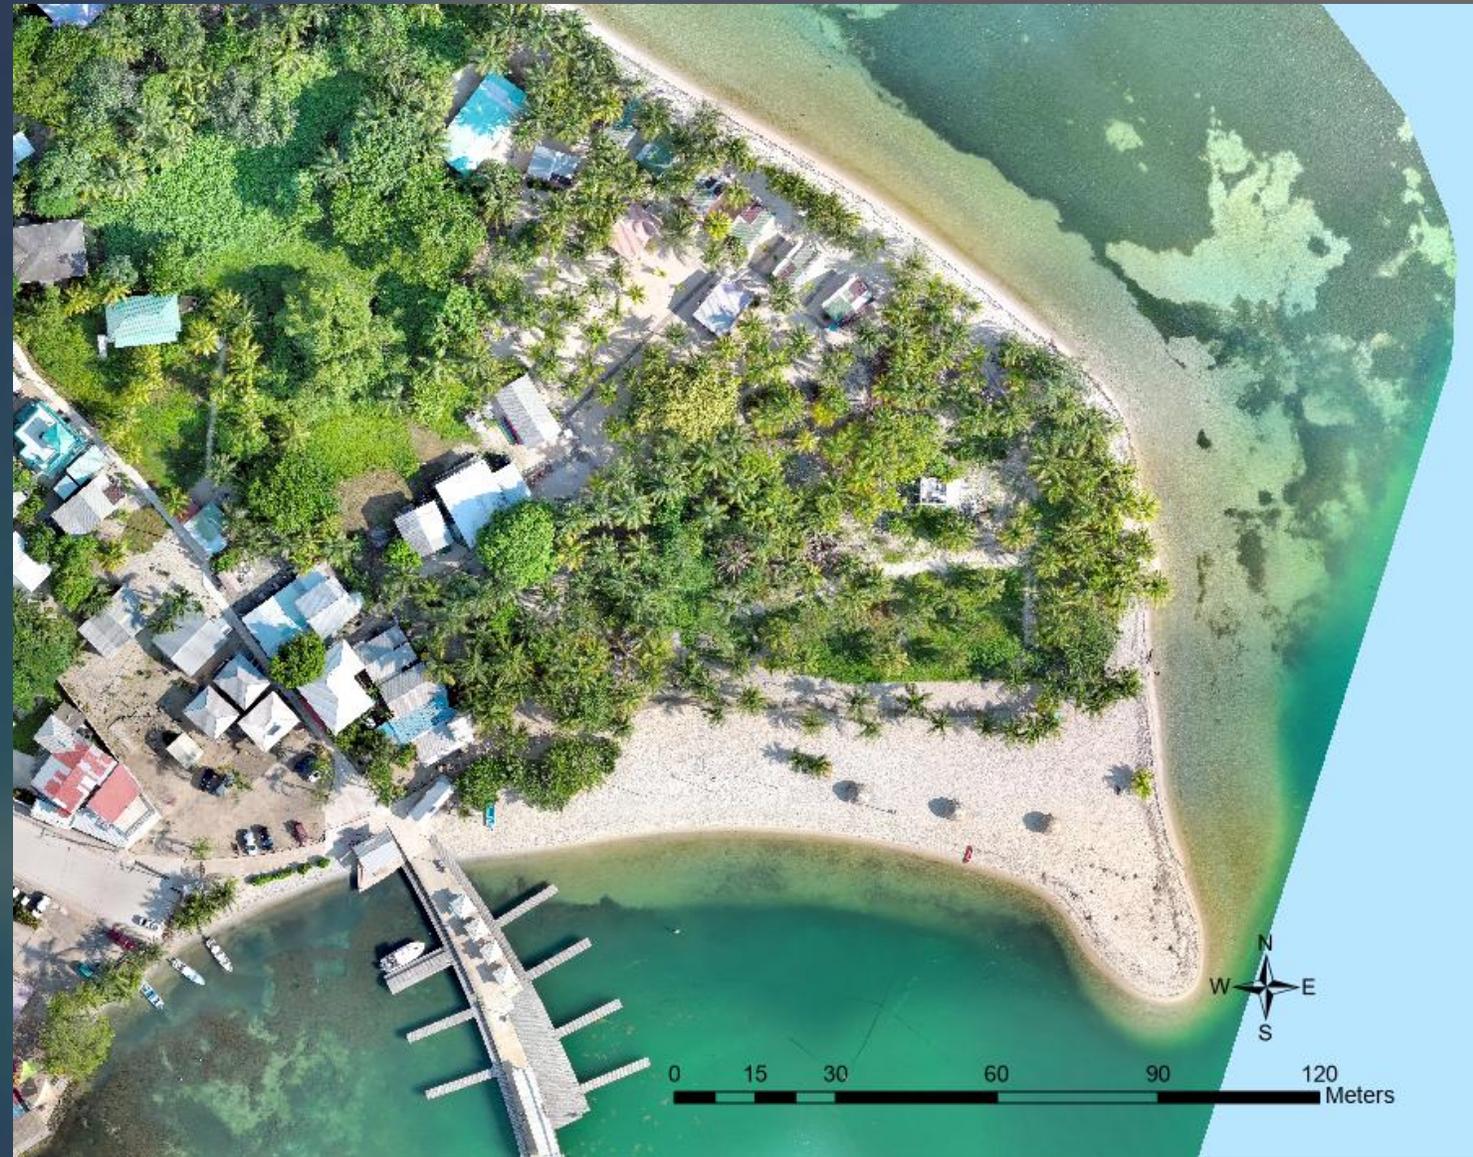
Field Data Collection: detailed drone photos

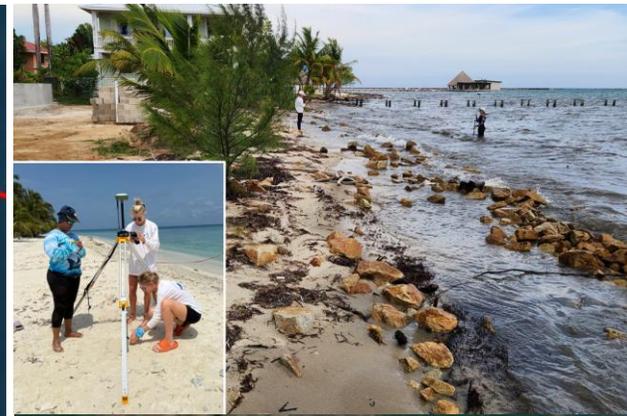
Field Data Collection: bathymetry and beach-profile survey

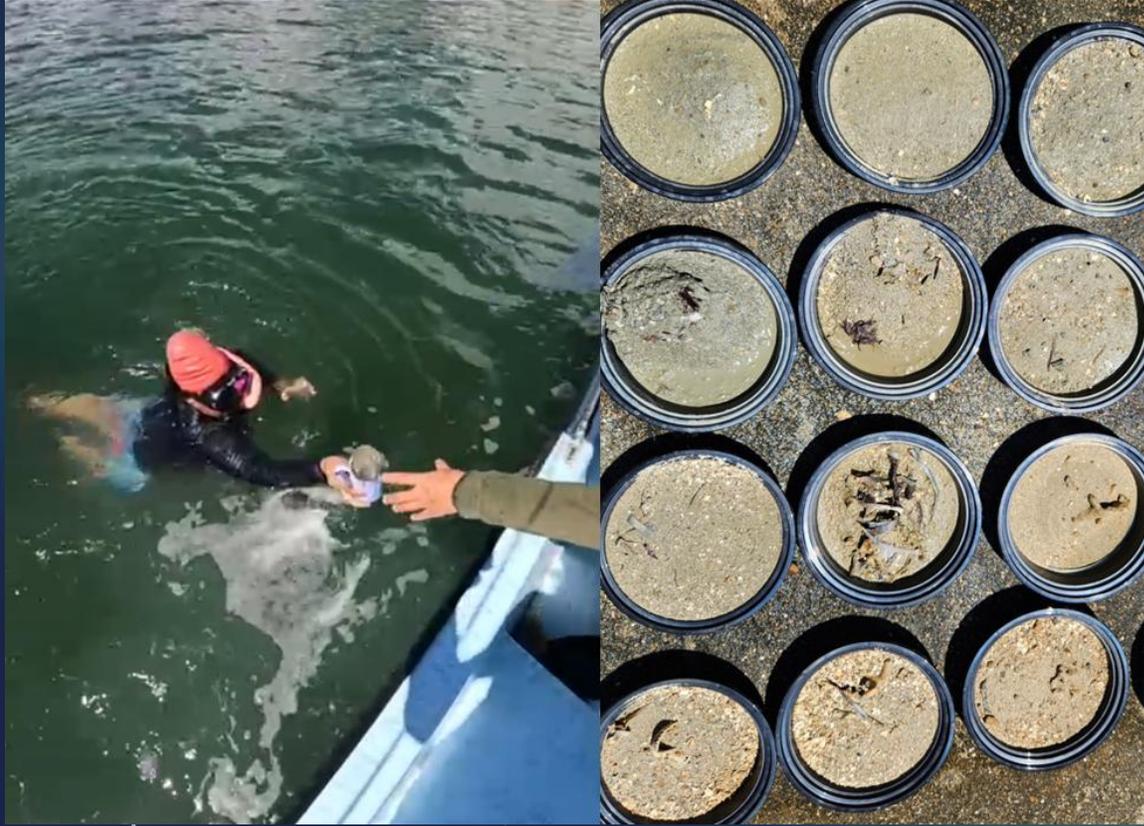
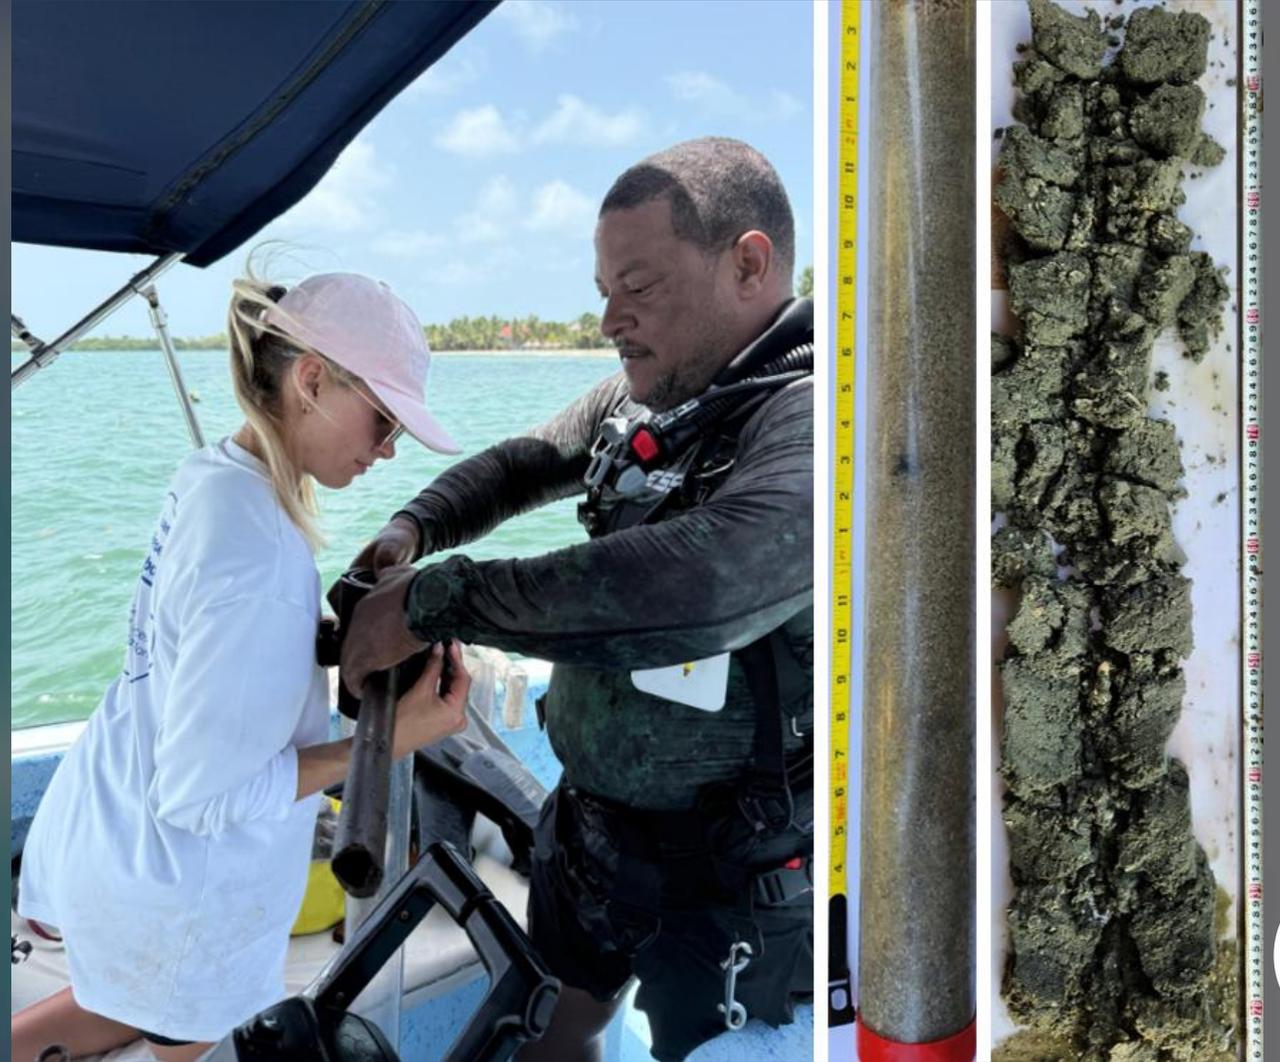
Field Data Collection: surface and sub-surface sediment sampling

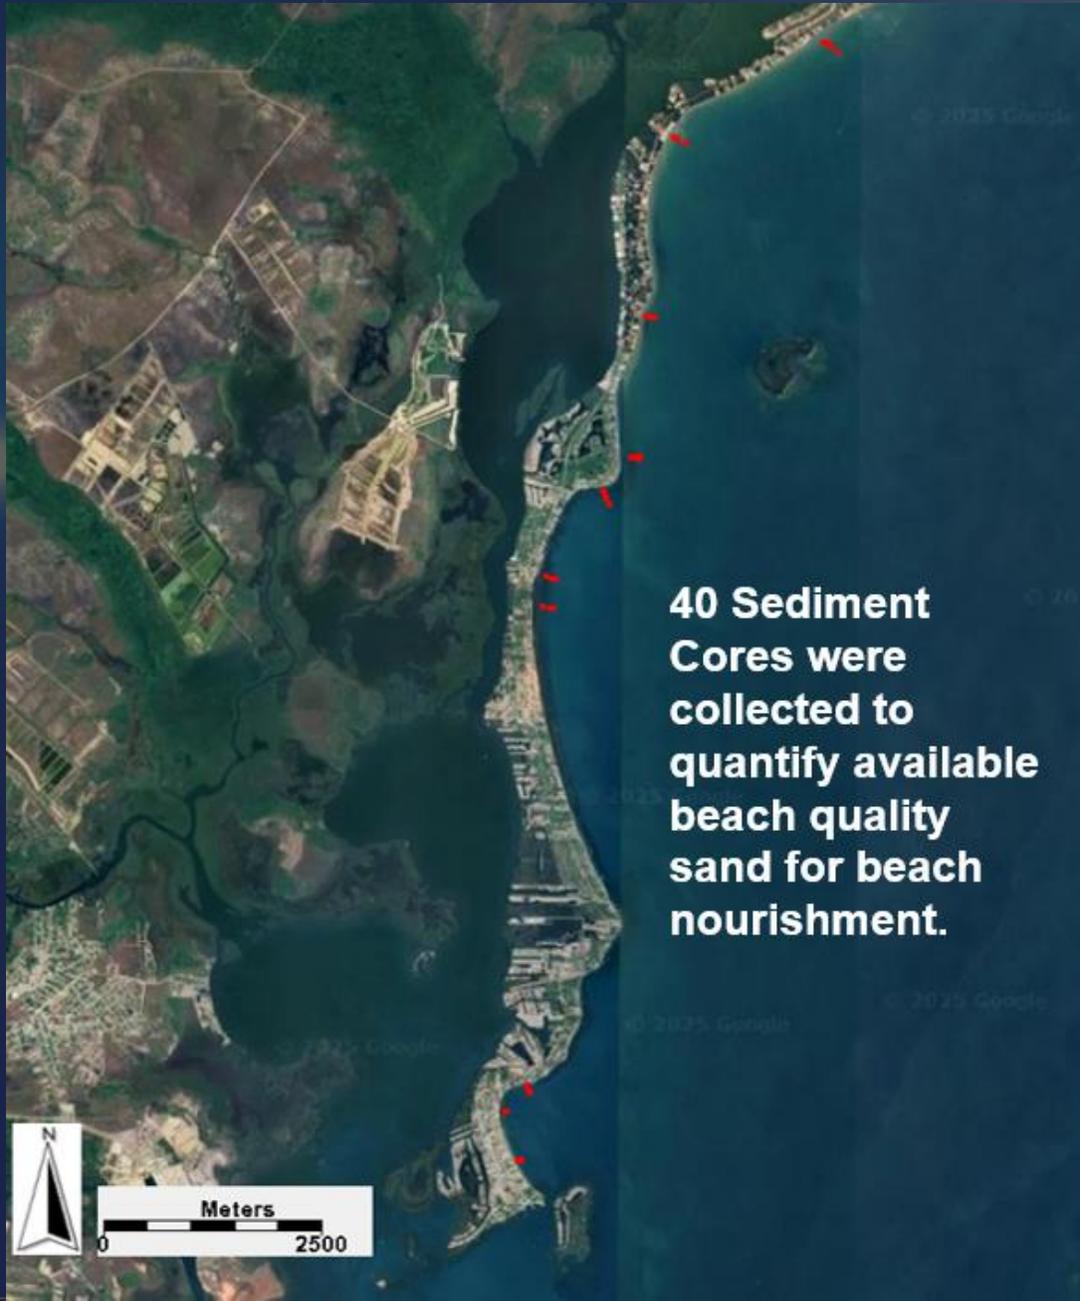
Field Data Collection: surface and sub-surface sediment sampling

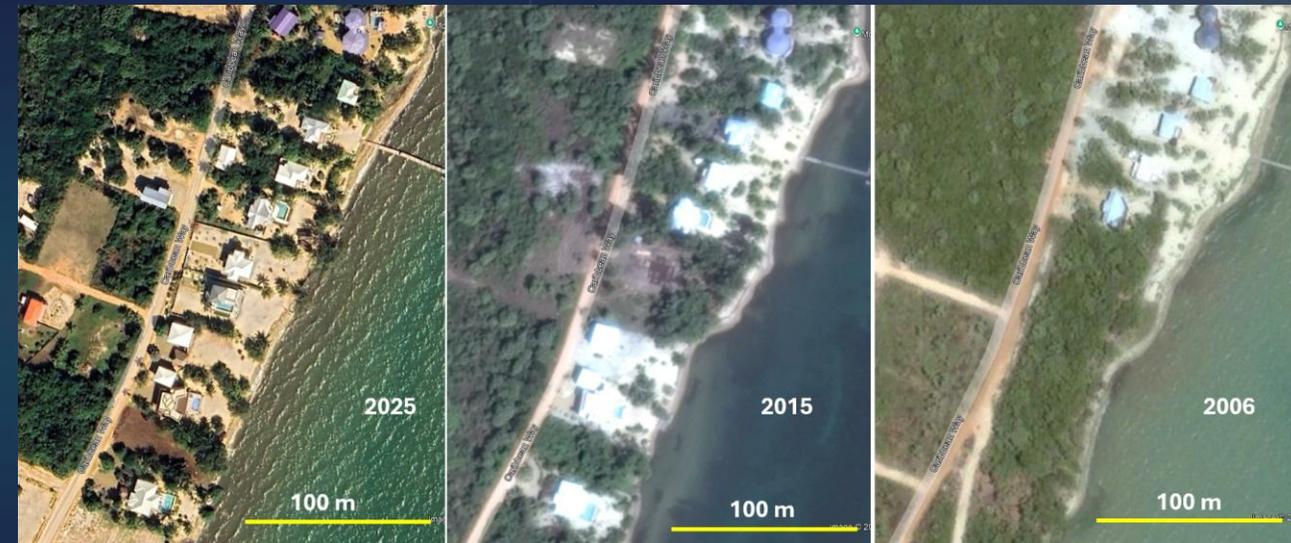
The problem

Following this trend, the coast can become 100% developed in ~31 years since 2004, or ~10 years from now.

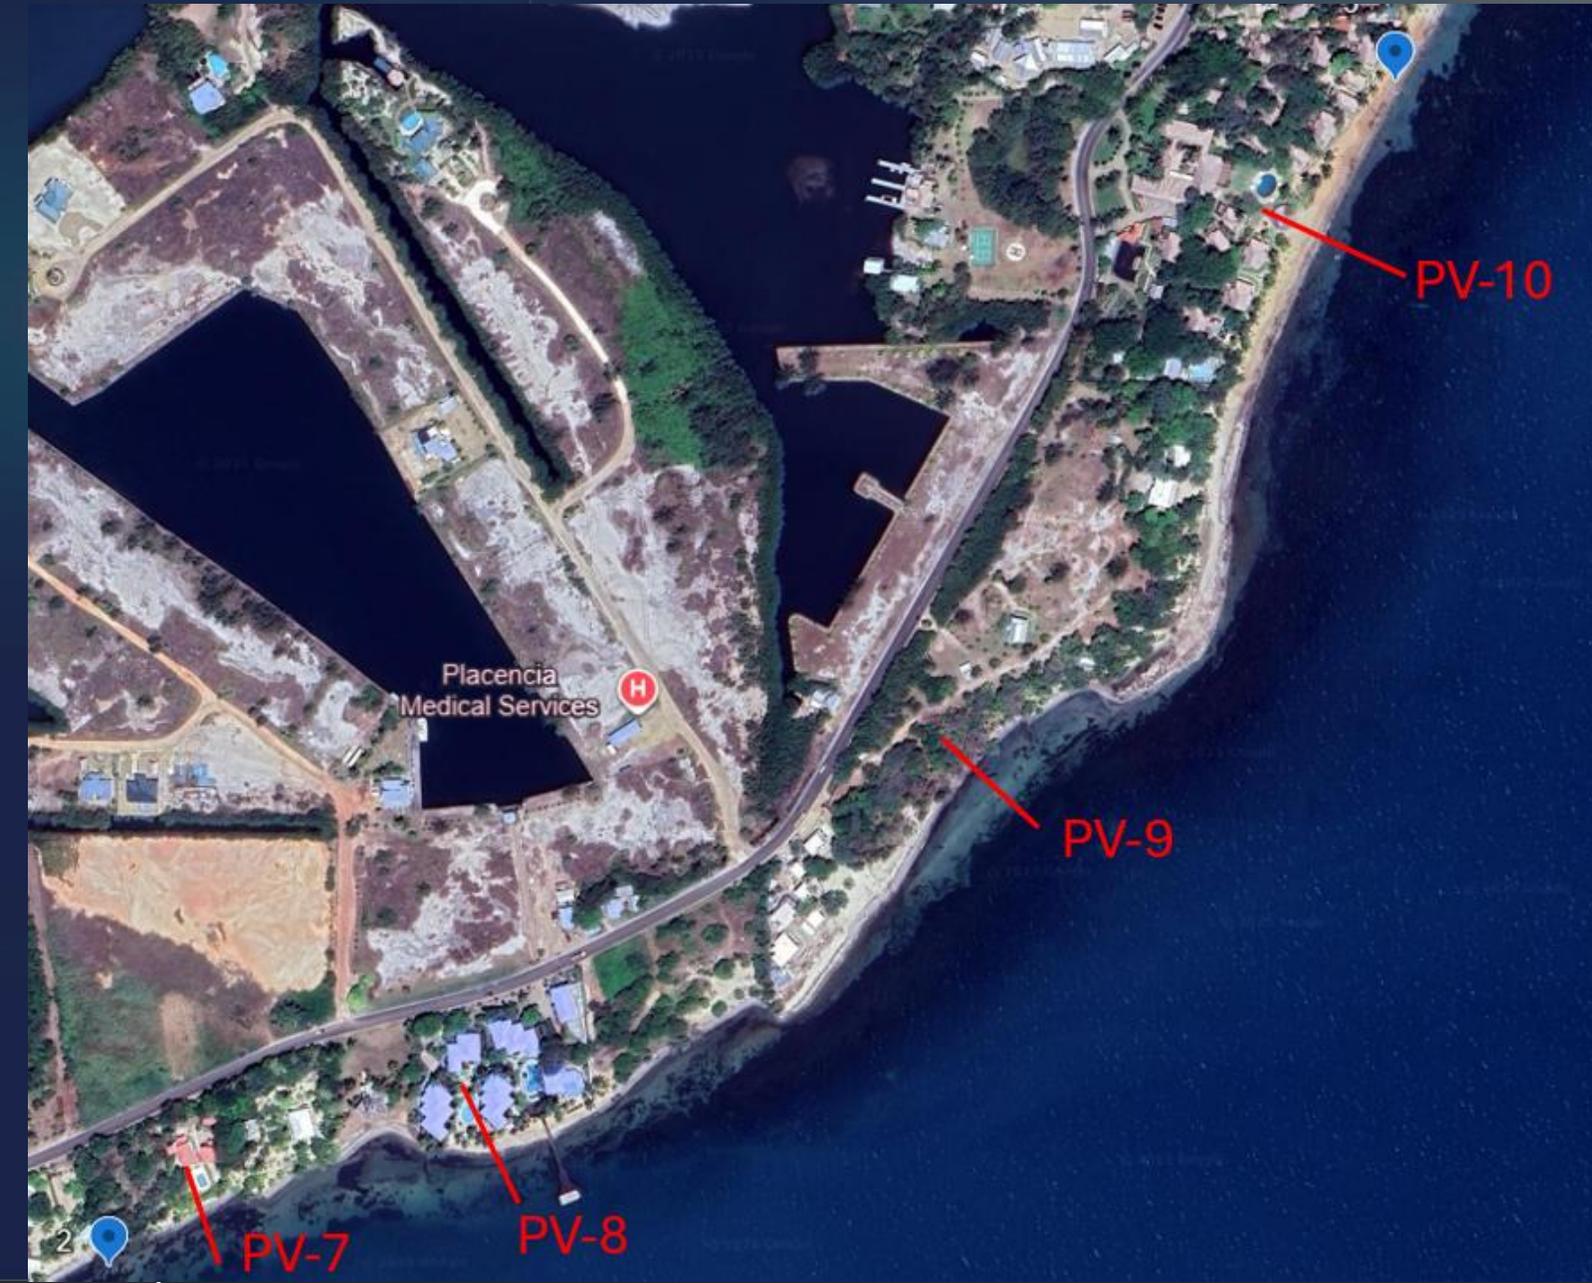
7. Since 2004;
2013- 0.21m loss
2019- .15m loss
2024- 3.14m gain
2025- 4.35m loss

8. Since 2004;
2013- 0.92m loss
2019- 1.3m gain
2024- 9.2m loss
2025- 7.5m loss

9. Since 1988,
2004- 12m loss
2013- 21m loss
2019- 13m loss
2024- 14m loss
2025- 20m loss

10. Since 2004,
2013- 2.5m gain
2019- 4.5m gain
2024- 4.3m gain
2025- 8.8m gain

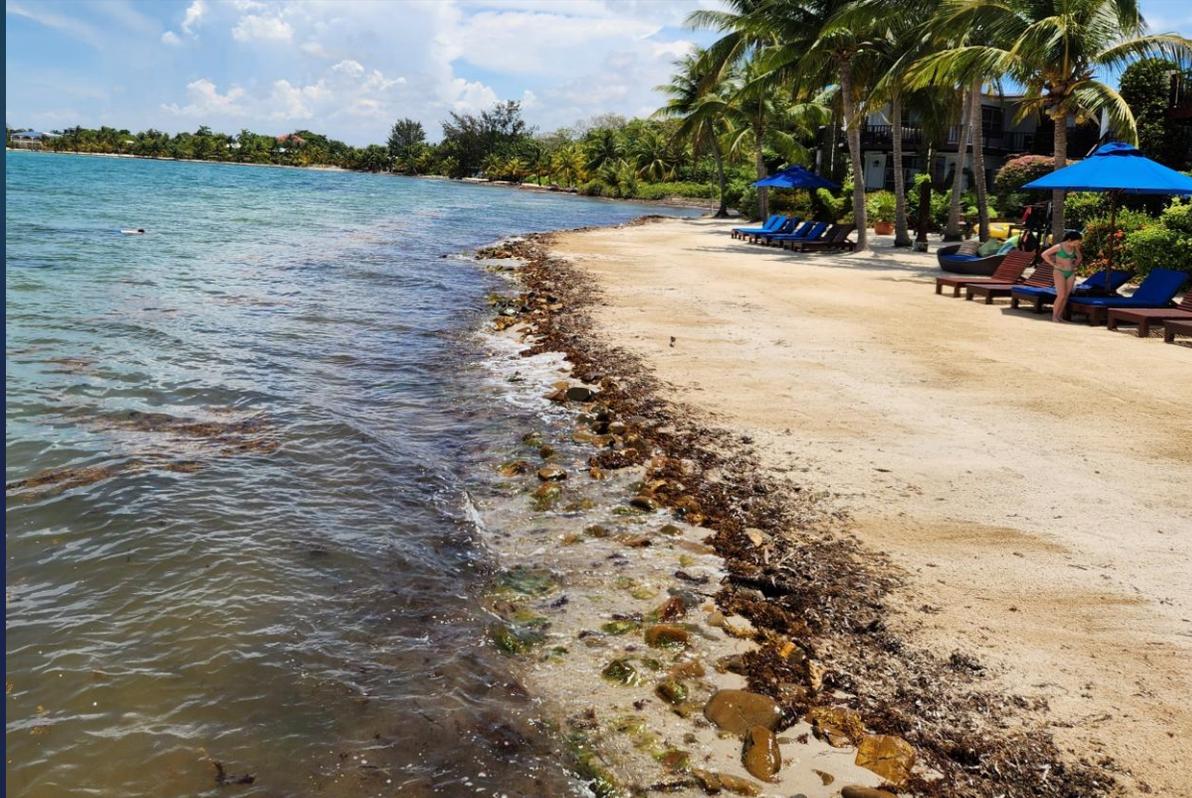
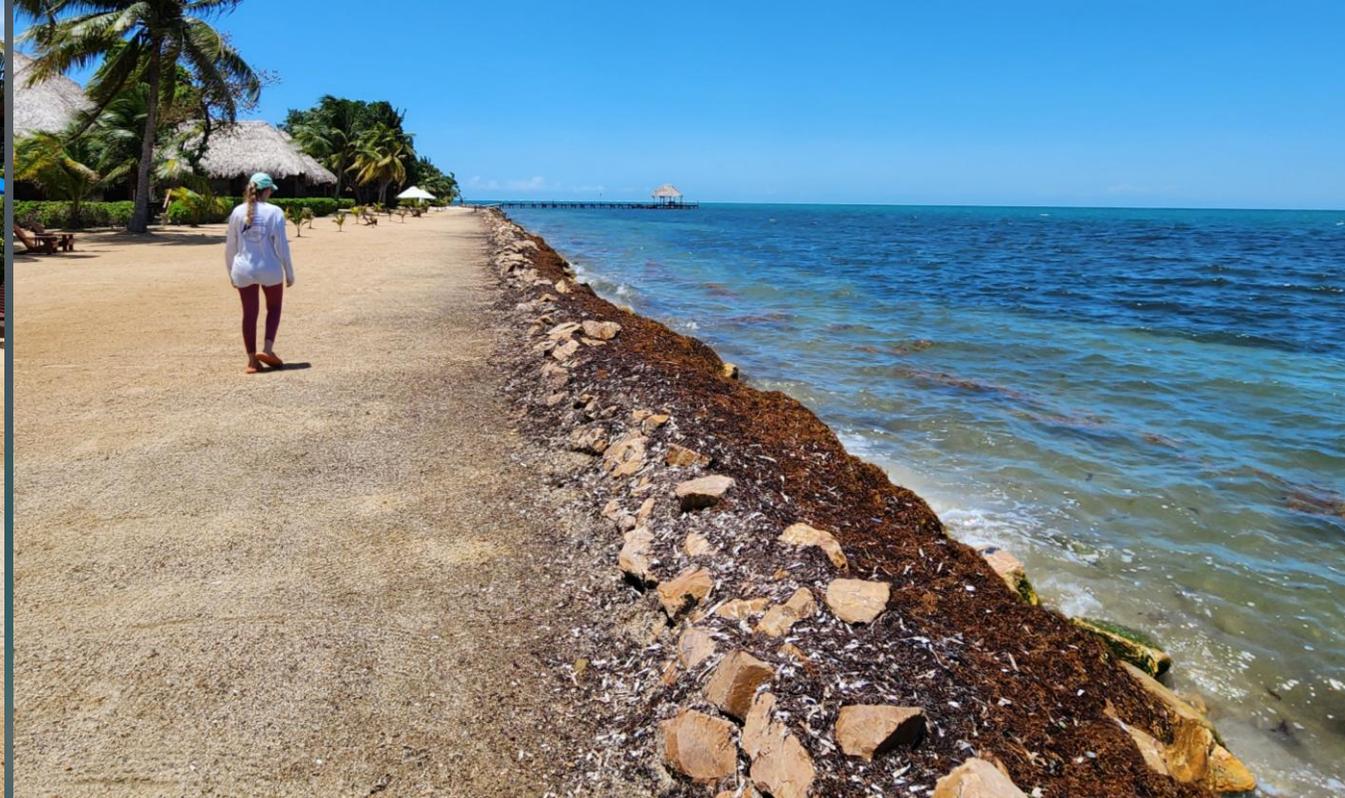
Long-term: Interruption of sand supplies to the coast from rivers

Short-term: interruption of longshore sand transport by property-scale "shore protection" measures

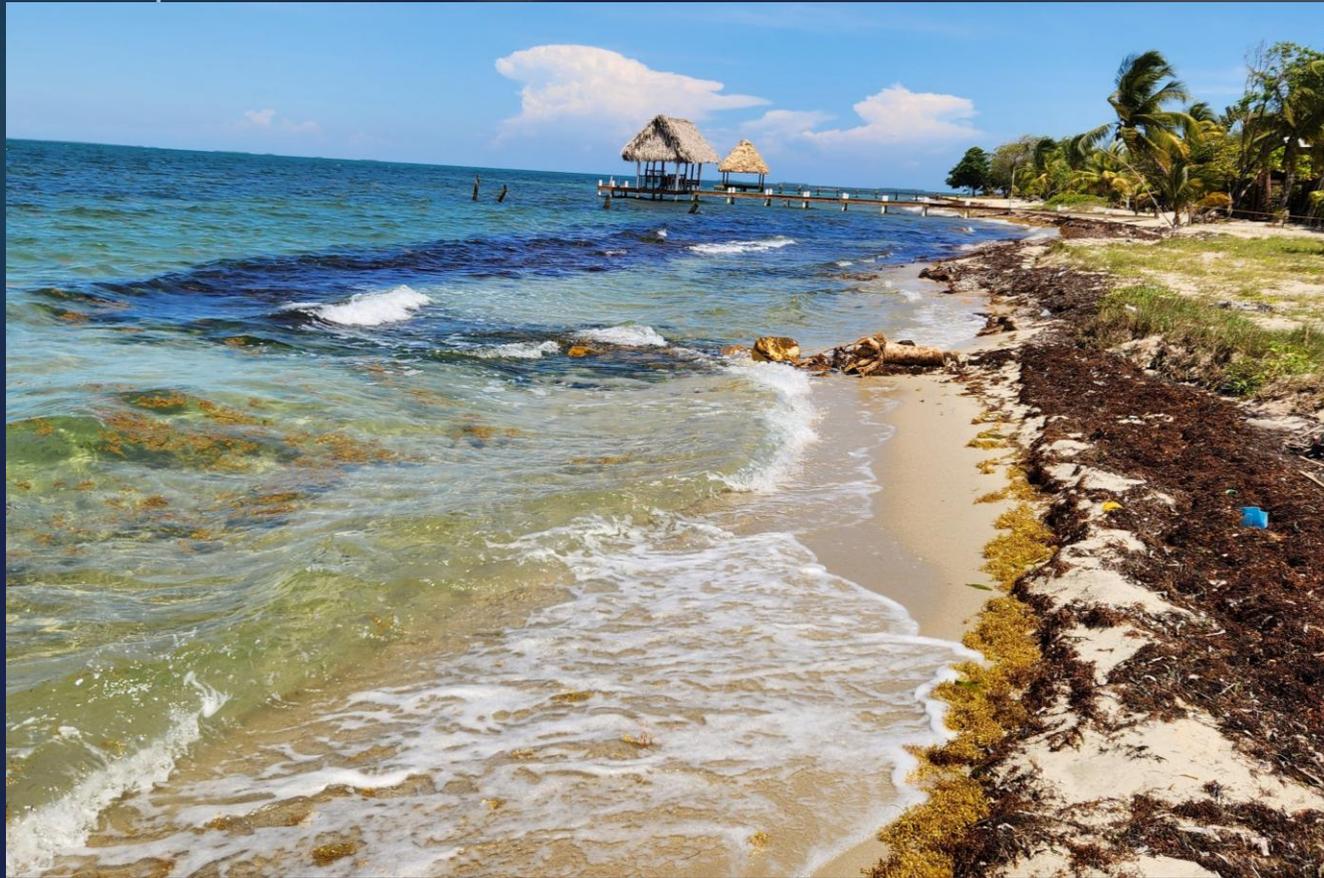
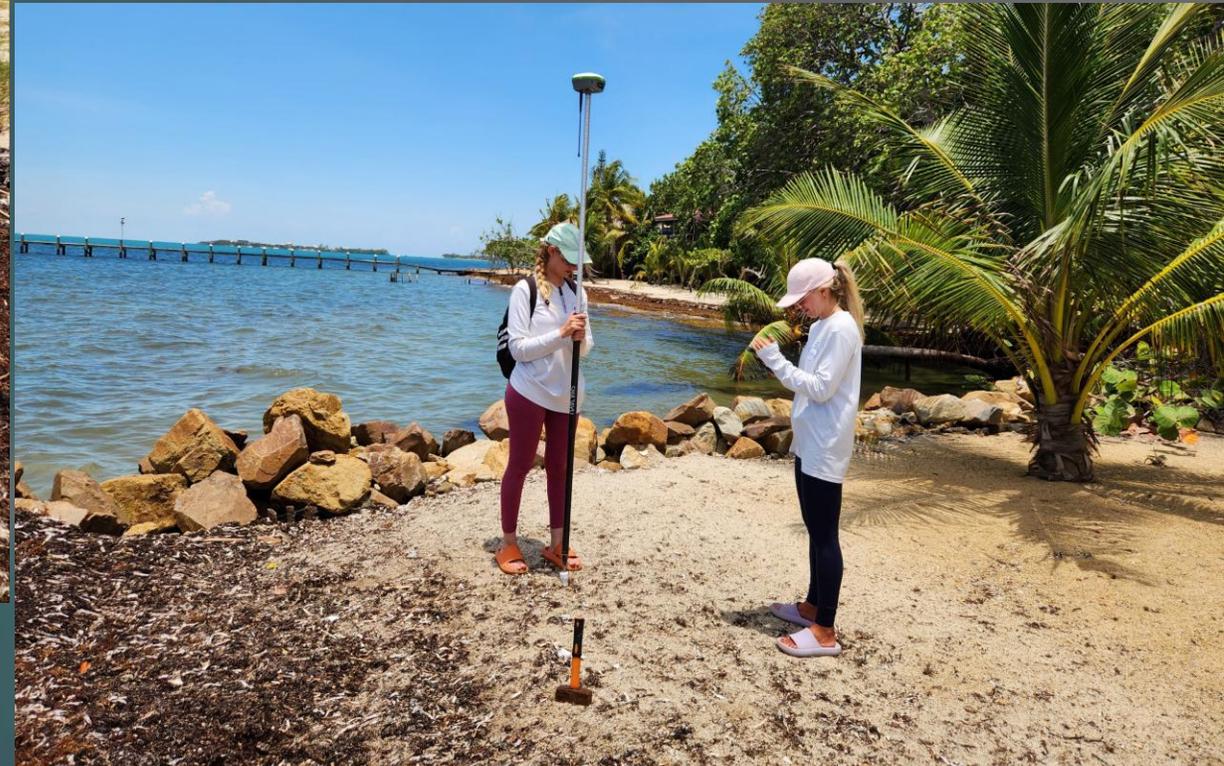
Long-term: Interruption of sand supplies to the coast from rivers

Short-term: interruption of longshore sand transport by property-scale "shore protection" measures

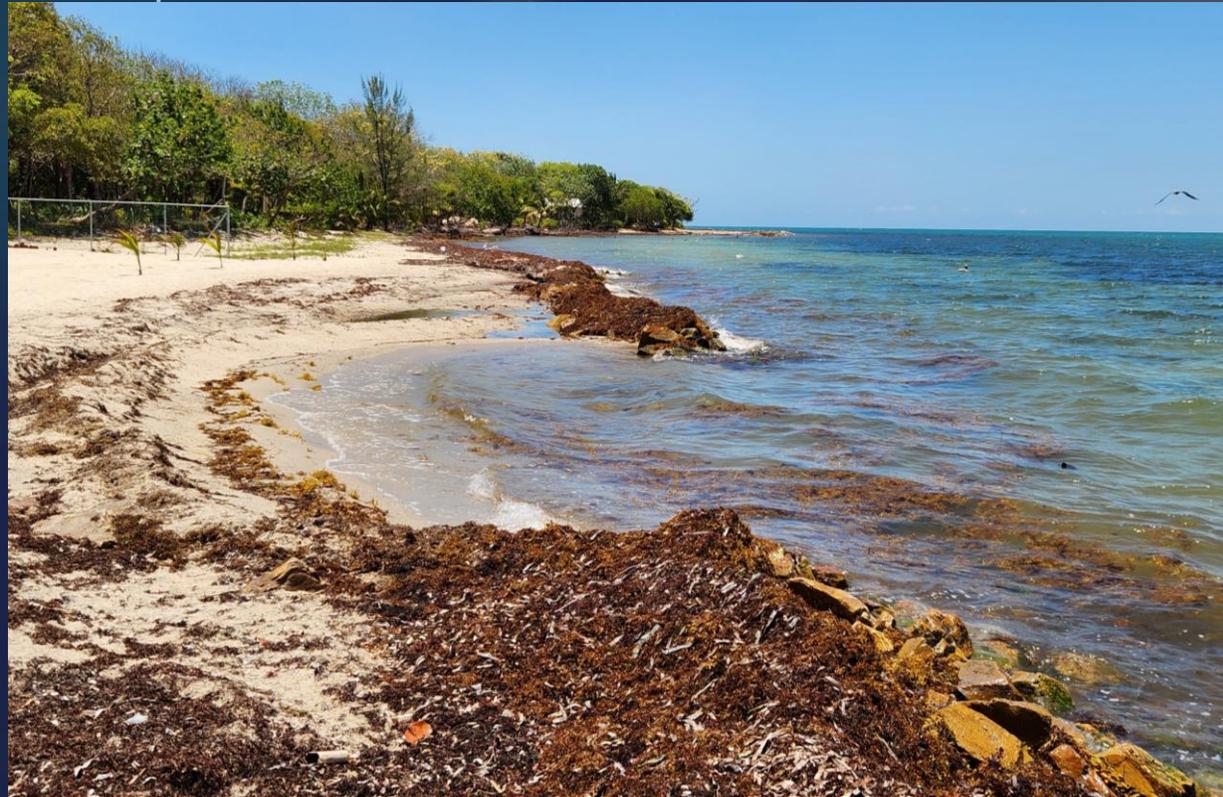
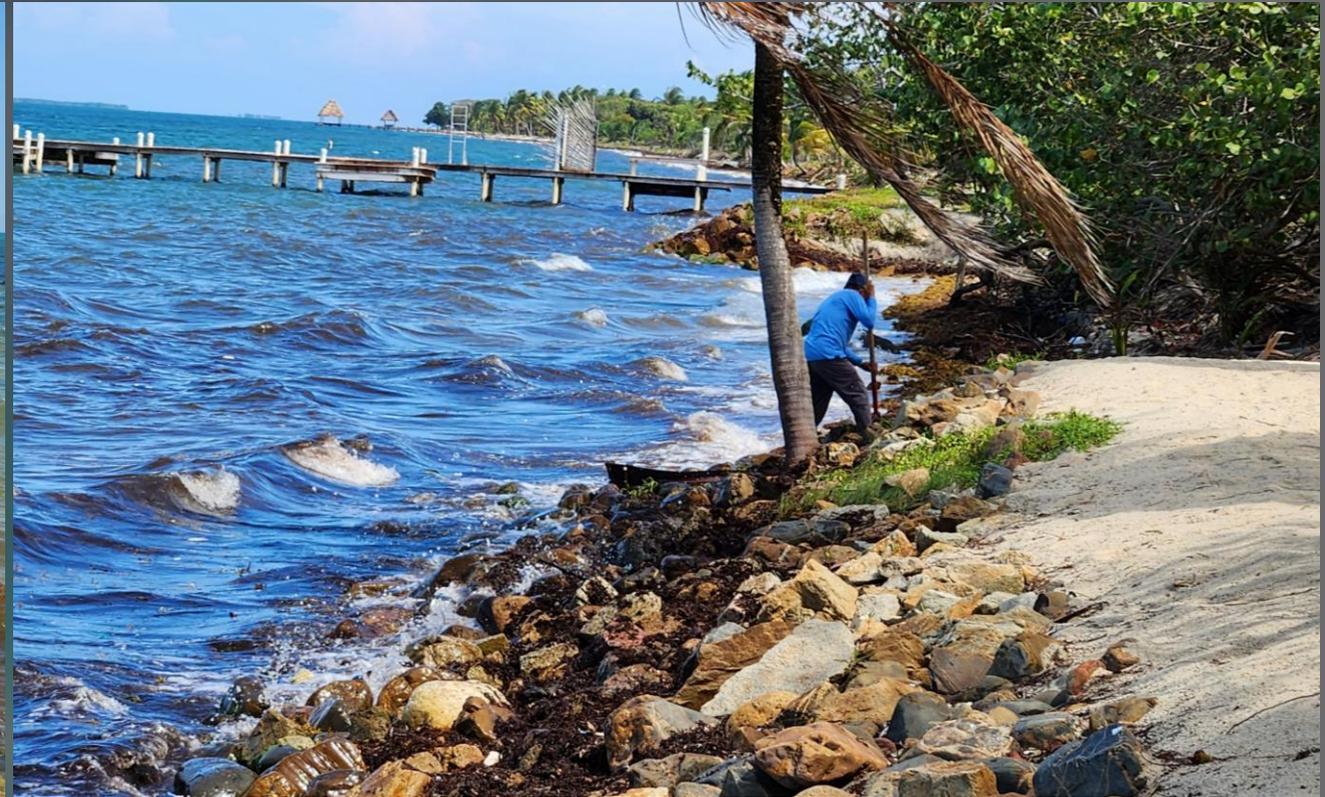
Long-term: Interruption of sand supplies to the coast from rivers

Short-term: interruption of longshore sand transport by property-scale "shore protection" measures

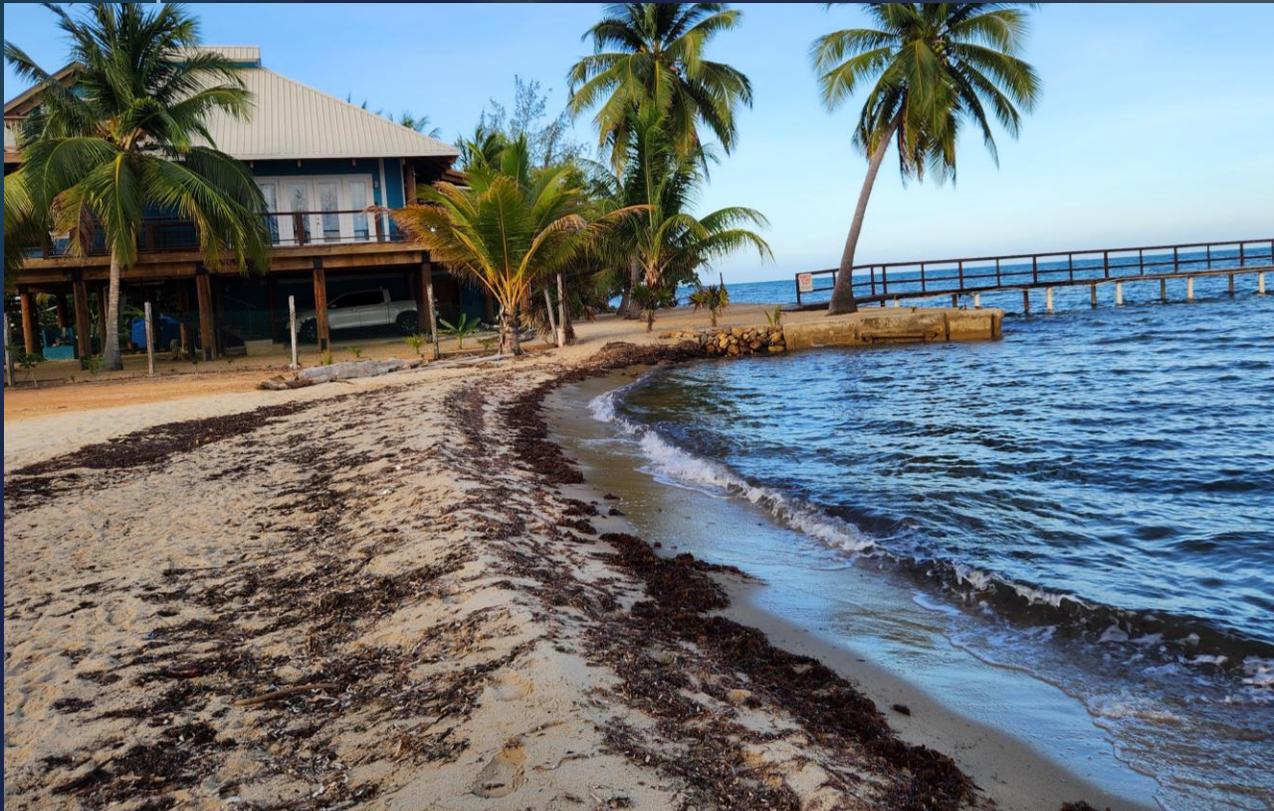
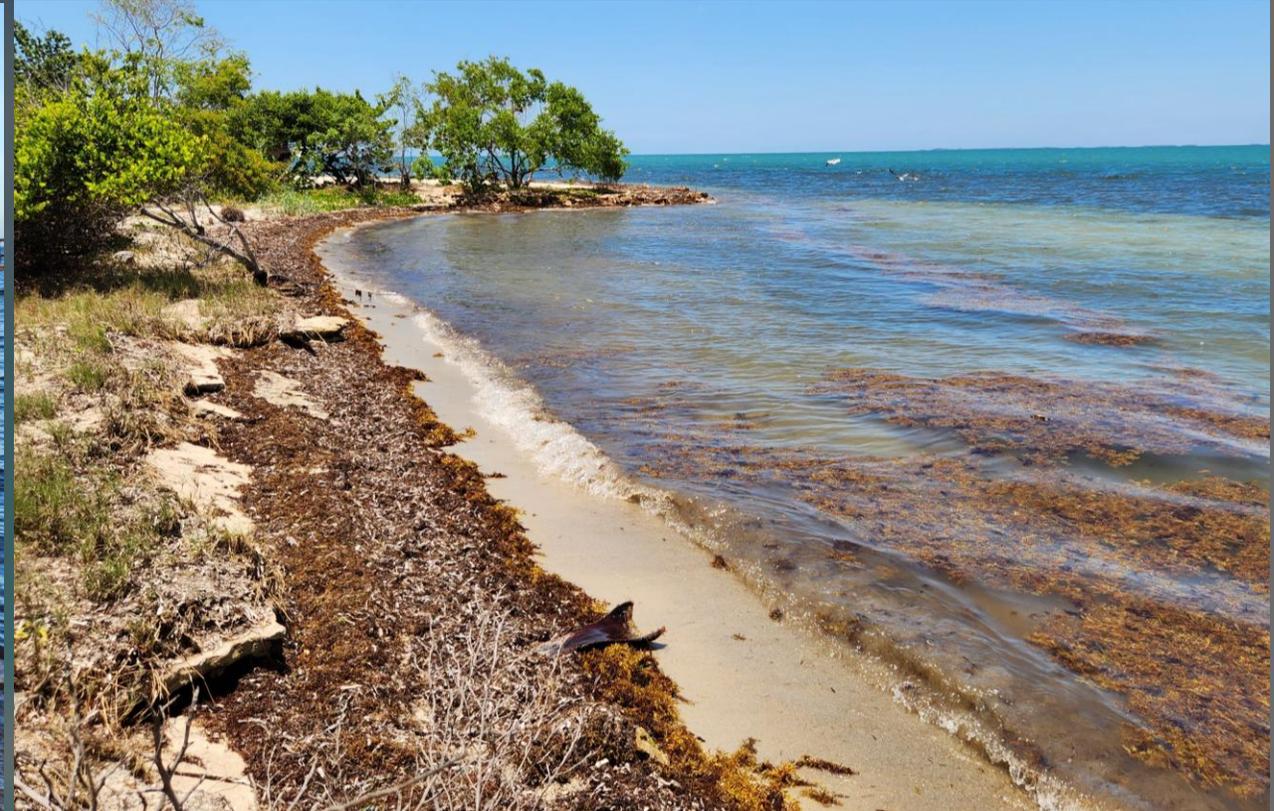
Long-term: Interruption of sand supplies to the coast from rivers

Short-term: interruption of longshore sand transport by property-scale "shore protection" measures

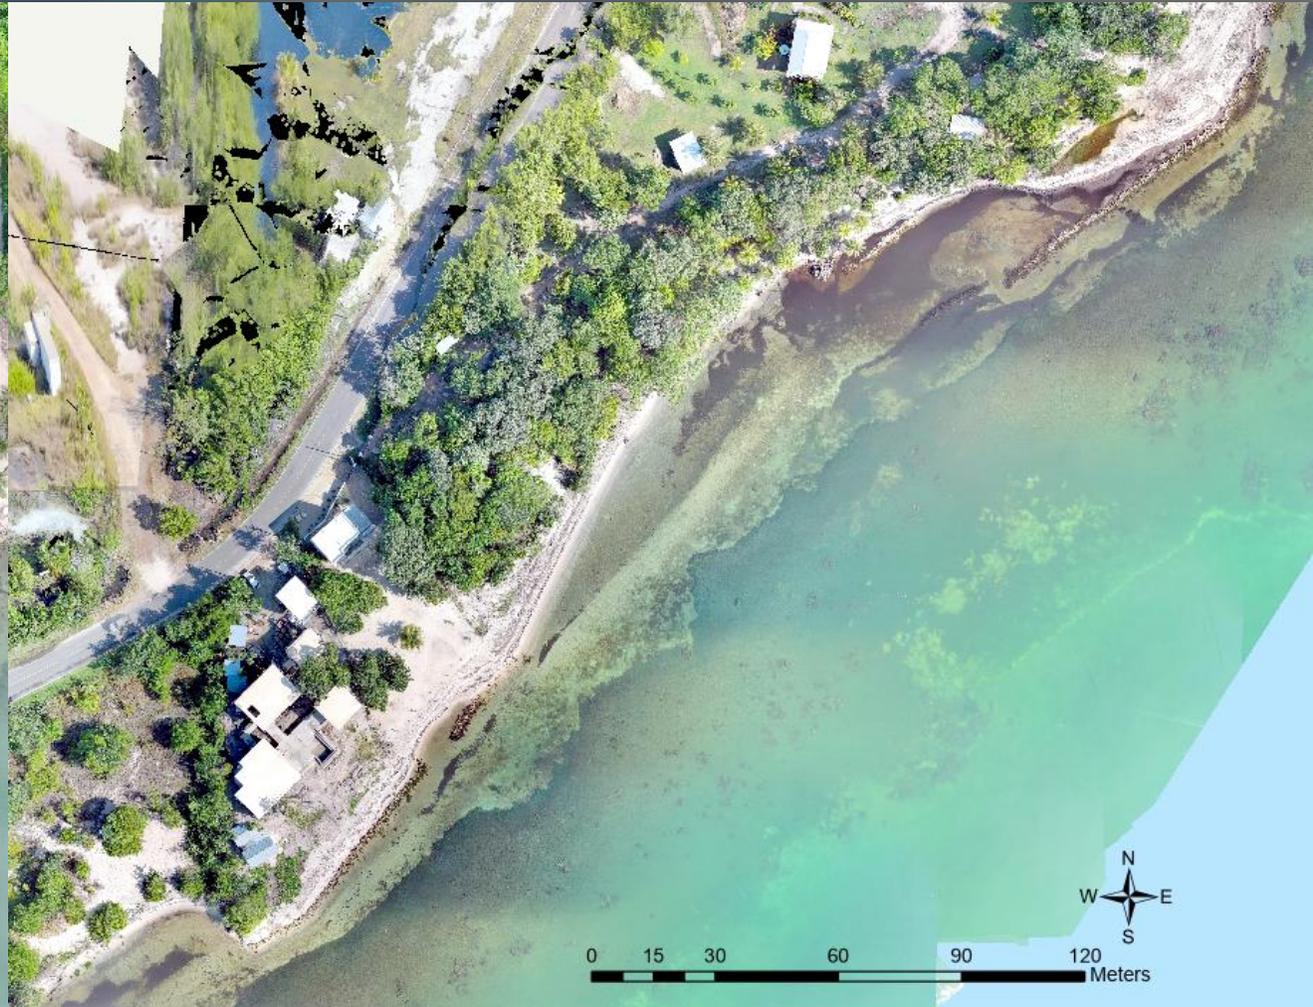
Long-term: Interruption of sand supplies to the coast from rivers

Short-term: interruption of longshore sand transport by property-scale "shore protection" measures

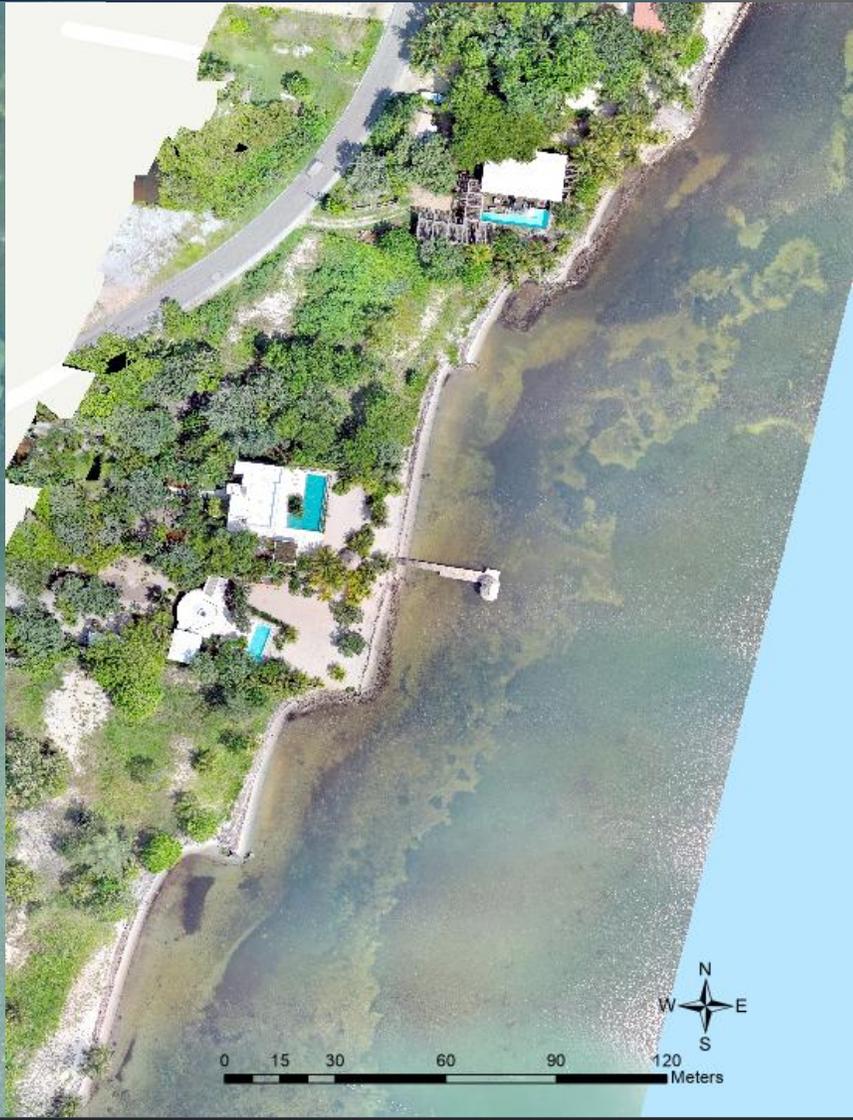
Long-term: Interruption of sand supplies to the coast from rivers

Short-term: interruption of longshore sand transport by property-scale "shore protection" measures

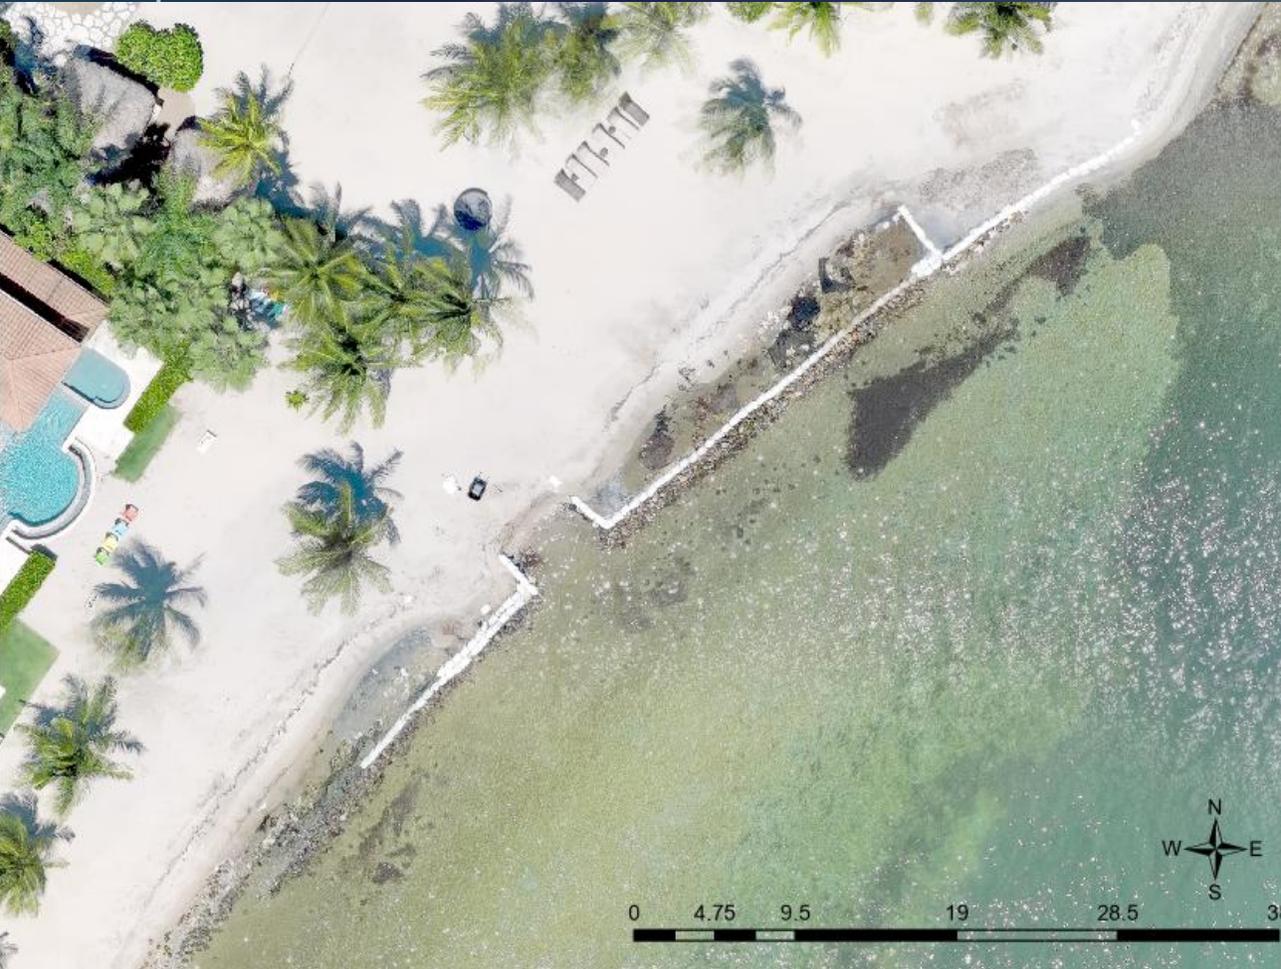
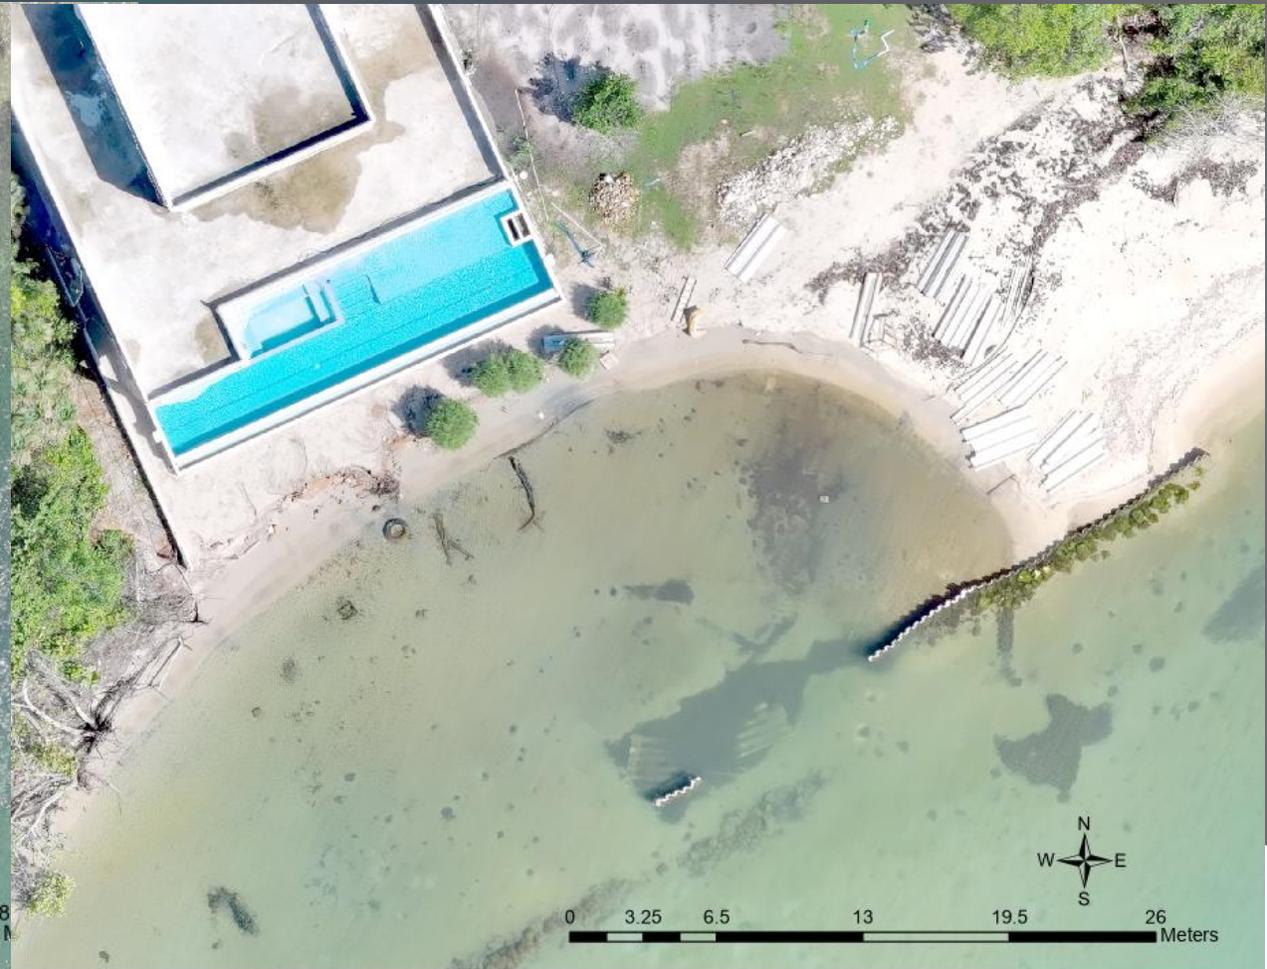
Long-term: Interruption of sand supplies to the coast from rivers

Short-term: interruption of longshore sand transport by property-scale "shore protection" measures
