Beach Erosion and Shore Protection along Placencia Peninsula, Belize

School of Geosciences

University of South Florida

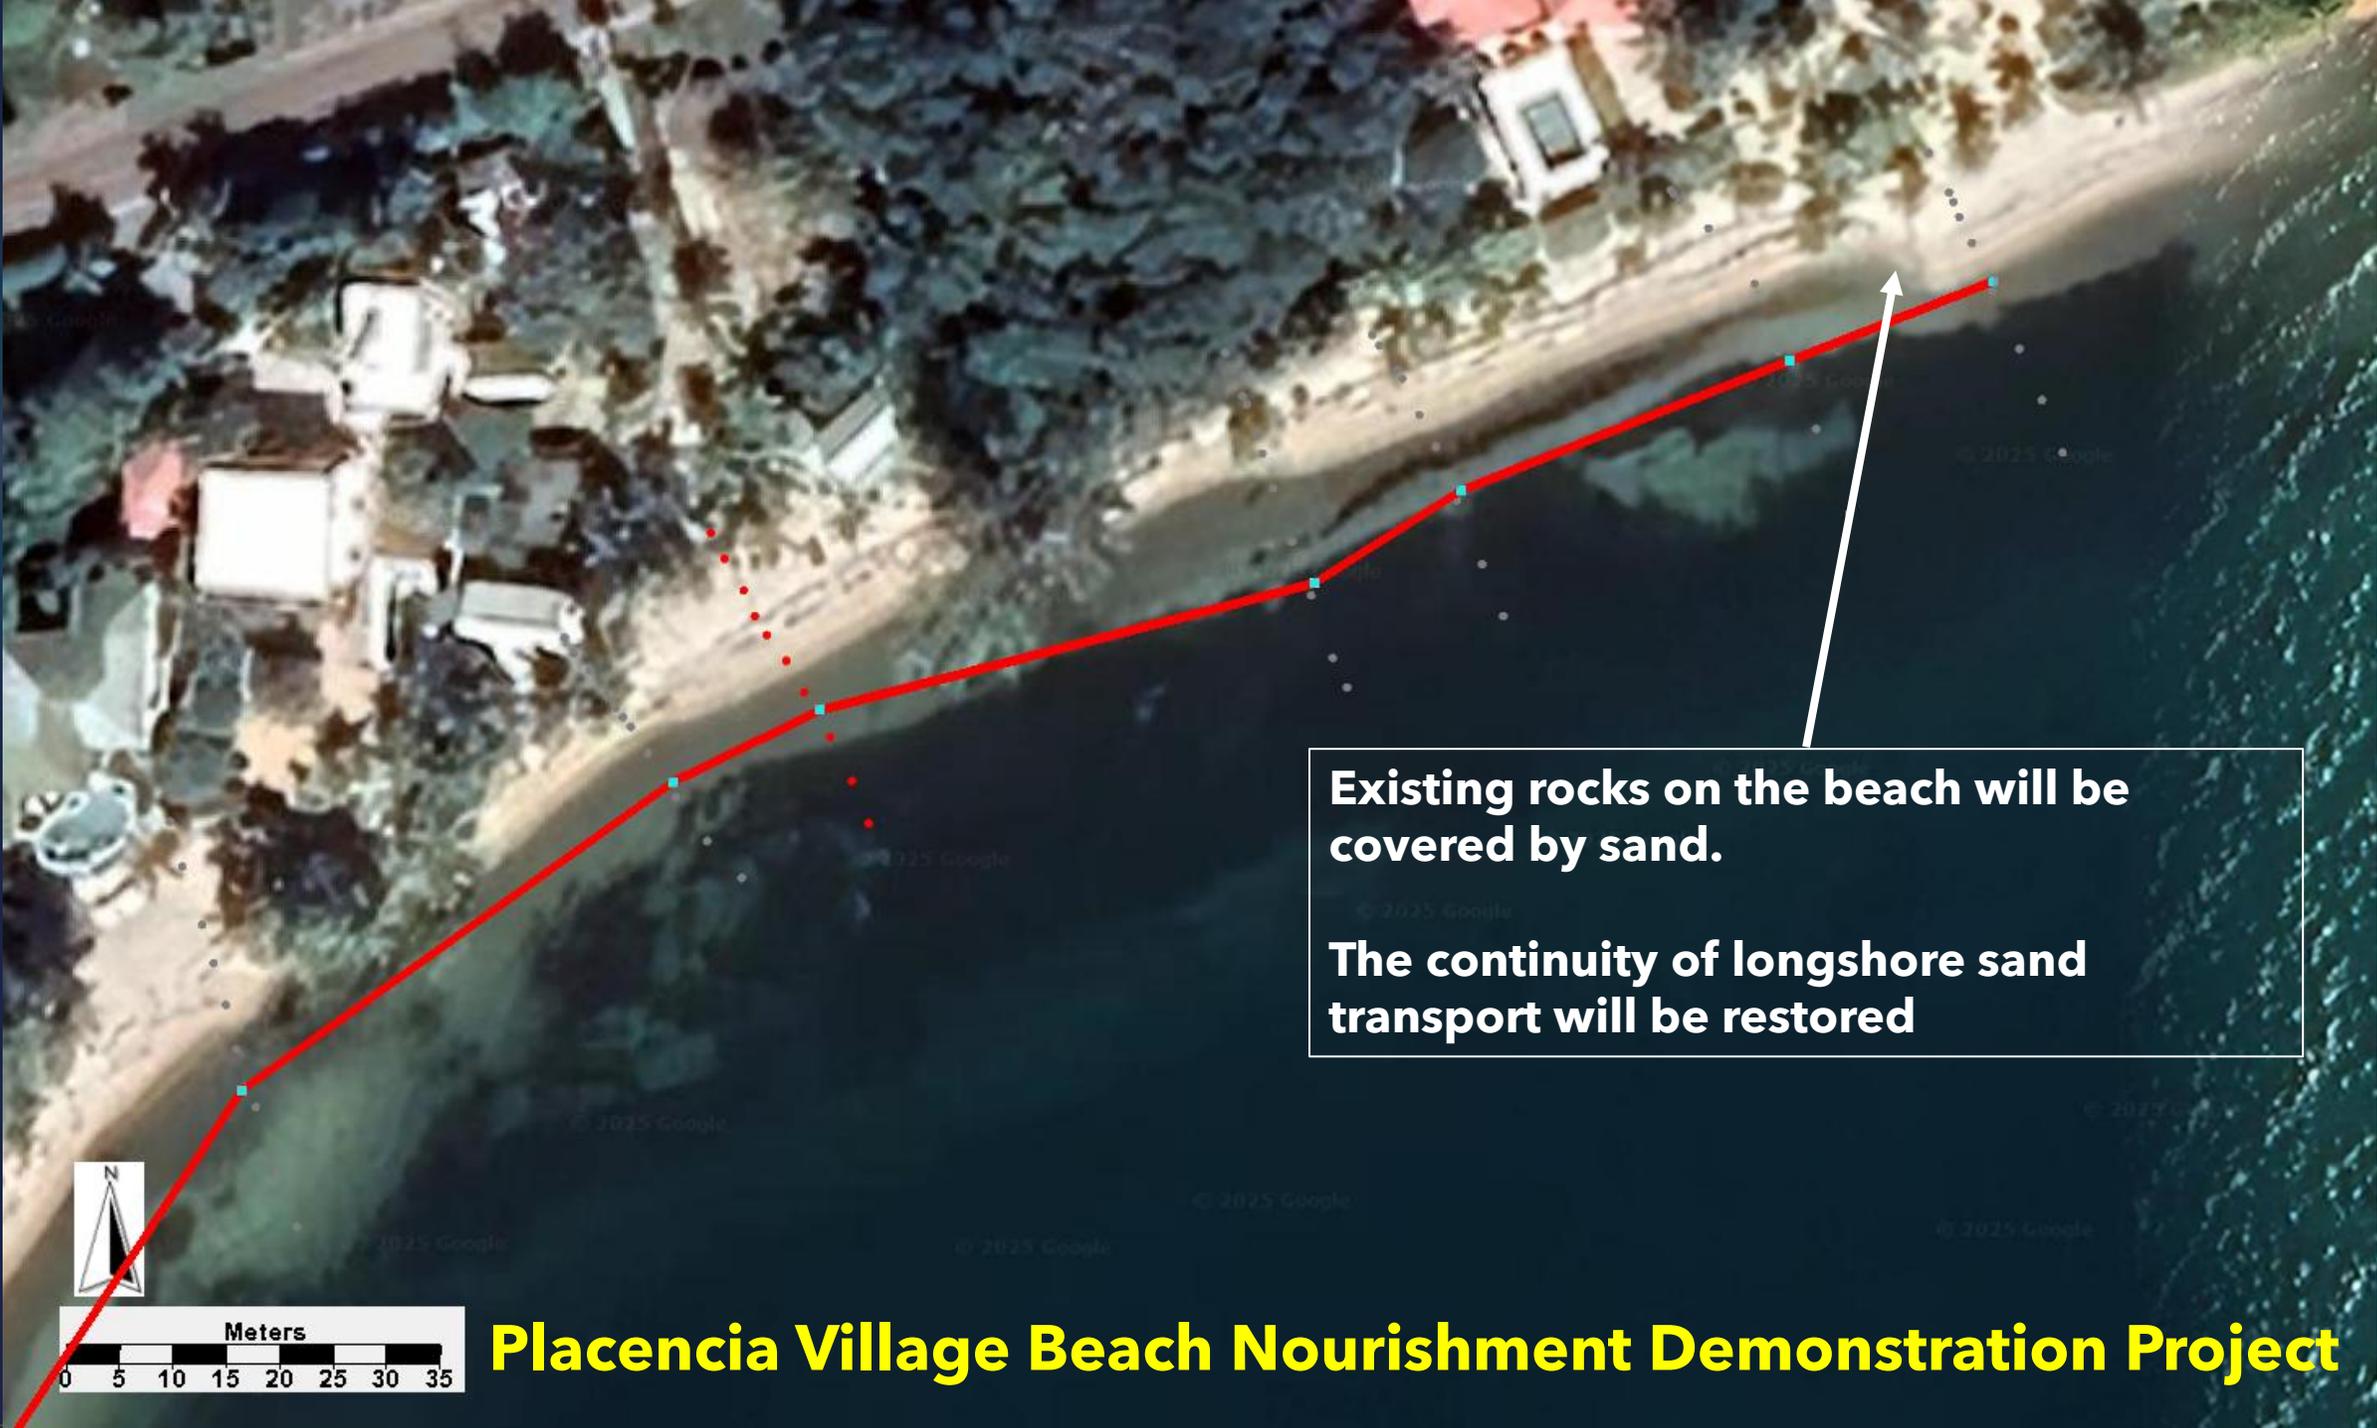
Design of beach nourishment demonstration projects

Existing rocks on the beach will be covered by sand.

The continuity of longshore sand transport will be restored

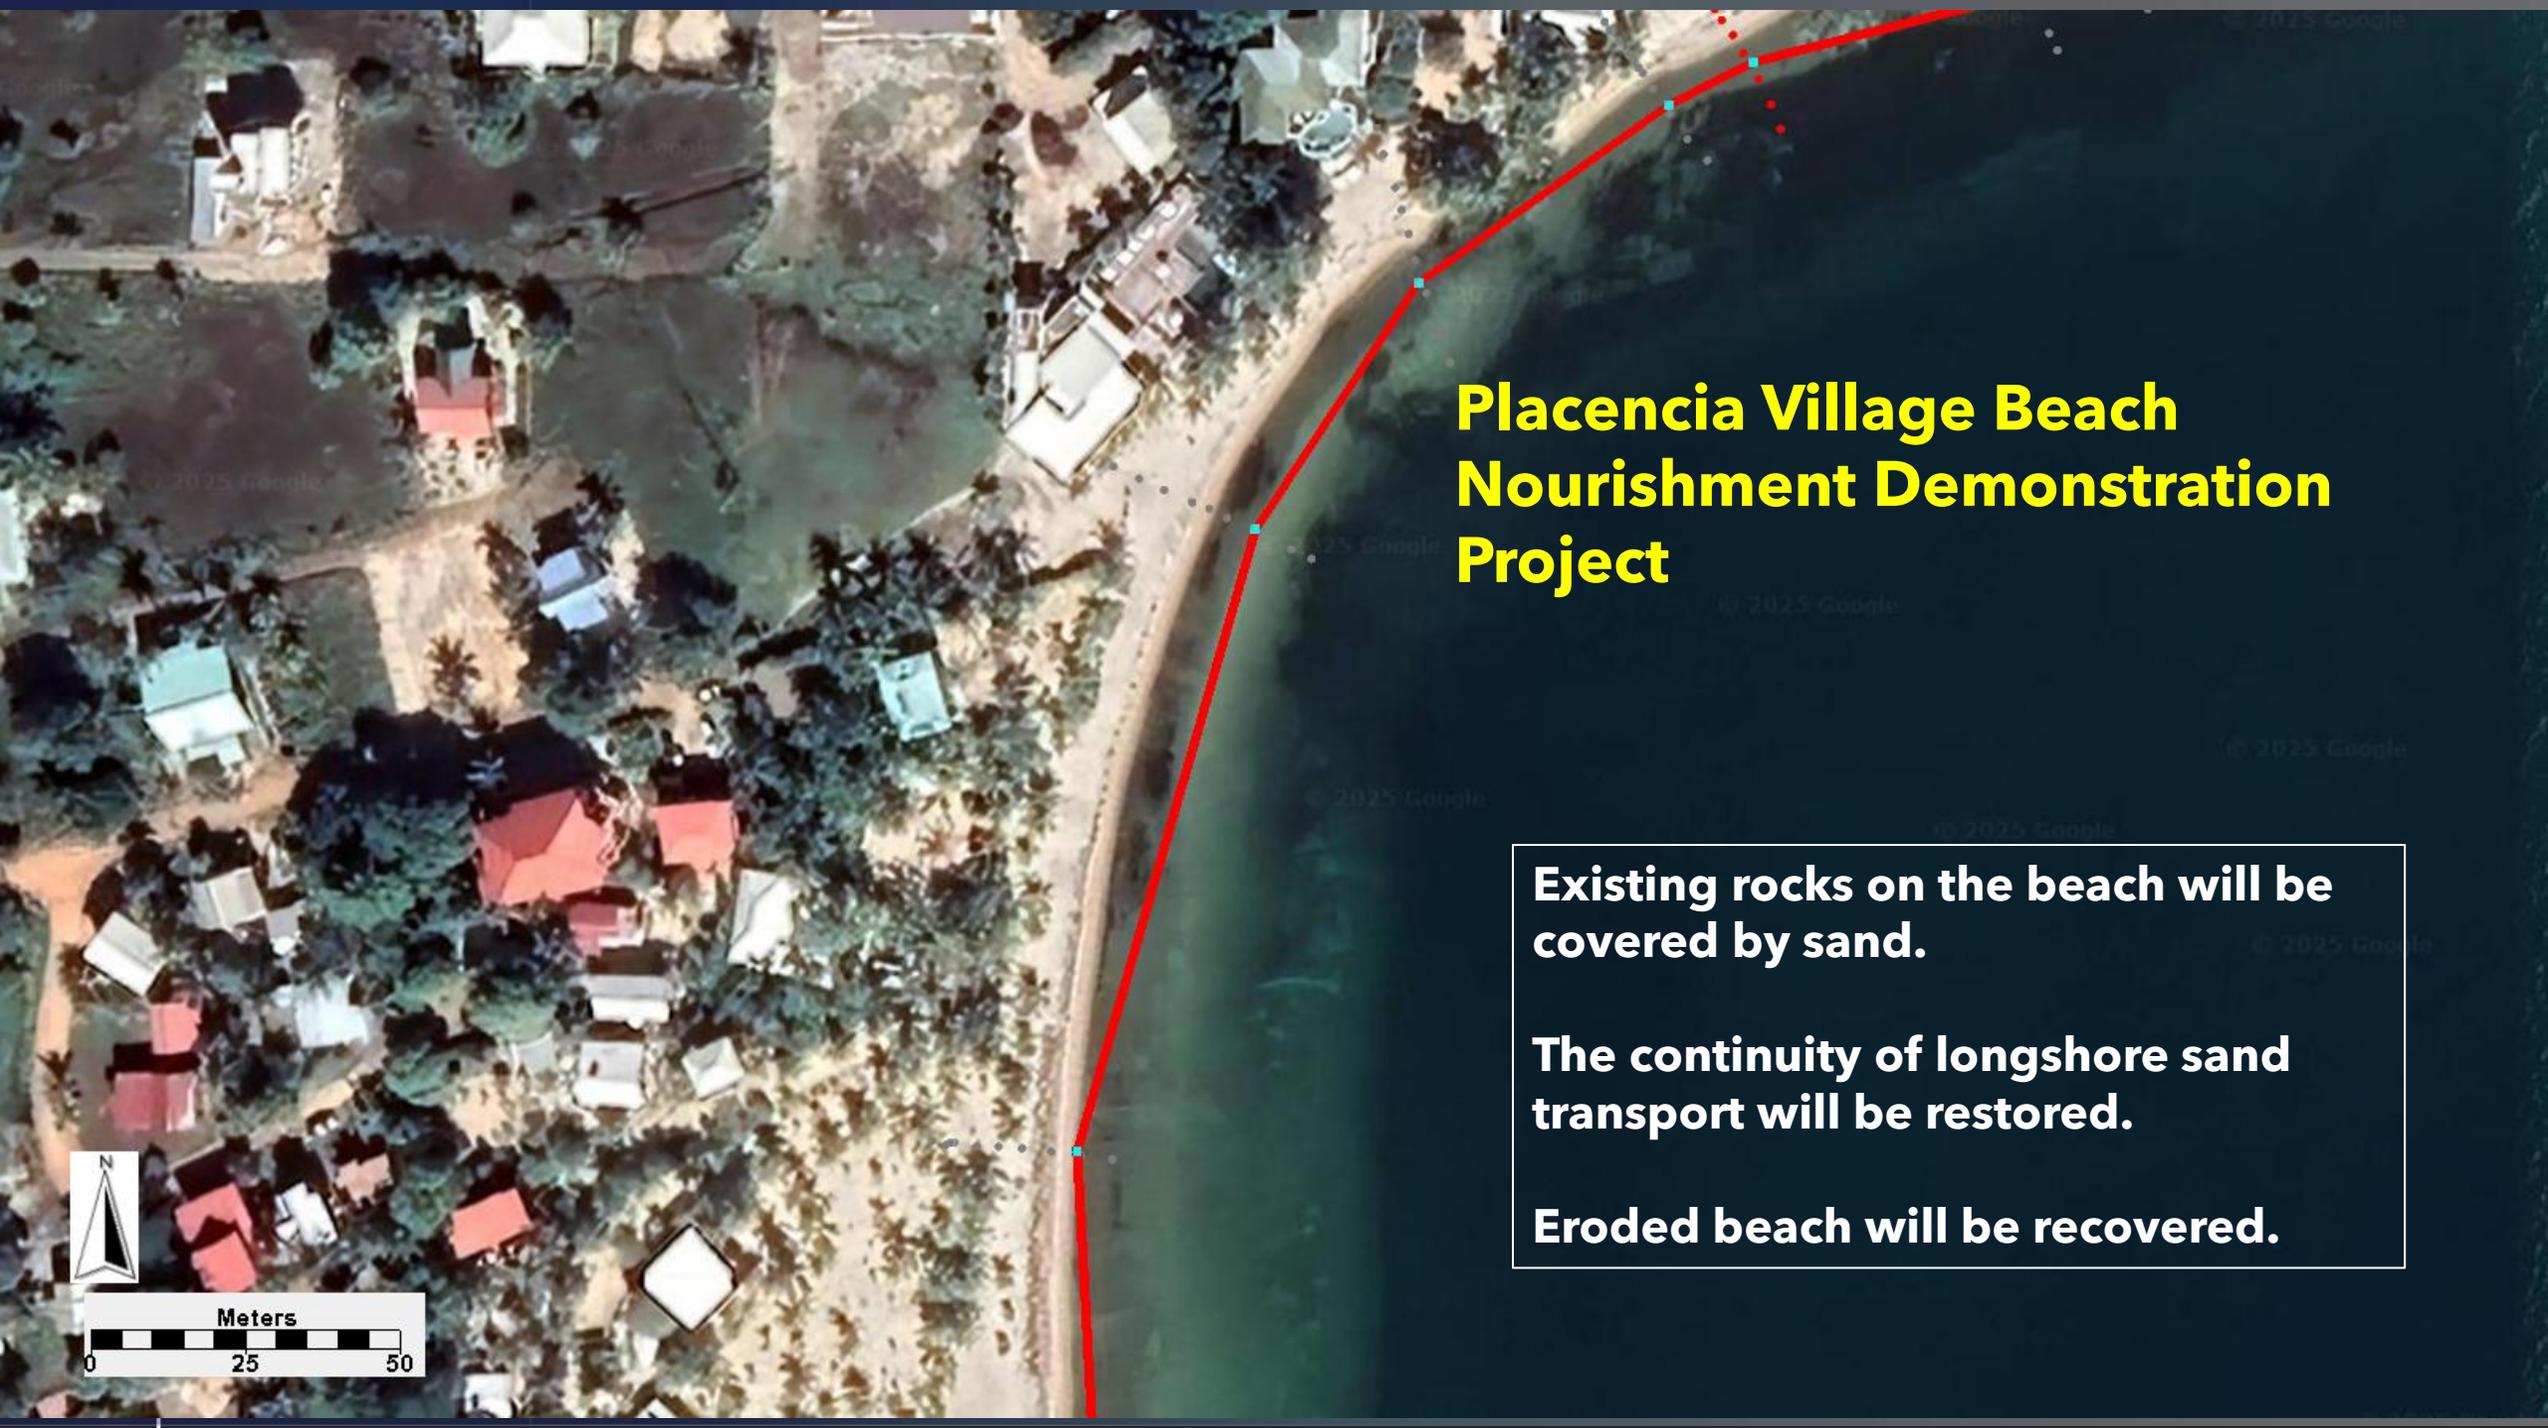
Placencia Village Beach Nourishment Demonstration Project

An aerial photograph of a coastal area. On the left, there is a residential area with several houses, some with red roofs, surrounded by lush green vegetation. A sandy beach runs along the coast. To the right of the beach is a body of water. A thick red line is drawn along the coastline, starting from the bottom left and curving towards the top right, indicating the project area. Small blue squares are placed along this red line. The text 'Placencia Village Beach Nourishment Demonstration Project' is overlaid in yellow on the right side of the image.

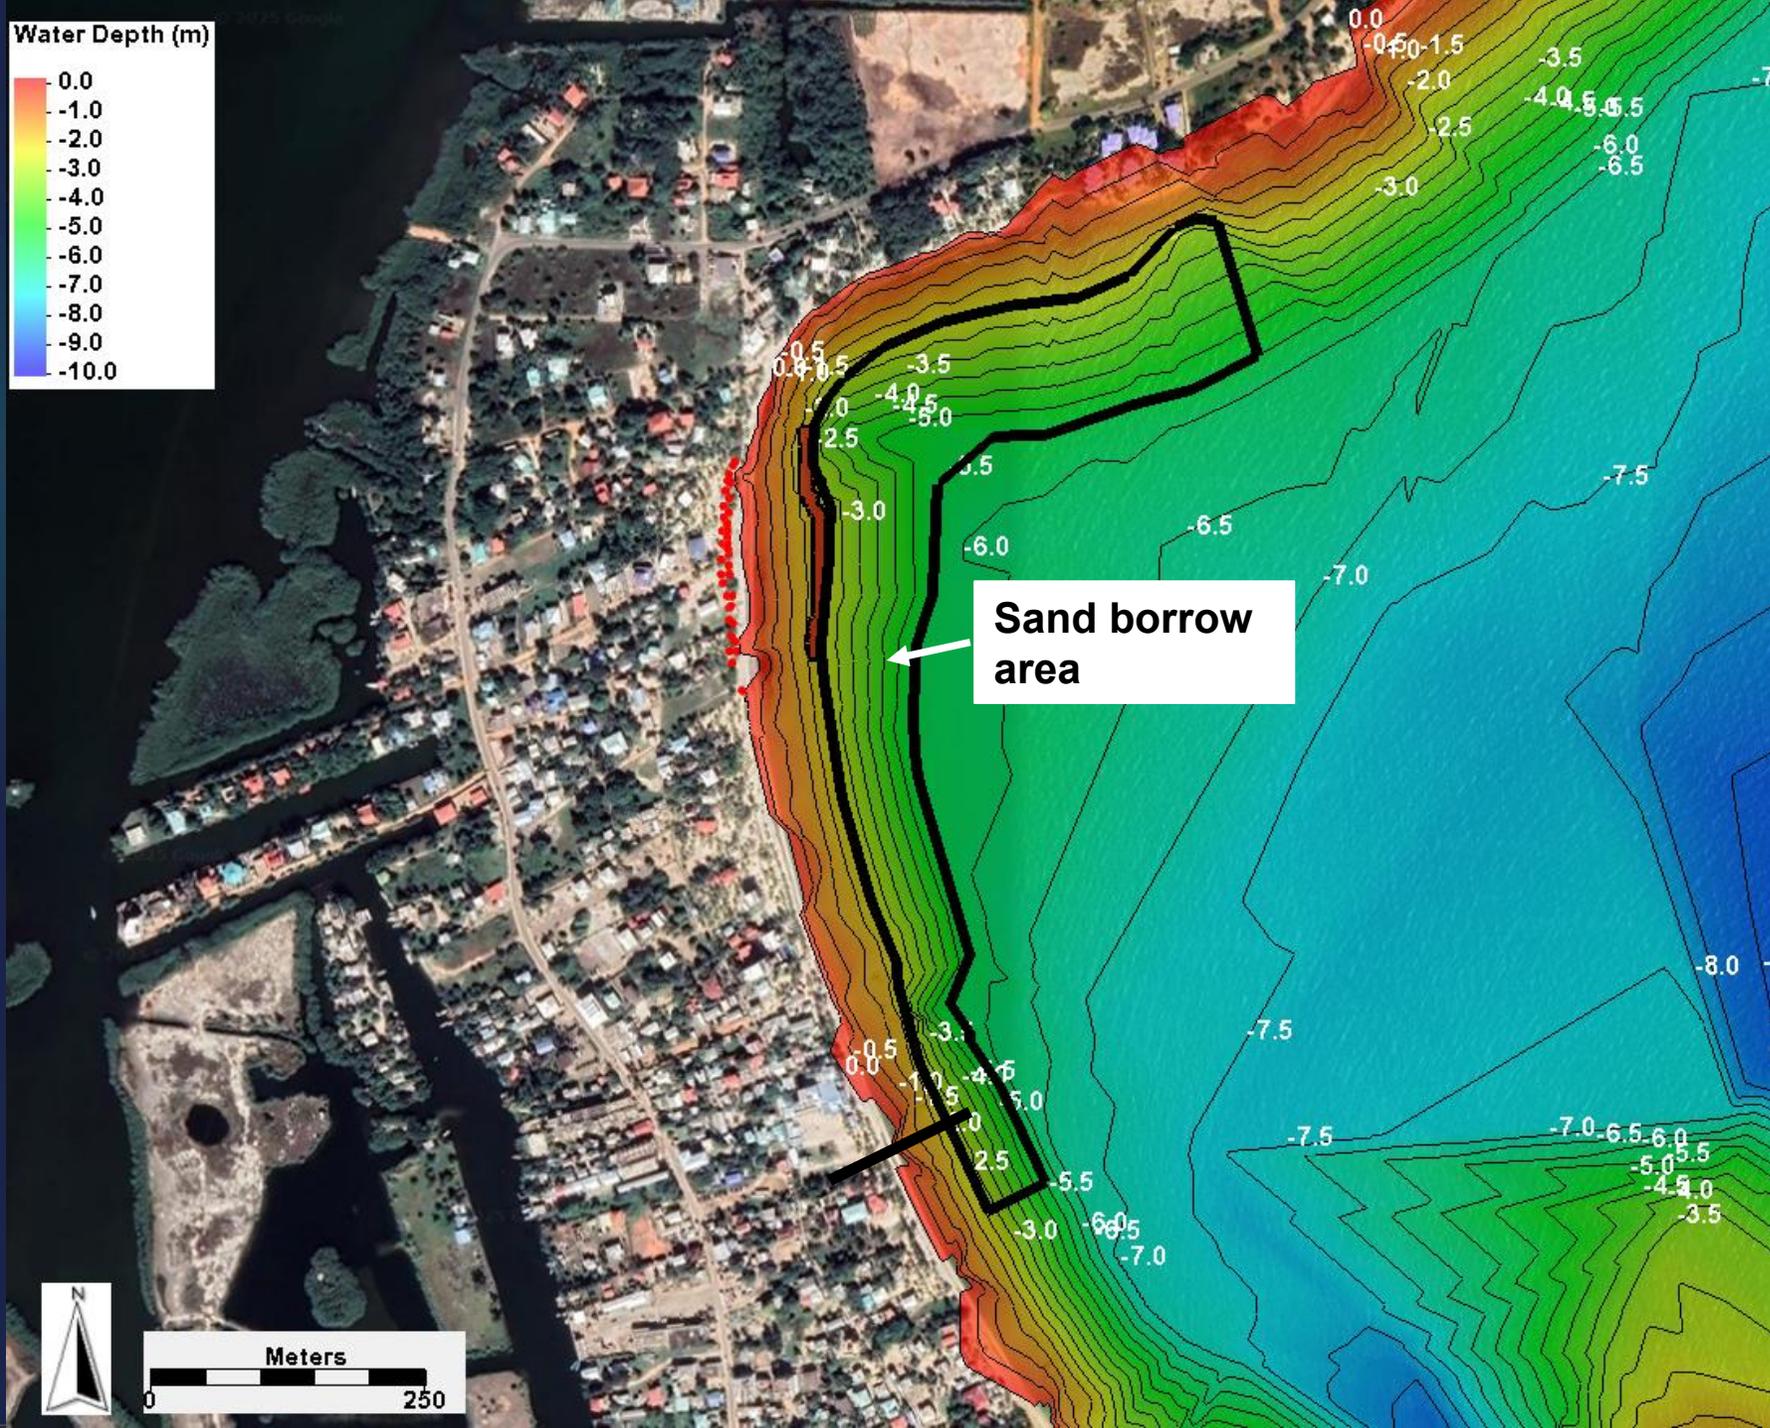
Placencia Village Beach Nourishment Demonstration Project

Existing rocks on the beach will be covered by sand.

The continuity of longshore sand transport will be restored.

Eroded beach will be recovered.

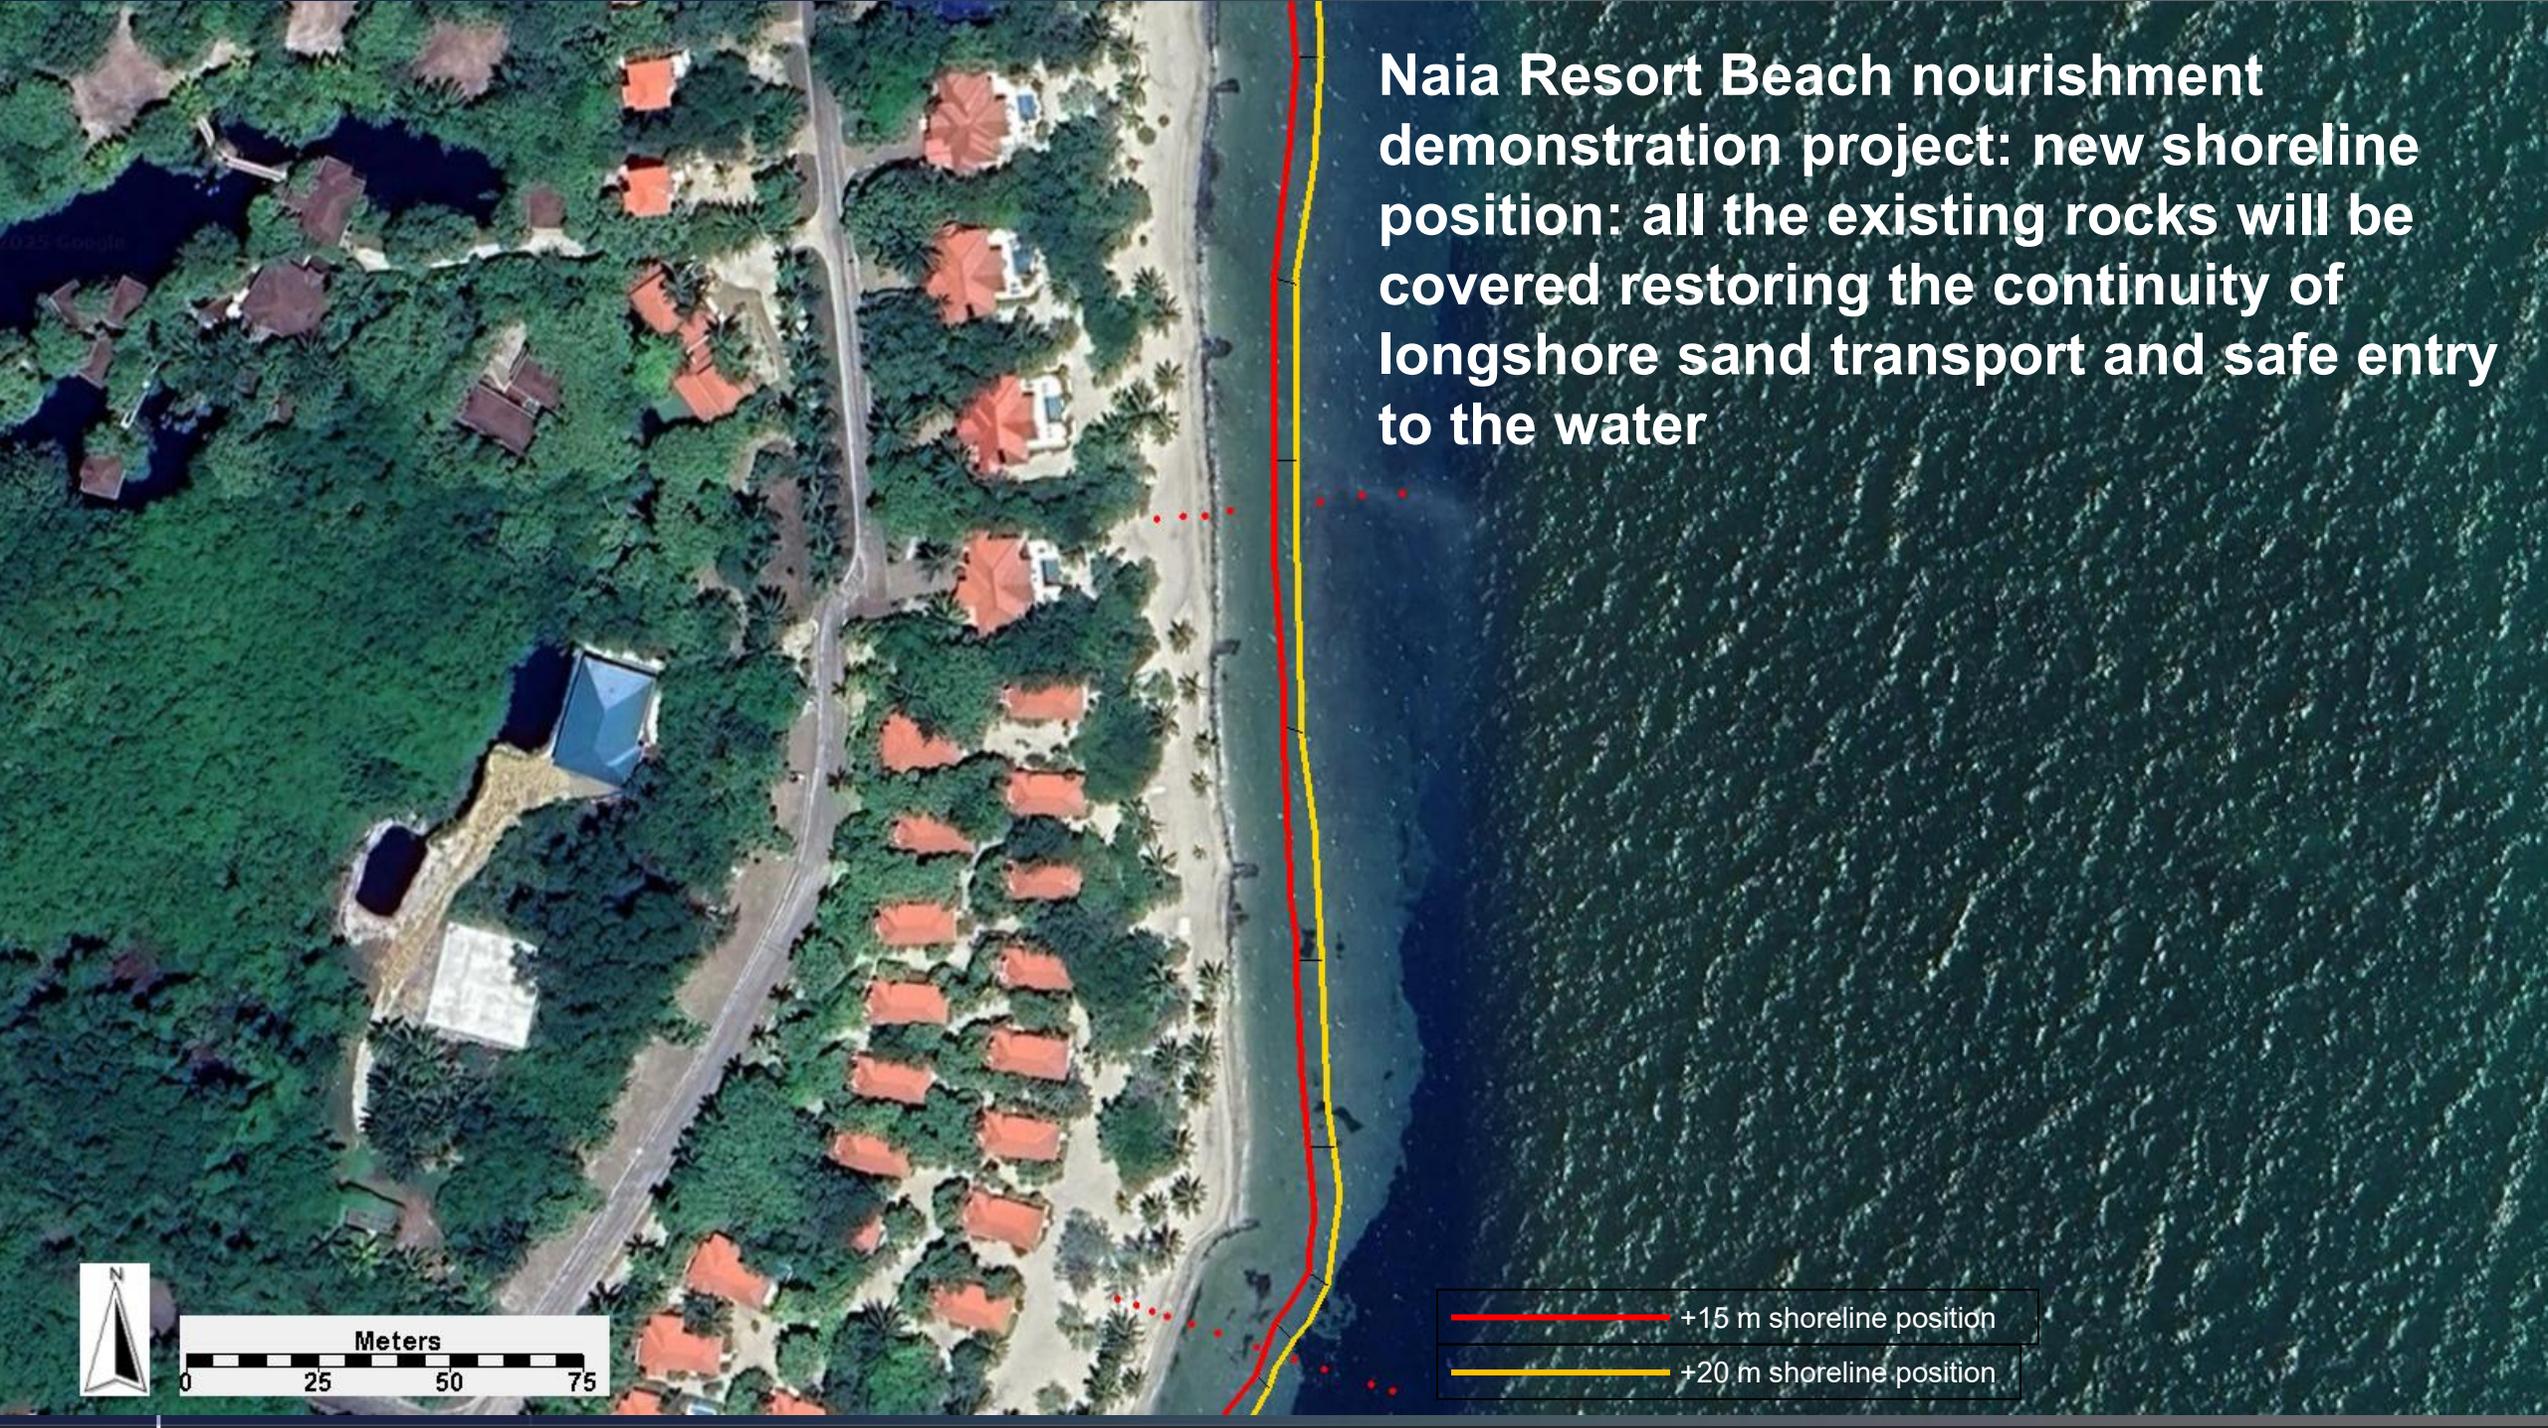
Naia Resort Beach nourishment demonstration project: new shoreline position: all the existing rocks will be covered restoring the continuity of longshore sand transport and safe entry to the water

- +15m shoreline position
- +20m shoreline position

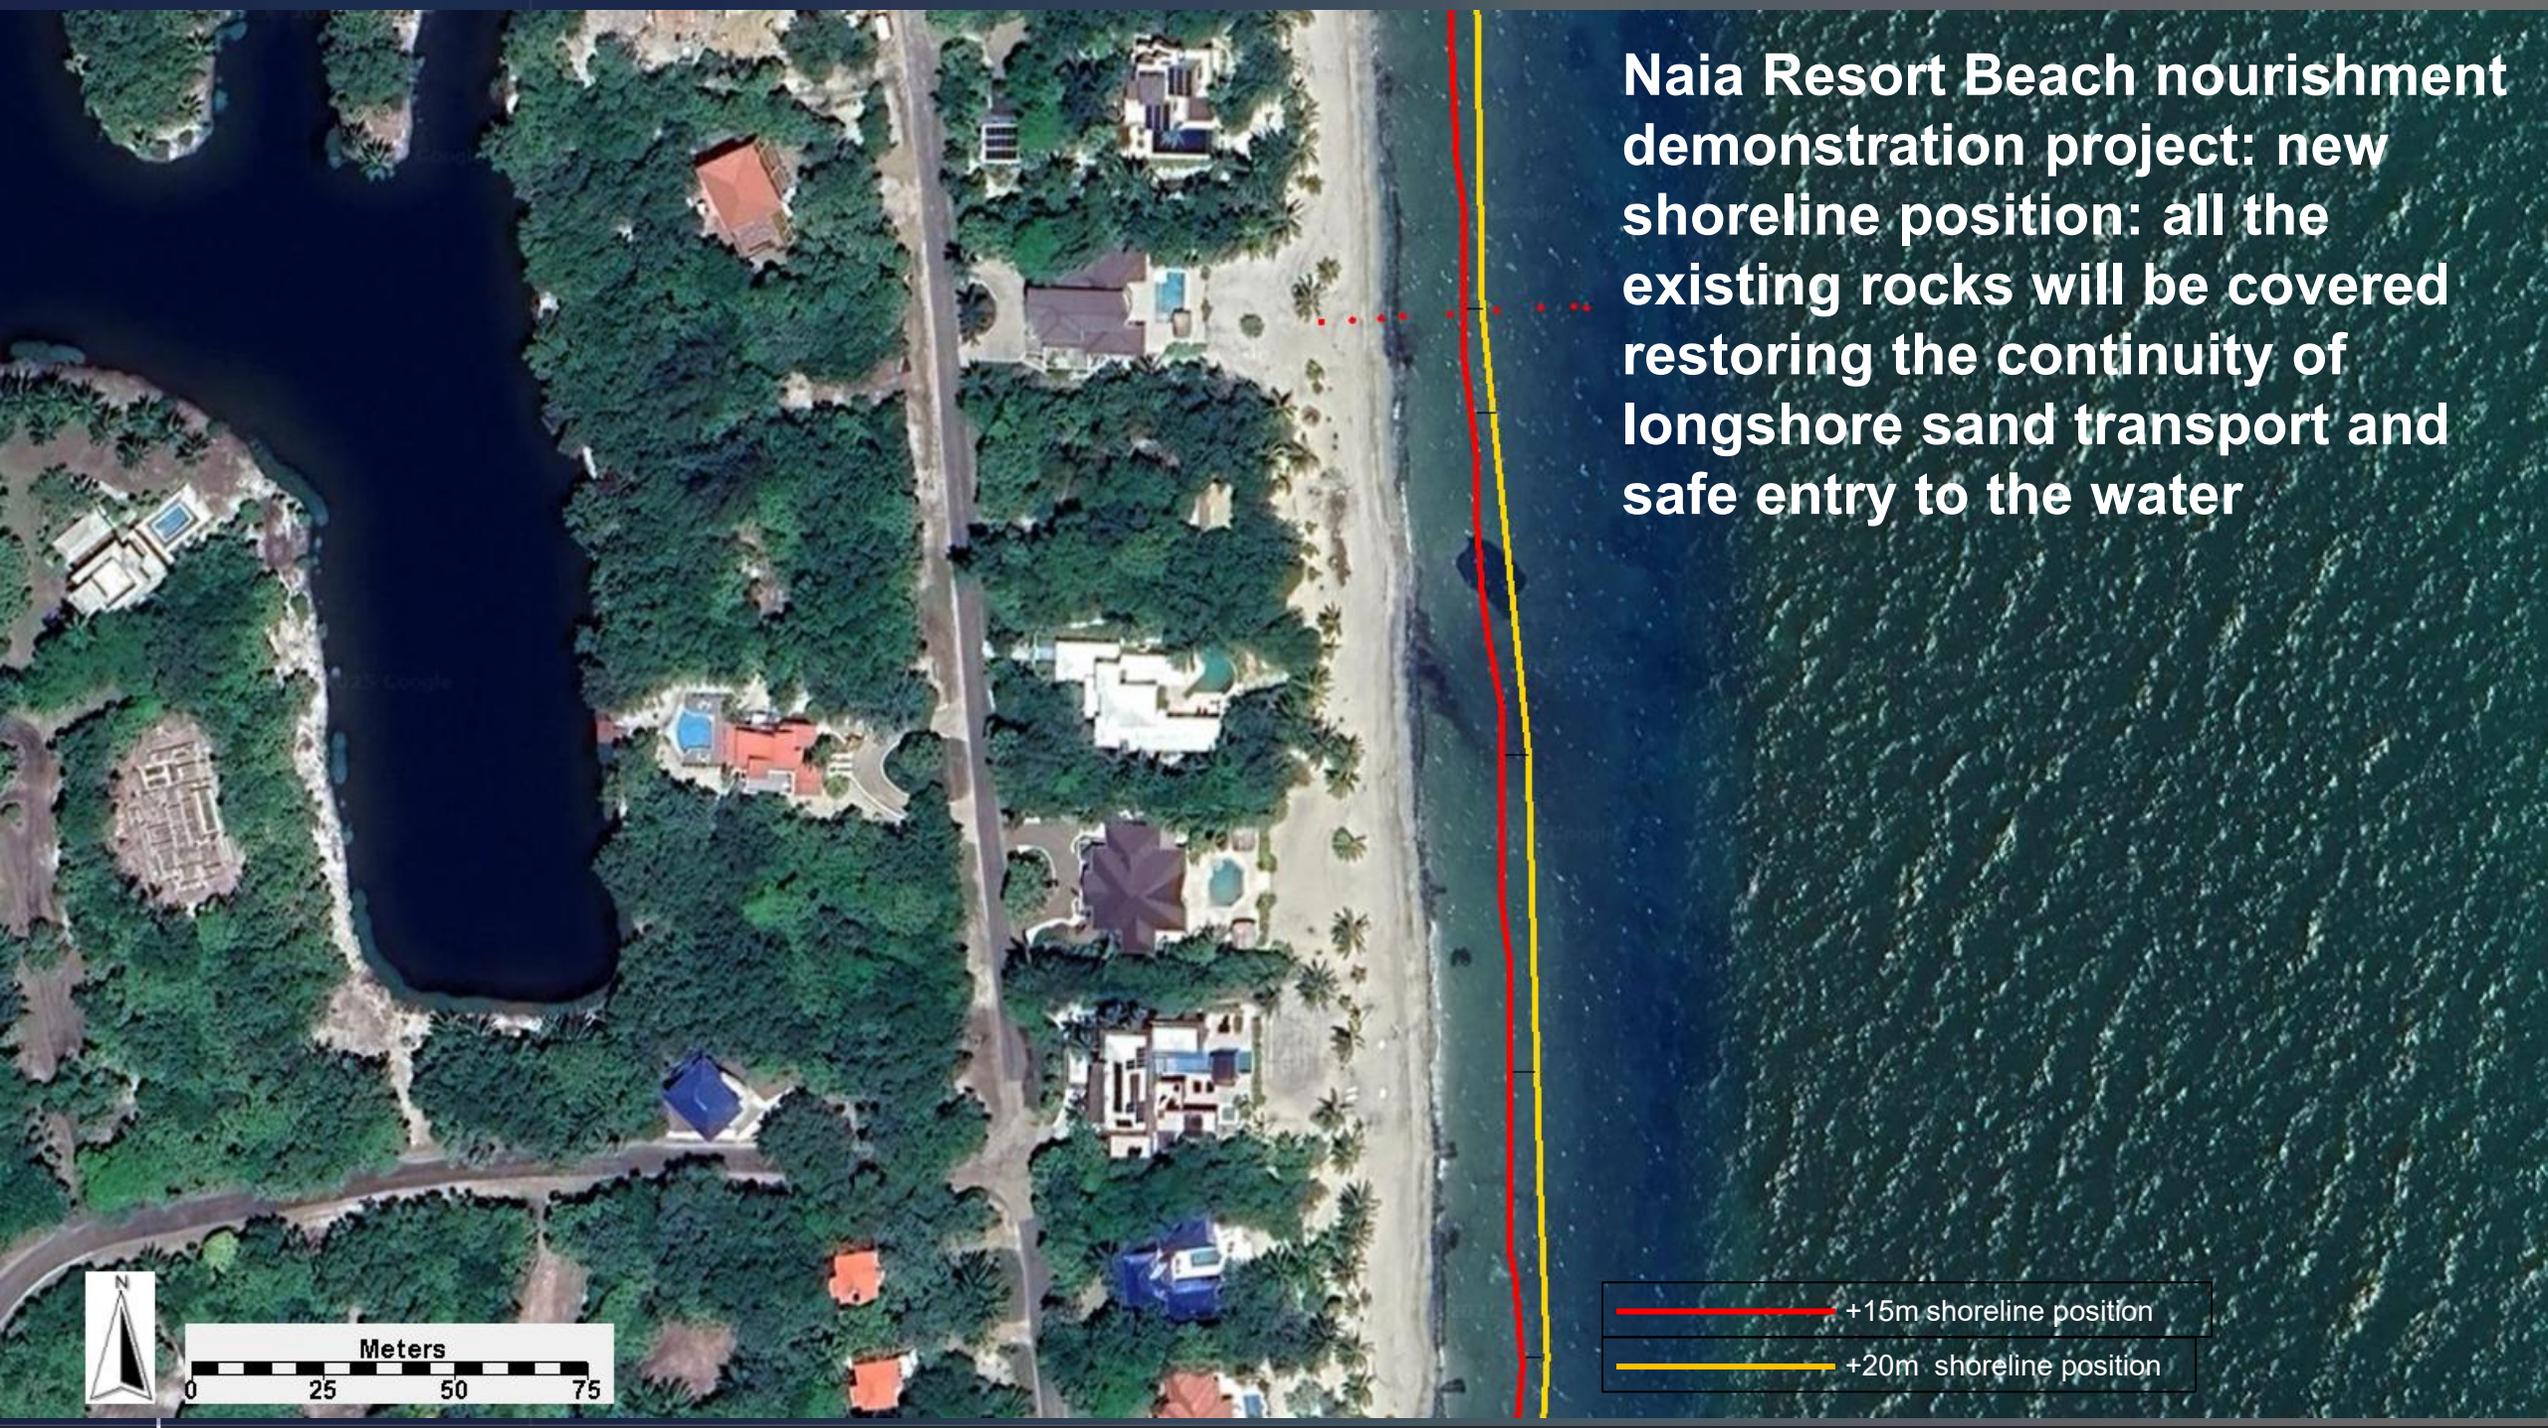
Naia Resort Beach nourishment demonstration project: new shoreline position: all the existing rocks will be covered restoring the continuity of longshore sand transport and safe entry to the water

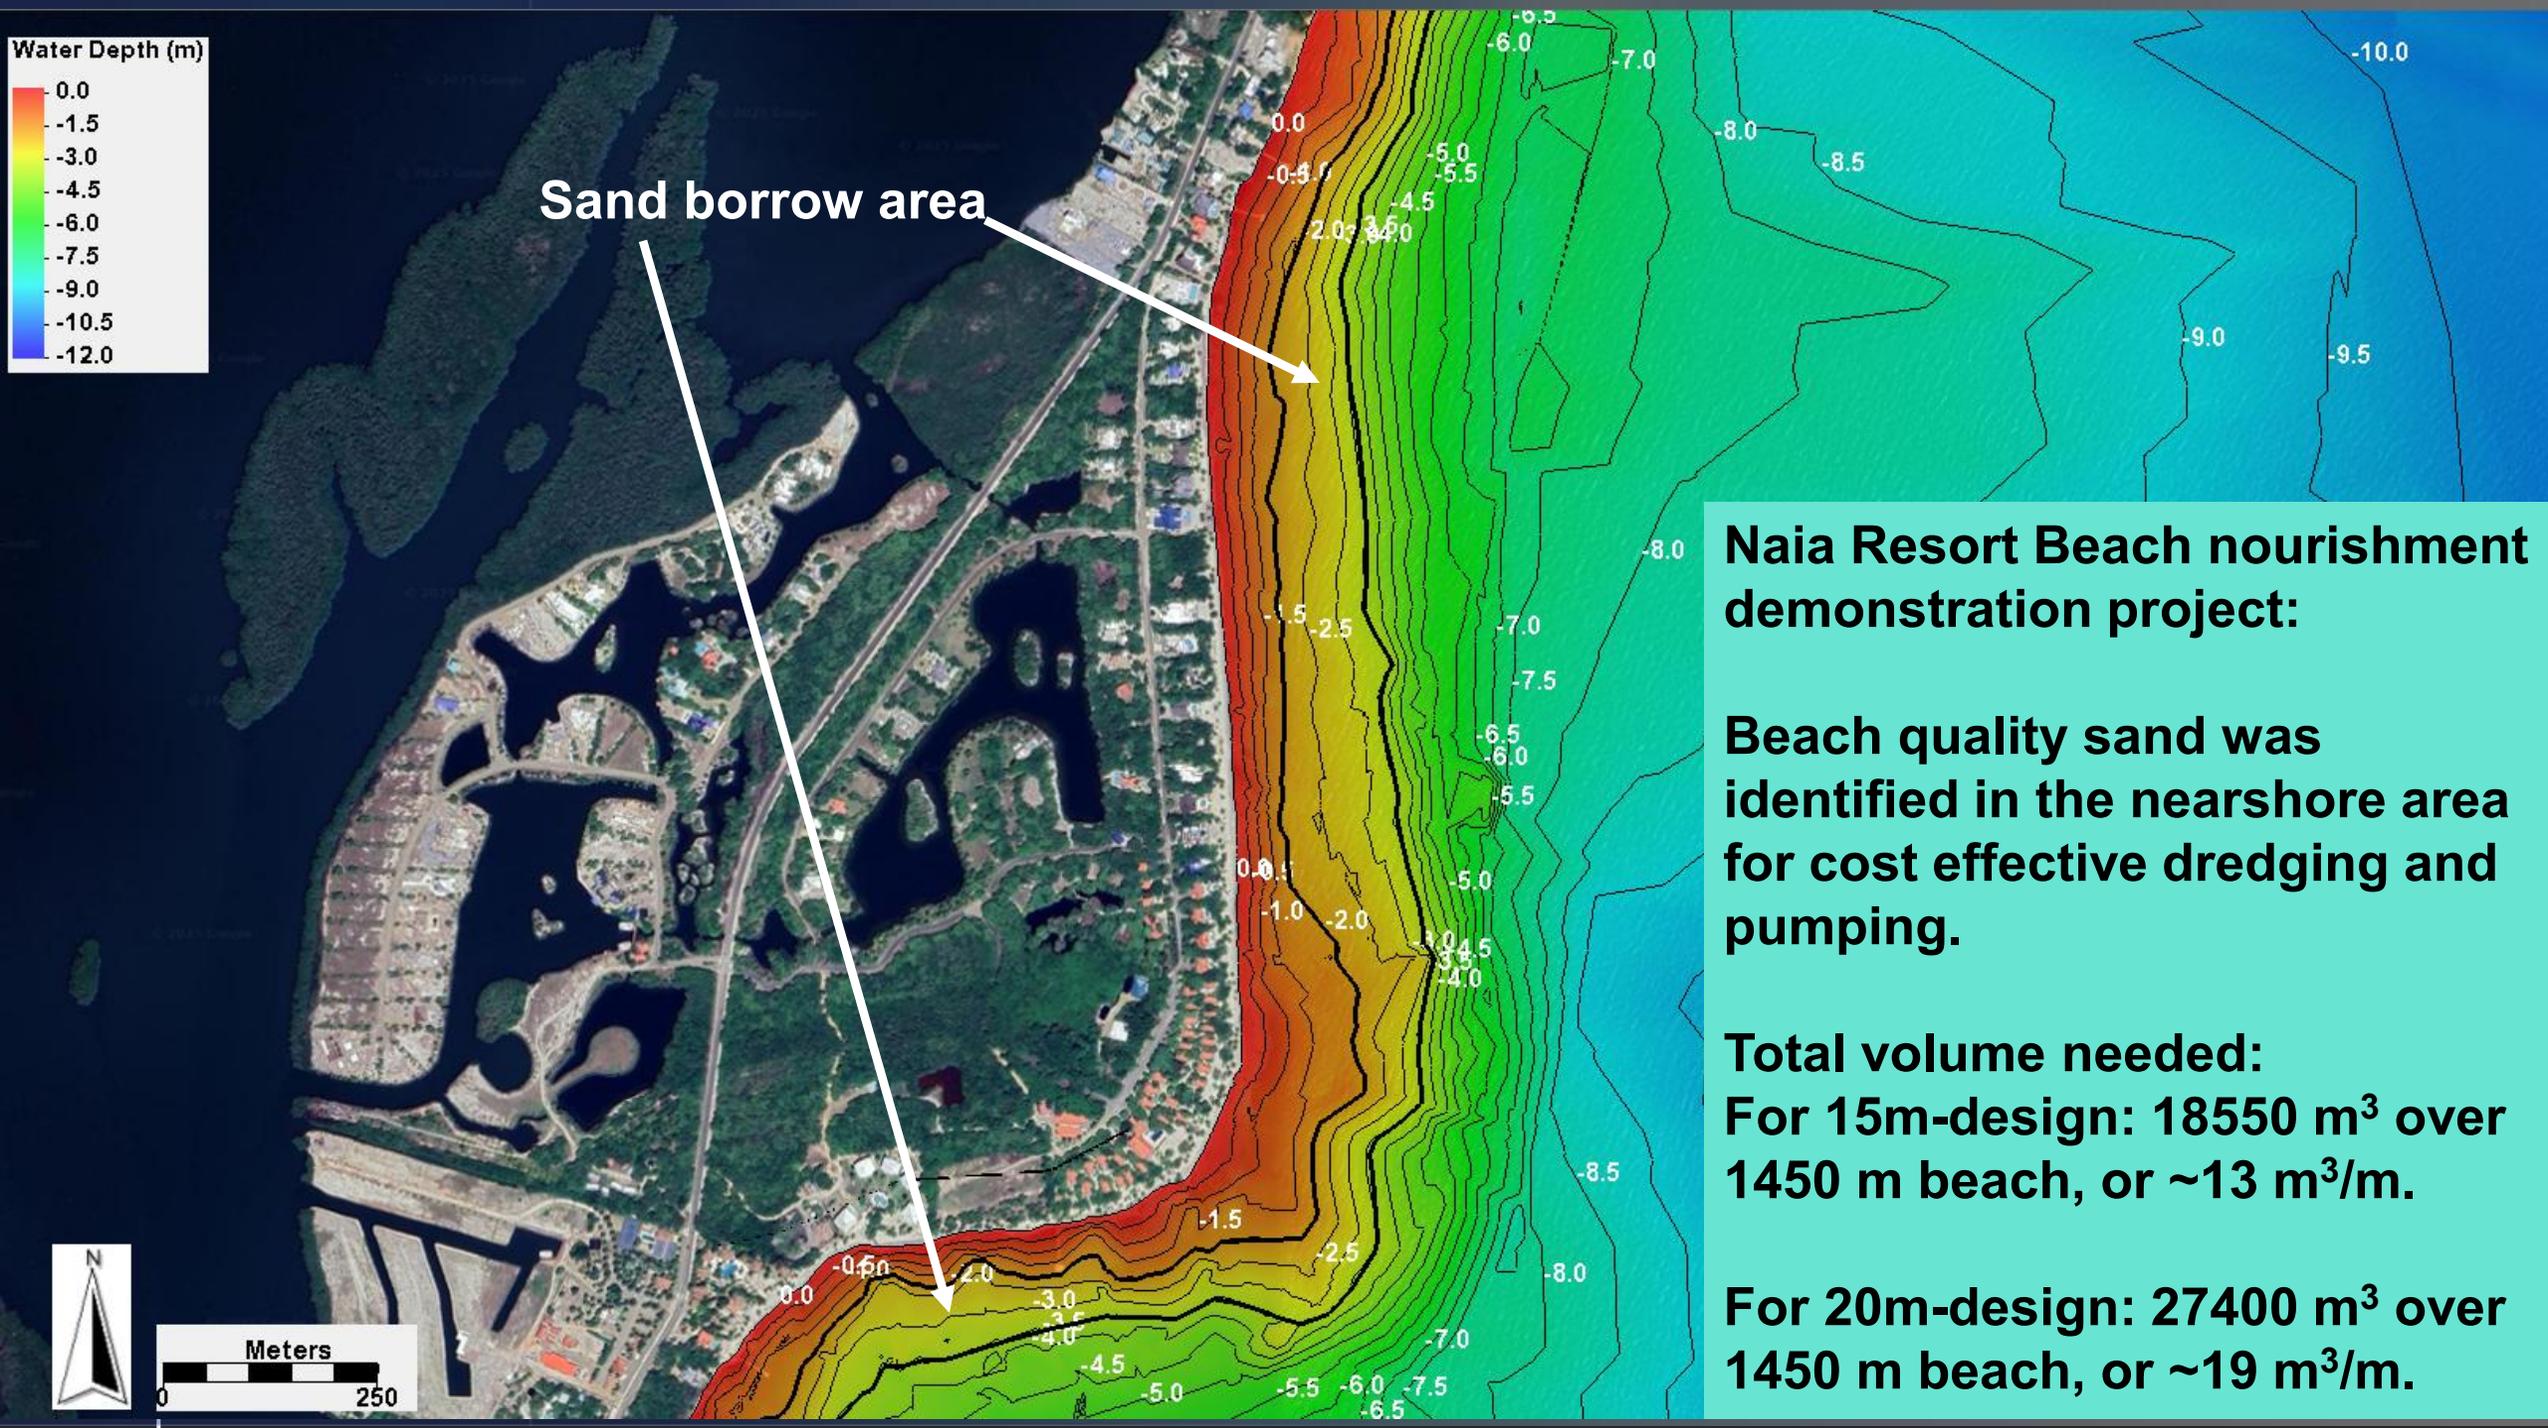
+15m shoreline position
-

+20m shoreline position
